NATIONAL TRANSPORTATION SAFETY BOARD

MATERIALS LABORATORY FACTUAL REPORT

Report No. 09-006

Place : Denver, Colorado
Date : December 20, 2009
Vehicle : Boeing 737-500
NTSB No. : DCA09MA021
Investigator : Adam Huray (AS-40)

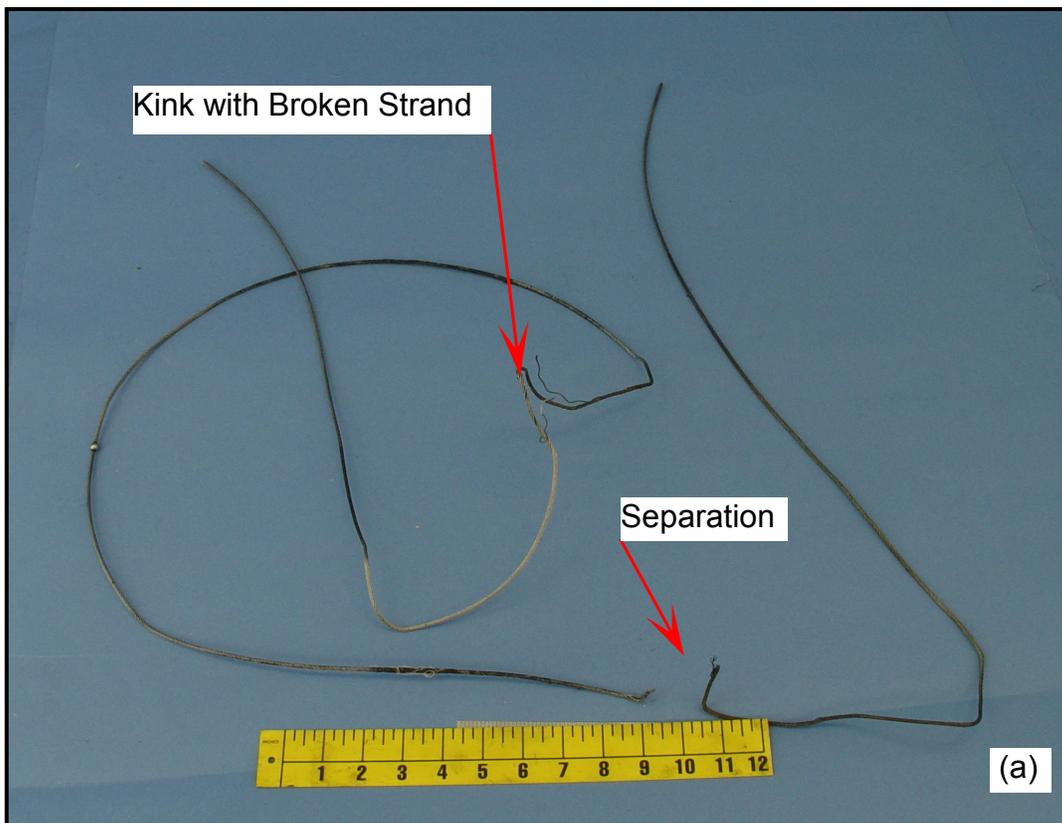
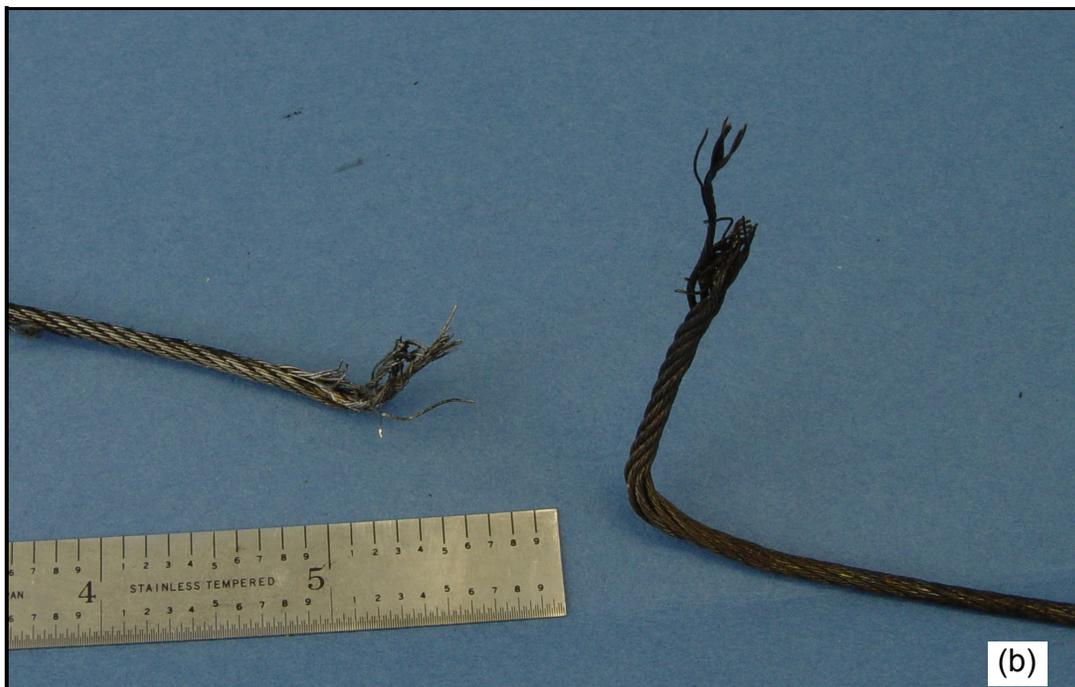
The received portions of the nose gear steering cable assembly are displayed in figure 1 (a). The pieces consisted of a shorter, 34 inch long section and a longer 75 inch section containing a ball stop fitting. The pieces were cut at one end and mated at the separation identified in figure 1. The separation was located approximately 20 inches from the ball fitting on the longer piece. In addition to the separation the cable was kinked at several locations with a single strand fracture at the most severe kink. The cable was nominally 3/32 (0.9375) inch in diameter and had 7 by 7 construction¹. Measurements found the maximum outer diameter of the cable to be between 0.101 and 0.102 inch.

Figure 1--Overall view (a) of as-received wires. Closer view (b) of separation area.

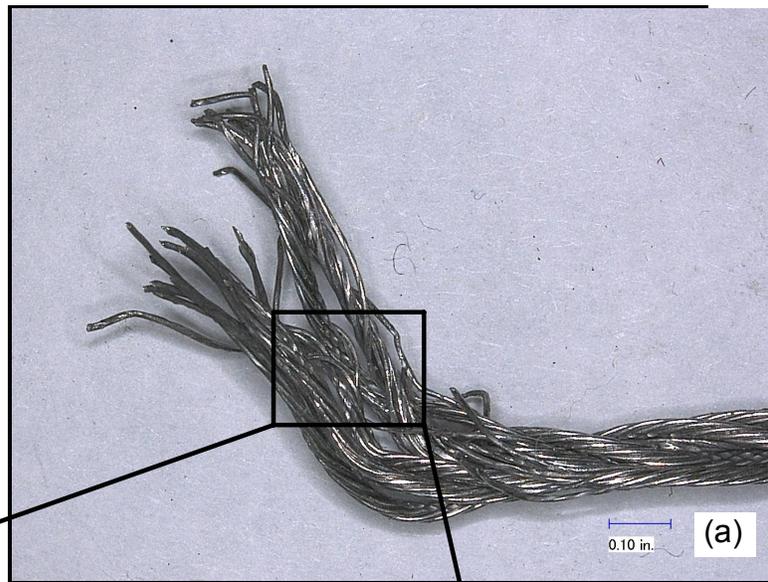
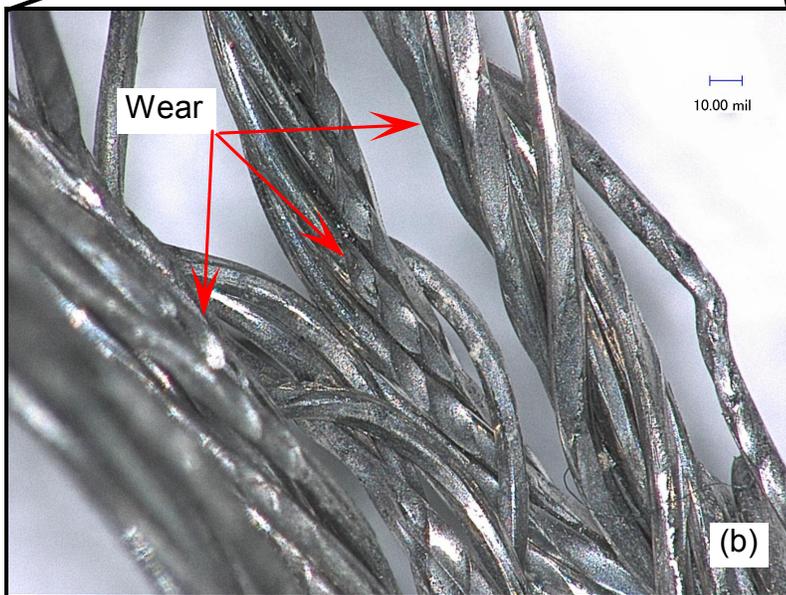
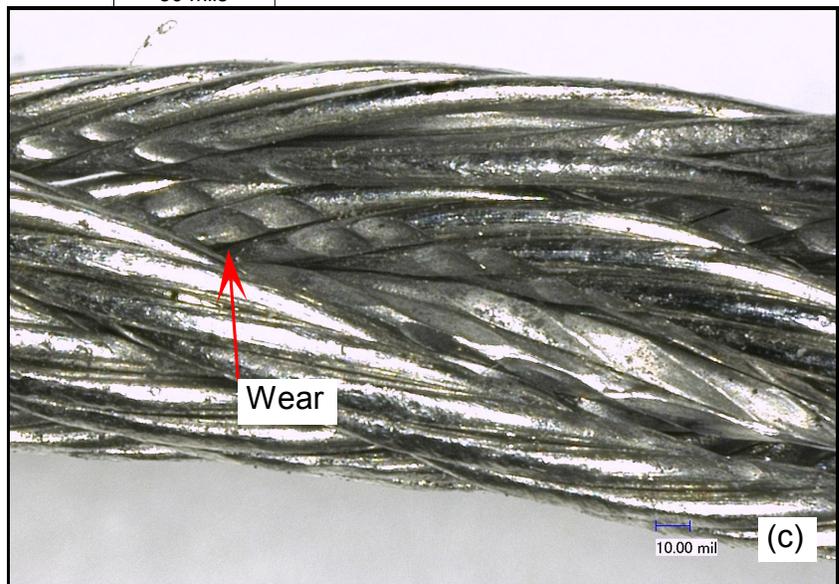
Portions of the cable, particularly near the separation, were partially covered with what appeared to be cable lubricant. Ultrasonic cleaning in acetone removed the adherent material. Magnified optical inspections in the immediate area of the separation revealed wear damage to the internal surfaces of the wires and strands as shown in figure 2. The amount of wear varied depending on location, with the most severe damage to the wires of the central strand. The location and geometry of the wear was typical of internal wear at a pulley location. Little or no wear was noted on the exposed surfaces of the cable adjacent to the separation. Manual unwinding of the cable revealed internal wear for a length of approximately 2 inches on either side of the separation.

Figure 2--Views of the separated end of the long piece (a) showing the internal wear (b) and (c).

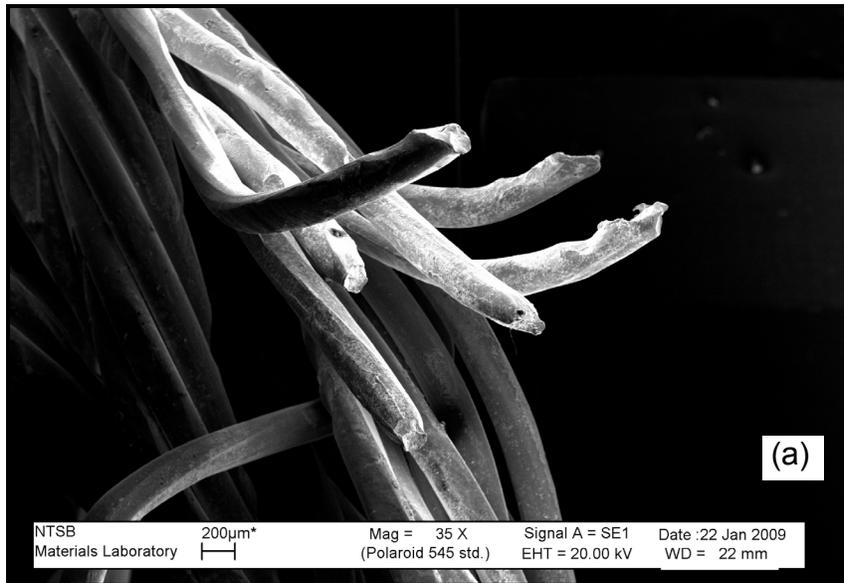
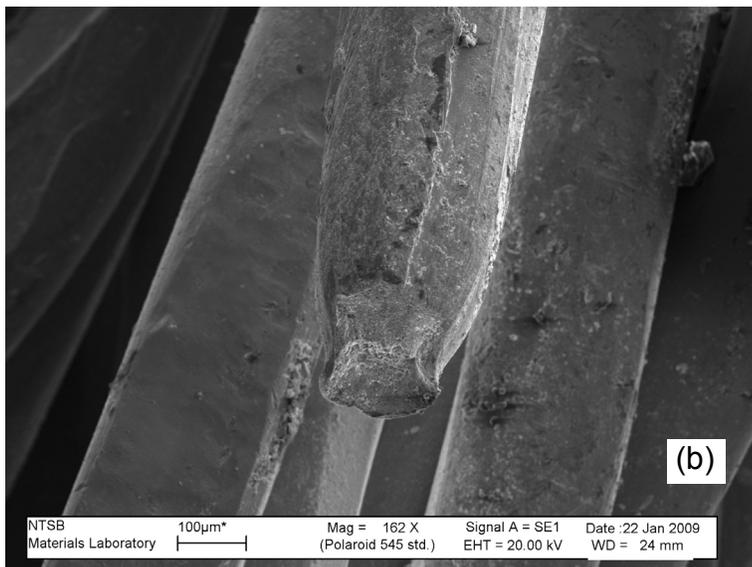
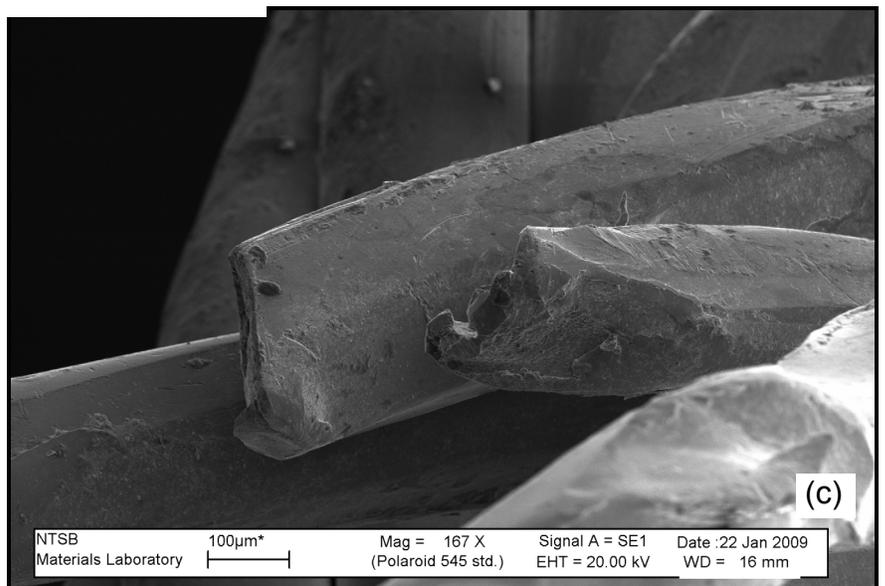
A piece of the cable including the separation was cut from the long cable length and examined with the aid of a scanning electron microscope (SEM), as shown in figure 3. SEM viewing revealed ductile dimple overstress fracture features on all separated wires. Individual wires also displayed various amounts of wear at the fracture locations, see figure 3 (a). Some wires showed no wear (b) while other wires were worn to chisel points before fracturing (c).

As a measure of wear, the remaining thickness at the fracture of 21 of the 49 cable wires was estimated, not including yielding from fracture. In the sampled wires, approximately 45% of the original thickness remained while about 55% of the original thickness appeared to have been removed by wear. Military specification MIL-DTL-83420² specifies a minimum breaking strength of 920 pounds for 3/32 inch, 7 X 7 construction, composition B (corrosion resistant steel).

Figure 3--SEM views showing wear at several fracture wires (a) and the absence of wear at some with overstress yielding (b). Wires worn to a chisel point (c).

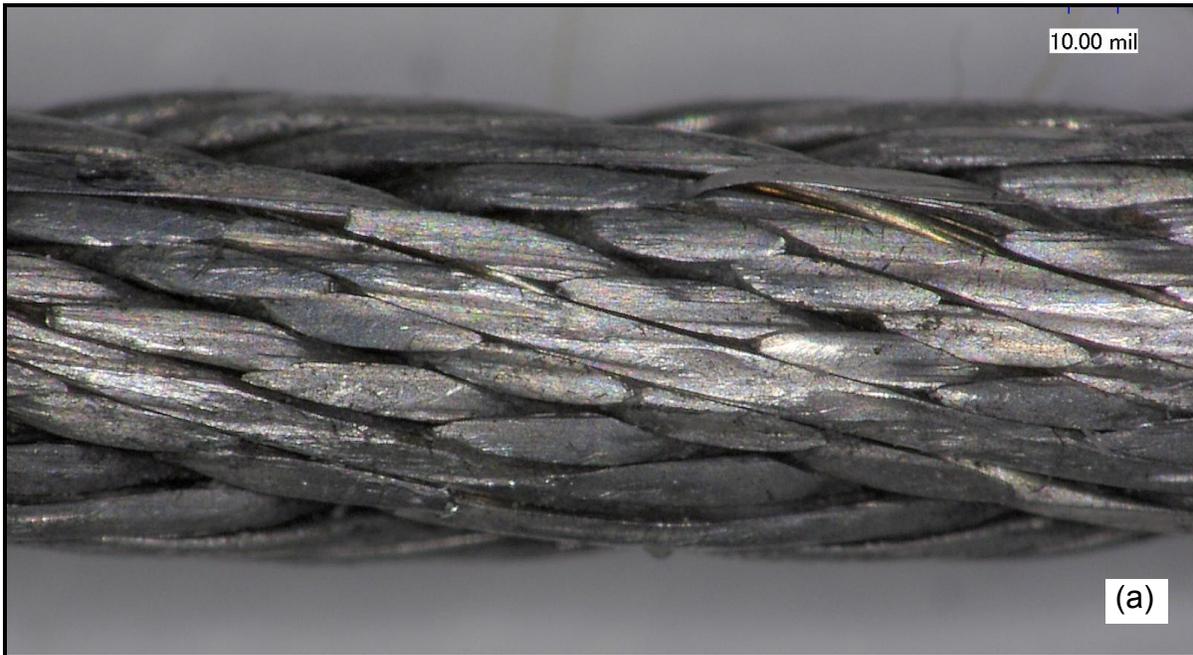
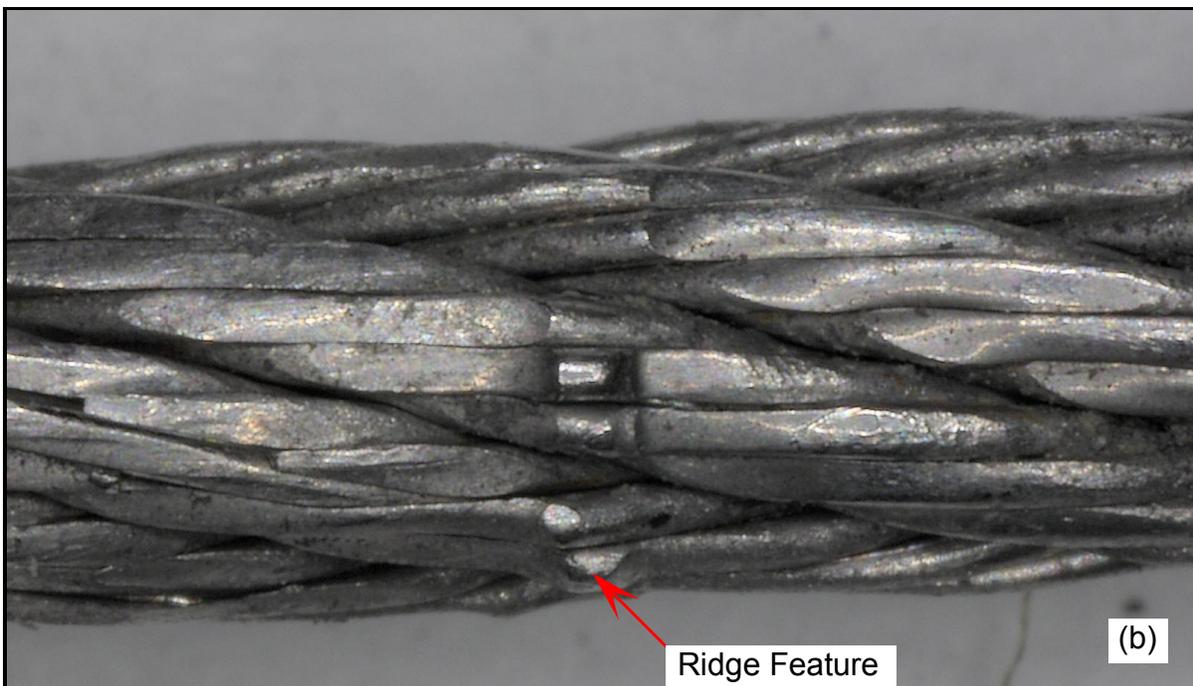
Visual inspection of the remaining cable lengths uncovered heavy external wear damage in two areas on the longer piece. One 2 inch long wear region was located about 12 to 14 inches from the fracture and another 2 inch long region about 26 to 28 inches from the fracture. Both wear regions had similar features as shown in figure 4. The external surfaces were worn nearly flat with a few wires nearly worn through their diameters. The cable diameter in these areas was about 0.09 inch. Both wear regions also had an unusual ridge feature near the middle of the wear area as shown in figure 4 (c). The ridge appears to be nearly unworn and approximately full diameter. The relative locations of the wear areas are denoted in the illustration contained in figure 5.

Figure 4--External wear on the cable away from the separation (a). The wear ridge (b) noted at two external wear locations.

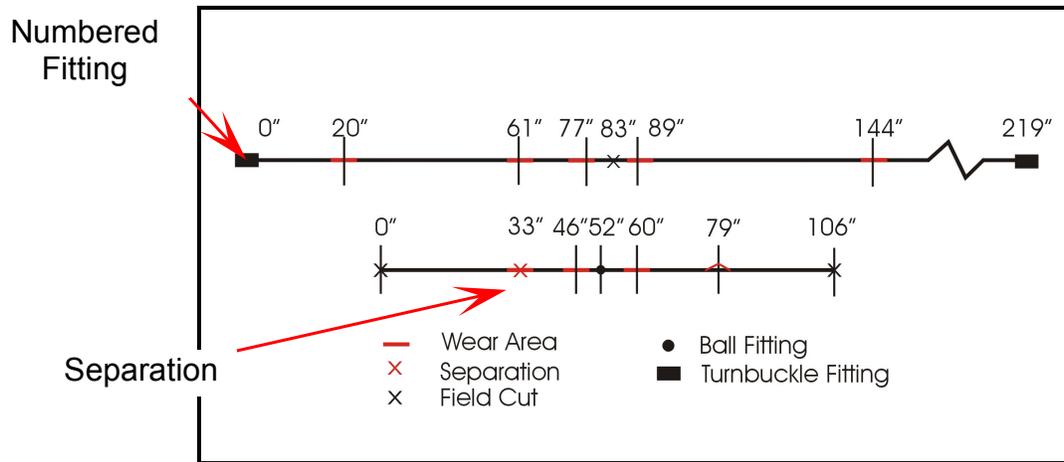
Figure 5--A illustration of the relative wear locations and other features on the separated cable (bottom) and on the exemplar cable (top).

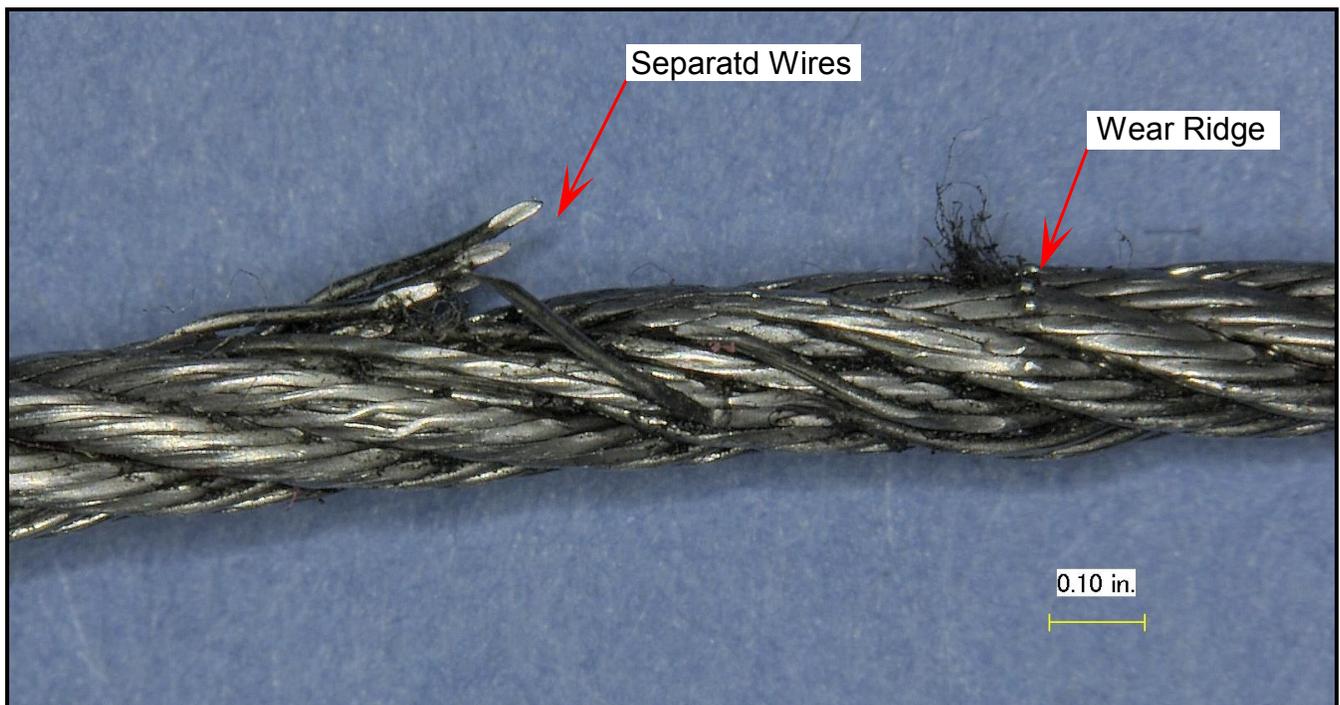
The cable was tagged "reason for removal" at a visible wear location 89 inches from the numbered fitting. Magnified visual inspections of this area revealed significant external wear to the strands and several separated wires, as shown in figure 6. Closer inspection found that the separated wires had been worn completely through their diameters. A wear ridge, similar to that seen on the accident cable, was noted near the broken wires. Further inspections of the cable uncovered four additional areas of external wear on the cable, one of which also contained the ridge feature. An illustration of the locations of the wear areas is shown in the upper portion of figure 5.

Figure 6--Wear and fractured wires on the exemplar cable.
