NATIONAL TRANSPORTATION SAFETY BOARD

MATERIALS LABORATORY FACTUAL REPORT

Report No. 09-013

Place : Weaverville, California
Date : August 5, 2008
Vehicle : S-61N Firefighting Helicopter
NTSB No. : LAX08PA259
Investigator : Mike Hauf (AS-40)

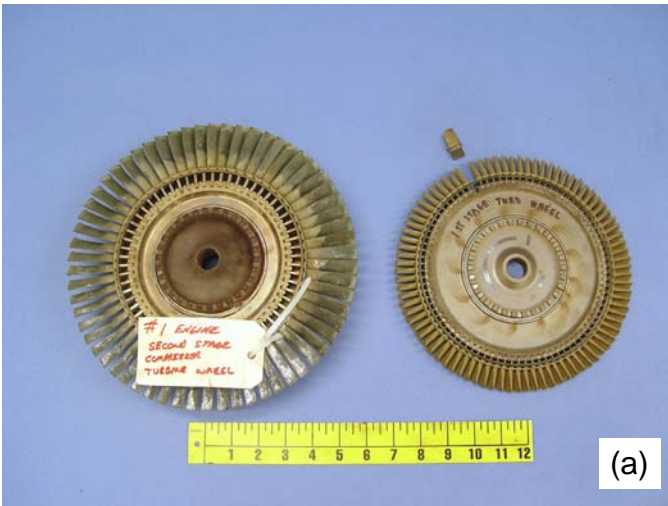
The various received components from the #1 and #2 engines are displayed in figure 1. Components of the two engines will be discussed separately below.

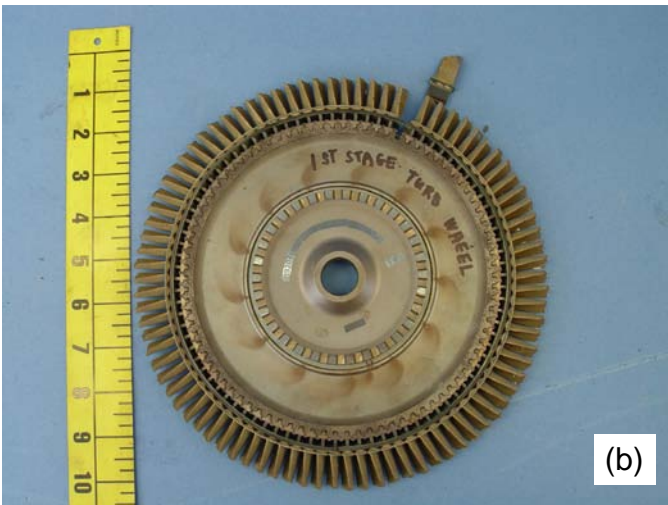
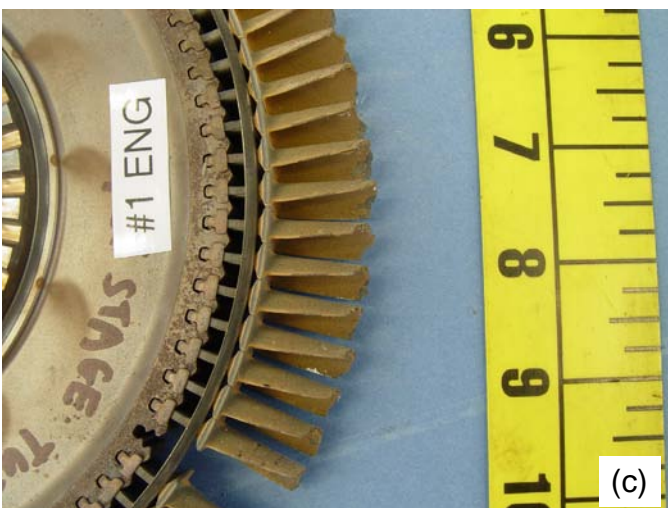
The blades of the 1st stage turbine were all fractured at approximately 2/3 span as shown in figures 2 (b) and (c). The airfoil surfaces of all blades were all dark tan in color with areas of lighter tan material. Figure 3 (a) shows a typical fractured 1st stage blade from the #1 engine and compares it to an unfractured one from the #2 engine. Magnified optical examinations found that the tan color was a deposit on the surfaces of the blade,

Close magnified examinations revealed similar features on all blades. Typical features included irregular chordwise fractures with rough dark fracture surfaces having a pronounced interdendritic pattern and multiple secondary cracks adjacent to the fractures. The fracture surfaces appeared typical of high temperature stress rupture separations on all blades with no indications of progressive cracking such as fatigue.

Figure 2--The 1st and 2nd stage turbines from the #1 engine (a) with closer views, (b) and (c), showing the blade damage to the 1st stage turbine.

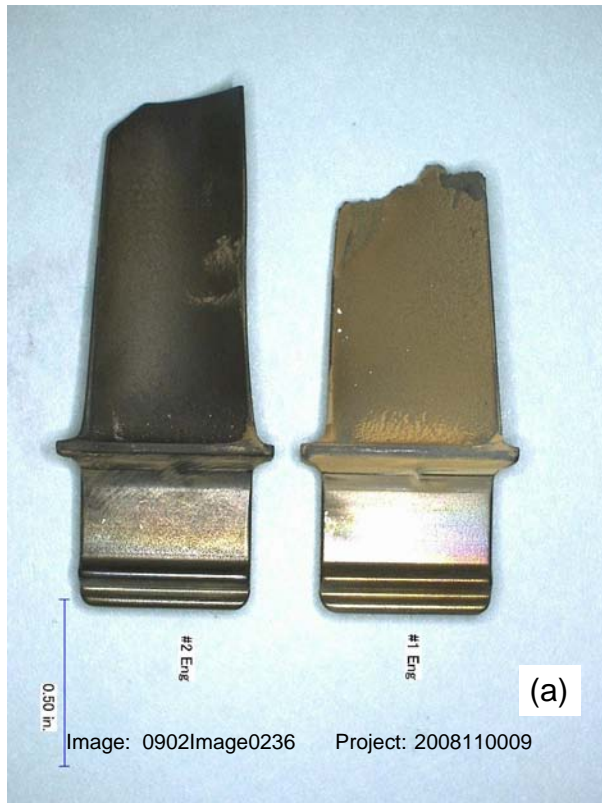
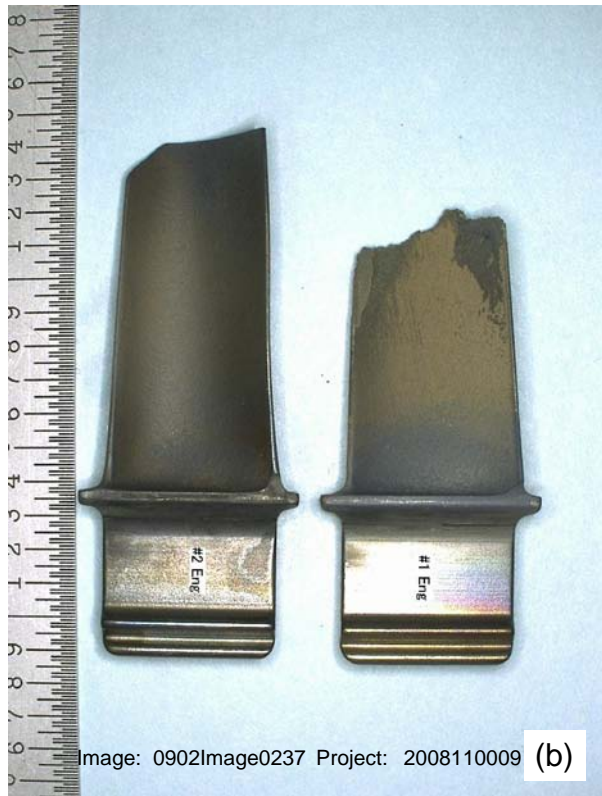
covering the original blade coating. In many instances, the tan deposits extended onto the fracture surfaces. The tan coating was significantly reduced but not fully removed by brushing the surfaces with soap and water, as shown in figure 3 (b).

Figure 3--Comparisons of the 1st stage turbine blades from the #1 engine (right) to the #2 engine, before (top) and after (bottom) cleaning.

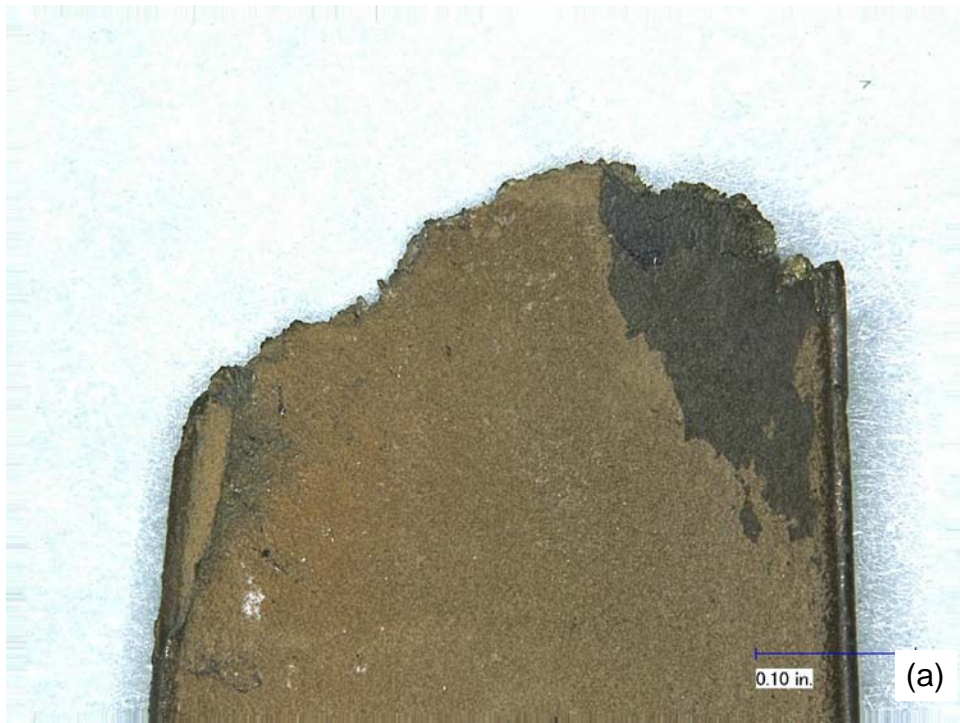
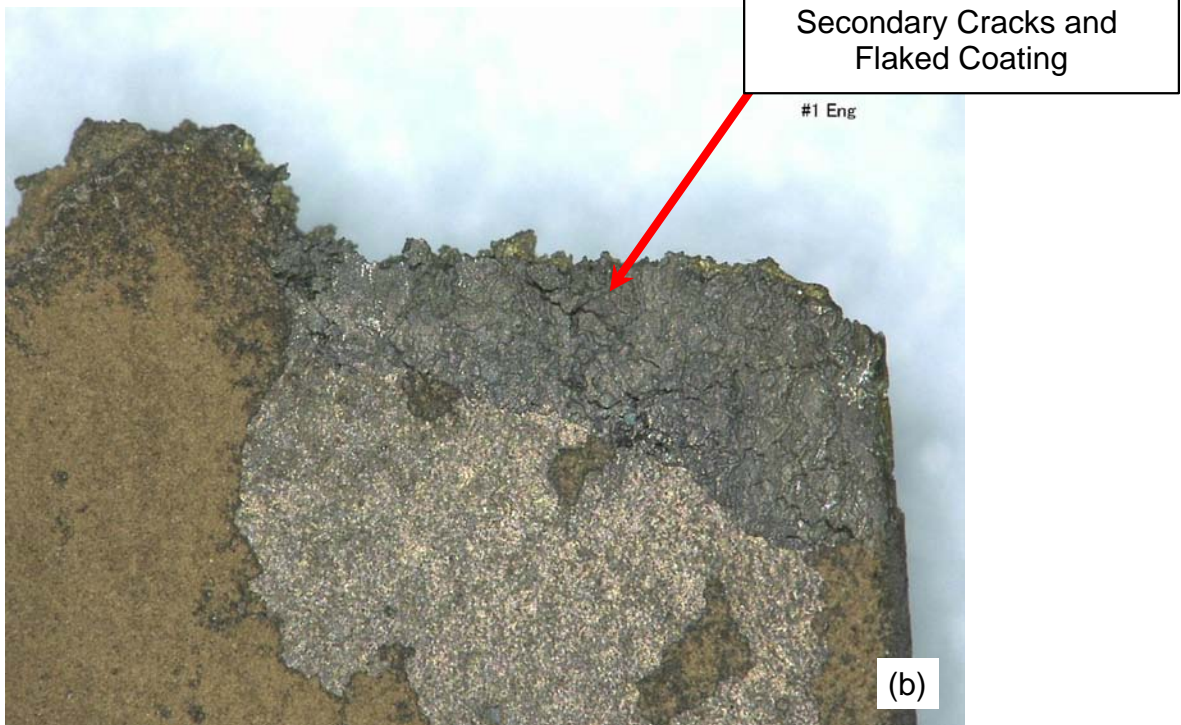
Examinations of many blades found that, typically, the original blade coating was intact on most of the blade surfaces but was typically partially spalled from the blade adjacent to portions of the fracture, in the vicinity of the secondary cracking and at the trailing edge on the concave side, as shown in figure 4 (a). Figure 4 (b) shows a closer view of the blade at the leading edge showing the secondary cracking with the attendant spalled coating, areas of intact original coating and areas of remaining tan deposits after cleaning. Elemental maps by energy dispersive x-ray spectrography of these areas, contained in figure 5, clearly showed the various constituents as the base metal elements (exemplified by chromium) in the spall coating area, predominantly aluminum where the coating was intact and mixture of elements that were mostly silicon and magnesium (silicon shown) in the tan deposit area.

Figure 4--Magnified views of a typical blade from the #1 engine at the fracture showing secondary cracking, tan surface debris and flaking of the coating.

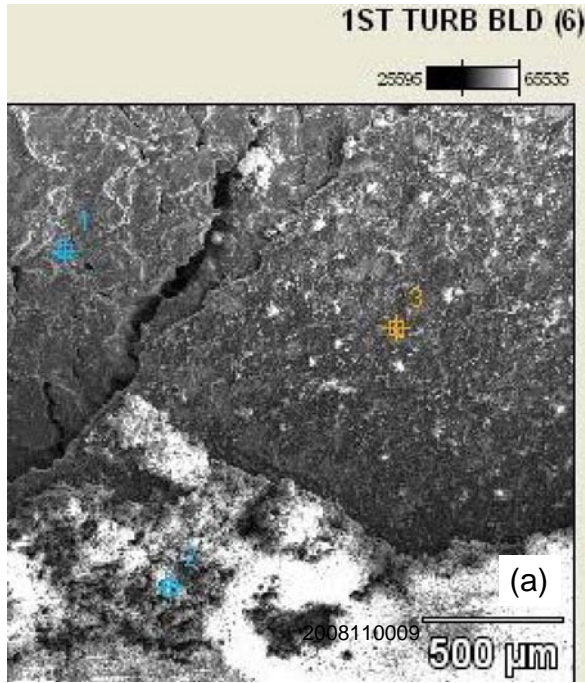
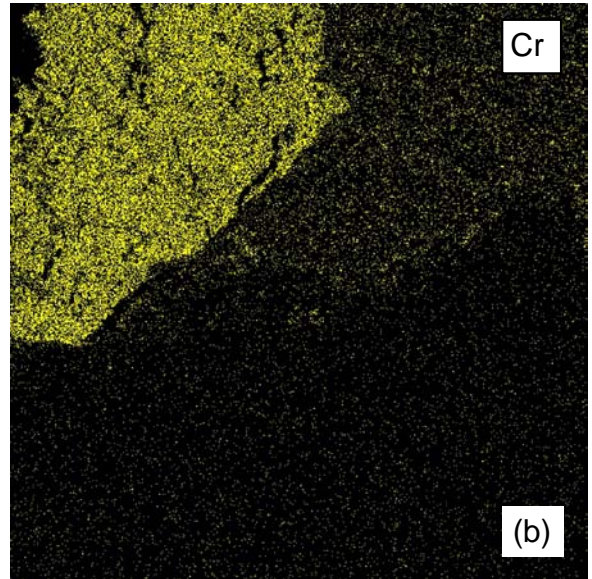
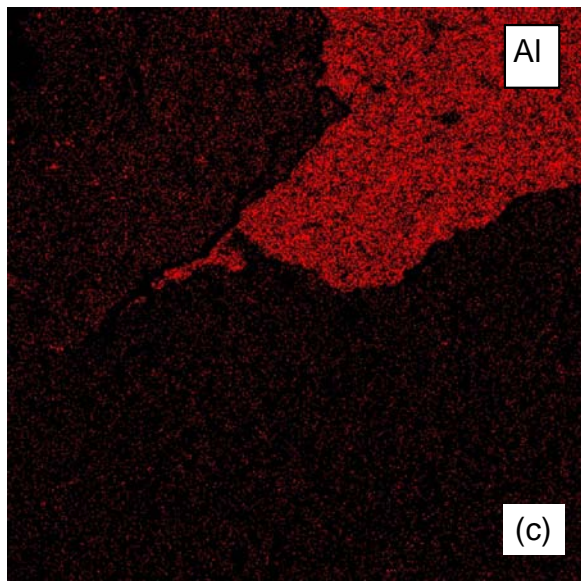
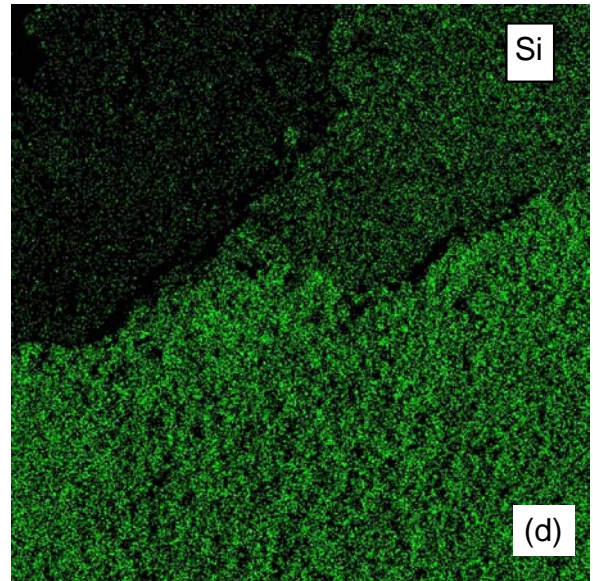
Figure 5--EDS maps showing the locations of base metal, represented by chromium (b), the intact coating represented by aluminum (c) and and the tan deposits represented by silicon (d).

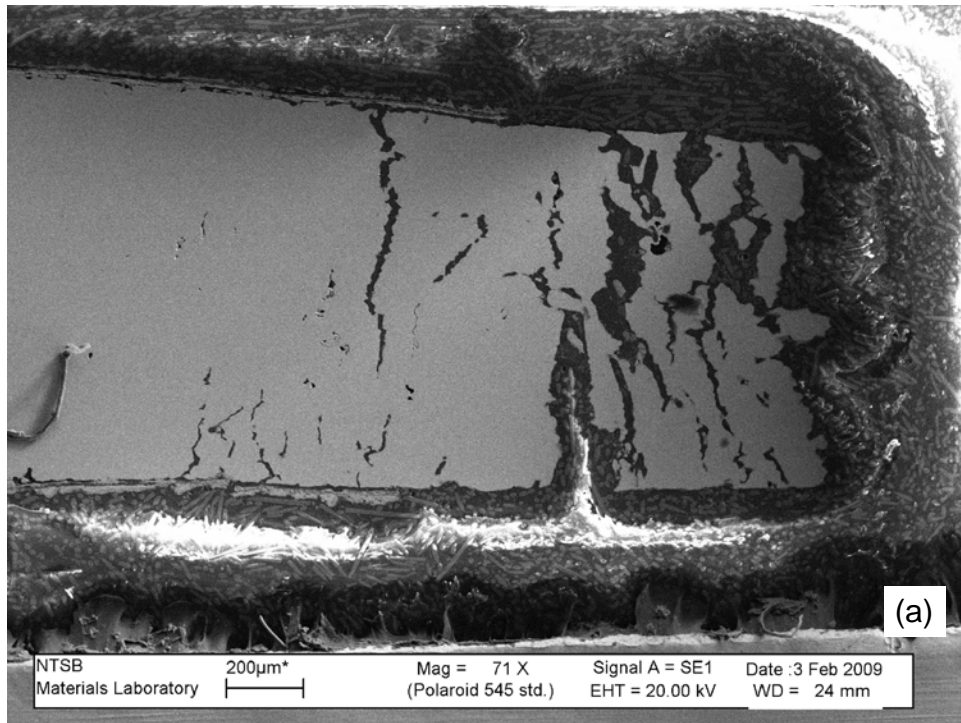
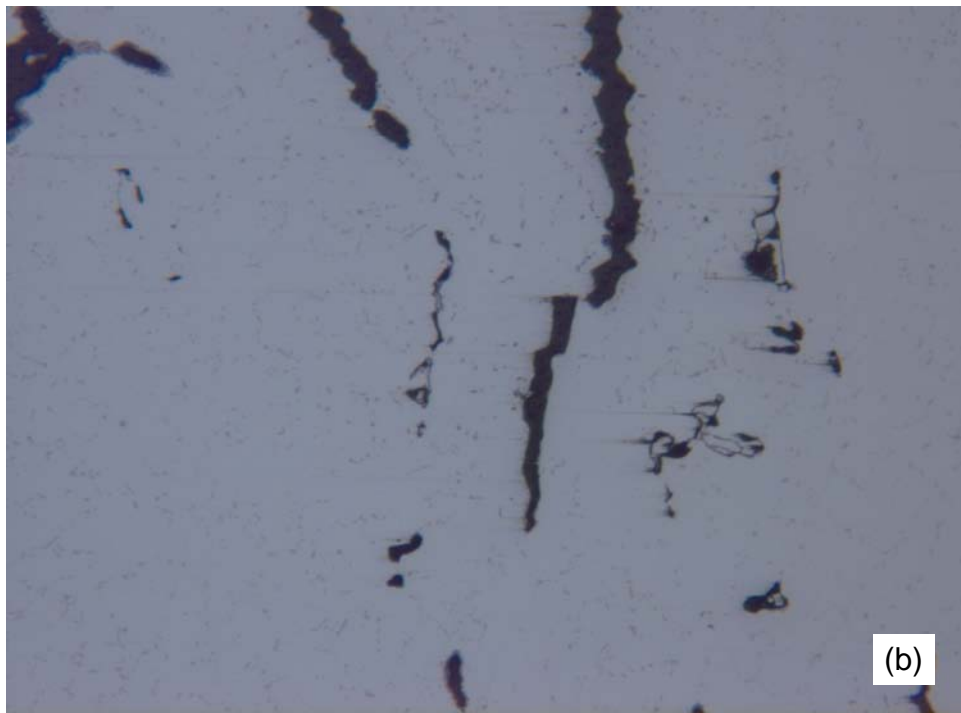
A longitudinal metallographic section was cut through a typical 1st stage blade at about $\frac{1}{4}$ chord. The unetched section displayed extensive secondary cracking in the immediate vicinity of the fracture as displayed in figure 6. When etched with Kalling's reagent², the cross section displayed significant microstructure variations from the base of the blade to the airfoil fracture area. In the base, figures 7 (a) and (b), the microstructure was typical of a solution treated and aged nickel based superalloy containing gamma prime particulates in a gamma matrix with dispersed intermetallics and clearly defined grain boundaries. However, near the fracture, figure 7 (c) and (d), the microstructure showed intermetallic particles in a dendritic structure with little or no gamma prime particulates and poorly defined grain boundaries. The microstructure was typical of high temperature exposure and partial resolution of the gamma prime. Along the airfoil length, the coating showed increasing oxidation toward the fracture and spalling adjacent to the fracture, as shown in figure 8.

Figure 6--SEM (a) and optical (b) views showing typical secondary cracking adjacent to the the fracture (at right in both views).

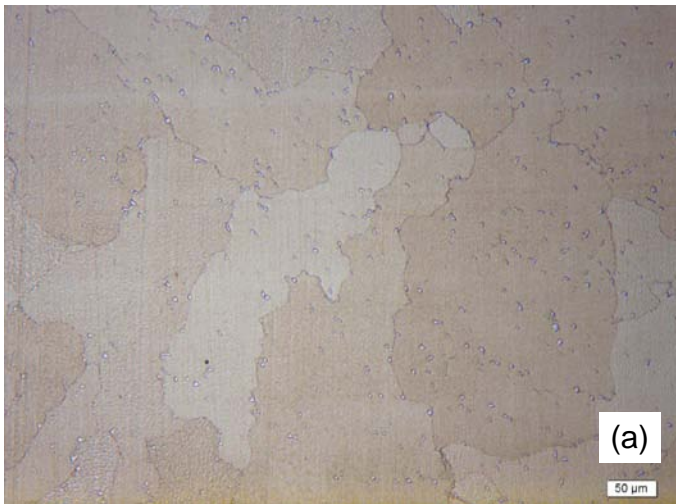
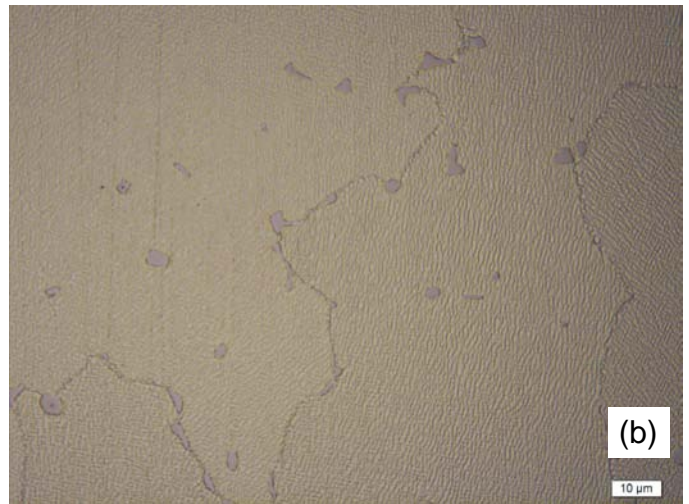
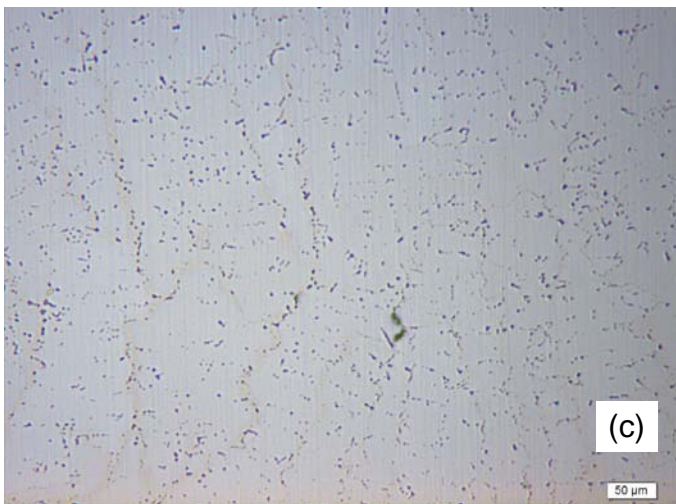
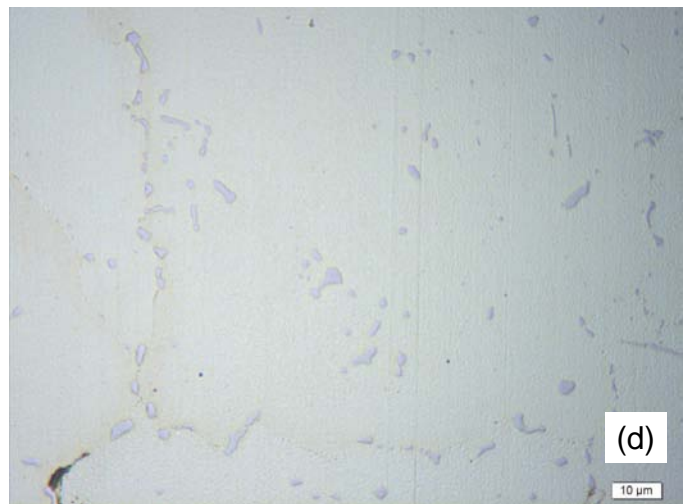
Figure 7--The microstructure of the 1st stage turbine blade from the #1 engine in the base (a) and (b) and near the fracture (c) and (d) showing resolution of the gamma prime phase. Kalling's Reagent etch.

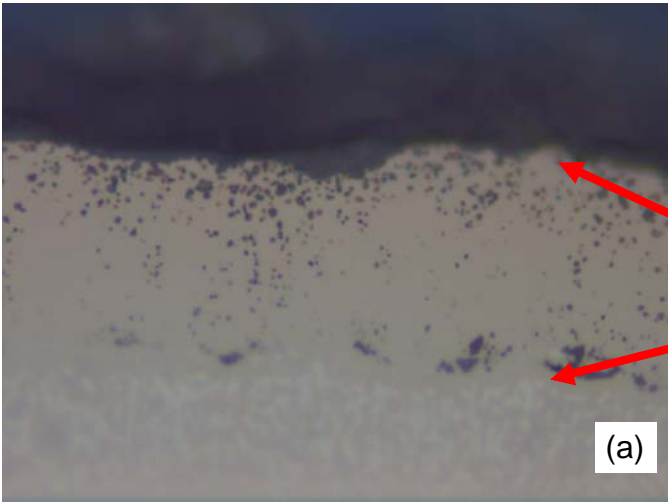
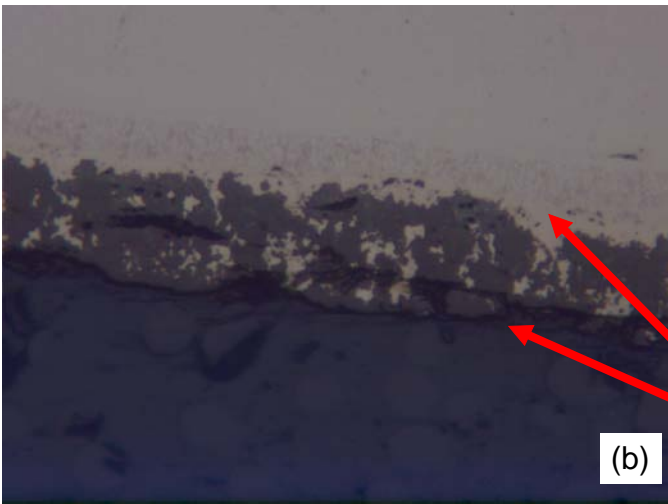
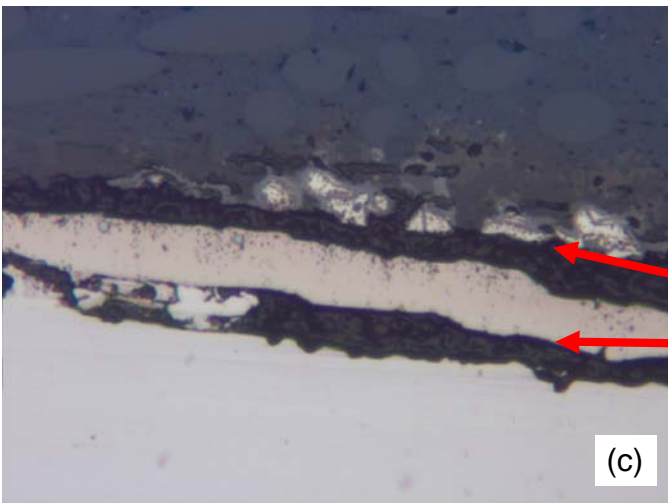
Figure 8--Microstructures of the coating material on the airfoil of the 1st stage turbine from the #1 engine, (a) near the base, (b) near midspan showing oxidation and cracking and (c) adjacent to the fracture showing spalling.

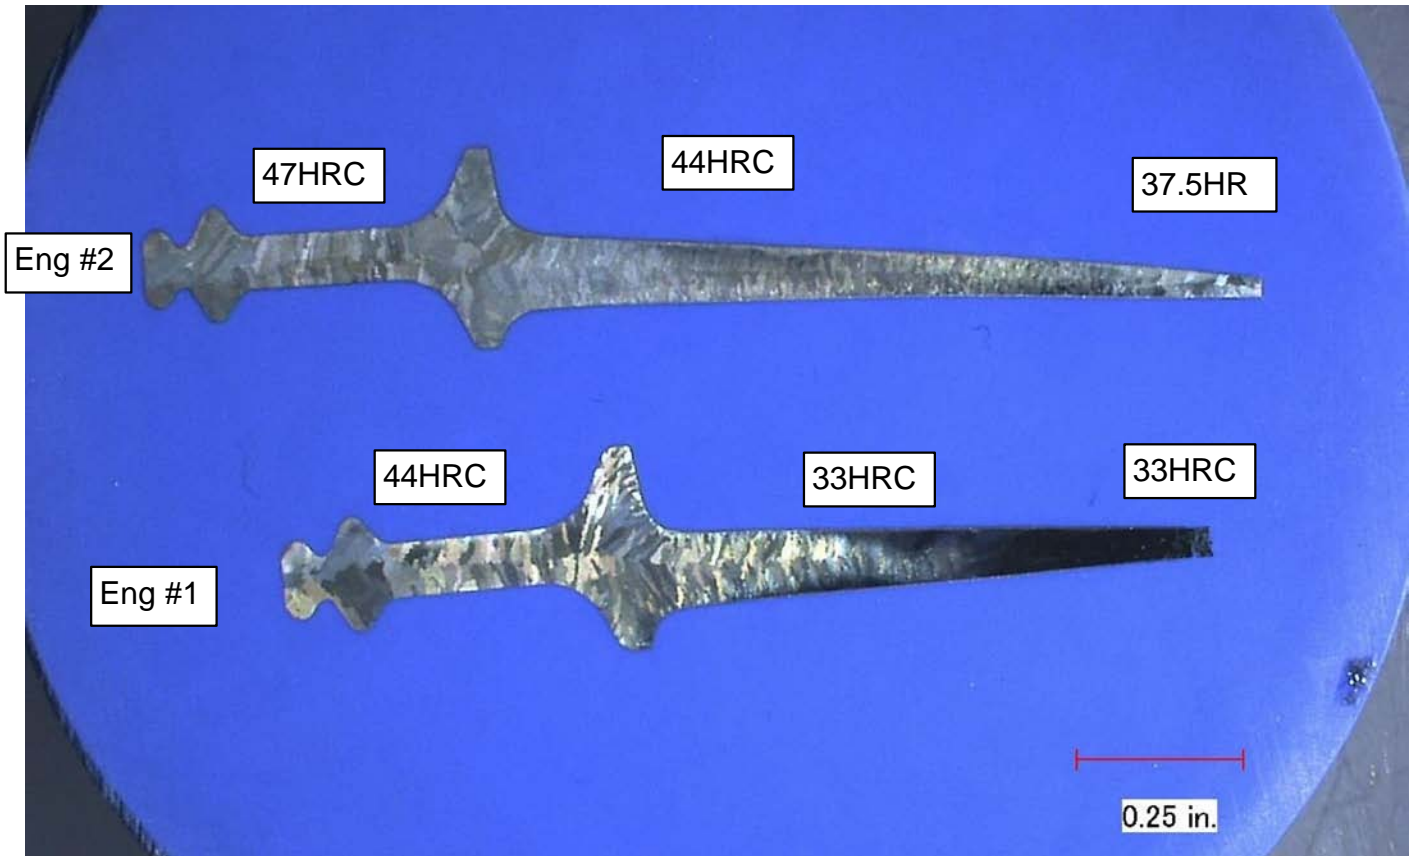
Knoop microhardness measurements on the polished cross section were taken in the base region, near mid span and adjacent to the fracture (tip) and showed decreasing hardness as indicated in the table below and shown on figure 9. Values for the #2 engine are also shown.

Base		Mid Span		Tip	
	HK ₅₀₀	HRC	HK ₅₀₀	HRC	HK ₅₀₀	HRC
#1 Eng	427	44	327	33	327	33
#2 Eng	465	47	438	44	366	37.5

Figure 9--A macrograph of the polished and etched blade sections from the two engines showing the overall macrostructure. Average hardness at different locations is also noted.

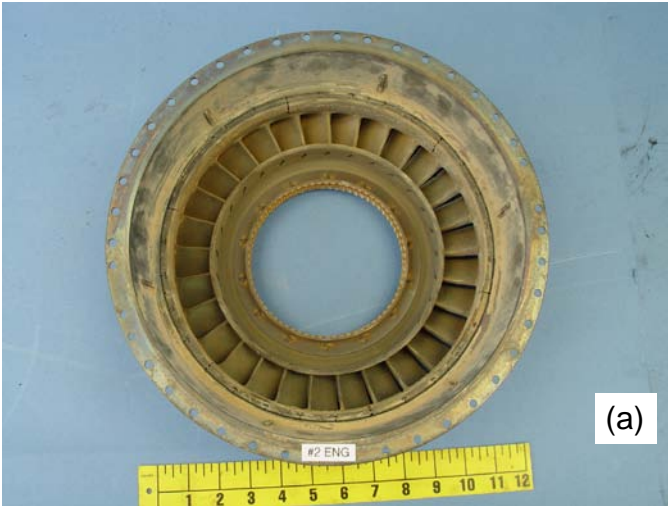
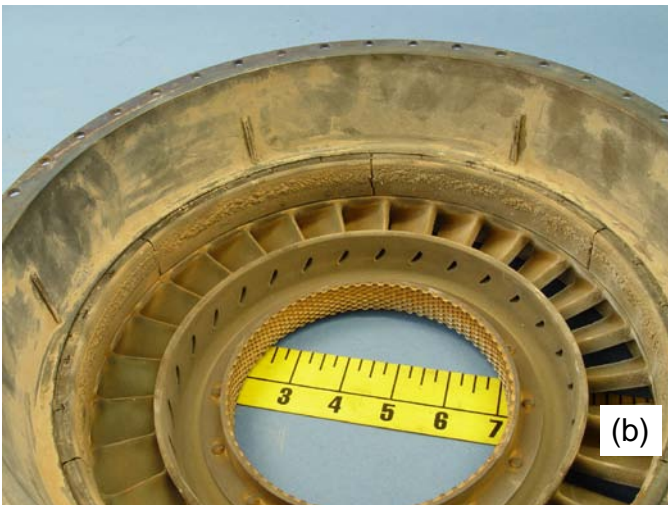
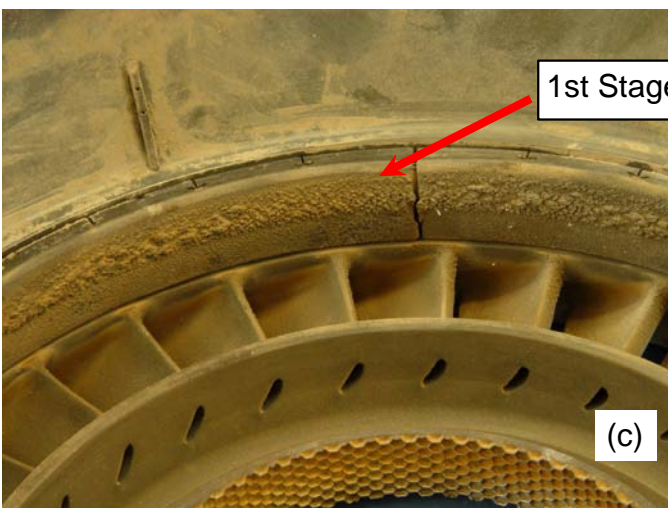
The 2nd stage turbine nozzle assembly is displayed in figure 10. No identifying markings were found on the assembly or attached turbine case. The assembly was generally intact but had large quantities of deposited material on the air seal segments inline with the 1st stage turbine disk. In locations, the built up deposits were nearly 0.1 inch thick. The nozzle, case and air seals were additionally covered with tan deposits previous identified on the 1st stage turbine. A portion of the deposited material was chipped / peeled from the air seals. The deposit was longitudinally sectioned mounted in phenolic material and lightly polished. The deposit cross section showed internal voids but otherwise appeared to be homogenous material through its thickness, as shown in figure 11 (a). An energy dispersive x-ray line scan, figures 11 (b) and (c), through the thickness of the material also showed a uniform composition except at discreet aluminum-containing intersected particles.

Figure 10--The 2nd stage turbine nozzle from the #1 engine showing the widespread tan deposits (a) with closer views (b) and (c) showing the deposits on the 1st stage airseal area.

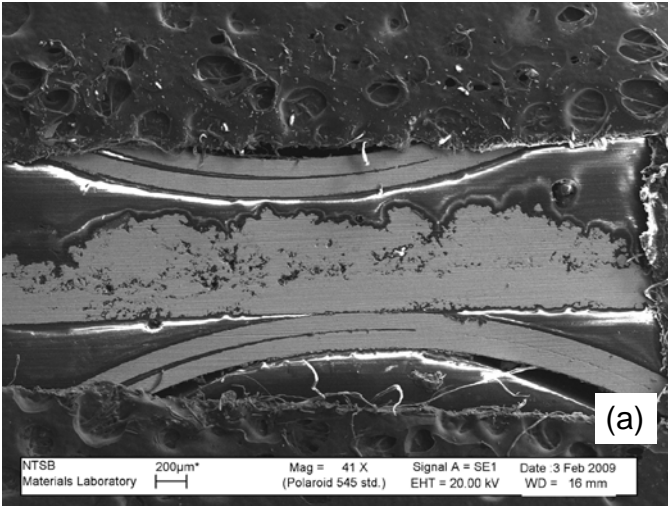
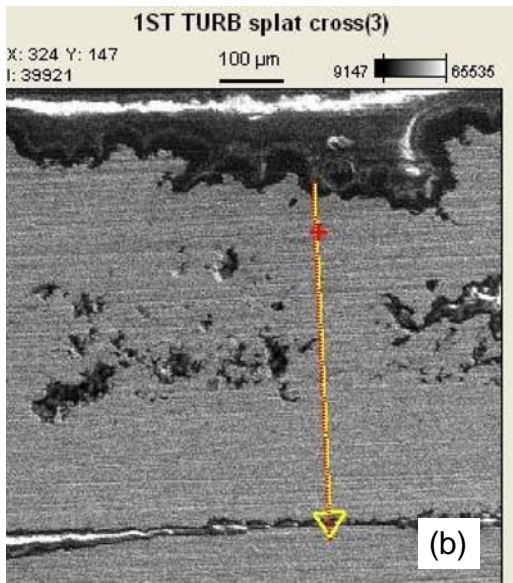
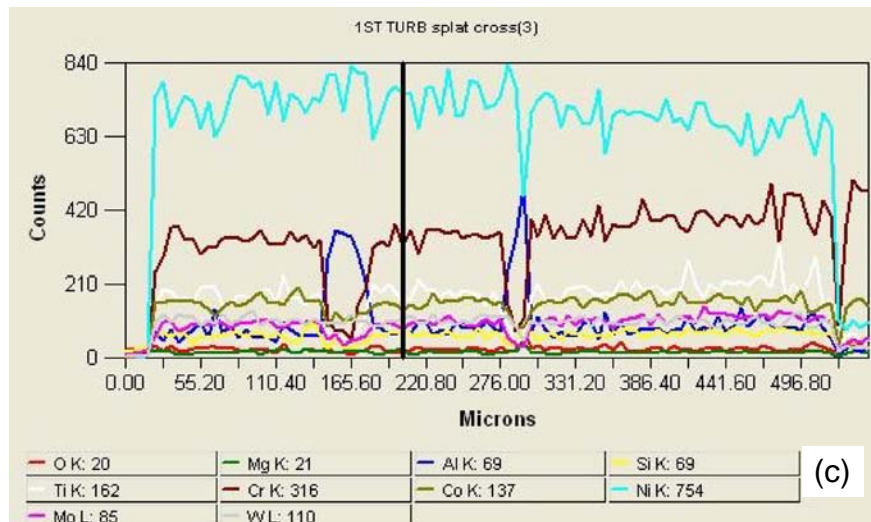
Figure 11--Cross section of deposited material on 1st stage airseal segments (a) with a closer view (b) showing the location of the EDS line scan presented in (c).

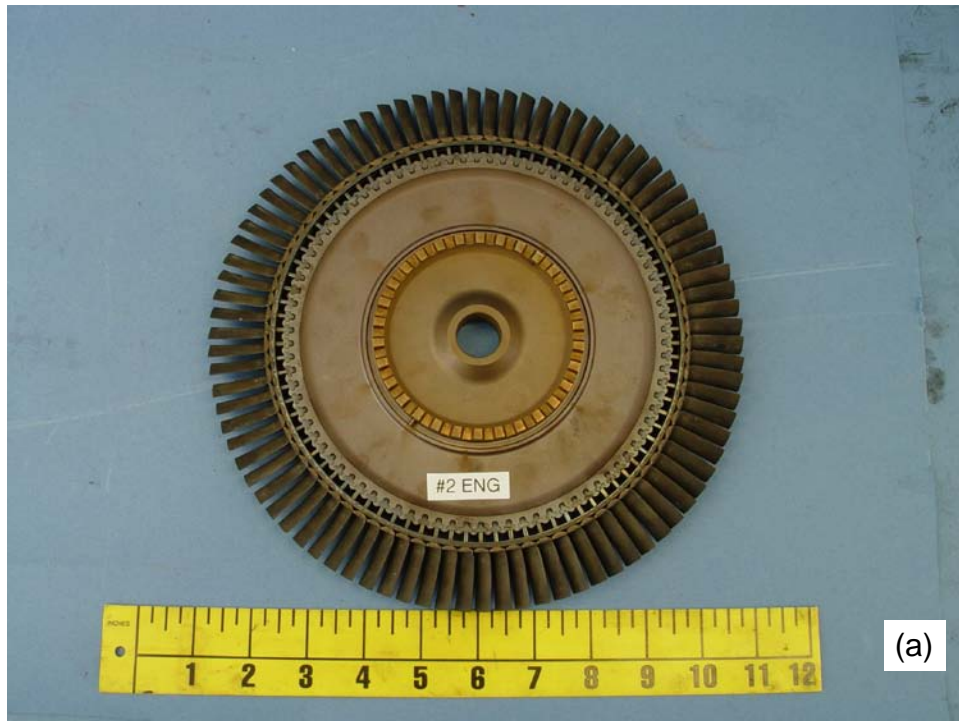
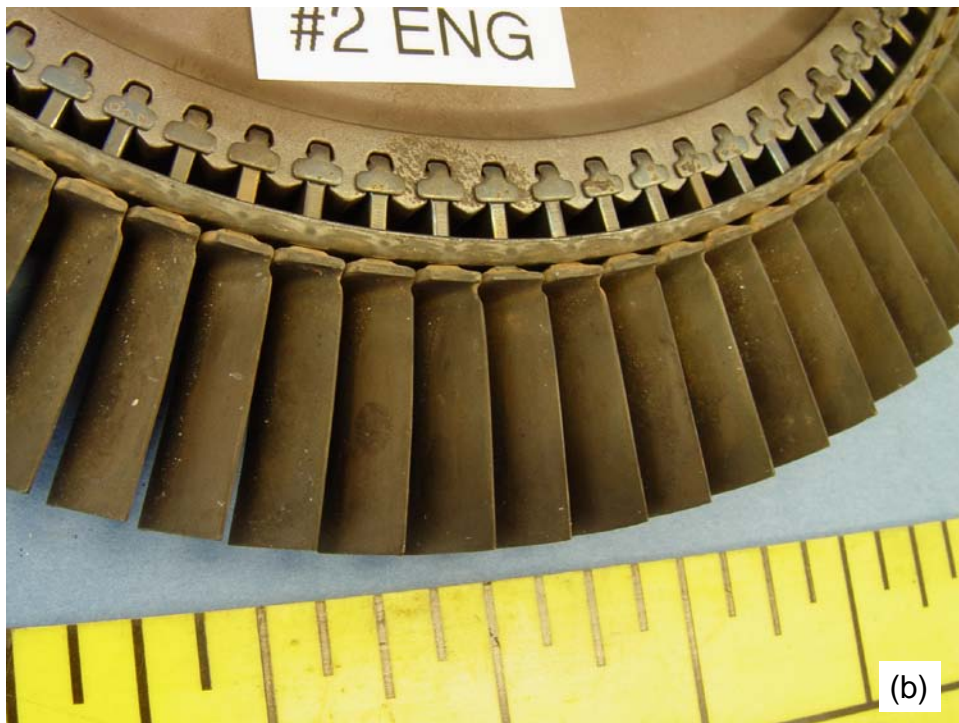
The 1st stage turbine assembly is displayed in figure 12. The assembly appeared intact with little or no visible mechanical damage. The turbine blades were intact showing a dark brown coloration as shown in figure 3. The blade coating appeared intact with no visible cracking or peeling or indications of thermal distress.

Figure 12--The 1st stage turbine from the #2 engine showing no apparent blade or coating damage.

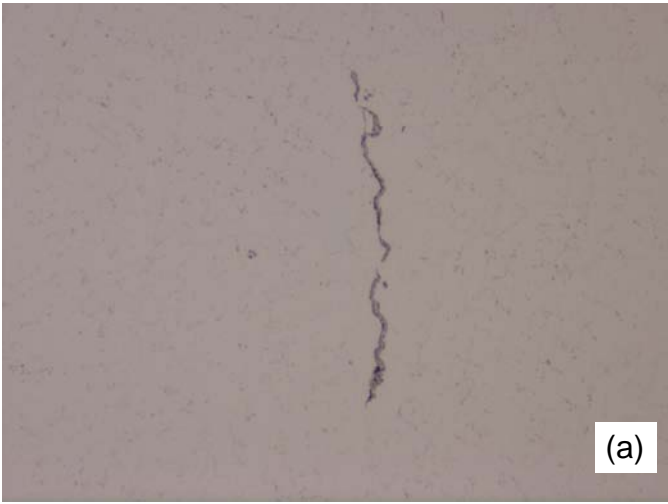
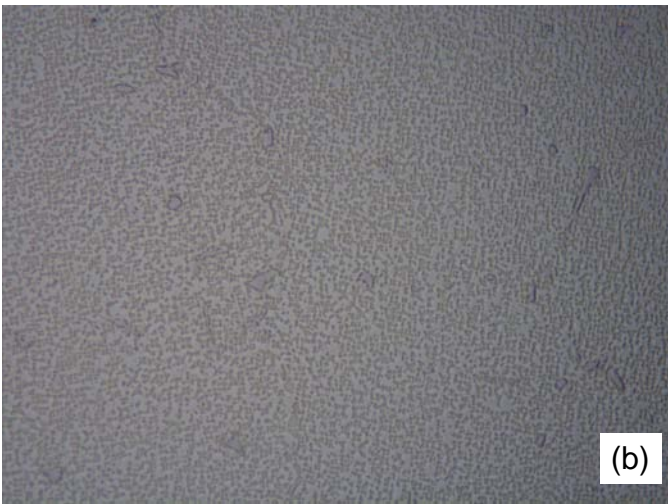
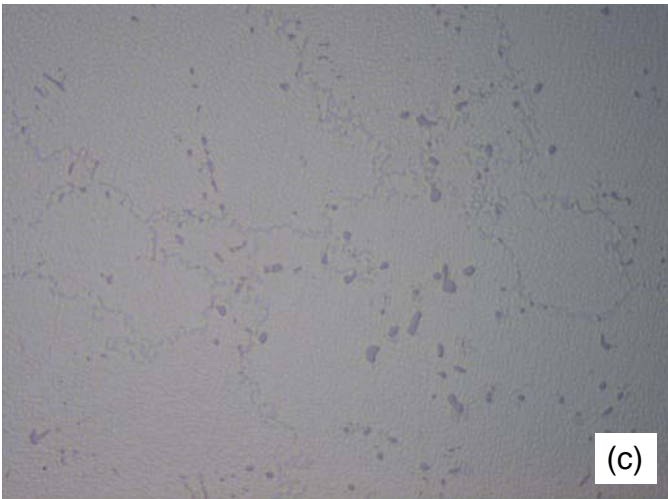
A longitudinal metallographic section was cut in the same plane as the sample from the #1 engine. In the polished but unetched condition, a dark transverse feature was noted at about 2/3 span, as shown in figure 13 (a). The feature appeared to be a line of oxides containing a few small pores.

When etched with Kalling's reagent, the revealed microstructure varied from base to tip as seen in the #1 engine blade. The base, figure 13 (b), and mid span, figure 13 (c) locations both showed gamma prime precipitates in a gamma matrix along with dispersed

intermetallic particles. However, the gamma prime was coarser at the mid span. At the tip region of the blade the gamma prime appeared to have been partially resolved leaving gamma prime remnants and intermetallics. Hardness (see table above) showed a decrease from base to tip but not to the extent of the blades from the #1 engine.

Figure 13--Micrographs of a 1st stage turbine blade from the #2 engine showing an oxide formation (a) near the tip (unetched) and the microstructures near the base (b) and at the tip (c).

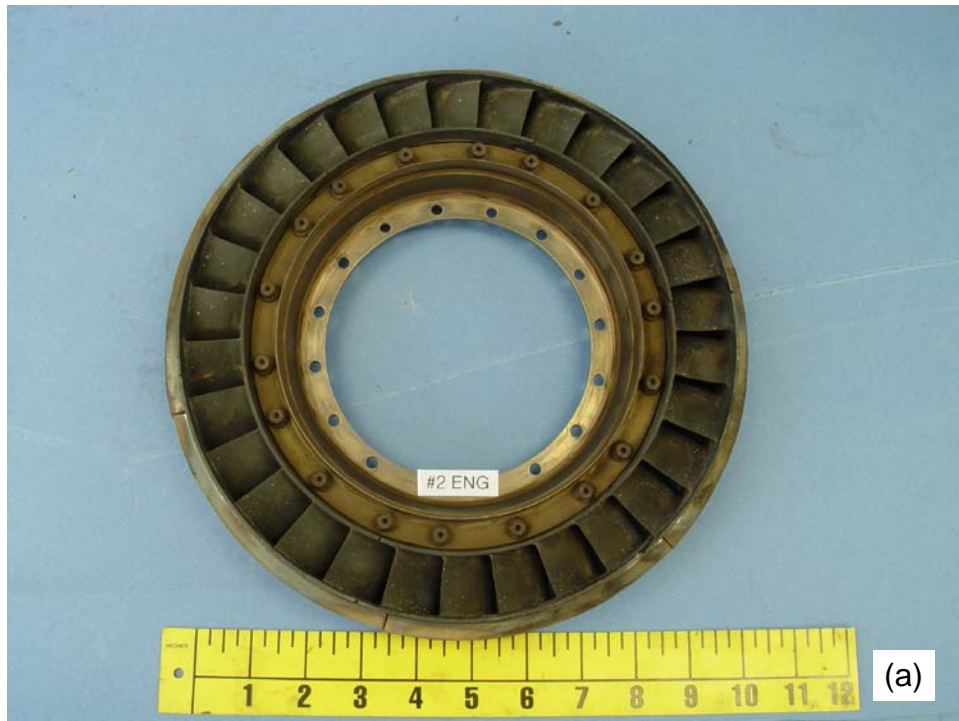
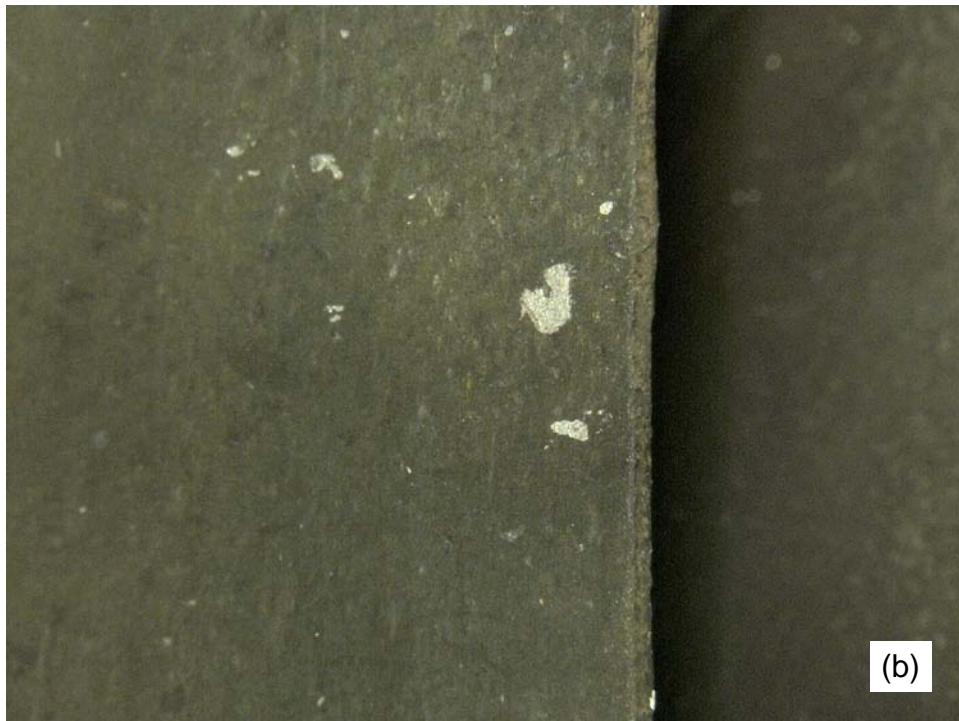
The 1st stage turbine nozzle assembly, shown in figure 14 (a), was generally intact and appeared undamaged. The nozzle vanes surfaces showed some spatter on the convex sides near the trailing edges, see figure 14 (b). EDS of the spatter established that it was predominately aluminum in composition.

Figure 14--The 2nd stage nozzle assembly from the #2 engine (a) with aluminum splatter on the trailing edges of the vanes (b).

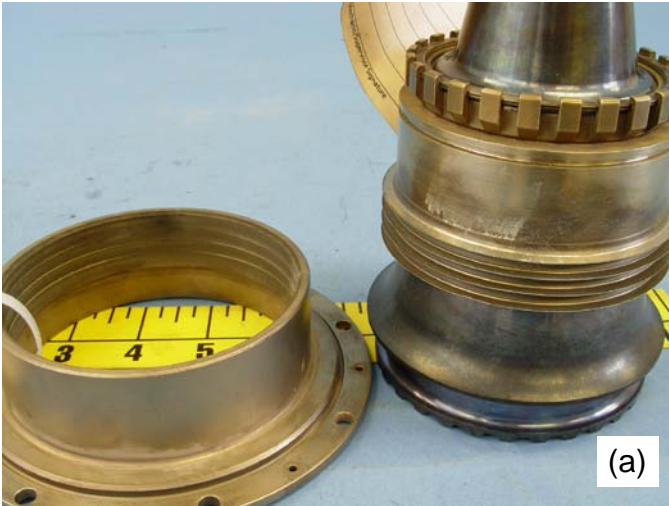
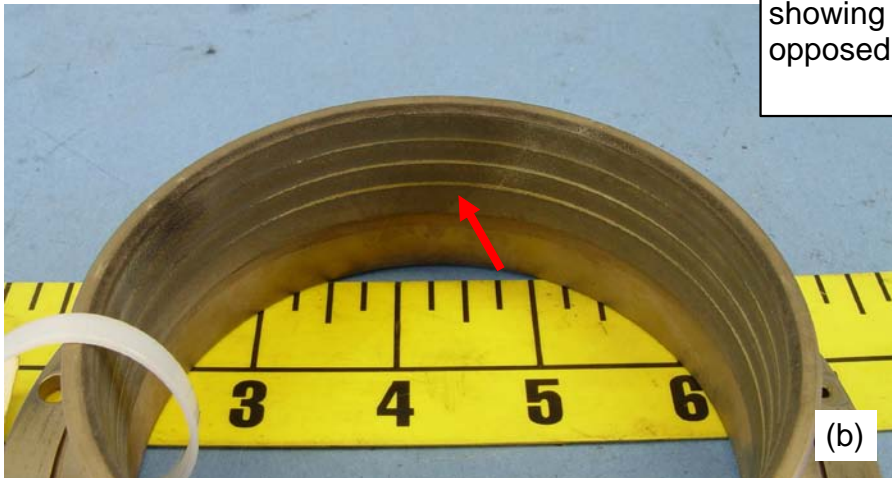
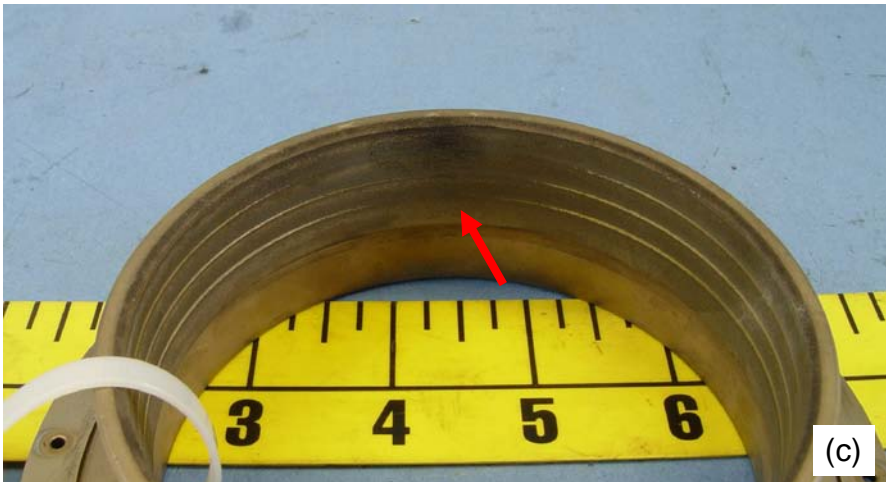
The forward turbine shaft and stationary seal are displayed in figure 15. The seal surfaces contained grooves in the abradable coating from contact with the knife edges on the turbine shaft. The grooves appeared deeper toward one side of the seal indicative of a slight axial misalignment between the shaft and seal.

Figure 15--The forward turbine shaft and stationary seal (a) with the seal showing various depth grooves on opposed sides (b) and (c).
