NATIONAL TRANSPORTATION SAFETY BOARD

MATERIALS LABORATORY FACTUAL REPORT

Report No. 09-019

Place : Weaverville, California
Date : August 5, 2008
Vehicle : Sikorsky S-61N
NTSB No. : LAX08PA259
Investigator : Mike Hauf (AS-40)

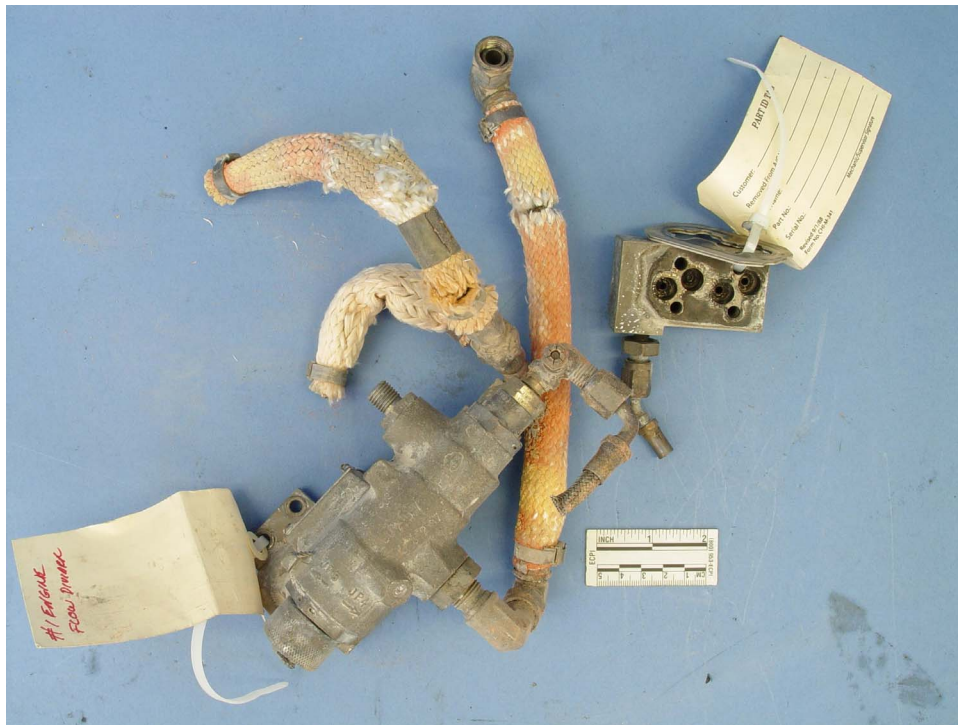
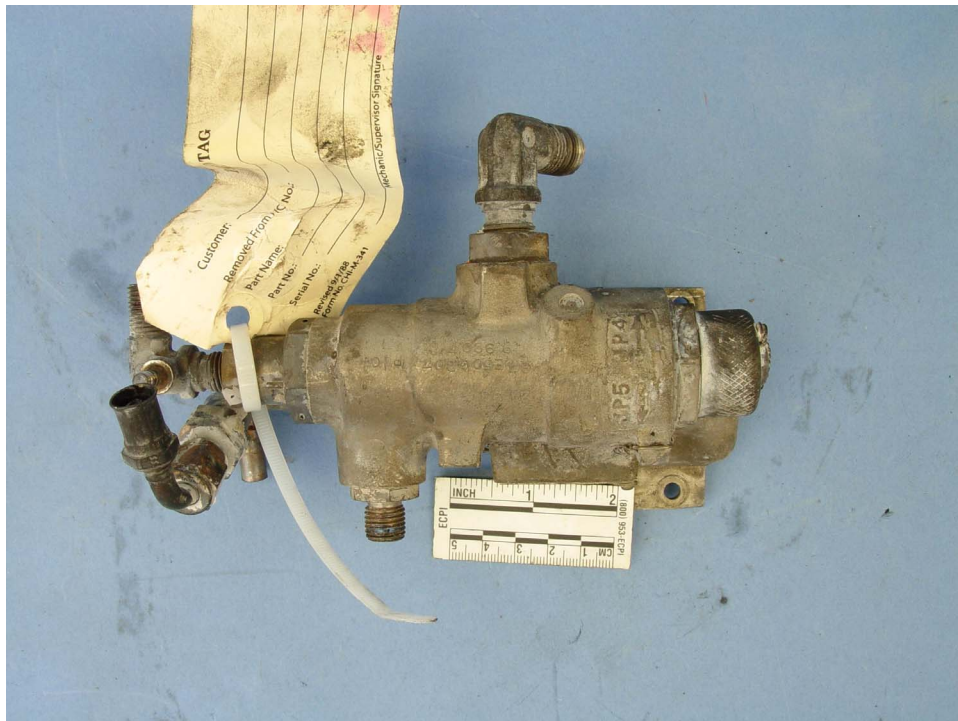
The components were received by the Materials Laboratory in the condition shown in figures 1 and 2. The Number 1 engine flow divider and flow divider block are shown in figure 1a. The Number 2 engine flow divider is shown in figure 1b. Multiple fittings were attached to both flow dividers and insulated hoses were still attached to the Number 1 engine flow divider. The Number 1 and Number 2 engine pilot valve assemblies are shown in figures 2a and 2b respectively. The spring and piston were still attached to the Number 1 pilot valve assembly, while the Number 2 pilot valve had been partially disassembled and the piston already extracted. Charred residue was observed at the fuel return openings at the back of the pilot valve assembly housings.

Figure 1: a) Number 1 engine flow divider and flow divider block as-received and b) Number 2 engine flow divider as-received.

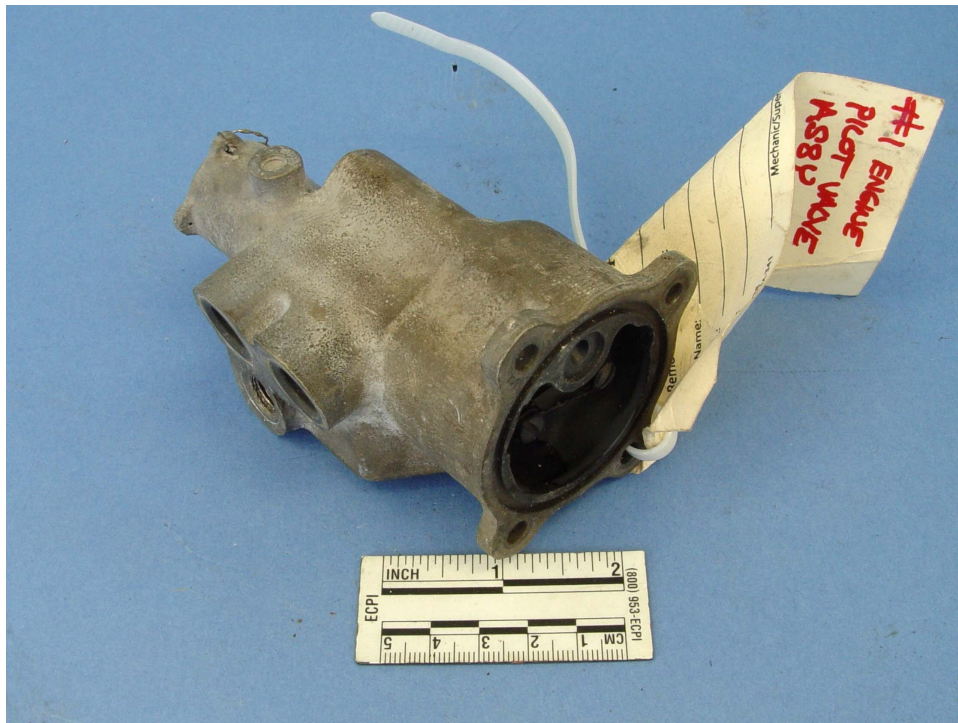
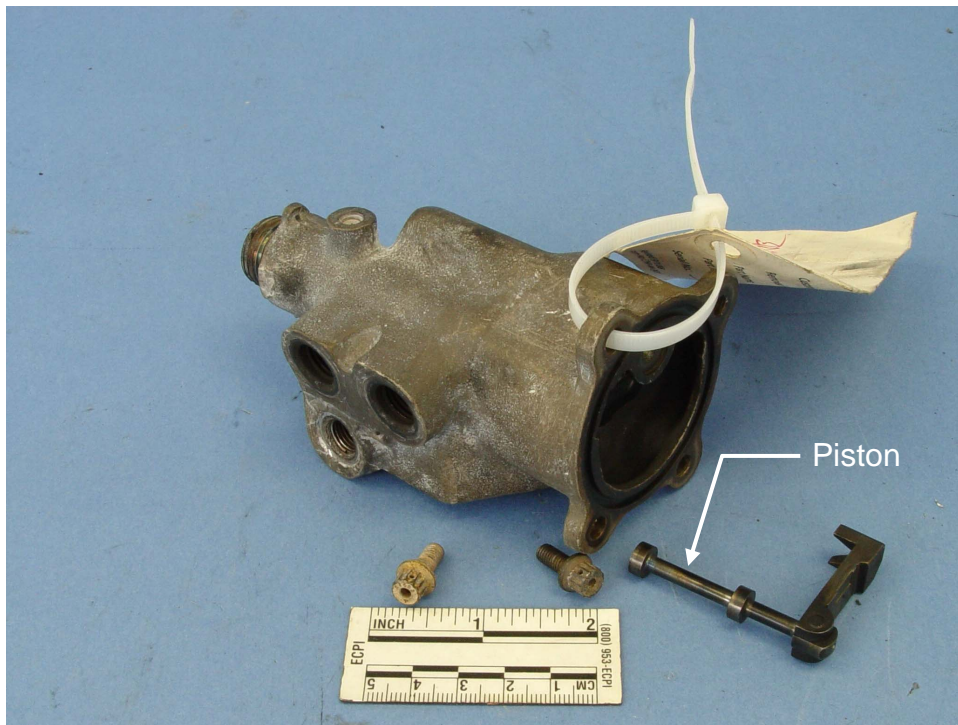
Figure 2: a) Number 1 engine pilot valve assembly as-received and b) Number 2 engine pilot valve assembly as-received.

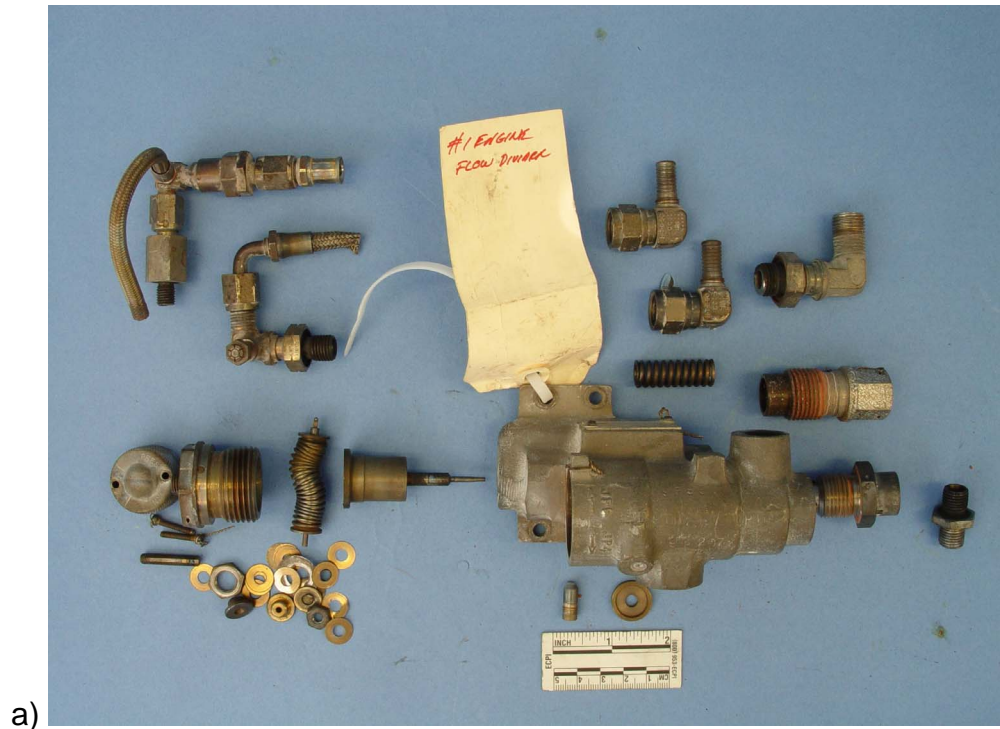
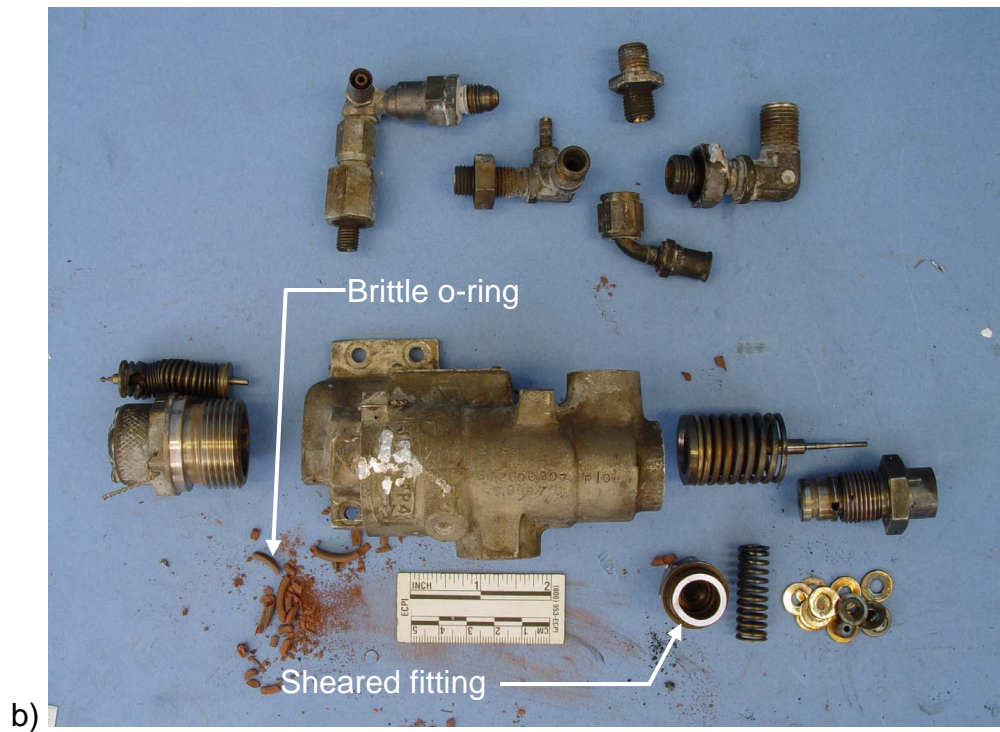
The o-rings and seals in both flow dividers were brittle and crumbled into small pieces during disassembly, a few pieces of which can be seen in figure 3b. There was a thin layer of charred residue at some of the fittings. Light from the fiber optic source was visible through all 90° elbow fittings, consistent with an open flow path. There were no signs of hard particulates, such as sand, metallic debris, or fibrous debris. The threads on one of the number 2 flow divider fittings seized while attempting to extract the fitting. Eventually the fitting itself sheared in half as indicated in figure 3b.

Figure 3: Photographs of flow dividers after disassembly; a) Number 1 engine flow divider; and b) Number 2 engine flow divider.

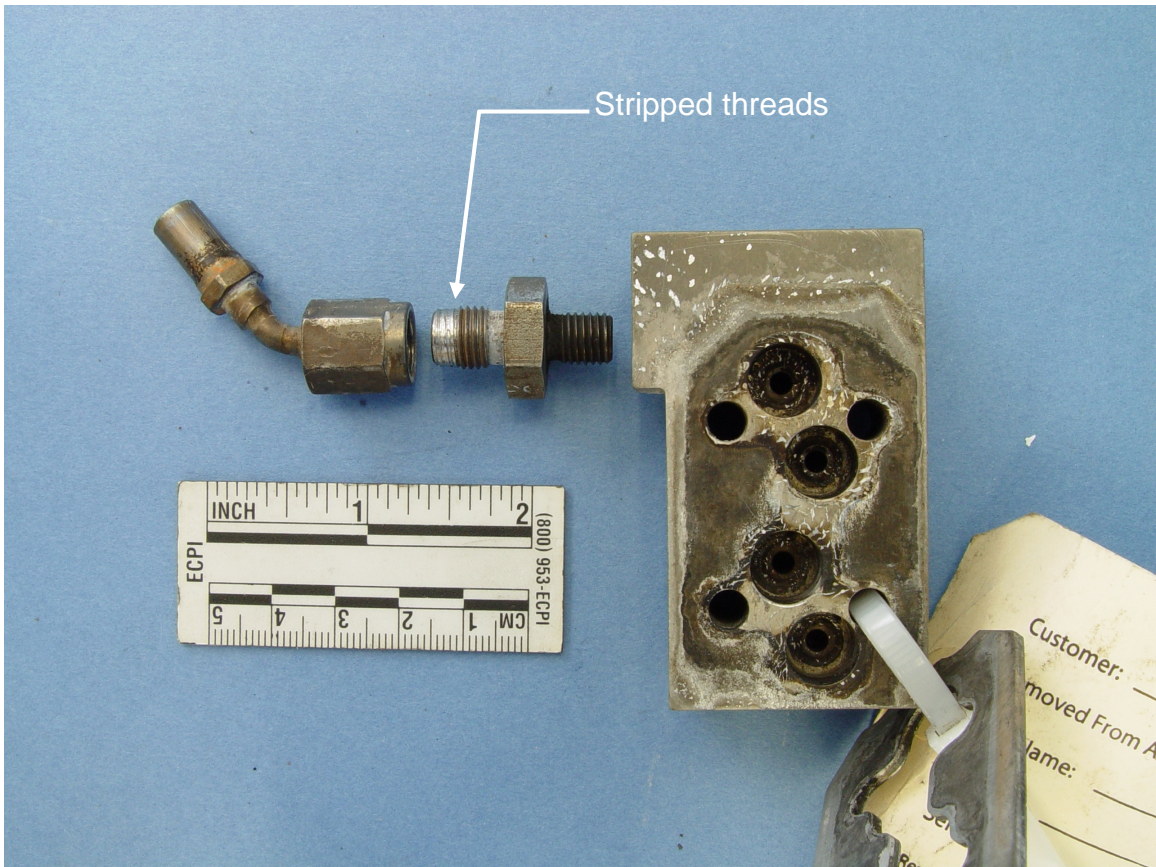
There were no signs of hard particulates on the Number 1 engine flow divider block. A brittle fragment of o-ring material had fallen into one of the ports on the block. Threads on a reducing coupler attached to the Number 1 engine flow divider block seized during removal, stripping the threads as indicated in figure 4. There were no obstructions in the 45° elbow or the reducing coupler.

Figure 4: Number 1 engine flow divider block after disassembly.

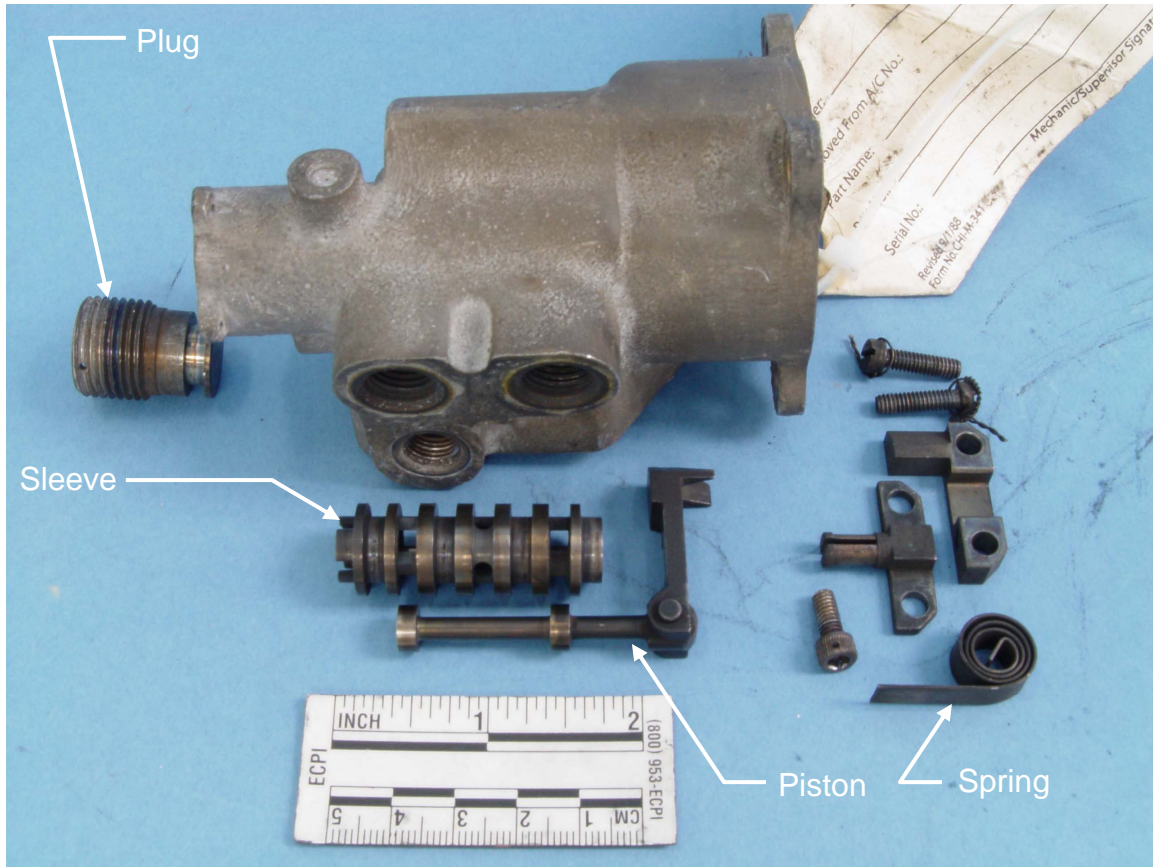
The Number 1 engine pilot valve was disassembled as shown in figure 5. The piston would not slide out freely and was extracted from the sleeve with needle-nose pliers by pulling and using a back-and-forth twisting motion about the longitudinal axis. After the plug was removed, the sleeve slid freely out of the opposite end of the assembly. The o-rings were brittle, crumbled, and some were partially burned. A side view of the sleeve and piston is shown in figure 6. The stem and rectangular regions on the left and right piston valves had a dark brown/blue discoloration consistent with exposure to heat. The size and shape of the dark rectangular regions were consistent with the dimensions of the stator vane actuator ports on the sleeve.

Figure 5: Number 1 engine pilot valve assembly after disassembly.

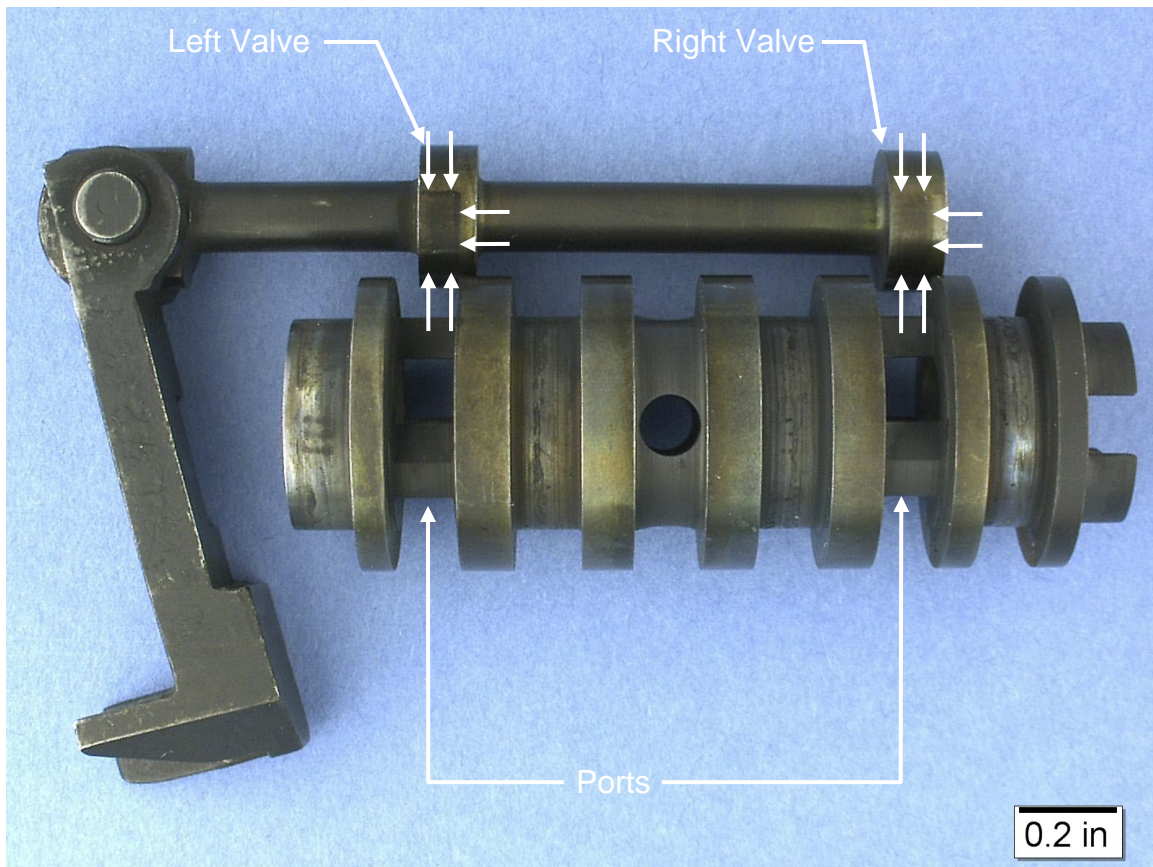
Figure 6: Photograph of the piston and sleeve from the Number 1 engine pilot valve. The valves on the piston have dark rectangular regions indicated by short arrows that are similar in size and shape to the stator vane actuator ports on the sleeve.

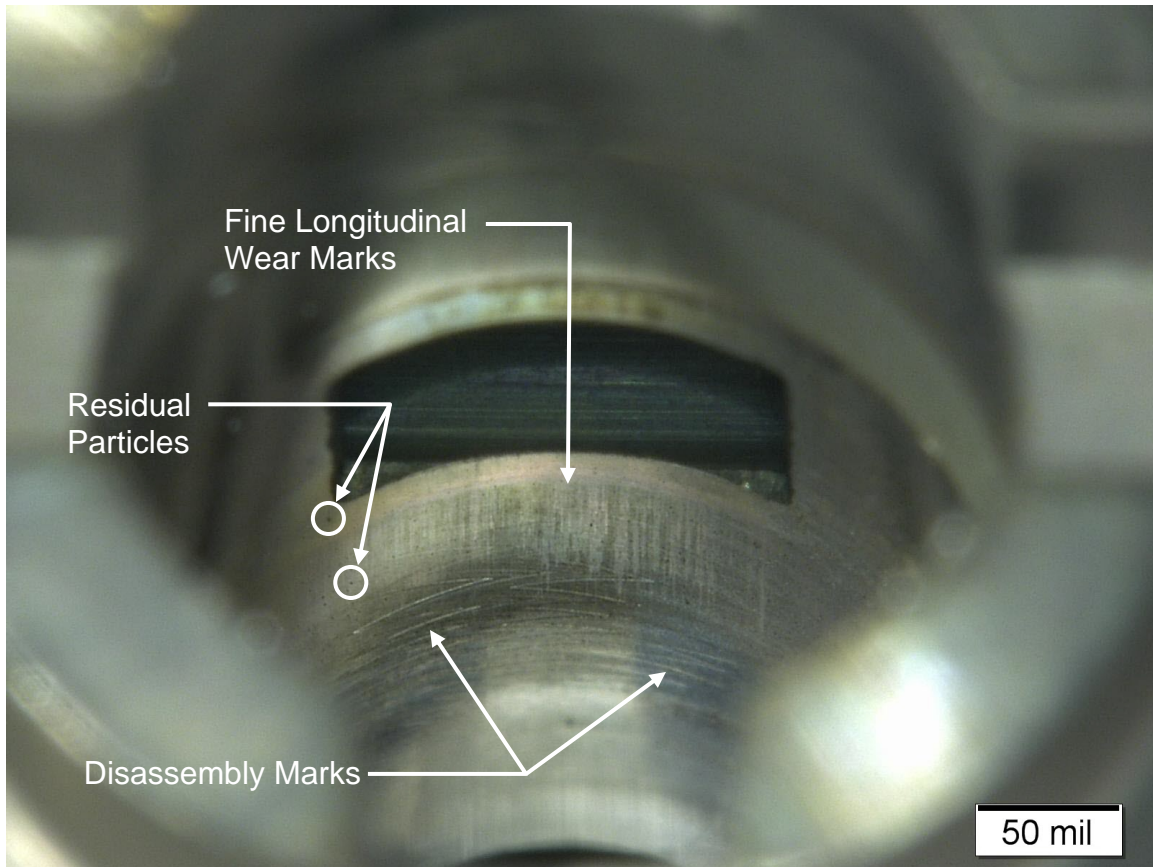
The inner bore of the sleeve appeared smooth with regions of brown/blue discoloration, occasional fine longitudinal wear marks, and marks resulting from the disassembly process. A typical micrograph at the right end of the sleeve inner bore is shown in figure 7. Fine longitudinal wear marks were observed near the stator vane actuator port. Further down the sleeve were helical scratch marks consistent with the motion used to extract the piston. Occasional fine black residual particles of unknown origin were observed on the inner bore as indicated in figure 7. There was no resolvable metallic debris or fibrous debris.

Figure 7: Micrograph of the Number 1 engine pilot valve sleeve inner cylinder. The micrograph was taken at the right end of the sleeve.

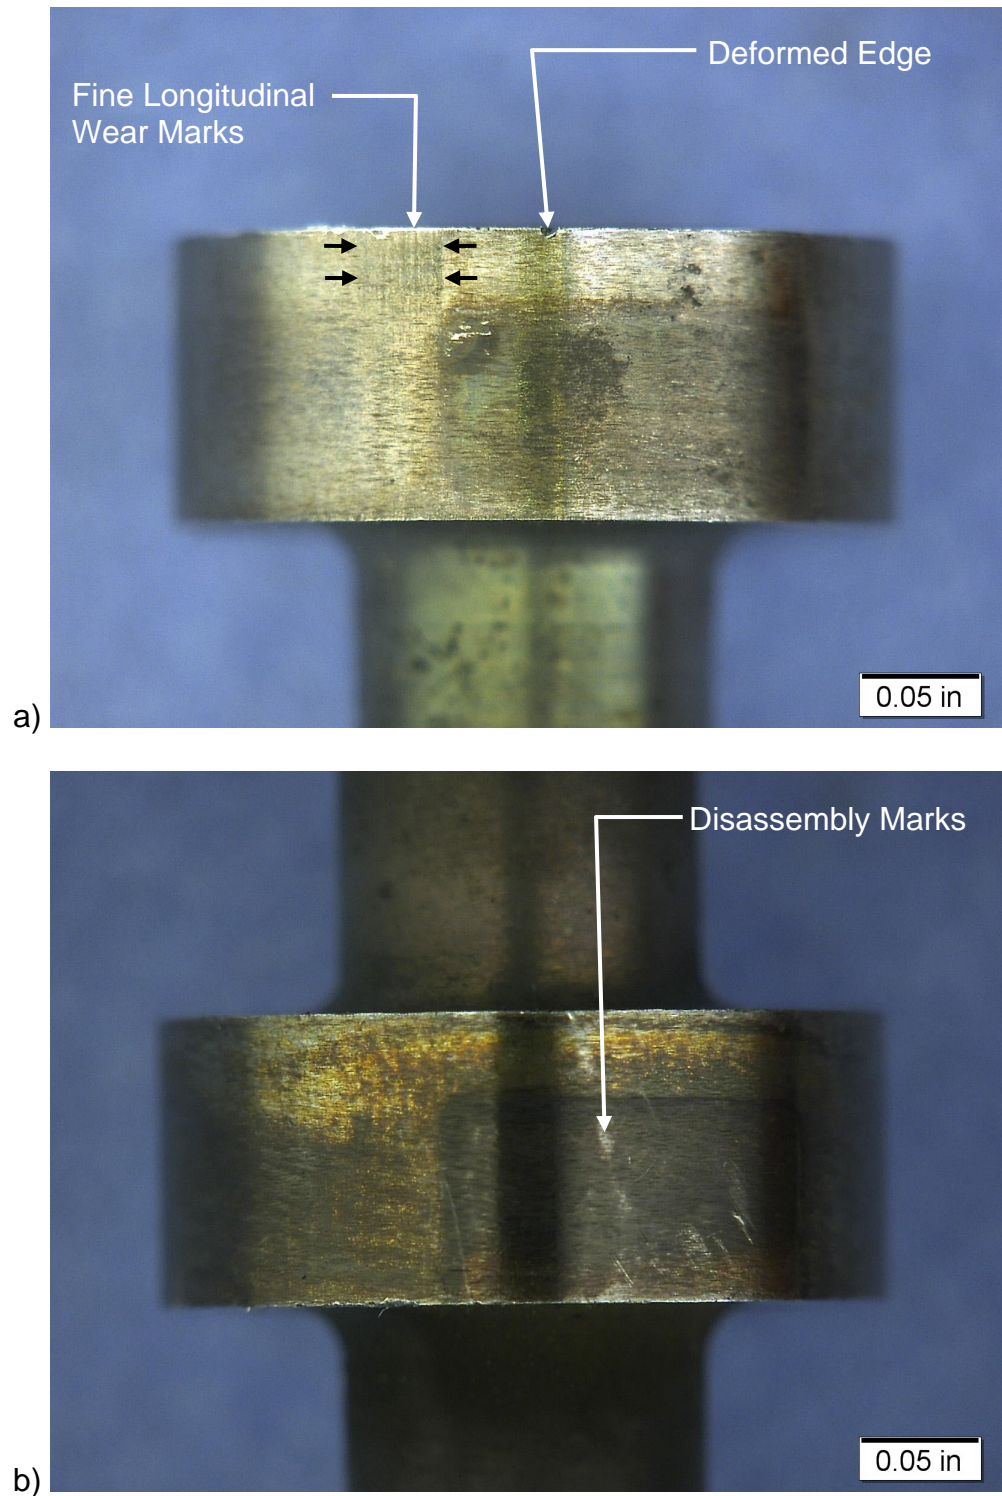
The surface finish on the piston valves was marred by a small deformed region along the right valve edge, occasional fine longitudinal wear marks, and marks resulting from the disassembly process. Micrographs of the right and left port piston valves are shown in figures 8a and 8b, respectively. A deformed spot on the edge of the right valve is indicated in figure 8a. It measured 0.007 inch across. An examination of the inner bore of the sleeve did not find conclusive evidence of a corresponding mark. Fine longitudinal wear marks, indicated in 8a, were observed near a discolored rectangular region on the piston valve, believed to coincide with the location of a sleeve port. Markings on the left valve, indicated in figure 7b, had a metallic color and tracked across the surface at arbitrary

angles, consistent with formation after exposure to heat and after disassembly of the piston.

Figure 8: Micrographs of the piston from the Number 1 engine pilot valve assembly; a) right piston valve and b) left piston valve (see Figure 6).

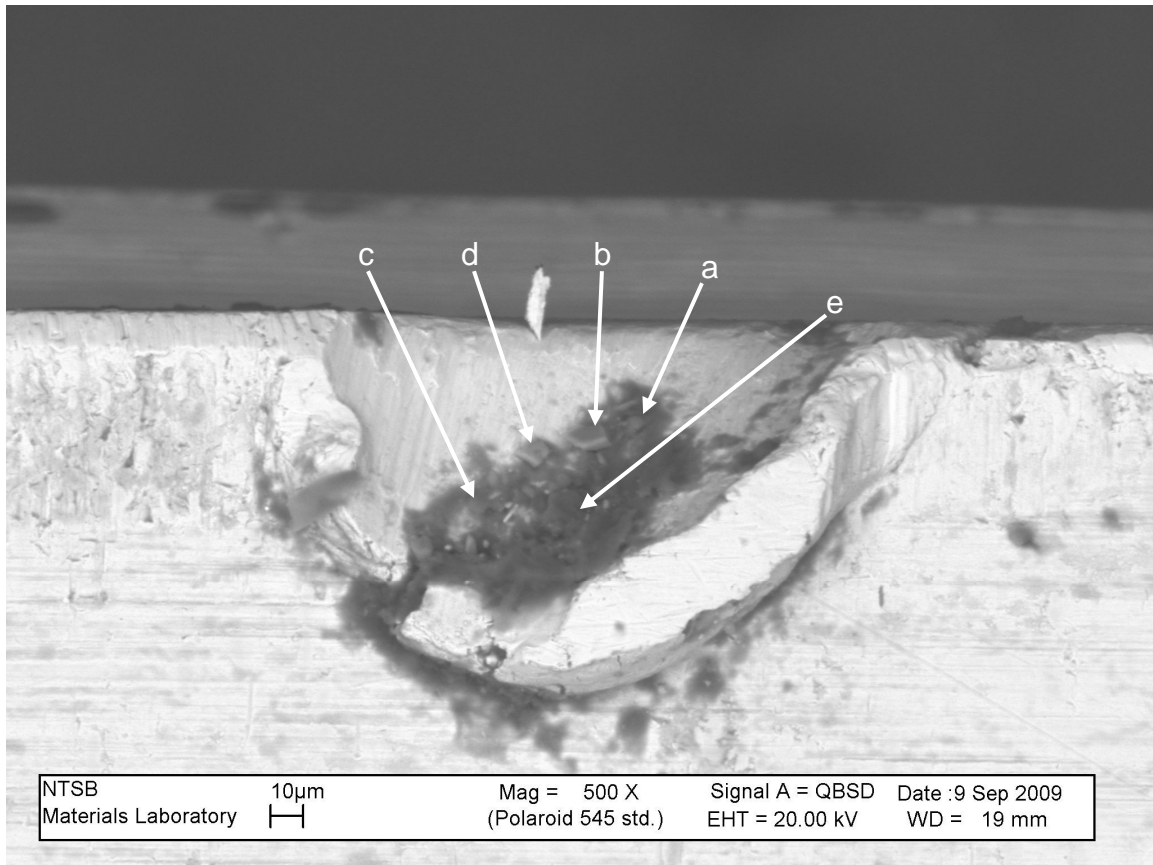
The deformed region along the edge of the right piston valve was examined by scanning electron microscopy (SEM). A backscatter electron detector operating in composition mode was used to discriminate between high and low atomic mass density regions. A higher magnification micrograph of the deformed edge in the same orientation as figure 8a is shown in figure 9. A raised edge of plastically deformed material surrounded an indentation. Small low atomic mass density particles in the 2 μm to 10 μm size range and formless low atomic mass density debris were observed in the indentation. Energy dispersive spectroscopy (EDS) was used to characterize the debris in the indentation. EDS spectra from five particles are shown in figures 10 a-e and the corresponding particles are labeled in figure 9. All five particles had a different composition. Detected elements consisted primarily of silicon, aluminum, carbon, oxygen, magnesium, and potassium.

Figure 9: Backscatter electron micrograph of the deformed edge region on the Number 1 engine pilot valve piston indicated in figure 8a.

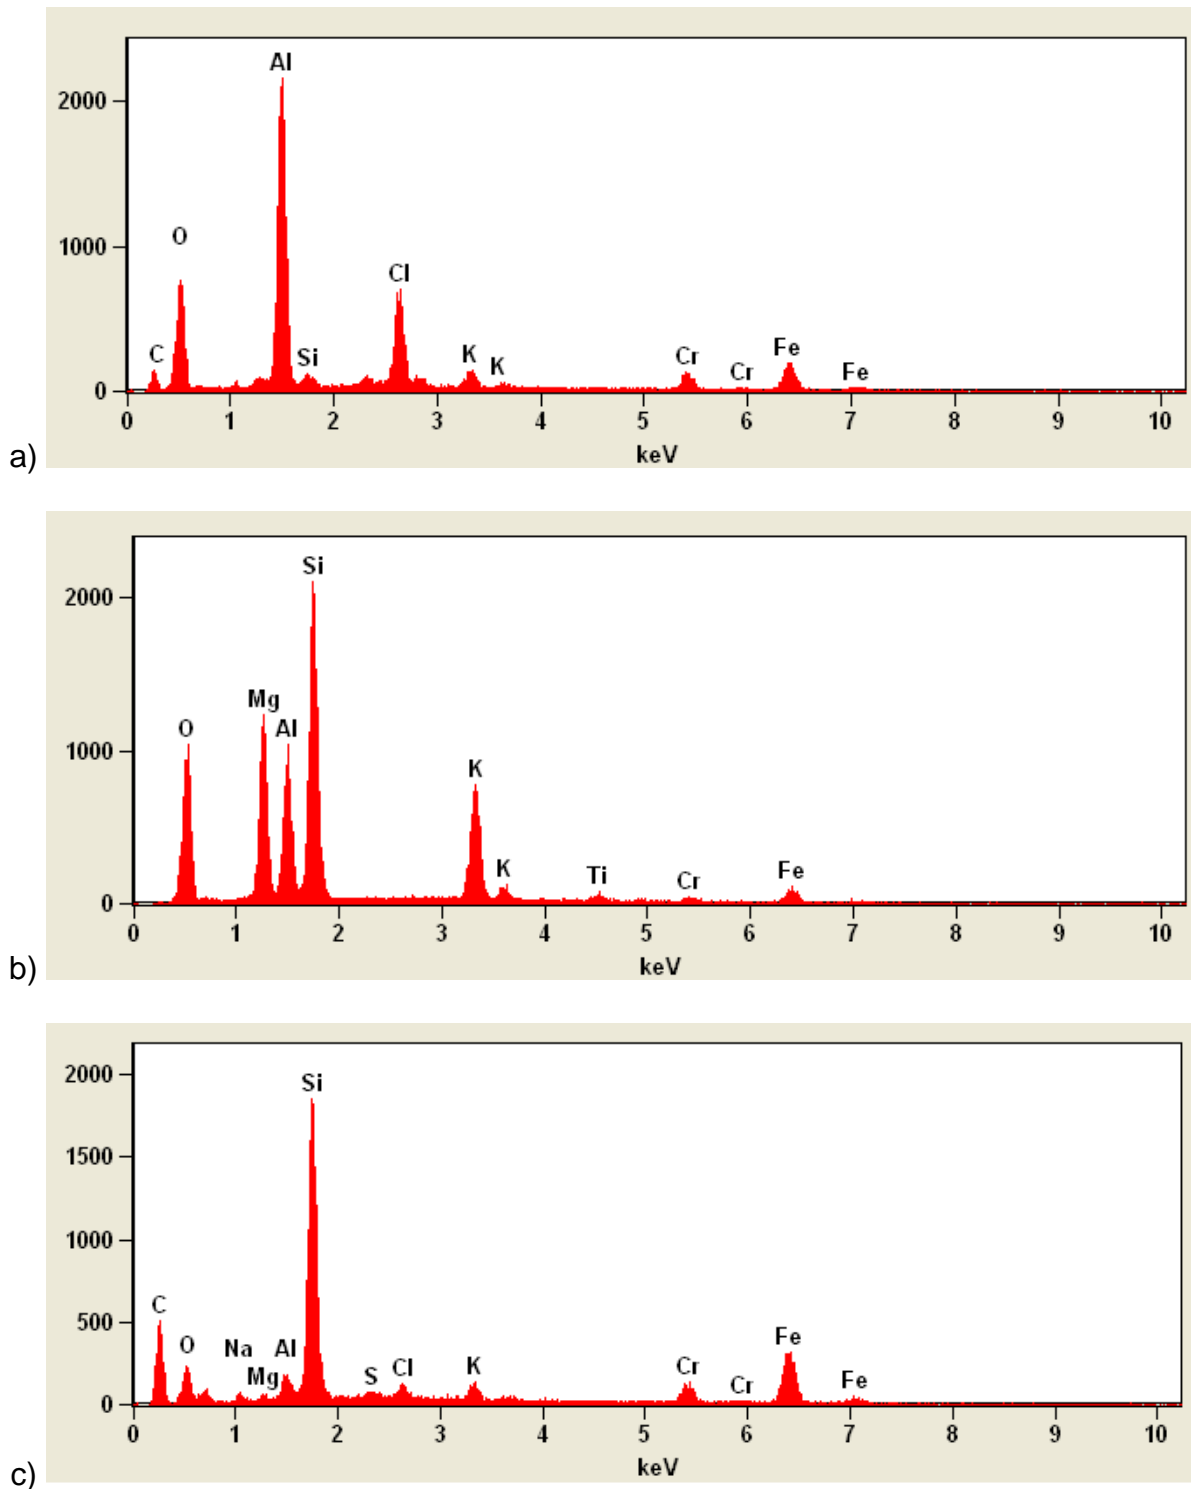
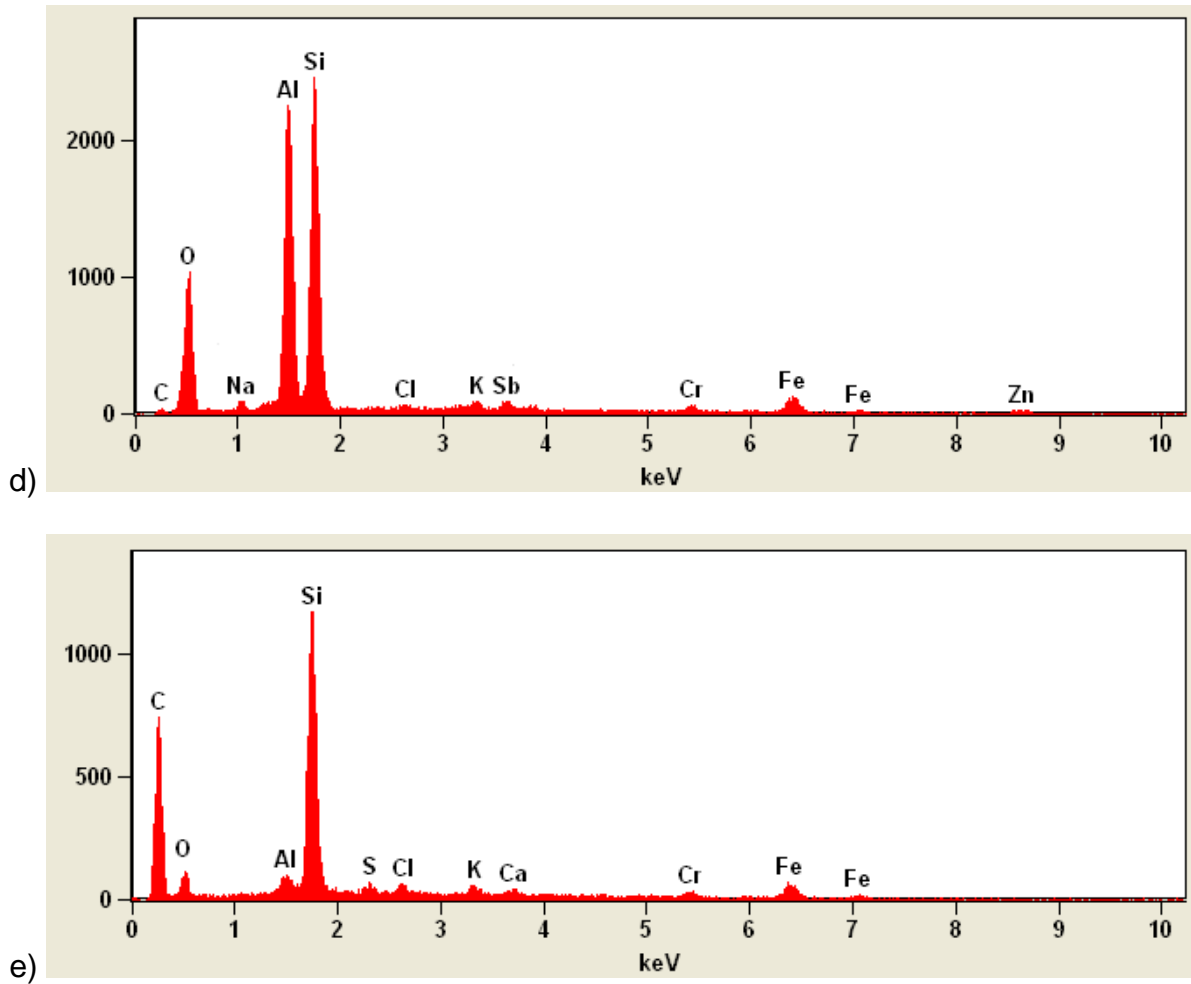
Figure 10: EDS spectra of embedded particles found in the deformed edge region of the Number 1 engine pilot valve piston. The locations of spectra a,b, and c are labeled in figure 9.

Figure 10 (cont.): The locations of spectra d and e are labeled in figure 9.

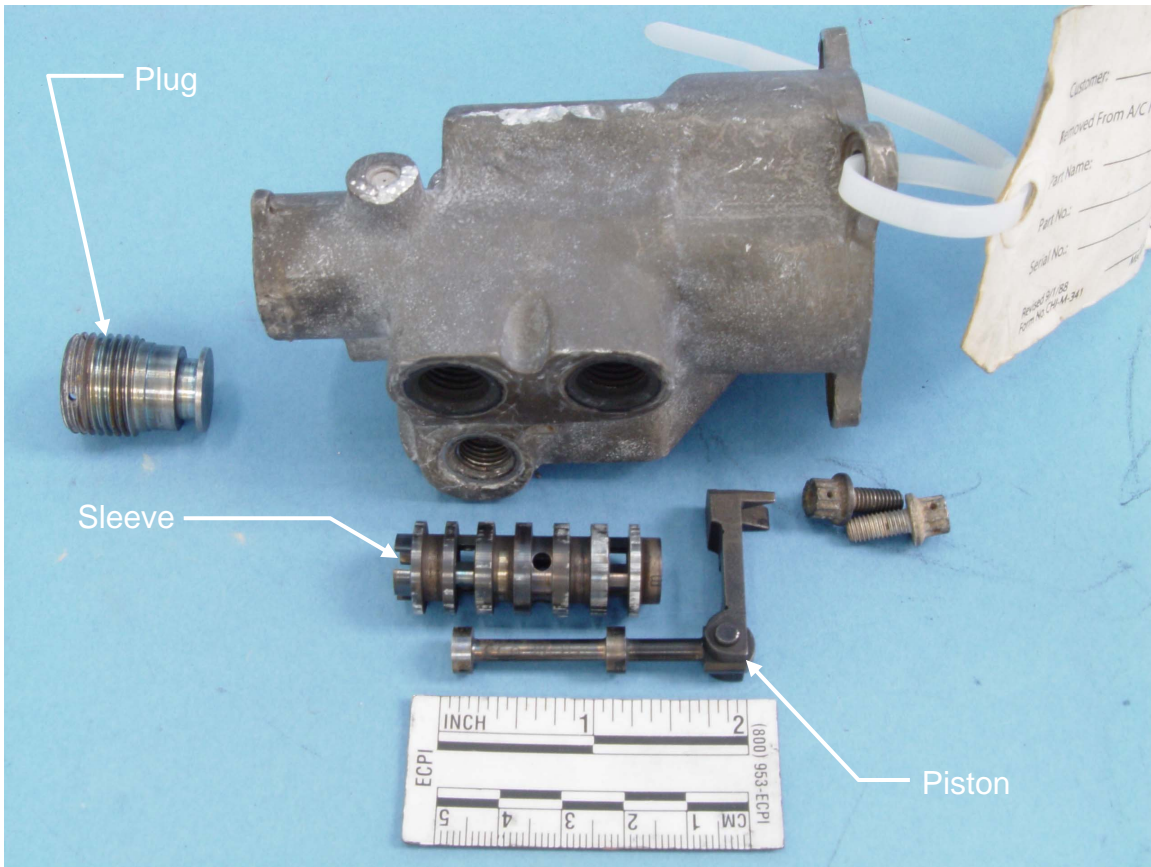
The Number 2 engine pilot valve was disassembled as shown in figure 11. The piston had already been extracted from the sleeve in its as-received state and could be inserted and removed from the sleeve by hand. After the plug was removed, the sleeve would not slide out of the assembly. The sleeve was extracted from the housing by heating the assembly in an oven to 175 °C for 15 min, placing it in a vice, pressing a flat end punch against the back of the sleeve and tapping it out of the housing. The pressure of the vice caused some deformation to the housing. The o-rings were brittle, crumbled, and some were partially burned. A side view of the sleeve and piston is shown in figure 12. Metal transfer from the manual extraction process was observed on the outer diameter of the sleeve. The stem and rectangular regions on the left and right piston valves had a dark brown/blue discoloration consistent with exposure to heat. The size and shape of the dark rectangular regions were consistent with the dimensions of the stator vane actuator ports on the sleeve.

Figure 11: Number 2 engine pilot valve assembly after disassembly.

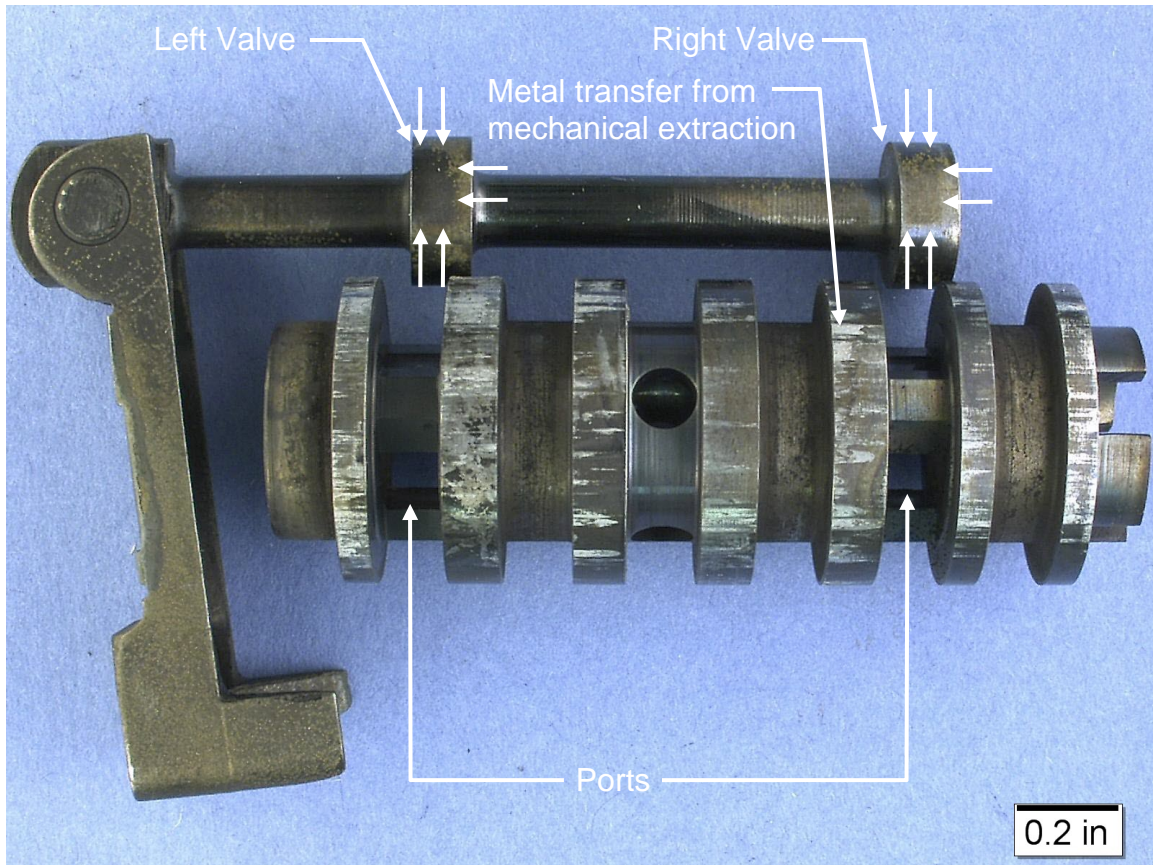
Figure 12: Photograph of the piston and sleeve from the Number 2 engine pilot valve. The valves on the piston have dark rectangular regions indicated by short arrows that are similar in size and shape to the stator vane actuator ports on the sleeve. The outside of the sleeve showed metal transfer marks consistent with the mechanical force required to extract it from the aluminum housing.

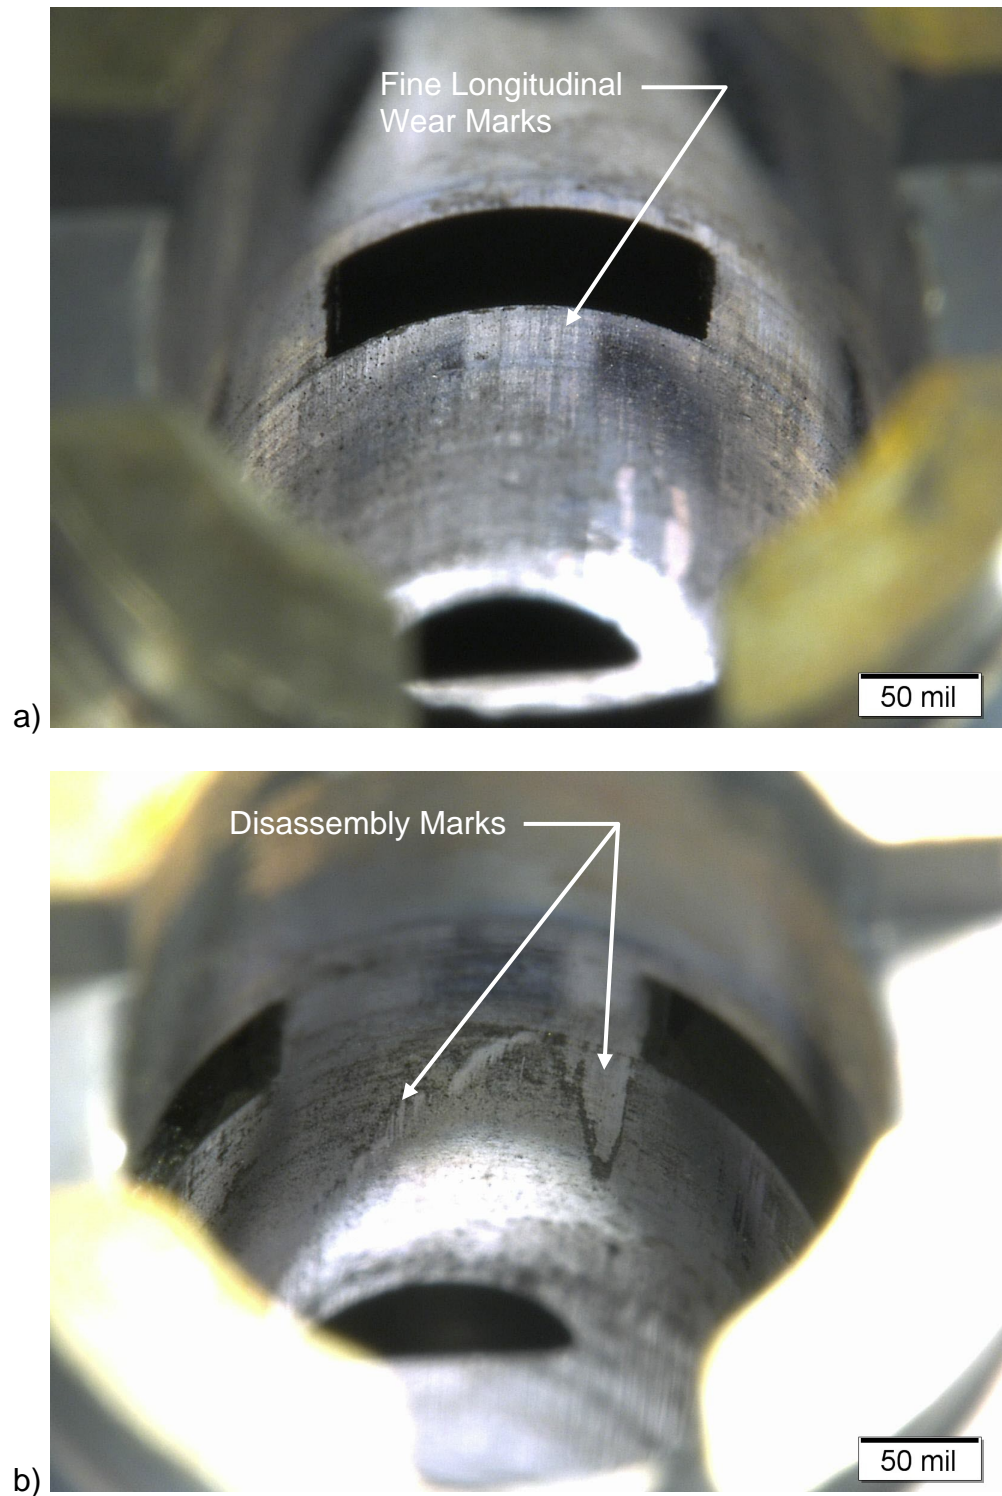
The inner bore of the sleeve appeared smooth with regions of brown/blue discoloration, occasional fine longitudinal wear marks, and marks resulting from the disassembly process. Fine longitudinal wear marks could be seen near the right stator vane actuator port as shown in figure 13a. Further down the bore were wear marks shown in figure 13b that had a metallic color, consistent with formation after exposure to heat. Occasional fine residual particles of unknown origin were observed on the inner bore of the sleeve similar to the sleeve in the Number 1 engine pilot valve. There was no resolvable metallic debris or fibrous debris.

Figure 13: Micrographs of the Number 2 engine pilot valve sleeve inner cylinder. The micrographs were taken at the right end of the sleeve; a) fine longitudinal wear marks and b) disassembly marks.

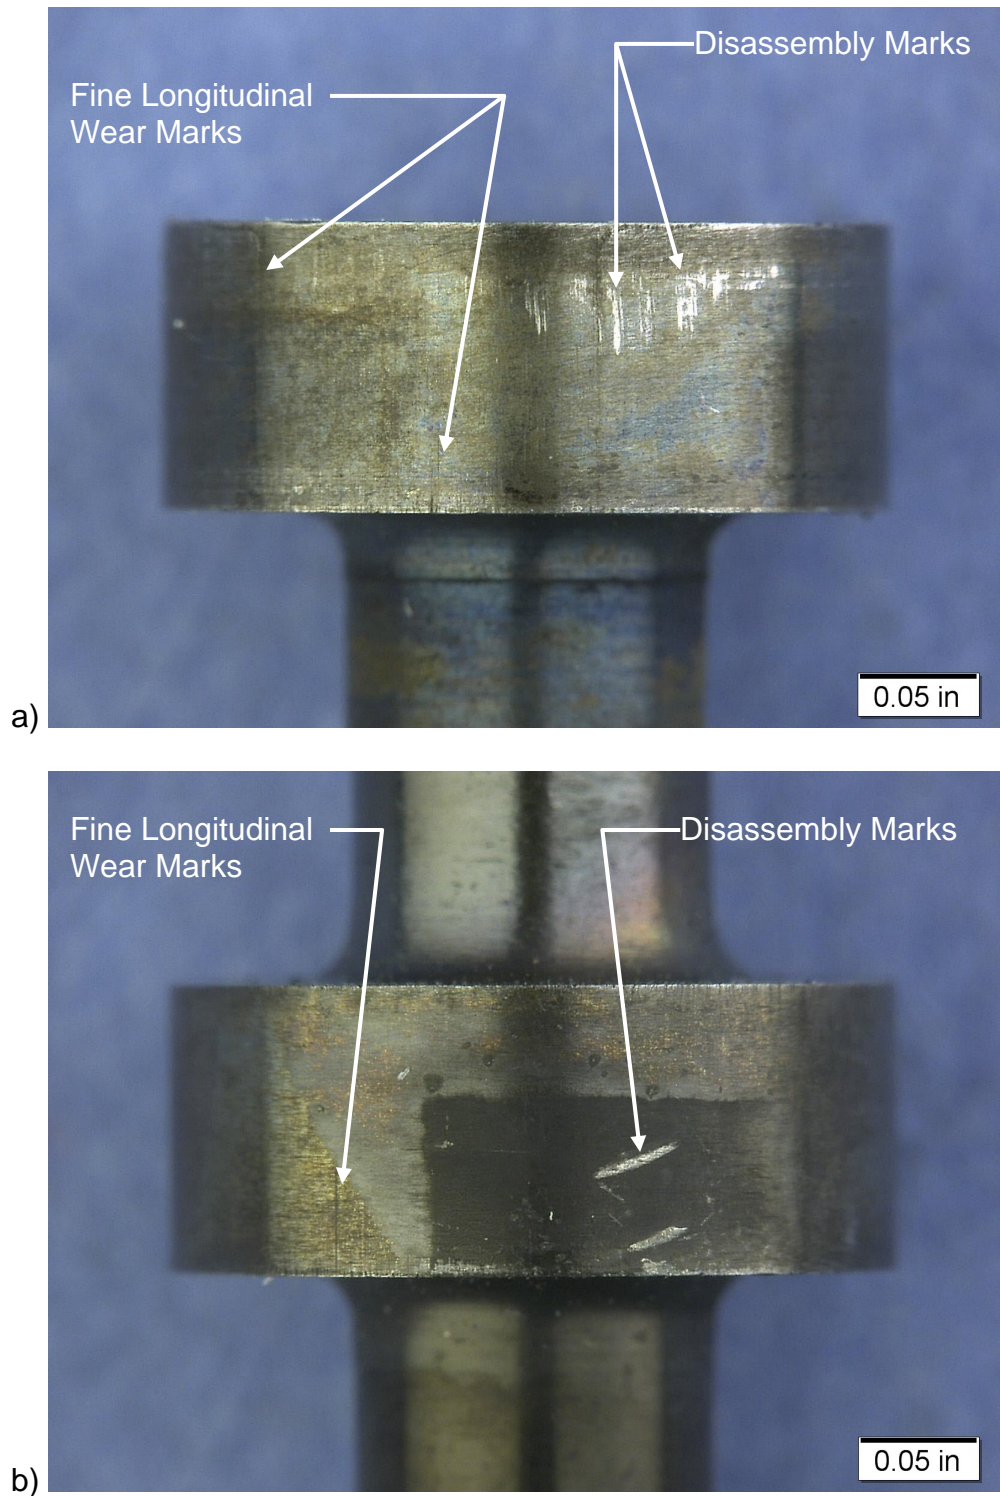
The surface finish on the piston valves was marred by occasional fine longitudinal wear marks and marks resulting from the disassembly process. Micrographs of the right and left port piston valves are shown in figures 14a and 14b, respectively. Examples of typical fine wear marks are indicated in figures 14a and 14b. Other marks on the valves

had a metallic color and tracked across the surface at arbitrary angles as indicated, consistent with formation after exposure to heat and after disassembly of the piston.

Figure 14: Micrographs of the piston from the Number 2 engine pilot valve assembly; a) right piston valve and b) left piston valve (see figure 10).
