NATIONAL TRANSPORTATION SAFETY BOARD

MATERIALS LABORATORY FACTUAL REPORT

Report No. 09-033A

Place : North Canton, Ohio
Date : December 19, 2008
Vehicle : Piper PS-32R
NTSB No. : CEN09FA099
Investigator : Mitchell Gallo
NTSB-NCRA

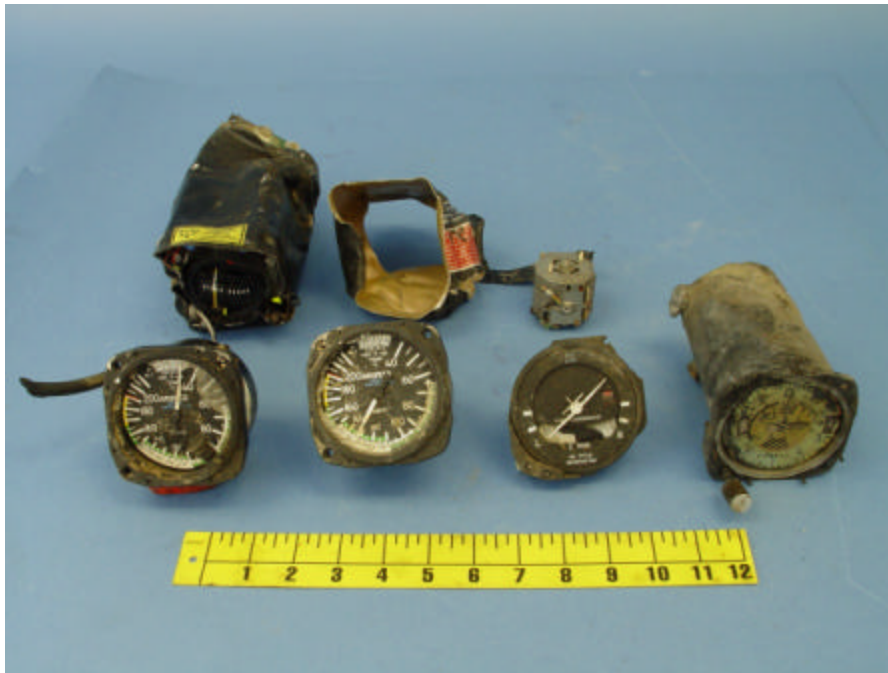
The indicators, gyro component, and annunciator panel were submitted to the Materials Laboratory for examination. The indicators and the gyro face as shown in Figures 1 and 2 were submitted to determine if there were any witness marks on the face of the indicators. No witness marks were found.

Figure 1. Overall (from left to right) of the two air speed indicators, horizontal situational indicator and the attitude indicator.

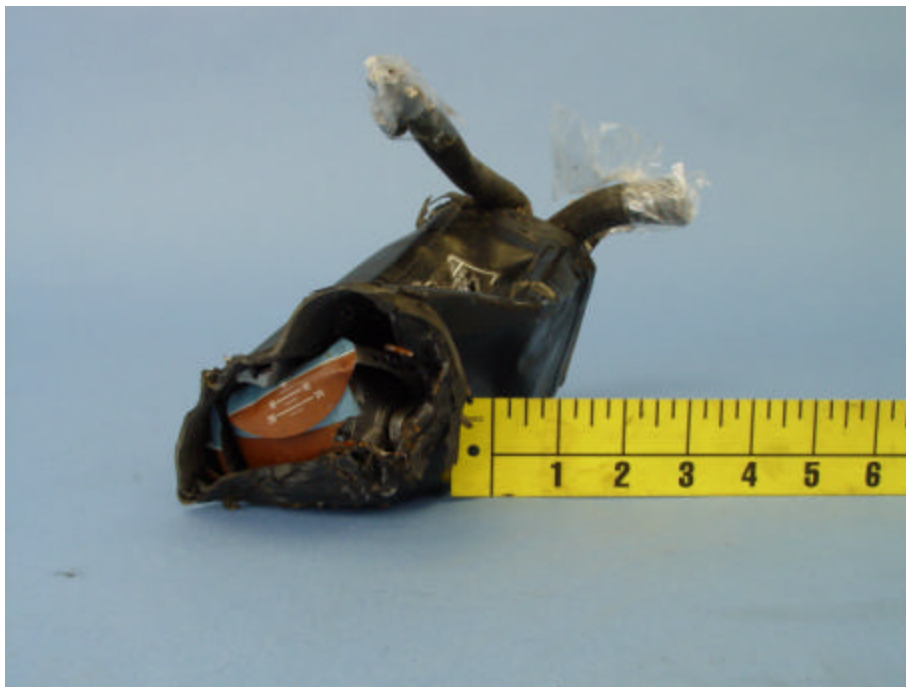
Figure 2. Directional gyro face

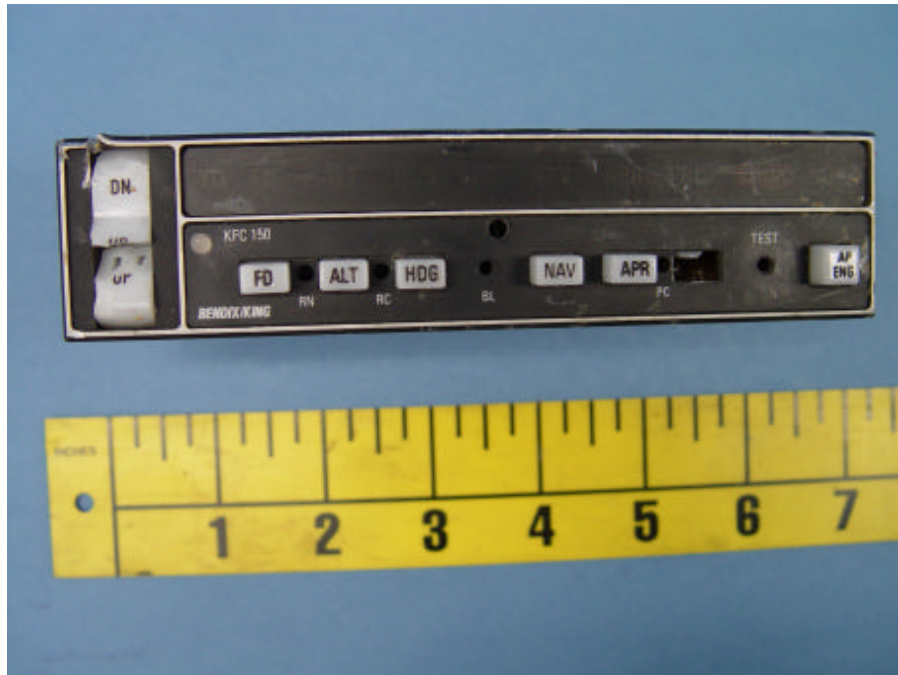
The annunciator panel was submitted to determine if there was hot stretching relaxation of the coils in the filaments of the indicator light bulbs shown in Figure 3. The annunciator panel light designations are shown in the chart below. The DN/UP switch on the left was a flip switch. The upper row "DN" contained indicator lights and the lower row "UP" were push buttons.

Figure 3. Annunciator panel

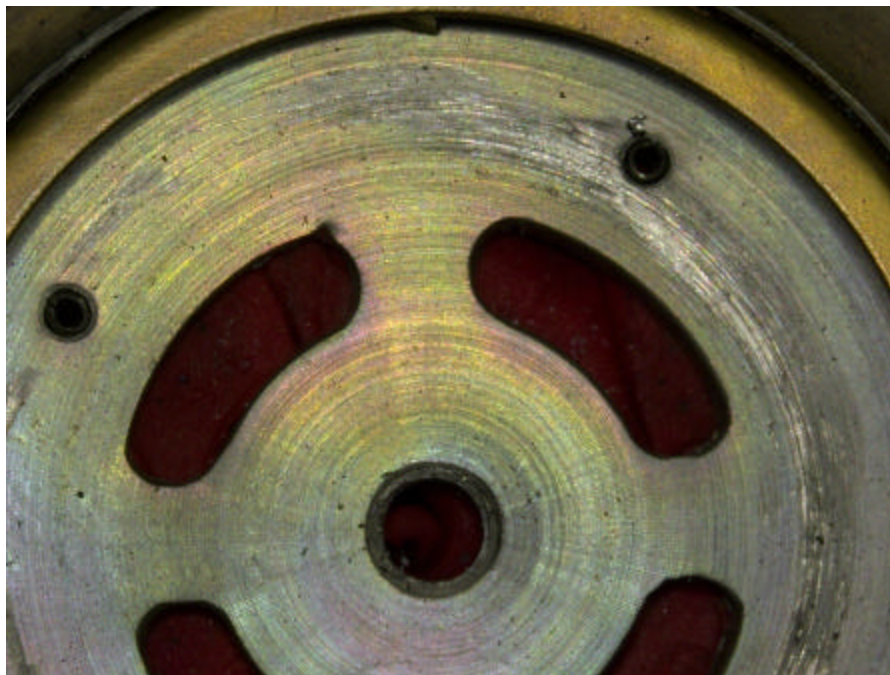
The unidentified gyro component was submitted to determine if it was rotating at the time of the impact. A partial circumferential smear was found on the gyro case as shown in Figure 4. The fins on the back of the gyro also demonstrated smearing as shown in Figure 5.

Figure 4. Smearing on gyro case

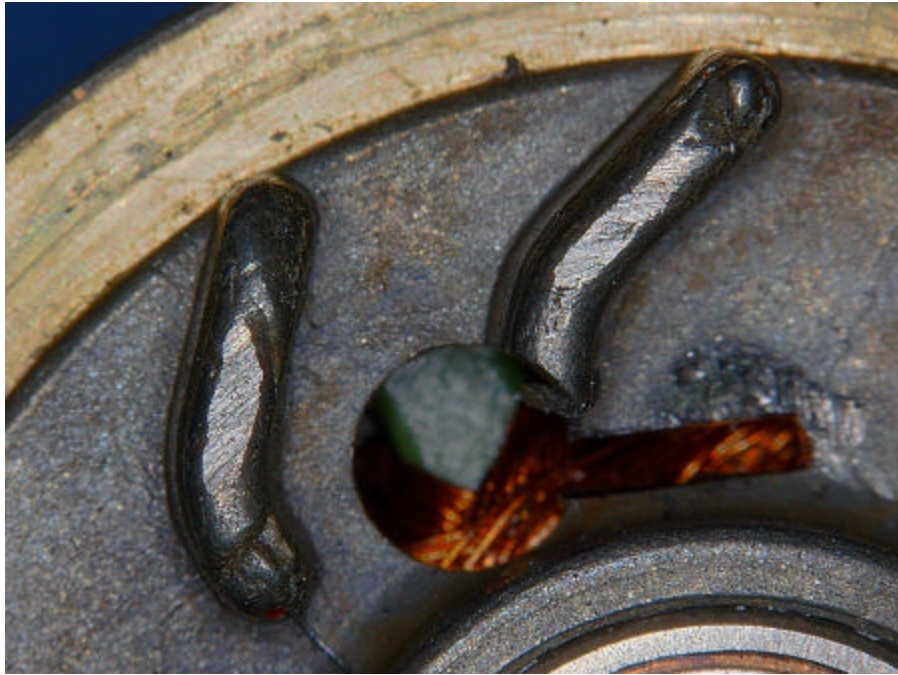
Figure 5. Smearing on fins of gyro

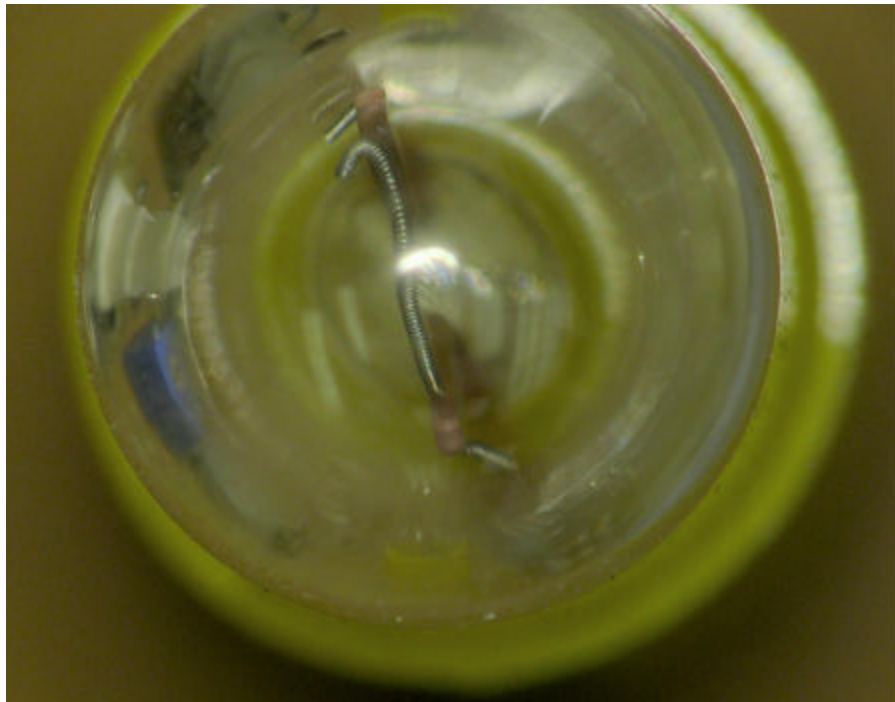
The filaments from the light bulbs for the “DN” and “UP” APR light, the “DN” and “UP” FD light, the AP light and the AP engine light were examined for stretching. The “DN” APR light filament was broken but not stretched as shown in Figure 6. The “UP” APR light filament was stretched as shown in Figure 7. The “DN” FD light filament was not stretched as shown in Figure 8. The “UP” FD light was stretched as shown in Figure 9. The AP light filament was not stretched as shown in Figure 10. The AP ENGINE light filament was stretched as shown in Figure 11.

Figure 6. "DN" APR light filament

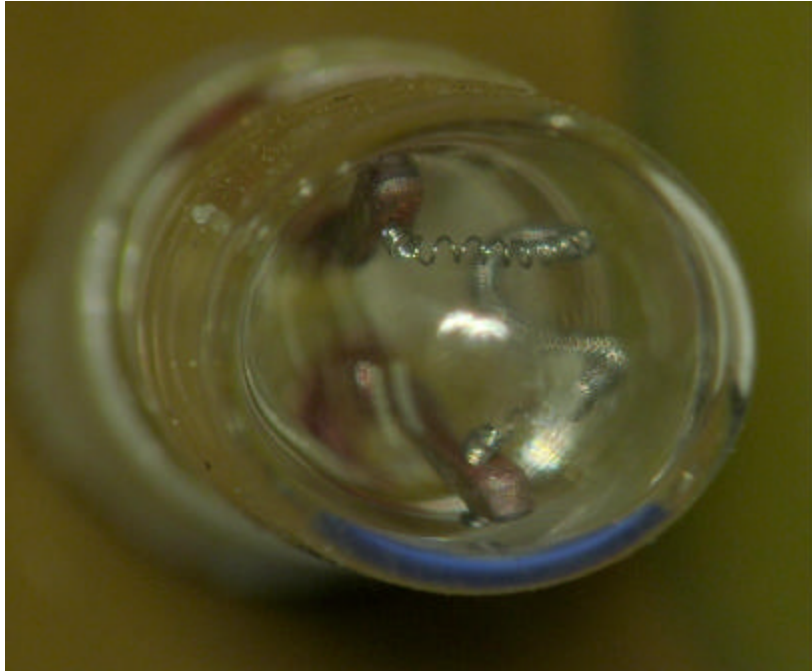
Figure 7. "UP" APR light filament

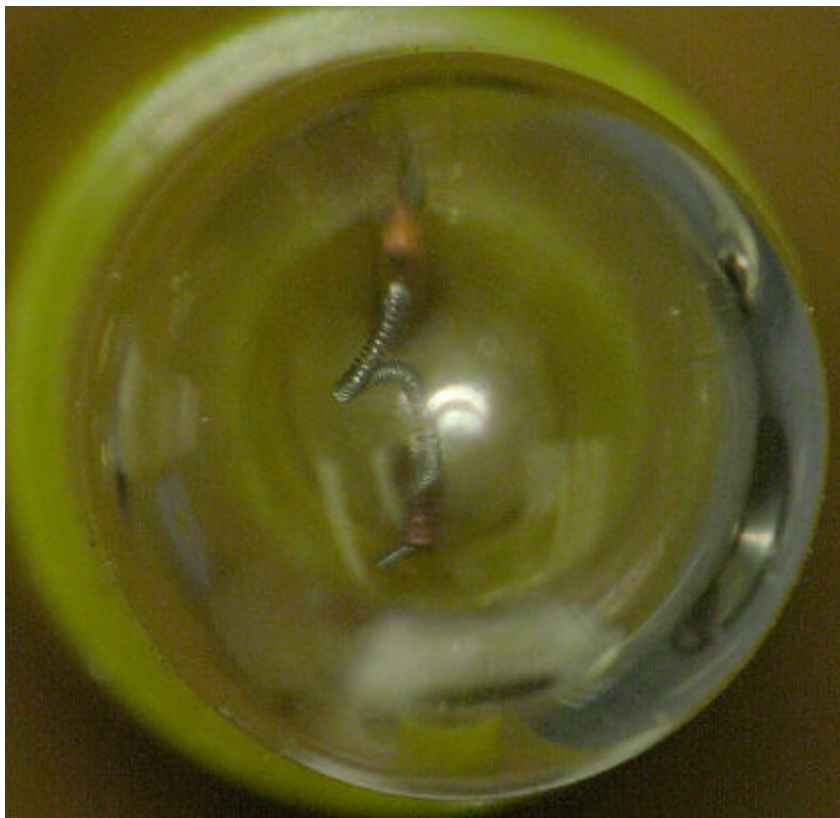
Figure 8, "DN" FD light filament

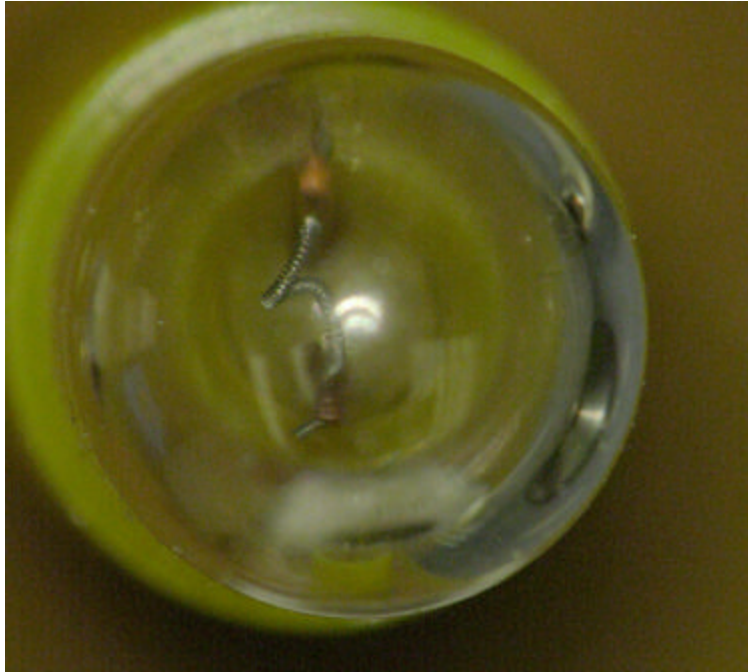
Figure 9. "UP" FD light filament

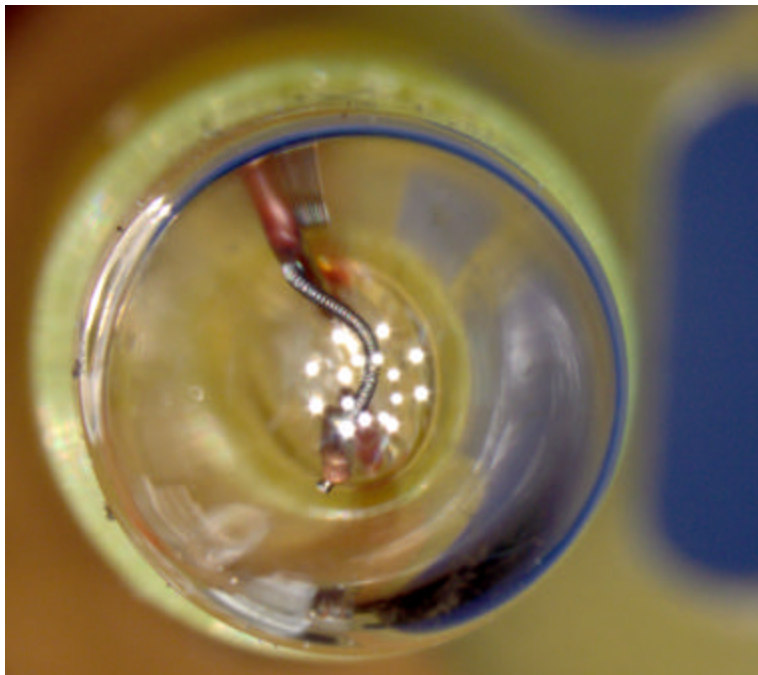
Figure 10. AP light filament

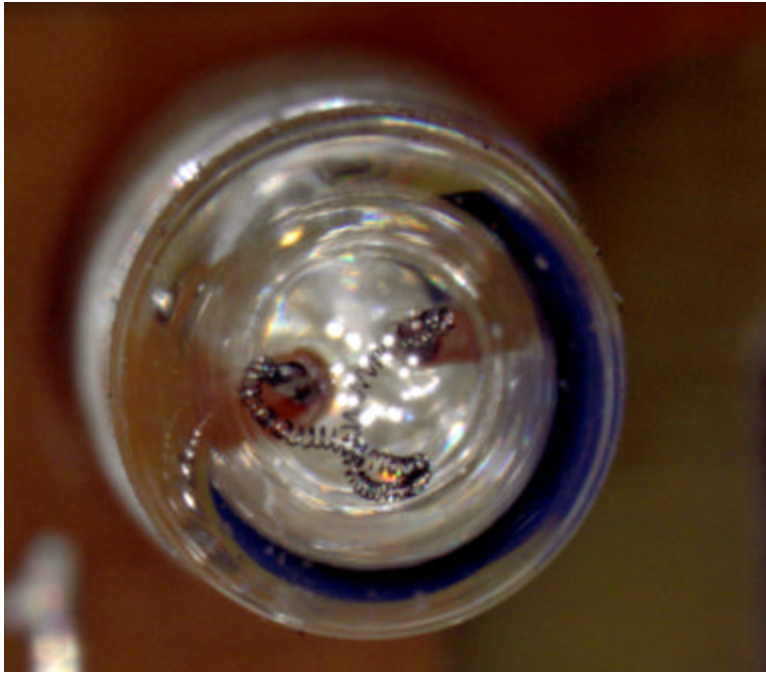
Figure 11. AP Engine light filament
