NATIONAL TRANSPORTATION SAFETY BOARD

MATERIALS LABORATORY FACTUAL REPORT

Report No. 09-055

Place : Denver, Colorado
Date : December 20, 2008
Vehicle : Boeing 737-500
NTSB No. : DCA09MA021
Investigator : Mark George

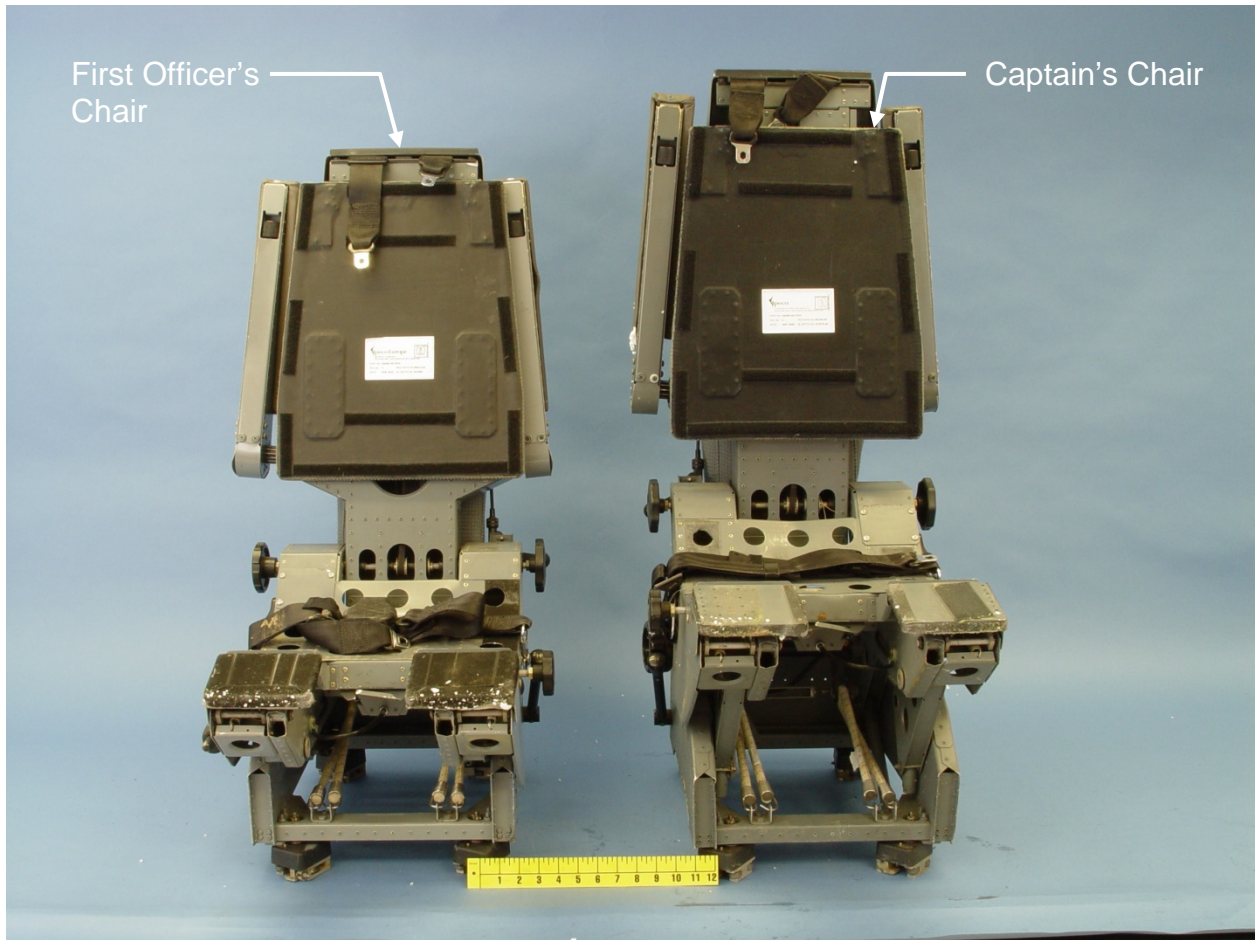
The captain's chair, first officer's chair and flight attendants' jump seat were received by the NTSB Materials Laboratory in the condition shown in figures 1 and 2. The harness anchor points on the front of the captain's chair seat bottom and first officer's chair seat bottom were fractured as shown for the captain's chair in figure 3. The fracture surface was consistent with an overstress fracture. The jump seat had been partially disassembled. The seat back of the flight attendants' jump seat had been removed from the seat assembly. Rods on the seat back retraction mechanism on either side of the seat back had fractured near the threaded ends. The seat belts showed no signs of excessive wear or tearing and were not examined further.

Figure 1: Photograph of the first officer's chair and captain's chair as-received.

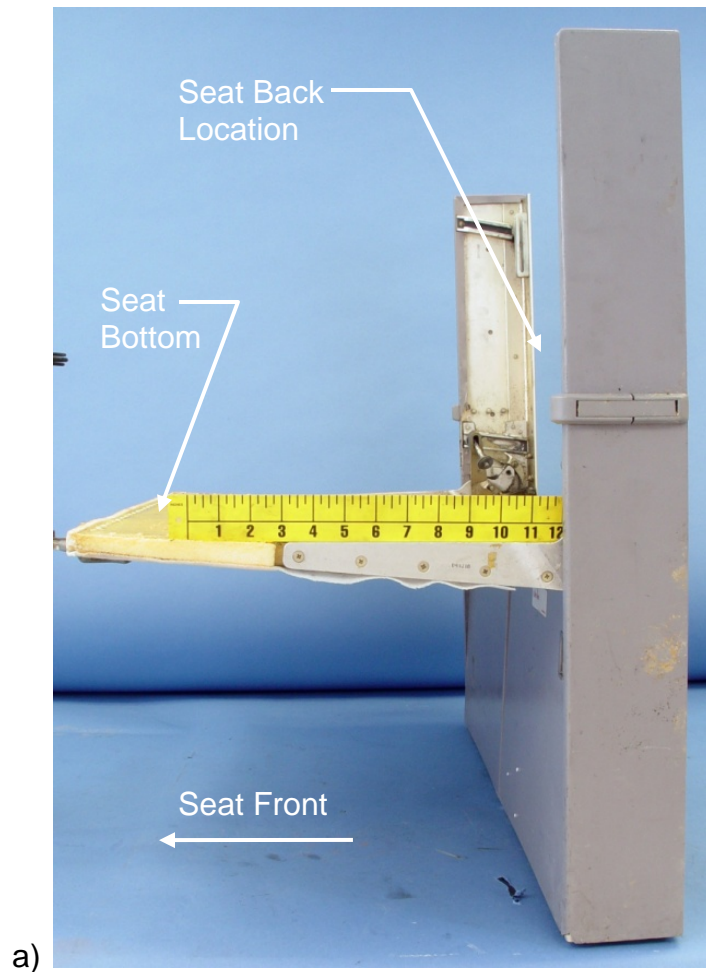
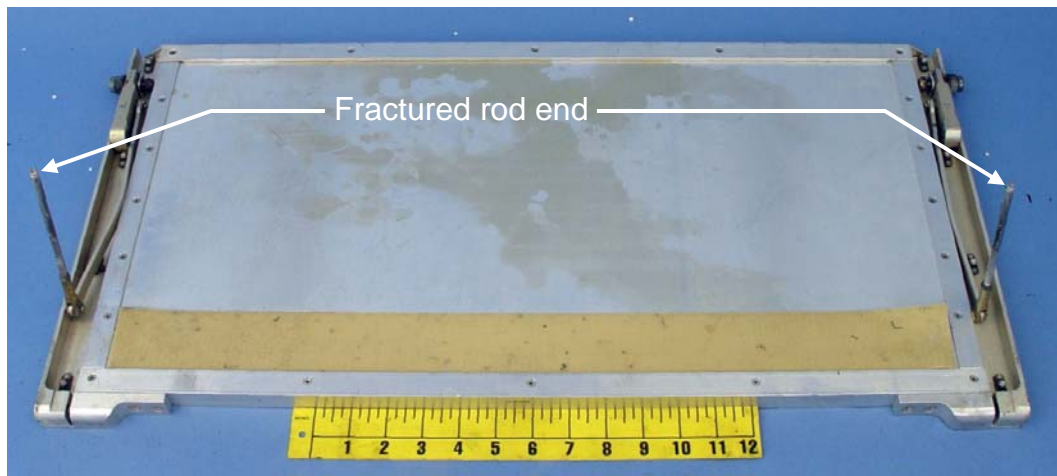
Figure 2: Photographs of the flight attendants' jump seat as-received; a) the seat bottom and shroud assembly; b) seat back viewed from the (hidden) backside.

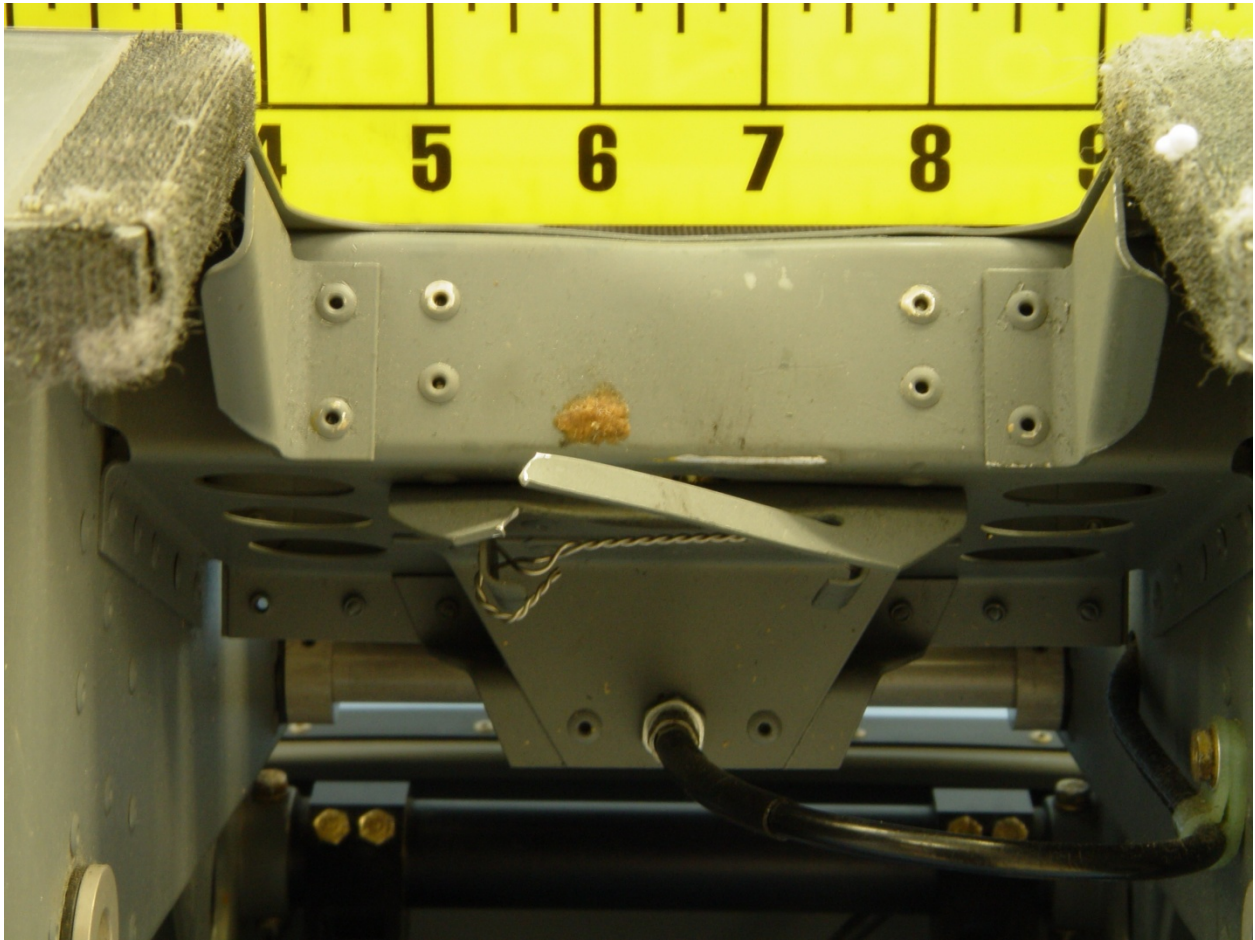
Figure 3: Fractured harness anchor point on the captain's chair.

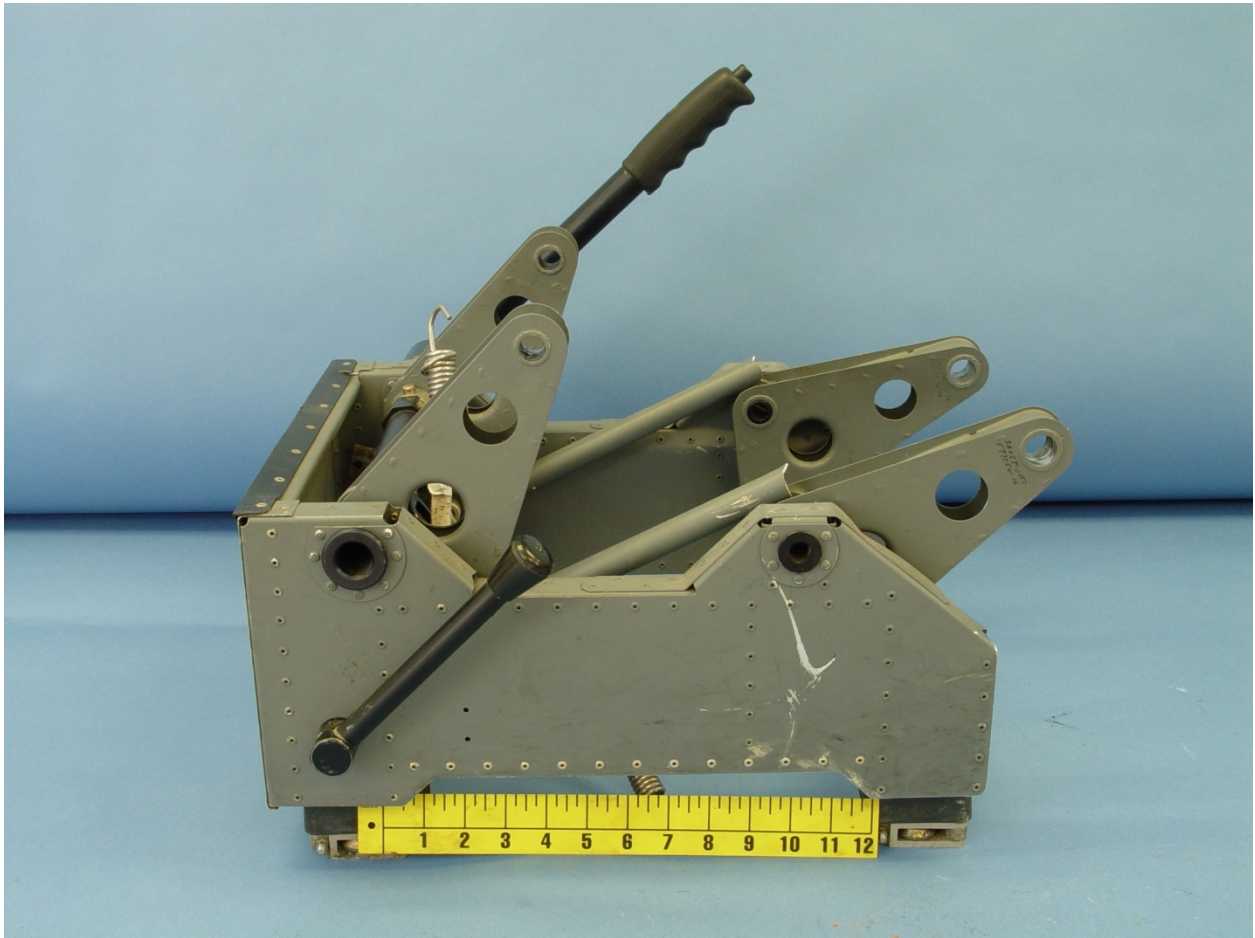
The seat bottom and seat back for each chair were removed in order to more closely examine the base of each chair. The base of the captain's chair is shown in figure 4 after removal of the seat. The linkage tubes and arm lifts were disassembled as shown in figure 5. The frames of both chairs were slightly deformed inward at the top. The linkage tubes on the captain's chair had fractured near the forward end as shown in figure 6a. The fracture surface was rough and at a 45° angle to the longitudinal axis as shown in figure 6b, consistent with an overstress fracture. The linkage tubes on the first officer's chair were intact. The outward facing flats on the pin guides of the rear arm lifts were scratched and deformed on both chairs as shown in figures 6a and 7, for the captain's chair and first officer's chair, respectively.

Figure 4: Photograph of the captain's chair after removal of the seat bottom and seat back.

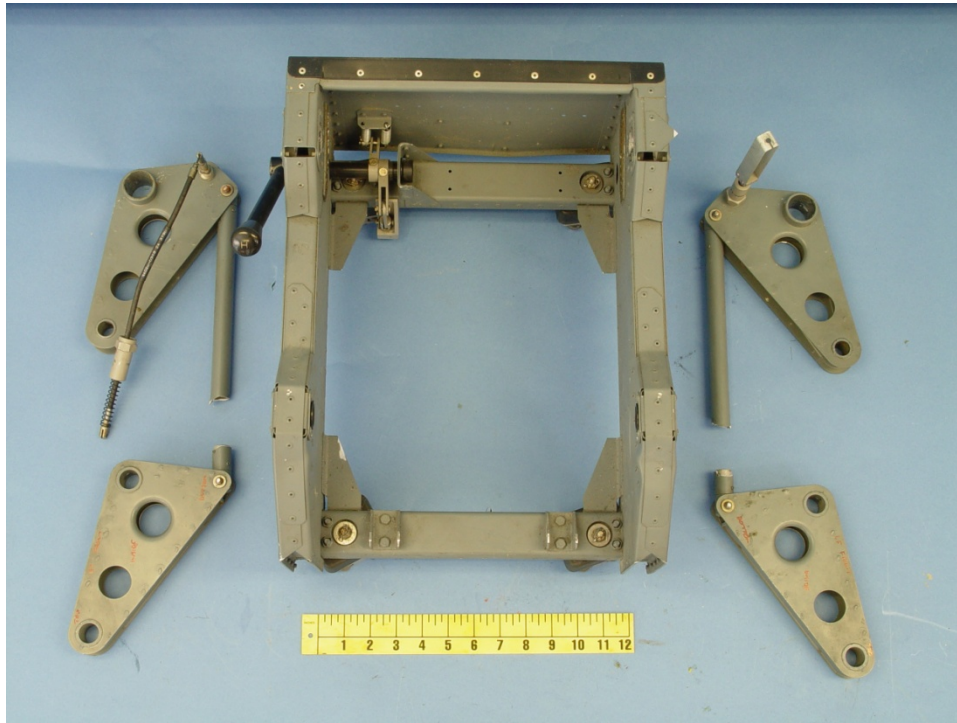
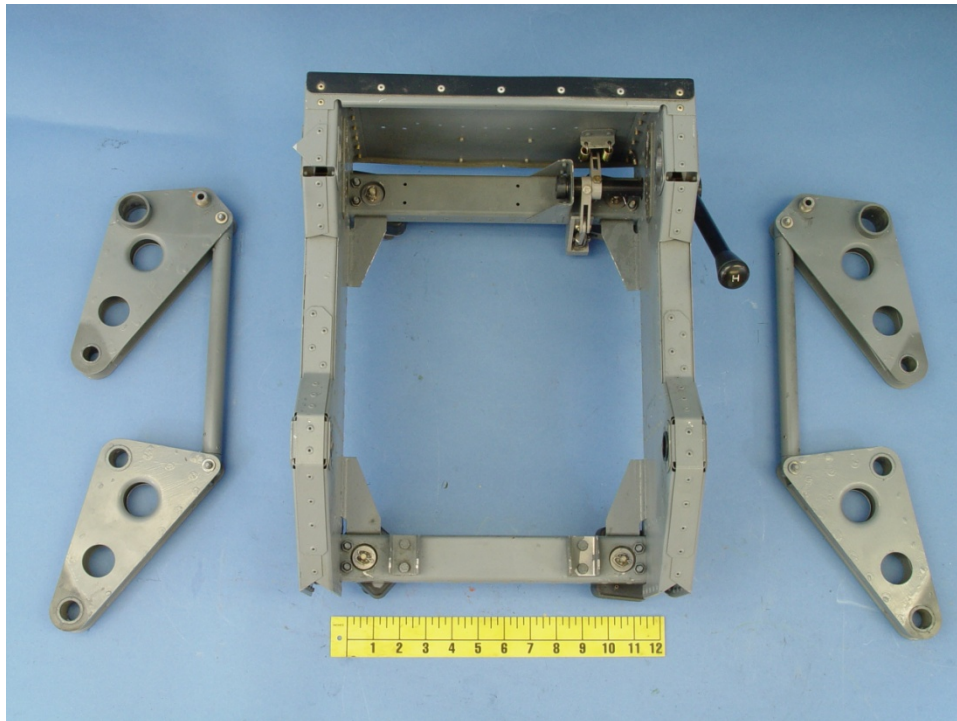
Figure 5: Photographs of flight deck chairs after disassembly of the chair lift mechanisms; a) captain's chair; b) first officer's chair.

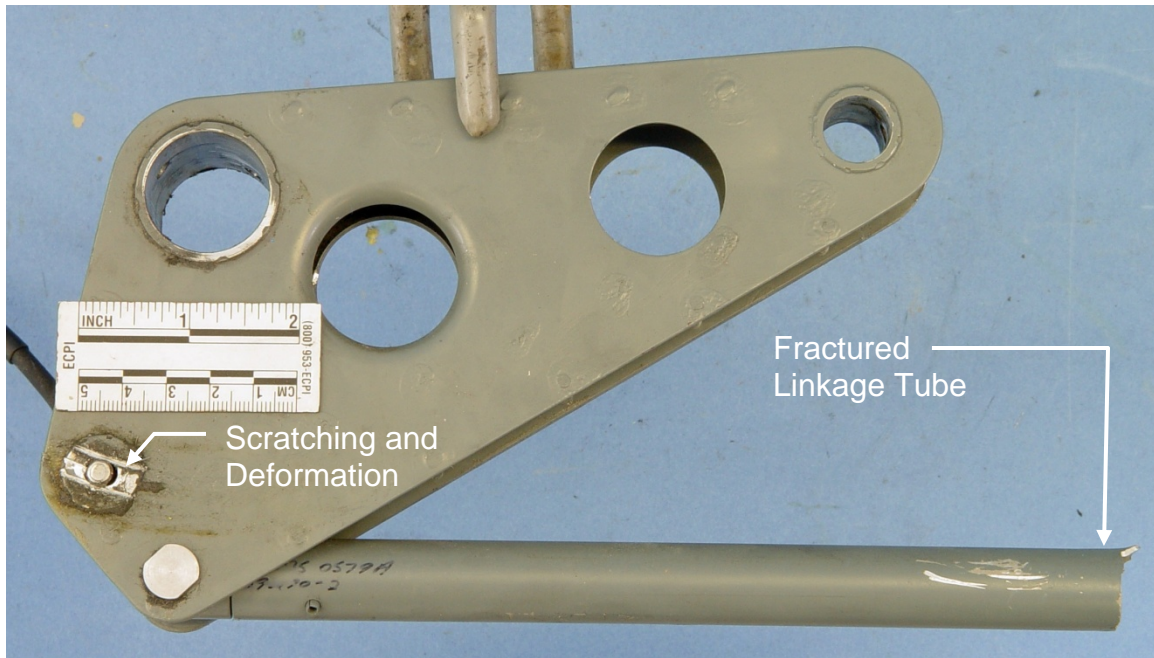
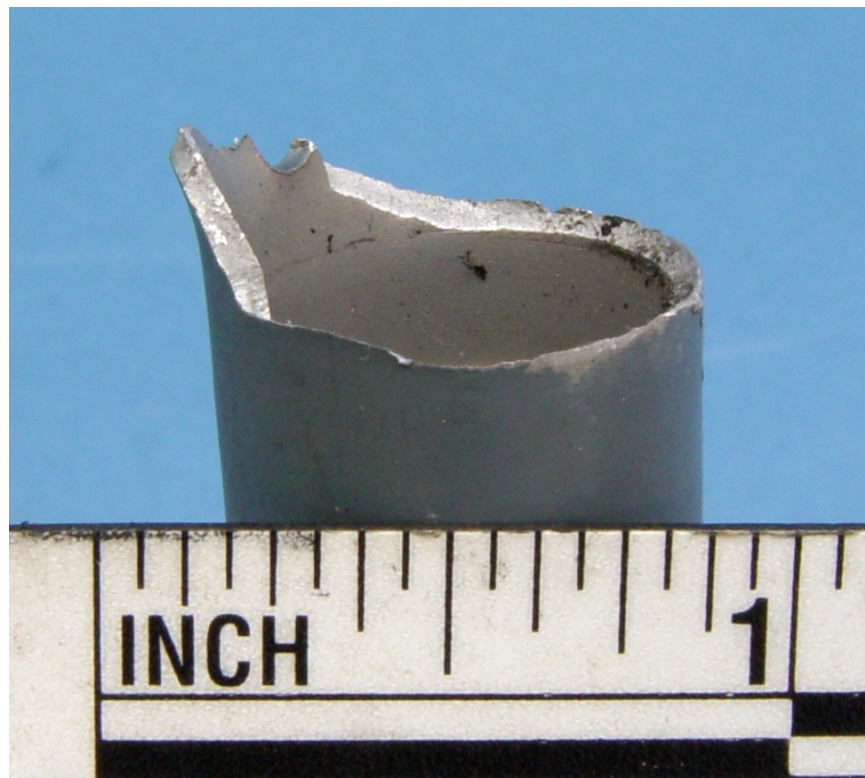
Figure 6: a) Photograph of an arm lift and fractured linkage tube from the captain's chair; b) Higher magnification image of the linkage tube fracture surface, consistent with overstress fracture.

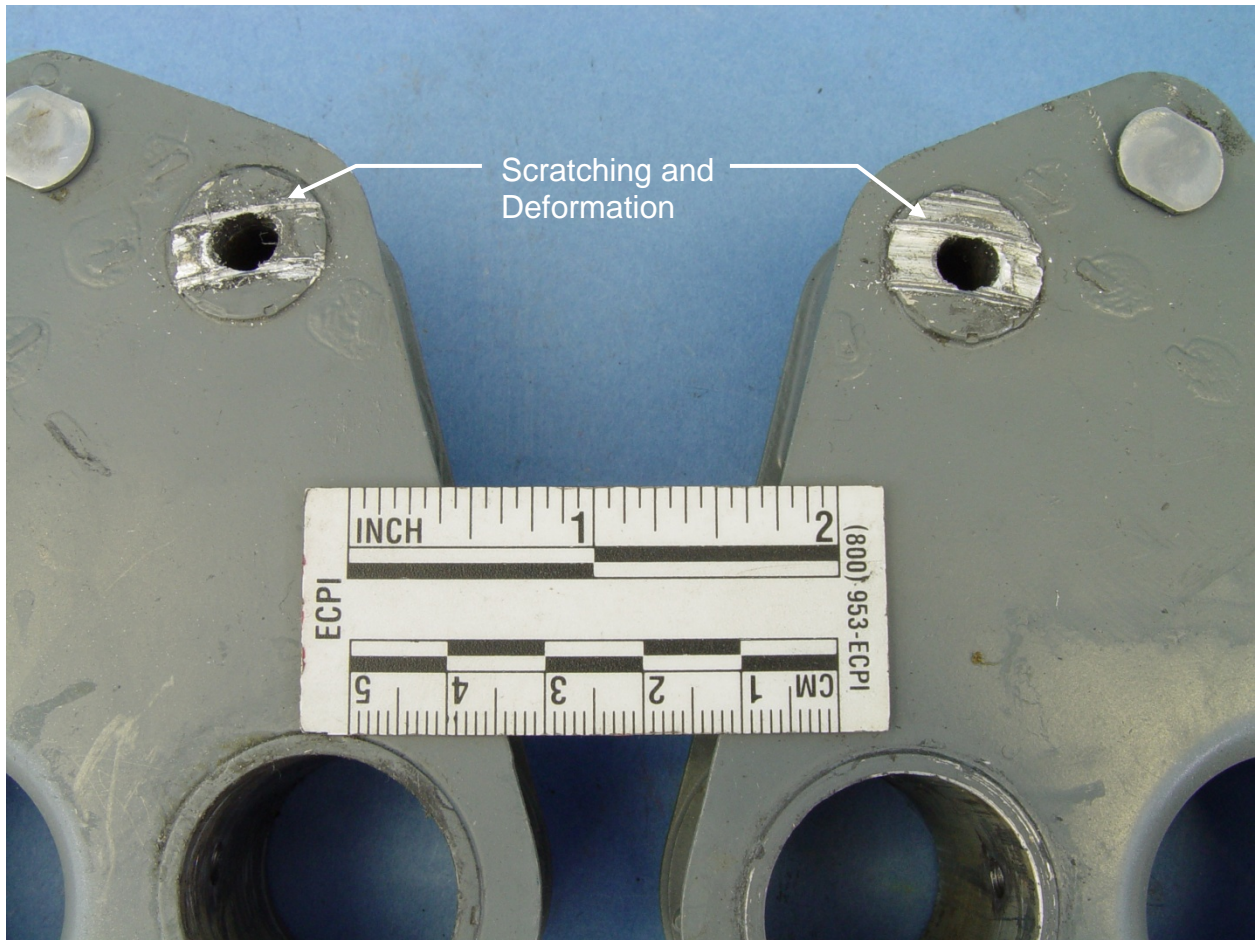
Figure 7: Photograph of the first officer's chair arm lifts. The flat faces on the pin guides are scratched and deformed.

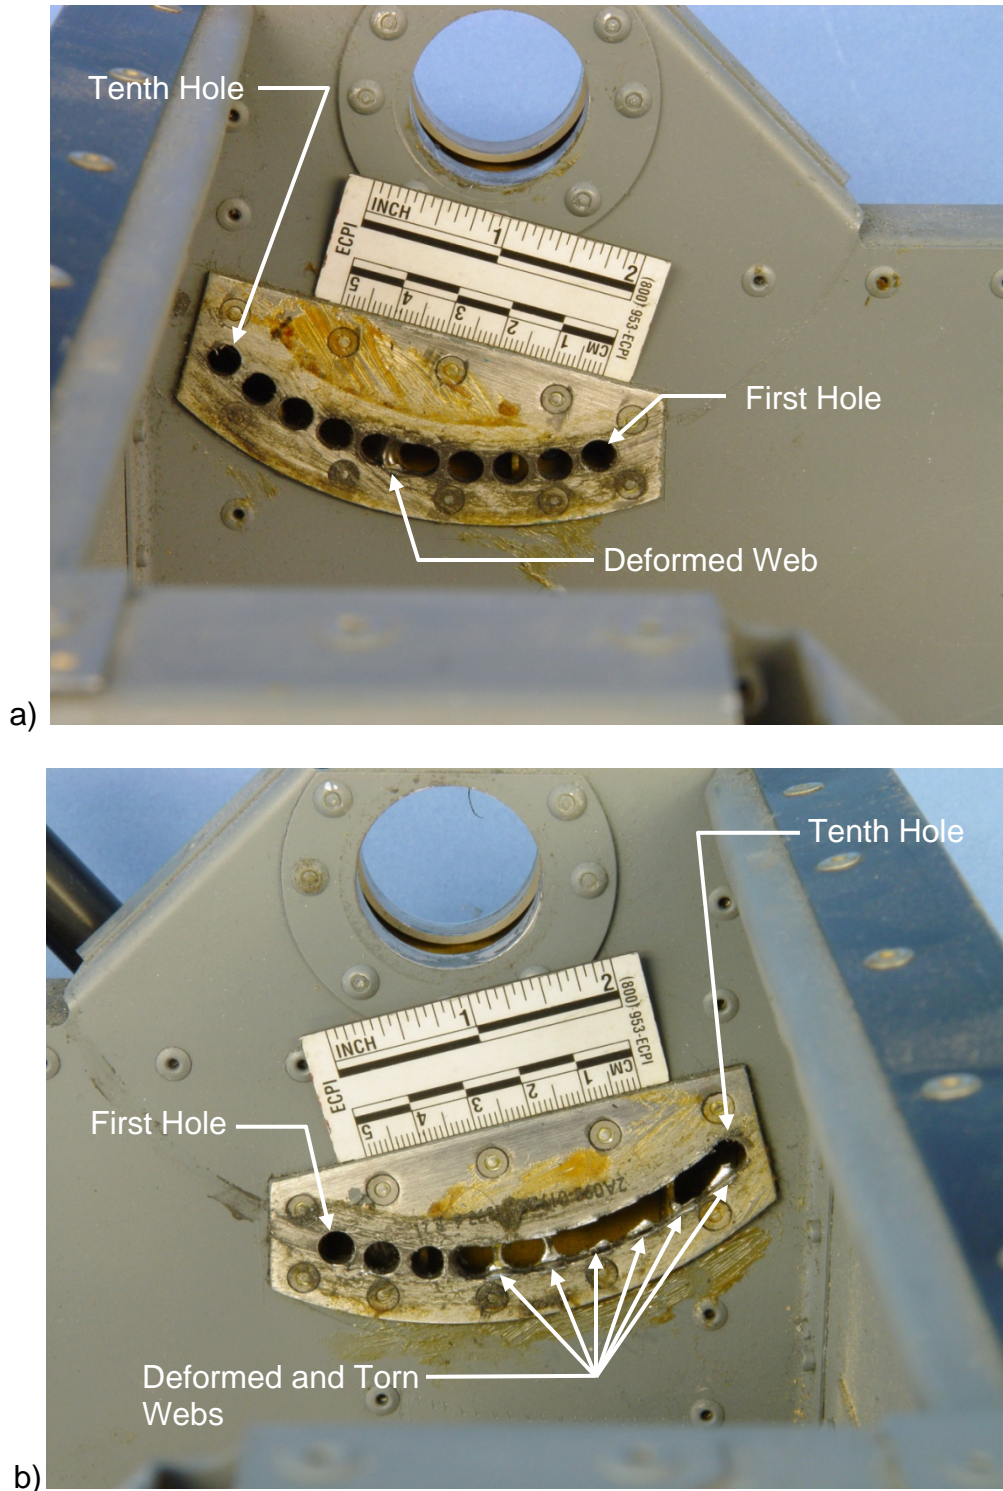
The left and right height adjustment lock plates for the captain's chair and first officer's chair are shown in figures 8 and 9, respectively. The lock plates on the captain's chair were covered with grease and dirt. The lock plates on the first officer's chair were clean to the unaided eye. Deformation was observed on the captain's chair lock plates. The web between the fifth and sixth hole on the left side lock plate was deformed in the aft direction as shown in figure 8a. By comparison, the webs on the right side lock plate were deformed or completely torn between the fourth and tenth holes. The deformation to the webs caused a raised edge to form along lines tangent to the tops and bottoms of the holes. The lock plates on the first officer's chair were also deformed. The webs on the left and right plates were torn and deformed between the eighth and tenth holes as shown in figures 9a and 9b, respectively. The deformation to the webs caused a raised edge to form along lines tangent to the tops and bottoms of the holes.

Figure 8: Seat height adjustment lock plates on the captain's chair. The faces of both plates were coated with dirt and grease; a) The left side lock plate had a deformed web between the fifth and sixth hole; b) The right side lock plate had deformed and torn webs between the fourth and tenth holes.

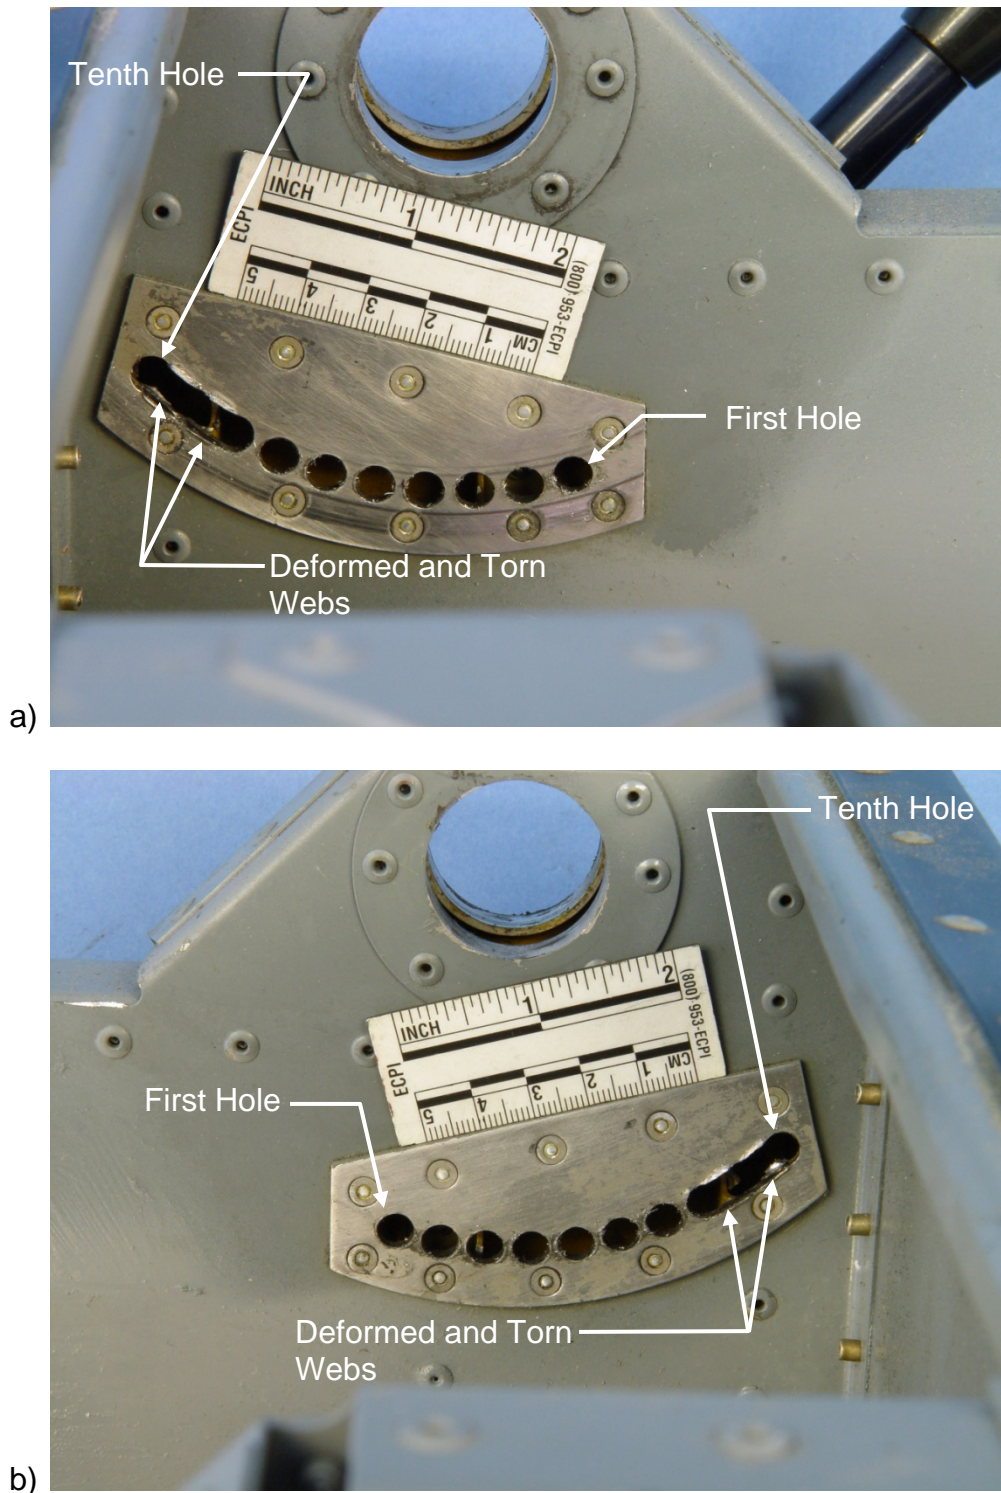
Figure 9: Seat height adjustment lock plates on the first officer's chair. Both sides had deformed and torn webs between the eighth and tenth holes; a) Left side lock plate; b) Right side lock plate.

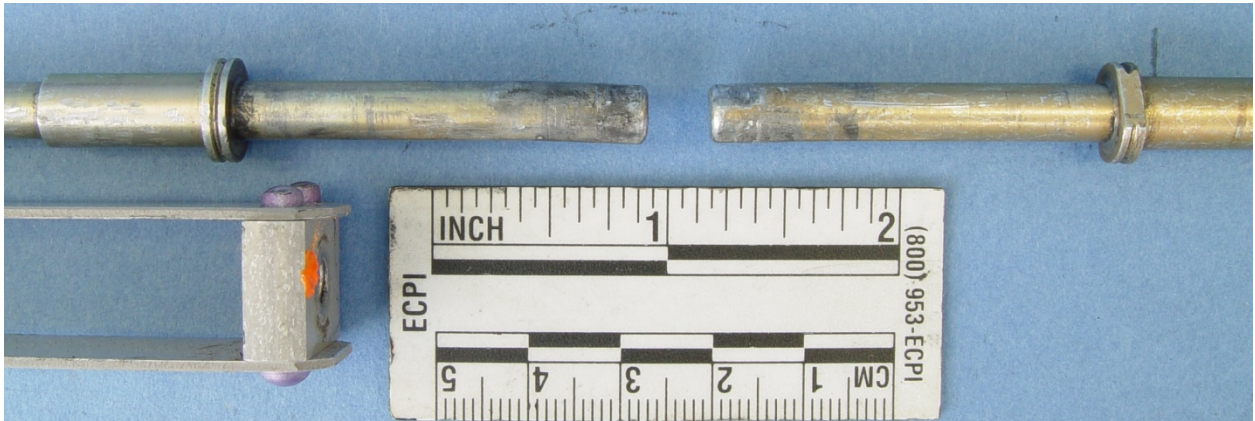
The seat height pins from the first officer's chair were removed from the arm lifts as shown in figure 10. Each pin had a slight bend along the outermost 0.5 inch of the pin.

Figure 10: The seat height adjustment lock pins from the first officer's chair.

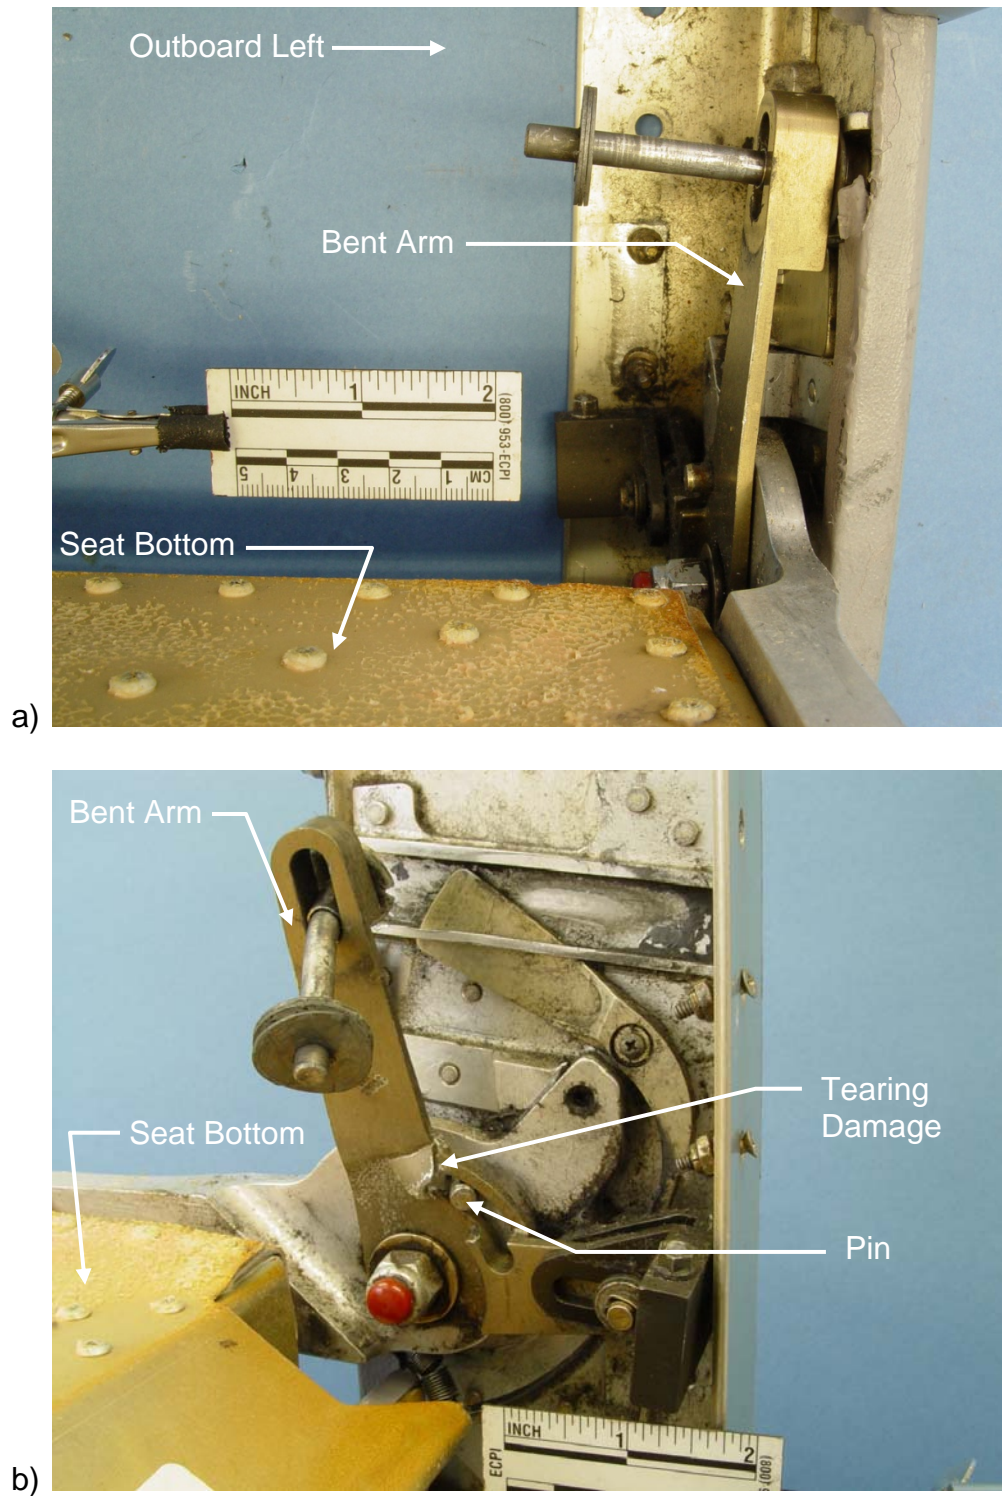
The left and right side seat back tracking mechanisms inside the jump seat shroud were deformed as shown in figure 11a and 11b. Both arms were deformed to the left side of the seat. The right side mechanism sustained tearing damage where a pin had been forced past the end of its track.

Figure 11: Photographs of the flight attendants' jump seat showing deformation to the seat back tracking mechanism; a) Left side of the seat; b) Right side of the seat.

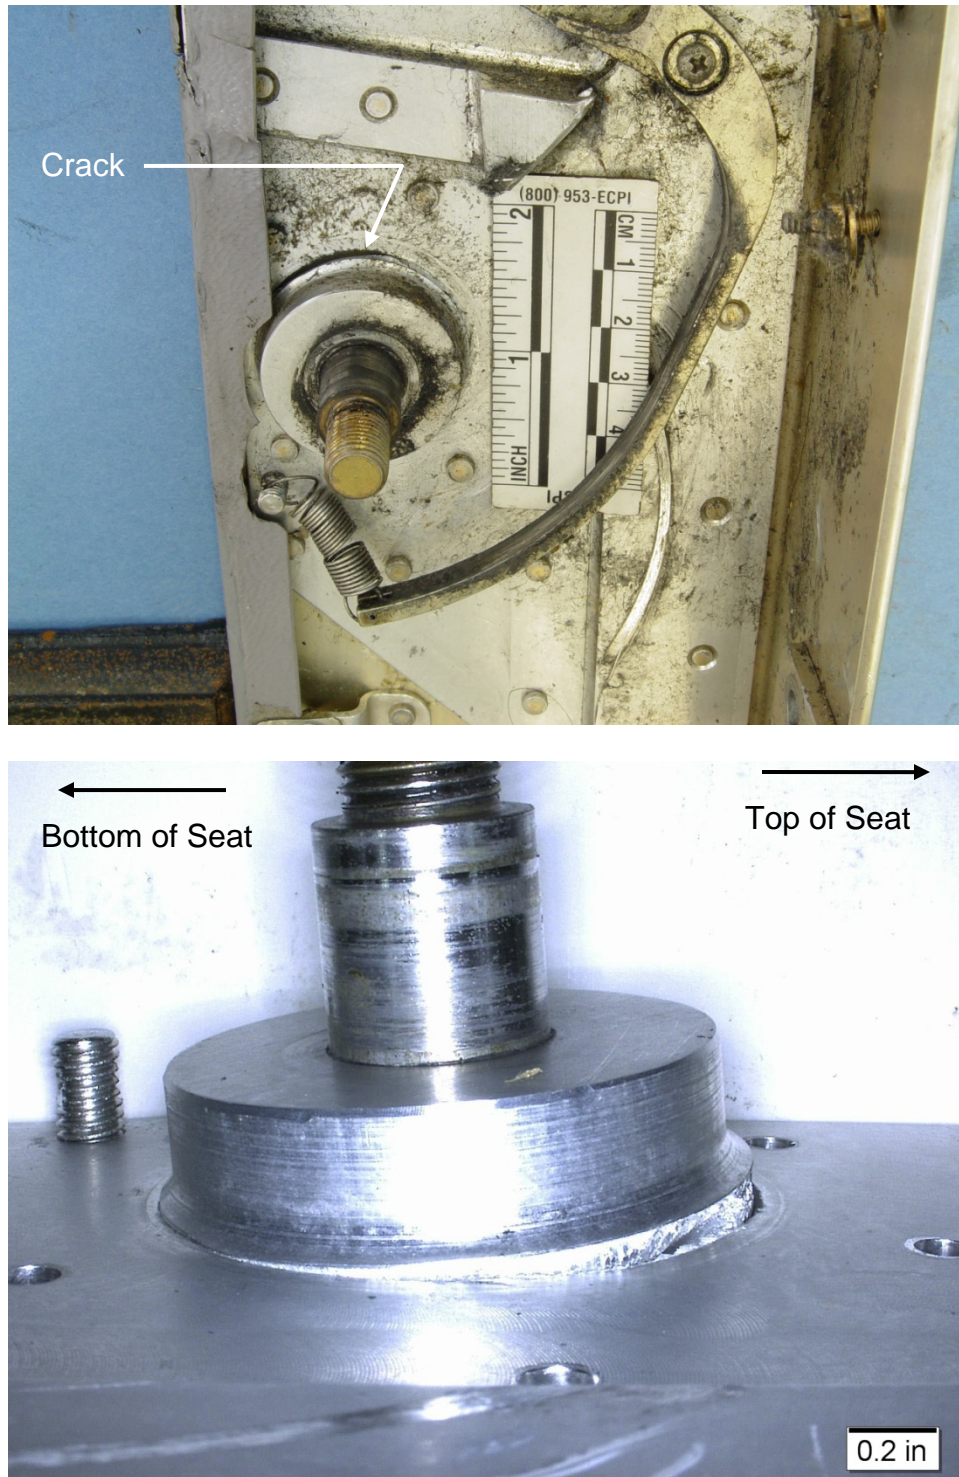
The seat bottom and seat back tracking mechanisms were removed from the jump seat in order to examine the pivot plate that houses the pivot bolt about which the seat bottom rotates. Cracks were observed at the base where the boss meets the landing on the left and right sides. The right side pivot plate is shown in figure 12a and a macrophotograph of the crack at the base of the boss is shown in figure 12b. The crack spanned approximately from the 4 o'clock position counterclockwise across the top of the boss to the 10 o'clock position. From there it deviated from the base of the boss and propagated through the landing to the forward end of the pivot plate. The left side pivot plate is shown in figure 13a and a macrophotograph of the crack (after sectioning) is shown in figure 13b. The crack followed the base of the boss approximately from the 12 o'clock position to the 2 o'clock position. From the 2 o'clock position the crack proceeded across the landing to the forward end of the pivot plate. From the 12 o'clock position the crack deviated from the base of the boss and propagated through the landing toward the seat stop for 0.5 inch. The crack then changed directions abruptly creating a curved crack path that terminated at a rivet hole. The seat stops on the right and left side pivot plates were deformed as shown in figures 14a and 14b, respectively. The stops were bent upward at the rearmost tip of the edge that stops the downward rotation of the seat bottom.

Figure 12: a) Photograph of the right side pivot plate with a crack visible at the base of the boss; b) Microphotograph of the boss viewing the 3 o'clock position.

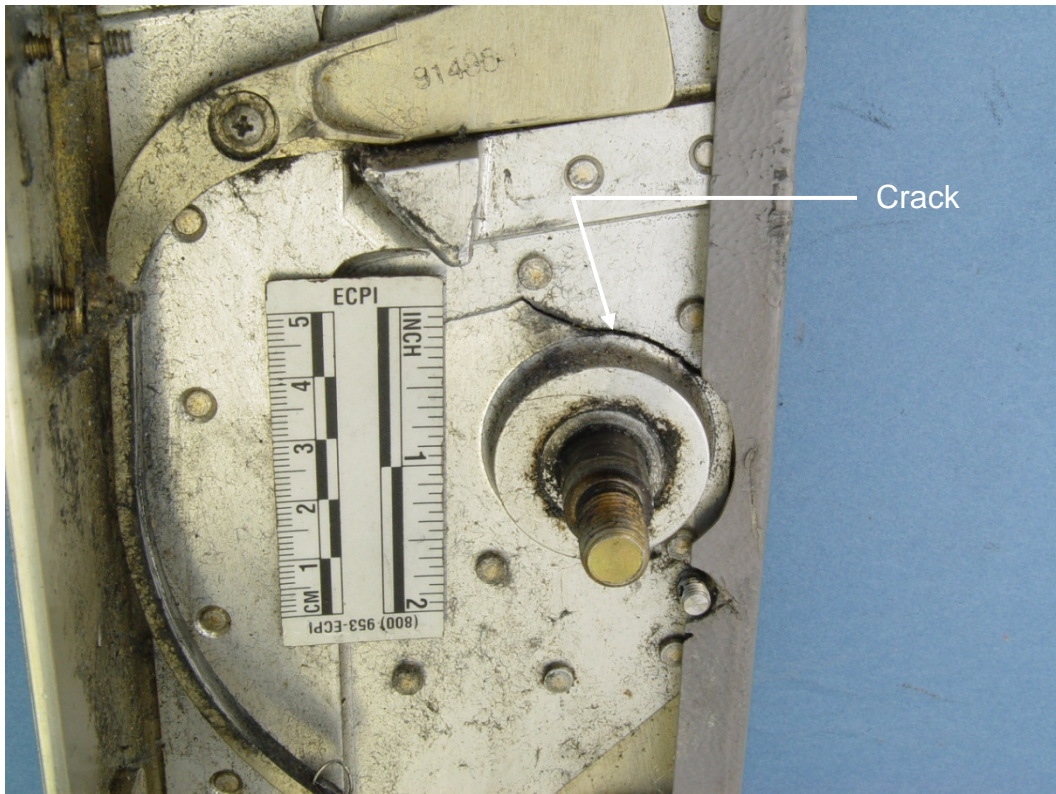
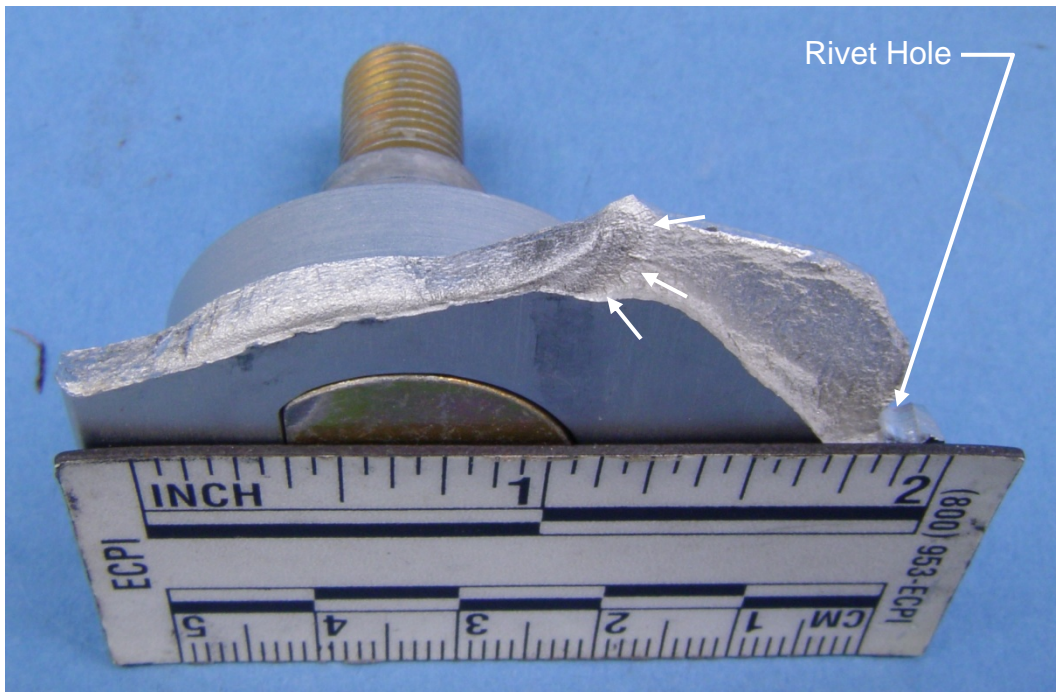
consistent with multiple crack initiation sites. A higher magnification micrograph in this region revealed fine striations consistent with fatigue crack propagation as shown in figure 15b. The initiation sites on the right side pivot plate were located at the root of a sharp radius observed at the base of the boss as shown in figure 16a. The left side pivot plate did not have a sharp radius at the base of its boss. The mode of crack extension on the right side boss changed from fatigue crack propagation to crack propagation under monotonic loading conditions at approximately the 1 o'clock position continuing clockwise as shown in figure 16b. The fatigue crack on the left side boss extended through the landing to the forward edge of the plate and to the position indicated by the short arrows in figure 13b.

Figure 13: a) Photograph of the left side pivot plate with a crack at the base of the boss that extended into the landing; b) Photograph of the crack face viewed from the backside of the pivot plate.

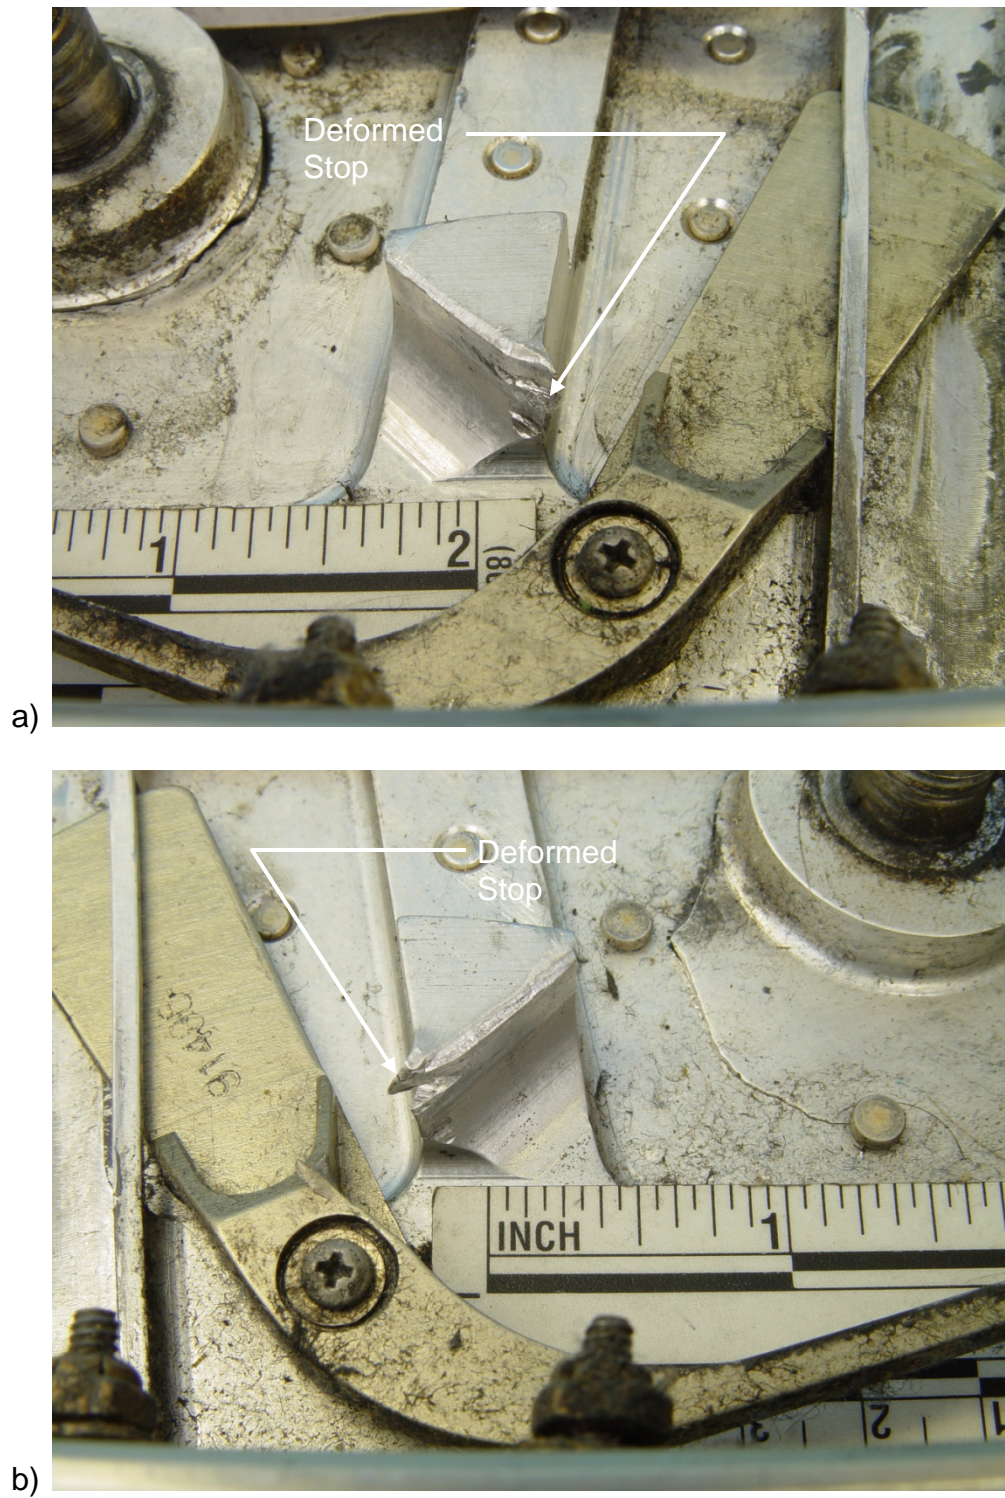
Figure 14: Photographs of the deformed seat stops; a) Right side; b) Left side.

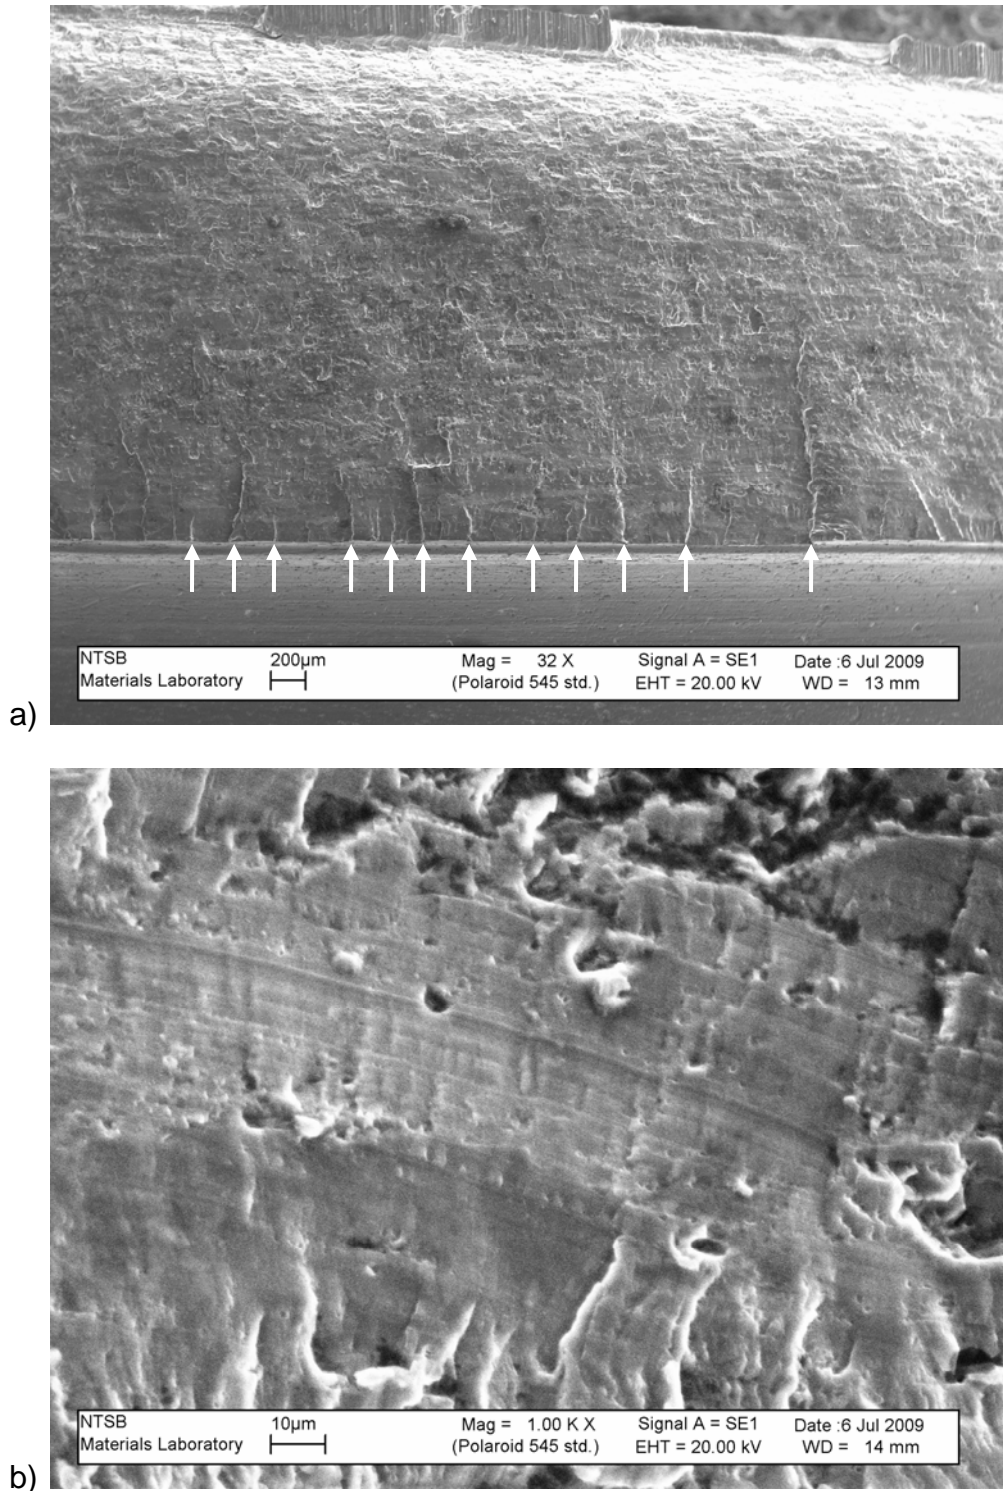
Features consistent with fatigue cracking were seen on both pivot plates. A scanning electron microscope (SEM) micrograph of the crack face at the 12 o'clock position of the right side boss is shown in figure 15a. Ratchet marks were observed at the base of the boss

Figure 15: SEM micrographs of the fatigue crack at the 12 o'clock position of the right side pivot plate boss; a) Arrows indicate the location of some of the ratchet marks; b) Fatigue striations.
