NATIONAL TRANSPORTATION SAFETY BOARD

MATERIALS LABORATORY FACTUAL REPORT

Report No. 09-055

Place : Denver, Colorado
Date : December 20, 2008
Vehicle : Boeing 737-500
NTSB No. : DCA09MA021
Investigator : Mark George

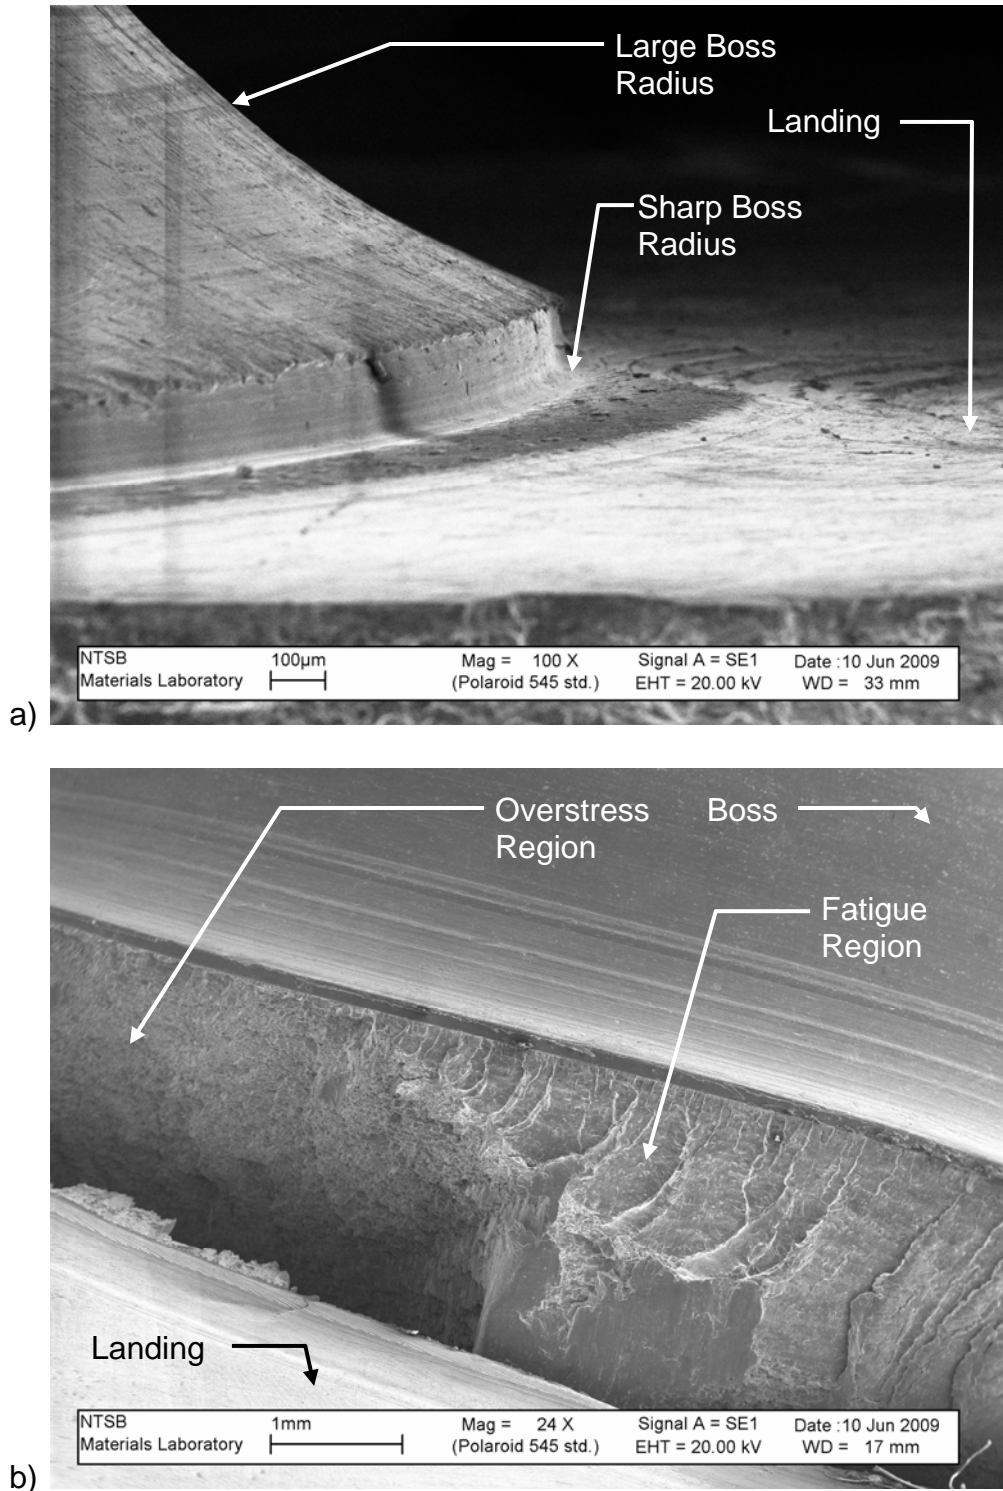
consistent with multiple crack initiation sites. A higher magnification micrograph in this region revealed fine striations consistent with fatigue crack propagation as shown in figure 15b. The initiation sites on the right side pivot plate were located at the root of a sharp radius observed at the base of the boss as shown in figure 16a. The left side pivot plate did not have a sharp radius at the base of its boss. The mode of crack extension on the right side boss changed from fatigue crack propagation to crack propagation under monotonic loading conditions at approximately the 1 o'clock position continuing clockwise as shown in figure 16b. The fatigue crack on the left side boss extended through the landing to the forward edge of the plate and to the position indicated by the short arrows in figure 13b.

Figure 16: a) SEM micrograph of the right side pivot plate showing the profile of where the radius at the base of the boss blends with the flat landing; b) SEM micrograph at the 1 o'clock position showing the transition from fatigue to overstress crack propagation.

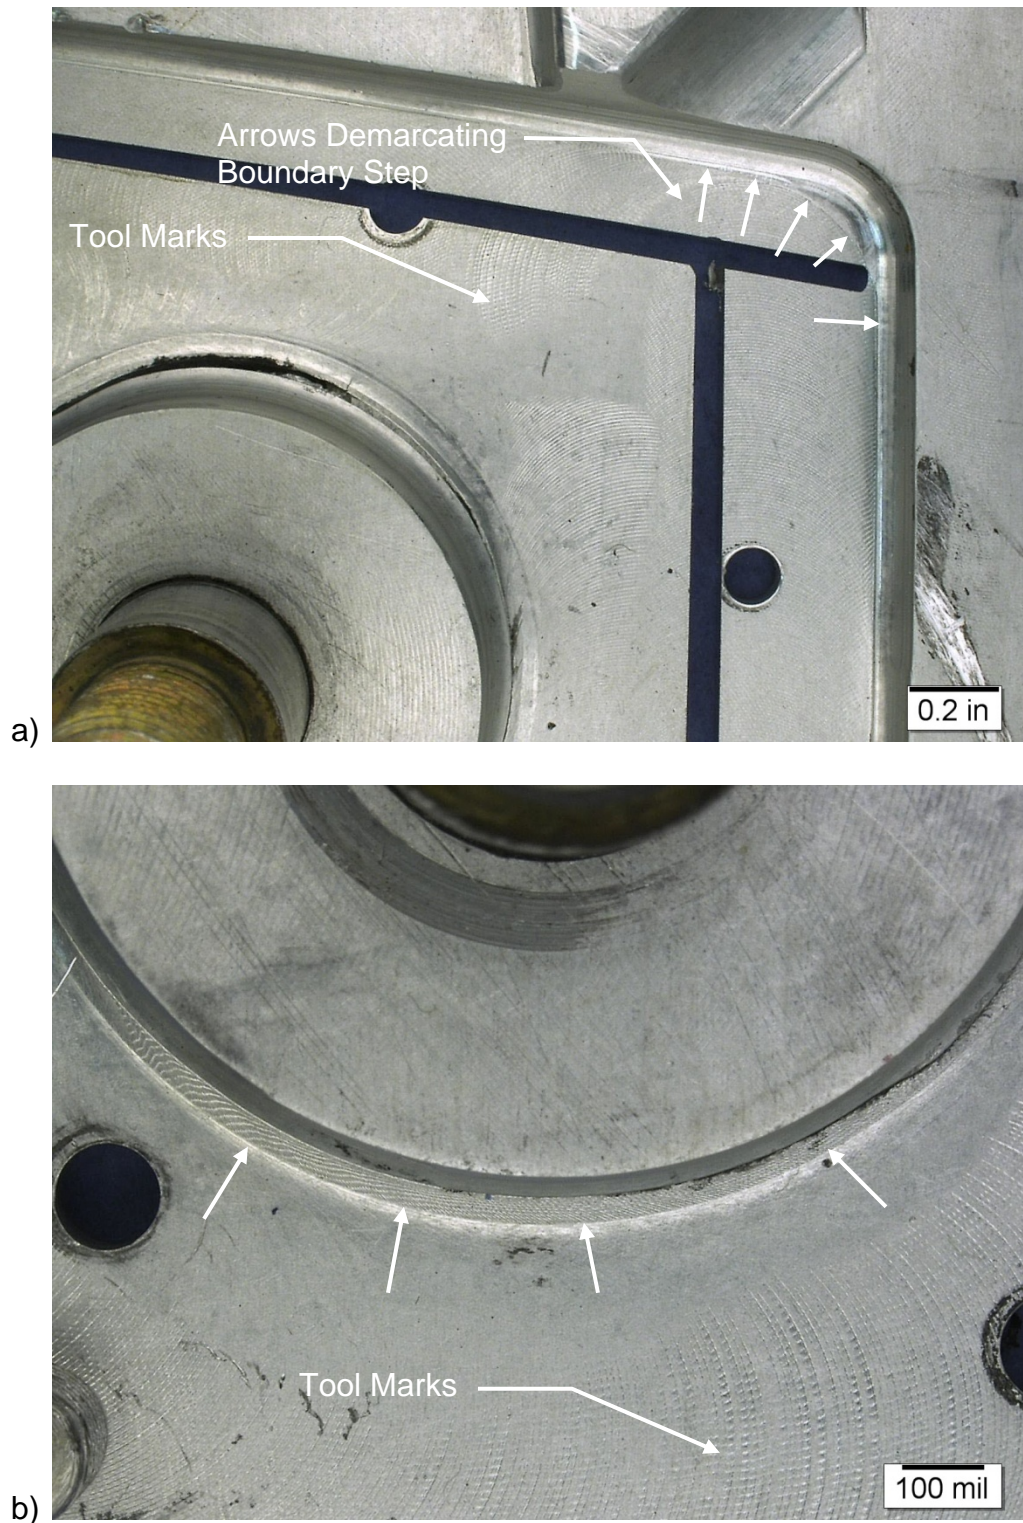
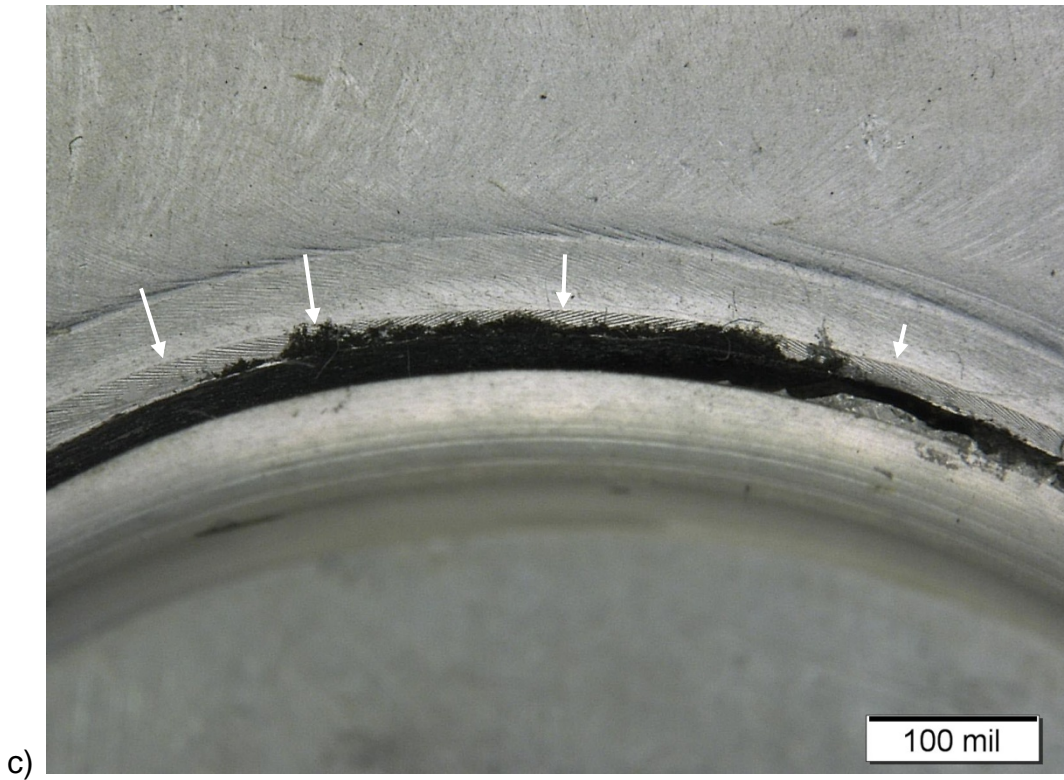
The landing of the right side pivot plate contained circumferential markings consistent with tool marks on the landing face as shown in figure 17a and 17b. The tool marks extended to the blended edge of the landing where it created a small step indicated by the arrows in figure 17a. The marks also were observed around the fillet at the base of the boss. The tool marks are shown at the 6 o'clock position as indicated by the short arrows in figures 17b and at the 12 o'clock position where the fatigue crack initiated as shown in figure 17c. No equivalent marks were observed on the left side pivot plate.

Figure 17: Microphotographs of the right side pivot plate landing; a) Tool marks were visible on the landing and a step was created at the landing edge; b) Tool marks on the landing at along the base of the boss at the 6 o'clock position.

Figure 17 (cont.): c) Tool marks at the base of the boss where the fatigue crack initiated.
