NATIONAL TRANSPORTATION SAFETY BOARD

MATERIALS LABORATORY FACTUAL REPORT

Report No. 10-092

Place : Aleknagik, Alaska.
Date : August 9, 2010.
Vehicle : DHC-3 Otter, N455A.
NTSB No. : ANC10MA068.
Investigator : Robert Swaim, AS-40.

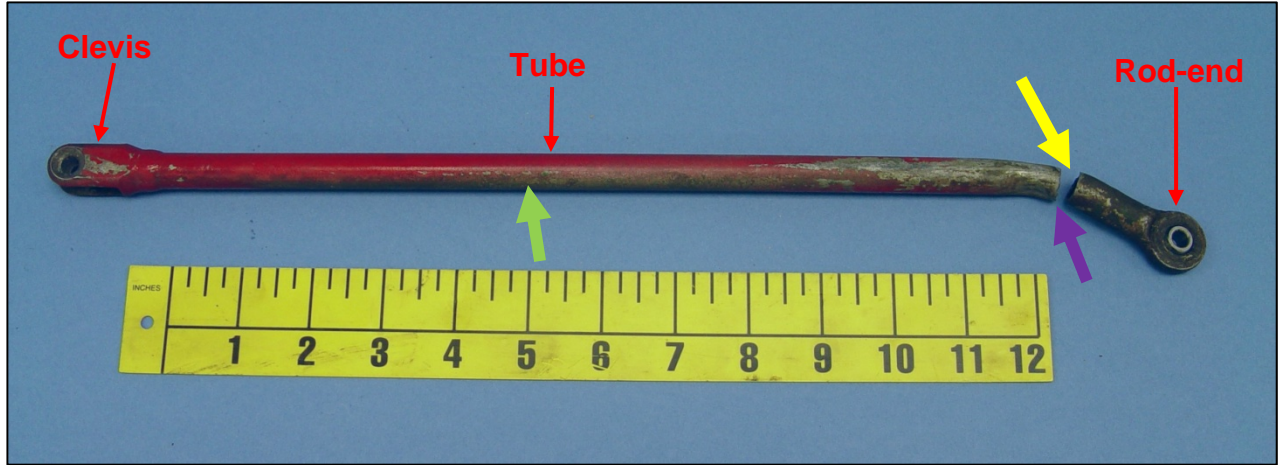
The two pieces of the flaperon control rod submitted for examination are illustrated in Figure 1. The control rod consists of a tube with a clevis welded at one end and a rod-end bearing welded on the other end. Examination of the control rod revealed that it had fractured adjacent to the rod-end to produce the fracture faces indicated by the yellow and purple arrows in Figure 1. The rod end was mostly covered in grease. The tube and clevis portions of the control rod were mostly covered in a red paint with the exception of approximately 3.5 inches of the tube adjacent to the fracture face and the area indicated by the green arrow. The unpainted area indicated by the green arrow extended along the length of the tube and displayed a red spattered pattern at its interface with the red painted area.

Figure 1. The two pieces of the flaperon rod received for examination.

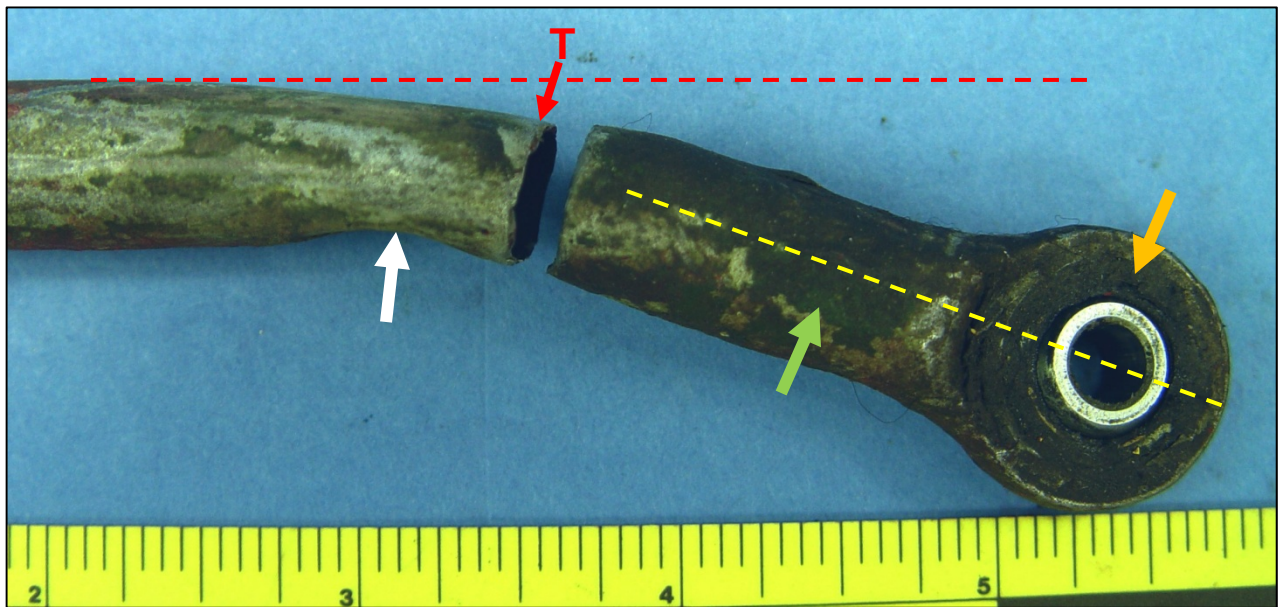
Features on the fracture faces were matched and the rod-end end of the control rod is illustrated in Figure 2. The red dashed line is a continuation of the rod surface to illustrate the degree of bending that had been applied and the red arrow, identified as "T", indicates what would have been the tension side of the tube during the bending event. The angle between the axis of the rod-end, indicated by the yellow dashed line, and the red dashed line was measured at 20-degrees. The white arrow indicates an arced indentation located in opposition to the tension side "T". The radius of the arc was measured at 0.5-inch on an OGP Smartscope¹ and a 1.0-inch diameter aluminum rod was found to be a snug fit in the indentation. The green arrow indicates green paint that was not covered by grease.

Examination of the grease indicated by the orange arrow in Figure 2 revealed that it consisted of a black surface layer that changed to a dark tan adjacent to the rod-end surface. Black filaments of a man-made material, of various lengths, were also observed in the grease. A majority of the grease was scraped from the rod-end with plastic forceps and approximately 50% of the sample was spread out on a plastic sample dish. Higher magnification examination confirmed that the black filaments were the only discernible non-grease contaminant.

Figure 2. A closer view of the fractured end of the flaperon rod.

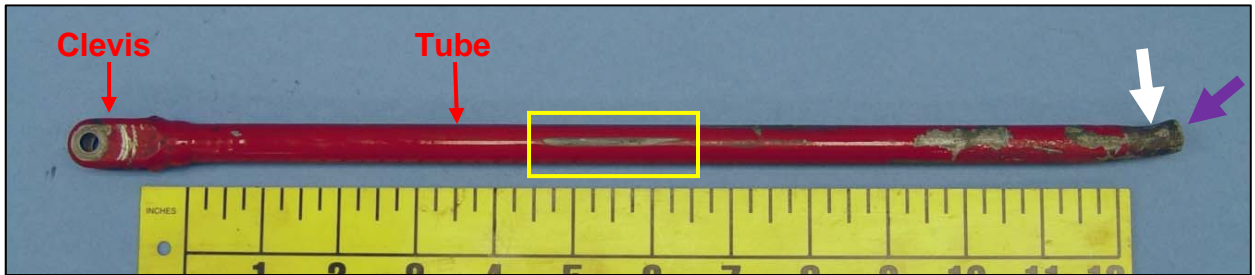
An examination of the tube and clevis portion of the control rod revealed a longitudinally oriented rubbing mark on the red painted side, opposite to the side illustrated in Figure 1. The rubbing mark initiated 5.75 inches from the center of the clevis attachment hole and was approximately 1.75 inches long. Along a majority of its length the rubbing mark was a uniform 0.08-inch wide. The tube and clevis portion of the control rod is illustrated in Figure 3 with the rubbing mark contained within the yellow box. A purple arrow indicates the fracture face, as in Figure 1, and a white arrow indicates the arced indentation, as in Figure 2. A closer view of the rubbing mark is illustrated in figure 4 with the mark indicated by a yellow arrow. A closer examination of the surface of the rubbing mark revealed a black powder scattered on a relatively smooth and uniformly abraded surface, indicative of a light contact over a period of time.

Figure 3. The opposing side of the flaperon rod and clevis illustrated in Figure 1.

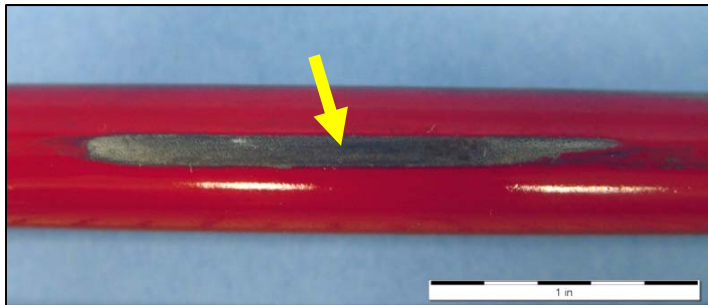
Figure 4. A closer view of the rub mark contained within the yellow box in Figure 3.

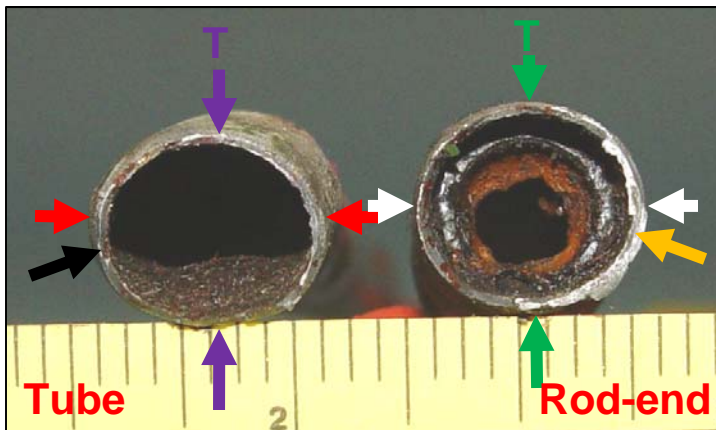
Visual examination of the fracture faces revealed that the rod-end fracture face appeared to be round and the tube fracture face appeared to be oval. The fracture faces were placed side by side for comparison and are illustrated in Figure 5 with a "T" indicating the tension side, as in Figure 2. The rod-end diameters at the green and white arrows were measured at 0.493-inch and 0.502-inch respectively. The tube diameters at the purple and red arrows were measured at 0.432-inch and 0.518-inch respectively. The orange arrow indicates a mechanically damaged area on the rod-end fracture face and the black arrow indicates the mating fracture face on the tube which was undamaged. A higher magnification image of the rod-end fracture face is illustrated in Figure 6 with a green arrow indicating the tension side and an orange arrow indicating the mechanical damage, as in Figure 5. The red arrows indicate the fracture faces that were inclined at approximately 45-degrees, consistent with an overload event and the black arrow indicates a similar inclined plane that had survived the mechanical damage event.

Figure 5. The tube fracture face indicated by the purple arrow in Figure 1 (left) and the rod-end fracture face indicated by the yellow arrow in Figure 1 (right).
