NATIONAL TRANSPORTATION SAFETY BOARD

MATERIALS LABORATORY FACTUAL REPORT

Report No. 10-095

Place : Aleknagik, Alaska.
Date : August 9, 2010.
Vehicle : DHC-3 Otter, N455A.
NTSB No. : ANC10MA068.
Investigator : Robert Swaim, AS-40.

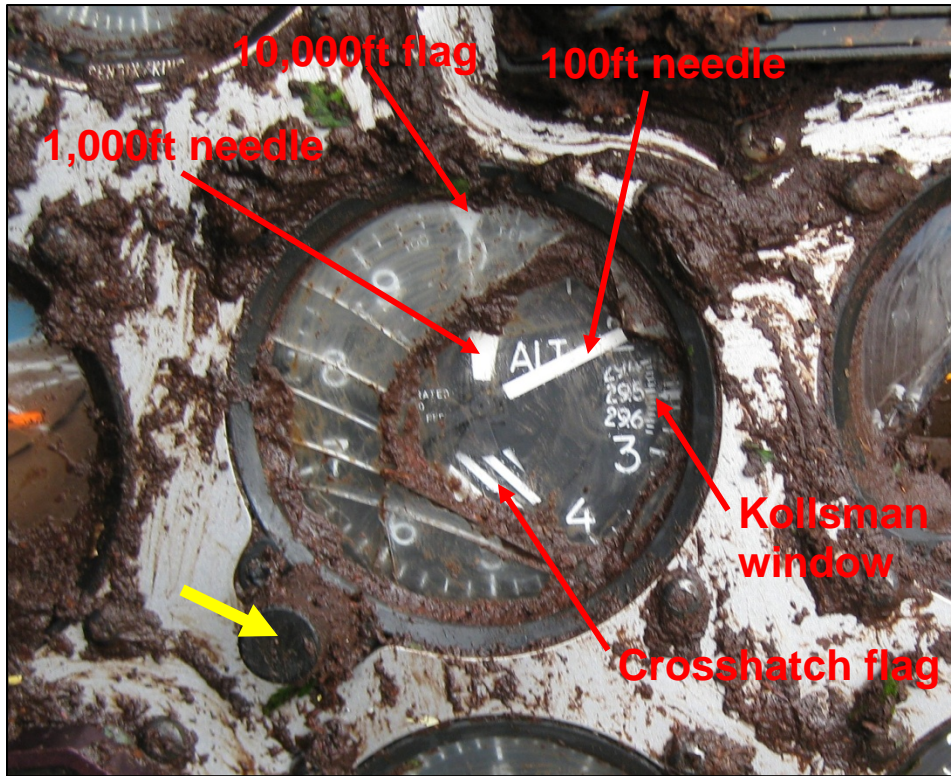
The altimeter to be submitted for examination is illustrated in Figure 1 as found at the accident scene. The 100ft needle which indicates 100 foot increments of altitude, the 1,000ft needle which indicates 1,000 foot increments of altitude, and the 10,000ft flag which indicates 10,000 foot increments of altitude are identified. The increments are numbered 0 – 9 on the dial and sub-divided into five (5) smaller divisions. The 10,000ft flag is indicating zero, the 1,000ft needle is indicating one small division past zero which corresponds to an altitude of 200 feet, and the 100ft needle is indicating the numerical 2, which corresponds to 200 feet. Figure 1 shows the altimeter indicating an altitude of 200 feet. The crosshatch flag is also identified and is a part of the 10,000ft flag. The crosshatch is increasingly obscured as the altitude increases and would be completely obscured at 20,000 feet, the altimeter's calibrated altitude. The Kollsman¹ window indicates the barometric pressure, in inches of mercury, the altimeter was set to. The barometric pressure indicated in the Kollsman window may be adjusted by turning the knob indicated by the yellow arrow. The Kollsman window was found set at a barometric pressure of 29.51 inches of mercury².

Figure 1. The altimeter as found at the accident scene.

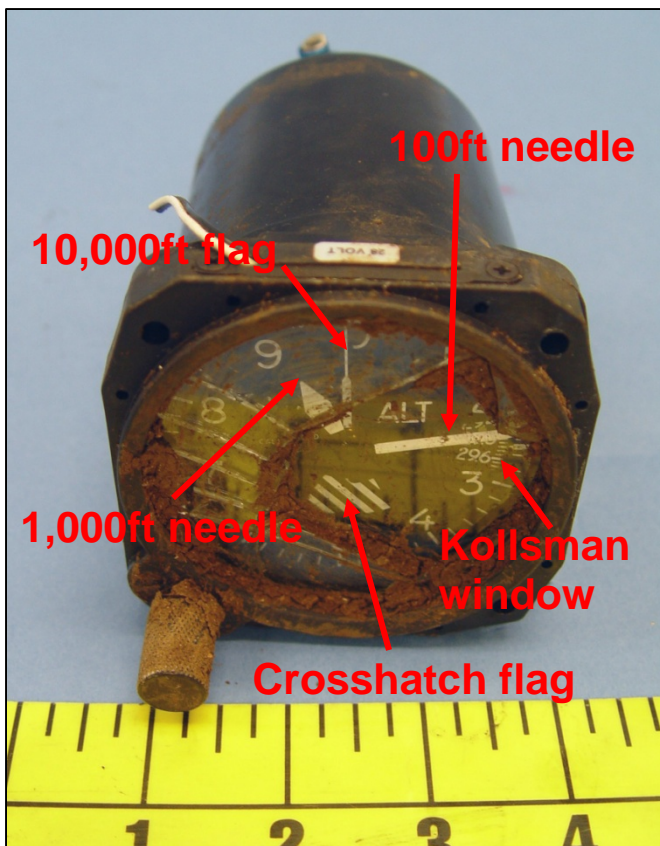
The condition of the altimeter as received at the NTSB Materials Laboratory is shown in Figure 2 and different values are displayed when compared to Figure 1. The 1,000ft needle is indicating between the #9 and the #0 numeral and the 100ft needle is indicating between the #2 numeral and the #3 numeral. The 10,000ft flag is located to the left of zero, indicating less than zero feet, and the crosshatch flag is fully visible. As received, the

needles are indicating minus 760 feet. The Kollsman window was still set at a barometric pressure of 29.51 inches of mercury.

Figure 2. The altimeter as received for examination.

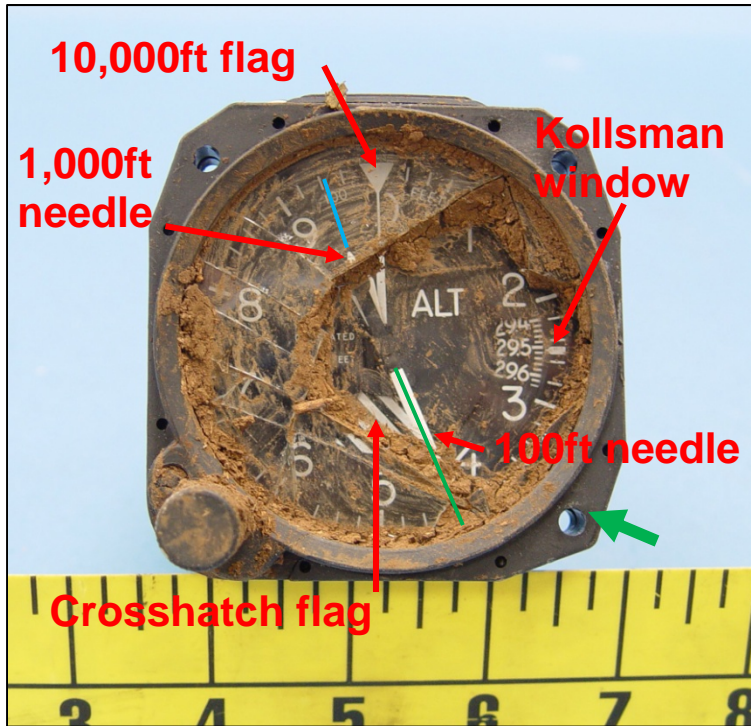
Prior to the start of the examination the altimeter reading was found to have changed again but was still displaying a negative altitude. The altimeter is illustrated in Figure 3 with the 100ft needle, the 1,000ft needle, the 10,000ft flag, the crosshatch flag and the Kollsman window identified. The 10,000ft flag is indicating less than zero feet and the crosshatch flag is fully visible. The 1,000ft needle, as indicated by the blue line, is pointing to the right of the 600ft graduation, counterclockwise from the "0" numeral. The 100ft needle, as indicated by the green line, is pointing to the right of the 600ft graduation, counterclockwise from the #5 numeral. As illustrated, the altimeter is indicating minus 560 feet. The Kollsman window was still set at a barometric pressure of 29.51 inches of mercury.

Figure 3. The altimeter immediately prior to the examination.

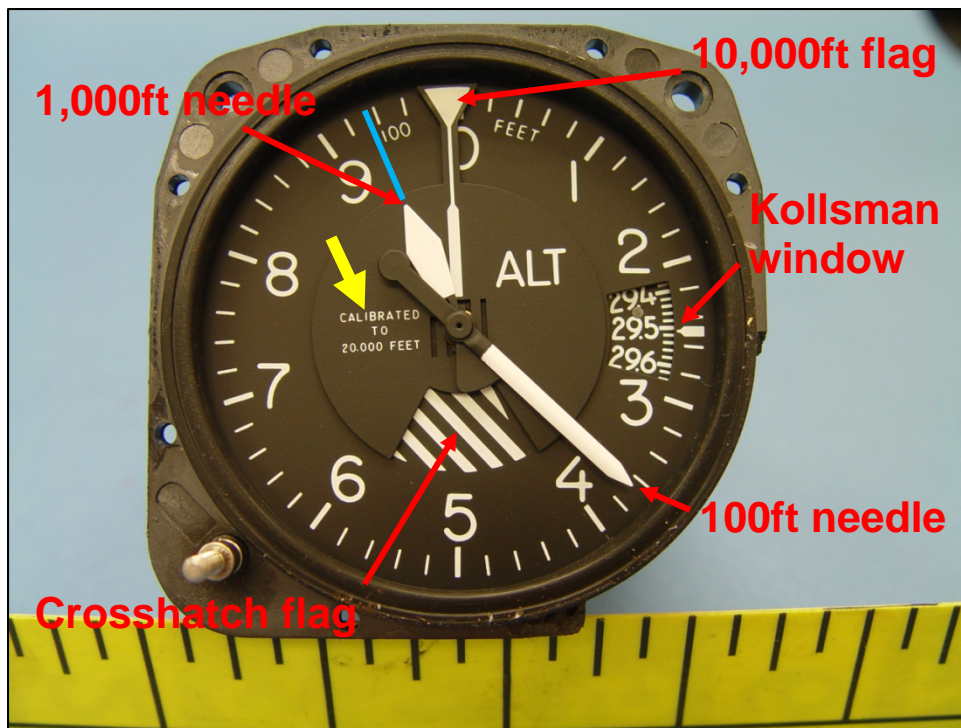
In order to see the altimeter dial more clearly the barometric pressure adjustment knob, indicated by the yellow arrow in Figure 1, was removed followed by removal of the front bezel, with the two glass covers (the outer cover was fractured and incomplete but the inner cover was intact). During removal of the bezel the quadrant of the case indicated by the green arrow in Figure 3 separated from the remainder of the case as illustrated in Figure 4. The exposed dial is illustrated in Figure 4 and the altimeter display had changed again but was still displaying a negative altitude. The 1,000ft needle, as indicated by the blue line, was pointing to the left of the 600ft graduation, counterclockwise from the "0" numeral. The 100ft needle was pointing to right of the 100ft graduation, counterclockwise from the "4" numeral. As illustrated, the altimeter is indicating minus 635 feet. The Kollsman window was still set at a barometric pressure of 29.51 inches of mercury.

Figure 4. The altimeter dial after removal of the glass covers.

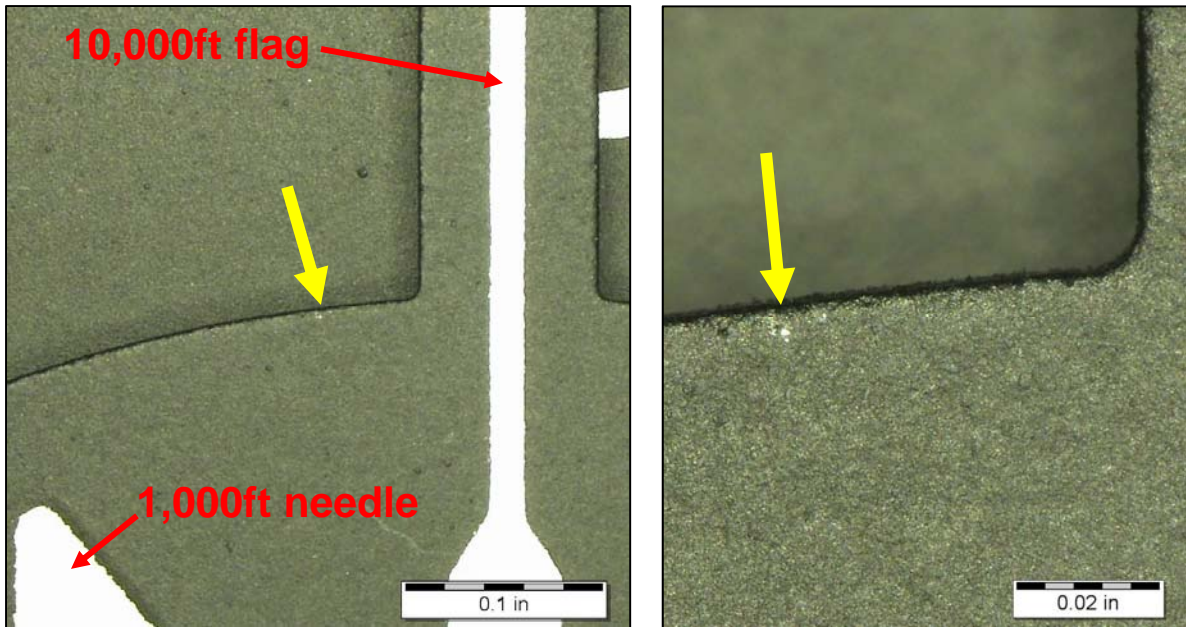
Initial examination of the dial face revealed that the needles were not visibly in contact with any portion of it at the time of the examination. An examination under ultra-violet light revealed that no fluorescing paint³ had been used on the dial or the needles and no fluorescing paint transfer from the underside of a needle was observed on the dial. Microscopic examination revealed what appeared to be white deposits located to the left of the 10,000ft flag. The area around the deposits is illustrated in the left image in Figure 5 with a portion of the 10,000ft flag and the tip of the 1,000ft needle identified. The deposits are indicated by the yellow arrow and illustrated in the right image in Figure 5 at a higher magnification. During manipulation of the altimeter under the microscope, the 1,000ft needle was found to move freely between the #1 numeral and the #4 numeral.

Figure 5. White marks observed to the left of the 10,000ft flag (left) and a closer view of the marks (right).

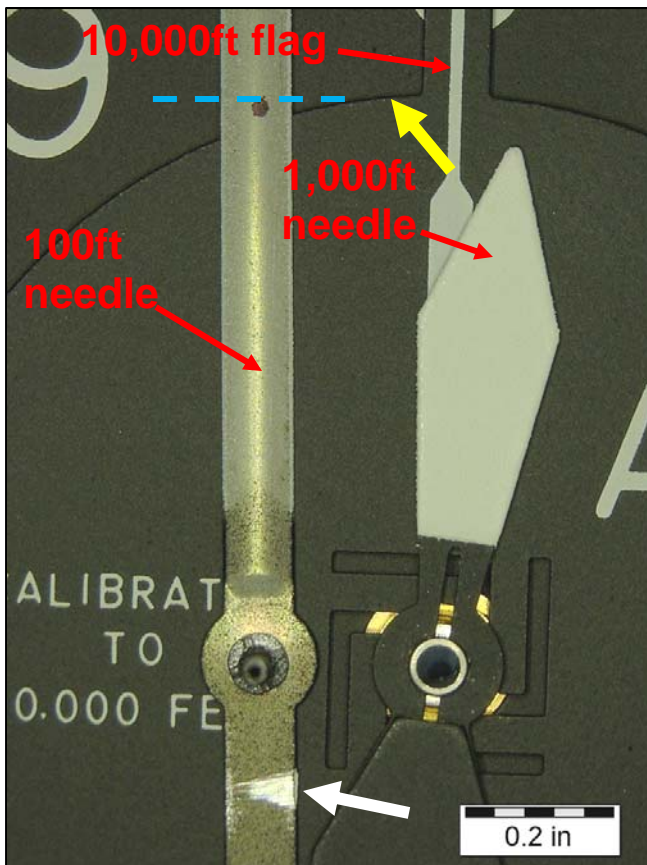
Figure 6. The inverted 100ft needle centered adjacent to the 10,000ft flag.

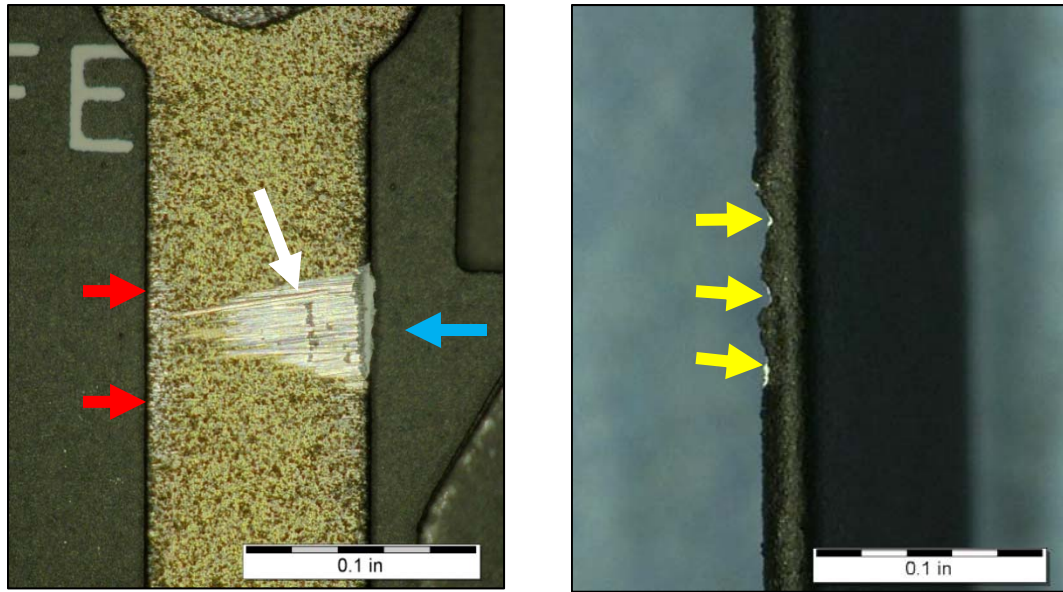
Examination of the 100ft needle revealed a distinctly scratched area on the underside of the shorter black painted portion. The scratches were oriented perpendicular to the edge of the needle, initiated on the edge of the needle and tapered off as distance from the edge increased. The inverted needle was placed adjacent, and parallel, to the 10,000ft flag with the needle's center aligned with the center of the dial. The inverted 100ft needle is illustrated and identified in Figure 6 with the 10,000ft flag and the 1,000ft needle identified. The scratched area is indicated by the white arrow. A closer view of the scratched area is illustrated in the left image in Figure 7 with the scratched area similarly indicated by a white arrow. Lighter scratches were observed along the opposite edge and are located between the two red arrows. A view of the initiation edge, in the direction indicated by the blue arrow in the left image is illustrated in the right image with yellow arrows indicating three distinct grooves in the edge. The underside of the needle was generally unpainted but a thin band of paint along the edges matched the paint on the upper surface and the area between the bands displayed small droplets consistent with overspray.

Figure 7. The scratches on the underside of the 100ft needle (left) and a closer view of the edge indicated by the blue arrow (right).

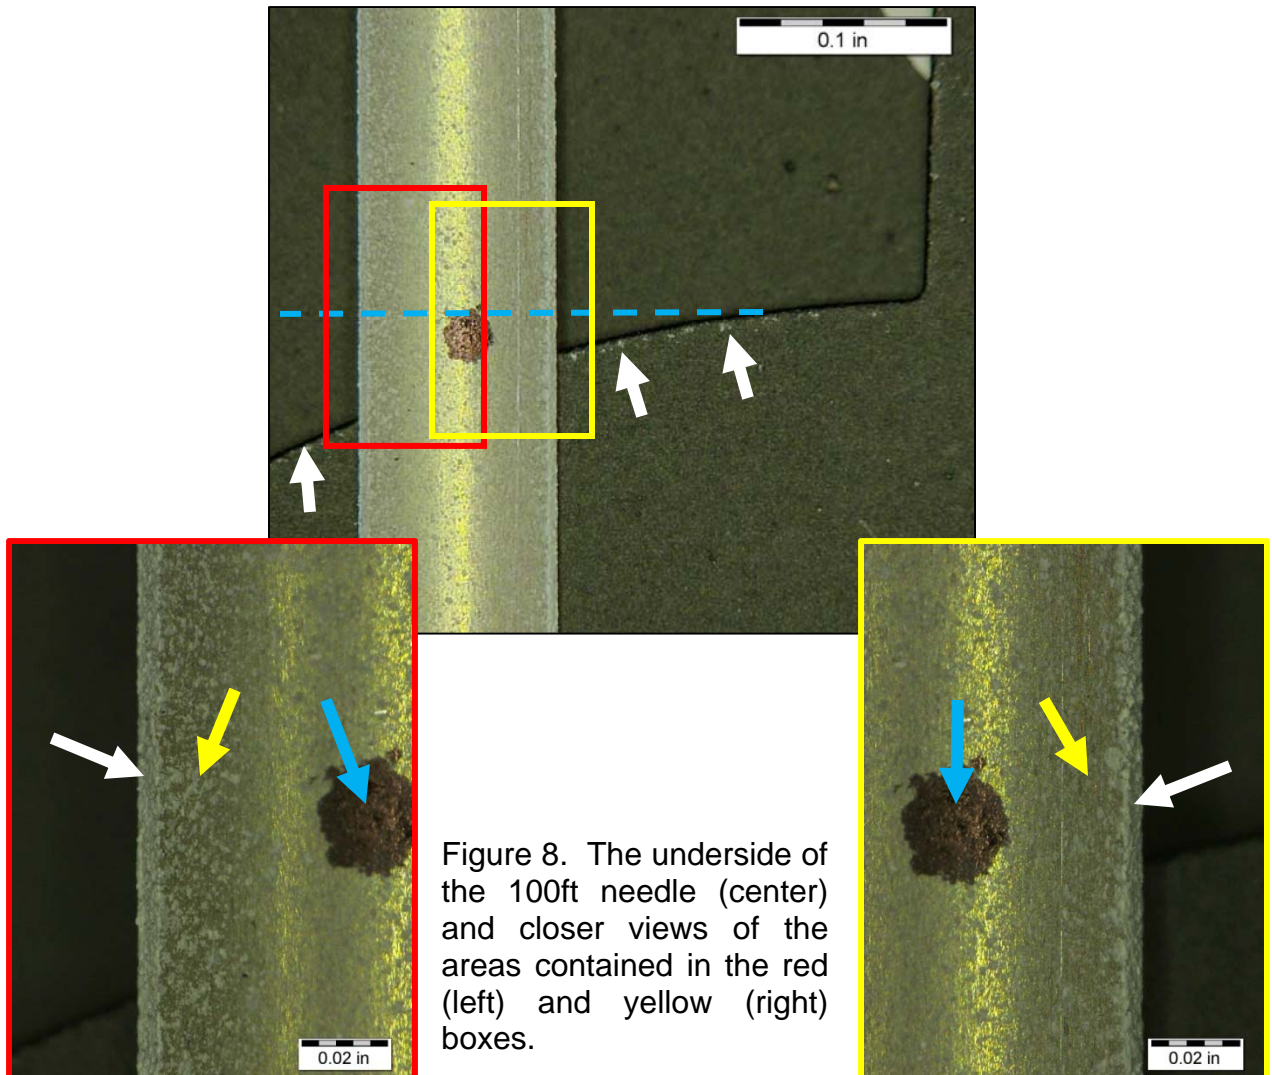
With the dial removed from the case, a more detailed examination of the dial was performed. The examination revealed what appeared to be more white deposits to the left of the deposits illustrated in Figure 5. The deposits are illustrated in Figure 8 and indicated by the white arrows. With the needle positioned as illustrated in Figure 6 the blue dashed line indicates the location on the underside needle where any paint would have been transferred from. The location was also indicated by marking the underside with the tip of a black marker. A closer view in the vicinity of the marker is illustrated in the central image in Figure 8 with the blue dashed line repeated as in Figure 6. Examination of the underside of the needle in the vicinity of the marker revealed no disturbance on the surface of the paint band along the edge. The area within the red box in the central image in Figure 8 is illustrated in the left image with the blue arrow indicating the marker. The white arrow indicates the paint band and the yellow arrow indicates the overspray droplets. The area within the yellow box in the central image in Figure 8 is illustrated in the right image with the blue arrow indicating the marker. The white arrow indicates the paint band and the yellow arrow indicates the overspray droplets.

Figure 8. The underside of the 100ft needle (center) and closer views of the areas contained in the red (left) and yellow (right) boxes.
