# NATIONAL TRANSPORTATION SAFETY BOARD

MATERIALS LABORATORY FACTUAL REPORT

Report No. 10-116

Place : Tucson, Arizona  
Date : July 25, 2010  
Vehicle : Eurocopter AS350B3, N509AV  
NTSB No. : WPR10FA371  
Investigator : Elliott Simpson, AS-WPR

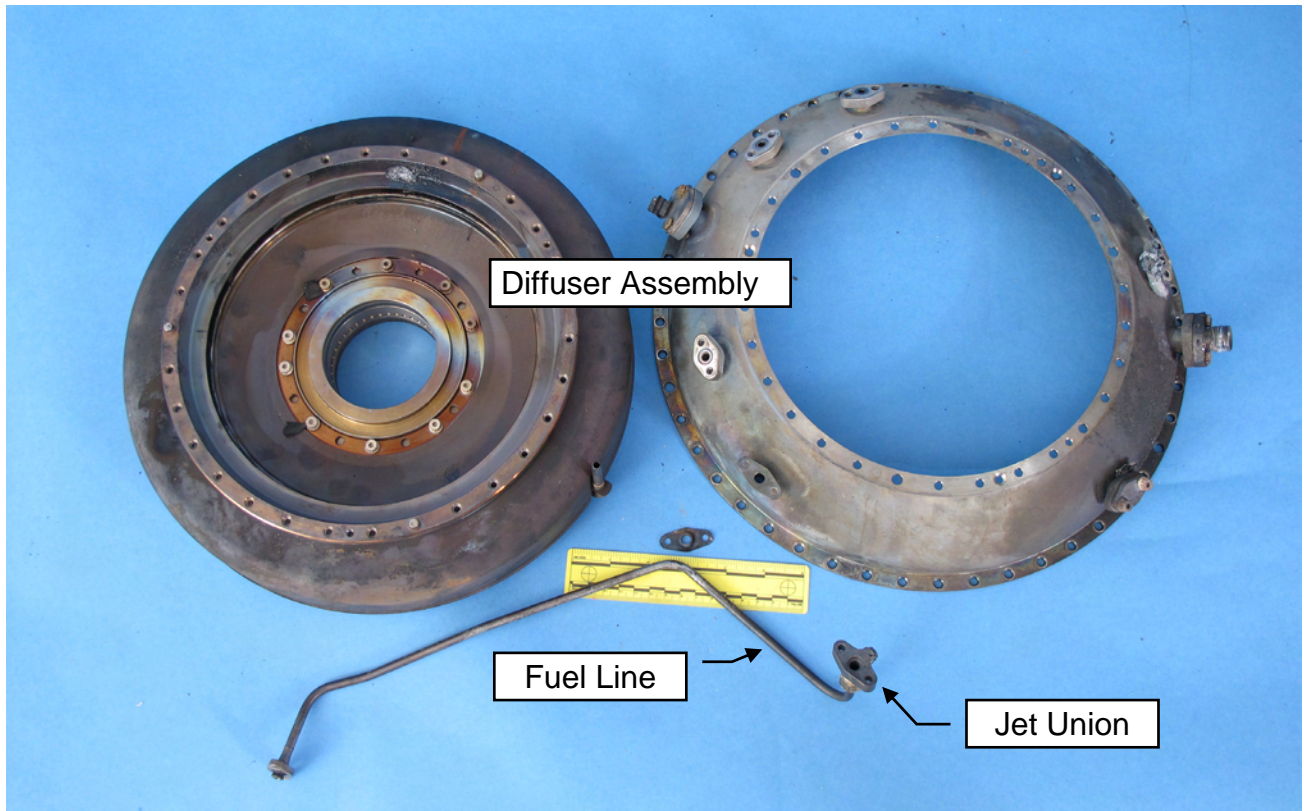
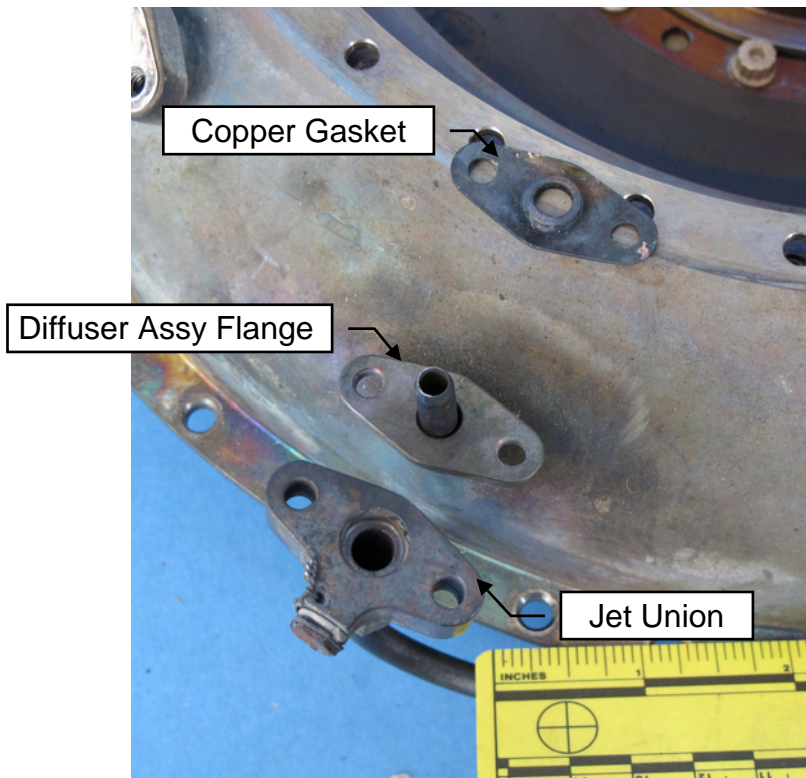
The as-received accident parts are displayed in the upper view of figure 1. The lower view show a closer view of the area where the fuel line, with jet union, is attached to the diffuser assembly with the copper gasket between. The components were intact but reportedly found disconnected at the jet union to diffuser connection.

Figure 1. Above are the as received labeled accident components. A closer view of the jet union diffuser interface is shown at left.

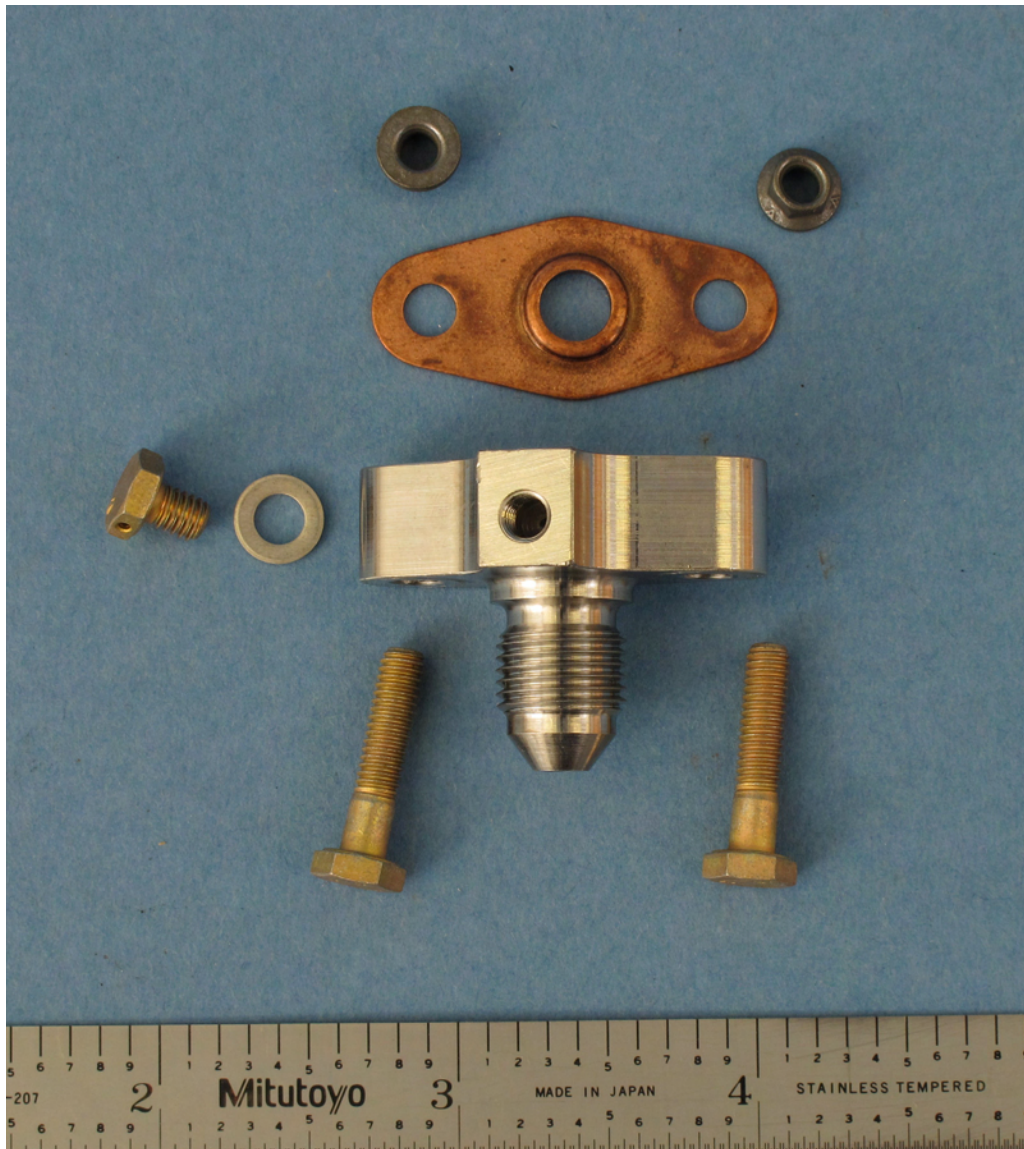
New exemplars of the components were also received for comparison. Figure 2 displays the exemplars of the jet union and associated attachment hardware.

Figure 2. The exemplar jet union and associated hardware.

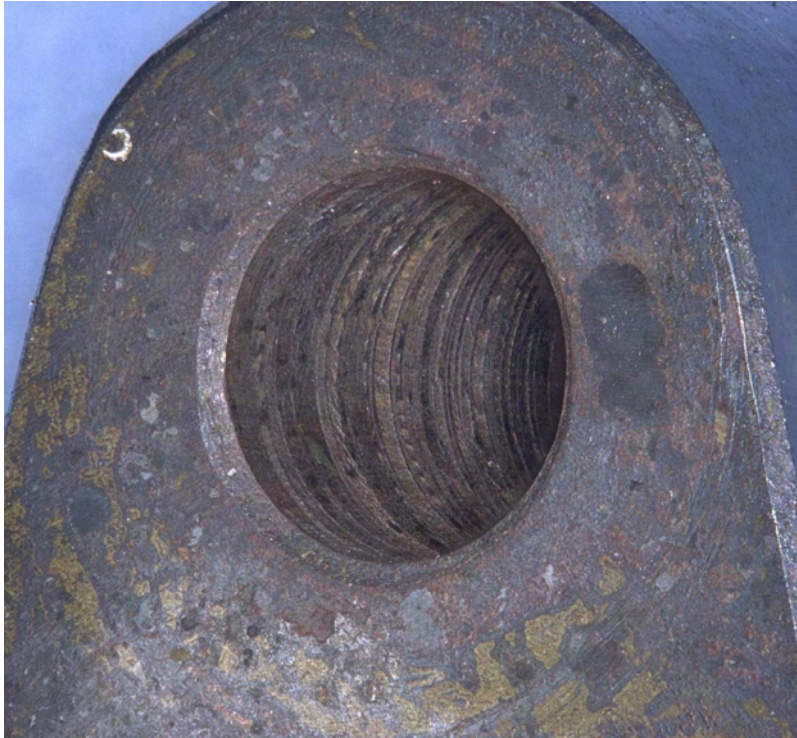
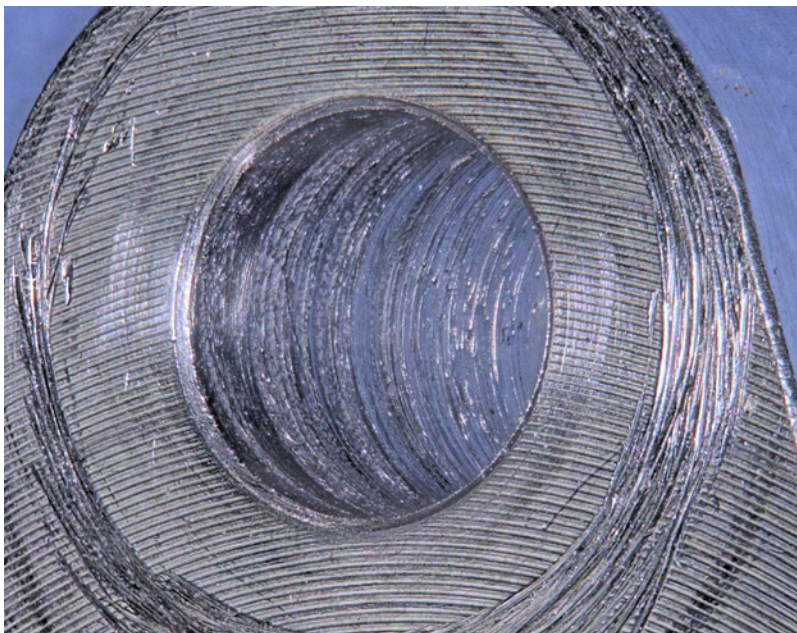
The bores of the accident jet union attachment holes were visually examined with a stereo microscope to inspect for possible thread contact from the attaching bolts. No obvious thread marks were identified; however, the holes were roughly machined making discrimination of thread marks from the surface texture problematic. The same holes in the received exemplar jet union also showed the roughly machined surface texture. See figure 3 for comparison of a typical accident jet union bore and the bore of the new exemplar jet union.

Figure3. Comparison views of the bores on the accident jet union at top and the exemplar union below both showing roughly machined textures.
