NATIONAL TRANSPORTATION SAFETY BOARD

MATERIALS LABORATORY FACTUAL REPORT

Report No. 11-001

Place : Miami, Florida
Date : October 26, 2010
Vehicle : Boeing 757-223, N626AA
NTSB No. : DCA11FA004
Investigator : Clinton Crookshanks, AS-40

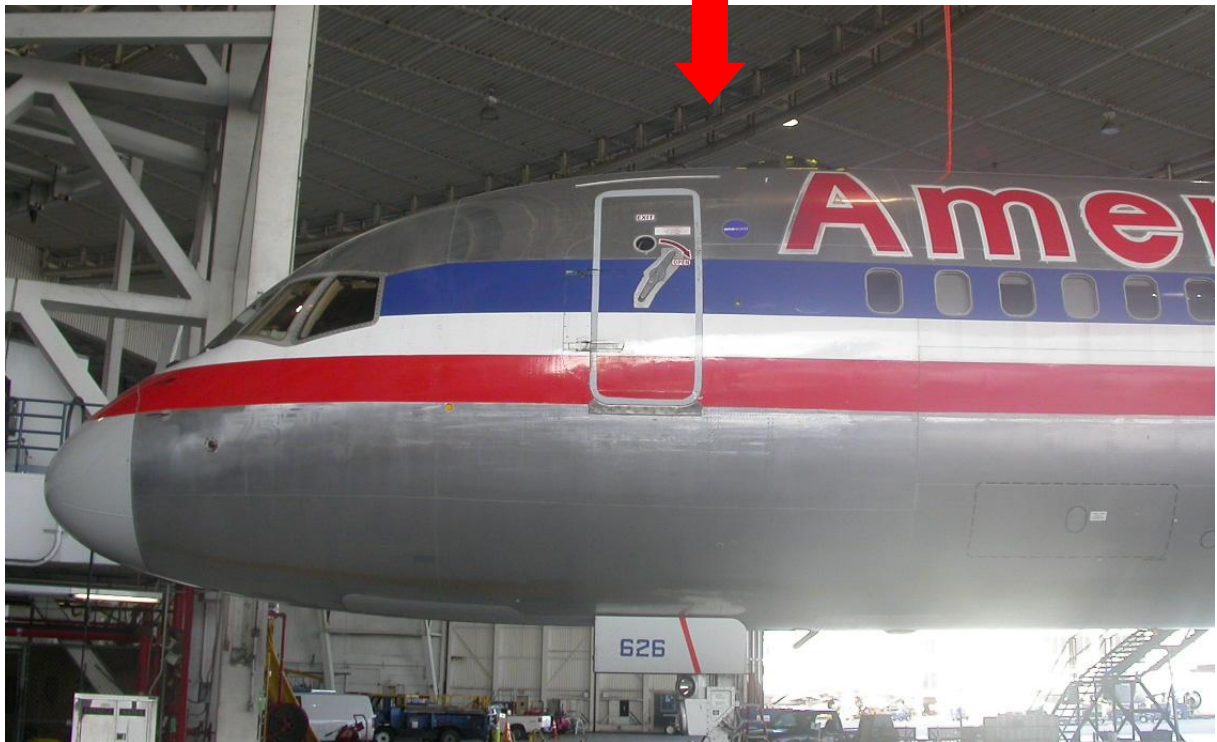
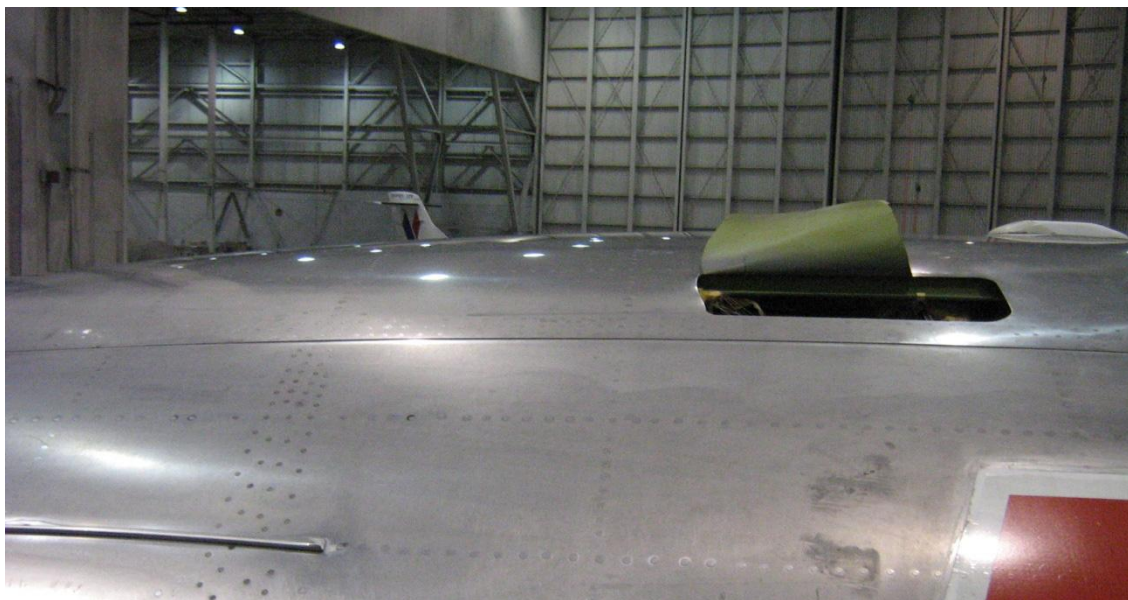
The airplane, shown in figure 1, was initially examined on October 28, 2010 in conjunction with the NTSB Structures Group. As shown, the fuselage skin had flapped open above and aft of the forward left (L1) entry door.

Figure 1—Skin flap location indicated by red arrow in upper view showing its relative location to the cockpit and the passenger entry door (L1). Lower view shows closer side view of the skin flap and resulting hole.

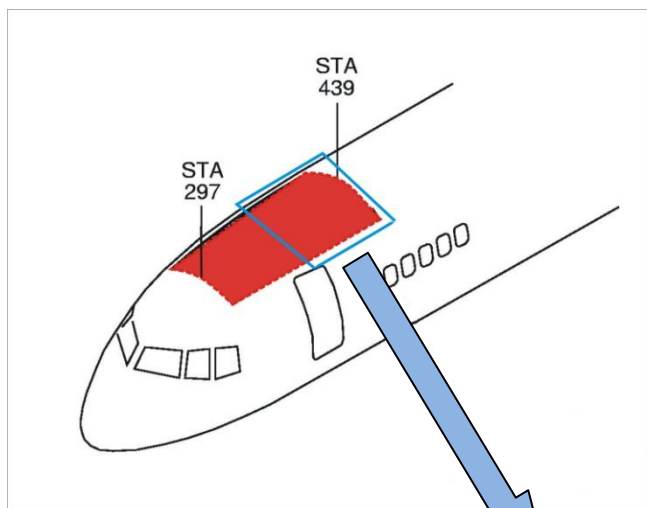
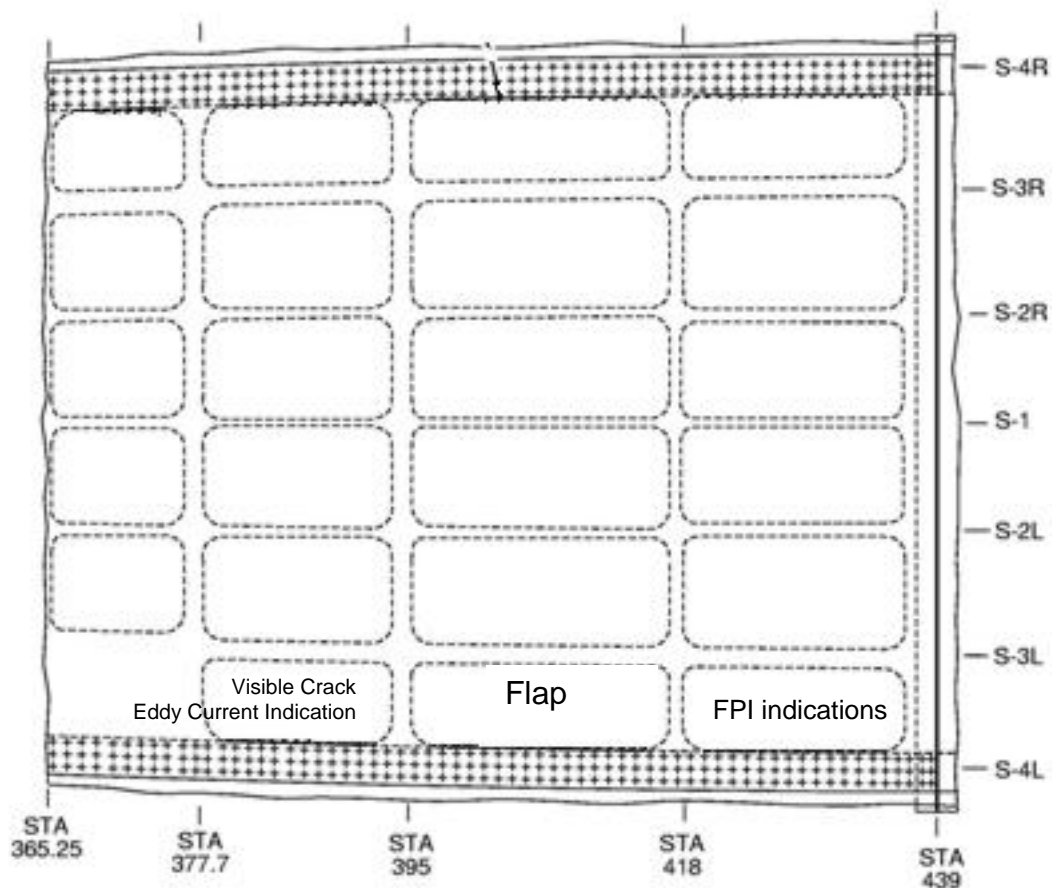
Figure 2—Illustration showing the location of the crown skin (in red) on the aircraft at left and some of the details of construction for the aft portion of the panel below. Fuselage bays containing the visible crack, the flap and crack indications are noted

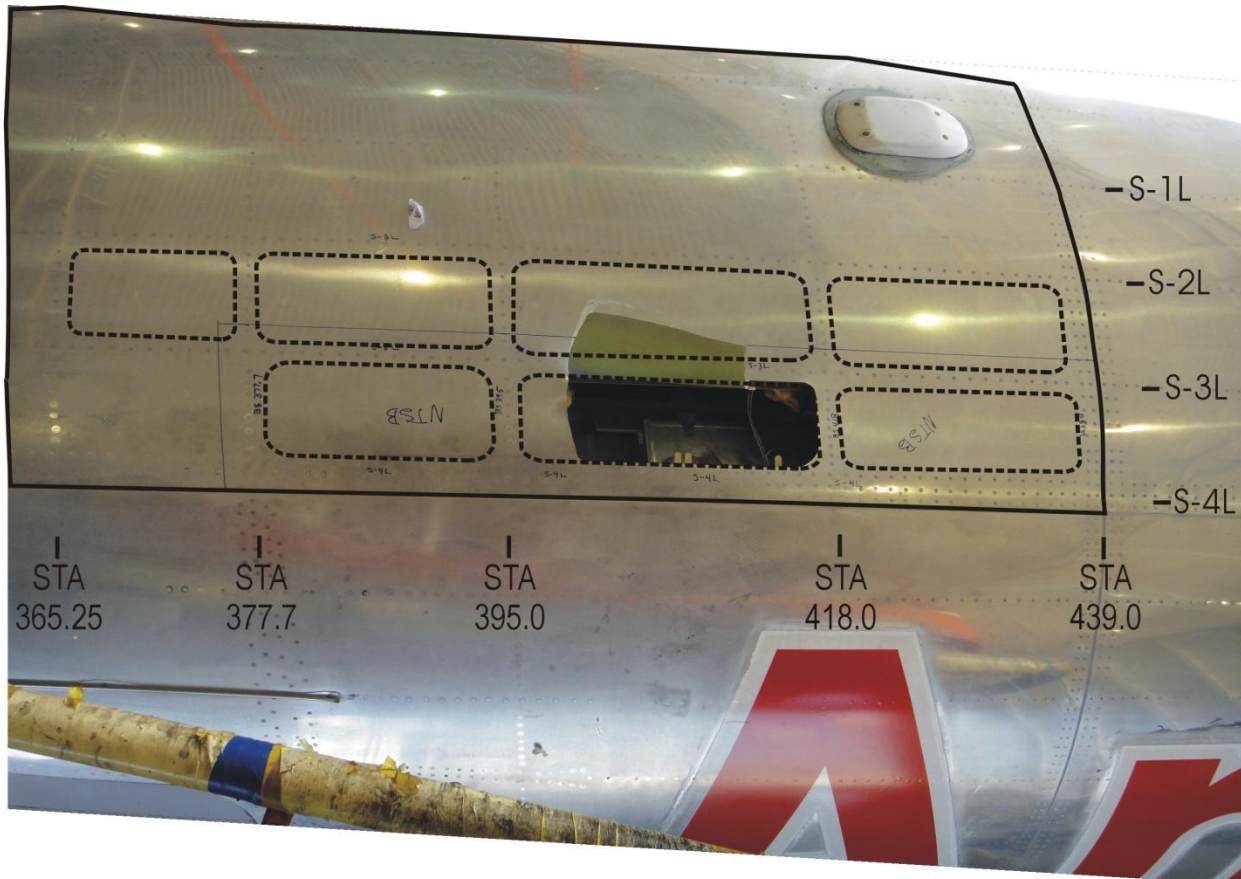
The flapped skin area was contained in the crown skin section between the stringer 4 left (S-4L) lap joint and stringer 3 left (S-3L), circumferentially and between tear straps located at body station (BS) 395 and 418 longitudinally, as shown in figure 3. The flap was wholly contained within the pocket of the 2nd fuselage bay forward of the butt joint at BS 439. The hole produced by the flap measured approximately 7 inches circumferentially and 18 inches longitudinally and generally followed the chemical milled steps just above the S-4L lap joint and the forward edge of the tear strap at the aft stringer. As examined, the forward 13 inches of the skin flap was bent outward (up) about 90 degrees along the lower chem-mill step at the S-3L pad. Abrasion marks on the forward edge of the flapped skin matched abrasions on the skin area above S-3L indicative of contact between the two areas. The aft 5 inches of the flap was fractured off and not recovered.

Figure 3—An overhead view of the skin flap and resulting hole and surrounding area with body station and stringers noted. Dashed lines denote the approximate location and shapes of the internal chemically milled pockets.

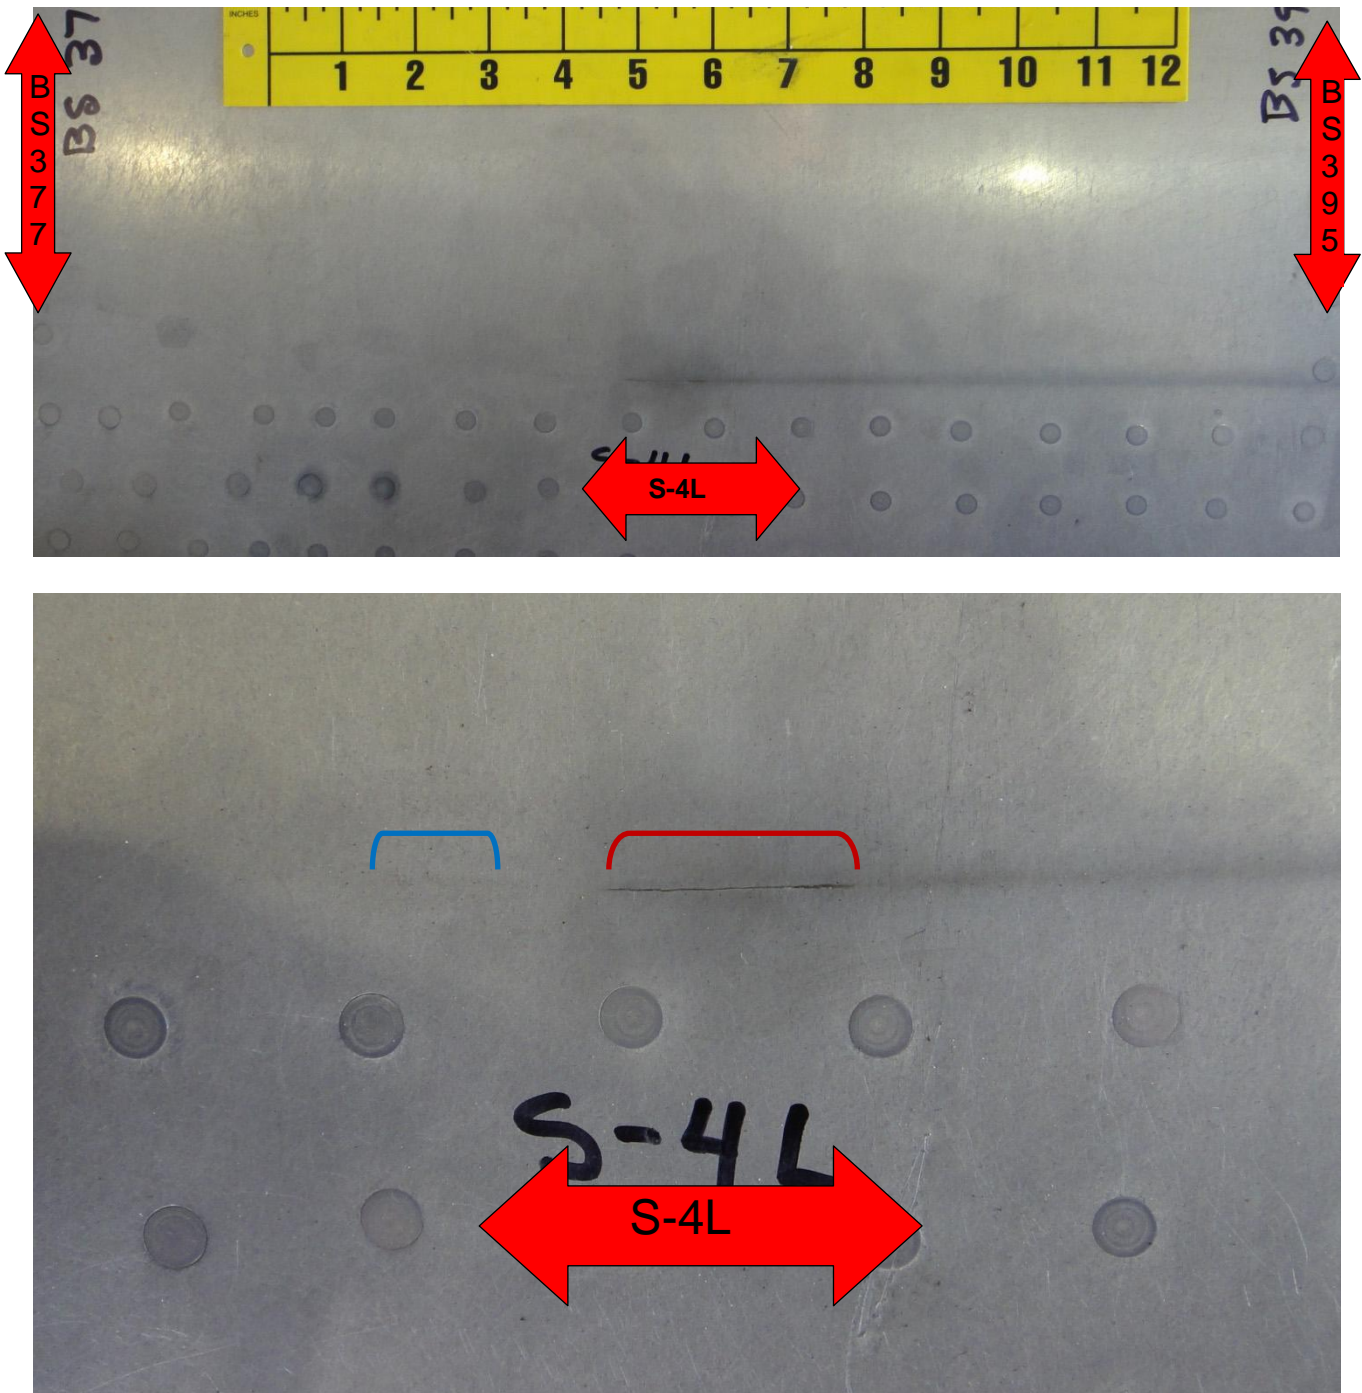
During initial visual inspections a longitudinal through-the-skin crack was uncovered between body stations 386 and 387 in the fuselage bay forward of the bay containing the flap. The crack location was highlighted by a faint smoky trail on the fuselage surface aft of the crack, as shown in figure 4. From the exterior, the crack appeared to coincide with the chemically milled radius above S-4L. Visually the crack was estimated to be approximately 1 3/16 inch long.

On-scene nondestructive inspection (NDI) of the panel using a sliding eddy current probe⁷ uncovered an additional 1 inch long crack indication just forward of the thru crack approximately between BS 383 and 384.

Figure 4—Closer views of the exterior surface of the forward bay showing the thru crack and trailing dark deposits (top) and at bottom the relative locations of the through crack (red bracket) and the eddy current crack indication (blue bracket).

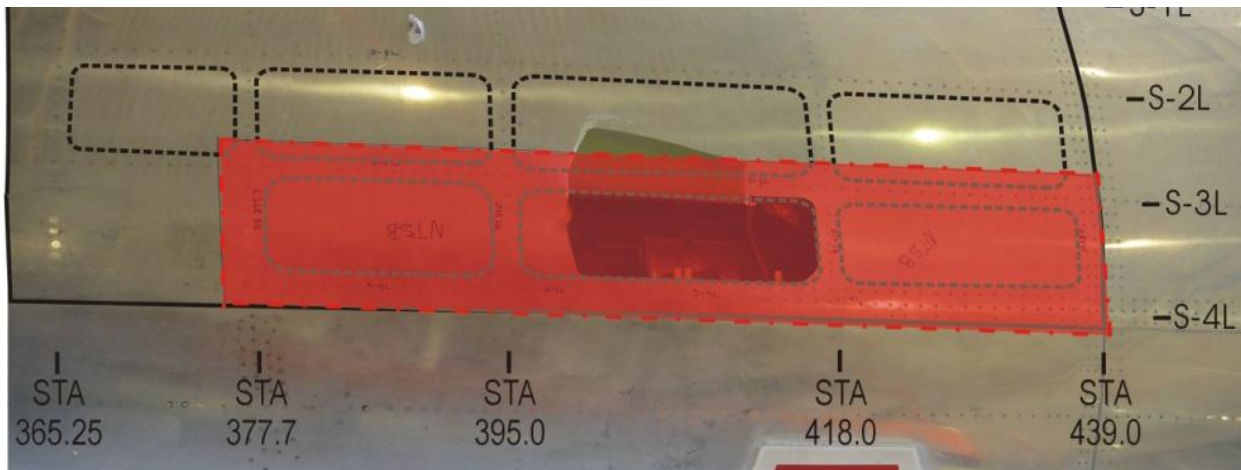
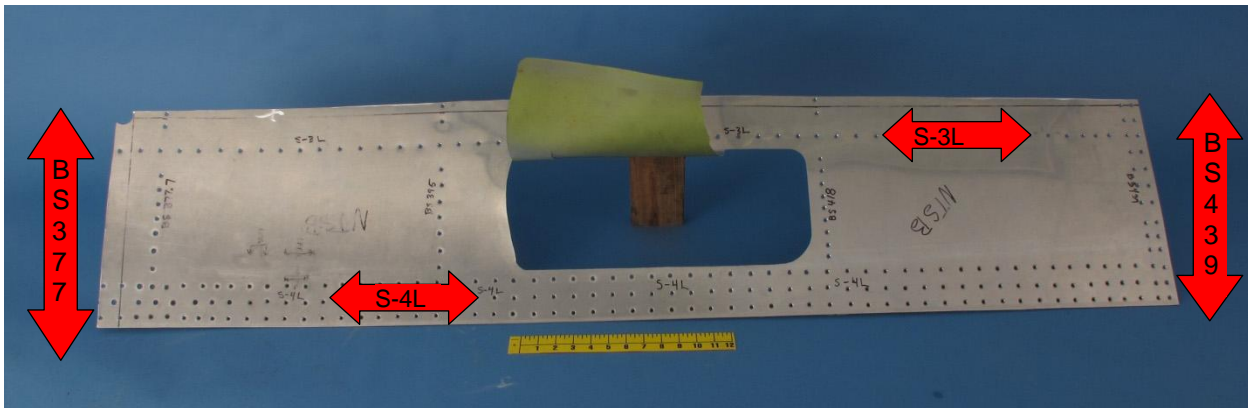
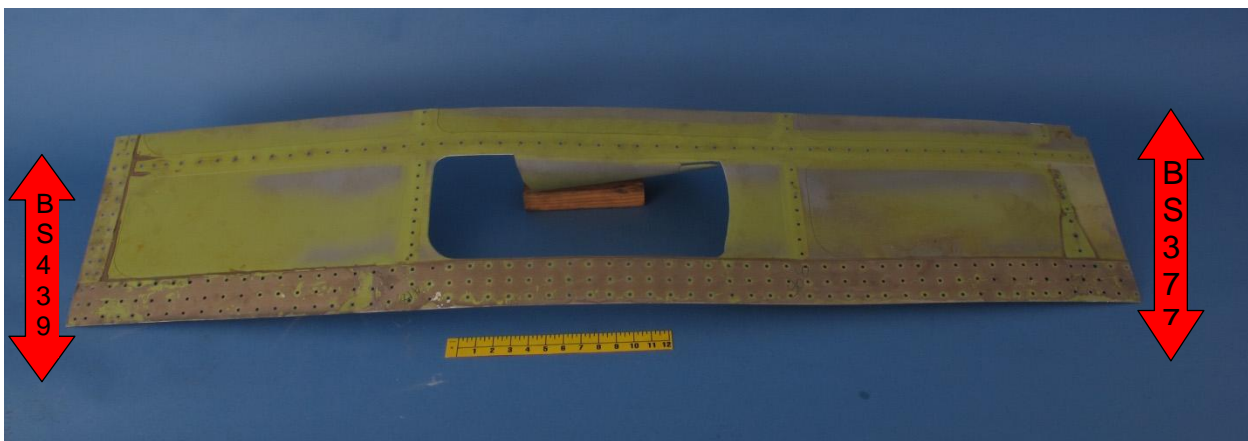
A section of the skin panel from the S-4L lap joint to 2 rivets above S-3L and from 2 rivets forward of BS 377.7 (approximately BS 374.4) to the butt joint at BS 439 was removed from the airplane for examination in the NTSB Materials Laboratory. The removed area is indicated by the shaded red box in the upper image of figure 5 with the exterior and interior surfaces of the removed section shown below. The removed section fully included the 3 pocketed fuselage bays along the aft left edge of the skin panel. For the purposes of this report the bays will be referred to as the aft, middle and forward bays.

Figure 5—Upper view illustrates the area of the crown skin removed with a shaded red box. Lower views show the exterior and interior surface of the as-removed panel section.

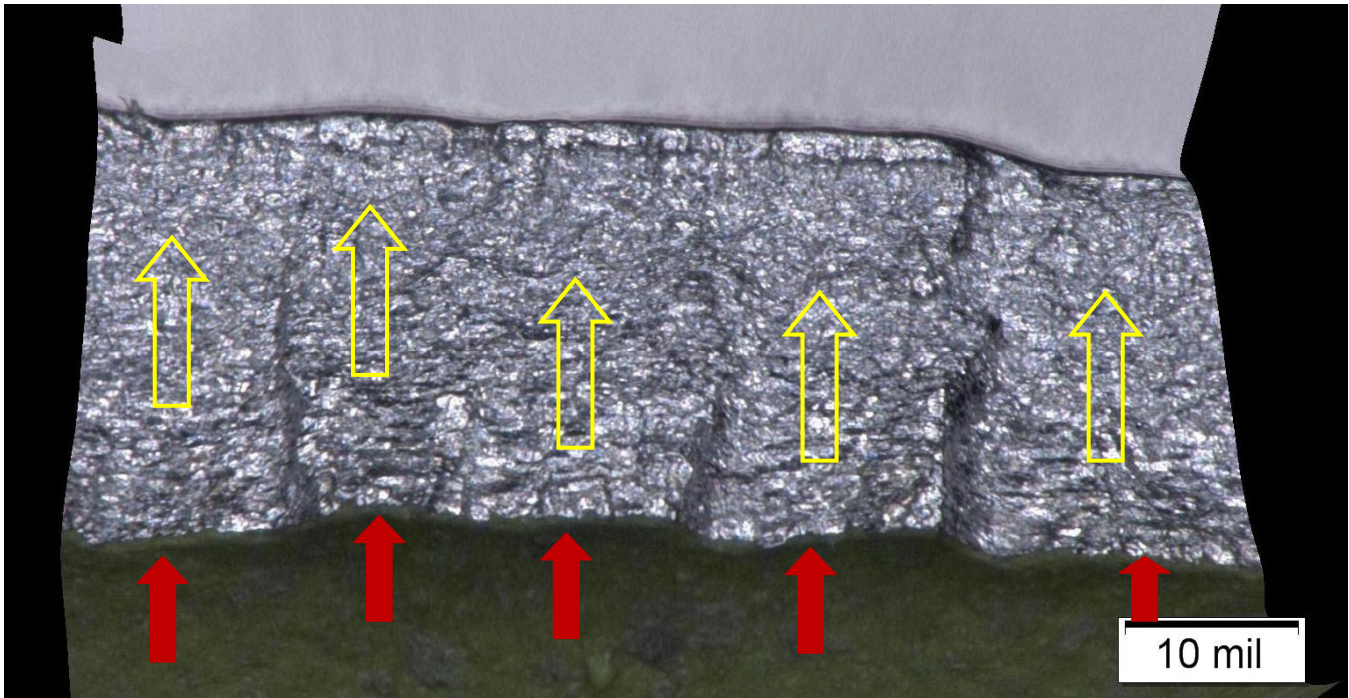
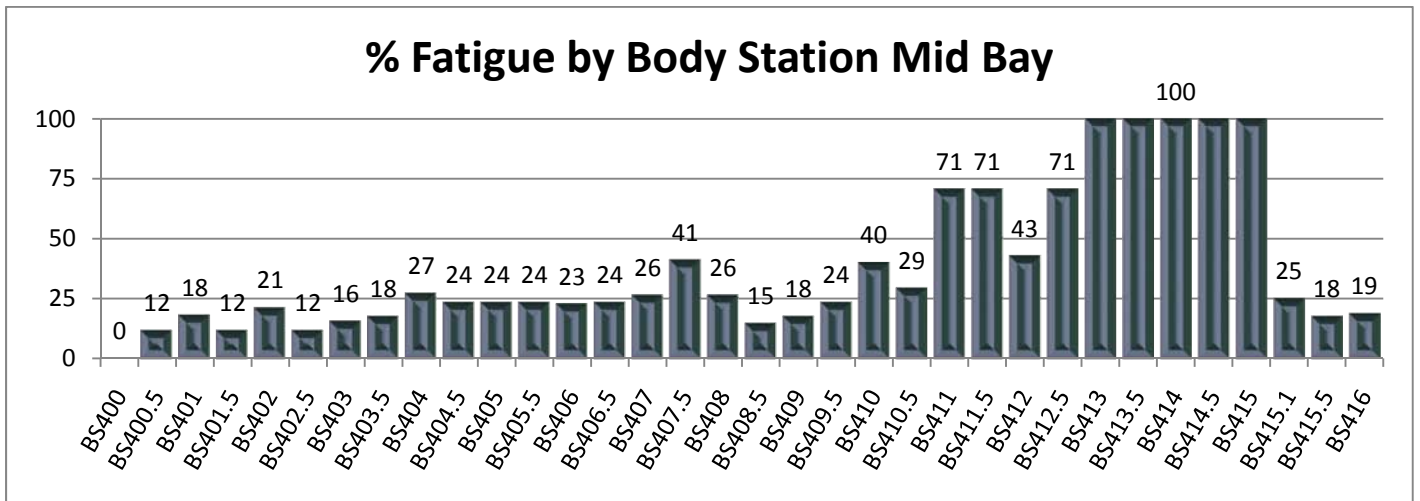
Magnified optical inspections of the skin fracture surfaces at the edge of the hole in the middle bay, after partial cleaning revealed through-the-thickness fatigue cracking along most of the longitudinal chem-mill step just above the S-4L lap joint. Fatigue cracking was noted along 15 inches of the 18 inch long longitudinal fracture region, approximately from BS 400.5 to BS 416. Magnified examinations indicated a multitude of fatigue crack initiation points on the interior surface of the panel with progression outward through the thickness of the skin. Many of the fatigue crack origins were slightly offset circumferentially from adjacent origins producing many ratchet marks in the fatigue region as the individual fatigue crack front grew and merged, as shown in the upper view of figure 6. Complete penetration of the skin by fatigue cracking was observed on an approximate 2 ½ inch length of the fracture located between BS 412 and 415. The remaining fatigue region showed partial penetration of the skin by fatigue fracture with ductile overstress fracture accounting for the remaining skin thickness. Estimates of the amount of fatigue crack penetration of the skin at half inch intervals are depicted by the chart in figure 6.

Figure 6—An area of fatigue showing typical multiple offset initiation points (red arrows) on the interior surface with progression (yellow arrows) outward through the thickness of the skin. Chart below plots the amount of fatigue as a percentage of total skin thickness along the edge of the hole. Image is a digital 3-D reconstruction.

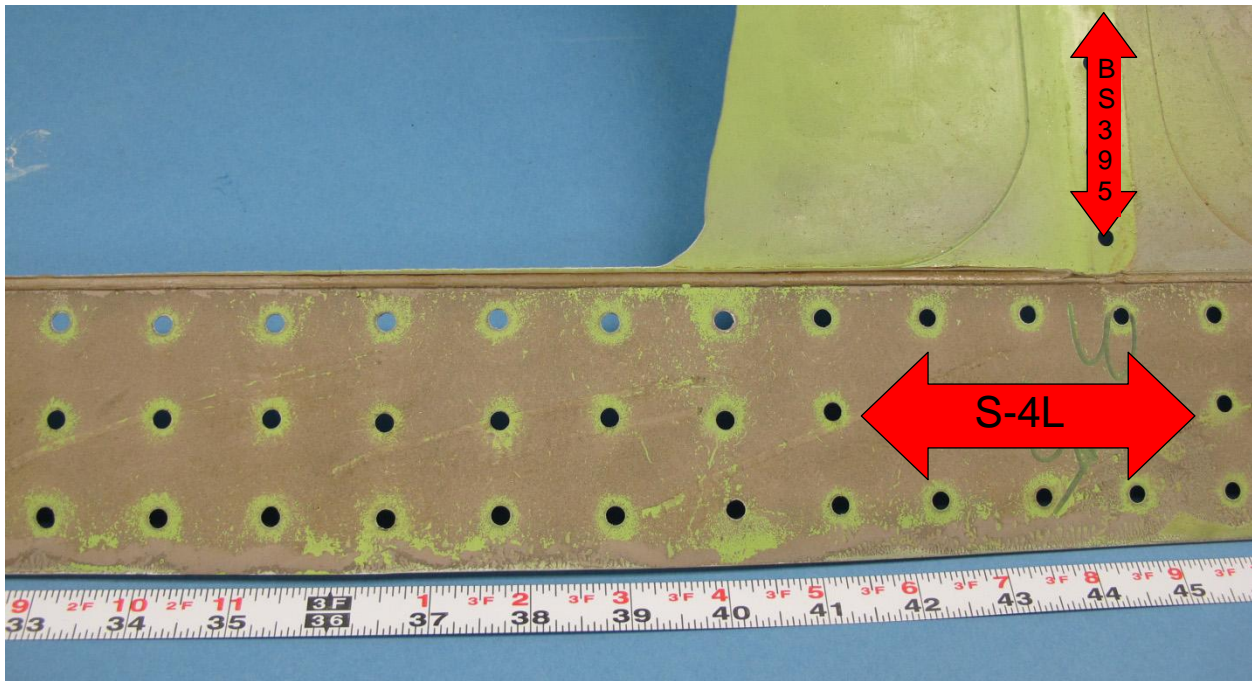
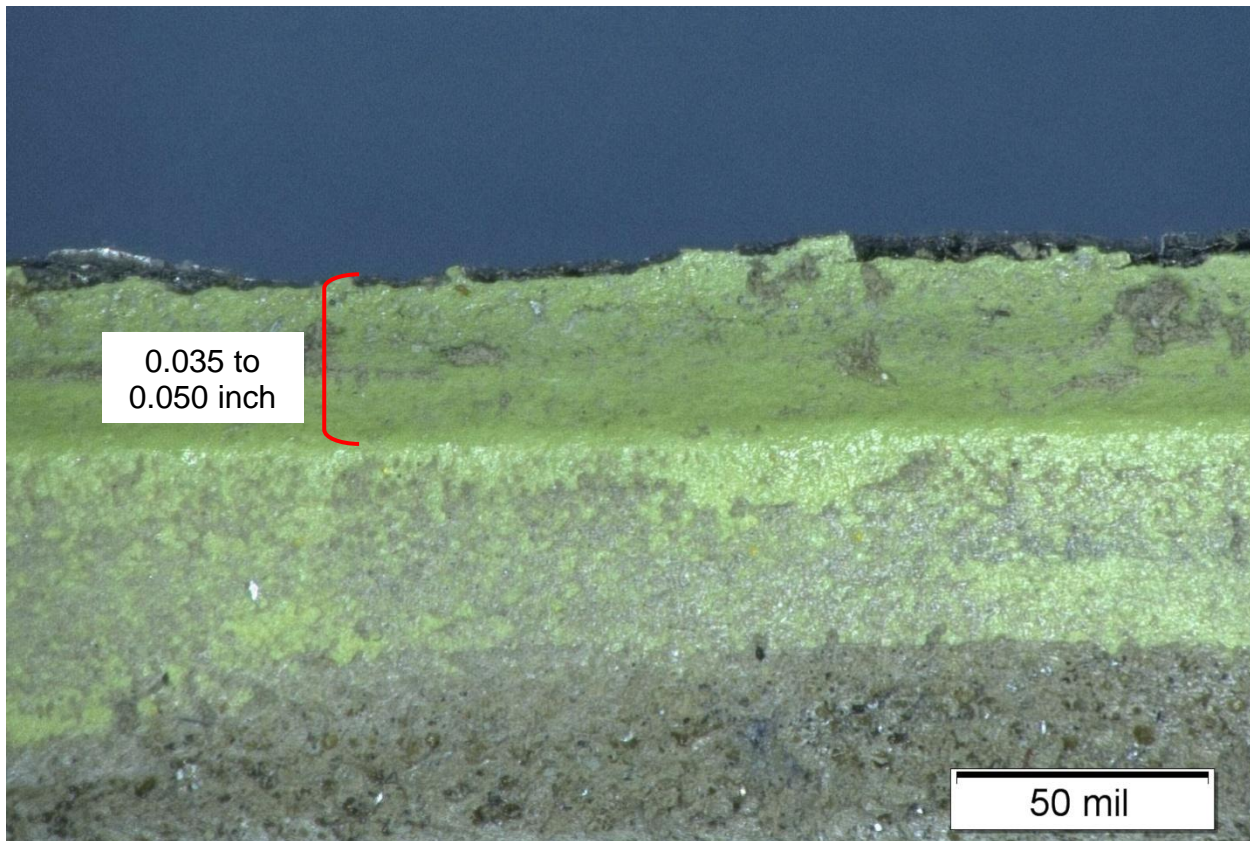
The fatigue region was approximately in line with the chem-mill step that also paralleled the lap joint at stringer 4 left. Along the lap joint the step was initially visually obscured on the interior by sealant extruded from the lap joint, as shown in the upper view of figure 7. The sealant was removed from the chem-mill step and adjacent surfaces by scraping with wooden instruments after soaking in acetone. With the sealant removed the fatigue regions were located along the transition from the chem-mill step to the thinner pocket region, at approximately 0.035 to 0.050 inch from the full thickness region of the panel (see figure 7 lower view).

Figure 7—The upper image shows the relationship of the flap to the chem-mill step at stringer 4L and the partial obscuration of the step by the sealant (brown). Lower view shows a close up view of the chem-mill step (bracket) after the sealant was removed.

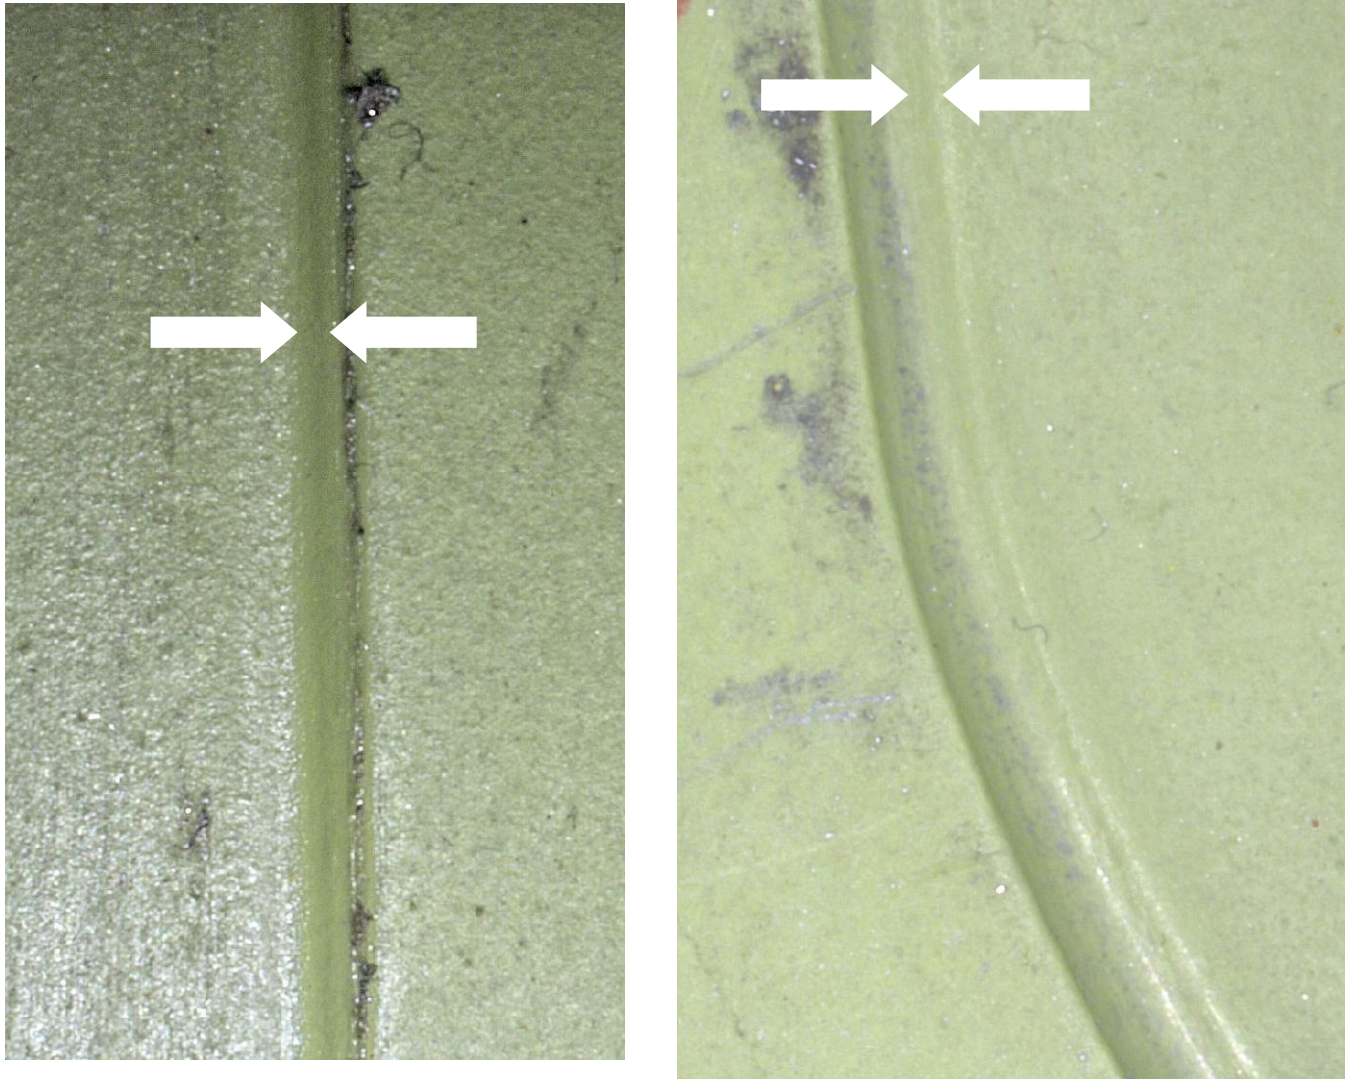
After removal of the sealant but with the primer intact, magnified visual examinations of the panel interior uncovered what appeared to be a smooth depressed line immediately adjacent to the intact chem-mill steps, as shown in figure 8. Visually the depressed line was apparent around each pocket on the removed panel including the received S-3L portion of the S-3L to S-2L fuselage bays.

Figure 8—Views depicting the visually depressed line (between arrows) at the chem-mill step.

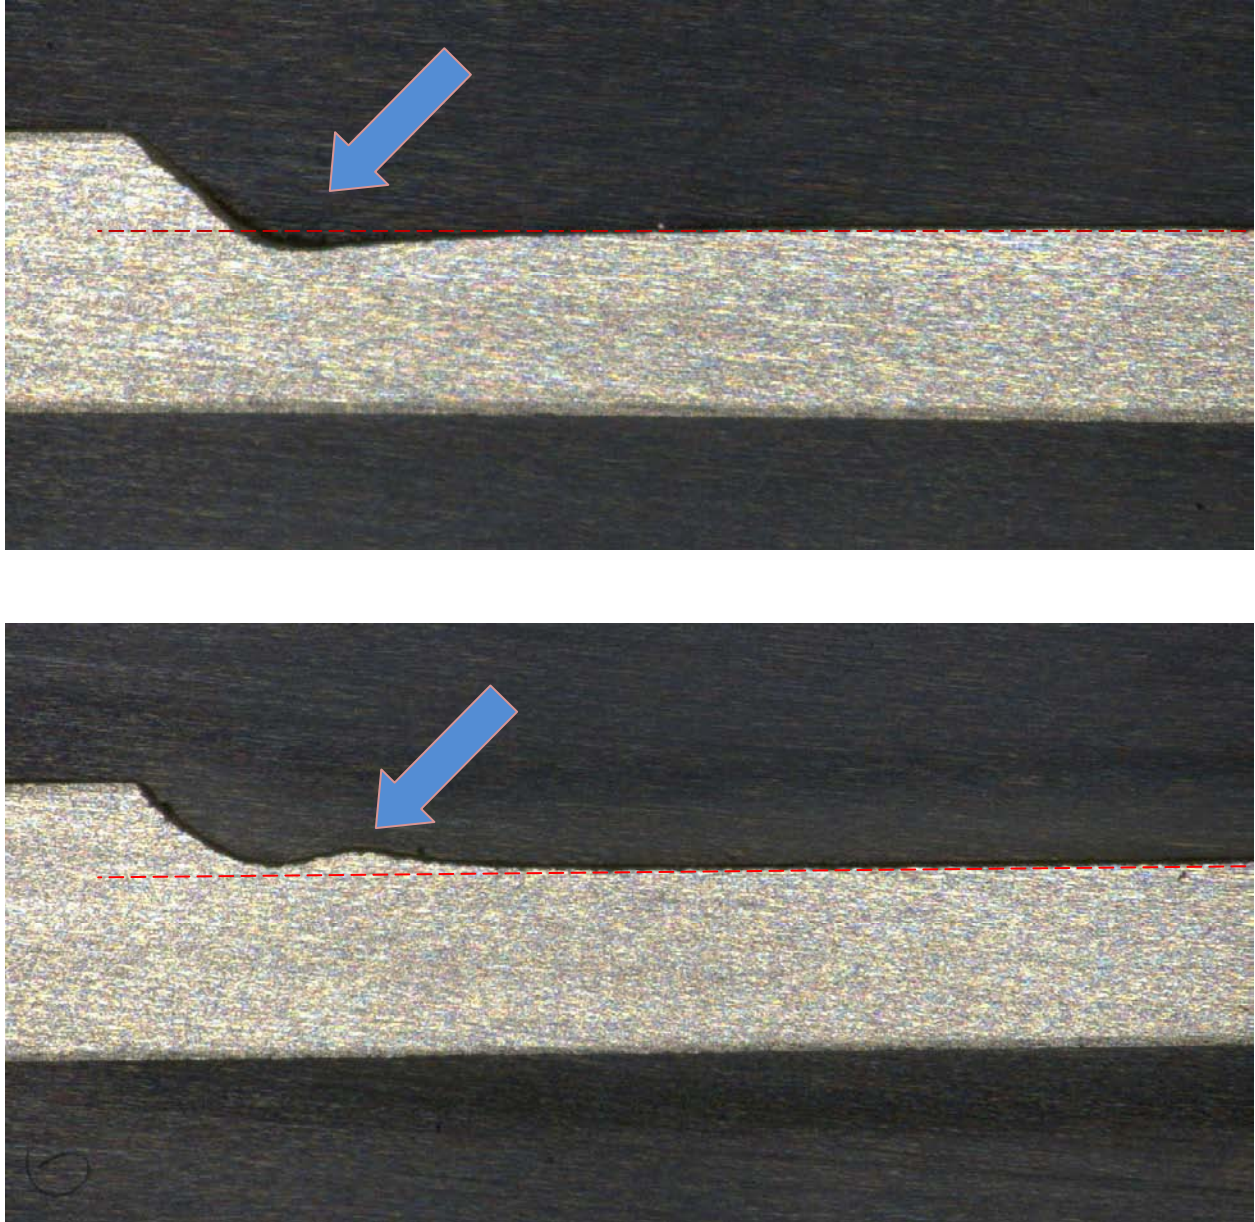
Several metallographic cross sections were prepared through the chem-mill steps at different locations around the fuselage bays including at stringer and tear strap locations. The sections revealed a pattern around each chem-mill pocket. On the S-4L sides of each pocket, thinning of the pocket material was noted immediately adjacent to the fillet. For the chemical milling process, this type of thinning, at this location is generally referred to as channeling¹⁴. On the S-3L sides of each bay locally thicker regions were present adjacent to the fillets. This type of geometric feature is generally referred to as ridging¹⁵. Typical profiles illustrating channeling and ridging found on opposite sides of the aft fuselage bay at BS 429 are displayed in figure 9. The sides of each pocket (along the tear straps) also followed consistent patterns in the fillet area. Channeling was noted for most of their lengths, changing to ridging for the last few inches. This pattern was exhibited by all of the fuselage bays in the removed portion of the crown skin. Fillets with channeling or ridging could be optically identified under laboratory conditions using moderate stereomicroscope magnifications and oblique lighting.

Both the AMS and Boeing specifications¹⁶ for chemical milling illustrate channeling and ridging as possible geometric features produced by the chemical milling process. Both specifications noted that neither feature is rejectable unless an associated dimension exceeds drawing requirements for that part. The drawing specified 0.062 inch (nominal) thick material prior to chemical milling. In the pockets the thickness was to be reduced to 0.040 inch +/-0.003 thick by the chemical milling process.

Figure 9—Cross sections through the chem-mill steps at BS 429. Upper profile shows channeling (arrow) at the lap joint step. Lower view shows ridging at the S-3L pad step. Dashed red lines are approximate projections of the average surface of the pocket.

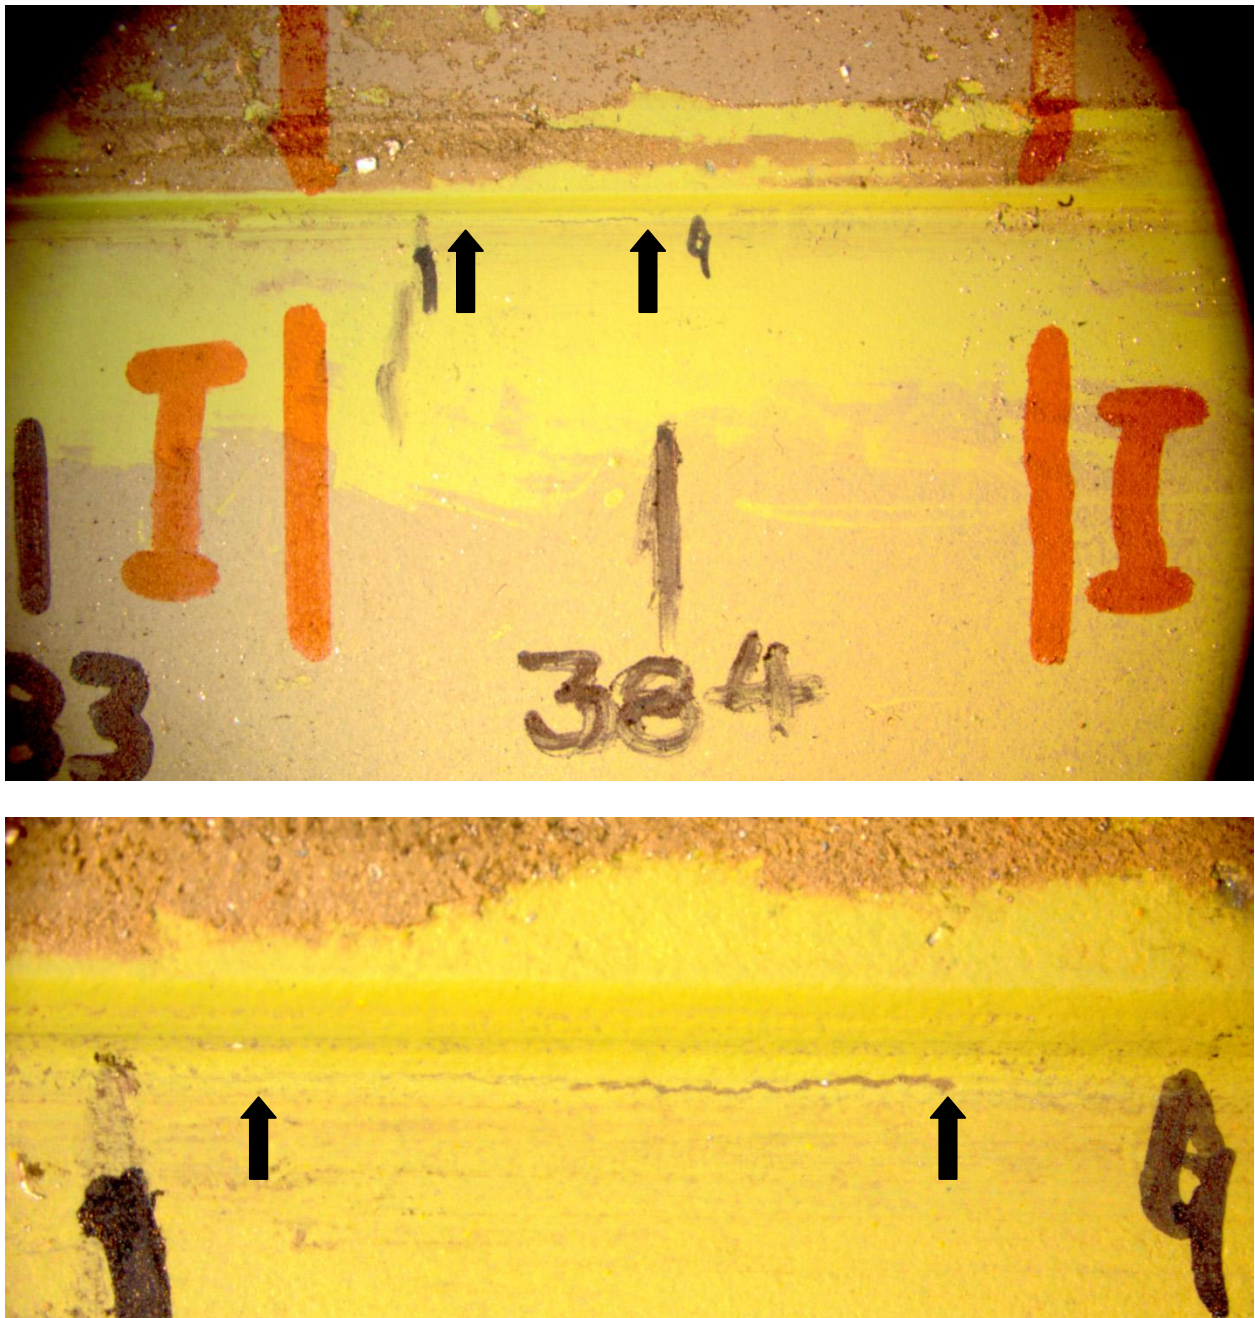
With the primer intact, the through crack (between BS 386 and 387) was clearly visible at low magnifications on the inner surface. At higher magnifications a portion of the crack indication at BS 384 was visible as cracking in the primer as shown in figure 10. With the primer removed a smaller portion of the crack indication could be discerned at high optical magnifications with oblique lighting.

Figure 10—Views of the interior surface of the forward bay at the eddy current crack indication at BS 384. Red “I” marks indicate approximate eddy current size of indication. Black arrows indicate the visible portion through the primer. Higher magnification view of the visual crack shown in the lower view.

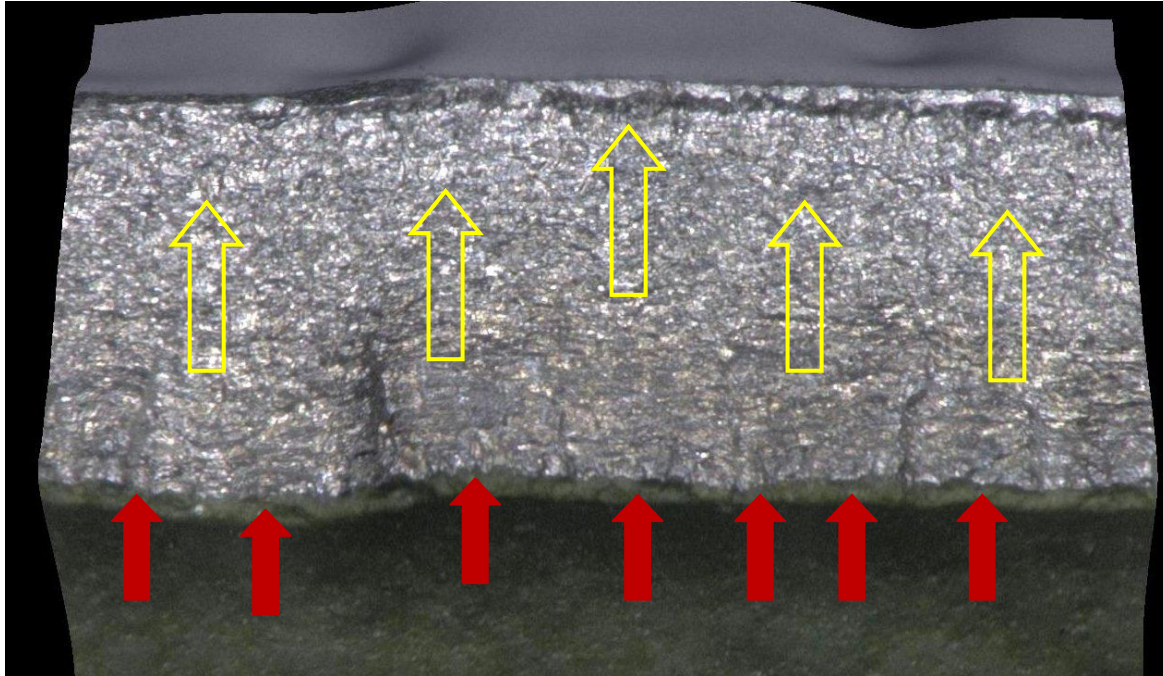
On the internal surface of the panel, the through crack was apparent from approximately BS 385.5 to BS 387. To open the through crack, the panel was saw cut from the lower edge of the lap joint to the visible ends of the crack and the created tab separated with little or no force. Visual magnified examinations of the exposed crack surfaces revealed surfaces consistent with fatigue cracking from multiple origins on the interior surface. The initiation and propagation of the fatigue crack was visually very similar to the flap at the middle bay.

Figure 11—A typical portion of the opened through crack showing multiple initiation points (red arrows) on the interior surface with propagation (yellow arrows) through the thickness of the skin. Image is a digital 3-D reconstruction. Approximate 150x Mag

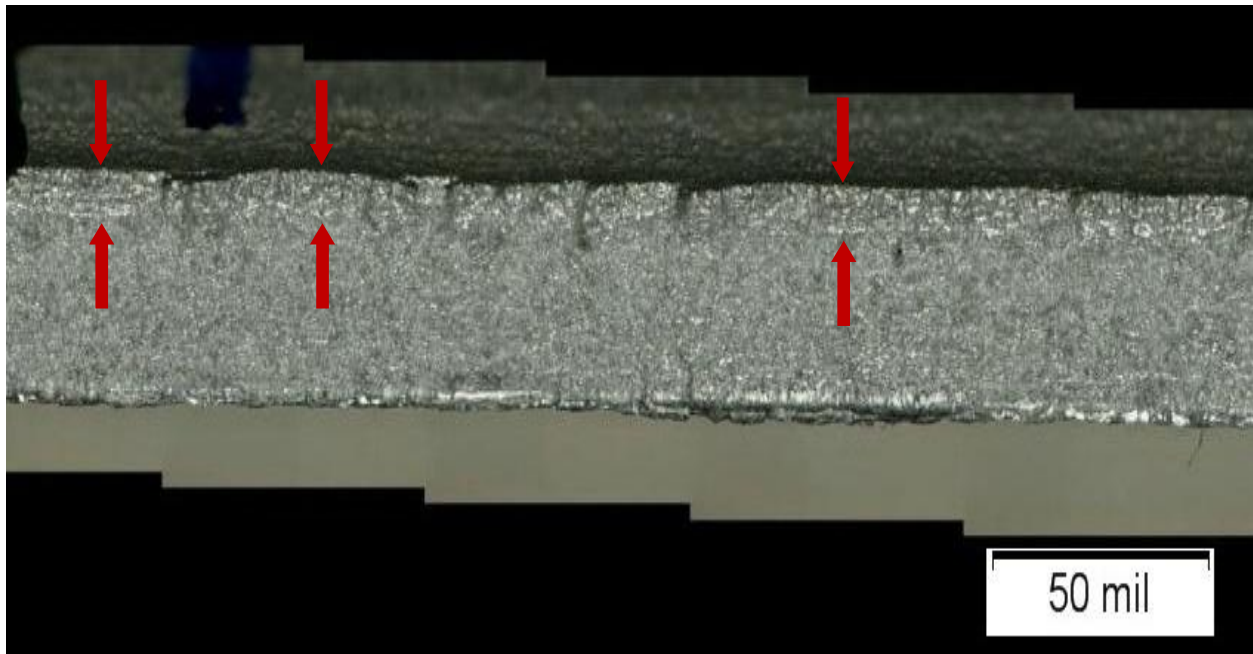
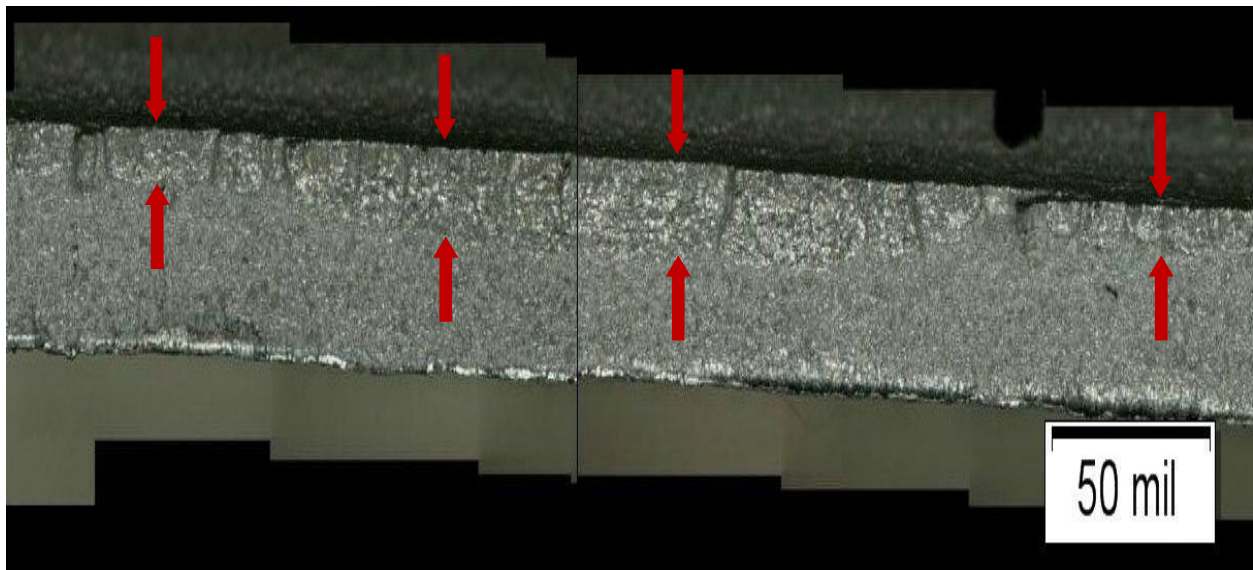
Figure 12—Upper view shows a typical portion of the opened crack in the forward bay with the fatigue regions, between red arrows. Interior surface and chem-mill step at top. Lower view shows the eddy current crack indication area. Both images are stitched mosaics. The upper image has been stretched 50% vertically and the lower image has been vertically stretched 100% to better show the fatigue.

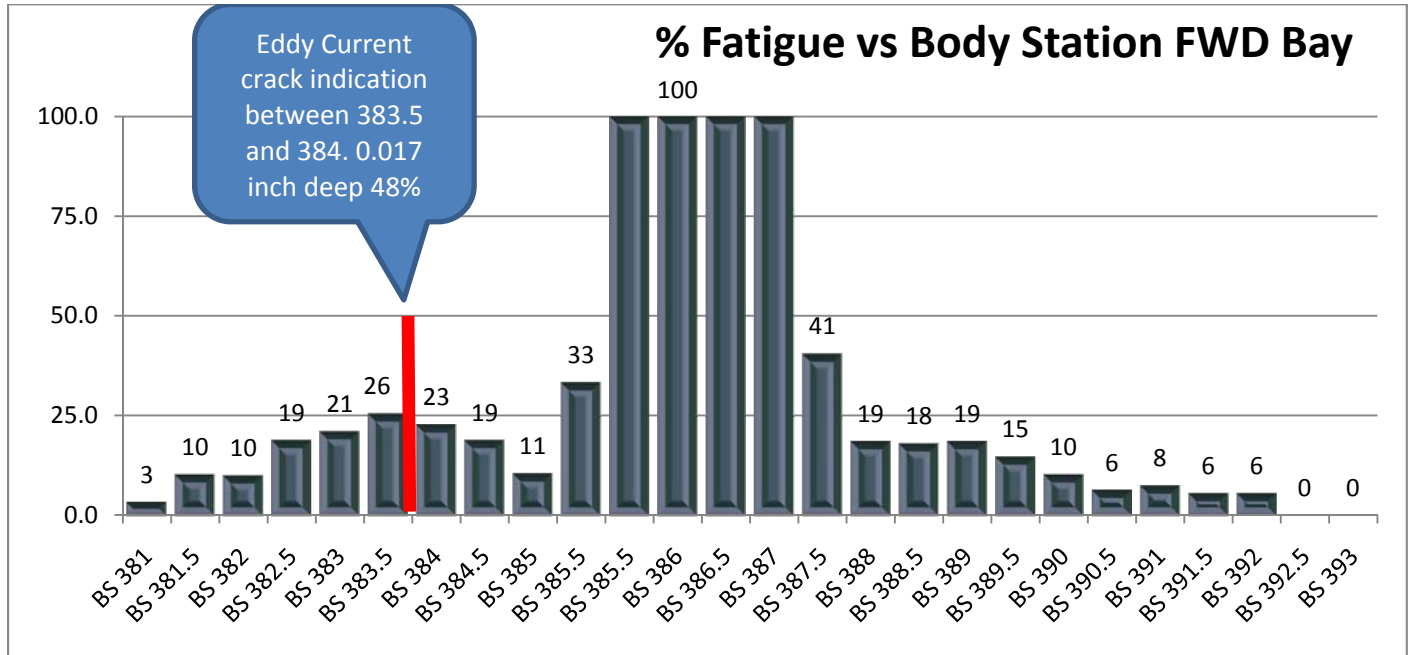
The adjacent chem-mill step areas of the forward bay were stripped of paint and visually inspected. Except at the previously noted eddy current crack indication, no cracking was visible at magnifications up to 50X. However, when the panel was cut and bent outward and fractured many additional areas of fatigue were noted propagating away from the interior surface, similar to the flap region in the middle bay. Including the through crack and the eddy current indication, fatigue was visible from about BS 381 to about BS 391.5. For most of the forward bay, the fatigue penetration was less than about 0.009 inches as shown in the upper view of figure 12. However, in the eddy current indication location, the fatigue penetration was up to 0.017 inch for a length of approximately 0.15 inch as shown in the lower view of figure 12. Measurements of relative penetration of the skin by fatigue measured at ½ inch body stations are depicted in figure 13. It should be noted that the deepest penetration noted above fell between the measurements point and is not reflected in the graph.

Figure 13—Graph showing the relative amount of fatigue penetration as a percentage of skin thickness in the forward bay. Measurements approximately every ½ inch. Note that the eddy current indication fell between measurement points.
