NATIONAL TRANSPORTATION SAFETY BOARD

MATERIALS LABORATORY FACTUAL REPORT

Report No. 11-001

Place : Miami, Florida
Date : October 26, 2010
Vehicle : Boeing 757-223, N626AA
NTSB No. : DCA11FA004
Investigator : Clinton Crookshanks, AS-40

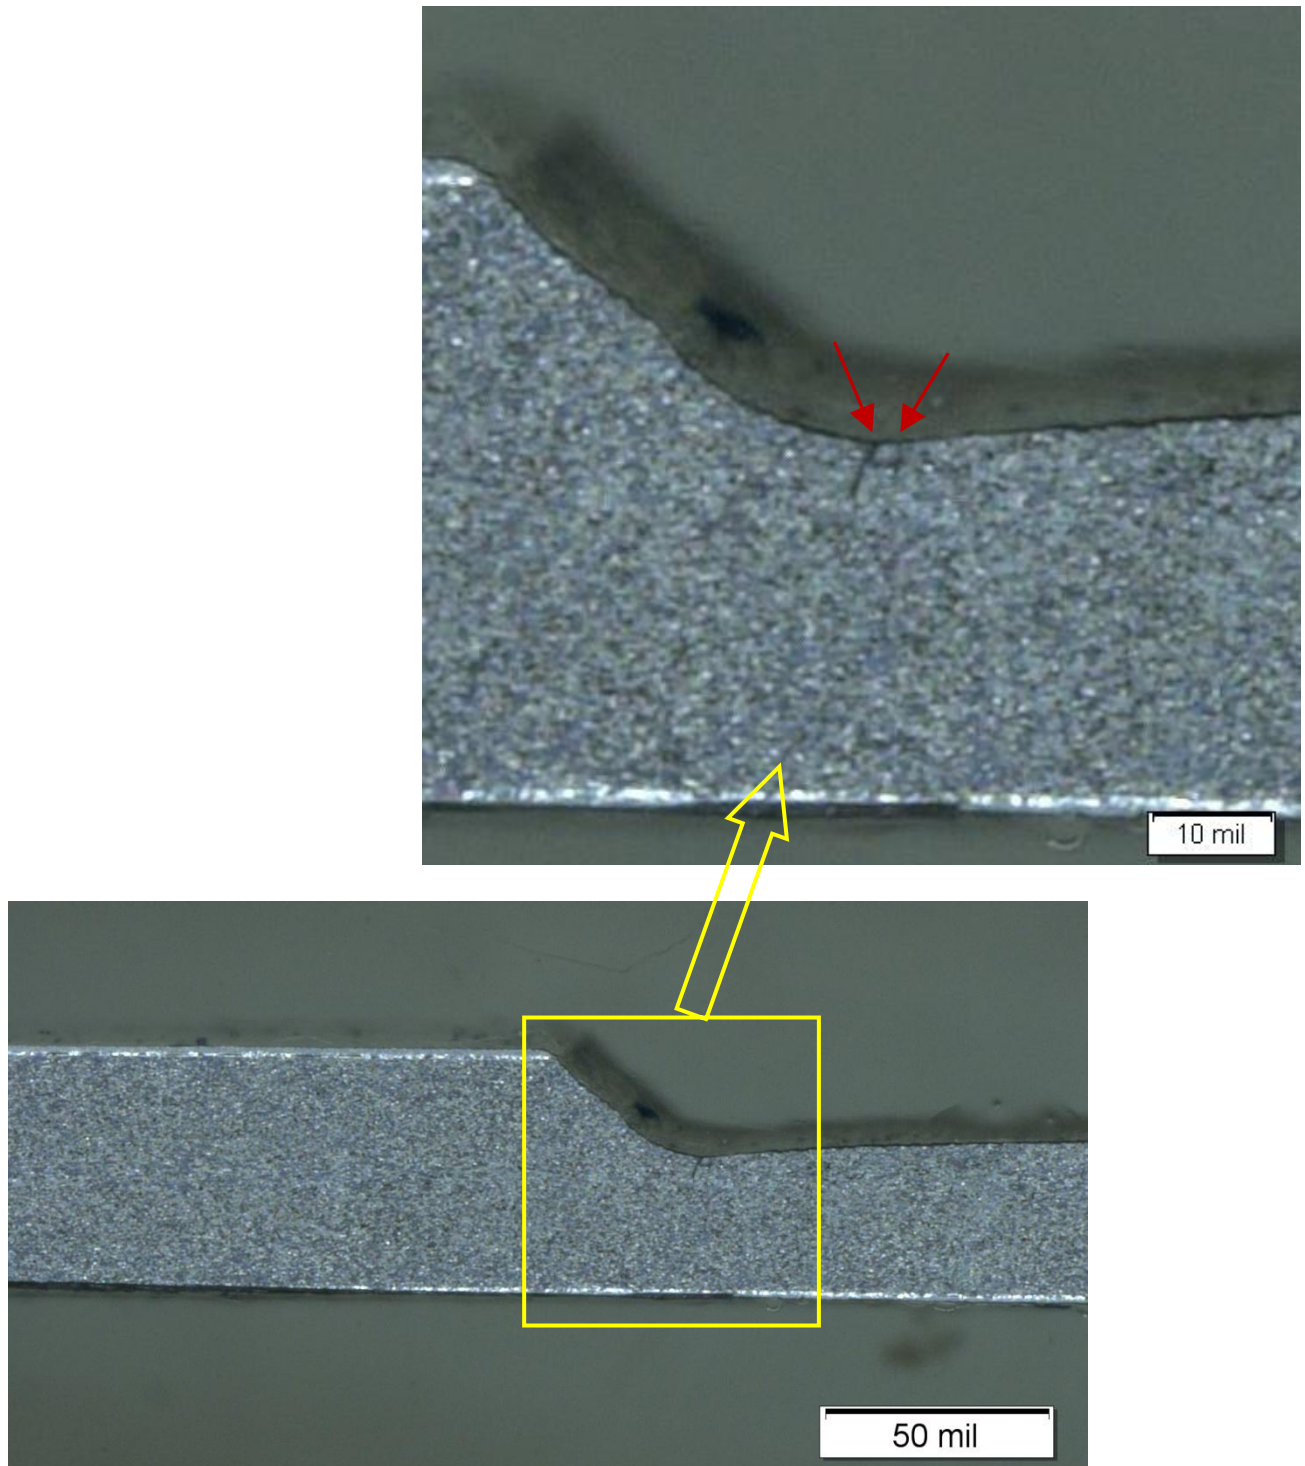
The previously mentioned metallographic sections taken for thickness measurements included one at BS 387.5 in the forward bay. The location was just aft of the through crack. Close inspection of the section revealed two 0.008 inch deep cracks in the thinnest section, as shown in figure 14.

No cracks were initially detected in the aft bay, by either eddy current or visual inspections. The bay was cut in half (about BS 428.5) and the forward portion was temporarily released to Boeing as a test piece for NDI procedures. Upon receipt Boeing stripped the paint from the chem-mill step areas and performed a fluorescent penetrant inspection (FPI). The FPI revealed a series of cracks along the chem-mill step at the lap joint. The indications extended from about BS 421.5 to the cut at BS 428.5. Subsequent FPI of the aft portion also uncovered crack indications extending aft another 1 inch, to about BS 429.5. A cross section at about BS 428.5 confirmed the indications by revealing 2 parallel 0.007 inch deep cracks at the minimum section thickness similar to that shown in figure 14.

Figure 14—Images of cracking (arrows) in channel of lap joint chem-mill step at BS 387.5. Cracks measured 0.008 inch deep.

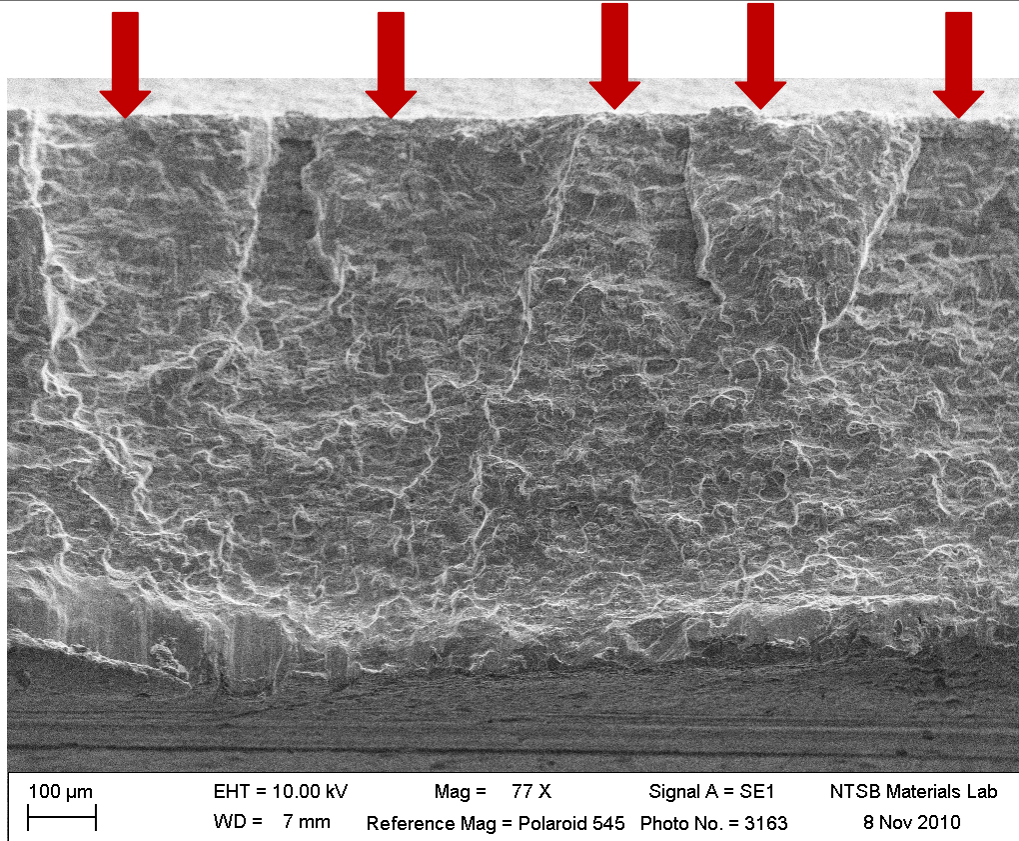
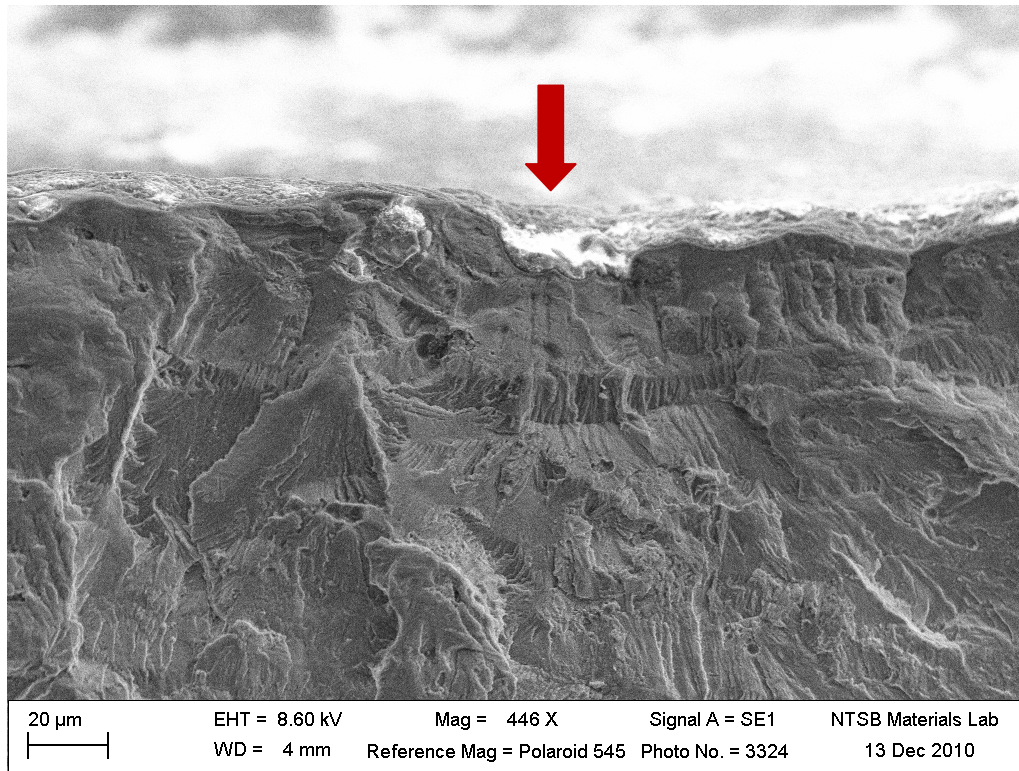
Portions of the flapped area, the through crack and the opened eddy current crack indication were examined with a scanning electron microscope (SEM). The SEM examinations confirmed the optical findings of multiple fatigue cracks initiating at the interior surface and propagating directly through the thickness of the skin. A typical view of fatigue at a full penetration area is displayed in the upper view of figure 15. Typically, the individual fatigue cracks independently initiated at surface features (pits) resulting from the chemical milling process, as shown in the lower view of figure 15. The individual cracks propagated independently, in many instances at slightly off set planes, through between 1/3 and 1/2 of the thickness before merging into a common fatigue front. In most of the fatigue areas a

Figure 15—A typical area of full thickness fatigue (BS 836.9) is displayed in the upper view showing multiple fatigue origins (red arrows) at the interior surface (top in both views). Many of the origins were at surface pits from the chemical milling process as shown at BS 412.5 in the lower view.

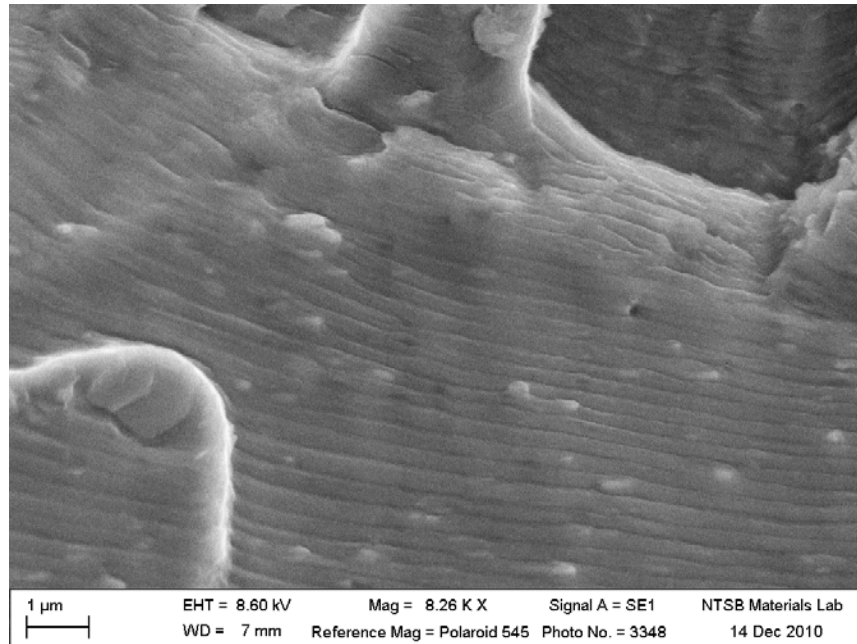
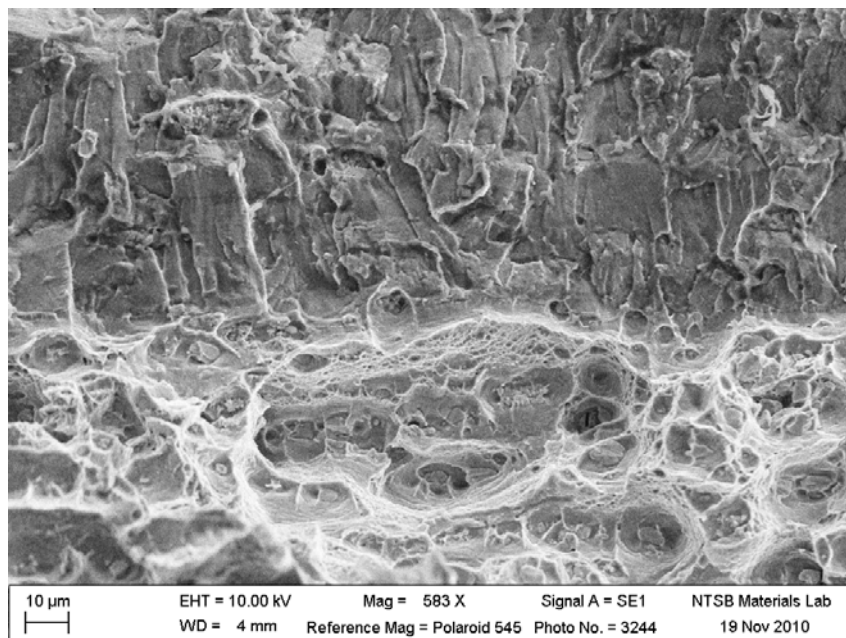
change in surface texture from relatively smooth to much rougher was apparent at about the merge area. Fatigue striations were typically visible throughout the fatigue regions, as typified in the upper view of figure 16. At regions of partial fatigue penetration the fatigue terminus was sharply delineated as shown in the lower view of figure 16.

Figure 16—Top view shows typical striations found in fatigue areas. Lower view shows a typical fatigue terminus in the partial fatigue penetration regions. Fatigue is propagating from the image top to the bottom in both views.
