NATIONAL TRANSPORTATION SAFETY BOARD

MATERIALS LABORATORY FACTUAL REPORT

Report No. 11-023

Place : Aleknagik, Alaska.
Date : August 9, 2010.
Vehicle : DHC-3 Otter, N455A.
NTSB No. : ANC10MA068.
Investigator : Robert Swaim, AS-40.

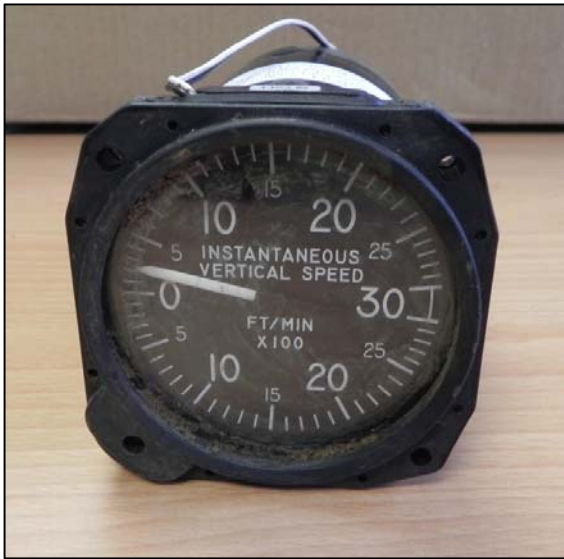
The display of the vertical speed indicator submitted for examination is illustrated in Figure 1. Examination of the instrument revealed an adhesive identification plate on the rear of the case displaying "PART NO. 7130", "SER NO. 8667", "DATE 3/05", "CODE C. 47", "TYPE II 0-3,000 FT/MIN", "United Instruments Inc, Wichita, KS". On the side of the case "MAR 29 2005" was stamped in white. Air currents were applied to the static source port and the needle was observed to fluctuate. Ultra-violet (UV) examination of the dial revealed no fluorescence. Examination of the dial revealed no indications that the needle had impacted it and the needle was observed to be at least 1/8-inch from the dial surface.

Figure 1. The face of the vertical speed indicator received for examination.

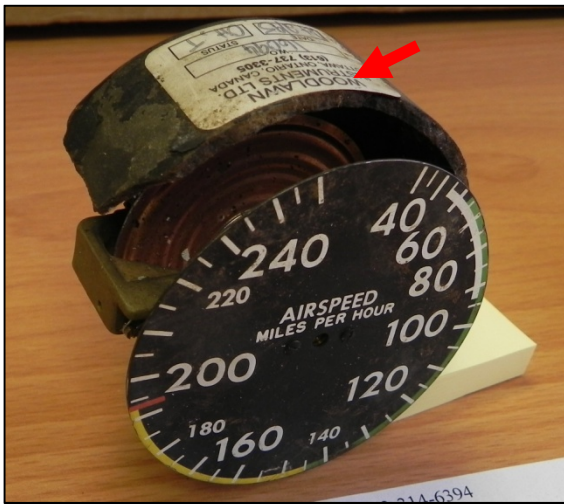
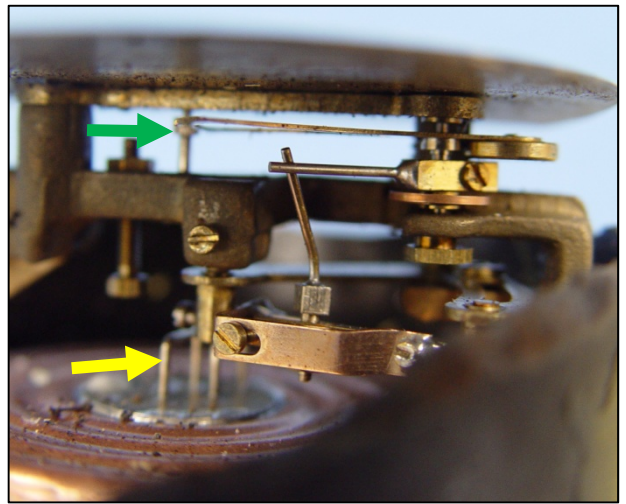
The airspeed indicator received for examination was missing a significant amount of its case and its bezel, exposing the inner mechanism. The needle and the portion of its pinion it was originally fitted on were also missing. The airspeed indicator is illustrated, as received, in the left image in Figure 2. Approximately 25% of an identification plate remained attached to the rear of the case and displayed "MANUFACTURED U", "RE. 1709", "2137193", "2", "TYPE C14", "M'F'R'S PART NUMBER", "SERIAL", "BEN", and "PI".

An overhaul sticker on the side of the case is indicated by the red arrow and displayed "Woodlawn Instruments Ltd.", "Ottawa, Ontario, Canada", "(613) 737-3305", "W.O.: 16094", "Date: 24 2/95" and "OH, T".

Examination of the inner mechanism revealed that it was intact although the rim of aneroid wafer had been bent for approximately 1/2-inch circumferentially. Mechanical manipulation of the aneroid wafer to reproduce the expansion it would receive during operation revealed continuity to the needle pinion. The inner mechanism is illustrated in the right image in Figure 2 with the wafer indicated by the yellow arrow and the needle pinion indicated by the green arrow. Slowly increasing air pressure was then fed into the pressure port at the rear of the case. The wafer expanded and the needle pinion rotated almost 360-degrees before the wafer burst open adjacent to the bent portion of the rim.

Figure 2. The airspeed indicator received for examination (left) and an internal view (right).

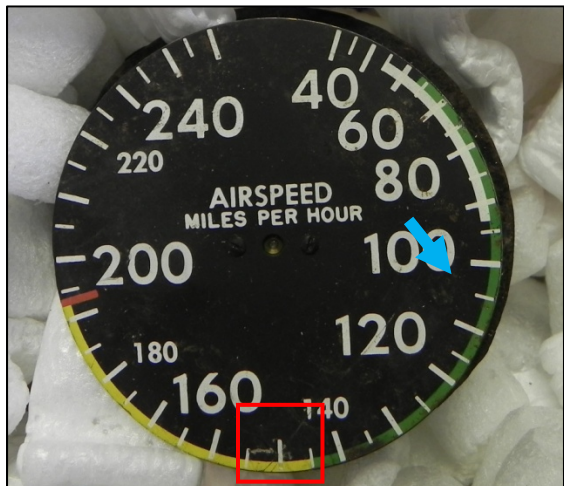
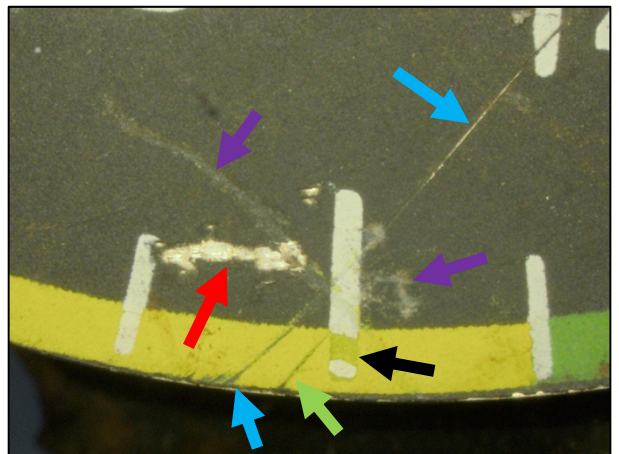
The dial displayed graduations indicating between 40 and 260 miles per hour (mph). A white arc was observed between the 55-mph graduation and 93-mph, a green arc was observed between 63-mph and the 145-mph graduation, a yellow arc was observed between the 145-mph graduation and 193 mph and a radially oriented red line was observed at 193-mph. Examination of the dial revealed missing paint, scuff marks and scratches mostly between the 150-mph and 155 mph graduations. The area between the 145 mph and the 155 mph graduations is contained within the red box in the left image in Figure 3 and is illustrated in the right image. The red arrow indicates the area of missing paint where the dial's base metal was exposed and the black arrow indicates the area on the 150-mph graduation where the missing white paint exposed the underlying yellow paint. The purple arrows indicate scuff marks in both side of the 150-mph graduation, the blue arrows indicate a scratch that extended from the periphery to the 100-mph number as indicated by the blue arrow in the left image and the green arrow indicates a scratch extending from the periphery to the 150-mph graduation. UV examination of the dial revealed no fluorescence.

Figure 3. The dial of the airspeed indicator (left) and a closer view in the vicinity of the yellow arrow (right).

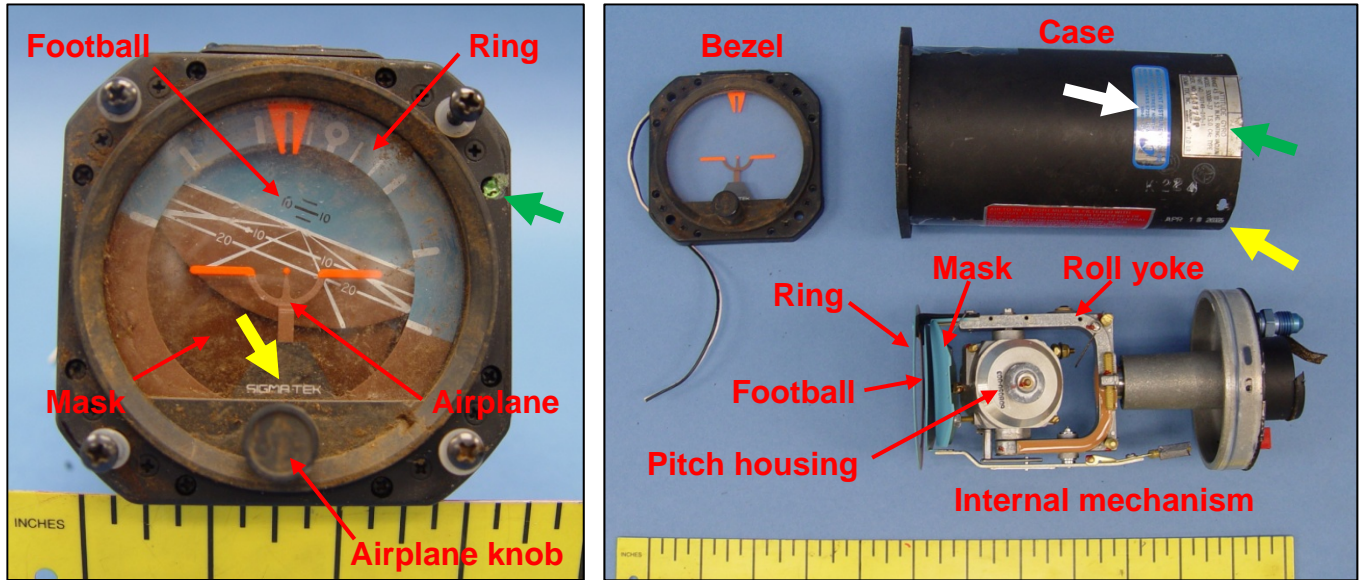
The face of the attitude gyro received for examination is illustrated in the left image in Figure 4 with the manufacturer indicated by the yellow arrow. UV examination of the face revealed that the orange components and the green material on the screw head indicated by the green arrow fluoresced. The airplane knob, the airplane, the ring, the football and the mask are identified. Rotation of the airplane knob was found to move the airplane up and down. When initially handled, and immediately after removing the bezel, the football was found to swing freely but the ring did not rotate. During subsequent handling of the instrument the ring became loose and rotated freely.

Examination of the case revealed the identification label indicated by the green arrow in the right image in Figure 4 that displayed "SIGMA-TEK", "model number 5000B-39", "serial number T36378P" and "part number 1U149-010-1". The adhesive label indicated by the yellow arrow displayed "MID-CONTINENT INSTRUMENT CO. INC." and the company's address. The date "FEB 23 2005" was stamped with white paint at the

location indicated by the yellow arrow and “MAR 29 2005 was also found similarly stamped on the case. The red label on the case detailed installation precautions.

Screws in the rear of the case were removed and the internal mechanism was extracted with the rear cover. The partially disassembled attitude gyro is illustrated in the right image in Figure 4 with the bezel, the case and the extracted internal mechanism identified. On the internal mechanism the ring, the football and the mask are identified for comparison with the left image. Examination of the internal mechanism revealed that the roll yoke rotated freely and the pitch housing assembly containing the air driven gyro, also rotated freely, limited only by the allowable movement of the football arm. The pitch housing was disassembled and an examination of the extracted rotor and the inner surface of the housing revealed no indications of contact.

Figure 4. The face of the attitude gyro (left) and the gyro partially disassembled (right).

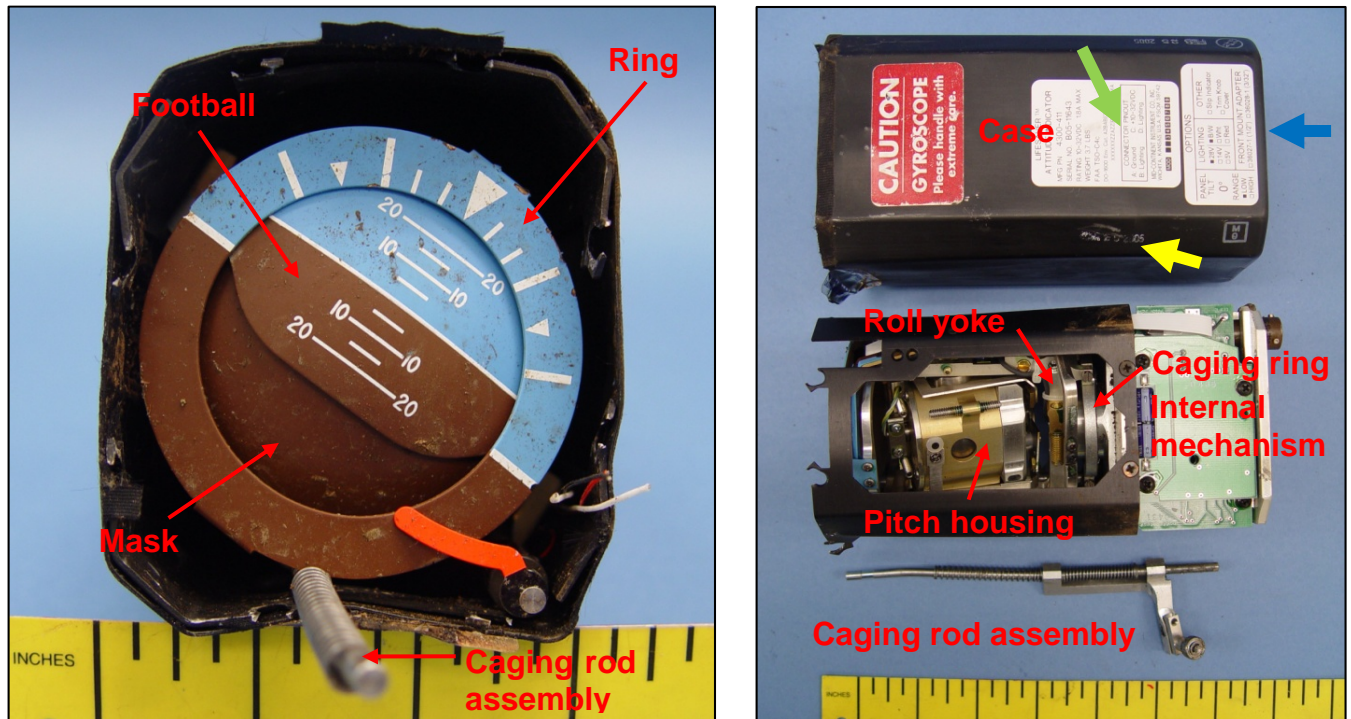
The case of the attitude indicator received for examination displayed indentations and deformation. The indicator was missing the bezel assembly, exposing the display. The face of the attitude indicator is illustrated in the left image in Figure 5 with the mask, the football and the ring identified. The caging rod assembly¹ protruded from the display and is also identified. UV examination of the face revealed that the orange flag fluoresced. The football was locked in place between the ring and the mask and the ring could only rotate approximately 10-degrees. The interior of the instrument was illuminated to find that roll yoke rotation was limited by the yoke contacting the buckled side of the case.

Examination of the case revealed the adhesive identification label indicated by the green arrow in the right image in Figure 5 which indicated that the instrument was a “LIFESAVER™ ATTITUDE INDICATOR” part number “4300-411”, serial number “B05-11643” manufactured by “MID-CONTINENT INSTRUMENT COMPANY”. A battery, attached to the rear of the case, displayed a label indicating its part number, “9015607” and its serial number, “B10-10964”. The battery was disconnected and removed to reveal a label indicating that it requires a “4 month max recharge” and was last charged “3/22/10”.

The internal mechanism was extracted from the case and during the extraction the caging rod assembly fell out. The partially disassembled attitude indicator is illustrated in the right image in Figure 5 with the roll yoke, the pitch housing the caging ring and the caging rod assembly identified. Examination of the caging rod revealed that the arm at the rear of had been bent rearwards. The arm on the caging rod assembly is illustrated in Figure 6 with the component parts identified and a yellow arrow indicating the location of the twist. The bearing that normally engages with the caging ring identified in the right image in Figure 5 was examined and found to rotate smoothly and easily. The football, the mask and the ring were obscured by the side plates which were then removed.

Figure 5. The face of the attitude indicator (left) and the indicator partially disassembled (right).

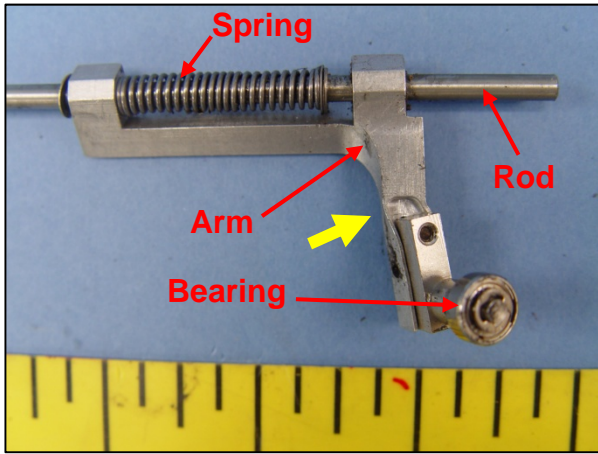
Figure 6. The twisted arm at the rear end of the caging rod assembly.

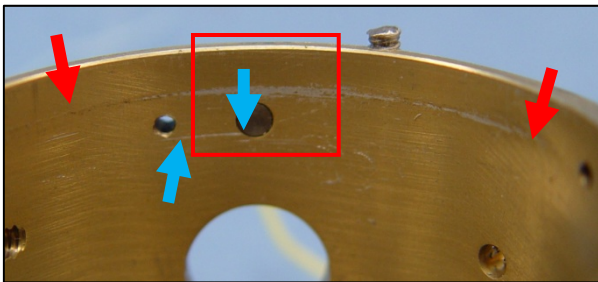
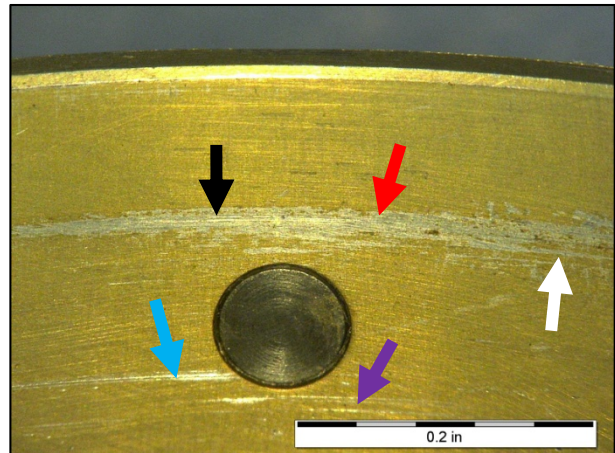
movement of the football arm. The pitch housing was disassembled and an examination of the rotor revealed no indications of contact with the housing. An examination of the housing's inner surface revealed circumferential bands of exposed base metal occupying approximately 100-degrees of arc and diametrically opposed. One of the bands is illustrated in the left image in Figure 7 and located between the two red arrows. On this side of the housing a second smaller band was observed and is located between the blue arrows. A closer view of the surface within the red box is illustrated in the right image in Figure 7 with the previously noted bands similarly indicated by the red and blue arrows. The black arrow indicates a distinct scratch on the band indicated by the red arrow and the white arrow indicates a distinctly circumferentially oriented portion of the band. The purple arrow indicates a group of circumferentially oriented scratches not evident in the left image.

Figure 7. Markings on the inner surface of the rotor housing (left) and a closer view (right).

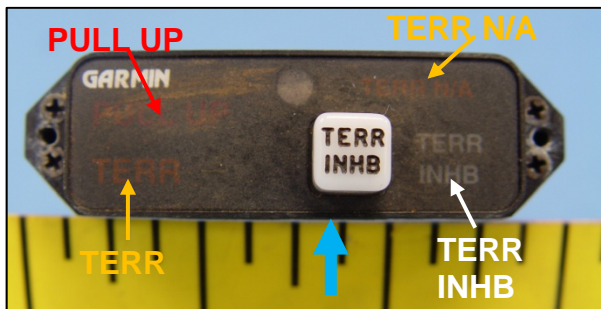
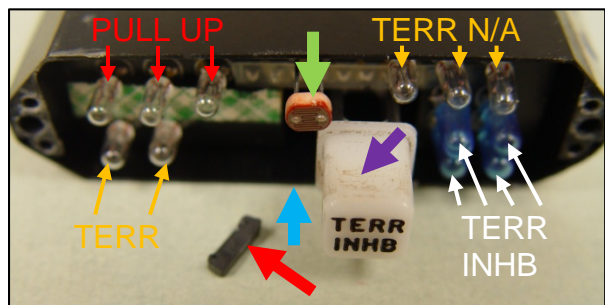
The case of the terrain awareness annunciator displayed an adhesive label identifying it as a model MD41-1028, s/n B05-10948 manufactured by "MID-CONTINENT INSTRUMENT Co, WICHITA, KS". Examination of the annunciator revealed that the white button identified as "TERR INHB" was protruding approximately 1/4-inch from the fascia. The examination also revealed that the multi-pin connector on the rear had been rotated slightly counterclockwise and was pointing slightly downwards, as viewed from the rear. The fascia of the terrain awareness annunciator displayed the name "GARMIN" and is illustrated in the left image in Figure 8 with the fascia indications identified in the colors they display when illuminated (red for "PULL UP", white for "TERR INHB" and amber for "TERR" and "TERR N/A").

Handling of the annunciator revealed a rattling noise indicating that there was a loose item inside it and when the fascia was removed a small piece of plastic material fell out. The annunciator is illustrated in the right image in Figure 8 with the fascia removed and the exposed bulbs identified as in the left image. The green arrow indicates a photocell used for automatic illumination dimming and a red arrow indicates the loose item that fell out.

Figure 8. The display of the terrain awareness annunciator (left) and with the fascia plate removed (right).

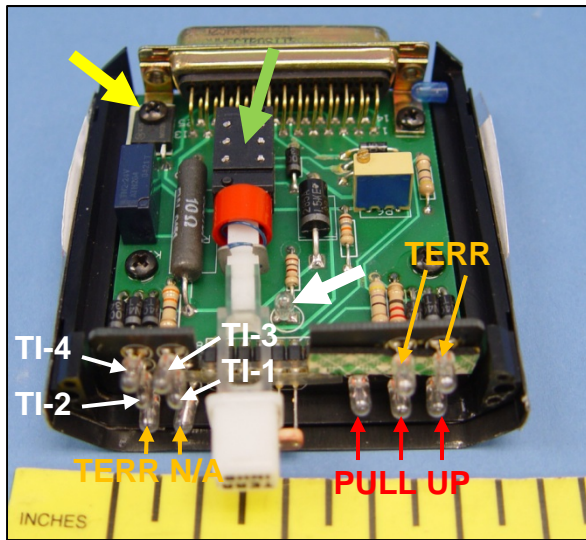
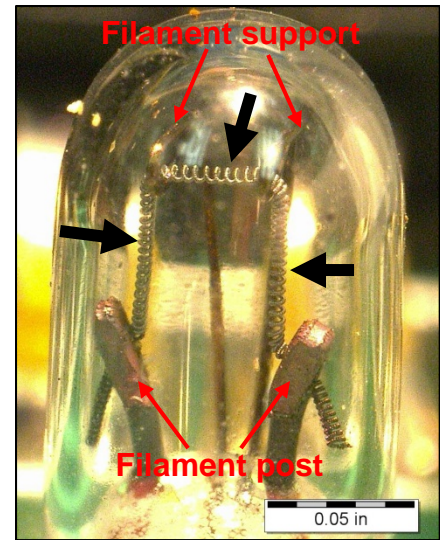
The lower half of the case indicated by the blue arrow in both images in Figure 8 was removed to reveal the main circuit board illustrated in the left image in Figure 9 with the annunciator inverted. The examination of the main circuit board revealed a matching fracture on the rear end of a chip where it was screwed to the mounting bracket for the multi-pin connector at the location indicated by the yellow arrow. The examination also revealed no indications of soil on the main circuit board or on the bulb circuit board.

Prior to an examination of the bulbs illuminating the fascia indications the blue sheaves on the "TERR INHB" illustrated in the right image in Figure 8 were removed. Microscopic examination of all bulb filaments revealed that, with the exception of the four "TERR INHB" bulbs, all the others displayed similar typical features. A typical bulb filament is illustrated in the right image in Figure 9 with the filament posts and the filament supports identified. The black arrows indicate portions of the filament that were uniformly coiled and intact. The annunciator bulbs are illustrated in the left image in Figure 9 and are

collectively identified as in Figure 8 with the exception of the "TERR INHB" bulbs which are individually identified as "TI-1", "TI-2", "TI-3" and "TI-4". A white arrow indicates an internal bulb that provides general instrument panel illumination and was included in the examination.

Repeated operation of the "TERR INHB" button revealed that the switch it was attached to was a momentary switch and the button returned to the protruding position previously noted when it was released. The switch is indicated by the green arrow in the left image in Figure 9.

Figure 9. The circuit board and bulbs in the terrain awareness annunciator (left) and a typical bulb filament, except for the “TERR INHB” bulbs below, (right).

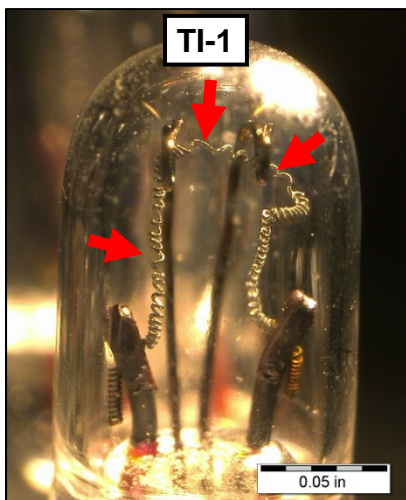
Examination of bulb "TI-1" revealed distinctive stretching at the locations indicated by the red arrows in the left image in Figure 10 and overall deformation of the filament.

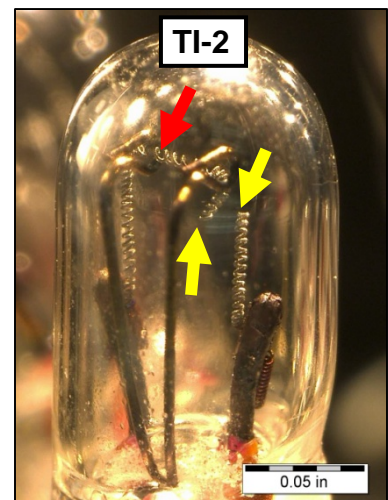
Examination of bulb "TI-2" revealed distinctive stretching at the location indicated by the red arrow in the right image in Figure 10. The filament was broken and the fractured ends are indicated by the yellow arrows with deformation at the end adjacent to the filament support.

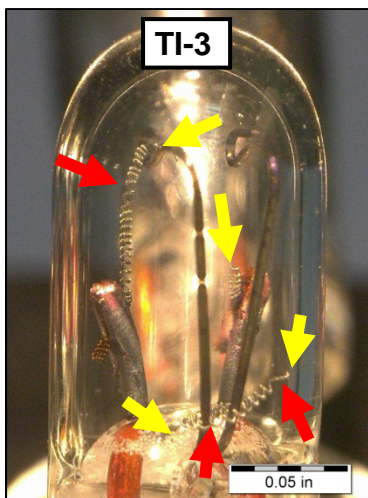
Examination of bulb "TI-3" revealed distinctive stretching at the locations indicated by the red arrows in the left image in Figure 11. The filament was broken, with a separated portion lying adjacent to the base of the filament supports, and the fractured ends are indicated by the yellow arrows.

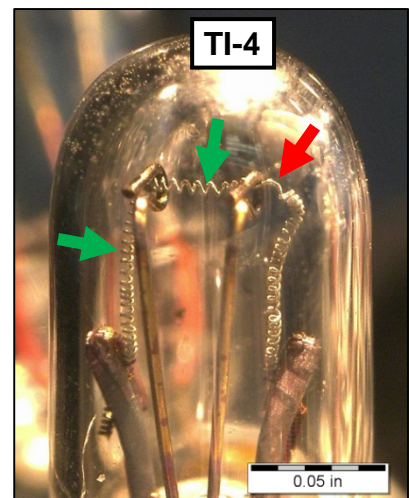
Examination of bulb "TI-4" revealed distinctive stretching and deformation at the location indicated by the red arrow in the right image in Figure 11. Minor stretching was observed at the locations indicated by the green arrows.

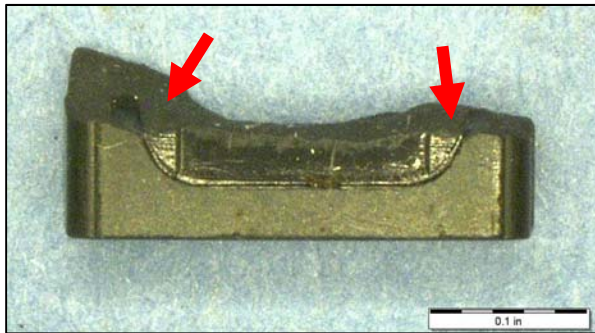
The loose item indicated by the red arrow in the right image in Figure 8 was a piece of black plastic material and is illustrated in Figure 12 with red arrows indicating the fracture face that matched the fracture face on the chip indicated by the yellow arrow in the left image in Figure 9.

Figure 12. The loose item indicated by the red arrow in the right image in Figure 8.

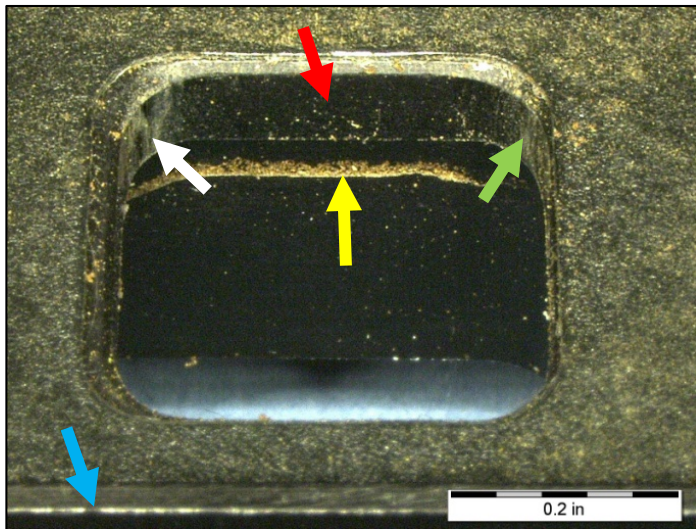
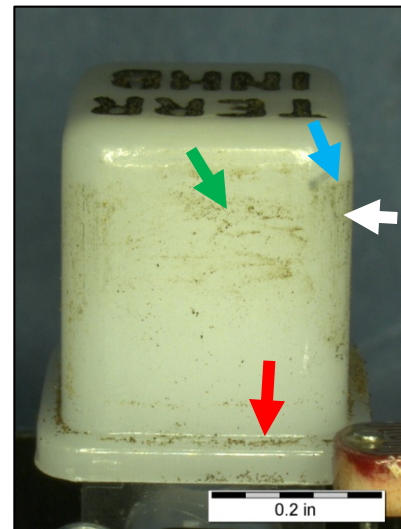
Examination of the "TERR INHB" button hole in the fascia revealed rub marks in the radiused corners and a thin band of a soil deposit on the inner surface of the fascia. A view of the hole is illustrated in the left image in Figure 13 with the lower edge of the fascia indicated with a blue arrow, as in Figure 8. The green and white arrows indicate the radiused corners that displayed a rubbed appearance when compared to the side indicated by the red arrow and the yellow arrow indicates the soil deposit. The side of the "TERR INHB" button normally adjacent to the fascia side indicated by the red arrow in the left image in Figure 13 is illustrated in the right image. The white arrow indicates the button corner that is normally adjacent to the fascia corner indicated by the white arrow in the left image and an examination of the corner revealed faint soil deposits with a longitudinal orientation. The green arrow indicates soil deposits on the side of the button that were located within 1/8-inch of the button face, the blue arrow indicates soil deposits that were located within 1/16-inch of the button face and the red arrow indicates soil deposits in the lower corner, normally located behind the fascia.

Figure 13. An inner surface of the terrain-inhibit switch fascia (left) and the normally adjacent side of the button (right).

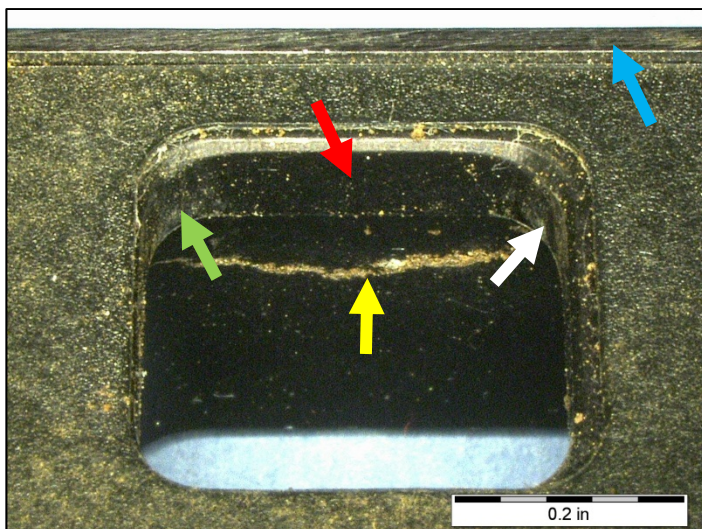
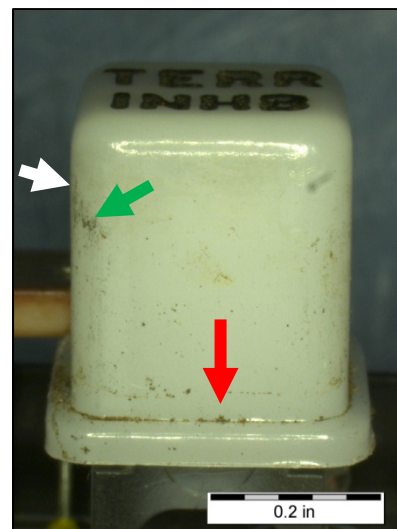
The opposite side of the hole illustrated in the left image in Figure 13 is illustrated in the left image in Figure 14 with the lower edge of the fascia also indicated with a blue arrow. As in the left image in Figure 13 the green and white arrows indicate the radiused corners that displayed a rubbed appearance when compared to the side indicated by the red arrow and the yellow arrow indicates the soil deposit. The side of the "TERR INHB" button normally adjacent to the fascia side indicated by the red arrow in the left image in Figure 14 is illustrated in the right image with a green arrow indicating soil deposits on the

corner and a white button indicating a portion of the deposits that displayed a longitudinal orientation. As in the right image in Figure 13, the red arrow indicates soil deposits in the lower corner, normally located behind the fascia.

Figure 14. The inner surface of the terrain-inhibit switch fascia (left) opposite to the surface illustrated in Figure 10 and the normally adjacent side of the button (right).
