NATIONAL TRANSPORTATION SAFETY BOARD

MATERIALS LABORATORY FACTUAL REPORT

Report No. 11-098

Place : Point Mugu, California.
Date : May 18, 2011.
Vehicle : Boeing 707-321B, N707AR.
NTSB No. : DCA11MA075.
Investigator : Bill English, AS-10.

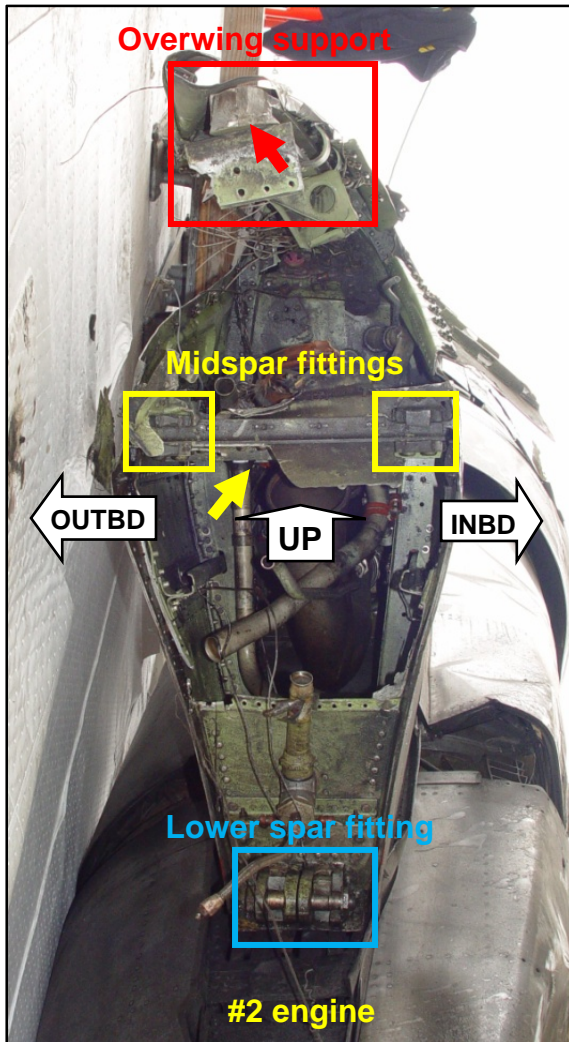
Figure 1. The rear of the #2 engine pylon as separated from the wing.

On-scene, the #2 engine was located on the edge of the runway with a majority of its pylon still attached. An examination of the pylon at the point of separation revealed distinctly flat fracture faces on the remaining portions of the inboard midspar fitting. The #2 engine was recovered to a hanger for easier examination. The rear end of the pylon, at the point of separation, is illustrated in Figure 1 with the image rotated to reflect the up (UP), outboard (OUTBD) and inboard (INBD) directions as indicated. The pylon is normally attached to the wing at the overwing support contained within the red box, the midspar fittings contained within the yellow boxes and the lower spar fitting contained within the blue box.

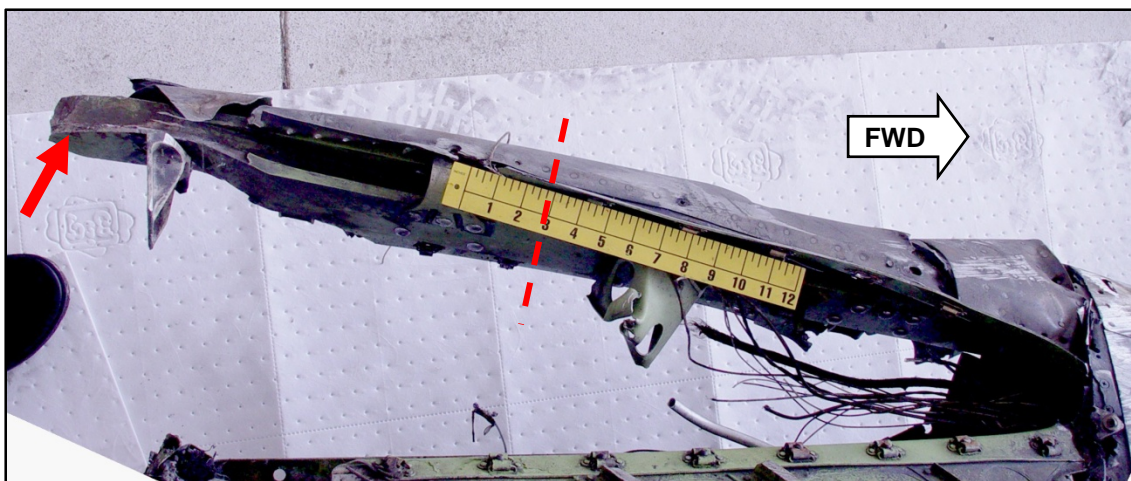
Figure 2. Side view of the overwing support contained within the red box in Figure 1.

Examination of the overwing support fitting revealed that it was approximately 35 inches long with a majority of its fairing still attached and was still connected to the front spar fitting. The forward end of the inboard overwing support fitting has two lugs which engage with the single lug on the front spar fitting. A side view of the support is illustrated in Figure 2 with the forward direction indicated. The rear end of the remaining

fitting indicated by the red arrow displayed a v-shaped fracture pointing to the rear. The remaining fairing was removed to reveal that the forward end of the overwing support fitting and the front spar fitting were intact but lateral manipulation of the support fitting revealed a degree of looseness. The fitting was sawn at the red dashed line and the rear portion, illustrated later in Figure 8, was retained for a more detailed laboratory examination.

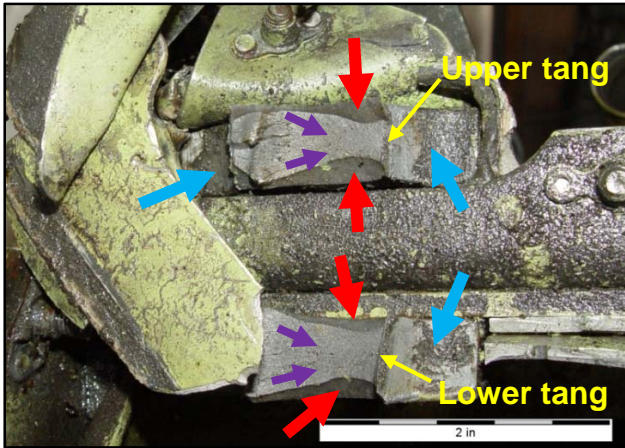
Figure 3. The remains of the outboard midspar fitting located within the yellow box in Figure 1.

The remaining portions of the outboard midspar fitting contained within the yellow box in Figure 1 are illustrated in Figure 3. The remains consisted of forward portions of the fitting's upper and lower tangs, as identified, with fracture faces located between the radii indicated by the blue arrows. The upper and lower tangs are identified on the midspar fitting illustrated in Figure 5. The fracture faces displayed rough grainy surfaces, as indicated by the purple arrows, and shear lips, as indicated by the red arrows, consistent with an overload event. The purple arrows in Figure 5 are parallel to surface lines on the overload fracture face which are referred to as chevrons¹ which point to the fracture origin, at the edge indicated by the yellow arrows. The location of the fractures on the upper and lower tangs is indicated by the red and green lines on the midspar fitting illustrated in Figure 5. In addition, the location of the outboard midspar fitting is illustrated later in Figure 7.

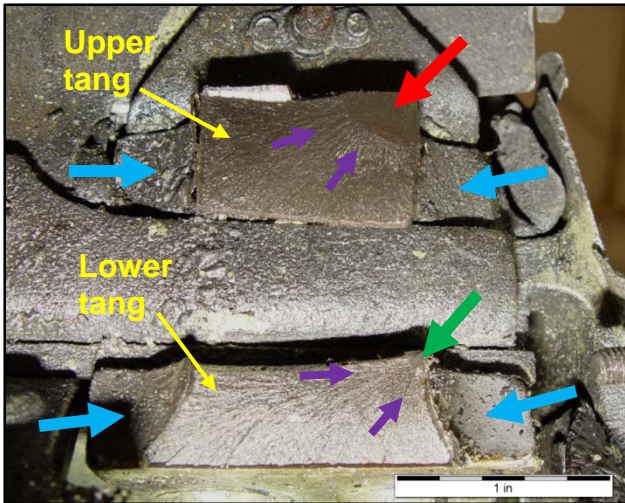
Figure 4. The remains of the inboard midspar fitting located within the yellow box in Figure 1.

The remaining portions of the inboard midspar fitting contained within the yellow box in Figure 1 are illustrated in Figure 4. The remains consisted of forward portions of the fitting's upper and lower tangs, as identified, with fracture faces located between the radii indicated by the blue arrows. The fracture face on the upper tang displayed the smooth region indicated by the red arrow. The smooth region displayed an arced terminus which appeared to emanate from the upper inboard corner of the tang. The remainder of the fracture face displayed the surface lines indicated by the purple arrows which appeared to radiate from the upper inboard corner of the tang, features consistent with fatigue. The location of the fracture on the upper tang is indicated by the red line on the midspar fitting illustrated in Figure 5.

The fracture face on the lower tang displayed the smaller smooth region indicated by the green arrow in Figure 4. The smooth region displayed an arced terminus which appeared to emanate from the upper inboard corner of the tang. The remainder of the fracture face displayed the surface lines indicated by the purple arrows which appeared to radiate from the upper inboard corner of the tang, features consistent with fatigue. The location of the fracture on the lower tang is indicated by the green line on the midspar fitting illustrated in Figure 5.

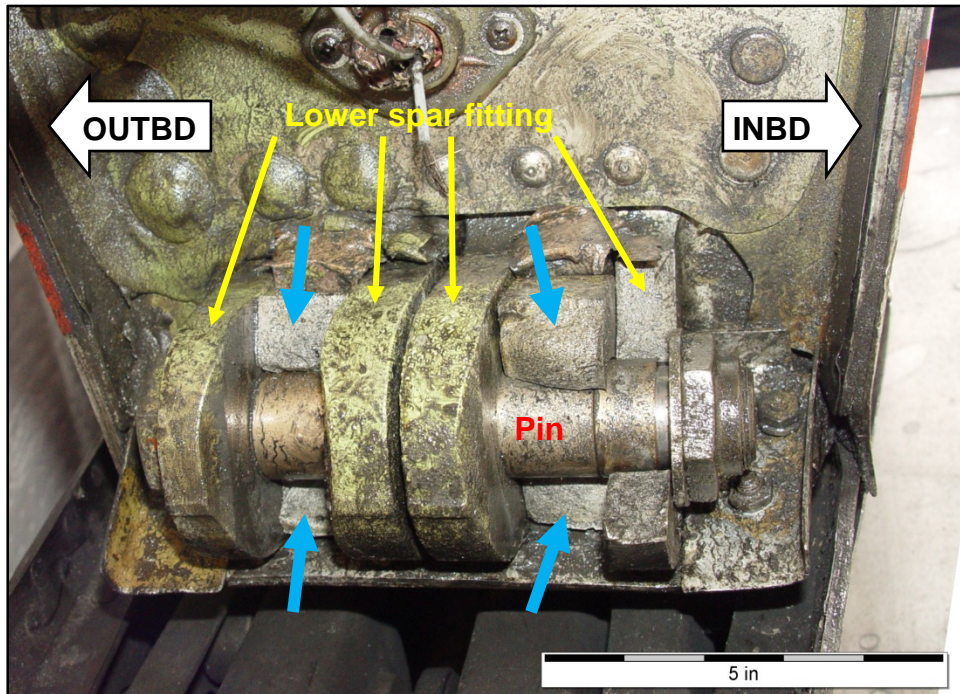
Figure 6. The lower spar fitting within the blue box in Figure 1.

Examination of the lower spar fitting contained within the blue box in Figure 1 revealed the three intact lugs and one fractured lug illustrated and identified in Figure 6. Portions of the diagonal brace forward clevis, indicated by the blue arrows were retained by the pin. Fracture faces on the lug and the clevis portions displayed a uniformly rough and grainy surface consistent with an overload event.

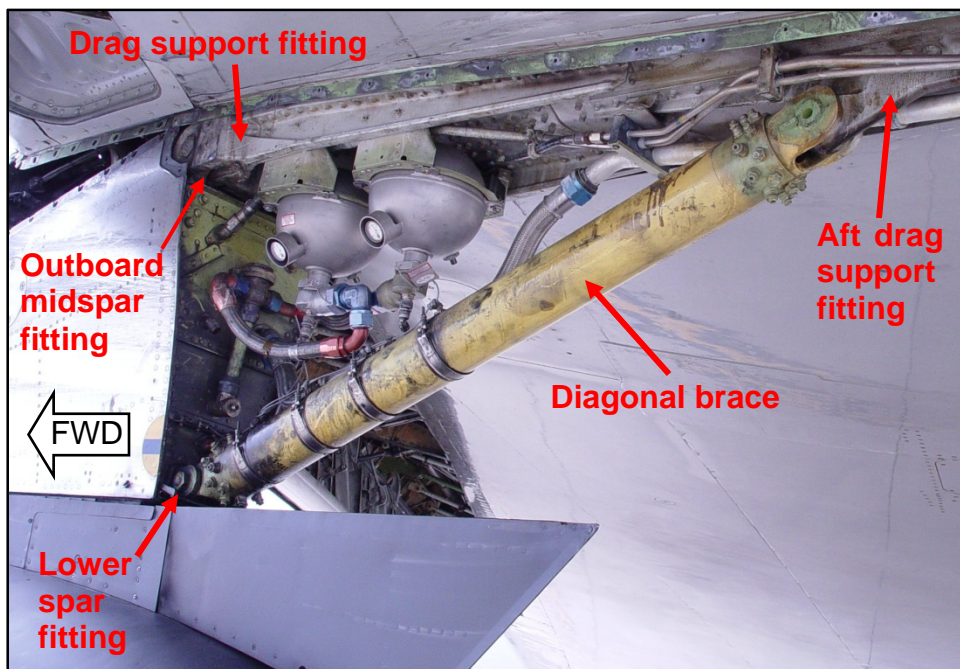
Figure 7. The location of the lower spar fitting and the outboard midspar fitting on the #2 pylon of N707AR's sister ship.

The accident aircraft had a sister ship which was also based at Point Mugu. The sister ship was made available by the operator and had several panels removed from the #2 pylon to enable comparison with the recovered #2 pylon from N707AR. The rear of the #2 pylon on the sister ship is illustrated in Figure 7 with exposed fittings identified. The lower spar fitting is identified with the diagonal brace attached to it, and to the aft drag support fitting. The outboard midspar fitting and the drag support fitting identified in Figure 5 are also identified. The figure also illustrates the limited access to the midspar fittings.

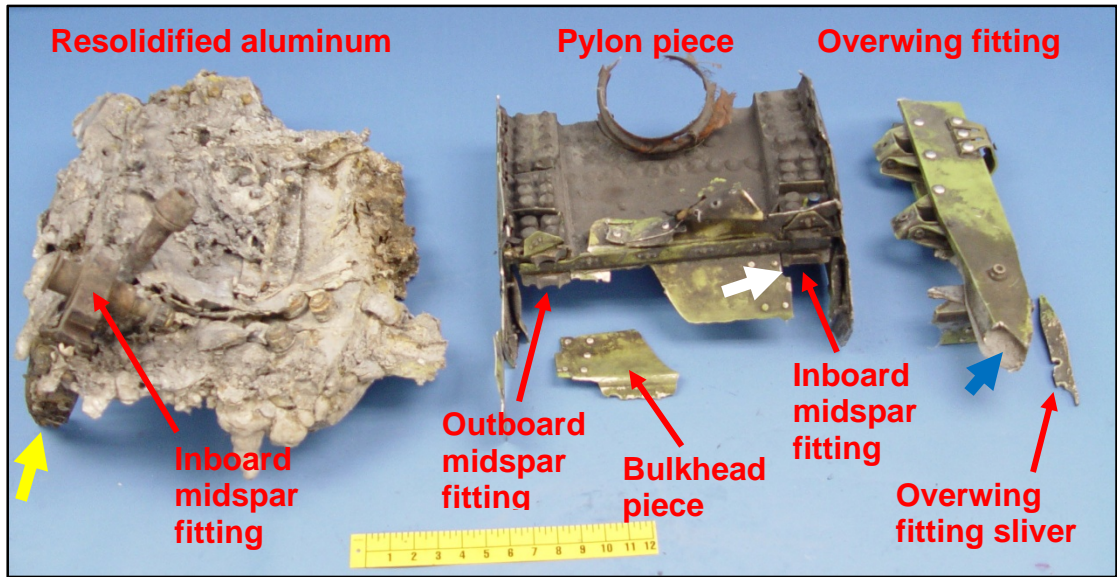
Figure 8. The pieces removed from the accident scene for further examination.

The pieces removed from the accident scene and the #2 pylon are illustrated and identified in Figure 8. The pieces consisted of, from left to right, the resolidified aluminum lump, the pylon portion containing the midspar fittings, the bulkhead piece found on the runway, the overwing fitting and the sliver found on the runway.

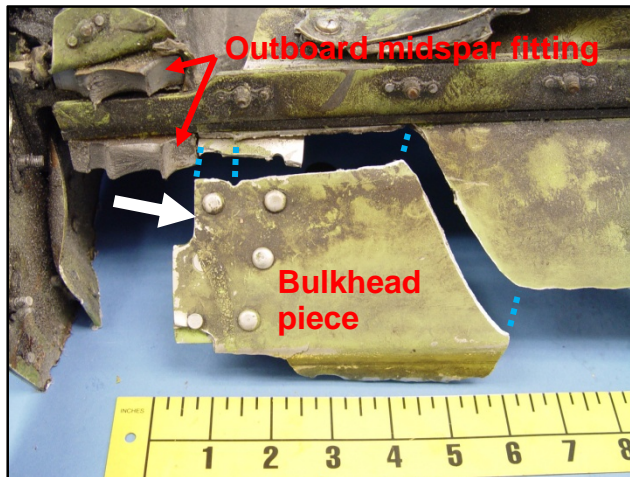
Figure 9. The bulkhead piece mated to the removed portion of the pylon.

Examination of the bulkhead piece identified in Figure 8 revealed a uniformly grainy fracture face inclined on a slant plane and features that mated with the pylon portion, just inboard of the outboard midspar fitting. The bulkhead piece is illustrated in Figure 9, and positioned adjacent to the mating fracture on the pylon piece, with distinct features on both pieces indicated by the blue dashed lines. The white arrow indicates the cut-out, adjacent to the outboard midspar fitting, which is similar to the cut-out indicated by the white arrow in Figure 8 and adjacent to the inboard midspar fitting.

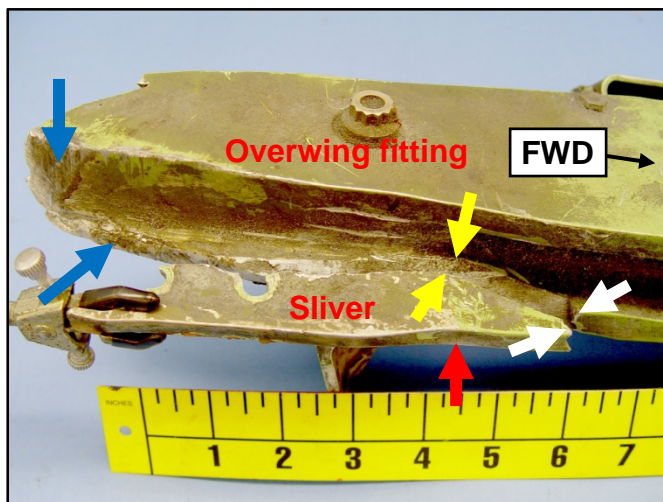
Figure 10. The overwing fitting sliver mated to the removed portion of the overwing fitting.

Examination of the sliver identified in Figure 8 revealed a uniformly grainy fracture surface on a slant plane and features that mated with the inboard side of the fractured rear end of the overwing fitting. The sliver is illustrated in Figure 10 and positioned adjacent to the mating fracture on the overwing support fitting with distinct mating features indicated by the white and yellow arrows. The red arrow indicates a distinct bend at the inboard lower edge of the sliver. The fracture faces indicated by the blue arrows in Figure 10 displayed mechanical damage that had obliterated most of the fracture features but the fracture face on the outboard side, indicated by the blue arrow in Figure 8, displayed a uniformly grainy that was slightly cupped and displayed chevrons pointing to the rearmost edge of the fracture, consistent with an overload event.

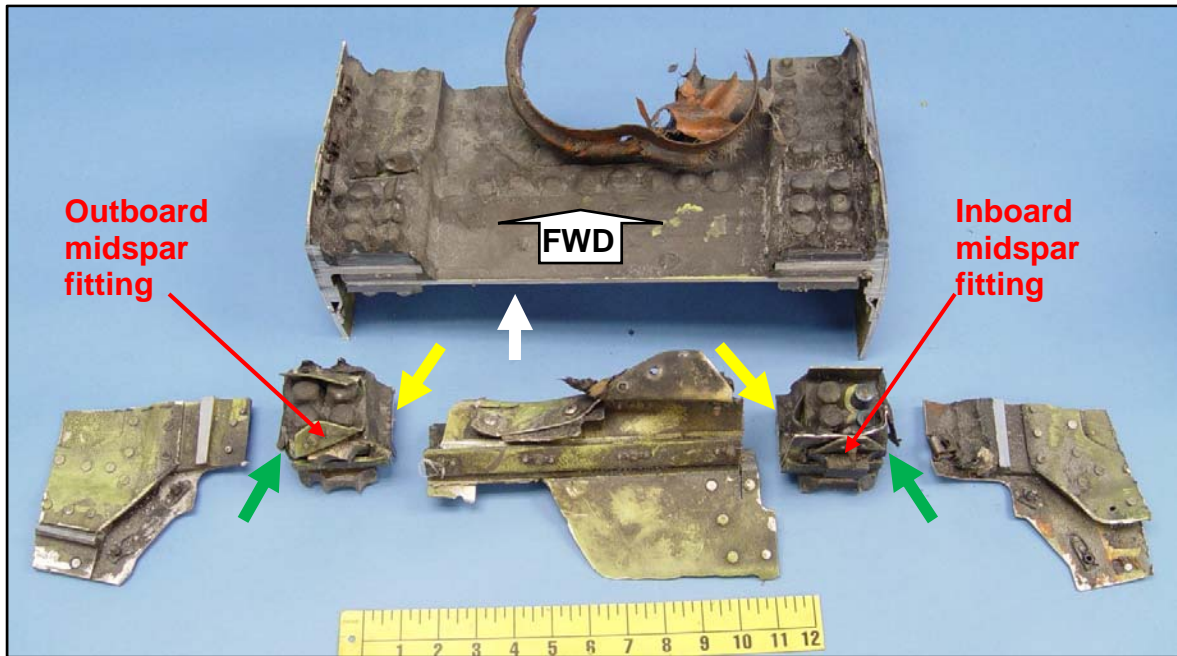
Figure 11. The inboard and outboard midspar fitting fractures removed from the removed portion of the pylon.

The midspar fittings identified in Figure 8 were separated from the pylon piece as illustrated in Figure 11. Saw cuts were made at the white arrow, the green arrows and finally at the yellow arrows. The removed inboard and outboard midspar fittings identified in Figure 11 were then ultrasonically cleaned in a detergent solution.

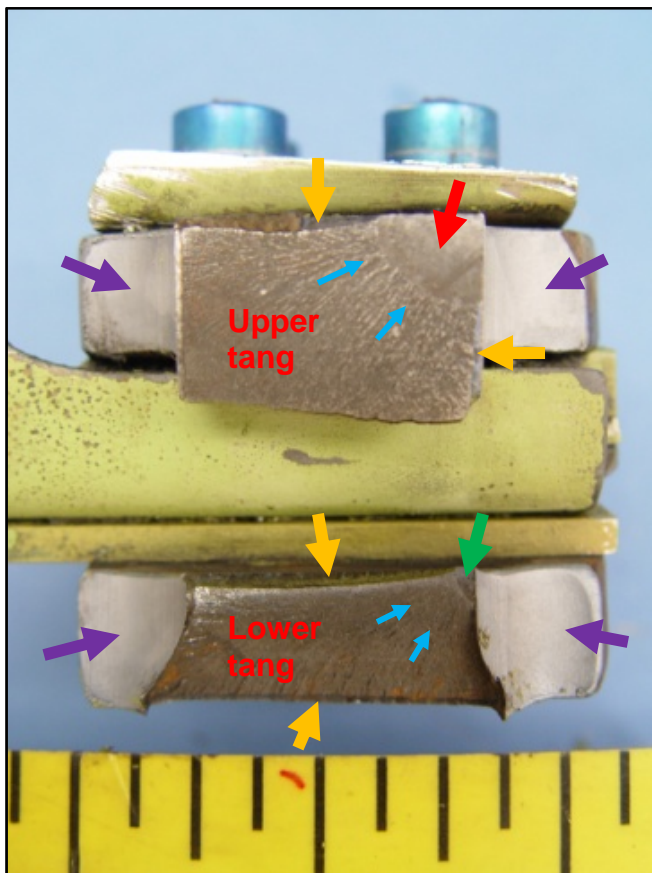
Figure 12. The fracture faces on the upper and lower tangs of the inboard midspar fitting after cleaning.

The inboard midspar fitting is illustrated in Figure 12 with the upper and lower tangs identified as in Figure 4. On the upper tang, the smooth fatigue region is indicated by the red arrow, the radial lines are indicated by the blue arrows and the orange arrows indicate shear lips on the upper and inboard edges. The purple arrows indicate the radii located forward of the fracture face and indicated by the red arrow in Figure 5. The radii displayed a uniformly light grey surface not evident on the other surface of the tang. On the lower tang, the smooth fatigue region is indicated by the green arrow, the radial lines are indicated by the blue arrows and the orange arrows indicate shear lips on the upper and lower edges. The purple arrows indicate the radii located forward of the fracture face which displayed a uniformly light grey surface not evident on any other surface of the tang, consistent with only the radii being plated. A review of drawing 65-2536 revealed that on midspar fittings part number 65-2536-7 and -8, the radii, and the sides of the adjacent lug, are electroplated with chromium in accordance with Boeing specification F-1.846.

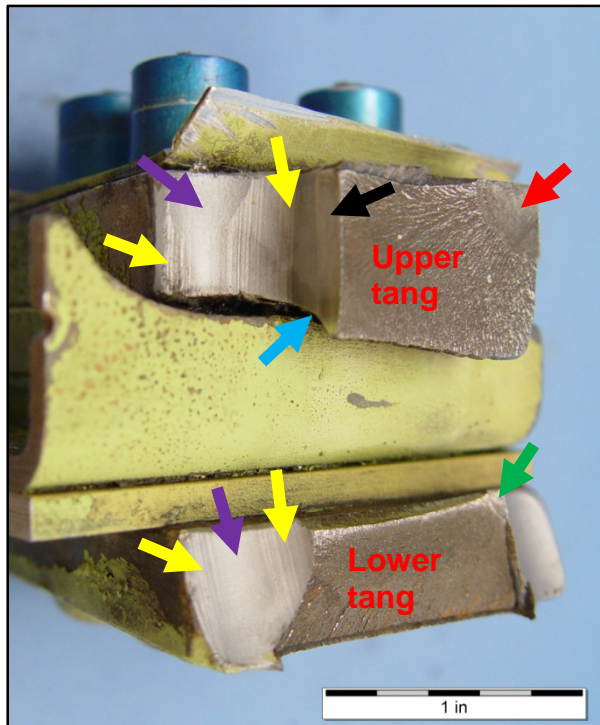
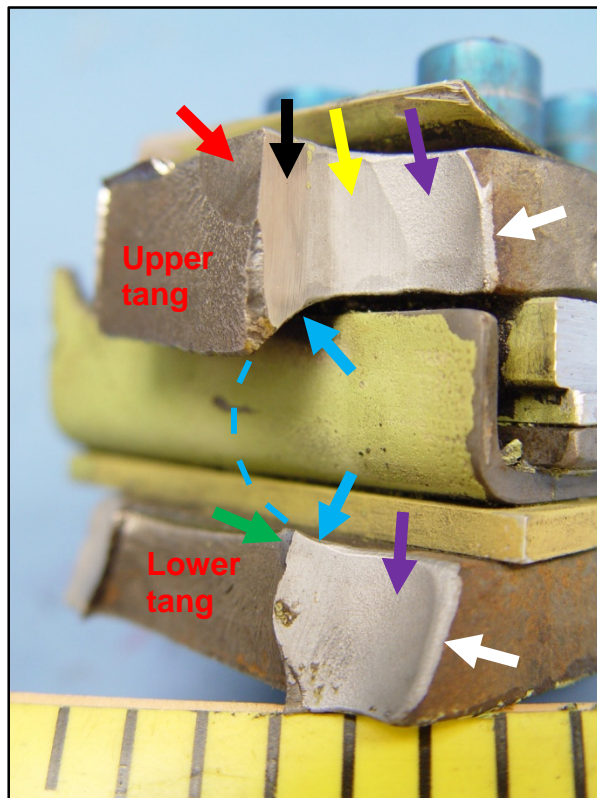
Examination of the inboard midspar fitting radii revealed that the uniformly light grey electroplated surface displayed textural differences. A view of the outboard radii is illustrated in Figure 13 with the tangs identified and the fatigue regions indicated by the red and green arrows as in Figure 12. The purple arrows indicate areas displaying a uniformly dimpled surface, the yellow arrows indicate areas displaying vertically oriented, slightly arced, parallel lines below the dimpled surface and consistent with

them being machining marks below the electrodeposit and the black arrow indicates vertically oriented and slightly arced machining marks on the electroplated surface. The blue arrow on the upper tang indicates a portion of the radius normally joining the upper tang to the lower tang. A view of the inboard radii is illustrated in Figure 14 with the tangs identified and the fatigue regions indicated by the red and green arrows as in Figure 12. The purple arrows indicate areas displaying a uniformly dimpled surface and the yellow arrow indicates areas displaying vertically oriented machining marks below the dimpled surface. The black arrow indicates vertically oriented machining marks on the surface of the electroplated surface, adjacent to the fracture face. The white arrows indicate areas where the electrodeposit had been applied outside of the radii edges. The blue arrows on the upper and lower tangs indicate portions of the radius normally joining them, as indicated by the blue dashed line.

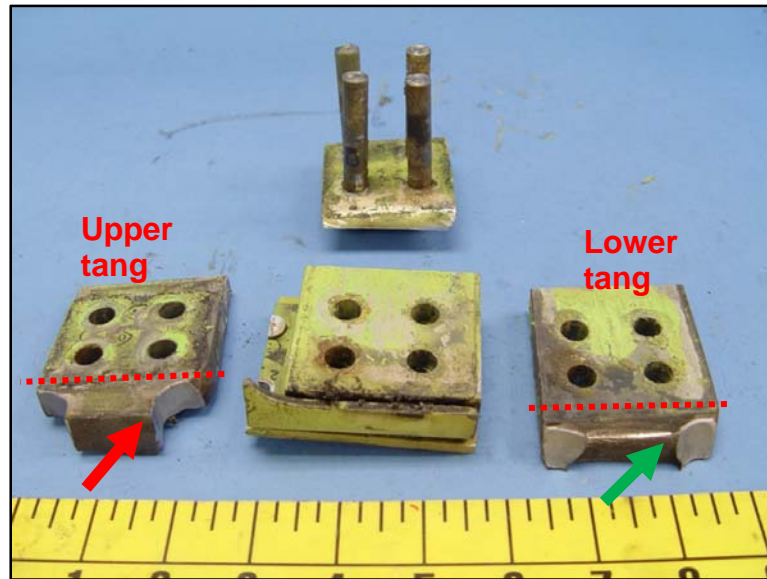
Figure 15. The disassembled inboard midspar fitting illustrated in Figures 11, 12, 13 and 14.

The inboard and outboard midspar fittings identified in Figure 11 were disassembled and detergent cleaned. XRF² analysis was performed on the inboard and outboard upper tangs which identified the material as alloy steel 4330, satisfying the material requirement in Boeing drawing 65-2536. The disassembled inboard fitting is illustrated in Figure 15 with the upper and lower tangs identified and the fatigue regions indicated by the red and green arrows as in Figure 12. An examination of the upper and lower tangs revealed no part numbers and an XRF analysis of the electrodeposit in the radii revealed that it consisted mostly of chromium, satisfying that requirement in Boeing drawing 65-2536 for the -7 and -8 part numbers. Measurement of the radii revealed an uneven curvature with a nominal radius of approximately 0.38-inch. AD 93-11-02 (document 2 in section C), effective July 6, 1993, referred to Boeing Service Bulletin 3183, dated January 28, 1988, which required that the -7 and -8 midspar fittings, with an electroplated 0.38-inch radius, were to be replaced by -23 and -24 fittings with a non-plated 1-inch radius. The AD required replacement prior to the accumulation of 12,000 flight hours or within 4 years or 4,800 flight cycles of the effective date of the AD, whichever occurred first.

To ease examination of the fracture faces, the fracture faces and their radii were separated from the tang by cutting along the red dashed lines in Figure 15. The paint was abrasively removed from the forward portion of the upper tang for hardness testing. Hardness testing at five (5) locations provided an average hardness of 46.4 HRC³ satisfying the 220 – 240 ksi⁴ requirement in drawing 65-2536 which converts⁵ to 46-48 HRC. The fatigue region on the upper tang, indicated by the red arrow in Figures 12 and 15, is illustrated in Figure 16 with the shear lips indicated by the orange arrows in Figure 12, similarly indicated. The yellow arrow indicates the arced terminus of the fatigue region and red arrows indicate crack arrest marks within the region, features consistent with fatigue propagation. The blue arrows indicate radially oriented lines outside of the fatigue region, typical of a fast overload fracture propagating from the

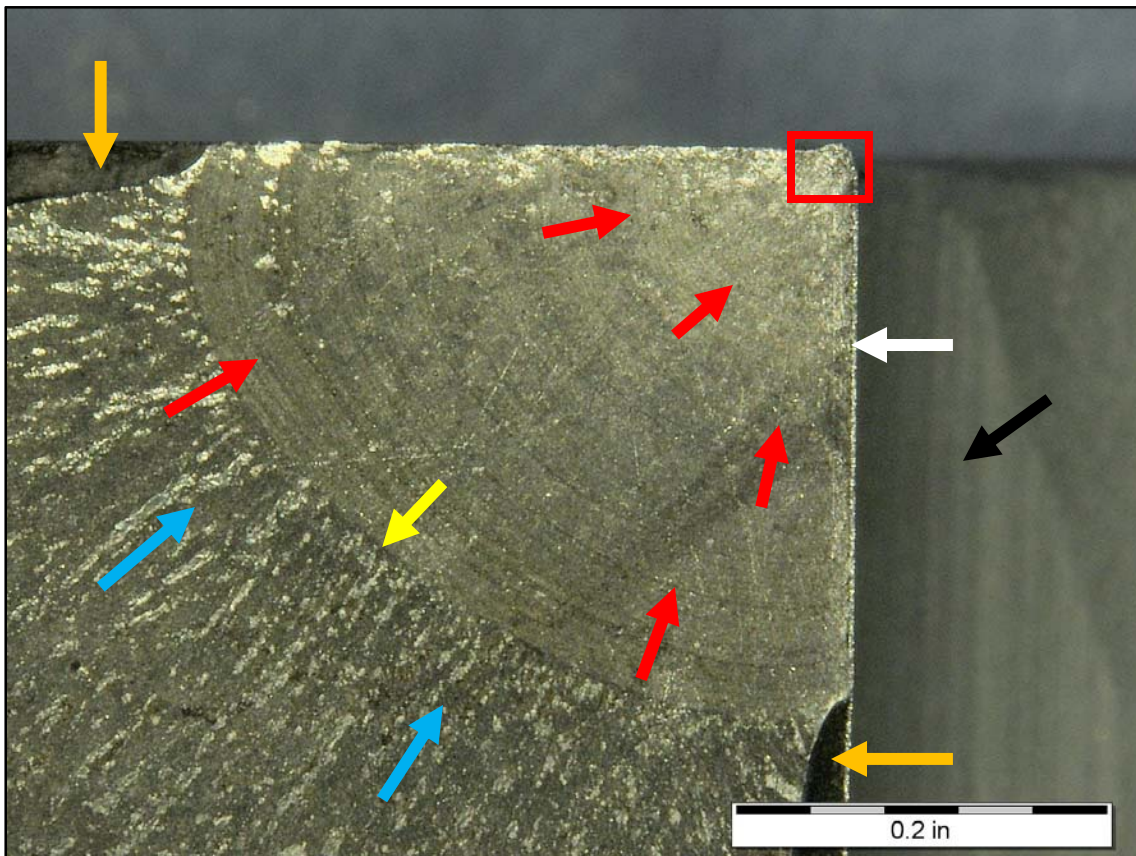
Figure 16. The fatigue region indicated by the red arrow in Figures 4 and 12.

arced terminus. The radial lines, the arced terminus and the arc of the crack arrest marks indicate that the fatigue initiated within the red circle. The black arrow indicates the machining marks on the electrodeposit and the white arrow indicates the thickness of the electrodeposit.

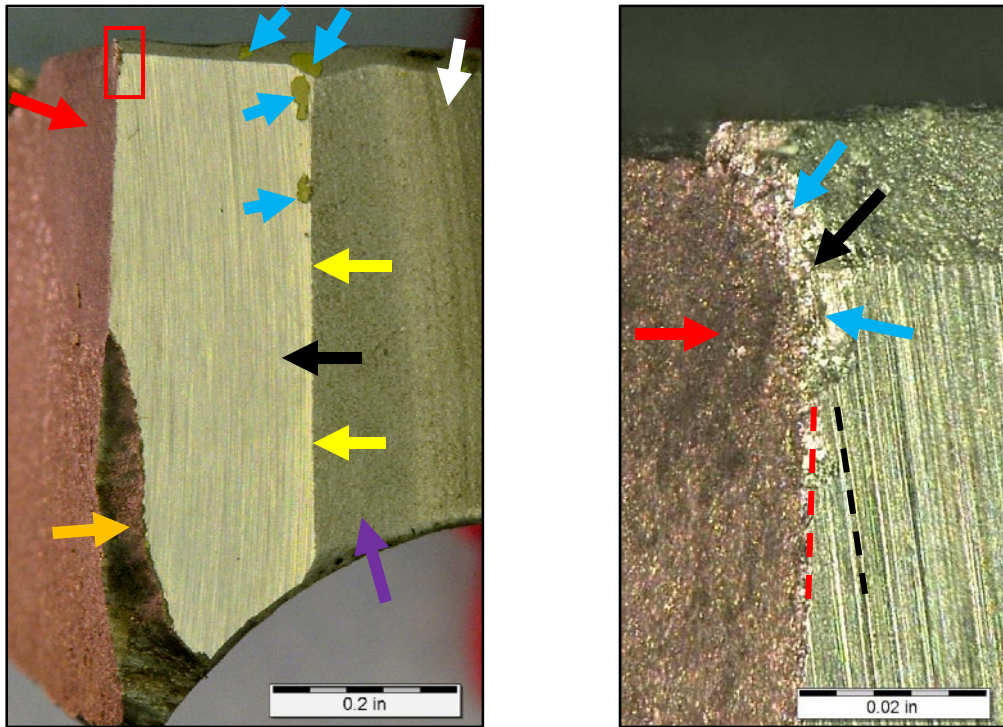
Figure 17. The inner radius of the inboard midspar fitting upper tang at the fracture face (left) and a closer view inside the red rectangle (right).

The examination of the electroplated radii on both tangs of the inboard midspar fitting had revealed distinct surface features namely a uniformly electroplated surface and machining marks below the electroplated surface but slightly arced machining marks on the plated surface were observed only on the radii of the upper tang. Examination of the outboard radius on the upper tang had revealed a shear lip adjacent to the plated surface whereas the inboard radius was adjacent to the fatigue region. The inboard radius, adjacent to the fatigue region is illustrated in the left image in Figure 17 with a red arrow indicating the fatigue region, a red circle indicating the fatigue initiation zone and an orange arrow indicating a shear lip. The white arrow indicates the electroplated surface with subsurface machining marks still evident, the purple arrow indicates the electroplated surface and the black arrow indicates the machining marks similarly indicated by the black arrow in Figure 14. The yellow arrows indicate the well defined edge of the machined area and the blue arrows indicate paint remaining on the machined area.

A closer view of the area within the red box in the left image in Figure 17 is illustrated in the right image with a red arrow indicating the fatigue region. The red dashed line drawn on the edge of the chromium electroplating and the black dashed line drawn on a machining mark suggest a convergence at the black arrow, within the fatigue initiation zone. The blue arrows indicate mechanical damage on both sides of the black arrow.

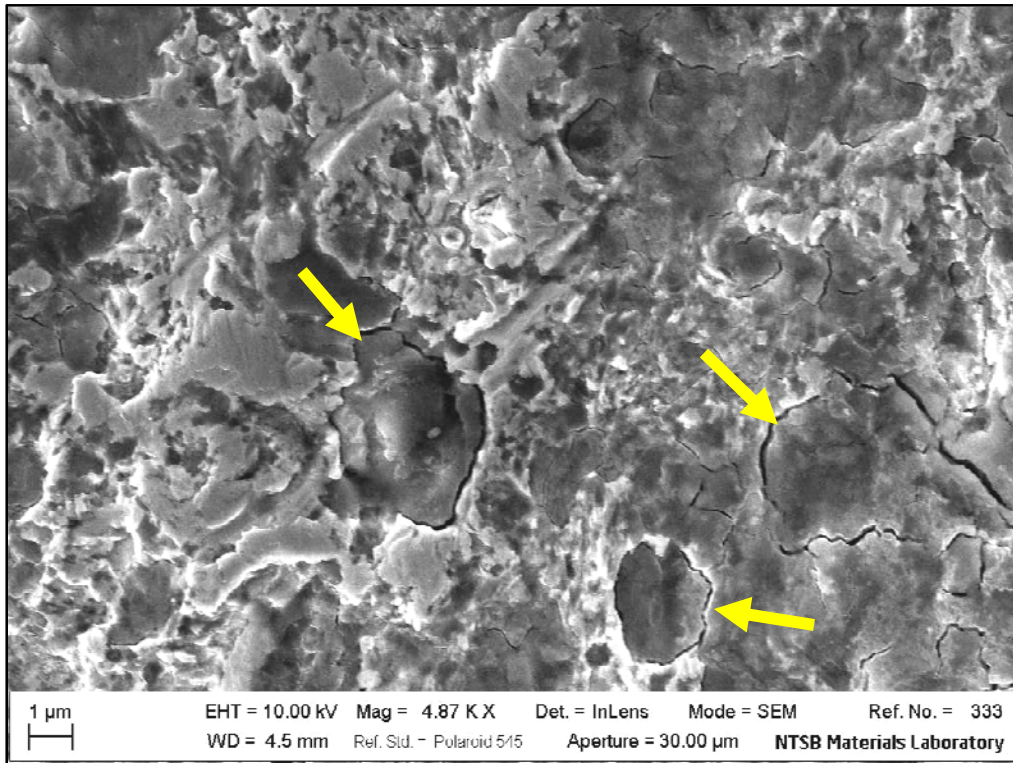
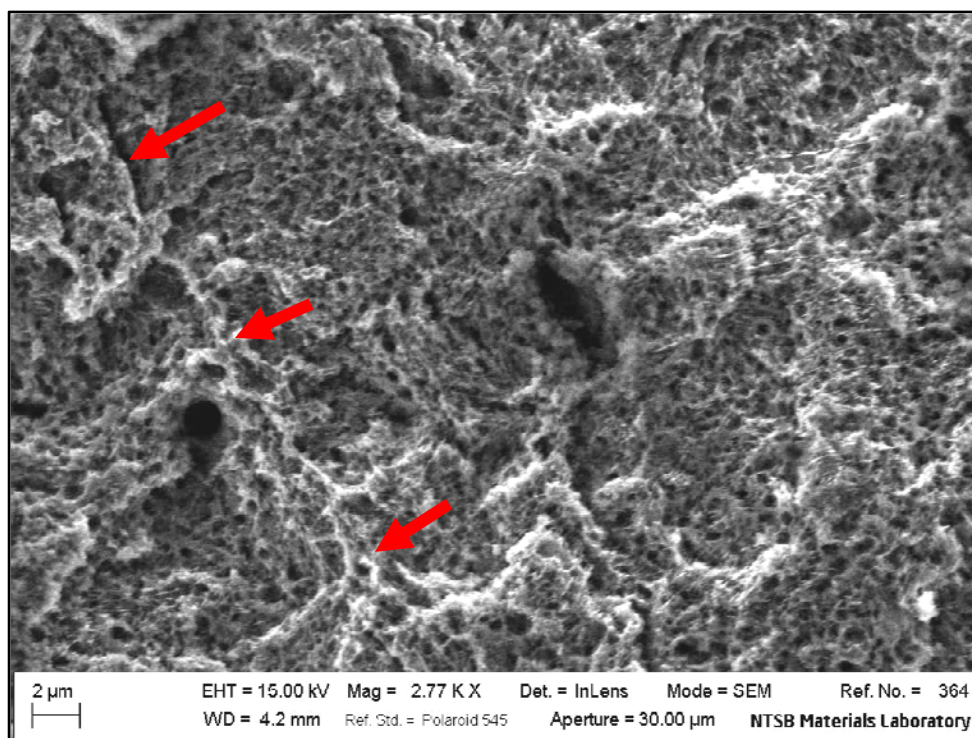
The portion of the upper tang containing the fracture face was ultrasonically solvent cleaned and installed in an SEM⁶ for a detailed examination. The examination revealed that the surface of the fatigue region was covered with corrosion product. A typical surface is illustrated in Figure 18 with yellow arrows indicating areas displaying surface cracking commonly described as “mud cracking”. As corrosion product can obscure, or obliterate, any fine fracture features the fracture surface was first cleaned by repeated applications of replica tape⁷. Re-examination of the fracture face in the SEM revealed that the corrosion product was still present. The corrosion product was then removed by an ASTM⁸ procedure using a solution of hydrochloric acid and hexamethylene tetramine⁹. After three applications, with subsequent cleaning and examinations, the corrosion product had been removed to reveal that any finer features had been obliterated leaving only the more gross, and corroded, crack arrest marks on a corroded surface. A typical area of the cleaned surface, for comparison with Figure 18, is illustrated in Figure 19 with red arrows indicating the remains of a crack arrest mark.

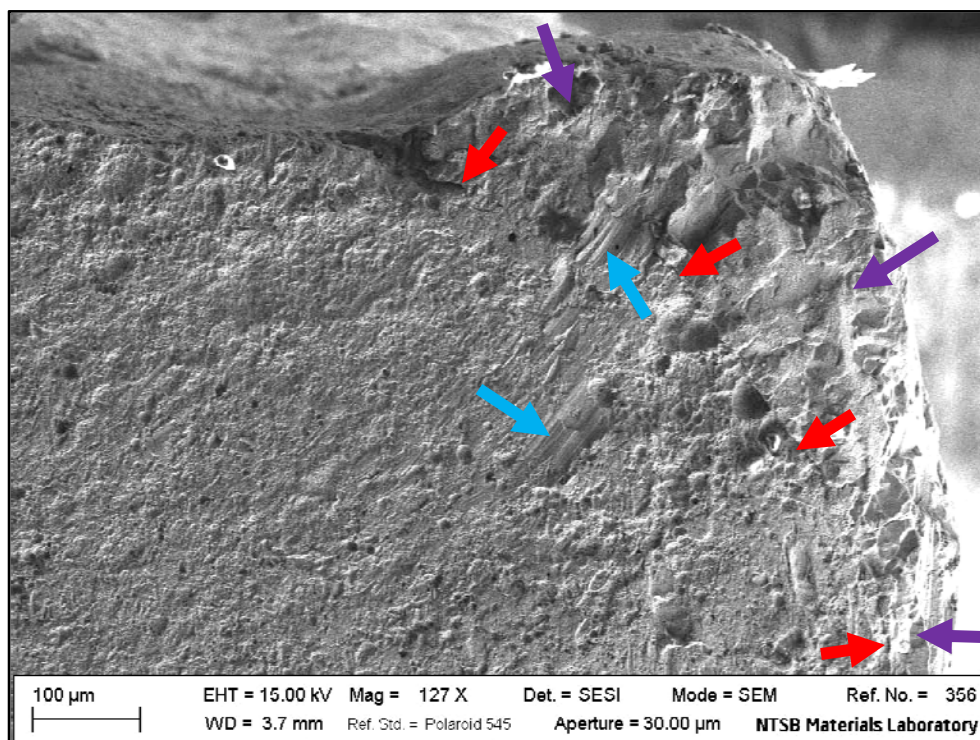
Figure 20. SEM micrograph of the initiation site within the red box in Figure 16.

SEM examination of the fatigue initiation site within the red box in Figure 16 revealed a corroded surface and chromium electroplating that was separating from the steel fitting. The initiation site is illustrated in Figure 20 with purple arrows indicating the chromium electroplating and red arrows indicating separations between the electrodeposit and the steel fitting. The blue arrows indicate mechanical damage on the fracture face.

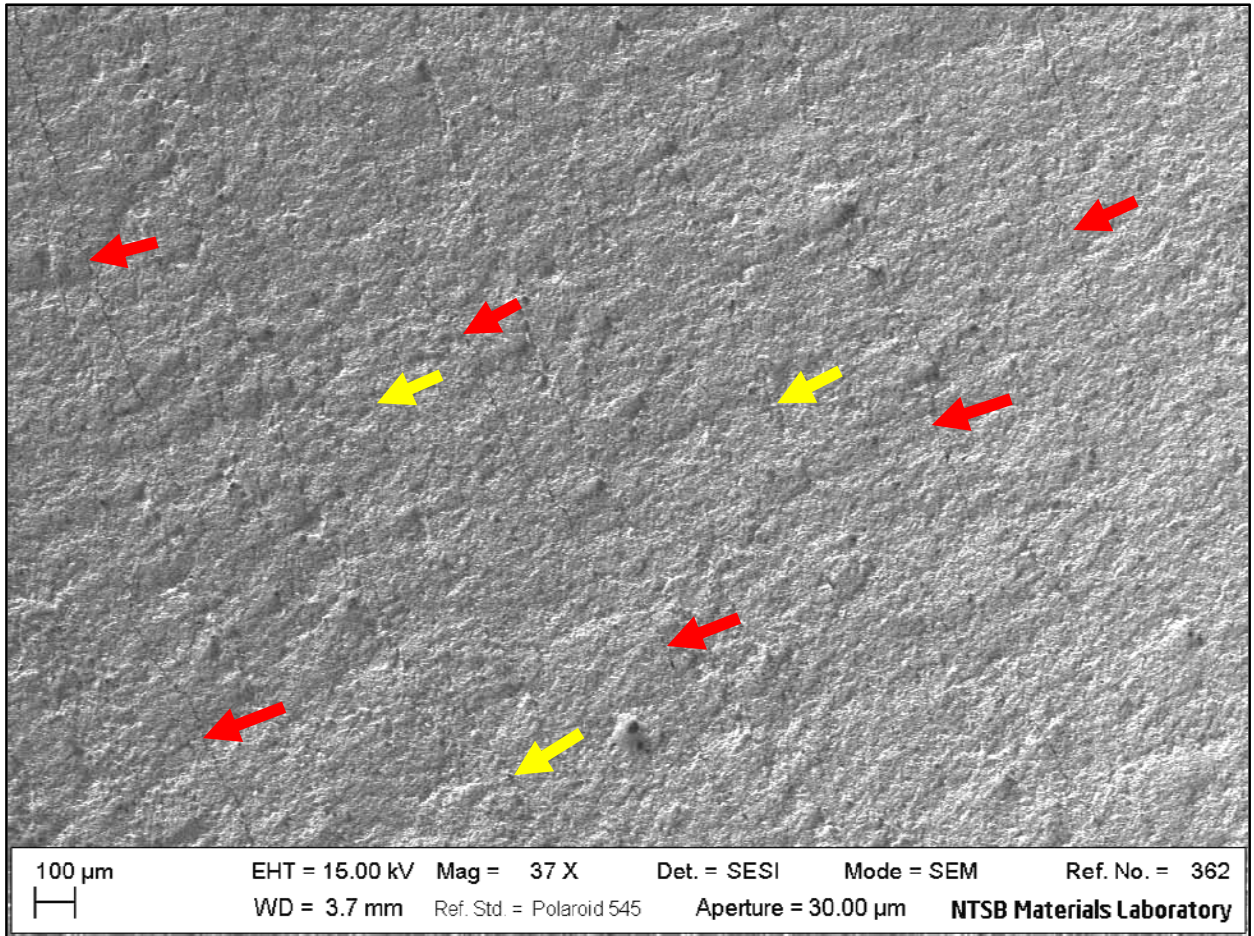
Figure 21. SEM micrograph of fissures in the fatigue zone that were revealed by the cleaning process.

The SEM survey of the fracture face also revealed fissures on the fracture face that were arced and oriented mostly parallel to the crack arrest marks. A typical area is illustrated in Fig 21 with red arrows indicating fissures and yellow arrows indicating the remains of corroded crack arrest marks.

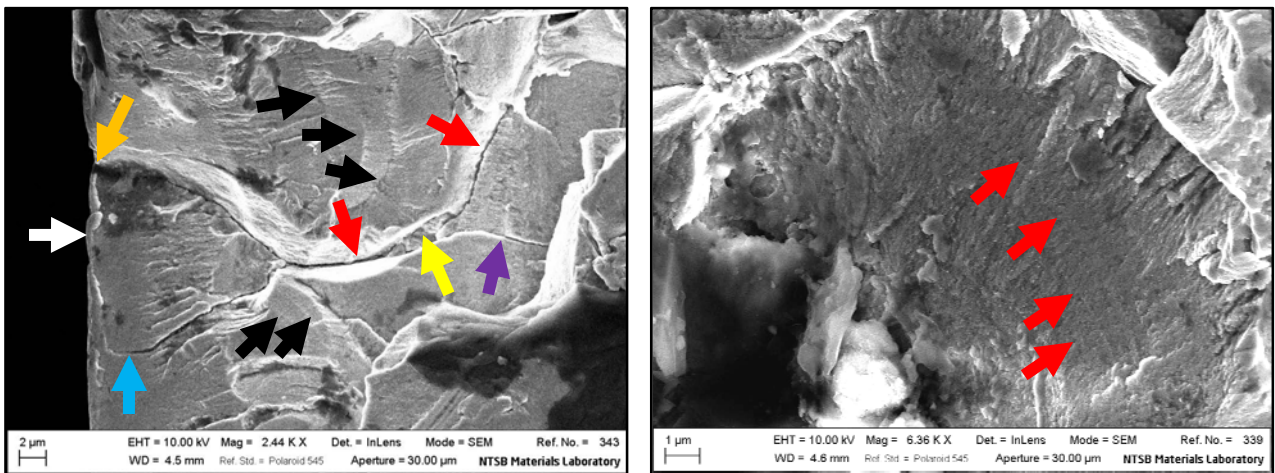
Figure 22. SEM micrographs of cracking (left) and fatigue (right) in the chromium plating.

The SEM survey of the chromium electroplating revealed internal cracks probably produced during the fracture sequence and areas containing crack arrest marks. Typical internal cracking is illustrated in the left image in Figure 22 with the red and purple arrows indicating a crack that had originated at the particle indicated by the yellow arrow. The orange arrow indicates where the crack indicated by the red arrow had penetrated to the surface indicated by the white arrow and the blue arrow indicates a secondary crack that did not penetrate to the outer surface. The black arrows indicate crack arrest marks in the areas between cracks.

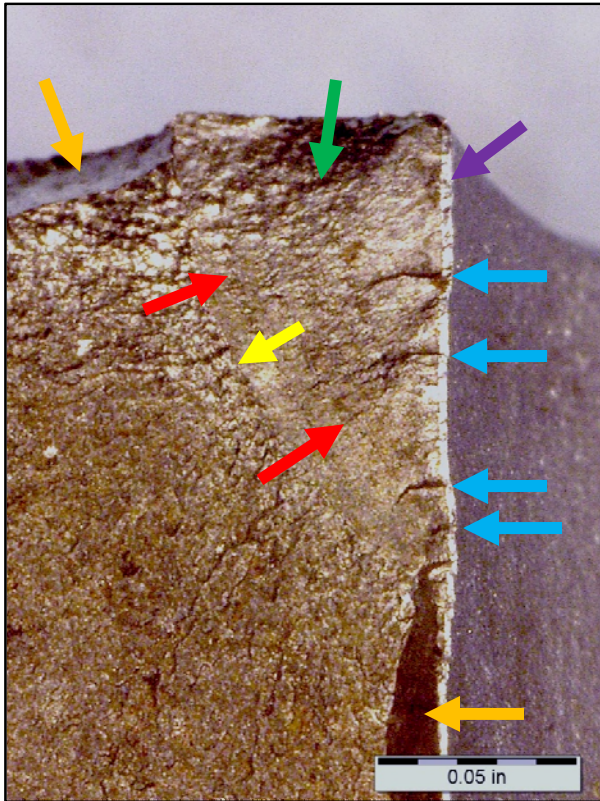
Figure 23. . The fatigue zone indicated by the green arrows in Figure 4 and 12.

The fatigue region indicated by the green arrow in Figures 12, 13 and 14 is illustrated in Figure 23 and similarly indicated. The yellow arrow indicates the arced fatigue region terminus and the orange arrows indicate the adjacent shear lips. The red arrows indicate crack arrest marks in the fatigue region and also indicate that the origin was along the edge of the radius. The blue arrows indicate ratchet marks¹⁰ that had initiated along the edge of the radius and propagated through the electrodeposit indicated by the purple arrow. Figure 24 is a closer view of the electrodeposit edge adjacent to the fatigue region and illustrates the steps associated with the ratchet marks indicated by the blue arrows as in Figure 23. The green arrow indicates the fatigue region and the purple arrow indicates the electrodeposit surface.

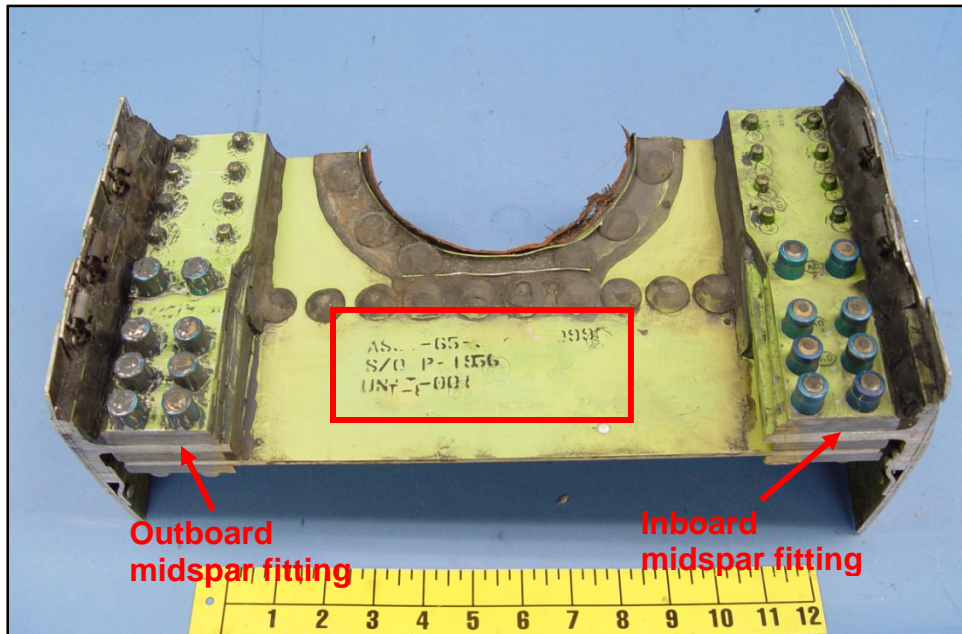
Figure 25. The upper surface of the removed portion of the pylon after removal of the sealant and cleaning.

The black sealant on the fitting hardware on the remaining removed portion of the pylon illustrated in Figure 11 was removed and the portion cleaned for examination. The sealant on the hardware for the inboard midspar fitting was found to lift off easily and the sealant on the hardware for the outboard midspar fitting had to be painstakingly cut off. The exposed hardware and the cleaned intervening bulkhead are illustrated in Figure 25 with the outboard and inboard midspar fittings identified. Examination of the surfaces around the hardware revealed indicators for holes but no identifications. Examination of the intervening bulkhead displayed "AS??-65-?", "?99", "S/O P-1956" and UNIT-001" with "T-8" partially overlaid on it and contained within the red box in Figure 25.

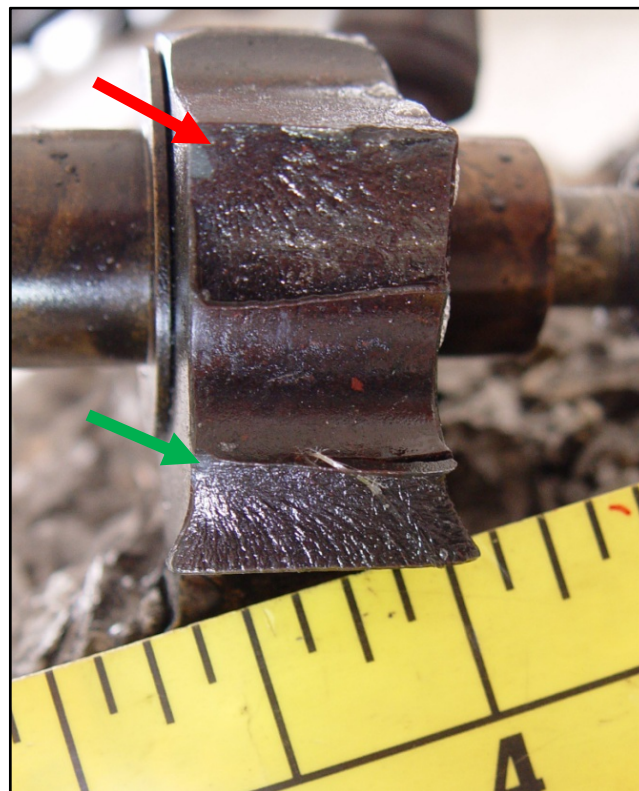
Figure 26. The fracture face on the portion of the inboard midspar fitting found mostly encased in the resolidified aluminum.

The resolidified aluminum lump identified in Figure 8 had a portion of the inboard midspar fitting protruding from its surface. The fracture face on the protruding portion of the fitting is illustrated in Figure 26 with the fatigue regions matching the fatigue regions in Figure 4 similarly indicated by the red and green arrows. The resolidified aluminum piece was x-rayed and found to contain the vertical tang still attached to the protruding lug portion of the inboard midspar fitting. The x-ray revealed the lug portion and vertical tang of the outboard midspar fitting with fracture profiles on the lug portion matching the fractures illustrated in Figure 3. Although the concentration was on the midspar fittings, the x-ray also revealed hardware sufficient to indicate that portions of the drag support fittings identified in Figure 5, were also contained.

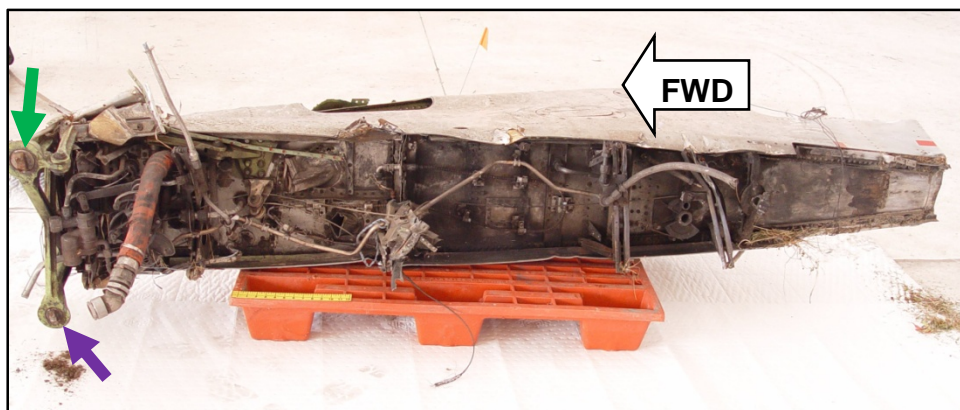
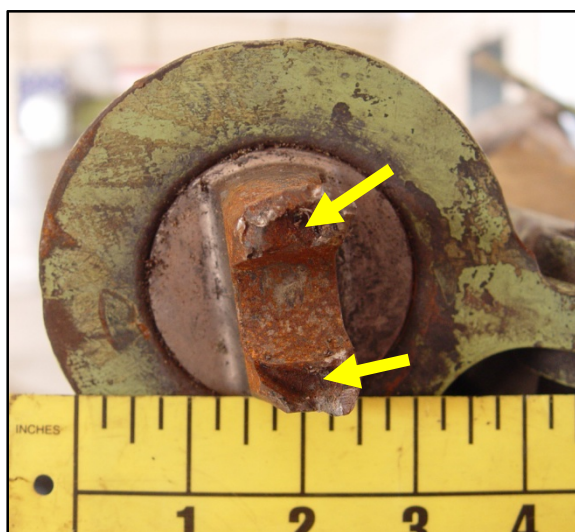
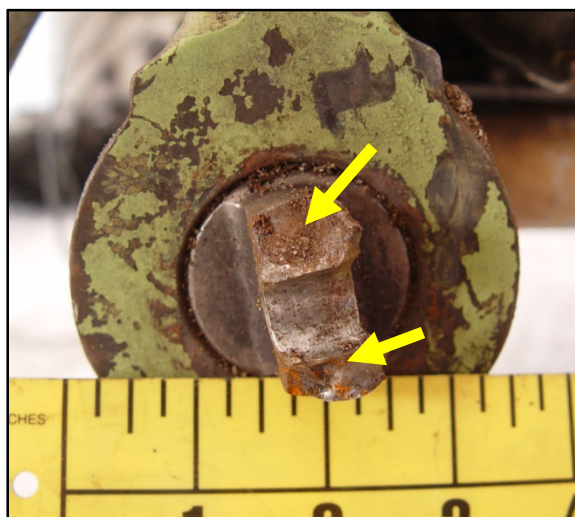
On scene, the #1 engine pylon had separated from the engine and both were recovered to the hanger for easier examination. The #1 pylon was examined for comparison with the pylon on the #2 engine. The underside of the #1 pylon is illustrated in Figure 27 with the forward direction indicated and the forward engine mounts indicated by the green and purple arrows. The forward engine mounts are attached to the engine by “fused” bolts which are designed to break first in the event of a catastrophic failure, ensuring that the front of the engine will drop downwards. The fractured outboard mounting bolt, indicated by the green arrow in Figure 27, is illustrated in Figure 28 with the fracture faces indicated by the yellow arrows. Examination of the fracture faces revealed mechanically damaged, but rough grainy surfaces with slant “cup and cone” features consistent with an overload event. The fractured inboard mounting bolt, indicated by the purple arrow in Figure 27, is illustrated in Figure 29 with the fracture faces indicated by the yellow arrows. Examination of the fracture faces also revealed mechanically damaged, but rough grainy surfaces with slant “cup and cone” features consistent with an overload event.

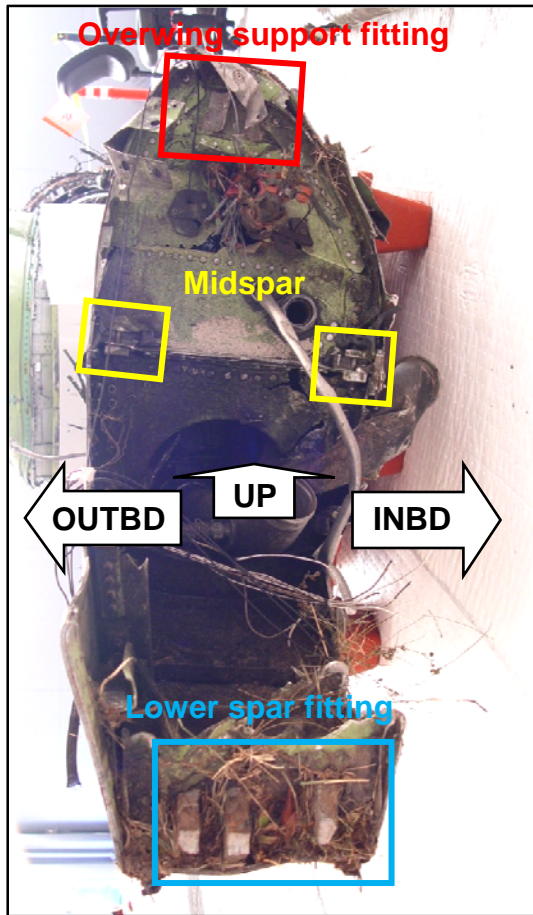
Figure 30. The rear end of the #1 pylon illustrated in Figure 27.

The rear of the #1 pylon is illustrated in Figure 30 and oriented similar to the #2 pylon illustrated in Figure 1 with the up (UP), outboard (OUTBD) and inboard (INBD) directions indicated. The pylon is normally attached to the wing at the overwing spar fitting contained within the red box, the midspar contained within the yellow boxes and the lower spar fitting contained within the blue box.

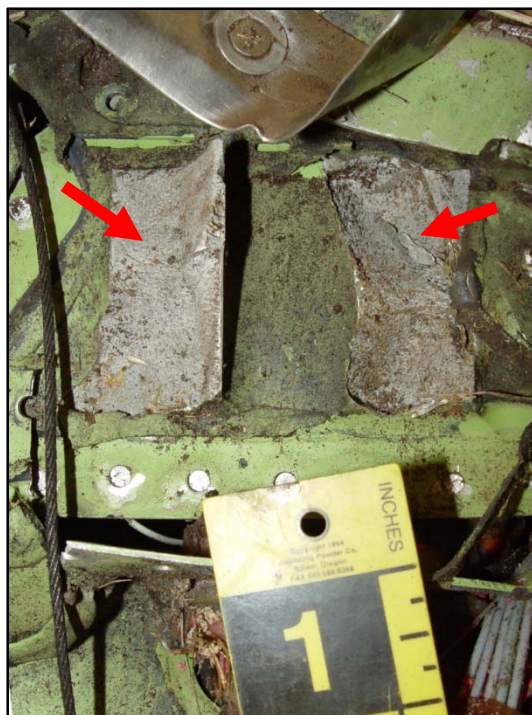
Figure 31. The overwing support fitting within the red box in Figure 30.

The forward end of the outboard overwing support fitting differs from the inboard support fitting and has three lugs which engage with two lugs on the front spar fitting. The remaining overwing support on the #1 pylon consisted of the fractured front spar fitting illustrated in Figure 31 with the two fractured lugs indicated by the red arrows. Examination of the fracture faces revealed a uniformly rough grainy surface and slant planes, consistent with an overload event.
