NATIONAL TRANSPORTATION SAFETY BOARD

MATERIALS LABORATORY FACTUAL REPORT

Report No. 11-098

Place : Point Mugu, California.
Date : May 18, 2011.
Vehicle : Boeing 707-321B, N707AR.
NTSB No. : DCA11MA075.
Investigator : Bill English, AS-10.

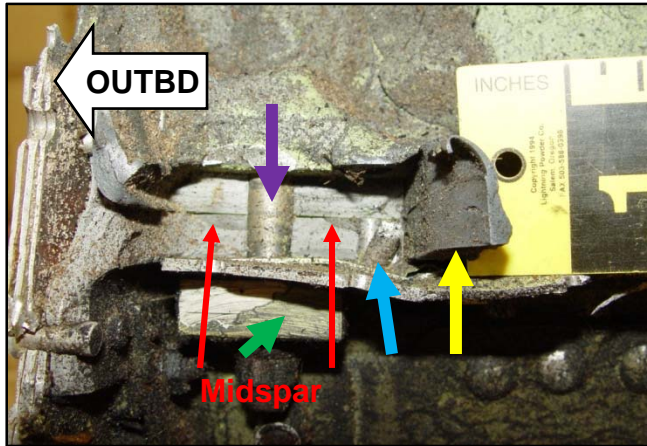
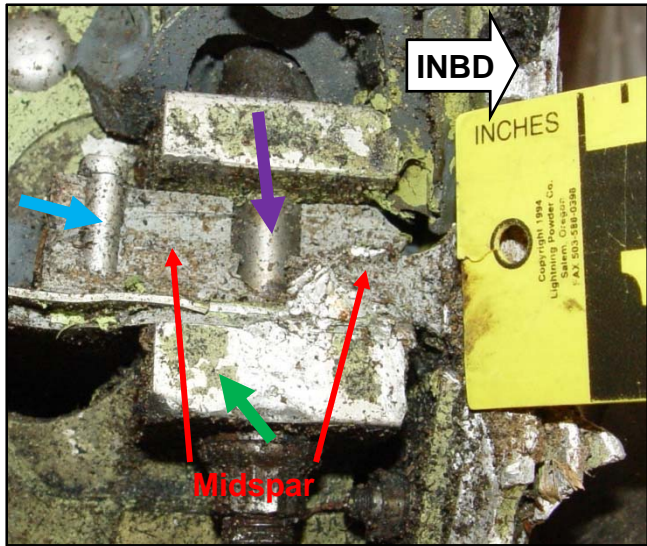
The midspar had fractured further forward than the fittings, almost directly below the front spar fitting for the overwing support. The outboard midspar area within the yellow box in Figure 30 is illustrated in Figure 32 with the midspar identified and an exposed attaching bolt indicated with a purple arrow (the remaining shank of an inboard

bolt is indicated by the blue arrow). Examination of the fracture faces indicated by the red arrows revealed a uniformly grainy surface. The green arrow indicates the painted end of a midspar structural member and the yellow arrow indicates a portion of the structure that was bent inboard. The inboard midspar area within the yellow box in Figure 30 is illustrated in Figure 33 with the midspar identified and an exposed attaching bolt indicated with a purple arrow (an inboard bolt is indicated by the blue arrow). Examination of the fracture faces indicated by the red arrows revealed a uniformly grainy surface. The green arrow indicates the painted end of a midspar structural member.

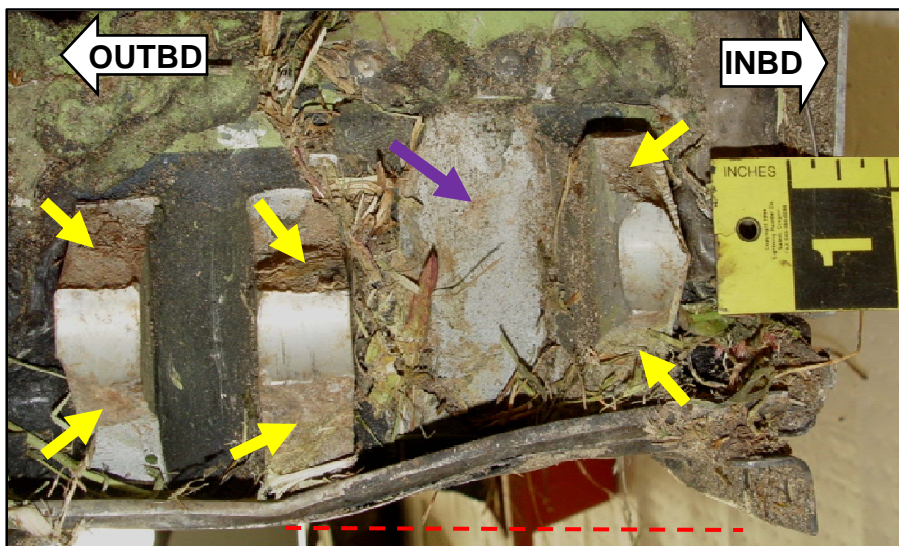
Figure 34. The lower spar fitting within the blue box in Figure 29.

The lower spar fitting on the #1 pylon is similar to the fitting on the #2 pylon illustrated in Figure 6. Three of the four lugs displayed similar fractures and the fourth lug had separated from the fitting base. The lower spar fitting is illustrated in Figure 34 after some vegetation removal and with the exposed fracture faces indicated by the yellow and purple arrows. Examination of the lug fracture faces indicated by the yellow arrows revealed uniformly grainy surfaces, slightly cupped and oriented radially to what remained of the attaching hole. Examination of the fitting fracture face indicated by the purple arrow revealed a uniformly grainy surface. The red dashed line is a continuation of the lower skin to illustrate the amount of upward deflection that had been applied to the lower spar fitting area.

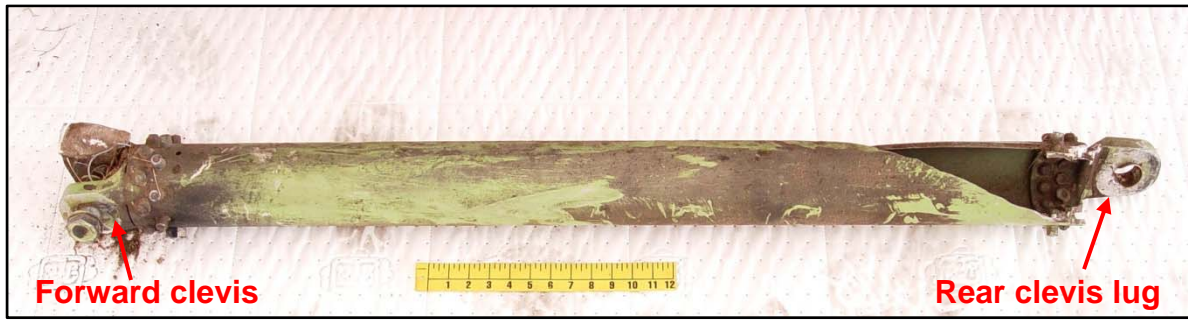
Figure 35. The #1 pylon diagonal brace.

A diagonal brace was recovered from the debris trail and is illustrated in Figure 35. The diagonal brace, as illustrated in Figure 7, connects the lower spar fitting to the aft drag support fitting and consists of a tube with a two lugged clevis at each end. Examination of the end of the brace identified as the forward clevis revealed that the attaching bolt was still located in the lugs and the gap between the lugs contained a lower spar fitting lug, confirming that it was the forward clevis. The forward clevis is illustrated in the left image in Figure 36 with a purple arrow indicating the fracture face on the lower spar fitting lug. The red arrows are positioned parallel to lines on the fracture surface and indicate that the fracture had initiated on the right vertical edge of the lug. The yellow arrows in the left image in Figure 36 indicate areas that did not contain a lug from the lower spar fitting but the spacing matched the lug spacing in Figure 34.

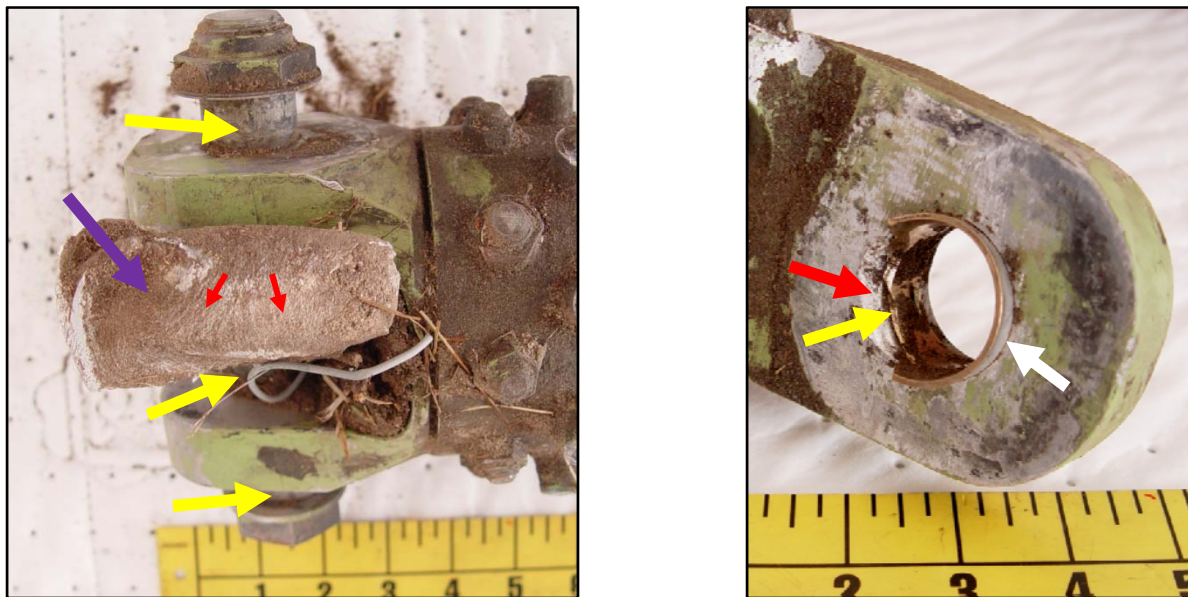
Figure 36. The forward clevis (left) and the rear clevis lug (right) identified in Figure 35.

The rear end of the diagonal brace consisted of a partial clevis, consisting of one of its two lugs, and a long narrow "V" shaped fracture in the tube. The clevis is illustrated in the right image in Figure 36 with a yellow arrow indicating a fractured edge on the lug bush and a red arrow indicating mechanical damage to the adjacent lug, where the missing portion of the lug bush had originally been located. The white arrow indicates the amount of the bush that had been relocated inwards.

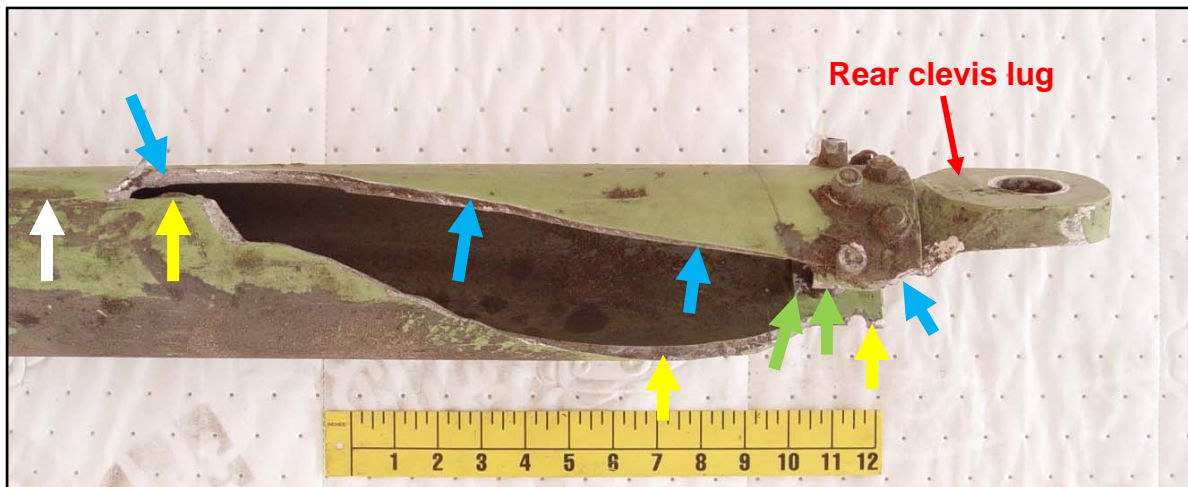
Figure 37. The fractured tube at the rear end of the diagonal brace illustrated in Figure 35.

The "V" shaped fracture at the rear end of the diagonal brace was approximately 18.5 inches long and is illustrated in Figure 37 with the remaining rear clevis lug identified and one side of the "V" indicated by blue arrows. The yellow arrows indicate the other side of the "V" which continued past the side indicated by the blue arrows as indicated by the white arrow. Examination of the fracture faces revealed a rough grainy surface with chevrons pointing toward the rear edge of the tube. The

green arrows indicate fracture faces on the portion of the clevis remaining in the tube which displayed uniformly rough grainy surfaces.
