NATIONAL TRANSPORTATION SAFETY BOARD

MATERIALS LABORATORY FACTUAL REPORT

Report No. 11-100

Place : Denver, Colorado.
Date : May 17, 2011.
Vehicle : Beech 1900D, N218YV.
NTSB No. : CEN11IA341.
Investigator : Clint Crookshanks, AS-40.

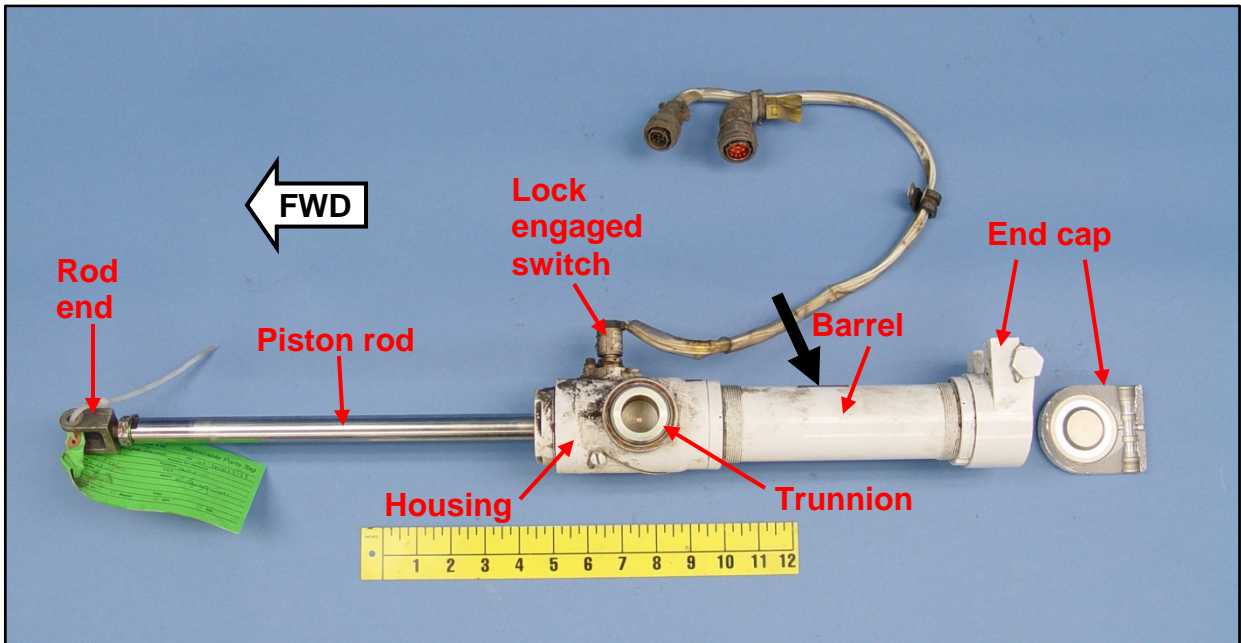
The nose landing gear locking actuator supplied for examination is illustrated in Figure 1 with the major components indicated and identified. The end cap consisted of the two pieces illustrated, each piece displaying a fracture face. For descriptive purposes the forward (FWD) direction is designated. Reportedly, the actuator had operated for 24,948 cycles on a different aircraft before being removed and overhauled. At the time of the accident the actuator had accumulated 29,553 cycles, 4,605 cycles since overhaul. Representatives from the NTSB, the FAA, Hawker Beechcraft (the aircraft manufacturer), and Great Lakes Aviation (the aircraft operator) were present for the examination.

A preliminary examination revealed an identification plate at the location indicated by the black arrow in Figure 1. The identification plate displayed "MFG BY", APPH WICHITA, INC.", WICHITA, KANSAS", APPH P/N 25700-22", HBC P/N 112-380022-23", "SER. NO. 583", and "MFG DATE 8/08". The examination also revealed that the piston rod was locked in the extended position. A review of the draft component maintenance manual revealed that the actuator has a mechanical locking

mechanism in the housing, which also activates the lock engaged switch. The lock can only be released by the application of hydraulic pressure in the retract port, which is located in the trunnion on the other side of the housing illustrated in Figure 1. The end cap houses the primary extend port, the secondary extend port and a shuttle valve which is located between the ports. In the event that primary pressure is lost, hydraulic pressure from an emergency source is applied to the secondary port, moving the shuttle to block the primary port and extending the actuator.

Figure 1. The nose landing gear actuator received for examination.

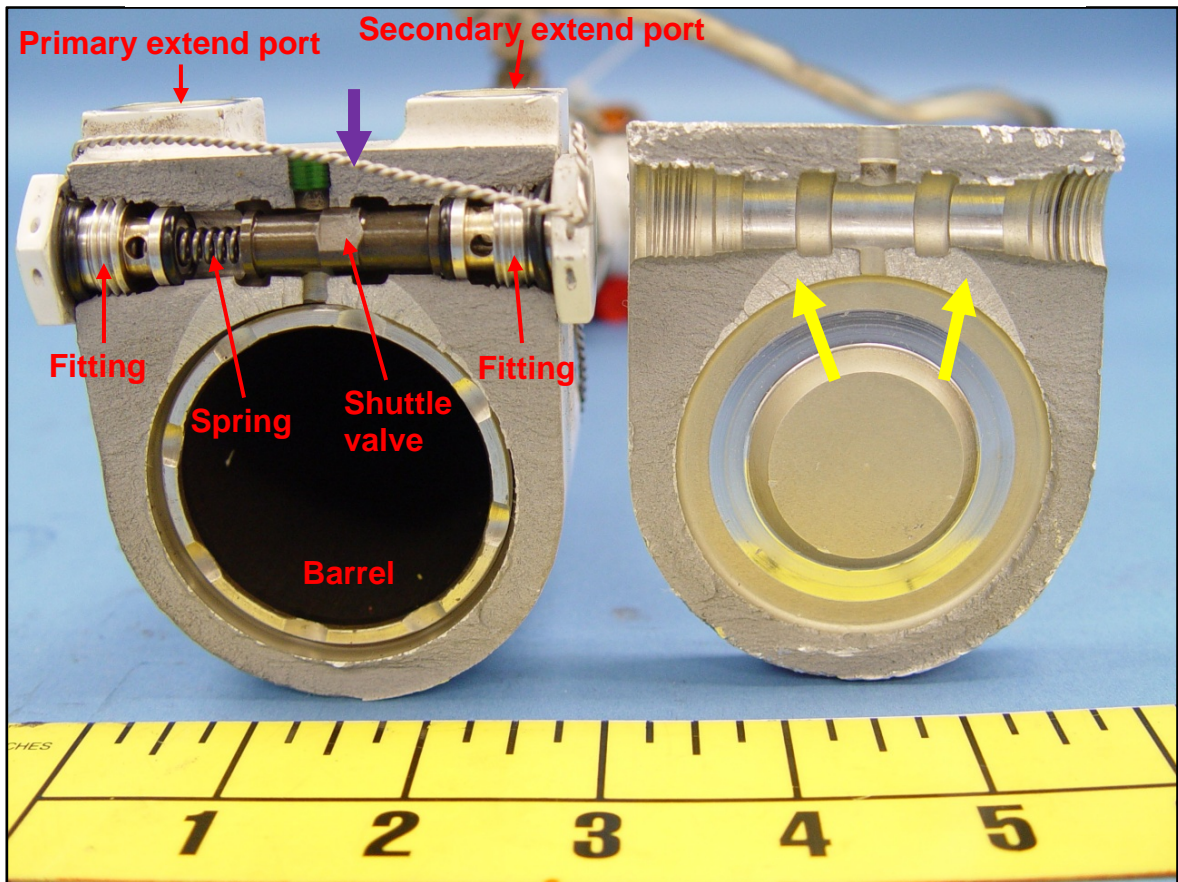
Examination of the fracture faces on the end cap revealed two distinct zones that extended from the inside diameter of the housing to the porting for the shuttle valve. A review of drawing 25705 (document 1 in section C) revealed that the inside diameter is the flat portion of a groove, with 0.08-inch radii at each end, machined into the rear of the housing. The two zones were located almost equally on both sides of the port from the shuttle valve to the inner diameter of the housing. The zones displayed ratchet marks¹ and an arced crack arrest mark, features consistent with fatigue. The rear portion of the housing is illustrated in the right of Figure 2 with yellow arrows indicating the fatigue zones. The front portion of the housing is illustrated in the left of Figure 2 with the extend ports and the shuttle valve components identified. The purple arrow indicates the intact locking wire which extended across the housing, appropriately locking shuttle fitting to shuttle fitting.

Figure 2. The fracture faces on the forward portion of the end cap (left) and the rear portion (right).

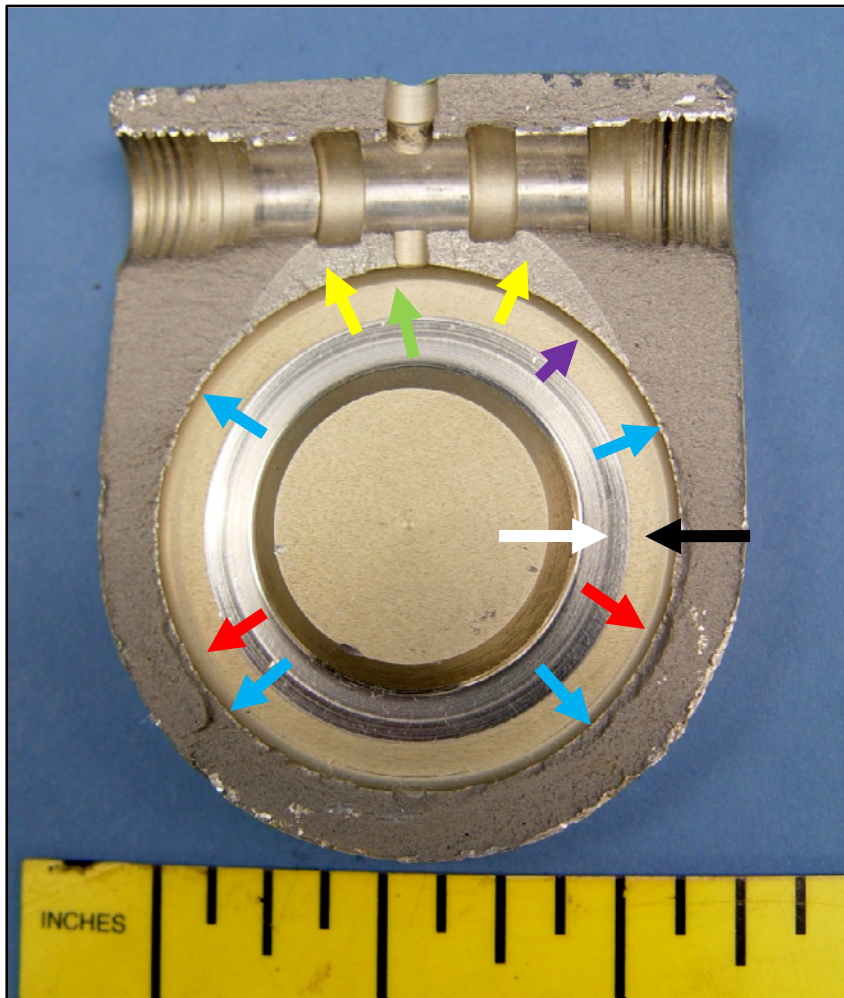
The rear portion of the housing is illustrated in Figure 3 with yellow arrows indicating the fatigue zones similarly indicated in Figure 2 and blue arrows indicating some of the smaller fatigue zones that had initiated around the inside diameter of the end cap. The rear face of the end cap consisted of the smooth surface indicated by the black arrow, and the machined surface indicated by the white arrow. The red arrows indicate the ends of a circumferential mark impressed into the smooth surface on the rear face of the end cap and measurement of the arc on an OGP Smartscope² revealed a diameter of 2.00-inch. The green arrow indicates a similar, shorter circumferential mark in the smooth surface which was measured at 2.02-inch diameter.

Figure 3. The fracture face on the rear portion of the end cap.

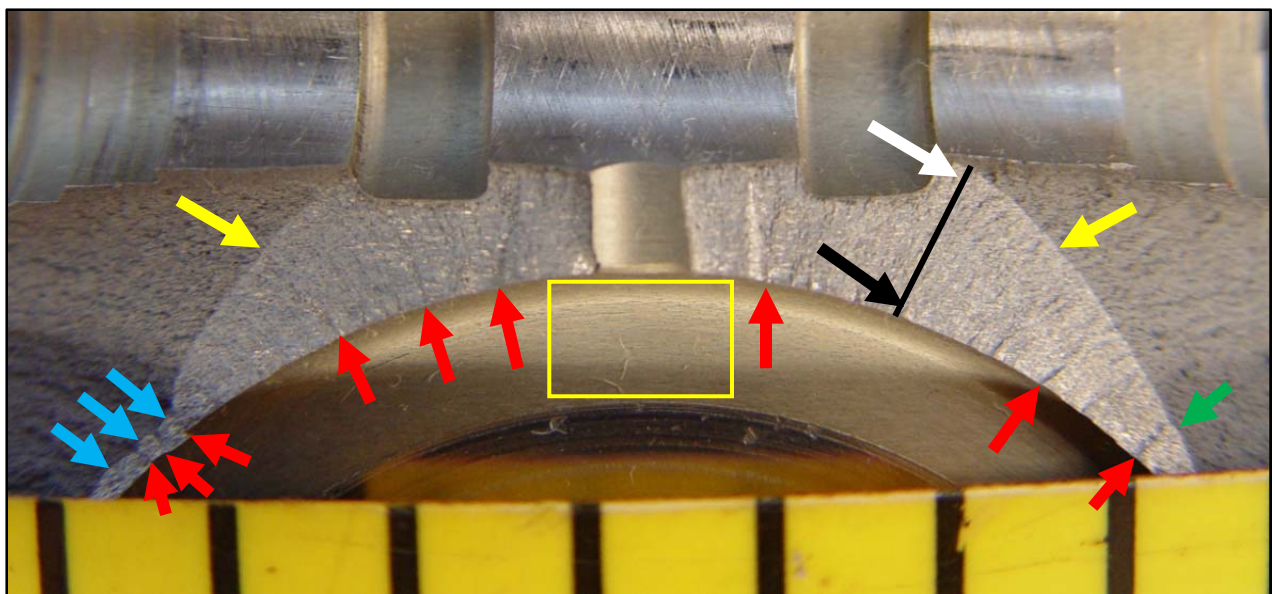
A closer view of the fatigue zones illustrated by the yellow arrows in Figure 3 is illustrated in Figure 4. The red arrows indicate ratchet marks initiating on the inner diameter of the end cap and the yellow arrows indicate the unified crack fronts of the fatigue zones. The blue arrows indicate arced crack arrest marks located between ratchet marks, where the individual fatigue zones had not propagated into a unified crack front. The green arrow indicates an arced crack arrest mark where the fatigue zone had almost unified with the crack arrest mark indicated by the yellow arrow.

The remaining rear portion of the end cap was installed in an SEM⁶ for an examination of the fatigue zones illustrated in Figure 4. The examination revealed multiple areas containing fatigue striations⁷. The fatigue striations illustrated in the SEM micrograph in Figure 10 were observed at the location indicated by the white arrow in Figure 4 while scanning along the black line. The white line in Figure 10 represents 20 μm ⁸ when drawn to the micrograph scale and contained 40 individual striations, a striation spacing of 0.5 μm . The fatigue striations illustrated in the SEM micrograph in Figure 11 were observed at the location indicated by the black arrow in Figure 4 while scanning along the black line. The black line in Figure 11 represents 5 μm when drawn to the micrograph scale and contained 28 individual striations, a striation spacing of 0.18 μm . The striation spacing of 0.5 μm and 0.18 μm were added together and divided by two to produce an average spacing of 0.34 μm . The distance along the black line in Figure 4 was measured at 0.223-inch which converts to 5,575 μm . By dividing the line length of 5,575 μm by the average striation spacing of 0.34 μm the number of striations along the black line was calculated at 16,397. It should be noted that the count was performed at the maximum propagated length available and is considered an approximate and a minimum. An accurate count could not be performed due to the fatigue zone propagating into the shuttle holes.

Figure 4. The fatigue zones indicated by the yellow arrows in Figure 3.

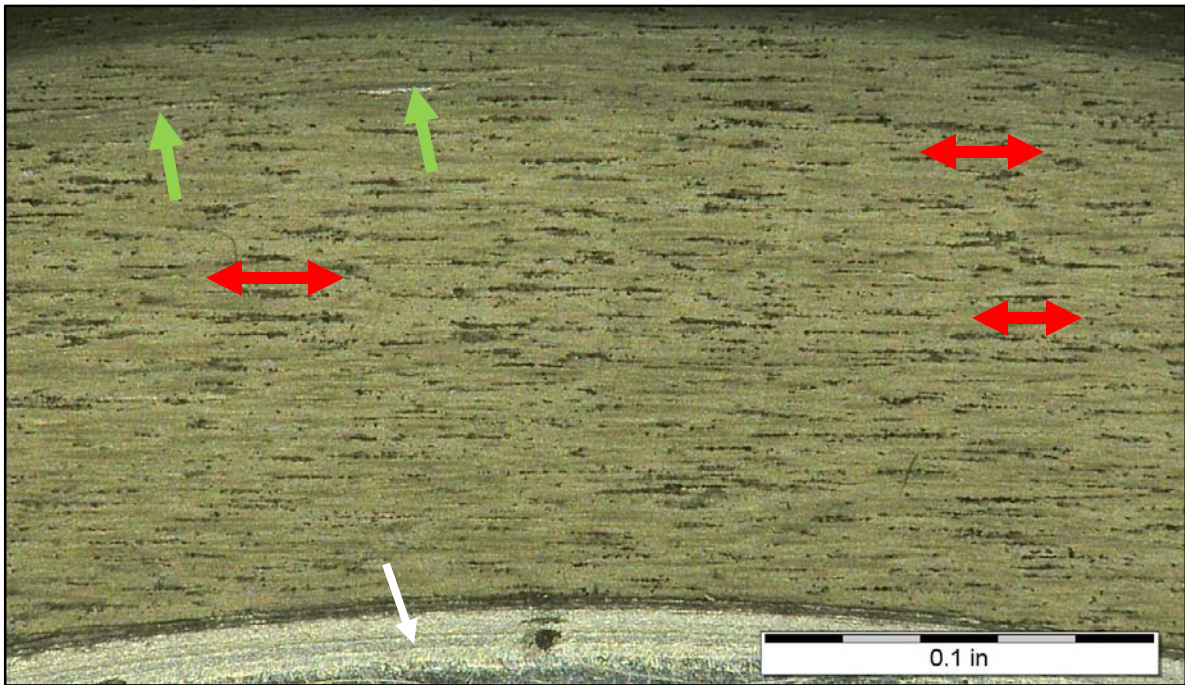
Examination of the annular rear face of the end cap revealed that it consisted of a smooth surface adjacent to the inner diameter and a surface of exposed bare metal

displaying circumferential marks consistent with a machining operation. A review of drawing 25703 revealed that the end cap was originally anodized after machining but revision C, dated April 7, 1979, changed the surface treatment to IRIDITE®³, which imparts a yellow color to the surface. The examination also revealed dark intermittent lines with a lateral orientation in the smooth area, suggestive of a grain orientation. The area within the yellow box in Figure 4 is illustrated in Figure 5 with the lateral orientation in the smooth area indicated by the red arrows. The green arrows indicate the circumferential impression indicated by the green arrow in Figure 3 and the white arrow indicates the machined surface. Drawing 25703 specifies a 32⁴ finish for the machining operations in the end cap. The smooth area extended into the radius where the fracture initiated and was found to satisfy the 32 finish on a standard surface comparator plate.

Figure 5. The inner edge of the fatigue zone illustrated in Figure 4.

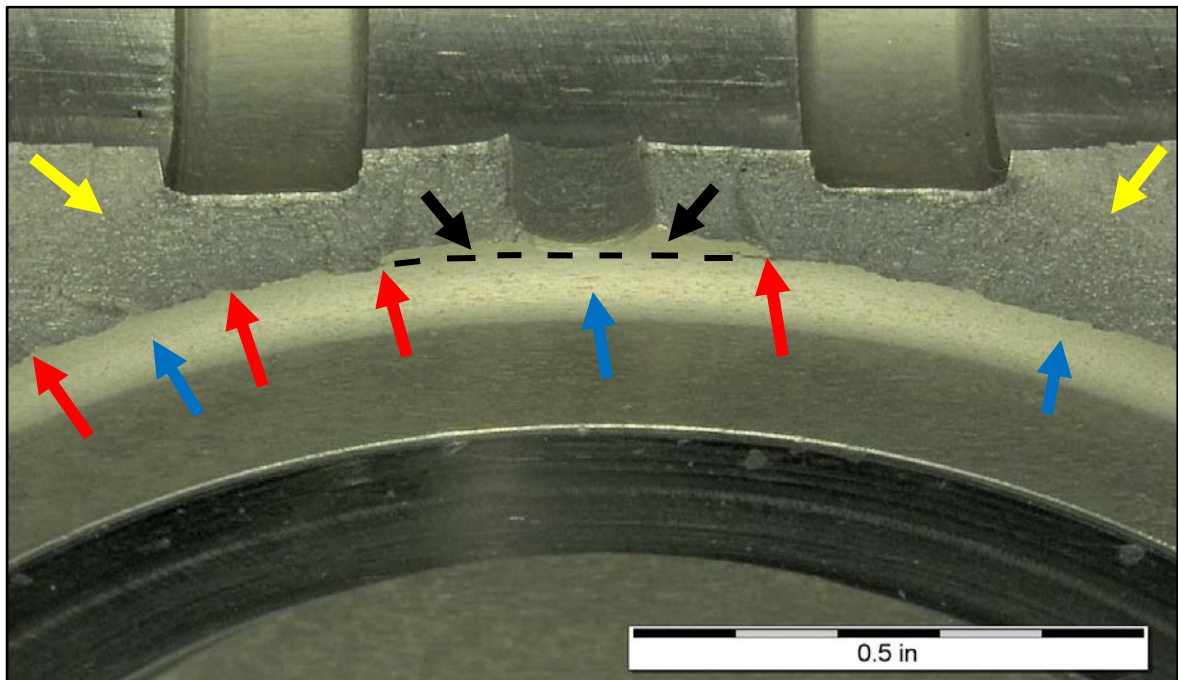
The radius adjacent to the fracture face is illustrated in Figure 6 with red arrows indicating some of the ratchet marks similarly identified in Figure 4 and yellow arrows indicating the fatigue zones also as in Figure 4. The blue arrows indicate the radius and the black arrows indicate the flat portion of the groove. The black dashed line indicates the transition between the flat portion and the radius which coincided with the edge of the fatigue zone.

Figure 6. The surface contained within the yellow box in Figure 4.

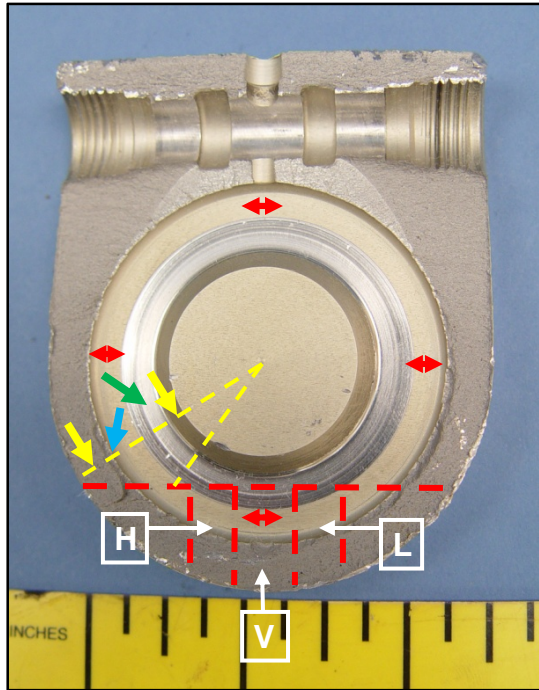
To verify the lateral grain orientation suggested by the dark intermittent lines illustrated in Figure 5, metallurgical samples were removed from the rear portion of the end cap by cutting along the red dashed lines in Figure 7. The samples identified as “H” for the horizontal axis, “V” for the vertical axis, and “L” for the longitudinal axis, were metallurgically mounted in order to display the orientation indicated by their identification, polished and etched with Keller’s reagent⁵. The etchant revealed grain orientation in the horizontal sample and laterally in the vertical sample, confirming the orientation illustrated in Figure 5 and indicated by the red arrows in Figure 7. A review of drawing 25703 revealed that revision N, dated February 19, 2010 added the grain orientation which was required to be in the longitudinal axis of the end cap.

Figure 7. Samples removed from the fractured rear portion of the end cap.

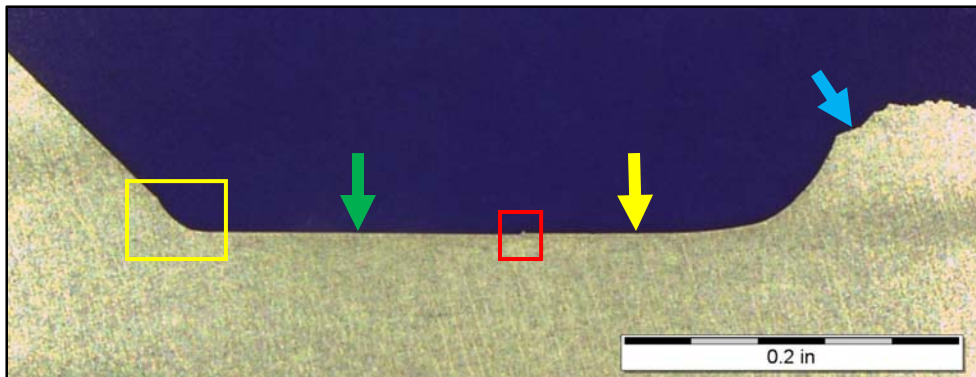
To confirm that the machined surface indicated by the white arrow in Figure 3 had been machined, the end cap was cut at the yellow dashed lines in Figure 7 and the removed sample metallurgically mounted in order to examine it in the direction indicated by the yellow arrows. The mounted sample was polished and etched with Keller's reagent and the area between the yellow arrows in Figure 7 is illustrated in Figure 8. The green arrow indicates the machined surface indicated by the green arrow in Figure 7, the yellow arrow indicates the as-cast surface, and the blue arrow indicates the smaller fatigue zone indicated by the blue arrow in Figure 7. A closer view of the radiused area within the yellow box is illustrated in the left image in Figure 9 with a green arrow indicating the machined surface and a red arrow indicating a bur of material typically displaced by a cutting tool. A closer view of the area within the red box in Figure 8 is illustrated in the right image in Figure 9 with a yellow arrow indicating the as-cast surface, a green arrow indicating the machined surface and a red arrow indicating raised material at the intersection of the two surfaces, consistent with use of a cutting tool. Measurements revealed that the raised material was 0.0025-inch above the machined surface and the machined surface was 0.0007-inch below the as-cast surface, as illustrated.

Figure 8. A sectional view between, and in the direction indicated by the yellow arrows in Figure 7.

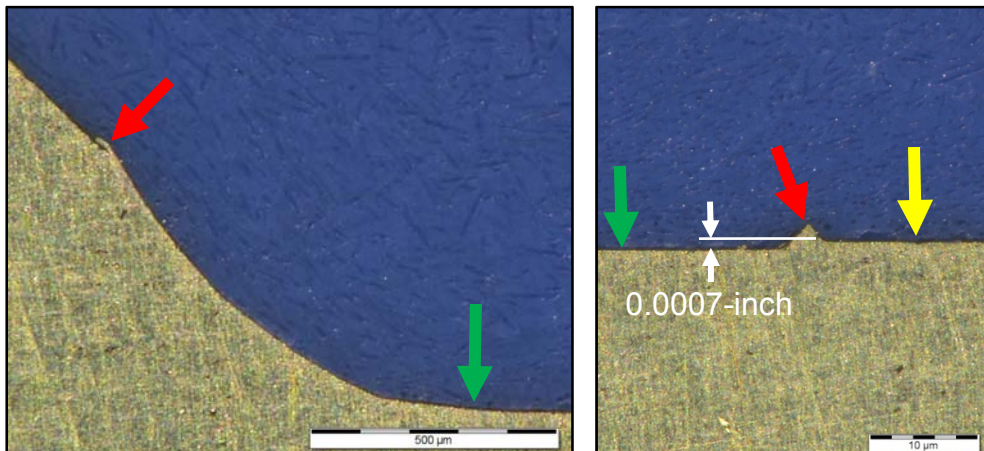
Figure 9. The area within the yellow box in Figure 8 (left) and the area within the red box (right).

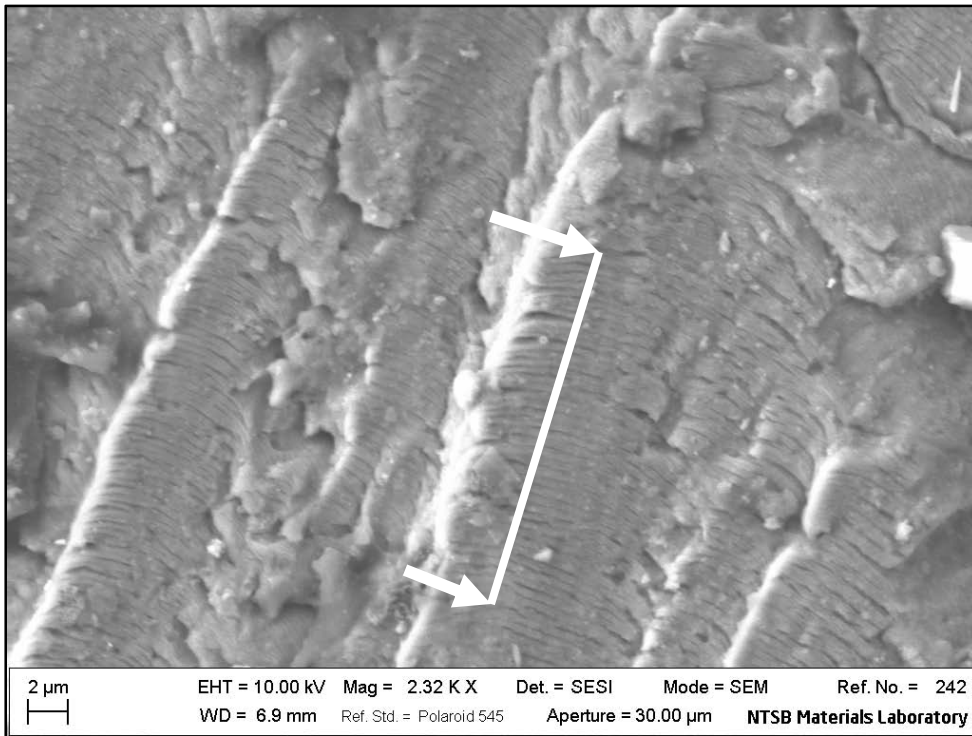
Figure 10. SEM micrograph of fatigue striations at the location indicated by the white arrow in Figure 4.

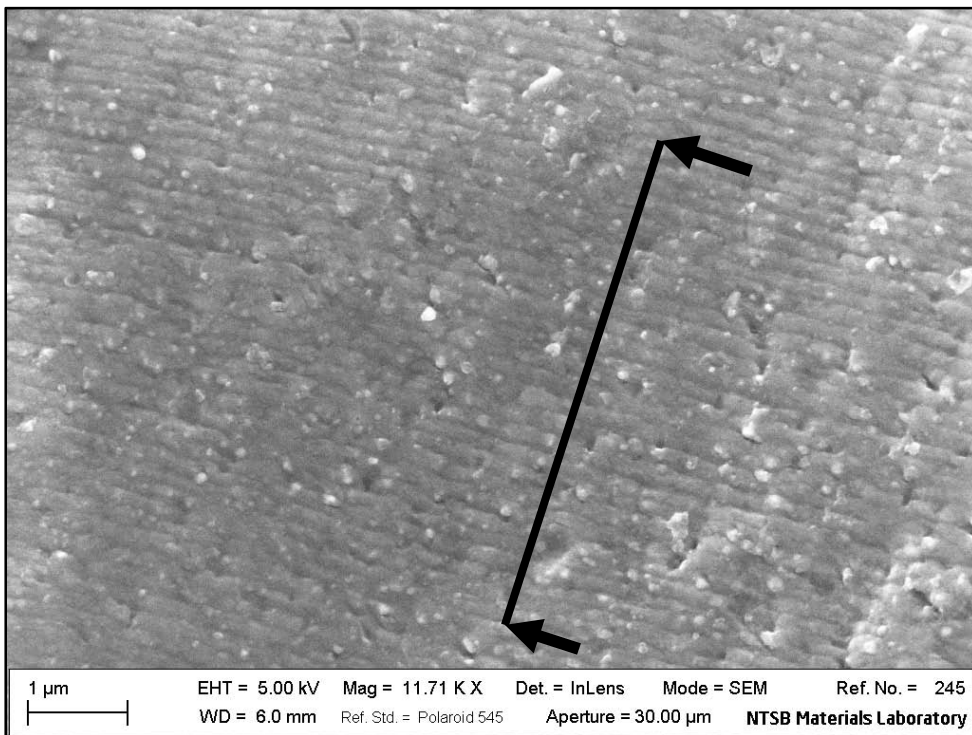
Figure 11. SEM micrograph of fatigue striations at the location indicated by the black arrow in Figure 4.

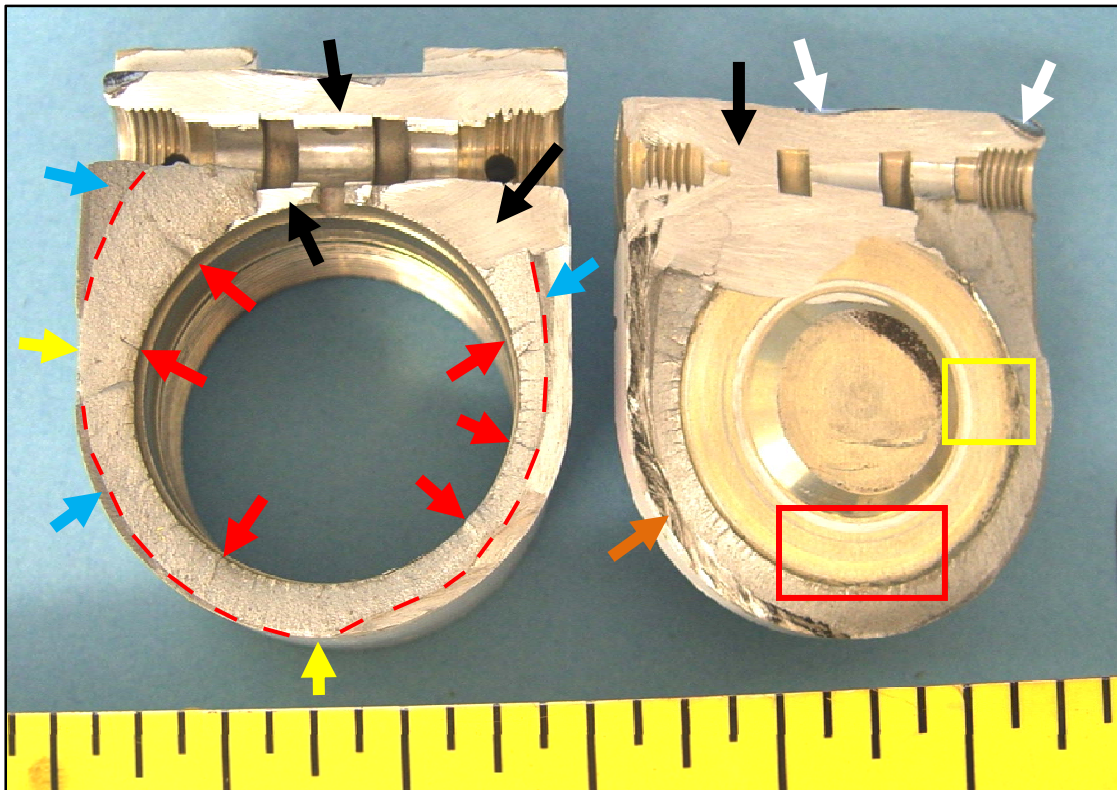
made available. The second end cap had fractured at a similar location and the fracture faces are illustrated in Figure 12 with black arrows indicating where the end cap had been cut to separate the two portions. The red arrows indicate ratchet marks initiating on the inner diameter and the red dashed lines indicate the terminus of the fatigue zone. It was noted that the fatigue zone had propagated further than the fatigue zone on the accident end cap especially into the uniformly thick wall portion of the end cap. The yellow arrows indicate locations where the fatigue had propagated through the uniform wall portion. The blue arrows indicate shear lips initiating where the fatigue zone terminated.

Figure 12. The fracture faces on the comparison end cap.

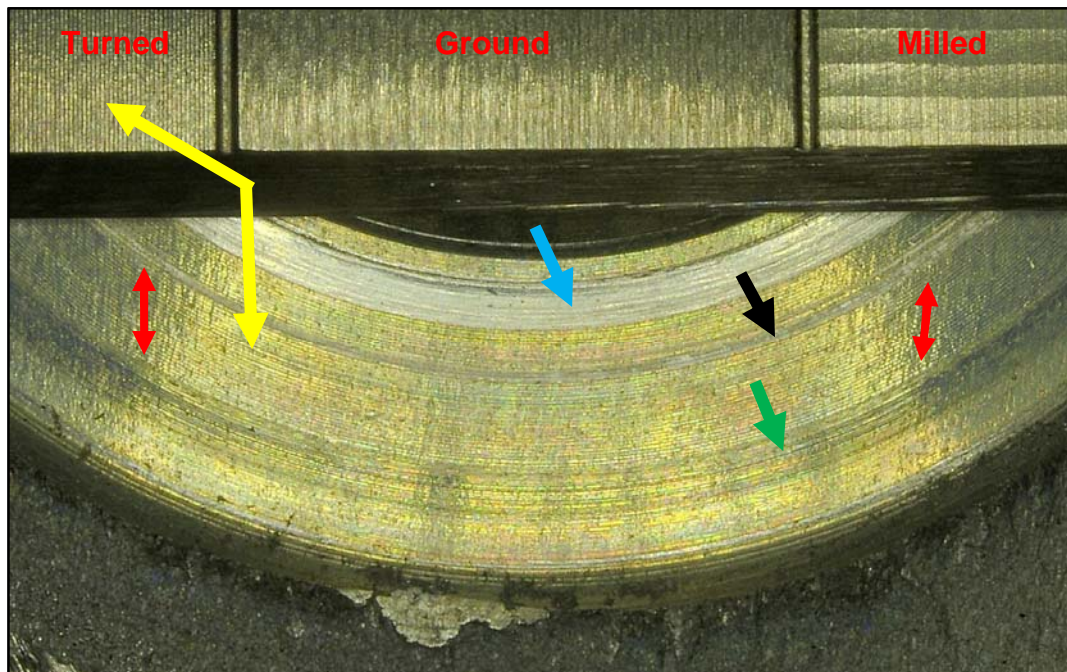
Examination of the rear face of the end cap revealed a machining mark and circumferential marks. The area within the red box in Figure 12 is illustrated in Figure 13 for comparison with Figure 5. A portion of a standard comparator plate with turned, ground and milled surfaces of a 63 finish (coarser than the 32 finish required by drawing 25703) is also illustrated in the figure. The yellow arrows indicate the surface finish on the end cap and the similar turned surface on the comparator plate. The green and black arrows indicate circumferential marks and the blue arrow indicates a circumferential band where a machining process had removed the coating to expose the underlying aluminum. Close examination of the surface revealed what appeared to be undulations on the coated surface displaying a vertical orientation. The orientation is indicated by the red arrows placed adjacent to some undulations.

Figure 13. The area within the red box in Figure 12.

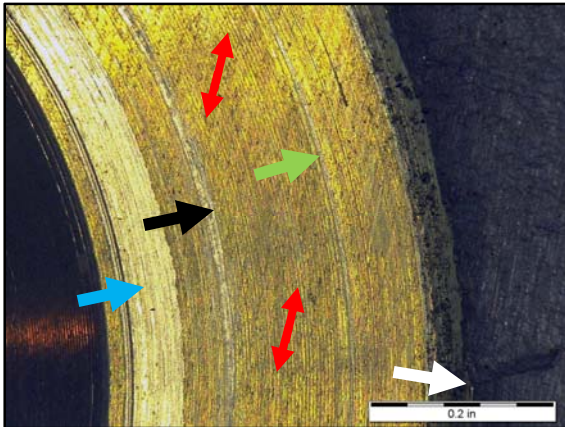
A closer view of the surface within the yellow box in Figure 12 is illustrated in Figure 14 with the circumferential band indicated by the blue arrow in Figure 13 similarly indicated. The circumferential marks indicated by the green and black arrows in Figure 13 are also similarly identified and were found to measure 1.96-inch diameter and 1.58-inch diameter respectively. The red arrows indicate the orientation of the adjacent dark intermittent lines that appeared to be similar to the grain orientation illustrated in Figure 5 but obscured by the distinct circumferential machining marks.

Figure 14. The area within the yellow box in Figure 12.

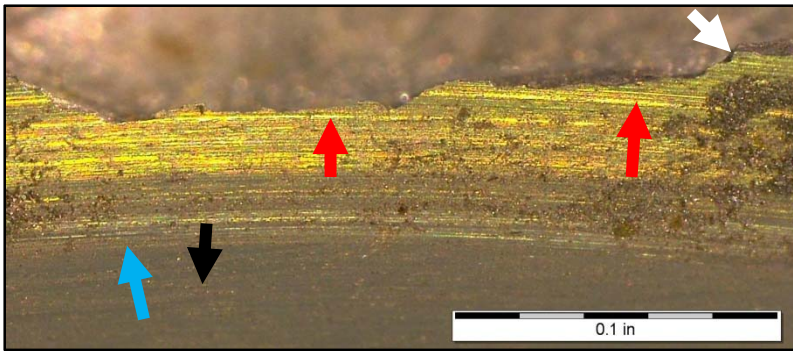
The groove radius contained within the yellow box in Figure 12 is illustrated in Figure 15 with a white arrow indicating the ratchet mark indicated by the white arrow in Figure 14. The radius exhibited a finish similar to that illustrated in Figure 14 and some of the more distinct machining marks are indicated by the red arrows. Examination revealed that although the edge of the fatigue fracture did not follow any particular machining mark, it was contained in the radius. The black arrow indicates the rear surface illustrated in Figure 14 and the blue arrow indicates the transition point from the rear surface to the radius.

Figure 15. The radius within the yellow box in Figure 12.

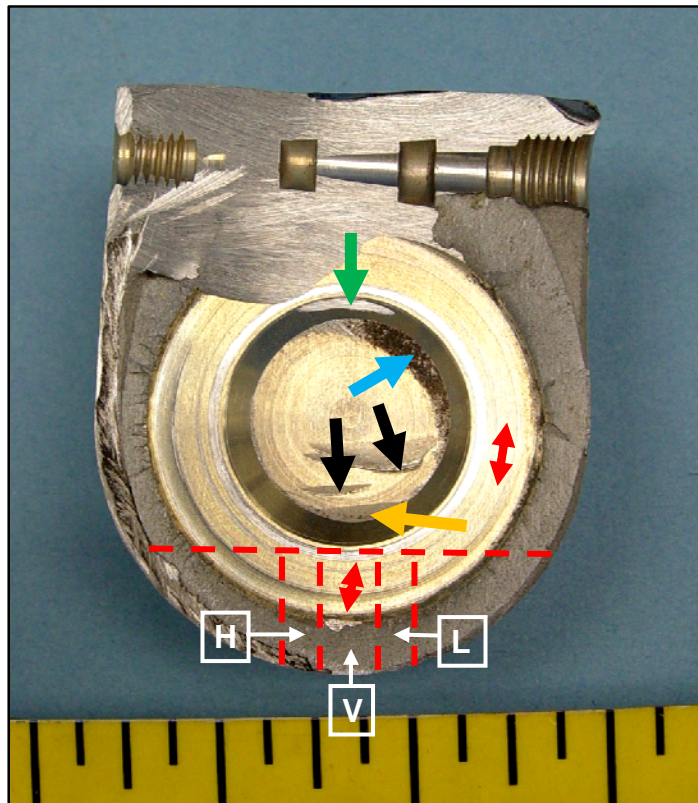
To verify the vertical grain orientation suggested by the dark intermittent lines illustrated in Figure 14, metallurgical samples were removed from the rear portion of the end cap by cutting along the red dashed lines in Figure 16. The samples identified as "H" for the horizontal axis, "V" for the vertical axis, and "L" for the longitudinal axis, were metallurgically mounted in order to display the orientation indicated by their identification, polished and etched with Keller's reagent. The etchant revealed grain orientation in the vertical sample and vertically in the longitudinal sample, confirming

the orientation illustrated in Figures 13 and 14 and indicated by the red arrows in Figure 15.

Figure 16. The fractured rear portion of the comparison end cap.
