NATIONAL TRANSPORTATION SAFETY BOARD

MATERIALS LABORATORY FACTUAL REPORT

Report No. 11-101

Place : Richmond, Virginia
Date : April 11, 2011
Vehicle : Piper PA-31-350, registration: N3547C
NTSB No. : ERA11LA240
Investigator : Dennis Diaz, AS-ERA

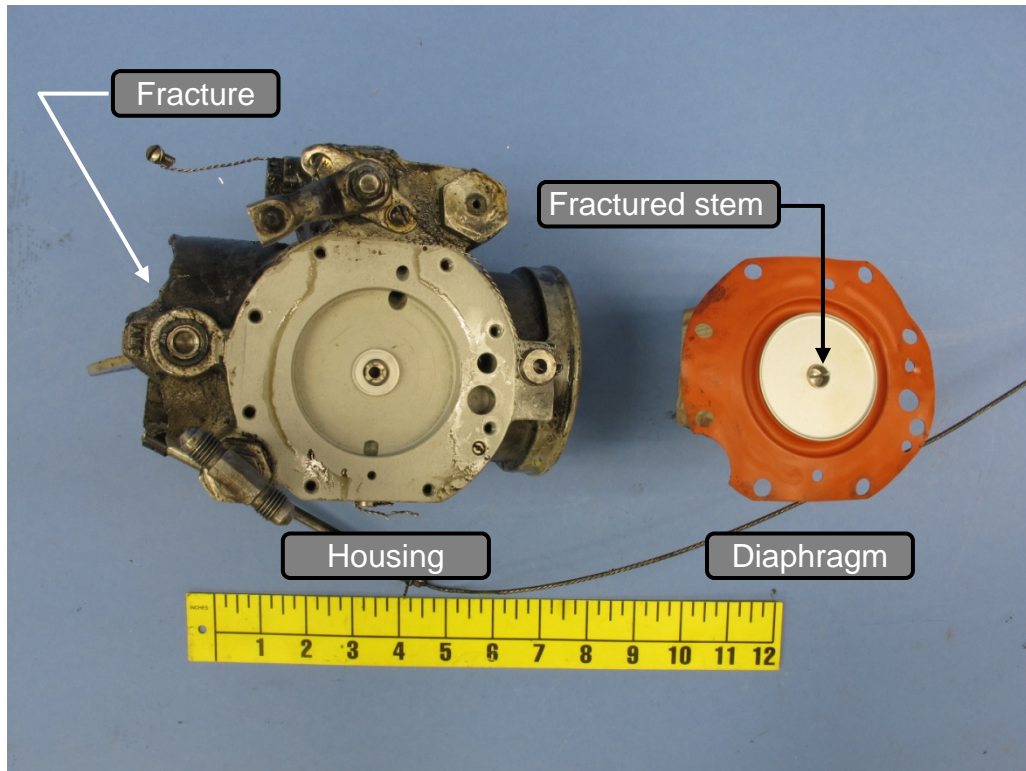
Pieces from the right engine fuel servo were received by the Materials Laboratory as shown in figures 1a and b. The fuel servo housing was fractured at one end and the fuel servo diaphragm had a fractured stem. The fracture was in the threaded portion of the stem and the stem was bent. The mating half of the fractured stem is shown in figure 1b.

Figure 1: Fuel servo housing and diaphragm with fractured stem; b) fuel servo assembly components including mating half of fractured diaphragm stem.

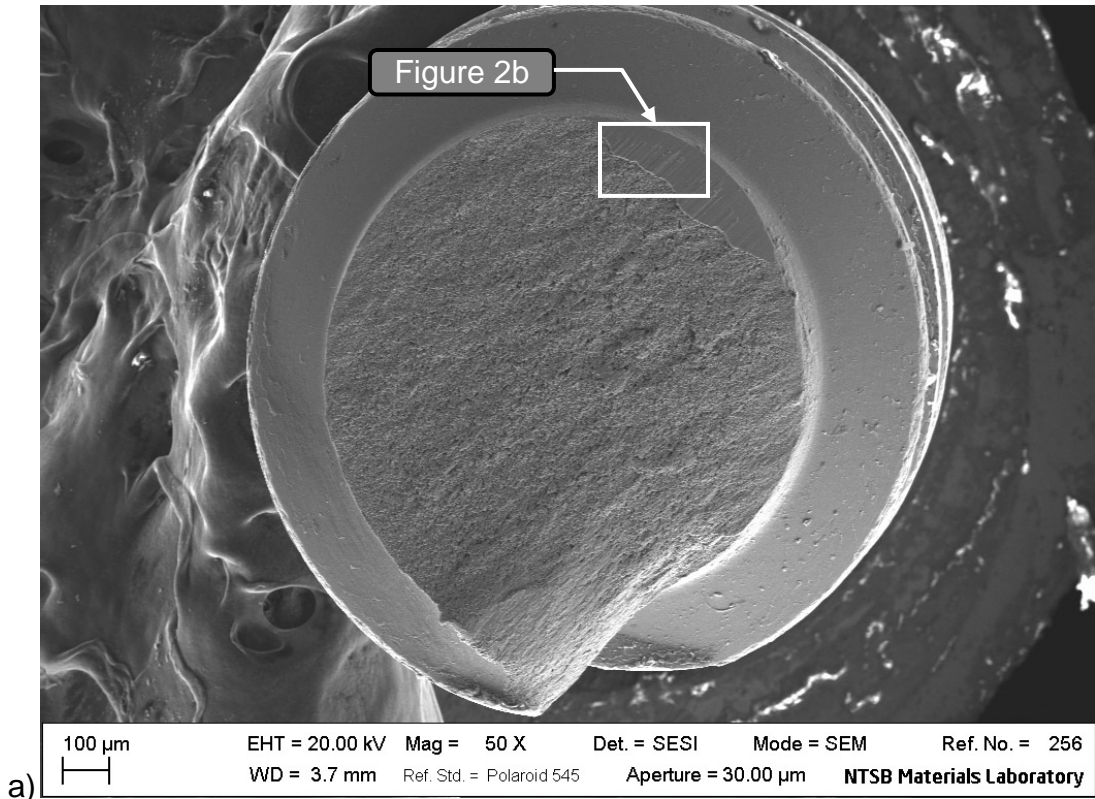
The fractured stem piece shown in figure 1b was cleaned with acetone and examined by scanning electron microscopy. The fracture was at the root of a thread as shown in figure 2a. A higher magnification view of the fracture surface was taken at the location shown in figure 2a and is shown in figure 2b. One small section of the fracture surface exhibited features consistent with smearing. The rest of the fracture exhibited dimple-shaped features, consistent with ductile fracture.

Figure 2: Scanning electron microscope images of fractured stem from figure 1b; a) overview of fracture surface; b) higher magnification view showing smearing and ductile fracture.
