NATIONAL TRANSPORTATION SAFETY BOARD

MATERIALS LABORATORY FACTUAL REPORT

Report No. 12-007

Place : Nashville, Pennsylvania
Date : December 22, 2011
Vehicle : Cessna 441
NTSB No. : ERA12FA120
Investigator : Paul Cox

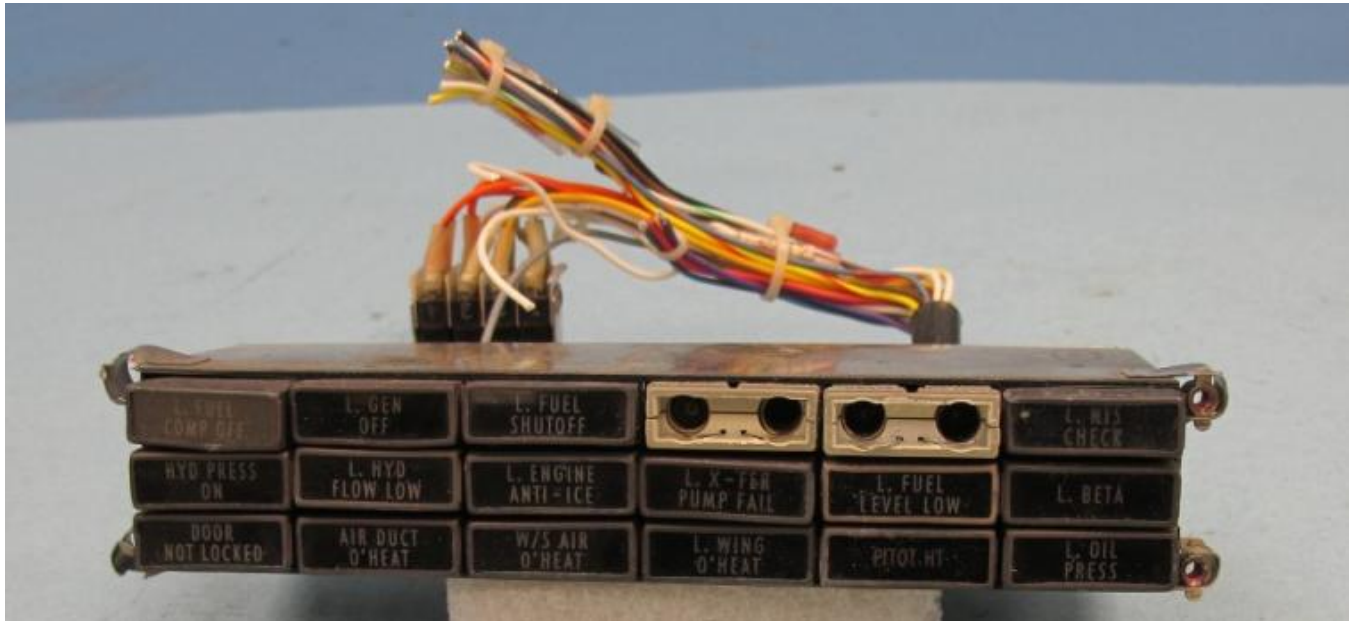
Figure 3. Left annunciator panel.

On the panels from the accident aircraft, the left and right BATT O'HEAT indicators had been replaced with PITOT HEAT. The face plates for the L FUEL PRESS LOW and the L AUX BOOST ON annunciator lights were missing and the L FUEL PRESS LOW annunciator was missing one bulb. The as-received panels are shown in Figure 3 and 4.

The investigator requested that the following annunciator lights be examined: on the left panel-L FUEL COMP OFF, HYD PRESS ON, L GEN OFF, L HYD FLOW LOW, L FUEL SHUTOFF, L FUEL PRESS LOW, L X-FER PUMP FAIL, L AUX BOOST ON, L FUEL LEVEL LOW, L BETA; and L OIL PRESS and on the right annunciator panel- R BETA, R OIL PRESS, R AUX BOOST ON, R FUEL LEVEL LOW, R FUEL PRESS LOW, R X-FER PUMP FAIL, R FUEL SHUTOFF, R GEN OFF, R HYD FLOW LOW, and R FUEL COMP OFF. The bulbs were examined with a 5X to 50X zoom stereomicroscope. On both panels, each annunciator light had two bulbs installed per light. The examination revealed some evidence of filament sagging on several of the bulbs, consistent with aging. Broken filaments were found in L GEN OFF, L HYD FLOW LOW, L X-FER PUMP FAIL and R HYD FLOW LOW annunciator lights. However, there was no evidence of hot filament stretching found on any of the filaments of the examined bulbs from both panels including those with broken filaments.

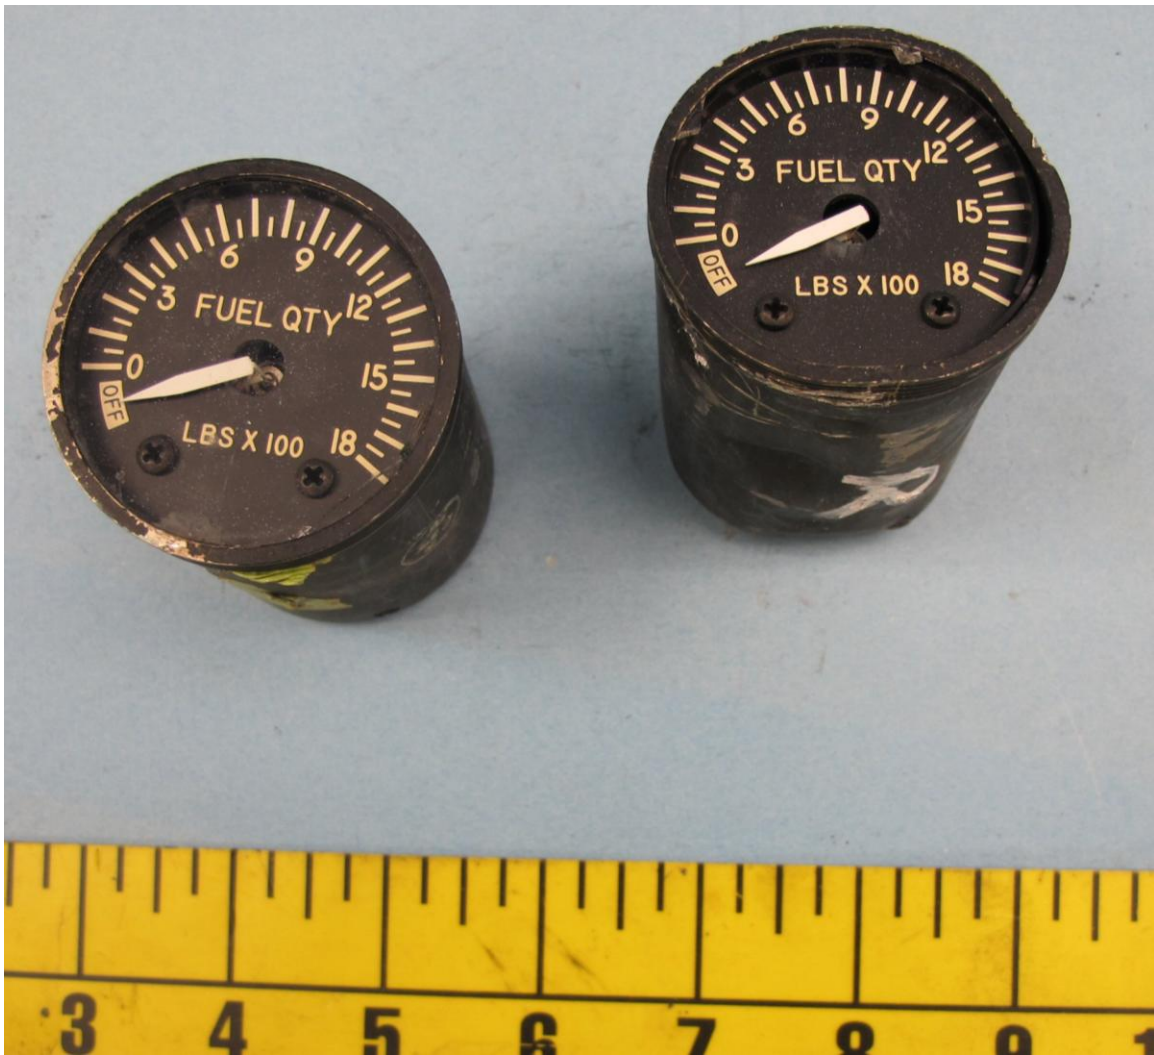
Figure 5. Left fuel quantity gauge (left) and right fuel quantity gauge (right).

The as-received fuel quantity gauges are shown in Figure 5. The faces of the left and right fuel gauges were examined for the presence of witness marks left by the gauge needles. The gauges faces were examined with a 5X to 50X zoom stereomicroscope. No witness marks were found on either gauge face.
