NATIONAL TRANSPORTATION SAFETY BOARD

MATERIALS LABORATORY FACTUAL REPORT

Report No. 12-015

Place : Green Cove Springs, Florida
Date : December 26, 2011
Vehicle : Bell 206B, N5016M
NTSB No. : ERA12MA122
Investigator : Robert Gretz, AS-ERA

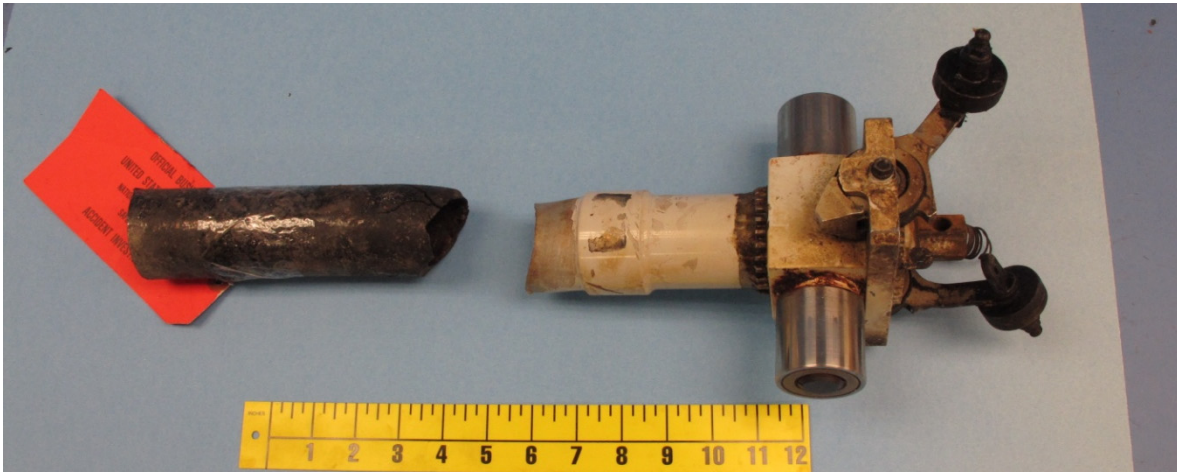
The as-received upper end of the main rotor mast is displayed in figure 1. The mast was fractured about 5 inches below the splined section and about 1 inch below the enlarged diameter. The mast had been saw-cut about 8 inches below the fracture. The mast section below the fracture was darkly discolored consistent with exposure to high temperatures while the section above the fracture was not.

Figure 1. Upper view displays the as-received components. Middle view shows the bending deformation in the mast above the fracture. View at left shows the fracture face.

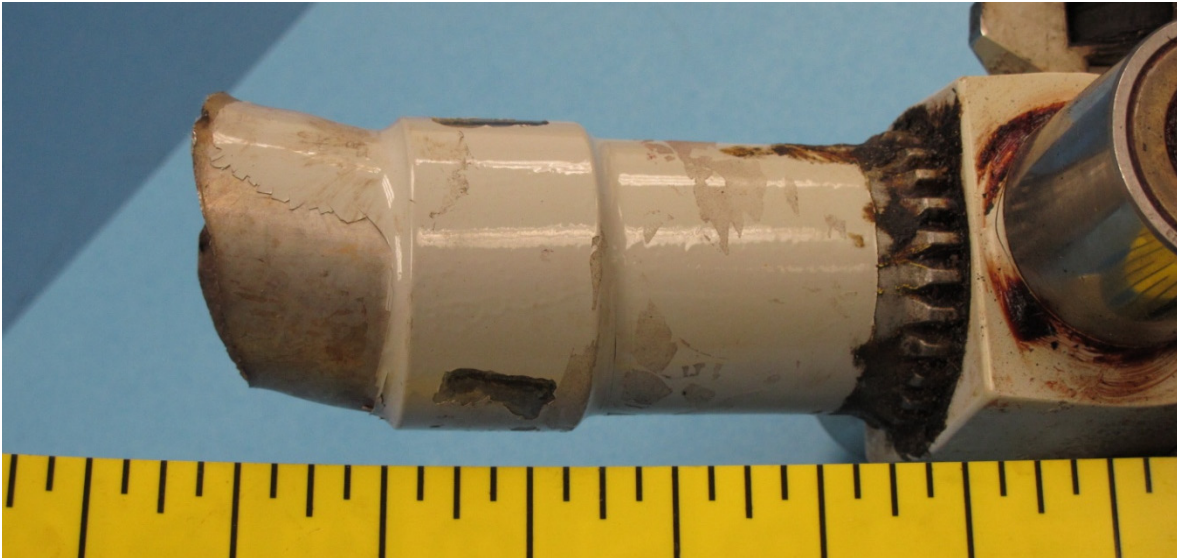
The mast was heavily deformed and bent above the fracture as shown in the middle view of figure 1. Magnified examination of fracture (lower view of figure 1) revealed large overstress shear lips completely around the mast. The orientation of the shear lips and the overall pattern of deformation were consistent with a bending overstress separation. No indications of torsion were noted in the fracture.

As visible in the middle view of figure 1, the paint was damaged at locations corresponding to contact with the main rotor yoke assembly. However, the mast was only lightly marked.
