NATIONAL TRANSPORTATION SAFETY BOARD

MATERIALS LABORATORY FACTUAL REPORT

Report No. 12-029

Place : Reno, Nevada.
Date : September 16, 2011.
Vehicle : North American P-51D, N79111.
NTSB No. : WPR11MA454.
Investigator : Clint Crookshanks, AS-40.

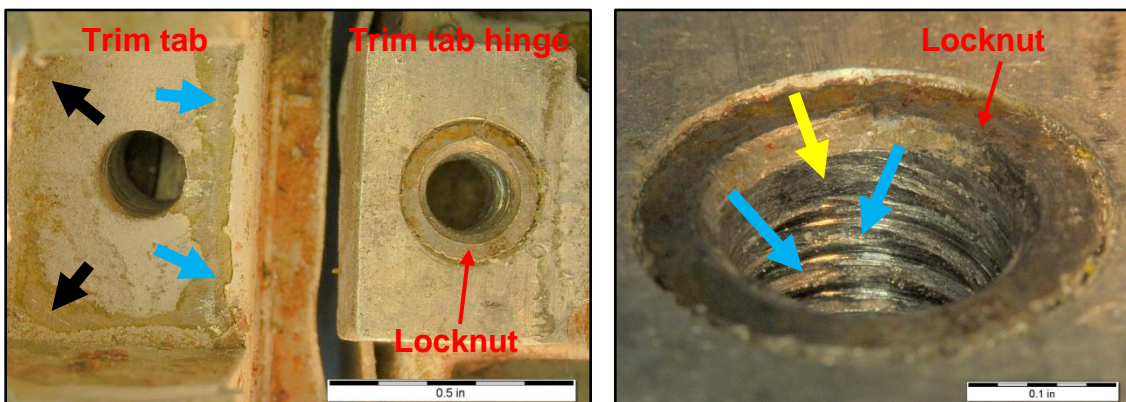
The threads in the locknut were examined after experiencing the difficulty re-engaging the screw and damage was noted on the initial threads. The locknut identified in the left image in Figure 3 is illustrated and identified in the right image. The yellow arrow indicates a flattened portion of a thread crest and the blue arrows indicate concave grooves on two adjacent thread crests, normally associated with an attempt to engage a screw that is not aligned (cross threading).

Figure 3. The mating surfaces of the outboard trim tab hinge with the trim tab (left) and the thread in the trim tab hinge locknut (right).

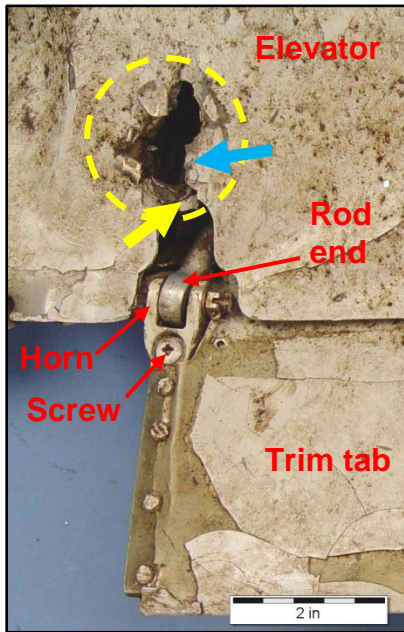
Before excising the center hinge damage observed in the lower skin of the elevator forward of the horn was examined. The examination revealed that the skin immediately forward of the cut-out for the trim tab controls had been deformed inwards and the skin forward of the deformed portion had been ripped in a short zigzag pattern with skin deformed inwards and outwards. The damaged area is enclosed within the yellow dashed circle in the left image in Figure 4 with a yellow arrow indicating the inwardly deformed skin and a blue arrow indicating the fractured edge produced by the deformation. The elevator and the trim tab are identified. The rod end which is the rear

fitting for the trim tab control, the horn, which is part of the trim tab hinge fitting and to which the rod end is bolted, and the screw which attaches the trim tab fitting to the trim tab hinge are also identified. Excising of the center hinge revealed areas where bare metal had been exposed immediately forward of the damage illustrated in the left image. The exposed areas are illustrated in the right image in Figure 4 with the damaged area indicated by the yellow dashed circle in the left image similarly indicated. Yellow arrows indicate thin, shallow, laterally oriented indentations where the material had been deformed forward and blue arrows indicate wide smears in longitudinally oriented bands.

Figure 4. Damage to the lower skin forward of the center hinge (left) and to the adjacent inner surface (below).

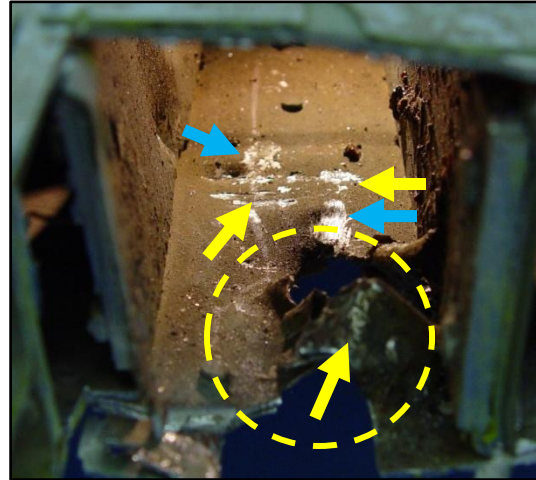
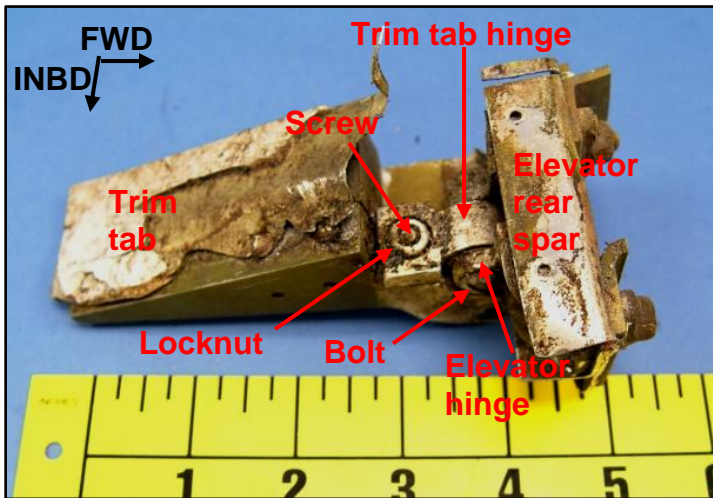
The rod end identified in the left image of Figure 4 was removed and the portion of the center trim tab hinge indicated by the red dashed lines in Figure 1 was excised and is illustrated in Figure 5 with the installed forward and inboard directions indicated. The elevator rear spar, the elevator hinge, the hinge bolt, the trim tab hinge and the trim tab are identified. A portion of the trim tab upper skin was missing, revealing the screw and the locknut which are also identified. The white arrow indicates filler similarly indicated in Figure 2. The center trim tab hinge illustrated in Figure 5 was inverted and is illustrated in Figure 6 with similar components identified. The horn, to which the rod end identified in the left image in Figure 4 was bolted, and the screw attaching the trim tab to the trim tab hinge, are also identified. The white arrow indicates a filler that had also been applied to the lower skin and was thinner at the trailing edge as indicated by the green arrow. The trim tab hinge was loose on the trim tab and could be rotated around the screw, limited by the clearance between the rear face of the trim tab hinge and the trim tab.

The screw identified in Figure 5 and 6 attaches the trim tab to the trim tab hinge and was found to be loose. The upper trim tab skin normally above the trim tab hinge was missing, as illustrated in the left image in Figure 5, and the tip of the screw was found to be flush with the locknut. The locknut is illustrated and identified in Figure 7 with the screw identified and a blue arrow indicating a portion of the first thread of the

Figure 5. The upper side of the center trim tab hinge excised from the left elevator.

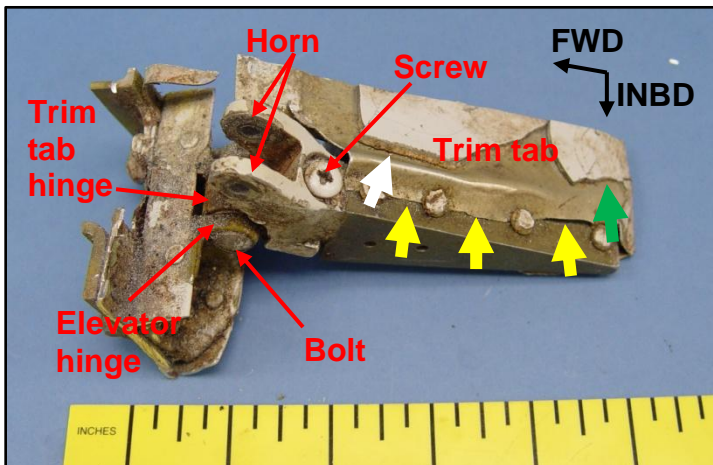
Figure 6. The lower side of the center trim tab hinge excised from the left elevator.

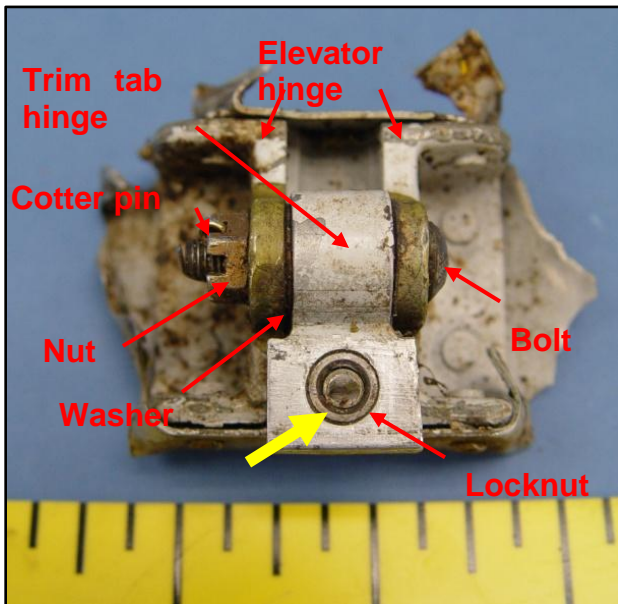
The inboard hinge identified in Figure 1 was supplied separated from the elevator and is illustrated in the left image in Figure 9 with the elevator hinge, the trim tab hinge, the hinge bolt and the locknut insert identified. The screw was observed fractured flush with the locknut and is indicated by the yellow arrow. A side view of the inboard hinge is illustrated in the right image in Figure 9 with the elevator hinge, the trim tab hinge and the bolt identified. The yellow arrow indicates the location of the fracture similarly indicated in the left image and the purple arrow indicates the protruding tip of the screw. The protrusion was measured at 0.08-inch. The end of the screw was ground flat, cleaned and subjected to XRF analysis which displayed a composition satisfying the material requirement in MS27039. The trim tab hinge containing the portion of screw was placed on an annular spacer to protect the fracture face and a hardness test performed on the ground end of the screw. The hardness of the screw was measured at 24 HRC.

Figure 9. The inboard hinge identified in Figure 1 (left) and a side view (right).

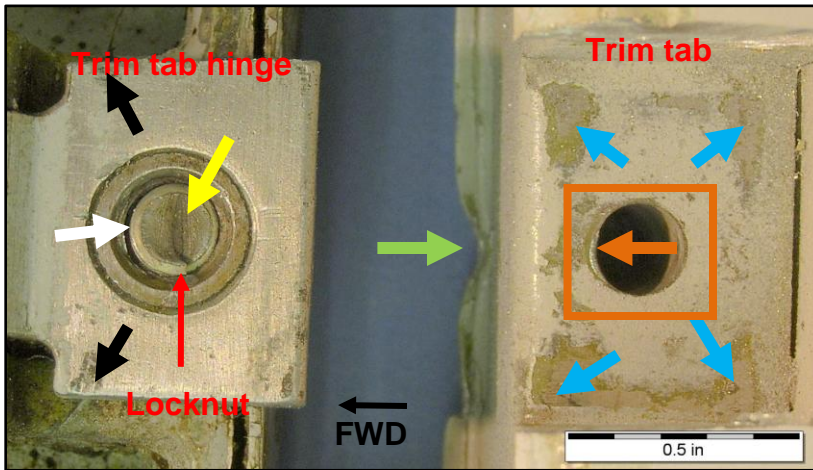
The trim tab skin located above the mating surface for the trim tab hinge was removed after the examination of the trim tab detailed later and the surface is illustrated in Figure 10 with the mating trim tab hinge surface. The black arrows on the trim tab hinge indicate areas where the base metal was exposed. The yellow arrow, as in Figure 9, indicates the hinge screw fracture face and the white arrow indicates a gap between the screw and the locknut. The blue arrows on the trim tab indicate areas where the paint had been removed exposing the primer and the brown arrow indicates a partial chamfer which would normally be located adjacent to the screw at the location indicated by the white arrow in the left image. The green arrow indicates an arced indentation in the trim tab lower skin which is described later and indicated by the white arrow in the right image in Figure 18.

Examination of the fracture face indicated by the yellow arrow in Figure 10 revealed ratchet marks⁹, and crack arrest marks originating at opposing sides, consistent with reverse bending fatigue that produced two fatigue zones with an overload region between them. The fracture face, with the trim tab hinge, was triple solvent cleaned then cleaned further by several applications of acetate replica tape and is illustrated in the left image in Figure 11. Red arrows in one fatigue zone indicate crack arrest marks emanating from multiple ratchet marks indicated by the green arrows in the root of the thread and terminating at the red dashed line. Yellow arrows in the second fatigue zone indicate crack arrest marks emanating from multiple ratchet marks indicated by the blue arrows in the root of the thread and terminating at the yellow dashed line. Measurements revealed that the fatigue zones were approximately even in area and the overload region between them occupied approximately 16% of the fracture face. The white arrows indicate the gap between the screw and the locknut similarly indicated in Figure 10. The purple arrow indicates the end of a thread, located between the dashed terminus lines, where the fracture had jumped from one thread root to another. A side view of the fracture face is illustrated in the right image in Figure 11 with the dashed terminus lines and similarly colored arrows transferred from the left

The hole in the trim tab usually occupied by the screw is contained within the brown box in Figure 10 and appeared to be elongated. The hole is illustrated at a higher magnification in Figure 12 with a brown arrow indicating the partial chamfer similarly indicated in Figure 10. The diameter of the hole was measured at the locations indicated by the red arrows and was found to range between 0.195-inch and 0.193-inch. The depth of the partial chamfer indicated by the brown arrow was measured at 0.010-inch. Examination of the partial chamfer revealed that it was located on the forward edge of the hole and consisted of trim tab material that had been displaced forward.

Figure 10. The mating surfaces of the inboard trim tab hinge and the trim tab.

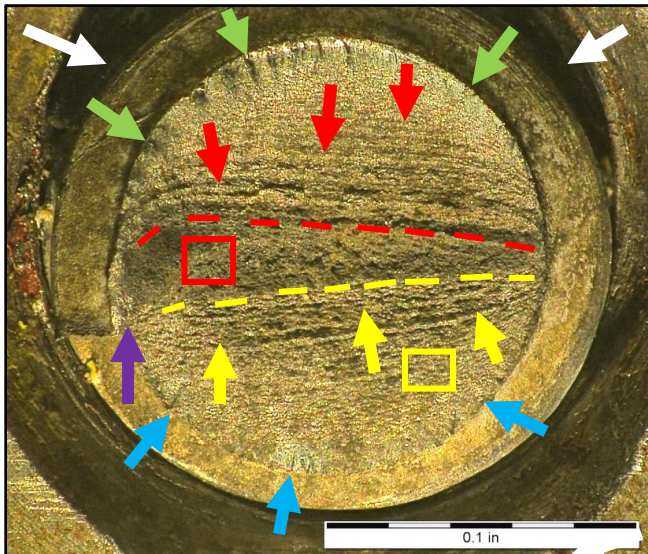
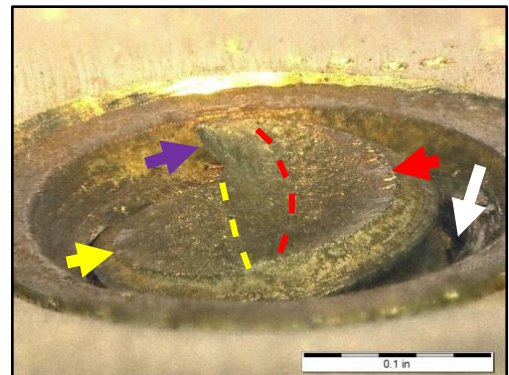
image. It was noted that the red-arrowed fatigue zone was relatively flat as it propagated from the root of the thread. The yellow-arrowed fatigue zone was initially flat but curved upwards as it approached the terminus of the red arrowed fatigue zone. The purple arrow indicates the fractured thread similarly indicated in the left image and the white arrow indicates the gap similarly indicated in the left image and in Figure 10.

The trim tab hinge was installed in an SEM¹⁰ and the fracture face illustrated in Figure 11 examined. An examination of the area between the red and yellow dashed lines revealed ductile dimples consistent with an overload and an image of the area within the red box is illustrated in Figure 13. A survey in the fatigue zones revealed mechanical damage in the vicinity of the ratchet marks that had obliterated any features that may have been present and corrosion on the crack arrest marks that obscured any finer features that may be present. The trim tab hinge was submerged in Evapo-rust¹¹ to remove the corrosion on the fracture face, solvent cleaned and the fracture face re-surveyed in the SEM. The survey in the areas displaying crack arrest marks revealed that most of the corrosion had been removed to expose a rough surface containing corrosion pits but two areas containing discernible striations were found. The area displaying the more defined striations was located within the yellow box in Figure 11 and is illustrated in Figure 14 with red arrows indicating the fatigue striations. The spacing between the striations illustrated was approximately 1 micron (0.00004-inch).

Figure 11. The fracture face on the left elevator inboard trim tab hinge screw indicated by the yellow arrow in Figure 10 (left) and a side view of the fracture face (right).

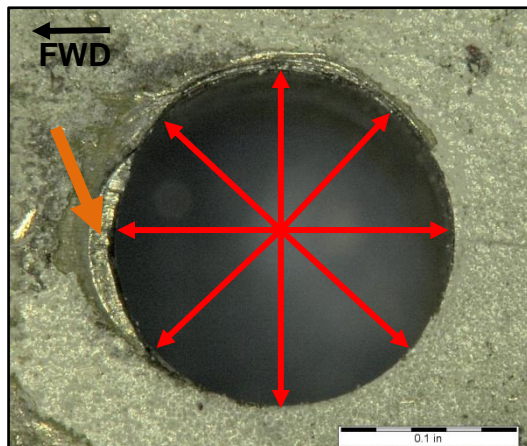
Figure 12. The inboard trim tab attachment hole located in the brown square in Figure 10.

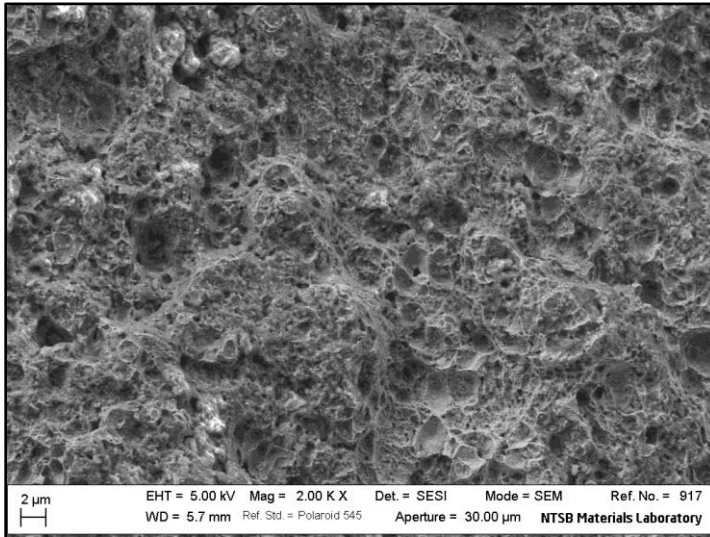
Figure 13. Typical fracture features located in the red box in Figure 11.

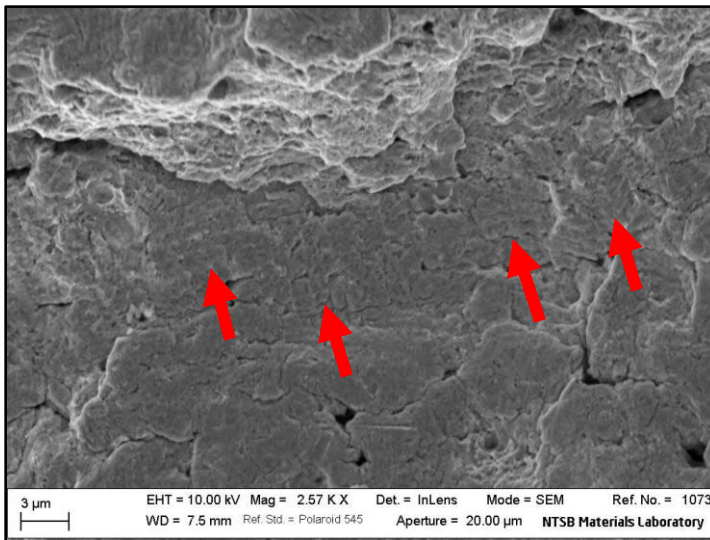
Figure 14. Fatigue striations located within the yellow box in Figure 11.

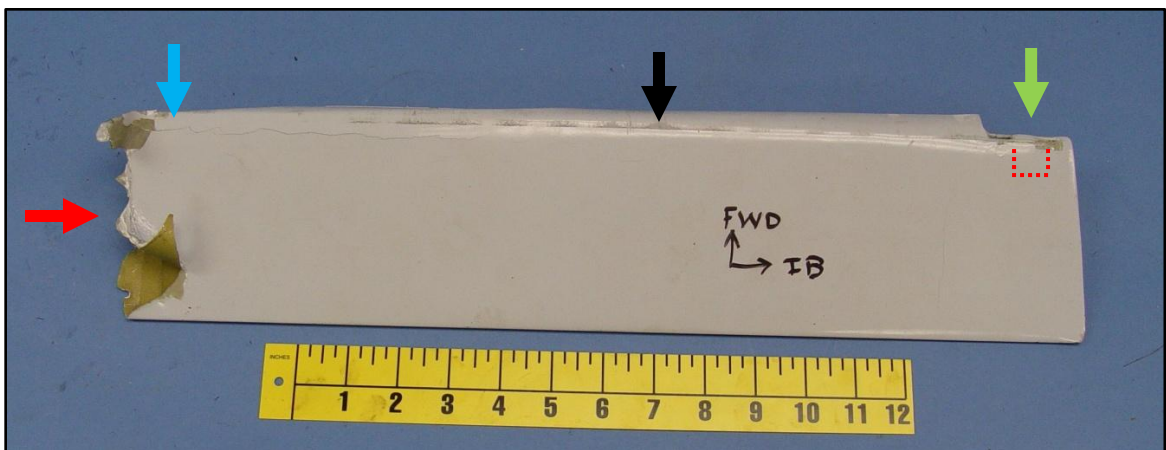
The upper surface of the inboard portion of the left elevator trim tab that departed the aircraft is illustrated in Figure 15 with the forward (FWD) and inboard (IB) directions indicated and a red dashed line indicating the portion removed to reveal the trim tab mating surface illustrated in Figure 10. The red arrow indicates the fractured outboard edge normally located at the center hinge. The surface was smooth, consistent with the use of the filler previously noted, and clean. The black arrow indicates a dark line across the leading edge.

Examination of the outboard end of the trim tab indicated by the red arrow in Figure 15 revealed a fracture face oriented on a slant plane, consistent with an overload event. The outboard end is illustrated in Figure 17 with a black arrow indicating the filler and a yellow arrow indicating an upward and forward curl on a portion of the upper skin. The red arrows indicate the partial rivet holes similarly indicated in Figure 16.

Figure 15. The upper surface of the inboard portion of the left elevator trim tab indicated by the blue arrow in Figure 1.

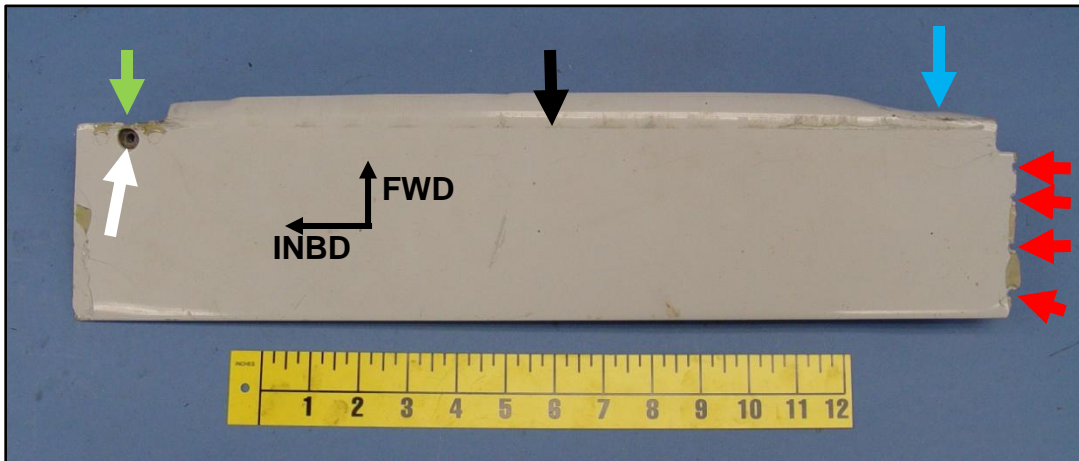
The lower surface of the inboard portion of the left elevator trim tab illustrated in Figure 15 is illustrated in Figure 16 with the forward and inboard directions indicated. The red arrows indicate partial rivet holes and the fractured edges between the holes

were found to match the fractured edges indicated by the yellow arrows in Figure 6. The black arrow indicates a dark line across the leading edge, similar to that observed on the upper surface and considered consistent with the trim tab contacting the adjacent edges of the elevator. The blue arrow, in this figure and in Figure 15, indicates an area of the leading edge, adjacent to the center hinge, which had been deformed rearwards. The white arrow indicates where the trim tab center hinge screw would have been located.

Figure 16. The lower surface of the inboard portion of the left elevator trim tab indicated by the blue arrow in Figure 1.

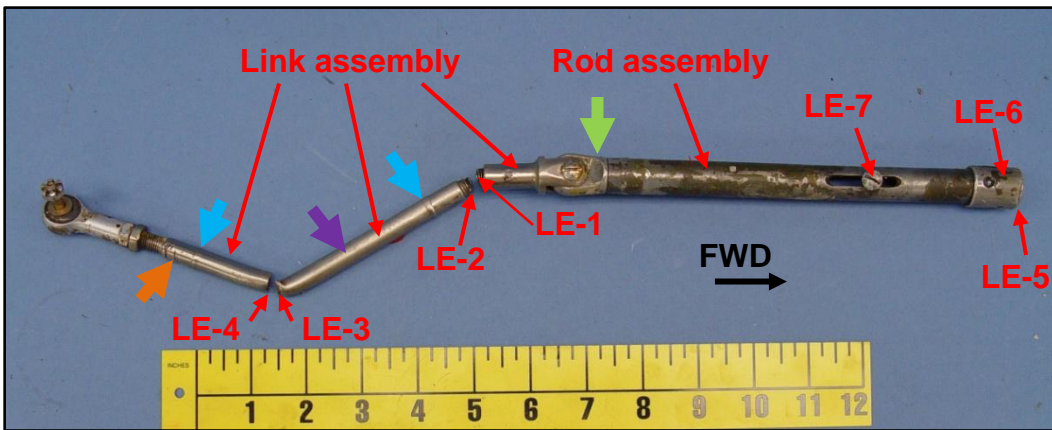
Examination of the pieces revealed that the link assembly now consisted of three pieces with fractures at the threaded adapter to the clevis, the mating fracture faces identified as “LE-1” and “LE-2” in Figure 20, and in the tube, the mating fracture faces identified as “LE-3” and “LE-4” in Figure 20. The rod assembly displayed a fracture face identified as “LE-5”, sheared rivets at “LE-6” and a fractured bolt identified as “LE-7”.

Figure 20. The left elevator trim tab actuator pieces identified in Figure 1 with the rod end and portion of the link assembly removed from the center hinge horn.

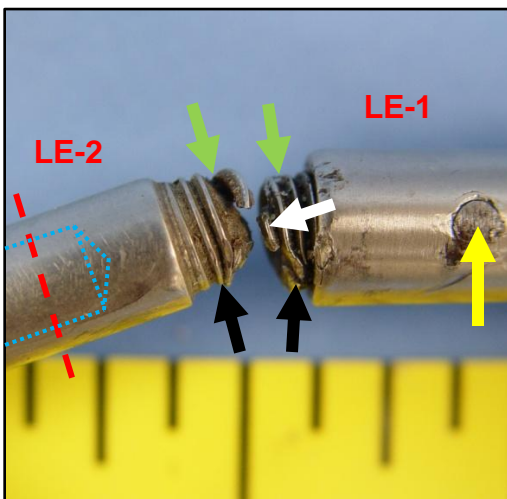
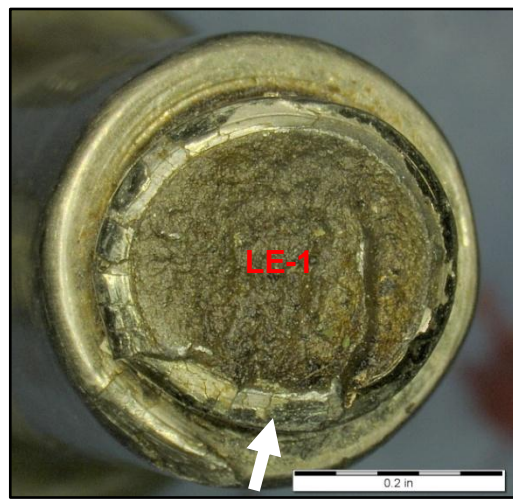
The mating fractures identified as “LE-1” and “LE-2” in Figure 20 are illustrated and identified in the left image in Figure 21 with a yellow arrow indicating the pin that locks the clevis to the threaded fitting. Examination revealed that the threaded portion of the fitting had fractured leaving a portion of the thread in the clevis. Matching the fracture faces, as illustrated, indicated that the adapter had been subjected to bending. Threads with a reduced pitch, as indicated by the black arrows, and threads with an enlarged pitch, as indicated by the green arrows, confirmed that the bending direction was as illustrated in the figure and in Figure 20. The fracture face “LE-1” is illustrated in the right image in Figure 21 and displayed a rough grainy surface consistent with an overload event. The white arrow indicates the portion of thread similarly indicated in the left figure. “LE-2” was separated from the link by cutting along the red dashed line in the left image and an examination of both cut ends revealed the drilled interior indicated by the blue dashed lines, consistent with drawing 99-52526.

Figure 21. The link fractures identified as LE-1 and LE-2 in Figure 20 (left) and the fracture face on LE-1 (right).

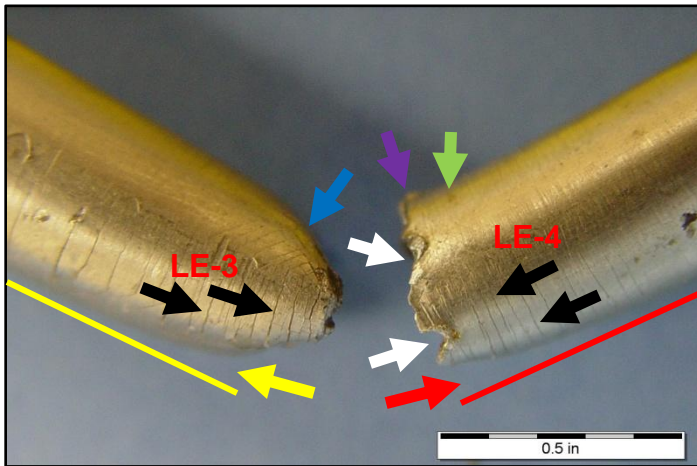
The mating fractures identified as “LE-3” and “LE-4” are illustrated and identified in Figure 22. Examination revealed that both had been subjected to bending and mechanical damage. On “LE-3” the yellow line was drawn parallel to the tube to illustrate the bending deformation indicated by the yellow arrow. On “LE-4” the red line was drawn parallel to the tube to illustrate the bending indicated by the red arrow. The purple arrow indicates an inwardly bent lip, which, with the bending indicated by the yellow and red arrows, confirms that the bending direction was as illustrated in the figure and in Figure 20. The black arrows indicate circumferential cracks in the plating specified in drawing 99-52526, also consistent with the bending direction.

Figure 22. The link fractures identified as LE-3 and LE-4 in Figure 20.

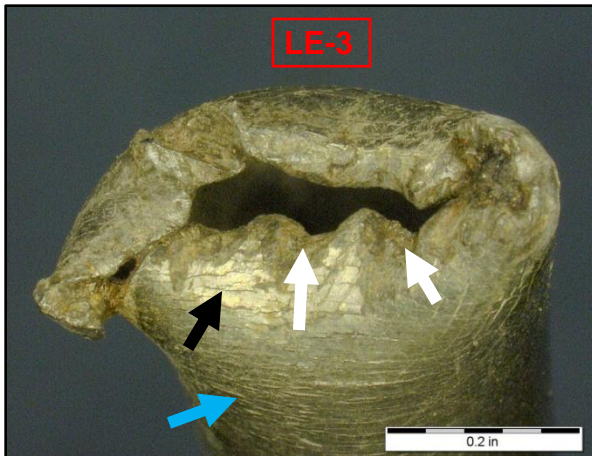
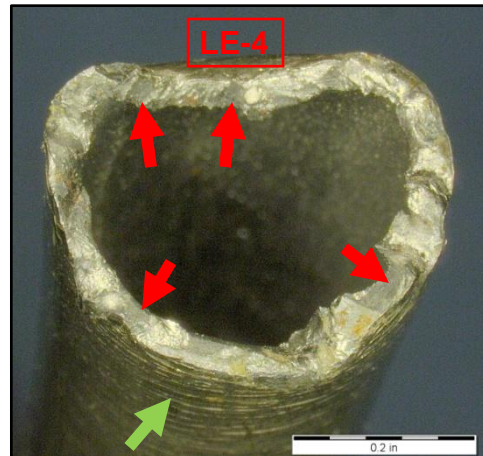
Examination of the fracture face identified as “LE-3” revealed bending and mechanical damage in the form of notches that had obliterated any fracture features. The examination also revealed that, in addition to the bending, the end of the tube had been compressed. The fracture face is illustrated in the left image in Figure 23 with

white arrows indicating distinct notches in the fracture face that were through the wall thickness of the tube. The blue arrow indicates a rippled surface consistent with compression of the surface on the inside of a bend and the location is also indicated by the blue arrow in Figure 22. The black arrow adjacent to the fracture face indicates cracks in the plating consistent with tension.

Examination of the fracture face identified as “LE-4” revealed bending and mechanical damage in the form of notches that had obliterated most of the fracture features. The fracture face is illustrated in the right image in Figure 23 with red arrows indicating areas containing fracture features that displayed a rough grainy surface consistent with an overload event. The green arrow indicates a rippled surface, consistent with compression of the surface on the inside of a bend and the location is also indicated by the green arrow in Figure 22.

Figure 23. The fracture faces identified as LE-3 (left) and LE-4 (right) in Figure 22.

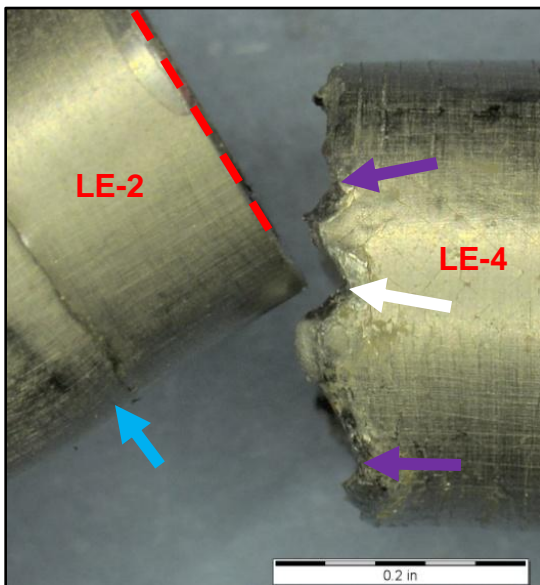
A side view of the notches in “LE-4” is illustrated in Figure 24 with the cut end of the tube indicated by the red dashed line in Figure 21. The blue arrow indicates the weld similarly indicated adjacent to “LE-2” in Figure 20 and the red dashed line indicates the cut indicated by the red dashed line in the left image in Figure 21. The notches were through the wall thickness of the tube and the square-cut end of the link was found to match the more distinct profile of the notch indicated by the white arrow and the less distinct notches indicated by the purple arrows.

Figure 24. Fracture face LE-4 with the cut end of the link indicated by the red dashed line in Figure 21.

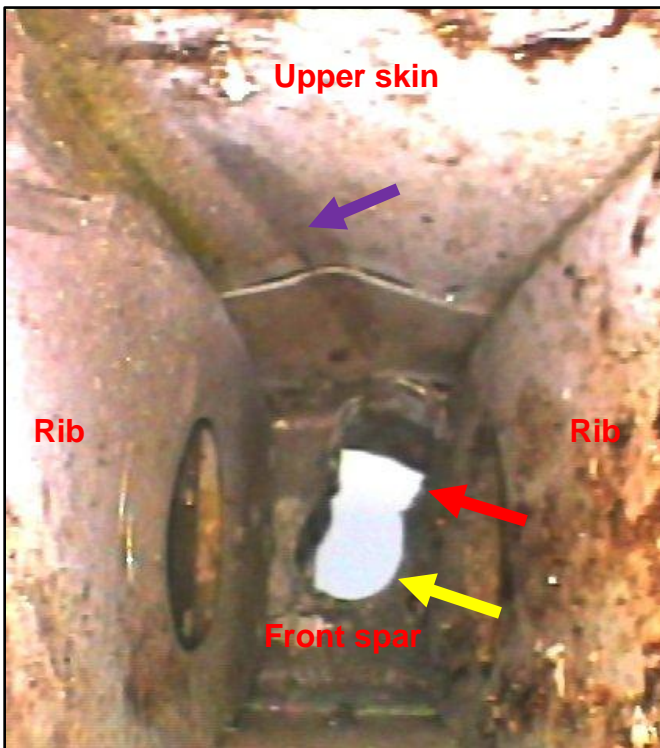
The trim tab link assembly and a portion of the rod assembly are normally located between ribs in the elevator. Examination between the ribs revealed a relatively long upward bulge in the upper skin and mechanical damage to the front spar. The bulge was evident on the upper skin of the elevator and is contained within the purple box in Figure 1. Prior to cutting the portion of the link assembly indicated by the purple arrow in Figure 20 it was found to match the length of the bulge. In Figure 25 the bulge is contained within the purple box and the adjacent portion of the link assembly is indicated by the purple arrow. A view between the ribs, looking forward, is illustrated in Figure 26 with the bulge in the upper skin indicated by the purple arrow. The yellow arrow on the rear face of the front spar indicates the original hole through which the trim tab control assembly is normally positioned and the red arrow indicates a second adjoining hole.

Figure 26. A view inside the actuator compartment of the left elevator, looking toward the front spar

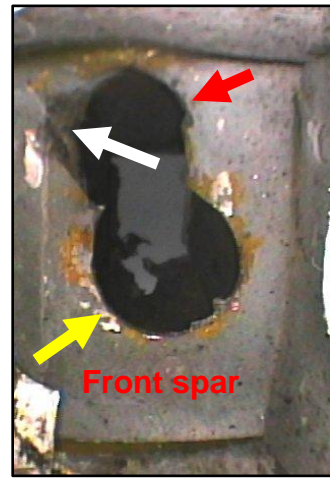
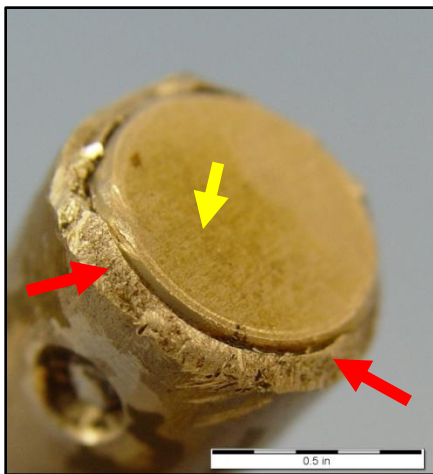
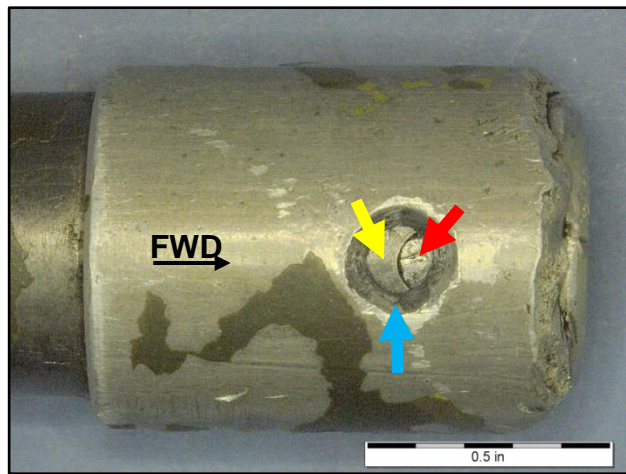
The fracture identified as "LE-5" in Figure 20 was located on a tubular portion of the rod assembly that was connected to the rod by two rivets. The fractured tube is illustrated in the left image in Figure 28 with red arrows indicating the fracture face which displayed a rough texture and was oriented on a slant plane, consistent with an overload event. The yellow arrow indicates the manufactured end of the rod.

Examination of the rivets attaching the tubular portion to the rod revealed that the two flat head portions of each rivet were missing leaving a fracture surface at the rod surface. A typical fracture observed at location "LE-6" in Figure 20 is illustrated in the right image in Figure 28 with the forward direction indicated. The fracture is one of the two on the rearmost rivet and displayed features similar to the two fractures on the forward rivet. The red arrow indicates the fractured shank of the rivet which was partially obscured and the blue arrow indicates the deformed chamfered hole originally occupied by the rivet head. The yellow arrow indicates the rod and measurement revealed a relative displacement of 1/16-inch. The fractured surface of the rivet shank displayed surface lines oriented on the rod axis consistent with a shearing action.

Figure 28. The fracture- at the forward end of the rod identified as LE-5 (left) and as LE-6 (right) in Figure 20.

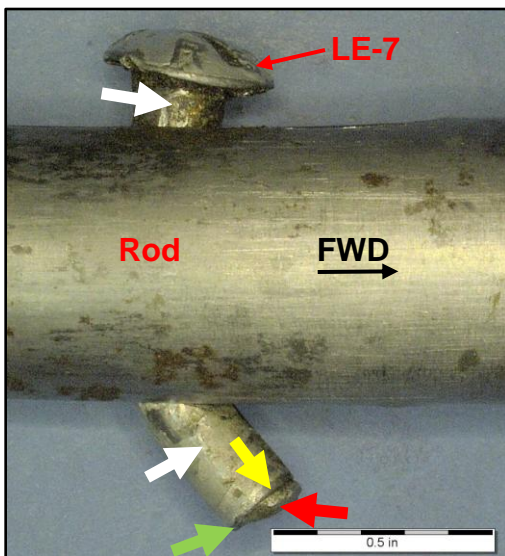
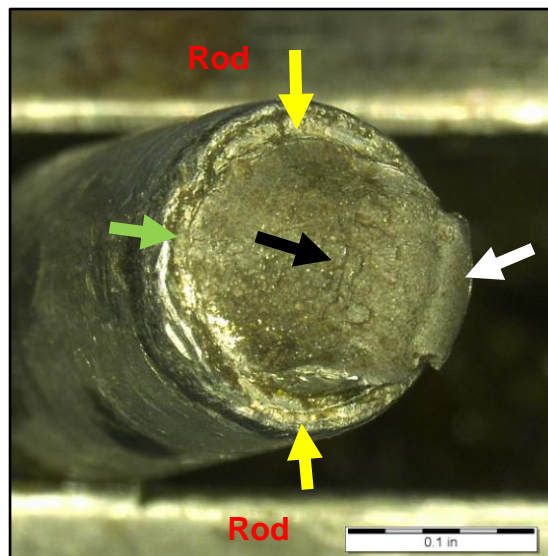
The bolt identified as "LE-7" in Figure 20 displayed a distinct bend and a fractured end. A side view of the bolt in the rod is illustrated in the left image in Figure 29 with the rod identified and the forward direction, as installed, indicated. The red arrow indicates the fracture face and the yellow arrow indicates the remaining edge of a groove normally located between the threaded portion and the shank of a bolt. The white arrows indicate the shank of the bolt normally located in the guide. The fracture face indicated by the red arrow in the left image is illustrated in the right image with the rod identified and yellow arrows indicating the edge of the groove indicated by the yellow arrow in the left image. The fracture face displayed a uniformly grainy surface with a slightly cupped profile initiating in the vicinity of the green arrow and lines on the surface were oriented toward the shear lip indicated by the white arrow, features consistent with a shearing action.

Figure 29. Side view of the bolt identified as LE-7 in Figure 20 (left) and a view of the fracture face indicated by the red arrow (right).

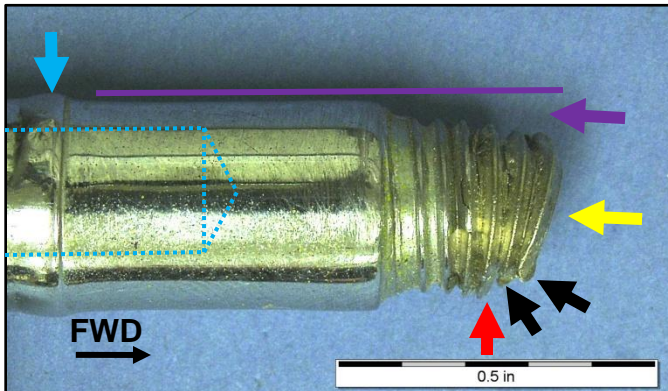
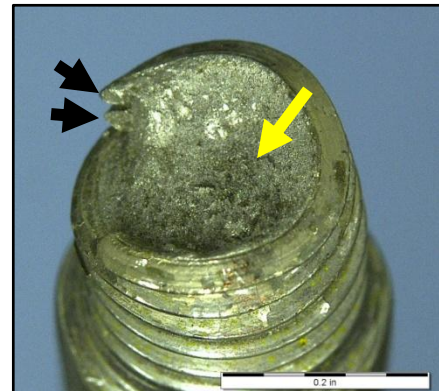
Figure 57. The forward end of the link identified in Figure 56 (left) and the fracture face indicated by the yellow arrow (right).

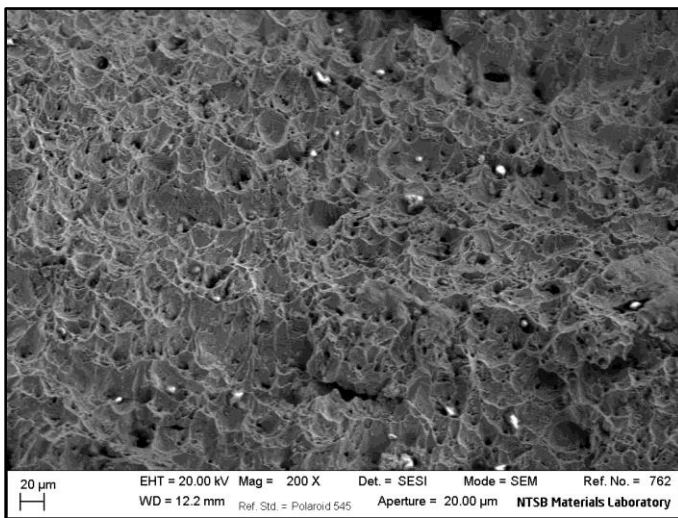
Figure 58. SEM micrograph of the fracture surface indicated by the yellow arrow in Figure 57.

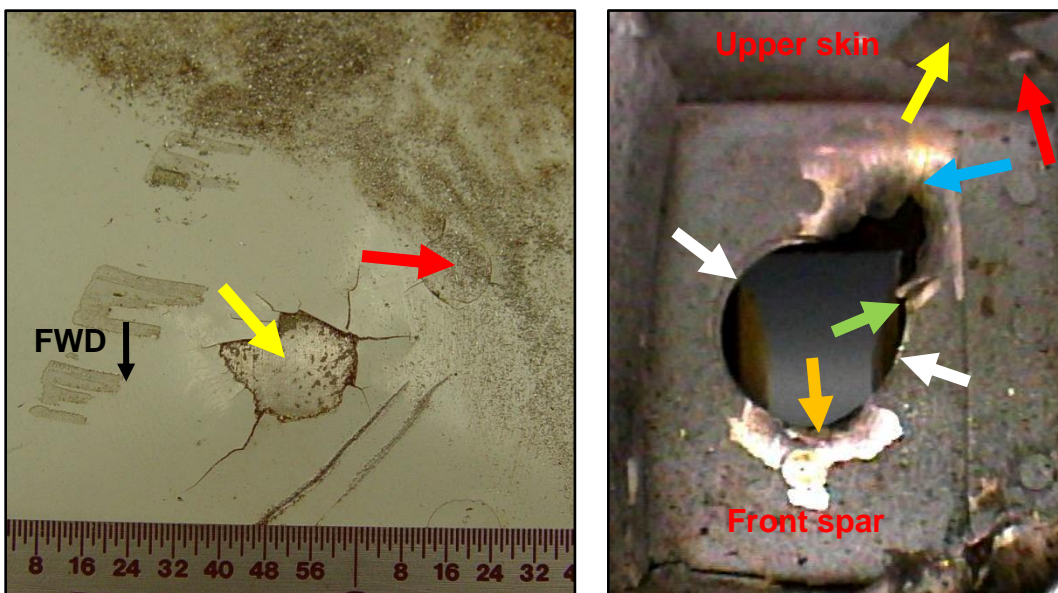
Figure 61. The bulged area in the purple square in Figure 43 (left) and a view of the trim tab rod hole in the elevator front spar, looking aft (right).

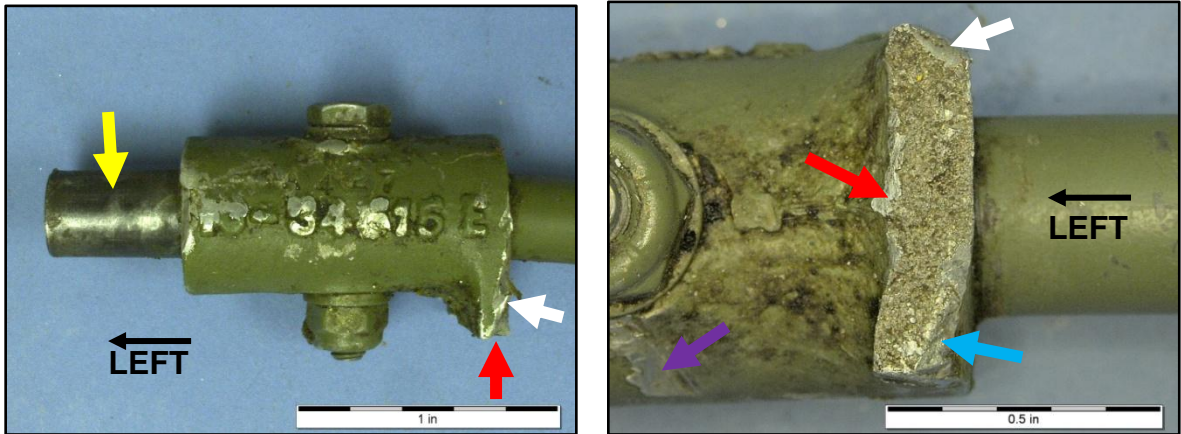
Figure 77. The bellcrank identified in Figure 76 (left) and the fracture indicated by the red arrow (right).

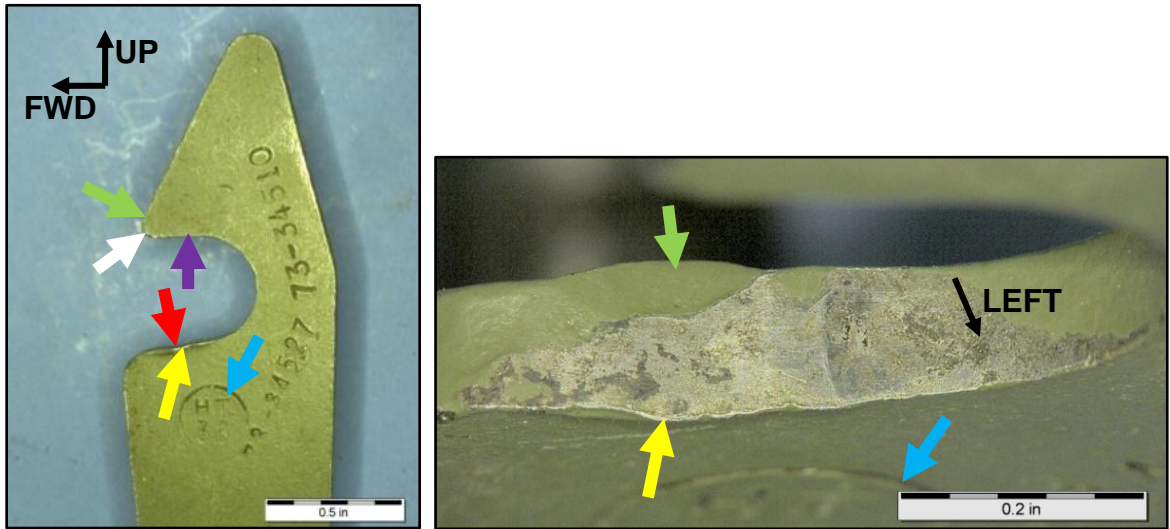
Examination of the upper contact face indicated by the purple arrow in the left image in Figure 78 revealed multiple contact marks adjacent to the right side that had exposed bare metal. The contact face is illustrated in the left image in Figure 79 with the left direction indicated. The yellow arrow indicates material that had been displaced to the right and up. The examination also revealed contact marks on the forward corner of the upper surface indicated by the white arrows in the left image and in the left image in Figure 78. The corner is illustrated in the right image in Figure 79 with the left direction indicated. The red arrow indicates the exposed bare metal of the contact mark at the corner and the green arrow indicates a continuation of the mark up the left side as indicated by the green arrow in the left image in Figure 78.

Figure 78. The left side of the hook indicated by the white arrow in Figure 76 (left) and the multiple contact marks on the lower edge indicated by the red arrow (right).

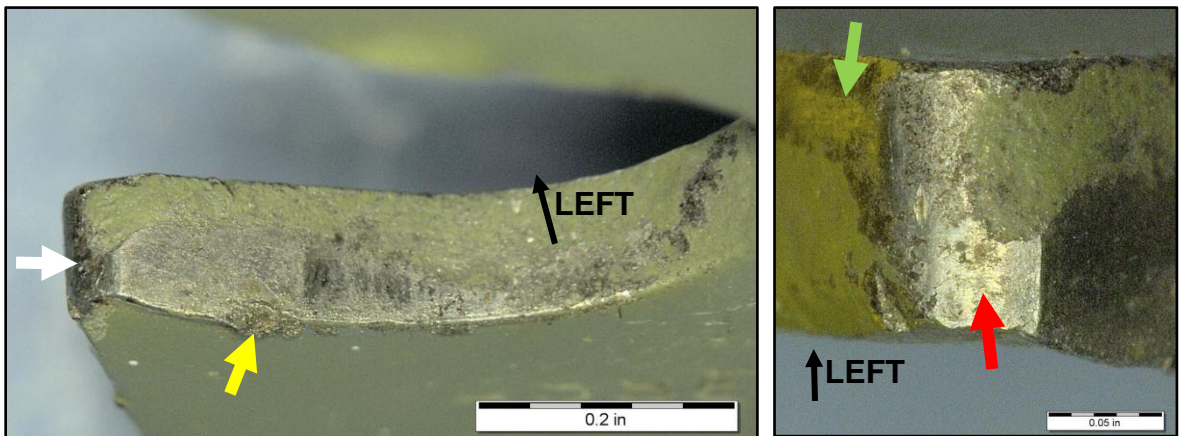
Figure 79. Multiple contact marks on the upper edge indicated by the purple arrow in Figure 78 (left) and the corner indicated by the white arrow in the left image and in Figure 78 (right).
