NATIONAL TRANSPORTATION SAFETY BOARD

MATERIALS LABORATORY FACTUAL REPORT

Report No. 12-042

Place : Las Vegas, Nevada
Date : December 17, 2011
Vehicle : Eurocopter AS350-B2, N37SH
NTSB No. : DCA12MA020
Investigator : Tom Jacky AS-40

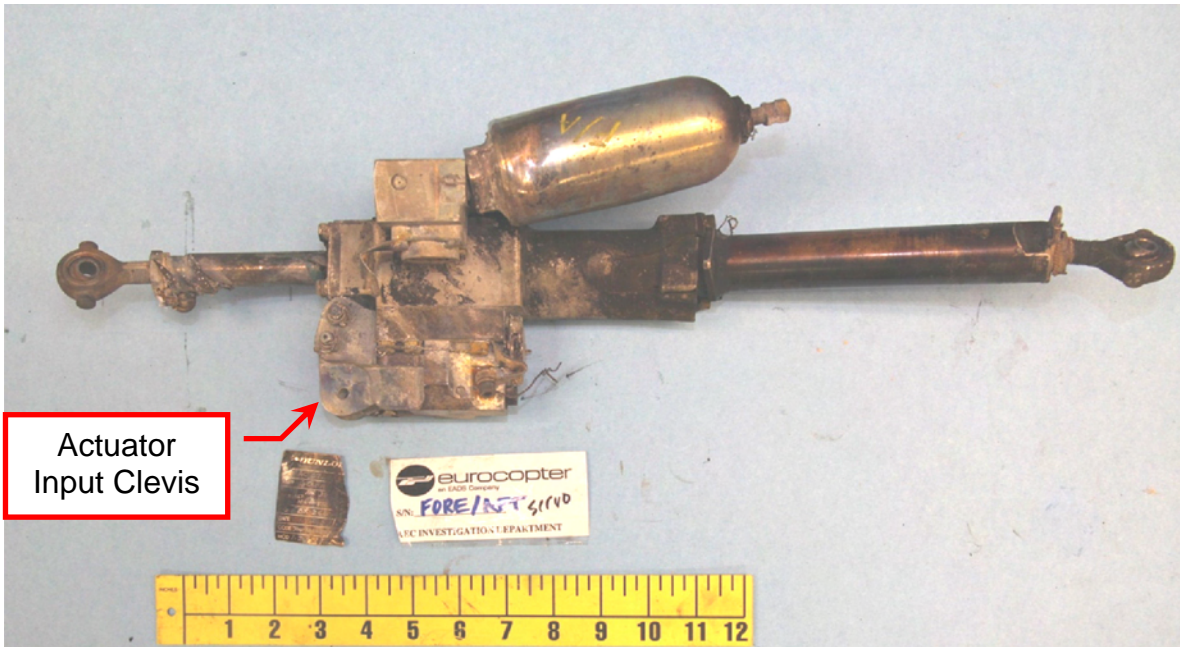
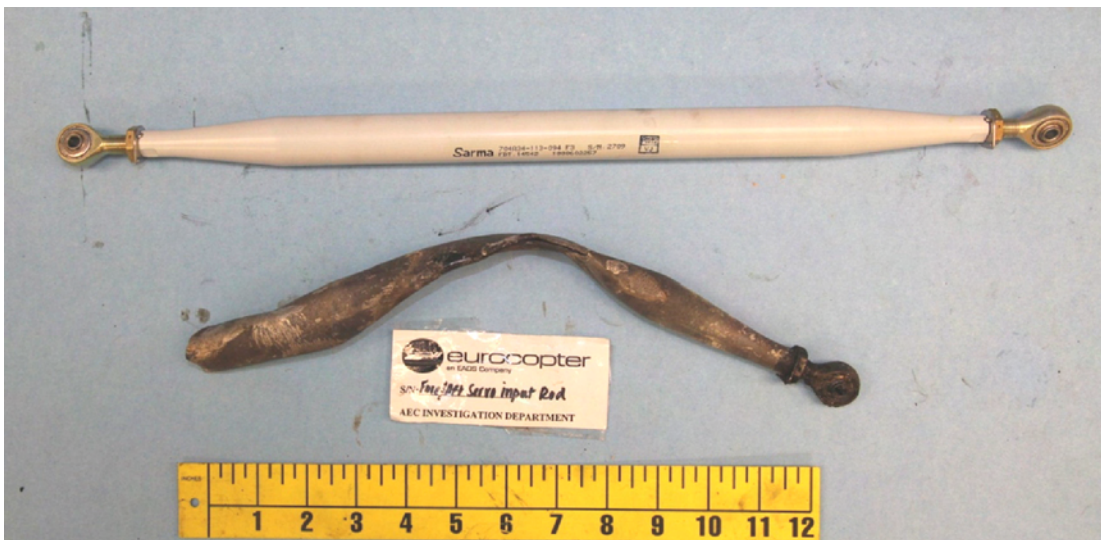
The as-received fore-aft servo, s/n BX264 is displayed in the upper view of figure 1 with the upper end (servo side) of the input rod shown in the middle view along with an exemplar rod. The upper end of the input rod was reportedly found disconnected from the servo in the wreckage of the helicopter. None of the fastening hardware was located in the wreckage. The lower end of the fore-aft servo input rod was found attached to its linkage (not shown). The input rod was also separated near the middle. The input rod supplies the servo with commands from the pilot and connects to the servo at the clevis area as denoted in the upper view of figure 1.

Both the input rod and servo were heavily sooted and discolored consistent with exposure to fire debris and elevated temperatures. Additionally, the paint on the input rod was mostly missing with the remaining paint completely charred. No indications of melting or incipient melting was noted on the aluminum tubular section. The upper portion of the rod was heavily deformed and crushed nearly flat in the middle, as shown in the lower view of figure 1. The rod was fractured through the large diameter tubular section about 330 mm (13 inch) from the top locking nut. Magnified examinations of the fracture revealed slanted fractures and accompanying deformation consistent with a predominant tensile overstress separation with some bending deformation.

Figure 1. An overall view of the as-received fore / aft servo at top with the upper end of the input rod shown below next to an exemplar new input rod.

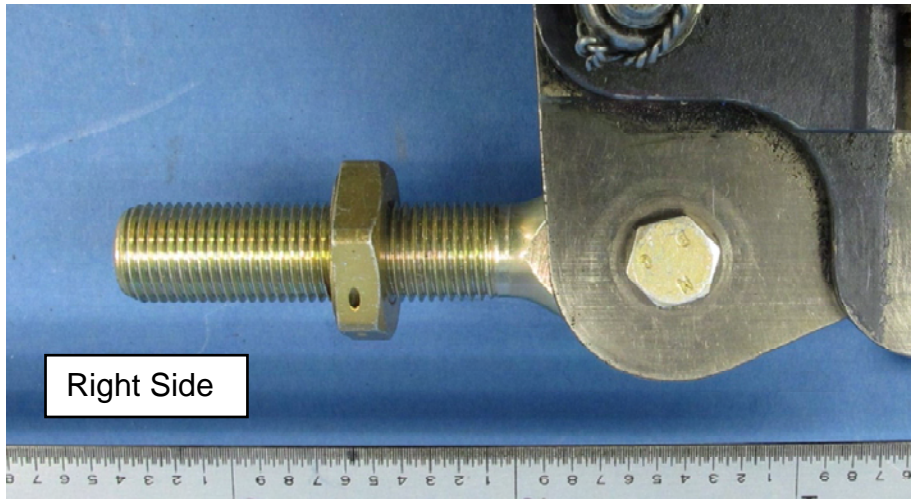
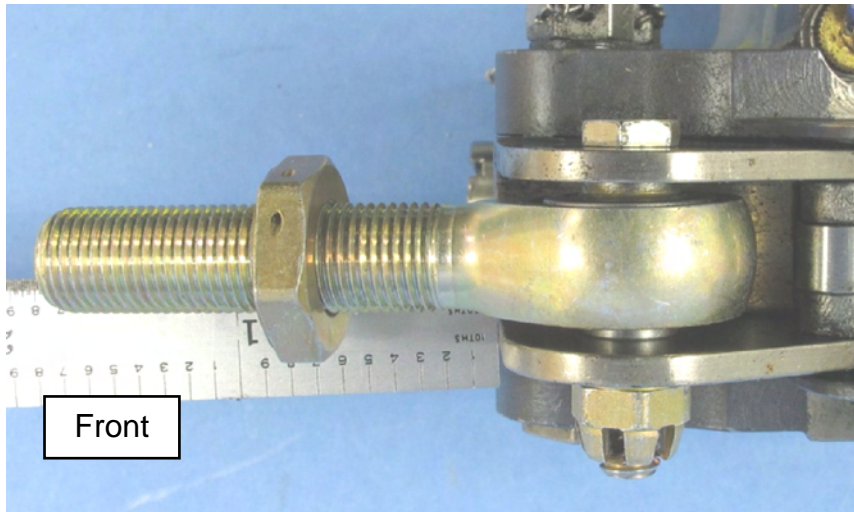
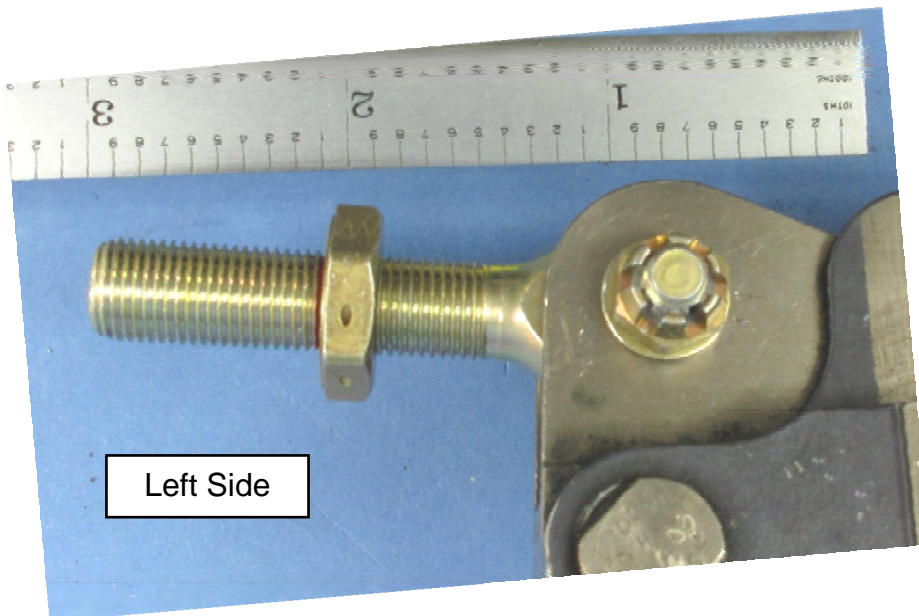
Figure 2 shows the normal arrangement of fastening hardware between the input rod (rod end fitting only shown) and the servo clevis using exemplar hardware. The bolt has a 6 mm diameter shank with a 20 mm grip length and drilled 1.0 threads per millimeter threads. The washer has an approximate 12 mm outer diameter and is placed under the nut for assembly. The nut is castellated (slotted) with a full-circle nylon locking

Figure 2. Three views typical arrangement of the input tube to the servo clevis using the accident clevis and exemplar hardware. Split pin not installed.

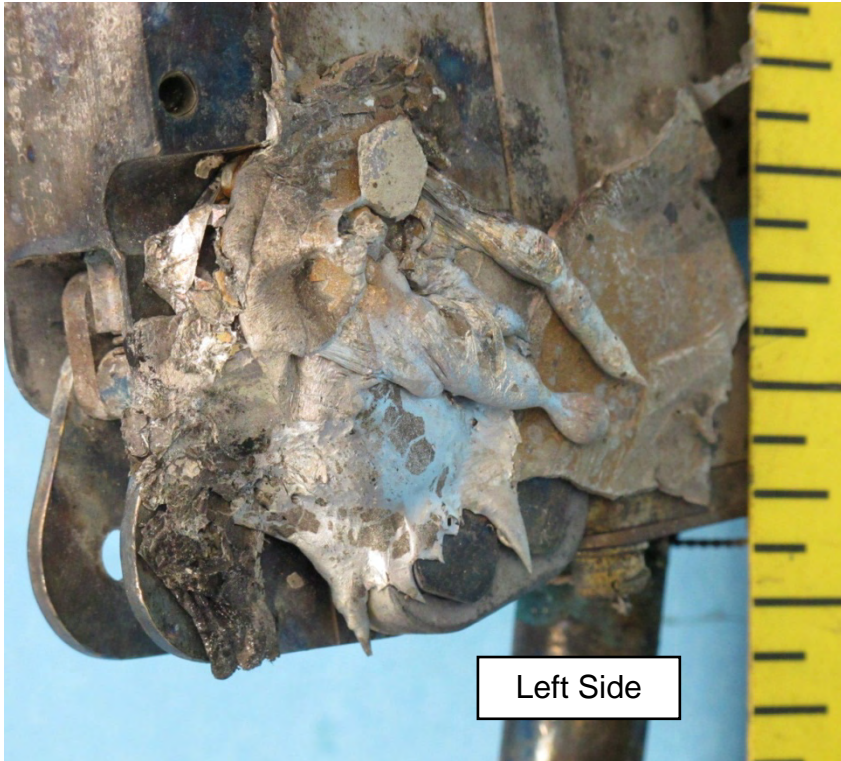
Figure 3 shows left and right side views of the input rod clevis area of the as-received servo. As can be seen in the upper view, the left side of the servo was partially covered by previously molten aluminum. The flow pattern of the aluminum indicates that it was deposited onto the servo while molten and then solidified in-place. The deposited aluminum covered the fastener hole in the left side tang of the input rod clevis. As-received the right side hole was unobstructed as shown in the lower view. However, the bore was partially covered with light tan-colored powdery deposits as found elsewhere on the exterior of the servo, as shown in figure 4. Minor dents and dings were visible in the lower edges of the clevis tangs as indicated by arrows in figure 4.

Figure 3. Images of the clevis are of the as-received fore/aft servo, left side at top, right side below.

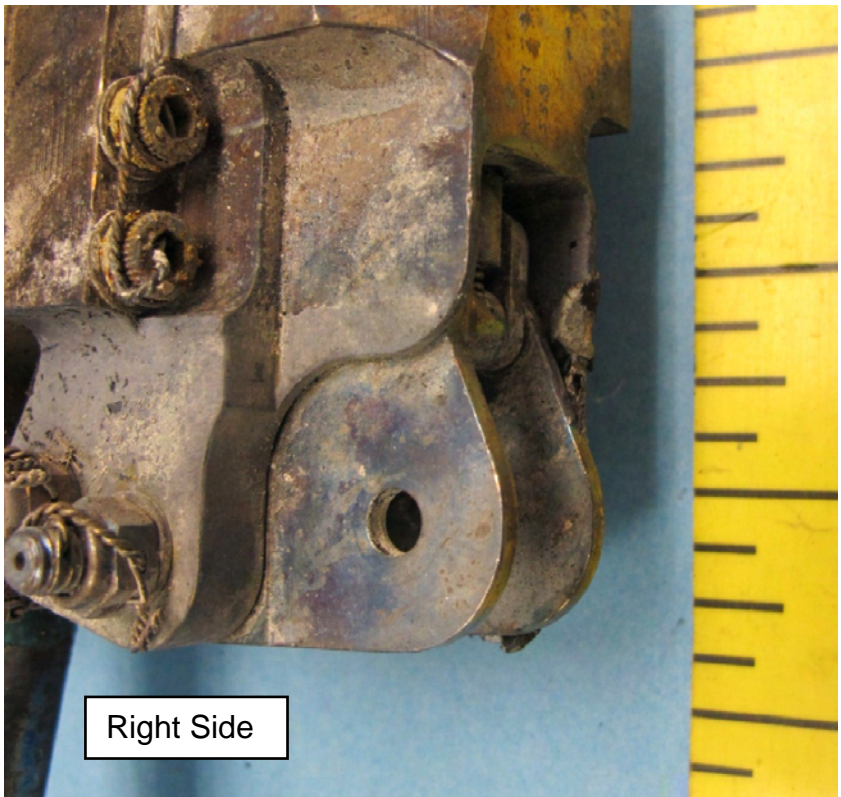
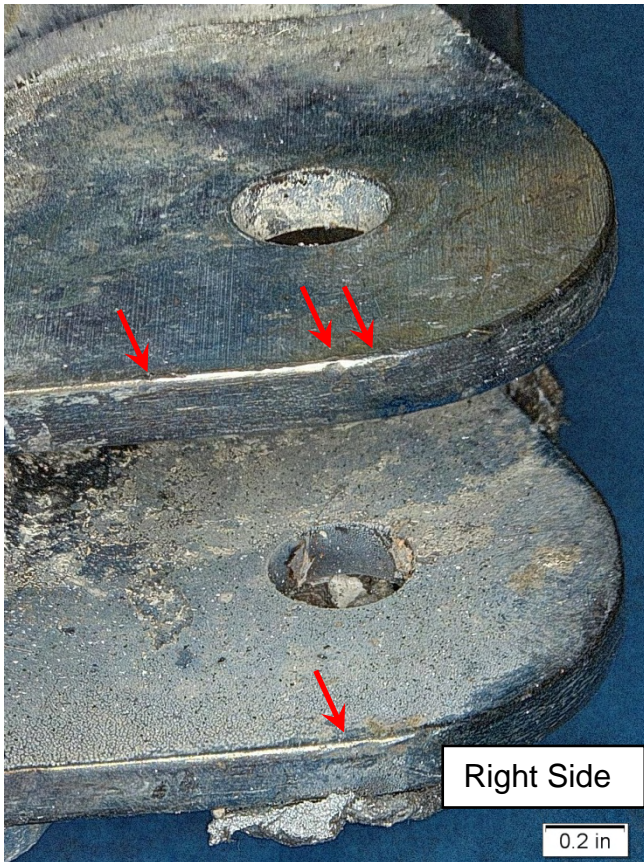
Figure 4. The left and right side clevis tangs showing powdery deposits in the bores. Minor dents in the lower edges of the tangs are denoted by arrows.

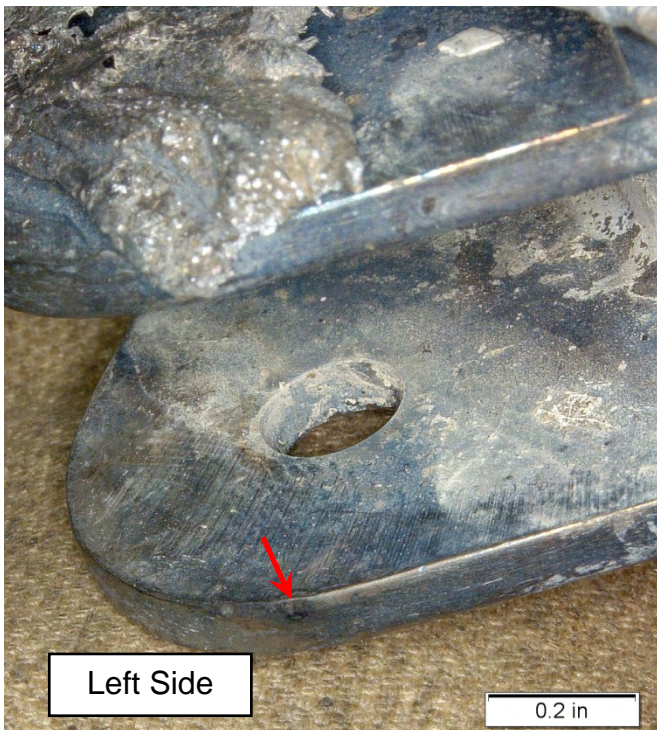
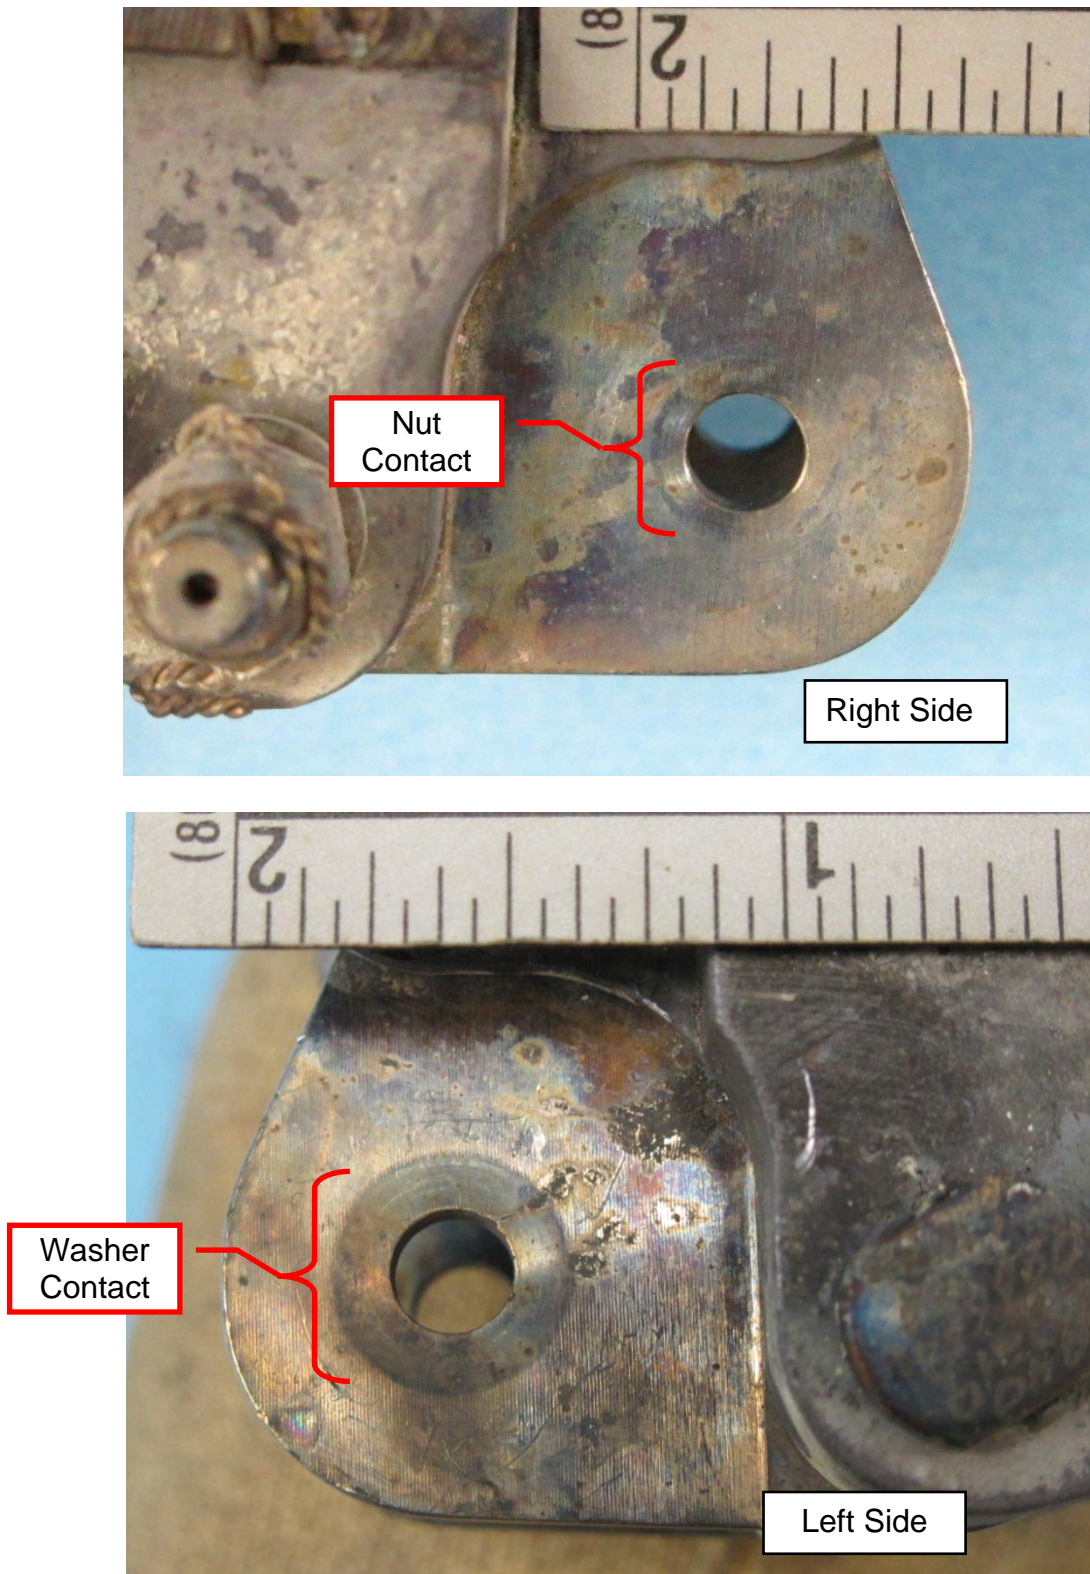
The previously molten aluminum was easily removed by hand from the left side clevis tang. The clevis area, including the bores, was then lightly wiped with a dry cloth to remove loosely adherent fire debris. The surfaces showed purple to stray colored patterns consistent with exposure to elevated temperatures. The cleaned outer surfaces of the clevis tangs are displayed in figure 5.

The clevis surfaces also showed faint concentric patterns around the fastener holes consistent with previous contact by fastening components. The outboard surface of the right side tang had a pattern about 9.3 mm (0.366 inch) in diameter consistent

with the underside of the specified bolt head, shown as the upper view in figure 5. Two additional faint concentric rings were also noted on this surface; one about 11.5 mm (0.453 inch) in diameter and the other about 16 mm (0.630 inch) in diameter. The outboard face of the left side tang had an 11.8 mm (0.465 inch) diameter pattern around the hole consistent with the size of the specified washer, as shown in the lower view of figure 5. Contact patterns were also noted on the inside surfaces of the clevis tangs consistent with the contact area of the rod end fitting on the input rod. Similar contact patterns were also visible on the used exemplar servo.

Figure 5. The outer surfaces of the cleaned clevis tangs showing the heat tinting (straw to purple colors) and contact patterns from fastening hardware, nut on right side and washer on left side.

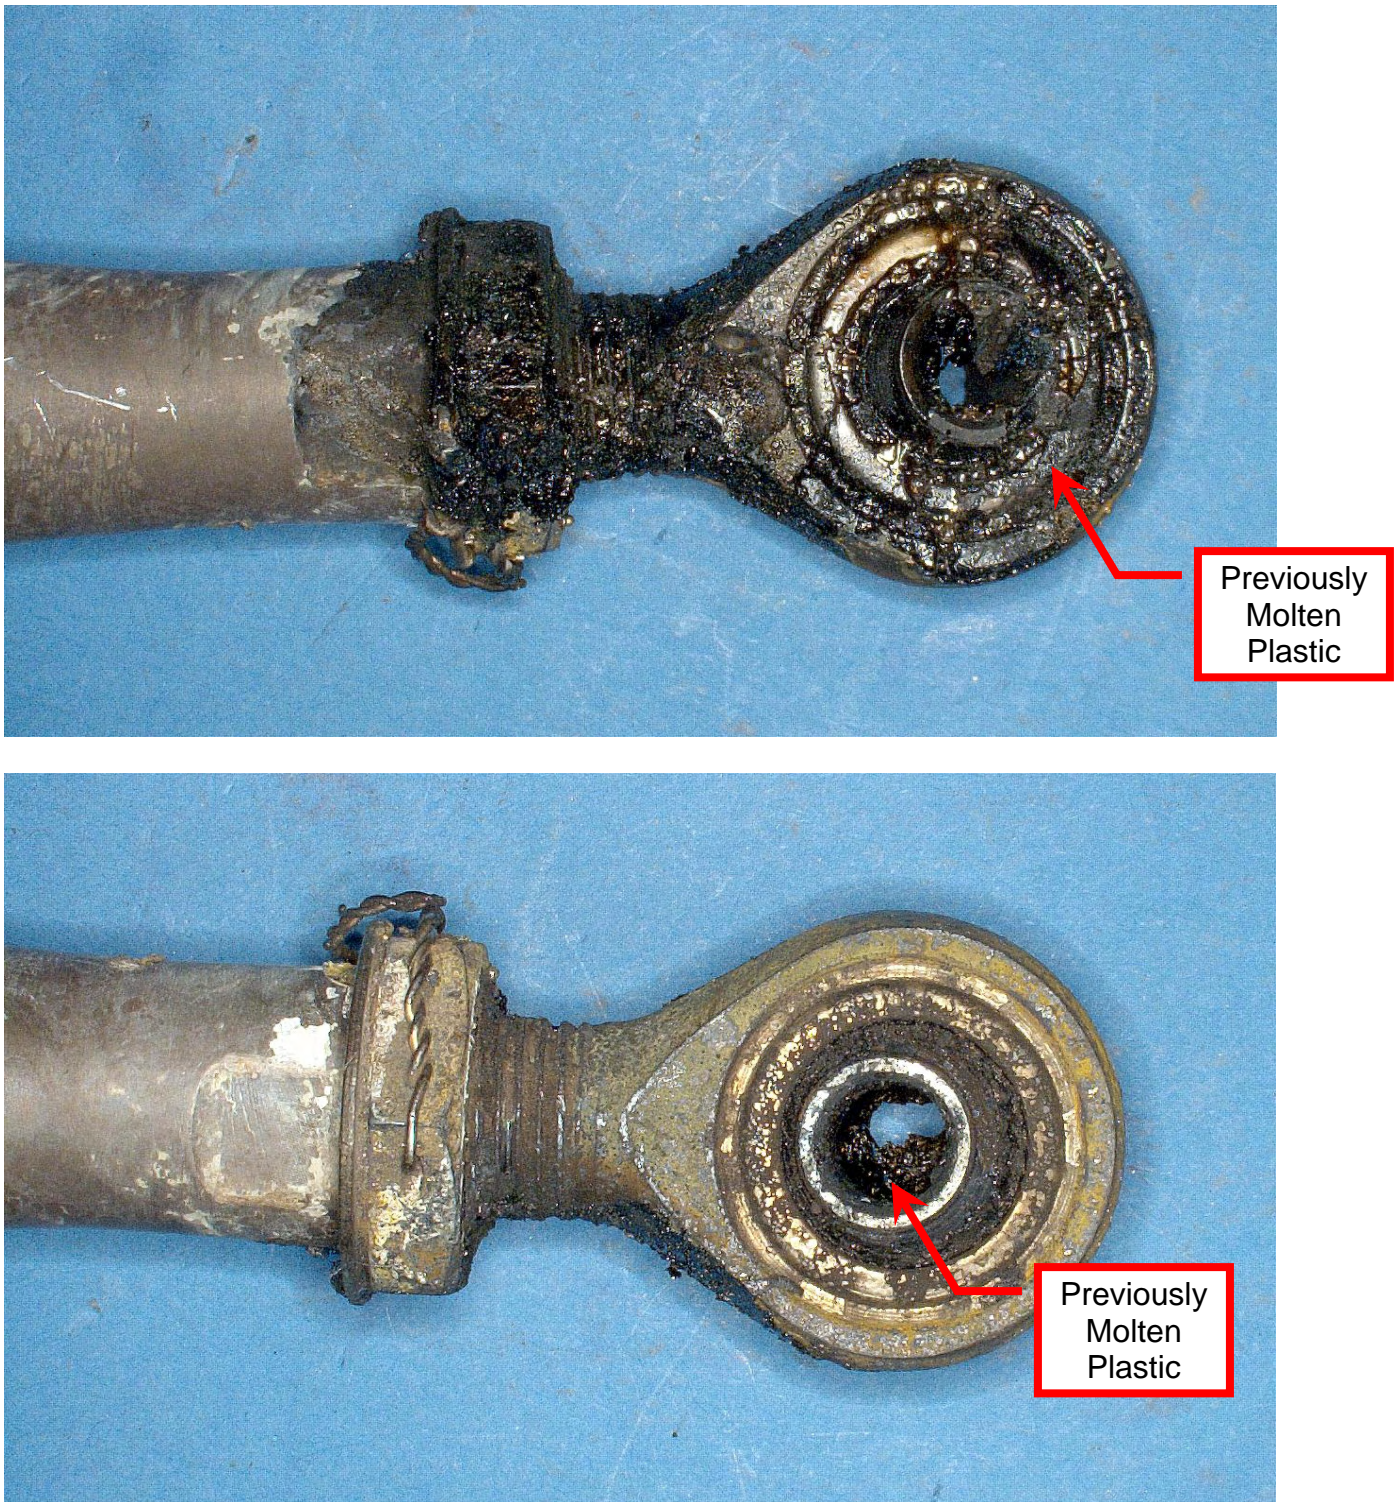
The servo side (upper) rod end fitting for the input rod is displayed in figure 6. One side of the fitting was partially covered in what appeared to be blackened and previously molten plastic-like material as shown in the upper view of figure 6. The charred material was tenaciously attached to the surfaces and partially blocked the bolt hole through the center of the fitting. The other face of the fitting was partially covered in dirt-like material as shown in the lower view of figure 6. As-received, the bearing in the fitting would not swivel or rotate with finger pressure.

Magnified visual examinations of the bearing head of the rod end fitting did not find any significant contact marks dents or dings.

Figure 6. Both sides of the input rod upper rod end fitting showing the black previously molten Nylon 12 material on one side (top) partially blocking the bolt hole (bottom).

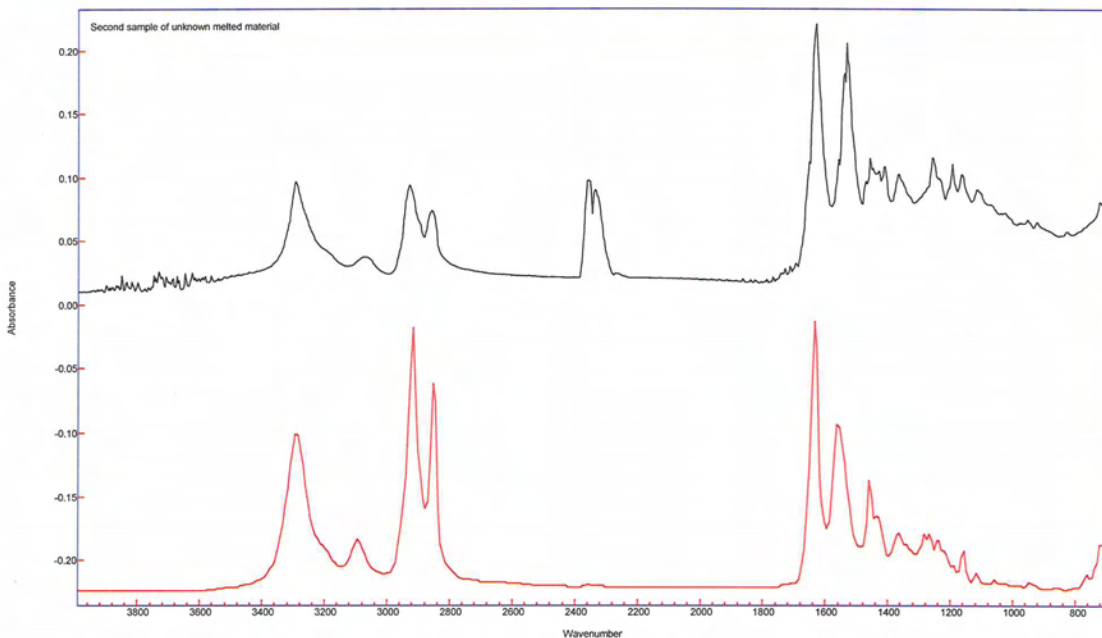
Fourier-Transform Infrared spectroscopic analysis⁵ (FTIR) of the plastic-like material on the rod end fitting in figure 6 identified it as poly(lauryllactam), a semi-crystalline polyamide commonly known as Nylon 12, see figure 7.

Figure 7. FTIR spectrum (upper black line) of the black material from the rod end fitting shown in the upper view of figure 6 compared to a standard spectrum for Nylon 12 (red line below).

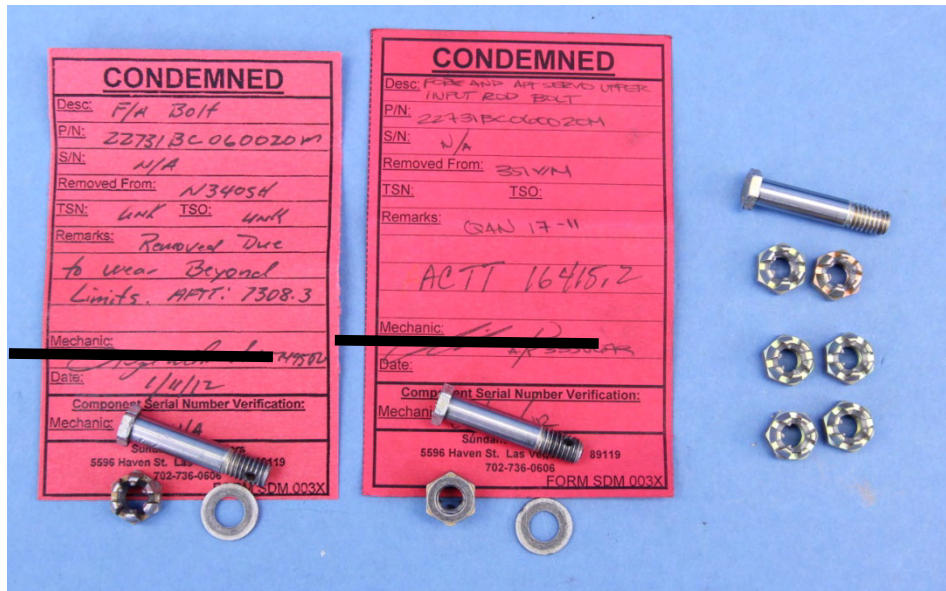
Two exemplar used nuts and bolts (6 mm) and several exemplar new nuts and a bolt were received for testing and examination, as shown in figure 8. One used exemplar was from an aircraft with 7,308.3 service hours and the other was from an aircraft with 16,415.2 service hours. It is unknown if the received bolts were original to the aircraft.

In the laboratory, the used nuts could be easily and fully tightened or loosened on the accompanying bolts with finger pressure. Torque measurements found that the turning resistance of the nuts on the bolts was approximately 1 in-lbf or less in both directions.

Figure 8. The exemplar hardware. Items removed from aircraft at left. New hardware at right.

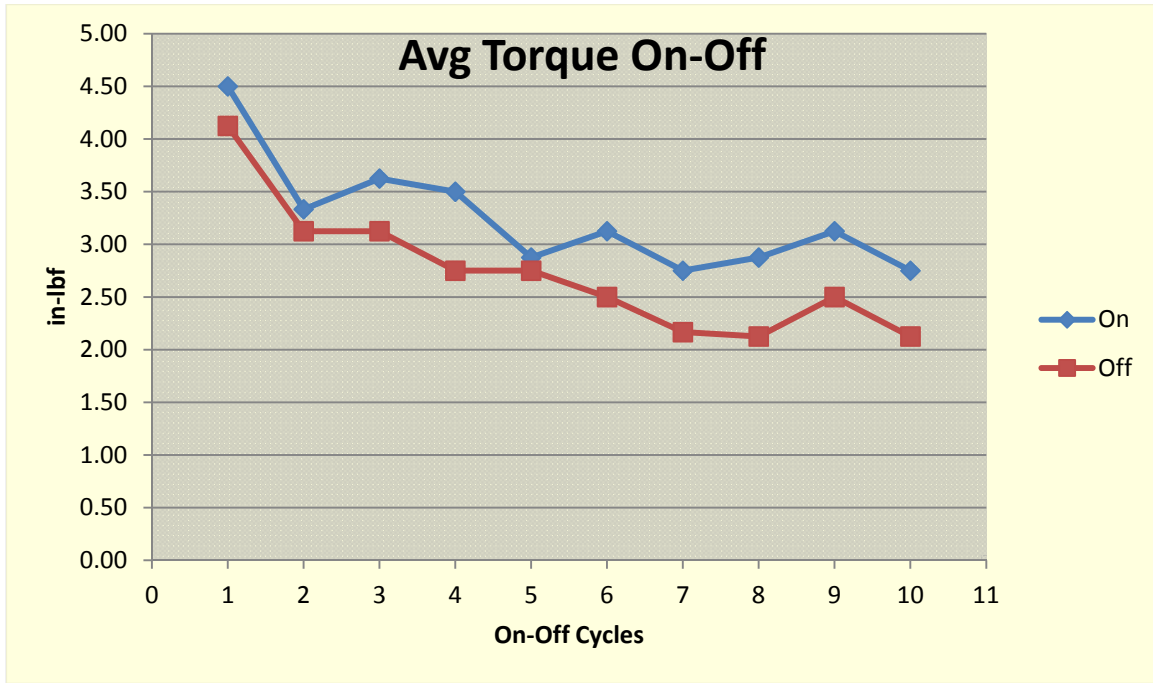
The averaged torque data for each on-off cycle are presented in figure 8. As shown, the first application of the nut resulted in the highest resistance torque with generally equal or lower torque values with successive on-off cycles. For the majority of valid instances, the tightening torque values were equal to or higher than the loosening torques for a particular nut.

Figure 9. Chart of average peak torques for new nuts during on and off cycles.
