NATIONAL TRANSPORTATION SAFETY BOARD

MATERIALS LABORATORY FACTUAL REPORT

Report No. 12-045

Place : Las Vegas, Nevada
Date : December 7, 2011
Vehicle : Eurocopter AS350-B2, N37SH
NTSB No. : DCA12MA020
Investigator : Carol Horgan, AS-40

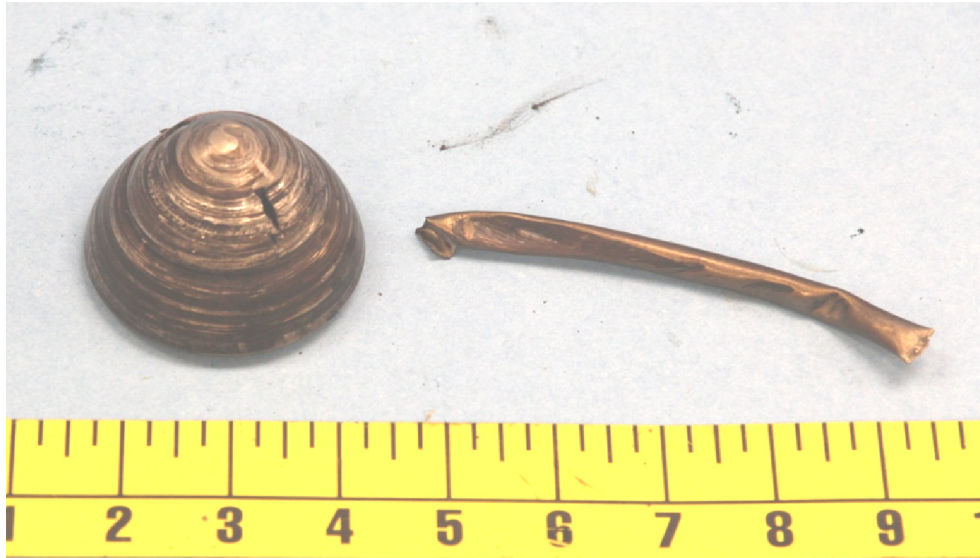
The axial compressor nose cone shown at left in figure 1 was deeply scored around its entire outer surface. X-ray fluorescence analysis (XRF) of undamaged areas found the material composition to be similar to that of AA 6061. Addition XRF testing in the damaged regions did not identify any transferred material.

The material of the as-received metal tubing shown at right in figure 1 was identified as an AISI 300 series stainless steel by XRF. Areas of the tube were crushed and exhibited significant rubbing damage. XRF in the rubbed areas identified significant amounts of titanium that were not present in undamaged areas.

Figure 1. The nose cone at left showing rotational marking and the crushed and abraded tube at right.

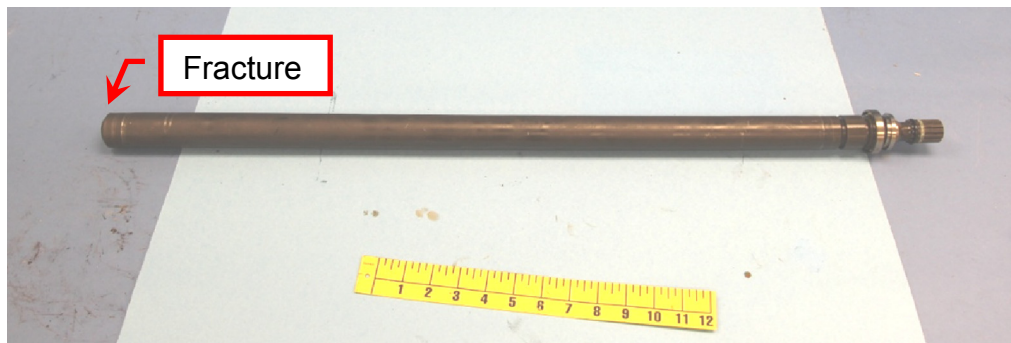
The freewheeling shaft, shown in figure 2, was fractured near its forward end as indicated. Microscopic examinations of the fracture revealed fracture and deformation patterns consistent with a bending overstress separation. No indications of torsional deformation were noted in the fracture or surrounding area. A contact mark and deformation area was located approximately 1 inch aft of the fracture. Close examinations found the contact mark to be consistent with stationary (non-rotational) contact with a mating object with the deformation centered at the contact.

Figure 2. The freewheeling shaft with the fracture at the left end

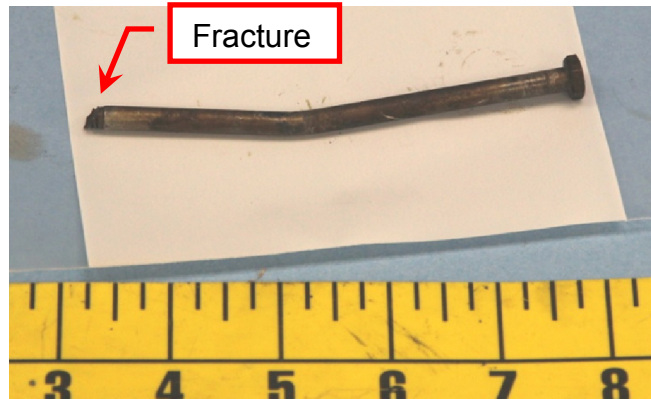
The freewheeling shaft to power shaft bolt was fractured through the threads and bent at about mid-grip as shown in figure 3. Microscopic optical viewing of the fracture revealed fracture features and deformation patterns consistent with a bending overstress separation through the threads.

Figure 3. The freewheeling shaft to power shaft bolt with overstress fracture at left end.

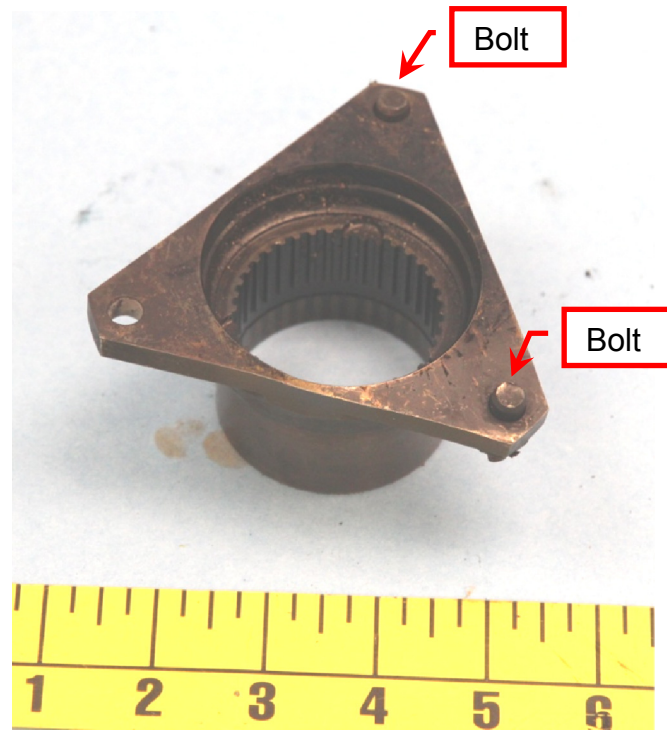
Two of the three PTO flange bolts were received in the flange as shown in figure 4. Both bolts were fractured through the grips adjacent to the bolt heads. Microscopic examinations of both fractures uncovered fracture features and deformation patterns consistent with predominately tensile overstress forces.

Figure 4. The PTO flange with two broken bolts.

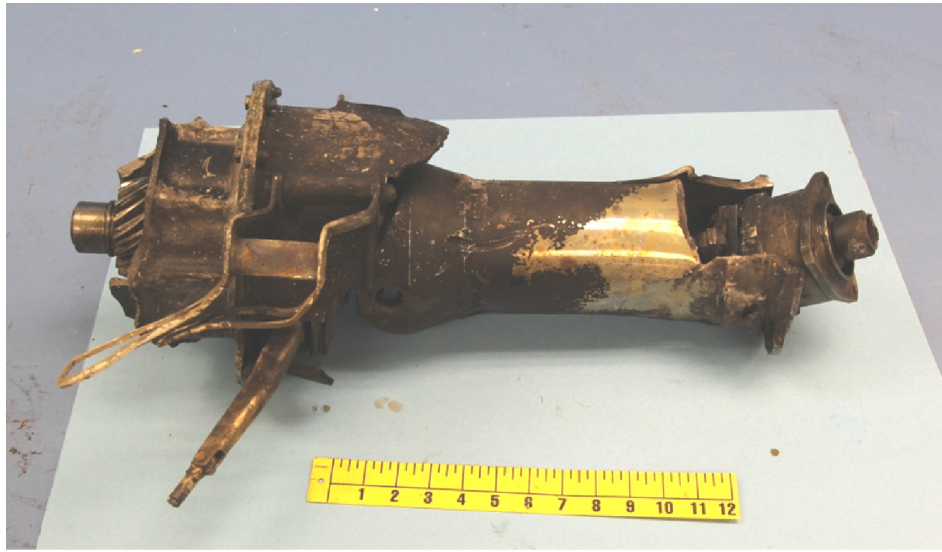
The transmission input shaft assembly and surrounding linking tube are shown in figure 5. The forward portion of the freewheeling shaft was attached to aft end of the assembly. The input shaft was fractured inside the linking tube adjacent to both the forward and aft coupling flanges. The fractures were located inside the linkage tube and not directly accessible. The forward fracture appeared typical of compression buckling of the tube and the aft fracture was consistent with bending. No significant rotational markings were visible inside the linkage tube.

Figure 5. The fractured transmission input shaft inside the linking tube

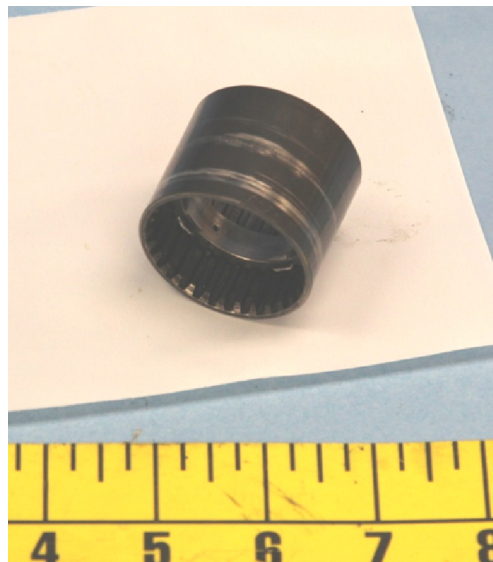
Figure 6. The muff coupling.

The muff coupling is displayed in figure 6. The outer surface had some minor circumferential surface scoring indicative of rotational contact. On the interior, the spline spacers on the forward side were crushed and flattened. The splines on both the forward and aft sides of the coupling were generally undamaged except for rotational contact and smearing on the visible ends of the splines
