# NATIONAL TRANSPORTATION SAFETY BOARD

MATERIALS LABORATORY FACTUAL REPORT

Report No. 12-058

Place : Surprise, Arizona  
Date : December 10, 2011  
Vehicle : Vans RV7-A  
NTSB No. : WPR12FA059  
Investigator : Michael Huhn

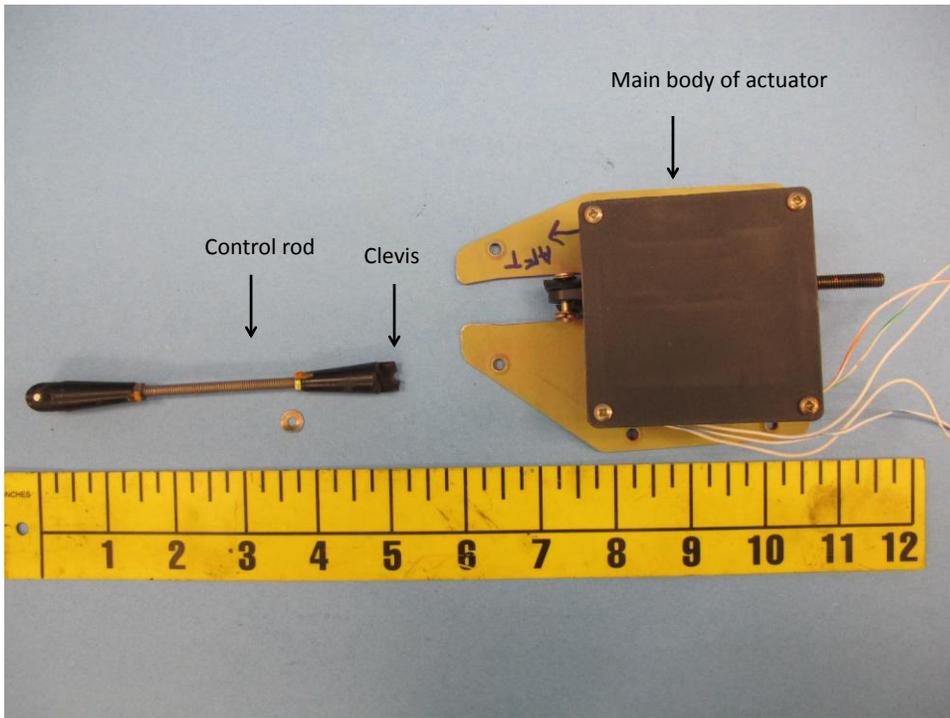
The elevator trim actuator and associated control rod from the accident aircraft was submitted to the Materials Laboratory to determine the cause of failure of a clevis at one end of the control rod and confirm if the failed clevis was fabricated from the specified material. An overall picture of the actuator and control rod can be seen in Figure 1.

Figure 1. Overall photograph of elevator actuator.

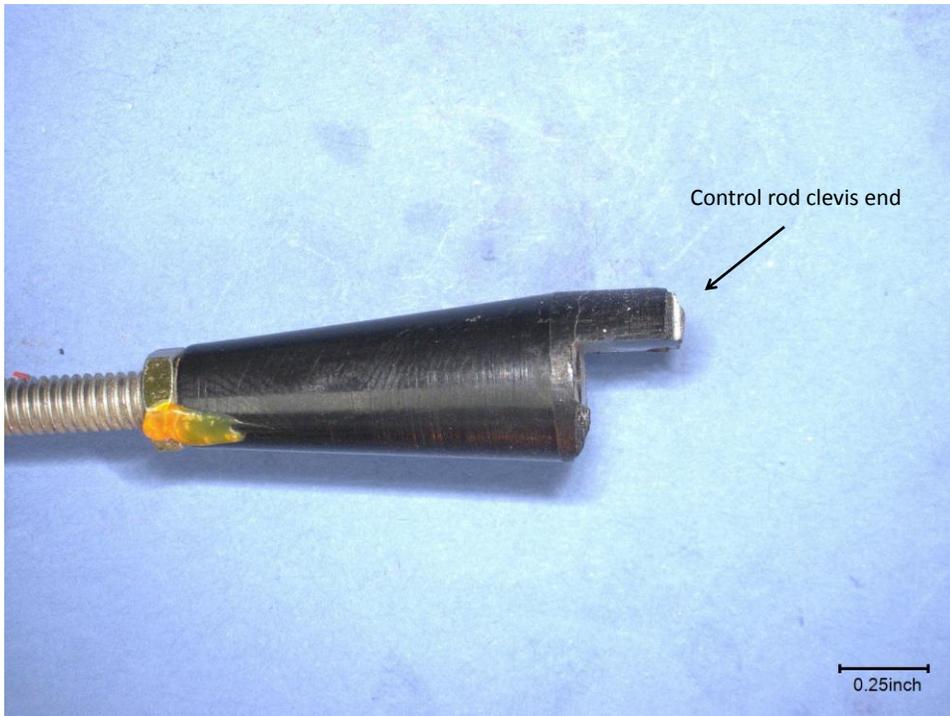
The control rod had completely separated from the main body of actuator at the clevis as shown in Figure 2. The clevis was specified to be injected-molded, glass-filled polyamide. The fracture surfaces from both pieces of the clevis were visually examined using a 5x to 50x stereo zoom microscope and a scanning electron microscope (SEM). Under the stereomicroscope, the fracture surface exhibited hackle and river pattern as shown in Figure 3. SEM micrographs of the fracture surface of the polymer matrix showed fracture features with rough and uneven surfaces, isolated peaks and dimples as shown in Figure 4. The micrograph also exhibited "cup and cone" features on the ends of the fractured glass fibers. All of these fracture features are consistent with overstress. The fracture features are consistent with the fractured rod loaded in cantilever bending from the inside clevis slot toward the outside.

Figure 2. Close-up photograph of clevis.

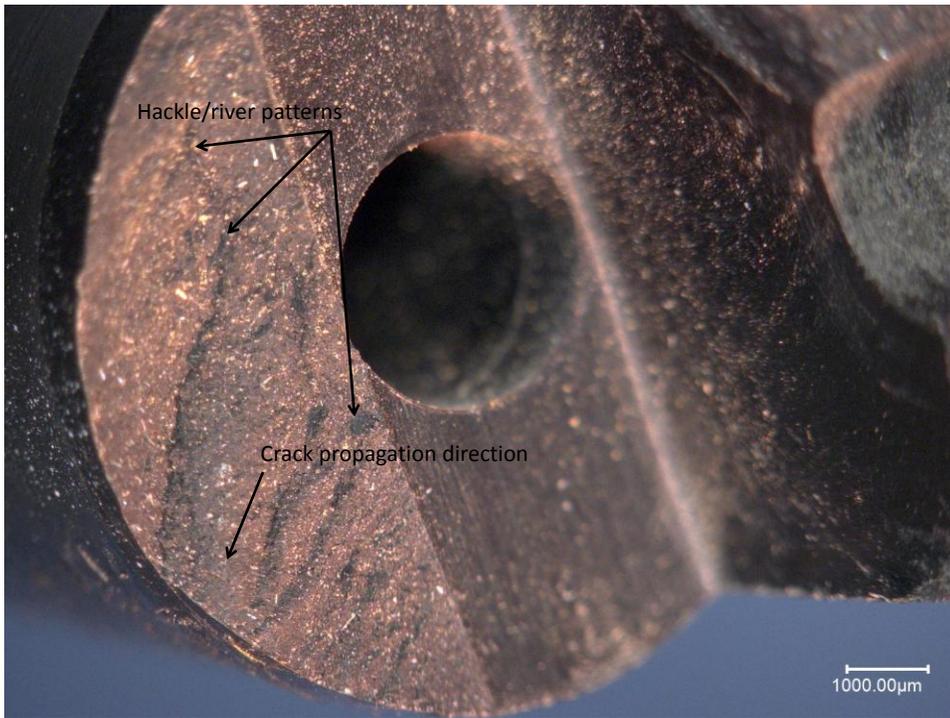
**Figure 3. Overstress features on fracture surface.**

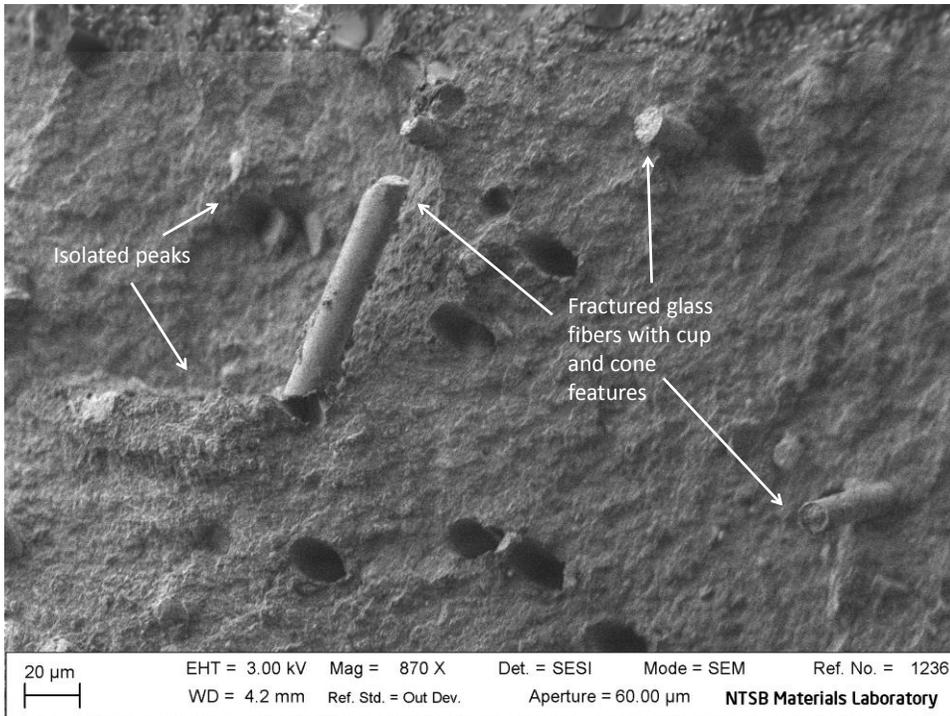
**Figure 4. Micrograph of fracture surface exhibiting overstress related features.**

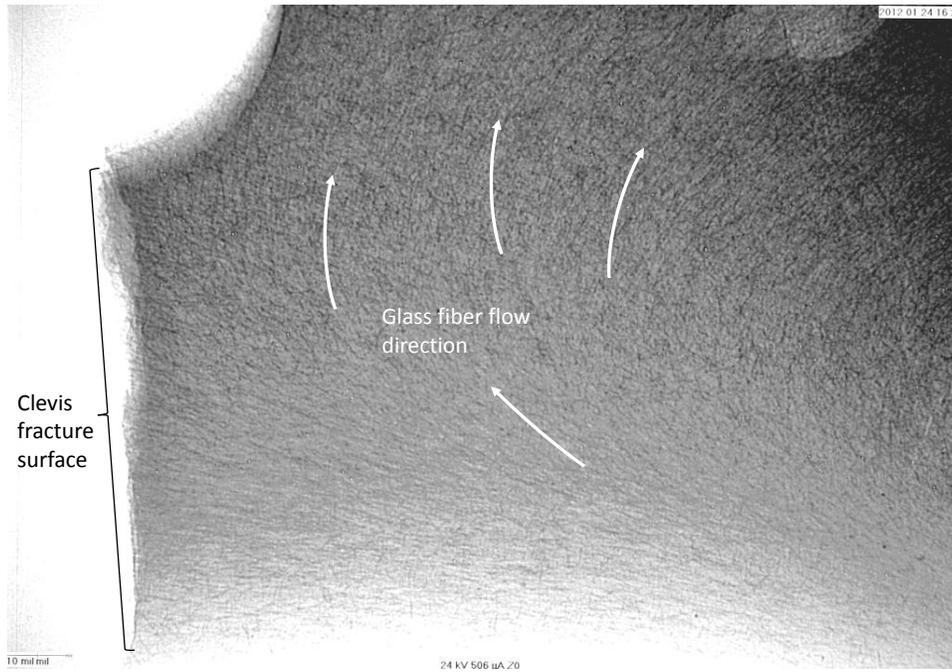
The failed clevis was x-rayed to determine the orientation of the glass fibers. The radiograph of the clevis is shown in Figure 5. The radiograph showed that the glass fibers uniformly distributed with proper orientation in the region of the fractured arm. No other anomalies such as porosity were noted in the radiograph.

**Figure 5. Radiograph of fractured clevis.**
