NATIONAL TRANSPORTATION SAFETY BOARD

MATERIALS LABORATORY FACTUAL REPORT

Report No. 12-068

Place : Miami, Florida
Date : October 29, 2011
Vehicle : Interplane SRO Skyboy, N58784
NTSB No. : ERA12FA052
Investigator : Jose L. Obregon, AS-ERA

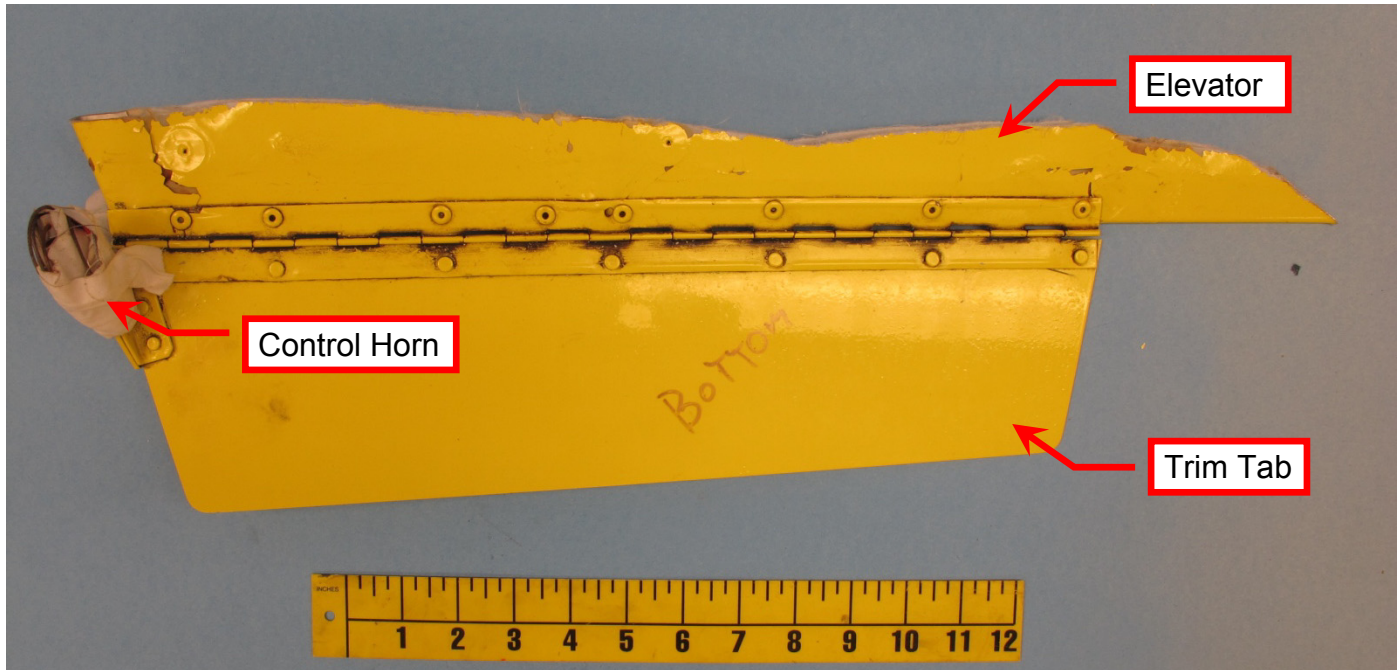
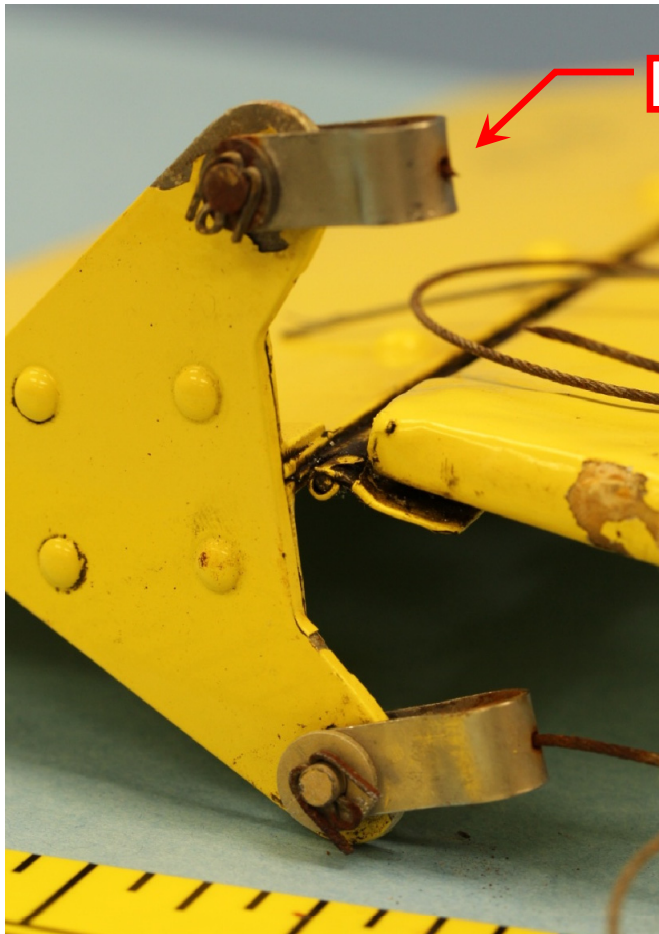
The lower surface of the as-received elevator trim tab is displayed in the upper view of figure 1 with a small section of the adjacent elevator attached. The control cable attachments are displayed in the lower view.

Separated Upper Cable

Figure 1. At top, the lower side of the as-received trim tab with control horn at left and adjacent elevator section. At left, a closer view of the tab's control horn with separated upper cable.

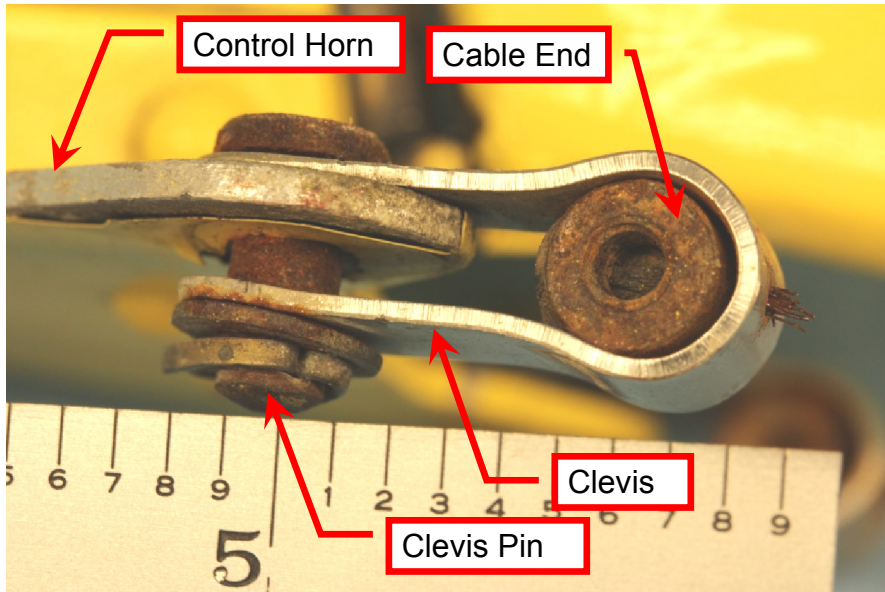
The control cables are attached to the trim tab control horn by pins through clevis fittings mounted on cylindrical, soldered cable ends as shown in figure 2. The upper control cable had parted at the clevis fitting as shown in the lower view of figure 2. As-received the clevis was frozen to the pin and the pin was frozen to the control horn and resisted movement by heavy hand pressure.

Figure 2. The upper control cable attachment to the horn at left with a closer view of the separated cable below.

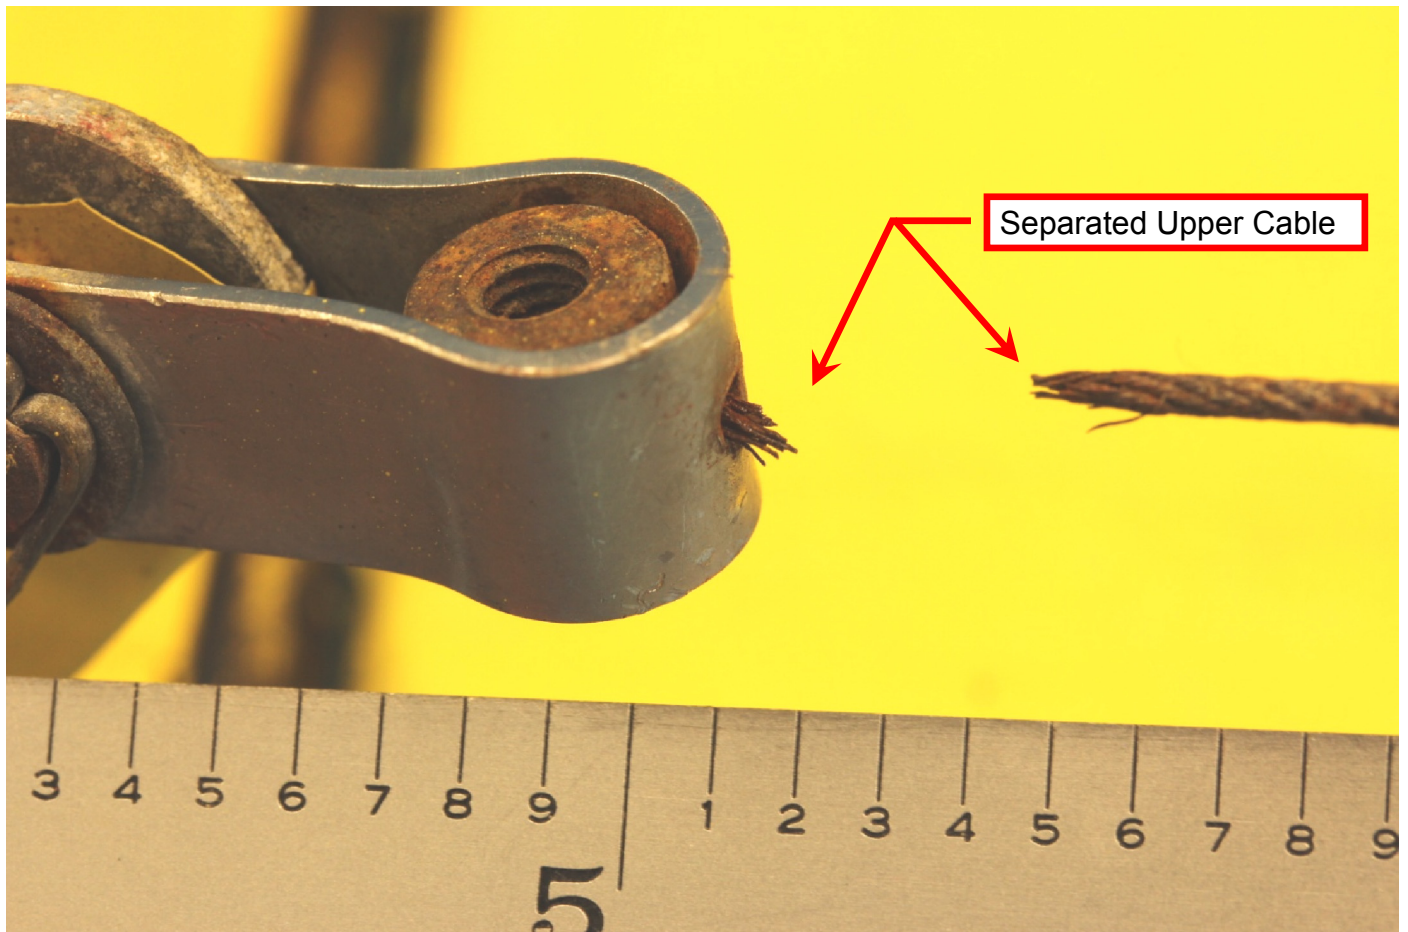
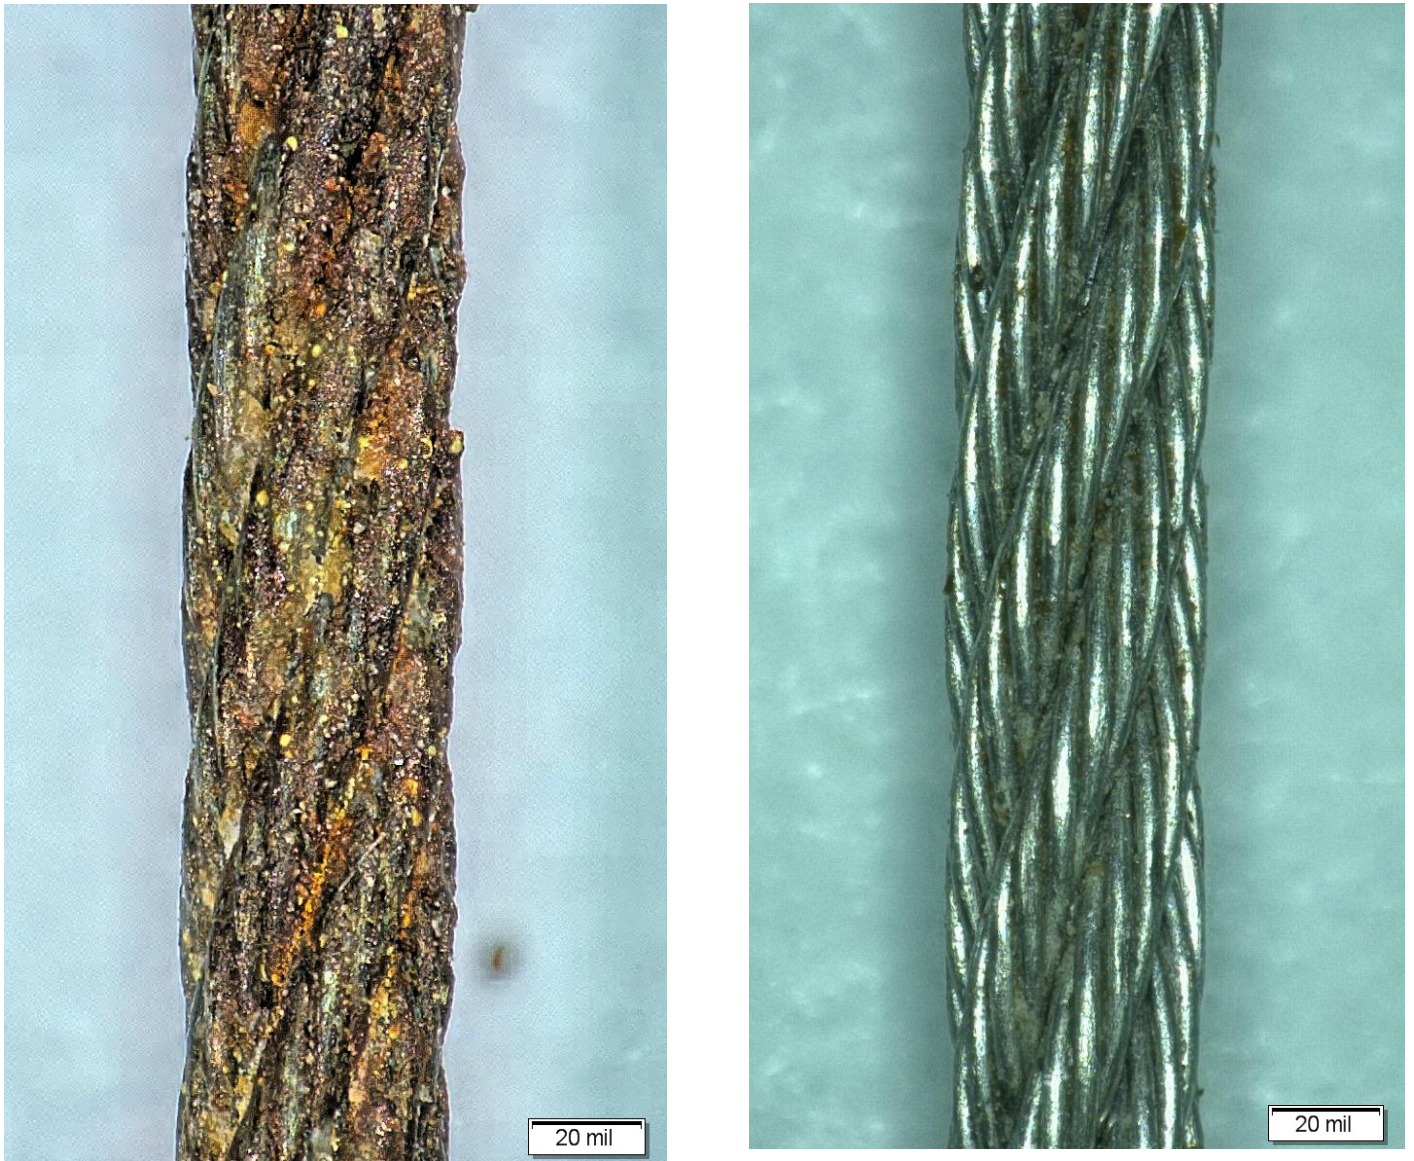
About 12.7 inches of the upper cable was received extending forward from the cable stop. The aft 11.3 inches of the cable had heavy red rust deposits covering the surfaces as shown in the left view of figure 3. The remaining cable surfaces were clean as shown in the right view of figure 3. No cable lubricant was noted in any area of the cable.

Figure 3. The surface of the upper cable in the corrosion area (left) and the clean area (right).

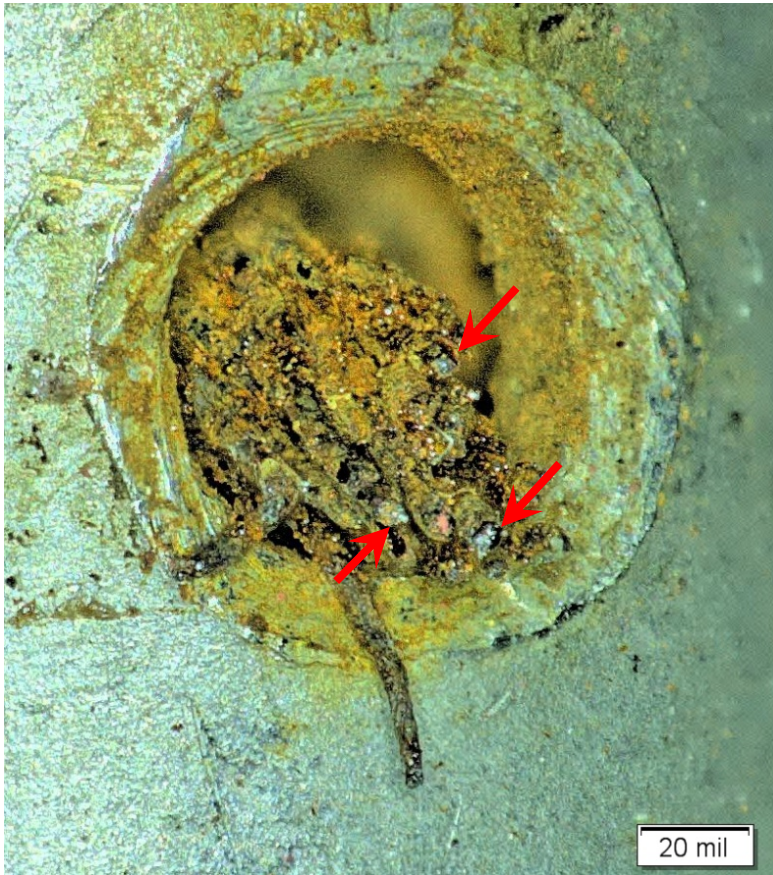
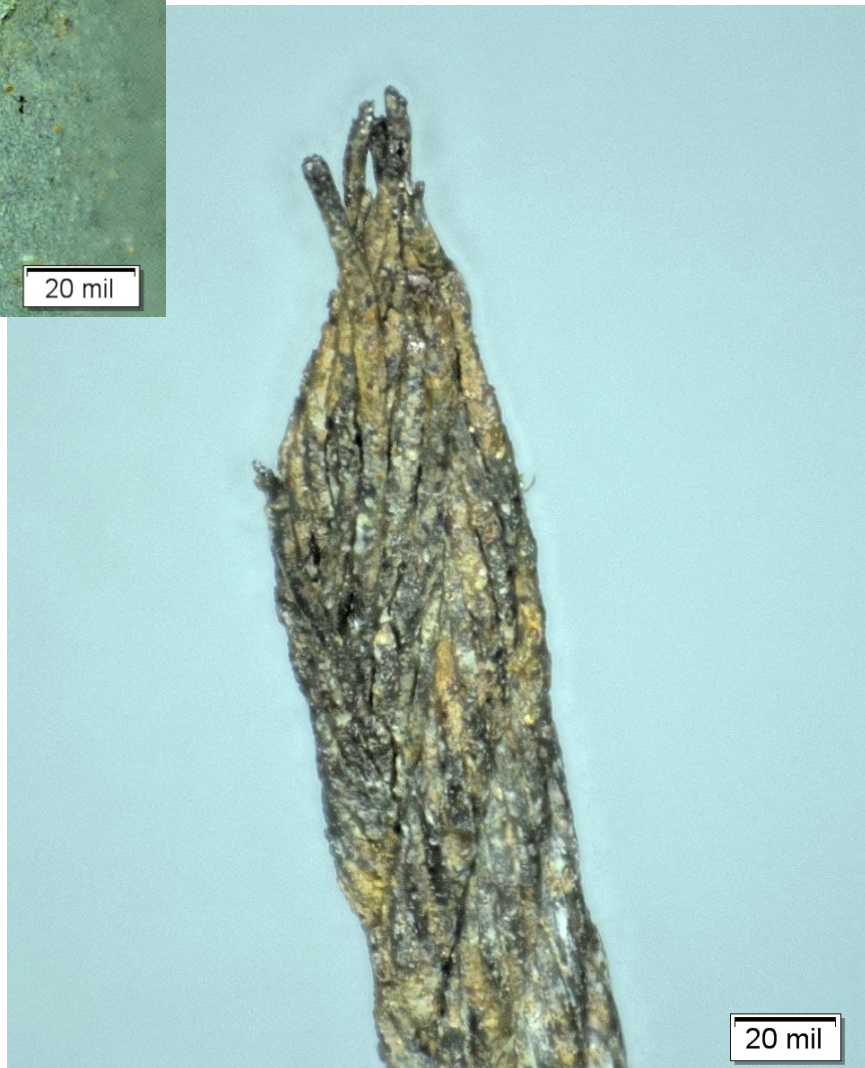
Close examinations of the cable separation found that all of the individual wire fractures were where the cable passed through the clevis as shown in the left view of figure 4. The cable remain tightly wound at the separation with no fraying or significant spreading of the wires or strands, as shown in the right view of figure 4. High magnification (~50X to ~100X) optical viewing uncovered only a few wires with clean identifiable fracture faces. The separated ends of the vast majority of the wires were obscured by red and black rust deposits and fractures were not visible. The clean fractures are denoted by arrows in the left view of figure 4.

Figure 4. The two side of the separated upper cable. At left, the aft side as the wires pass through the clevis. Arrows denote clean identifiable wire fractures. The forward wire separations are shown below.

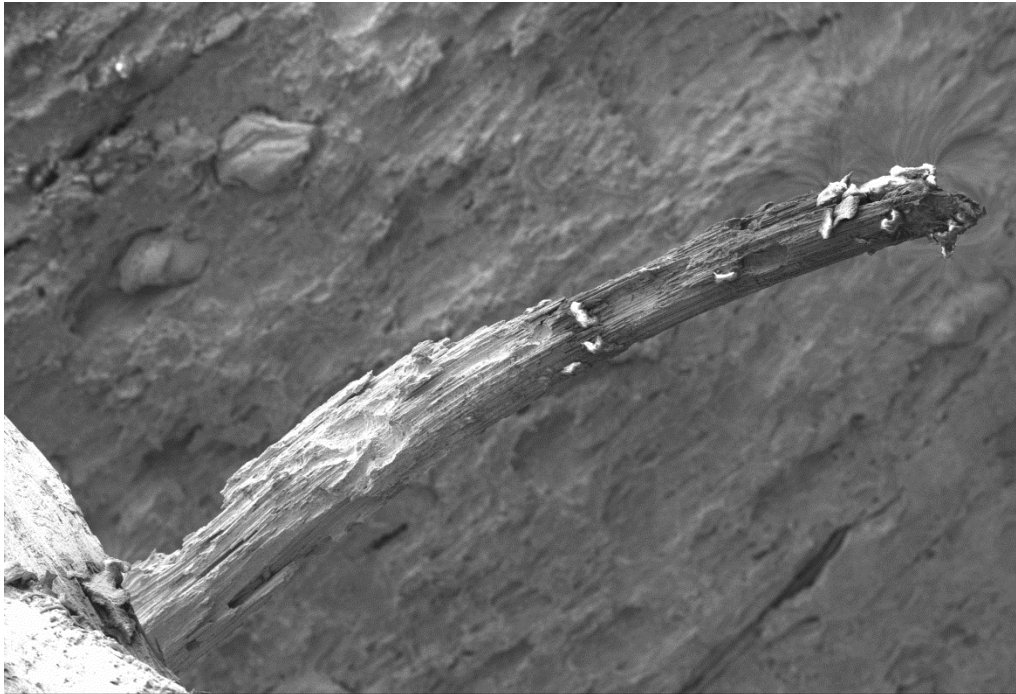
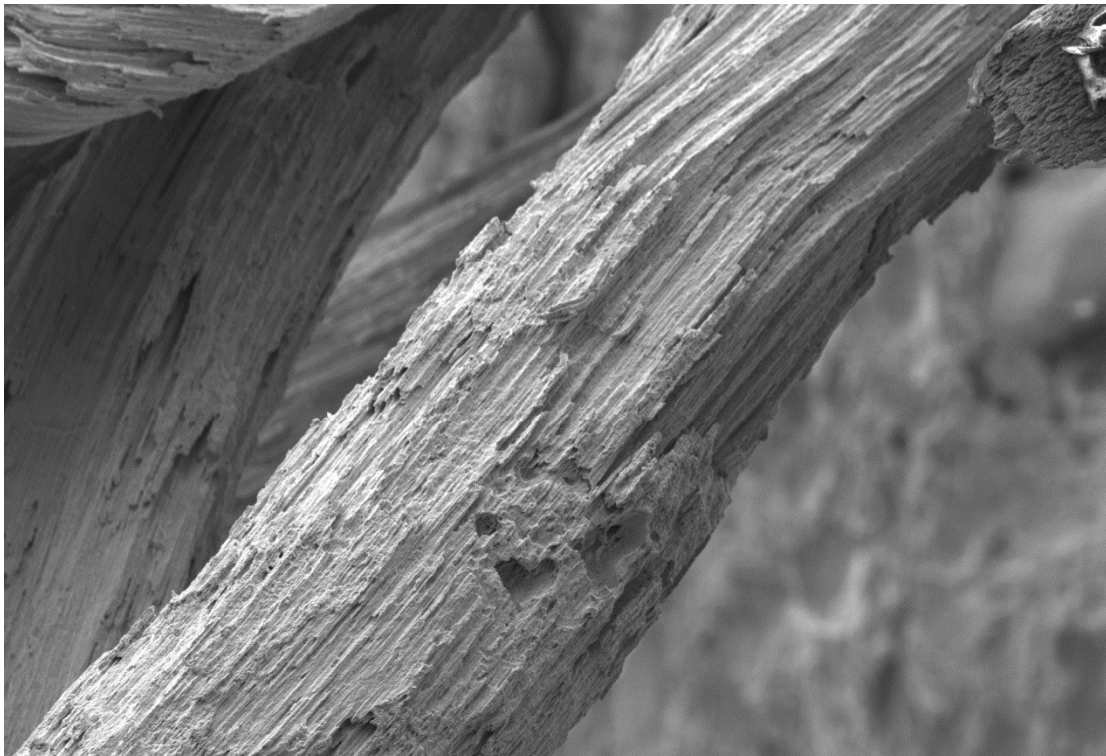
Ultrasonic cleaning in acetone removed much of the red rust deposits but not the darker deposits. The cable was restrained with a swag fitting and cut about 1 inch forward of the separation then cleaned in a commercially available deoxidizing solution⁴. The individual strands were then partially unwound for better viewing. Examinations with a scanning electron microscope (SEM) revealed severe corrosion damage of the wires adjacent in the area of the separation, as shown in the views of figure 5.

Figure 5. SEM views of typical corrosion damage to individual wires.

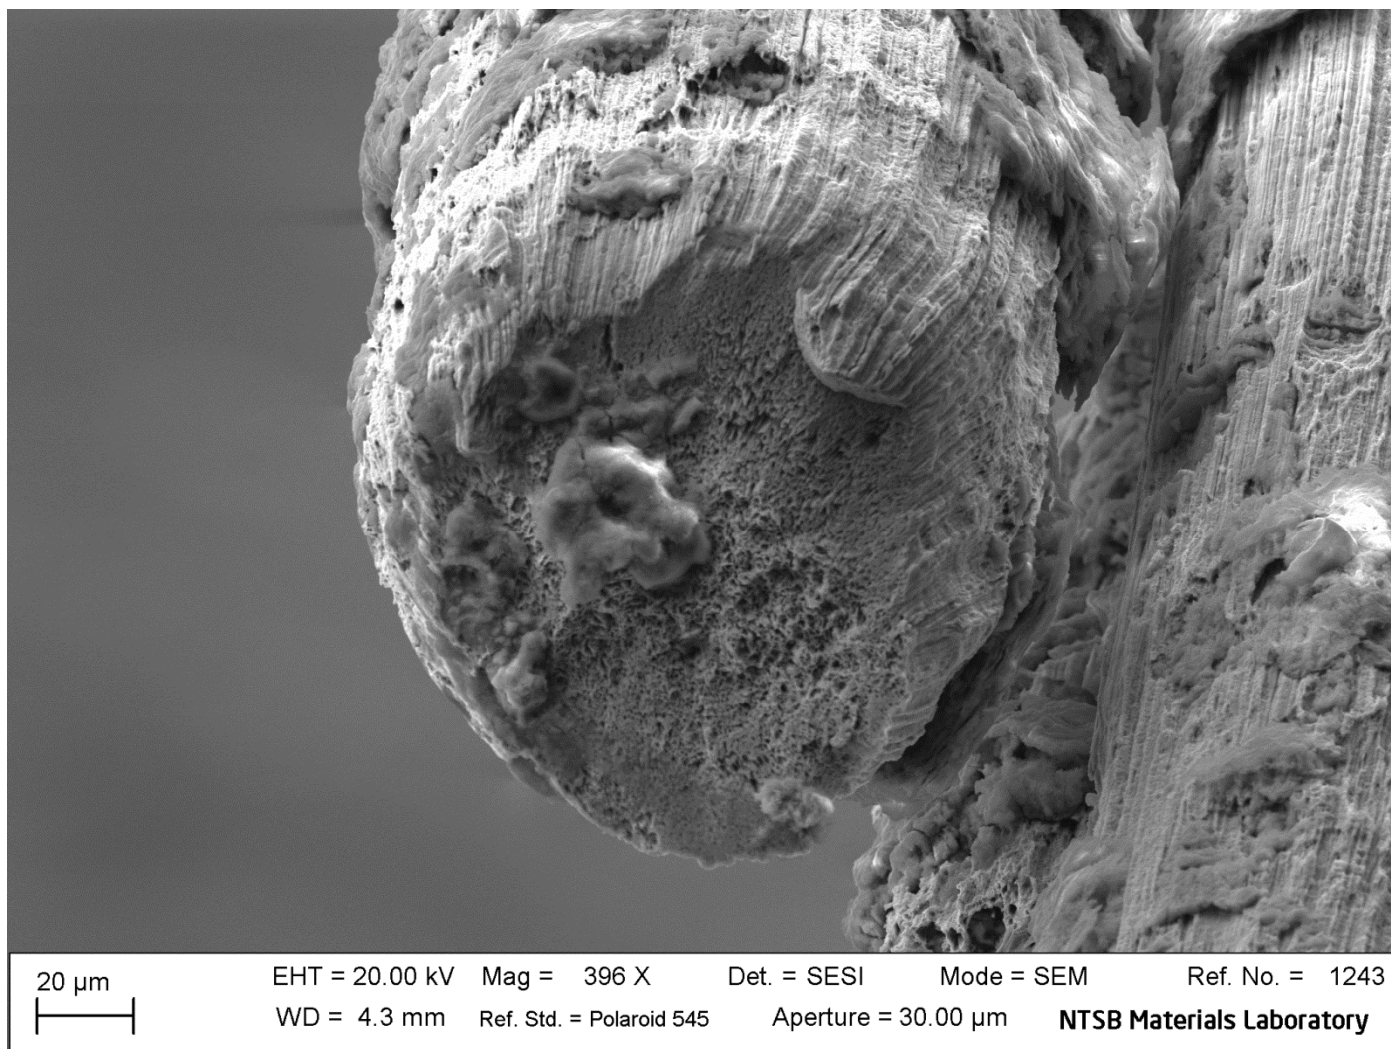
SEM examinations of the wire ends found that most were obliterated by corrosion and no features remained. The few wires where features remained were typical of overstress separations as shown in figure 6.

Figure 6. SEM view of one of the few wires with identifiable overstress fracture features.
