NATIONAL TRANSPORTATION SAFETY BOARD

Office of Research and Engineering
Materials Laboratory Division
Washington, D.C. 20594

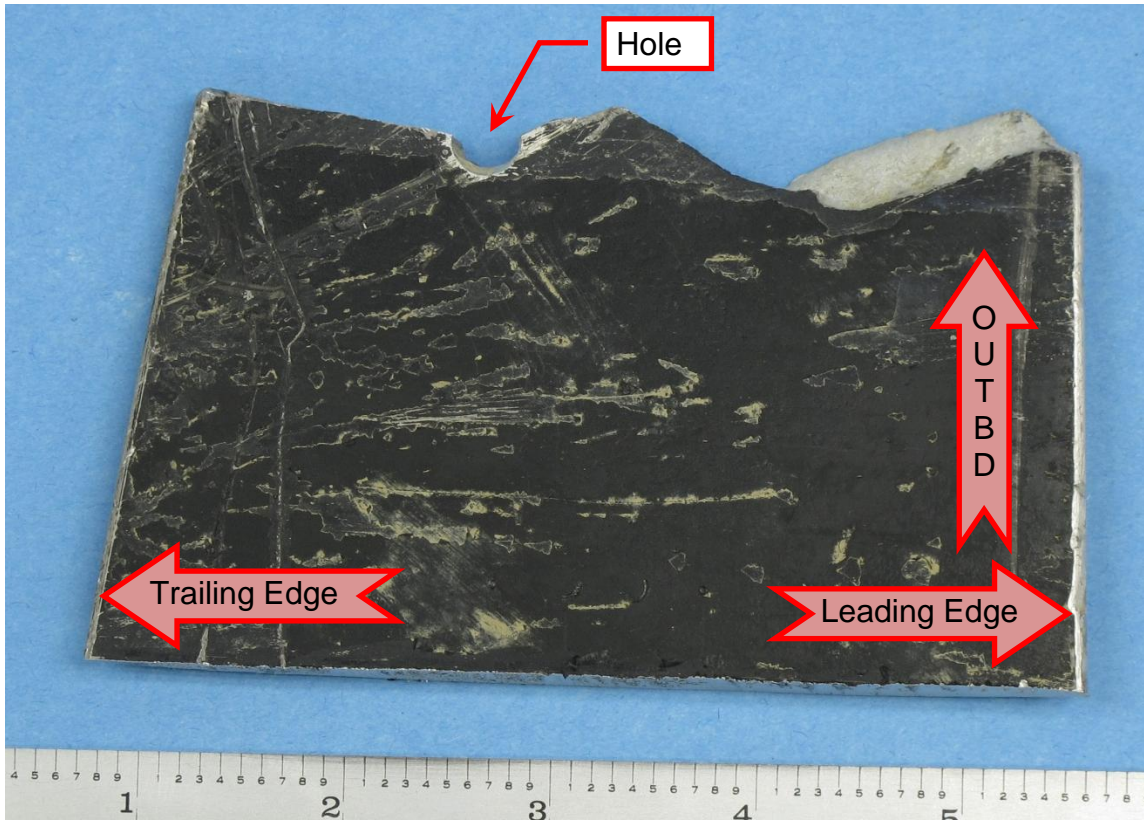
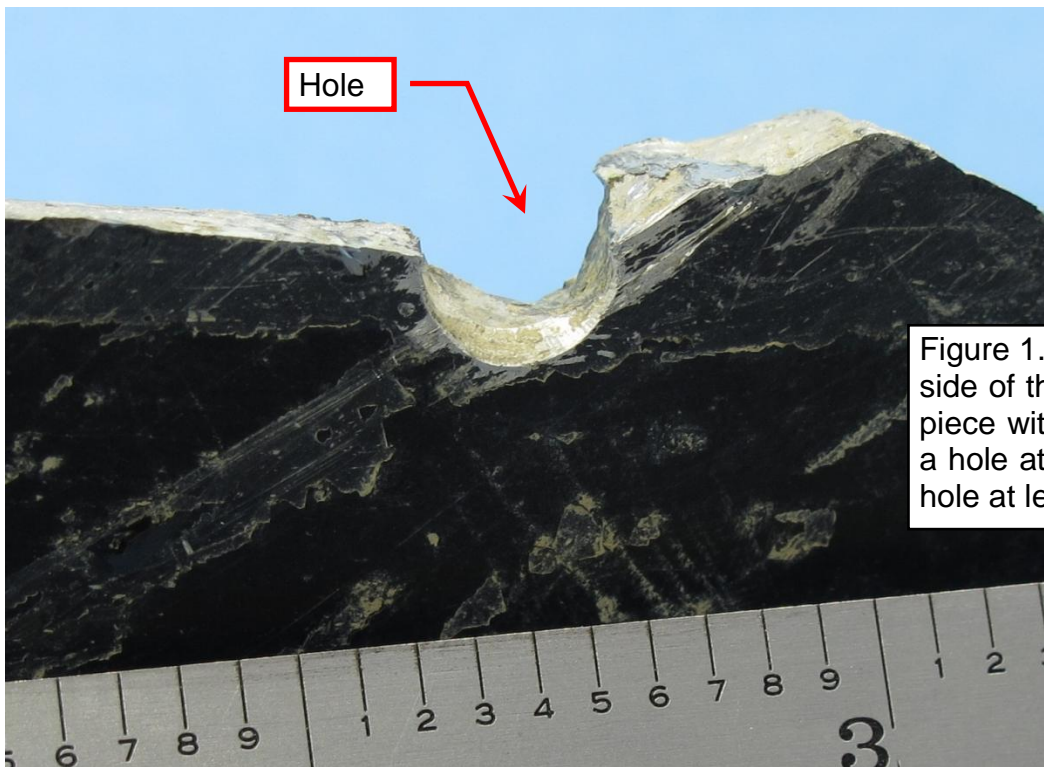
Figure 1. Overall view of the flat side of the as-received propeller piece with fracture separated by a hole at top. Closer view of the hole at left.

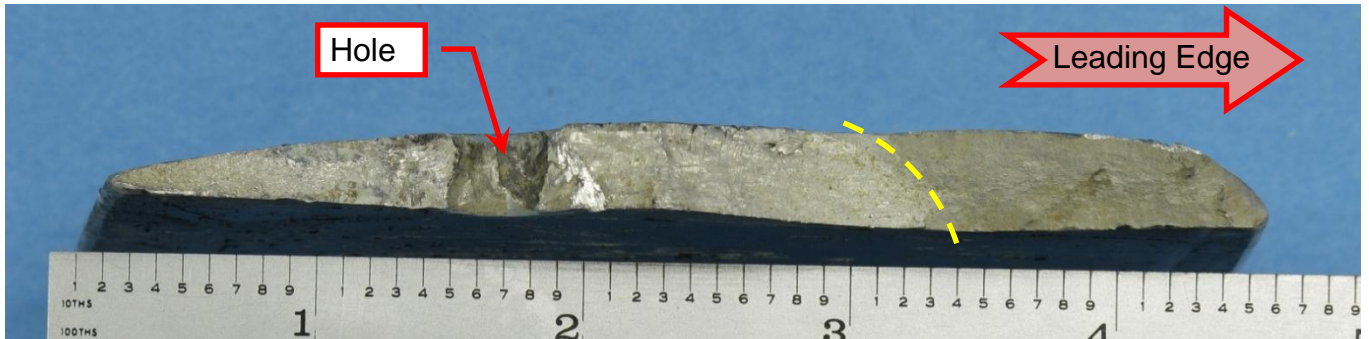
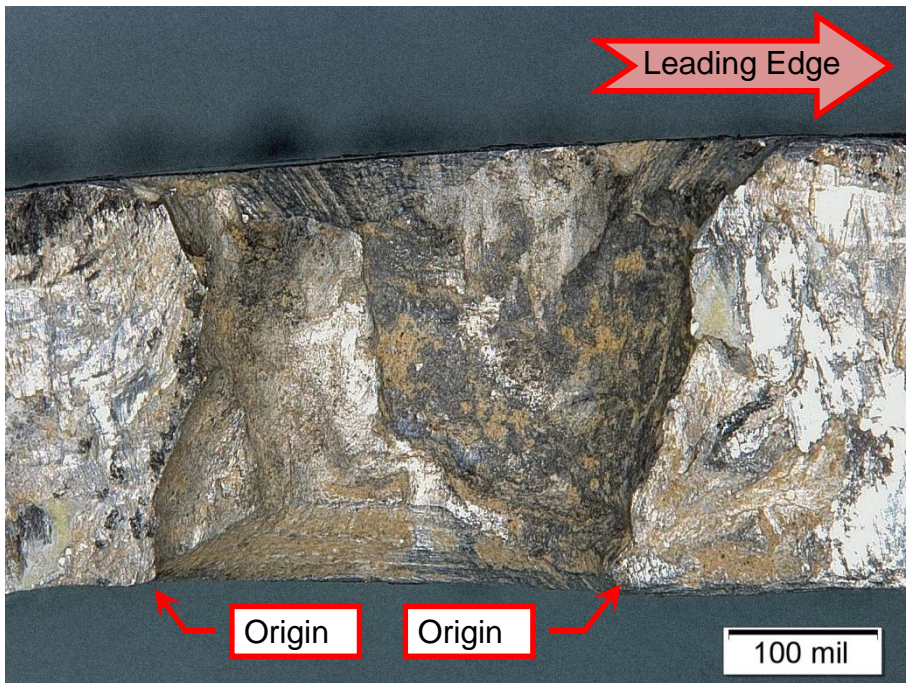
Figure 2. The entire blade fracture face at top with the approximate fatigue terminus at the dashed yellow line. Left view show a close-up of the hole with the approximate fatigue origin locations denoted. SEM views of the fatigue origins are shown below.

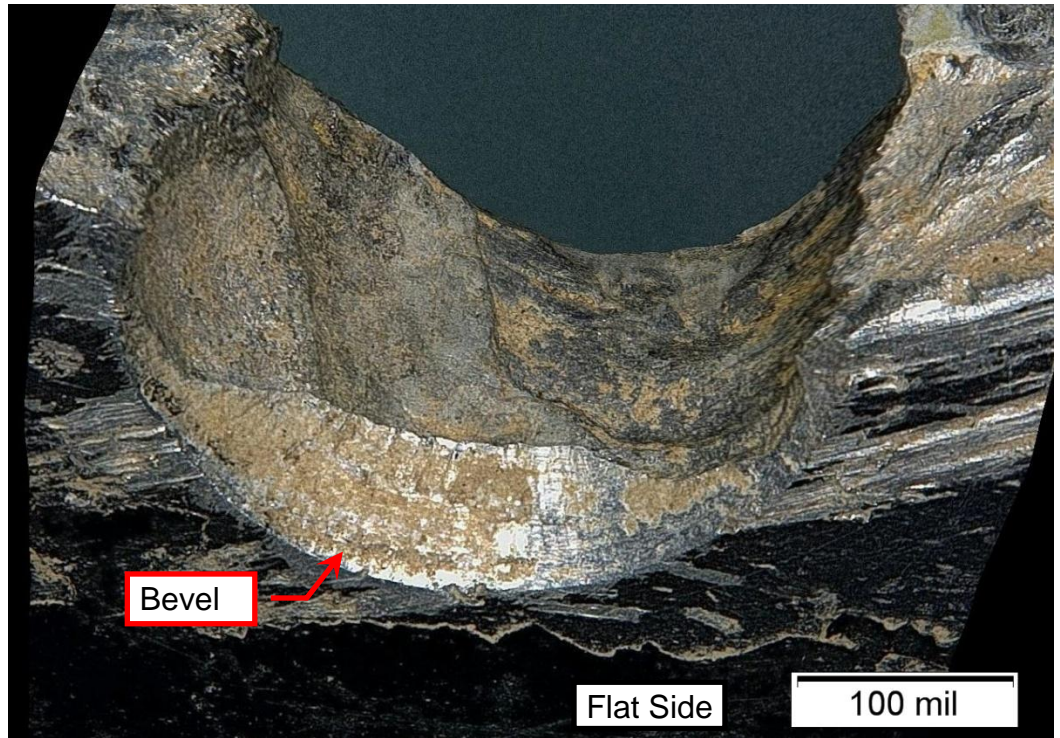
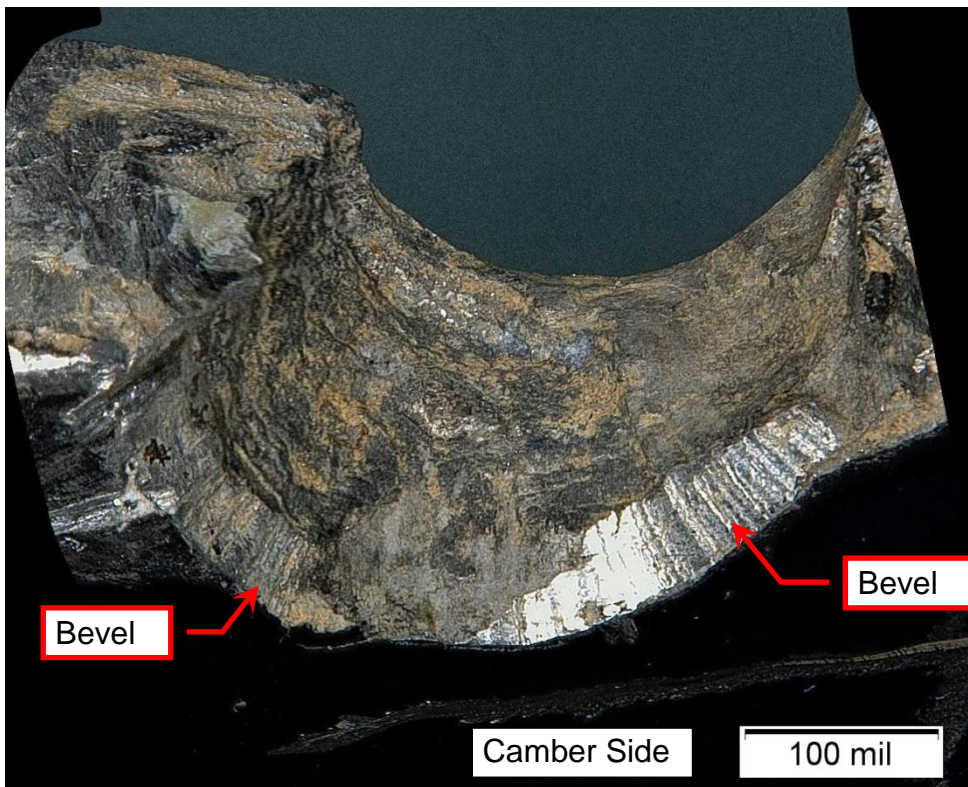
Figure 3. Optical 3-dimensional reconstructions of the hole and surroundings showing the surface features of the hole and the beveled edges on both the flat (top) and camber (bottom) sides.
