NATIONAL TRANSPORTATION SAFETY BOARD

MATERIALS LABORATORY FACTUAL REPORT

Report No. 12-116

Place : Houston, Texas
Date : September 10, 2012
Vehicle : Robinson R-22
NTSB No. : CEN12FA621
Investigator : Leah Yeager

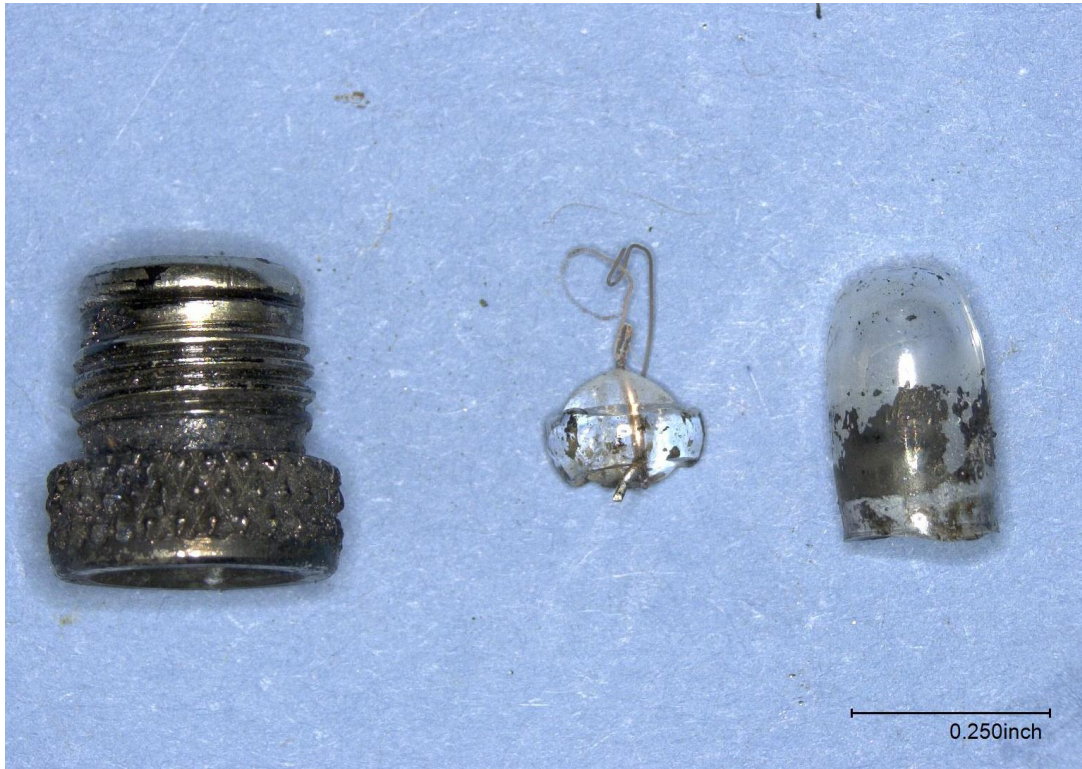
The light bulbs from the "Low Rotor" and "Clutch" warning lights were submitted to the Materials Laboratory for examination as shown in Figures 1 and 2. The glass globe from the "Clutch" light was intact but was loose from the base. The filament was broken, however a section of the filament was still attached to the base. Due to the fragility of the remaining filament, the filament section was removed from the light bulb and secured to a piece of carbon tape and placed on a mounting stub for examination in the scanning electron microscope (SEM). Under magnification, it was found that the filament exhibited hot coil stretching as shown in Figures 3 and 4.

Figure 1. Overall photograph of light bulb from "Clutch" warning light.

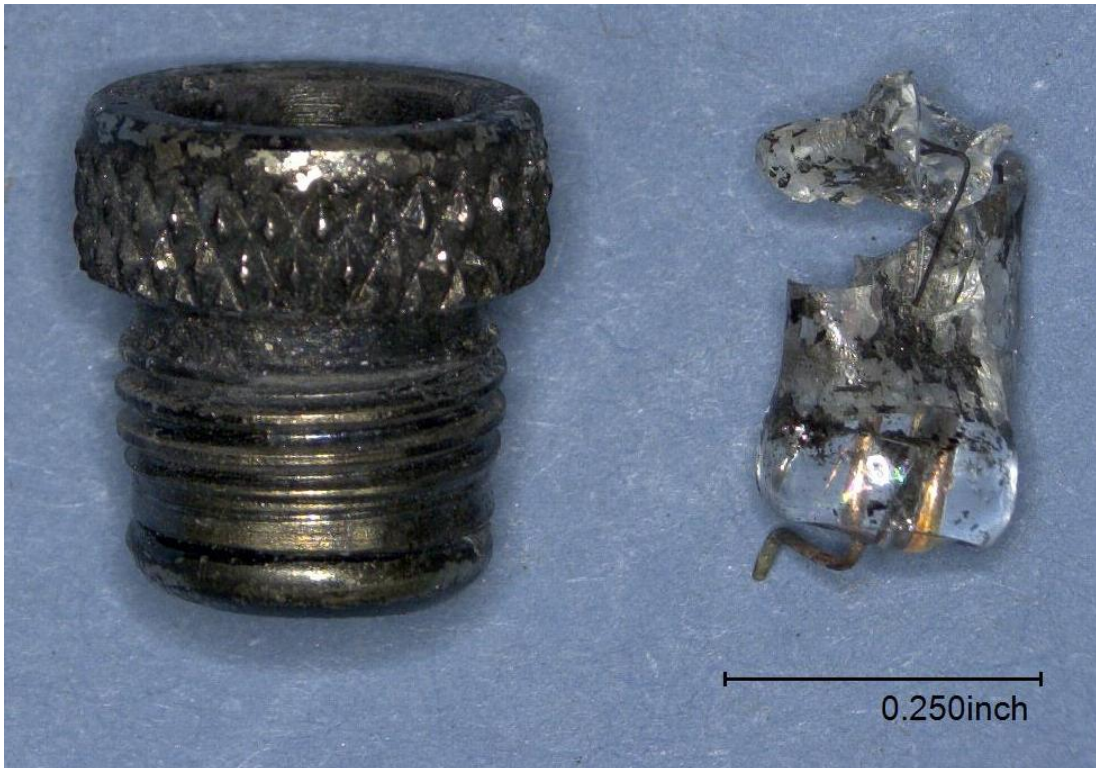
Figure 2. Overall photograph of light bulb from "Low Rotor" warning light.

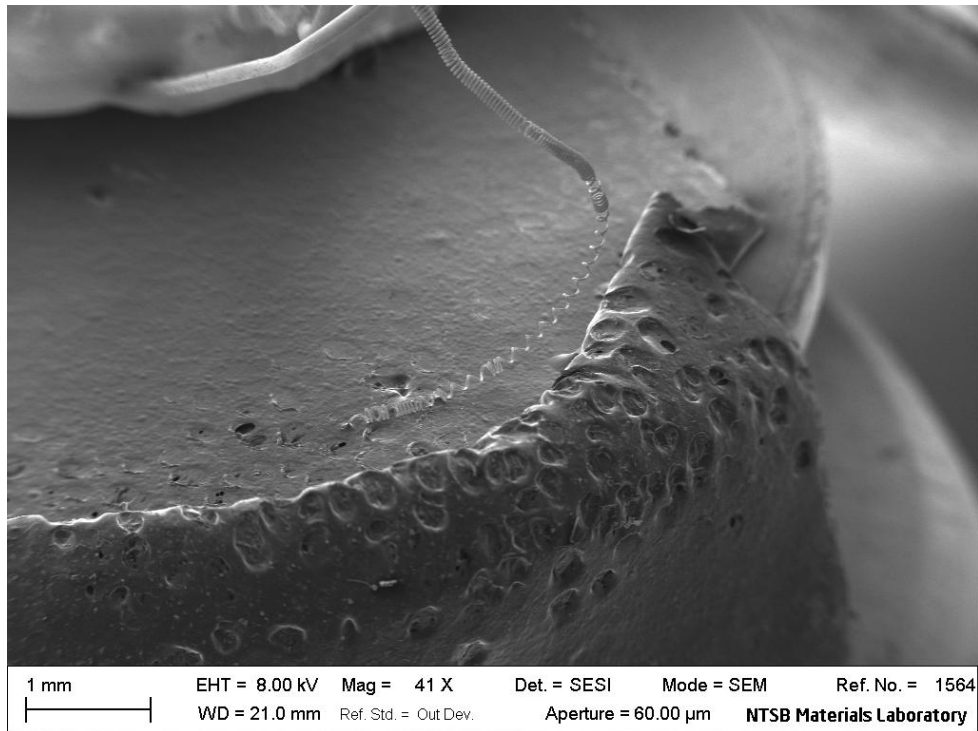
Figure 3. Scanning electron micrograph of filament section from "Clutch" warning light.

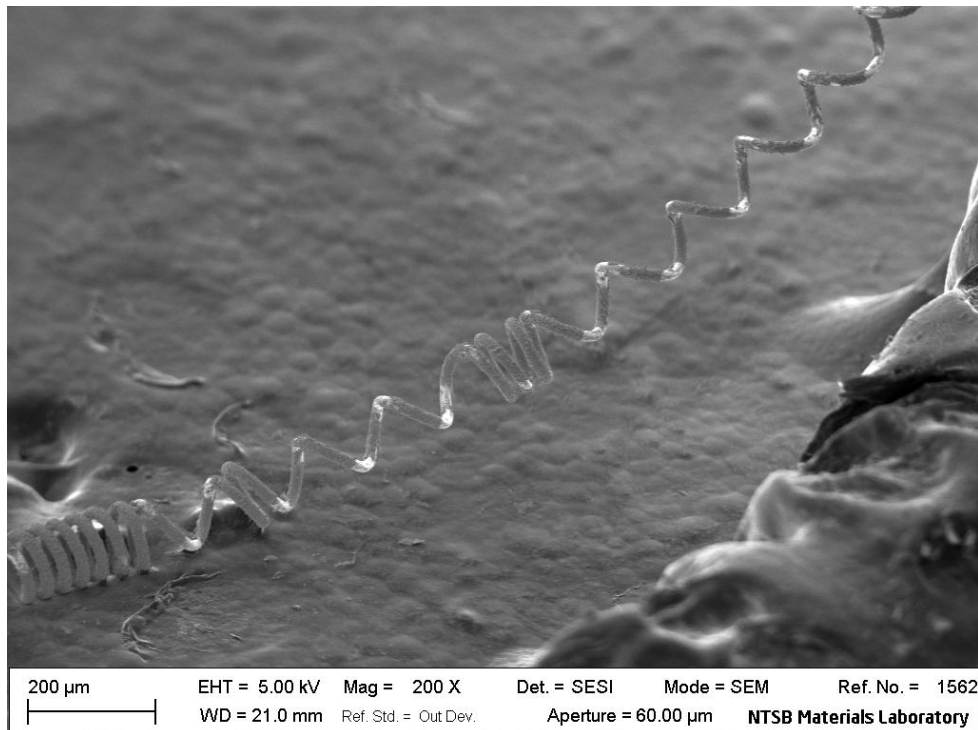
Figure 4. Scanning electron close-up micrograph of stretched filament section from "Clutch" warning light.

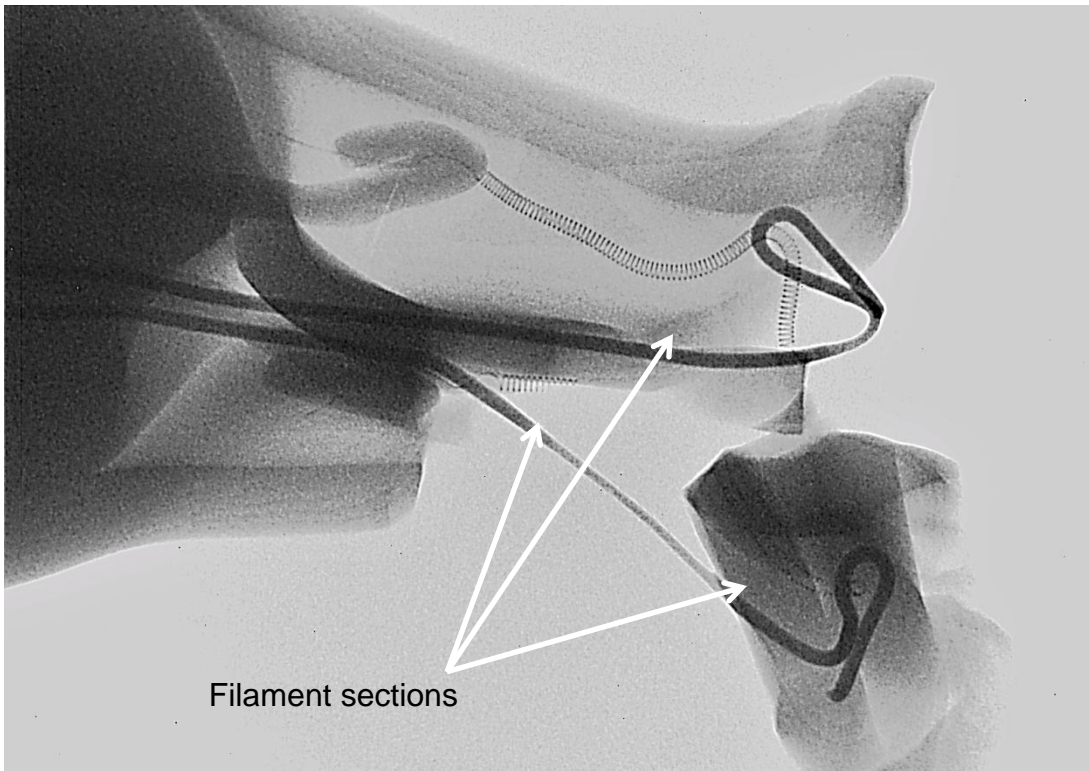
The glass globe for the "Low Rotor" light bulb had melted and encased the filament inside the glass. This bulb was x-rayed to examine the filament inside. The radiograph is shown in Figure 5. The filament was broken but exhibited no hot coil stretching.

Figure 5. Radiograph of light bulb from "Low Rotor" warning light.
