# NATIONAL TRANSPORTATION SAFETY BOARD

MATERIALS LABORATORY FACTUAL REPORT

Report No. 12-118

Place : Borrego Springs, California  
Date : September 8, 2012  
Vehicle : Moore MXS Experimental, N21MX  
NTSB No. : WPR12LA407  
Investigator : Patrick Jones, AS-WPR

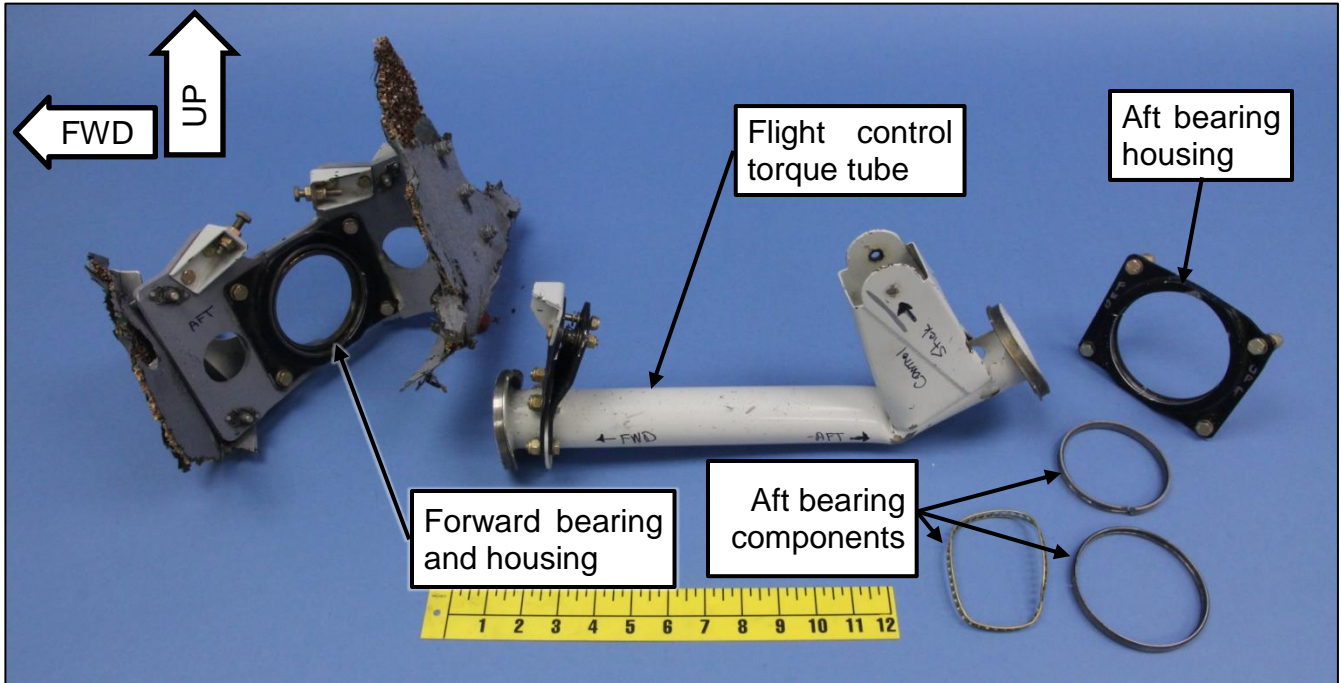
An overall view of the submitted components is shown in figure 1. The flight control torque tube was separated from the forward and aft bearings. The forward bearing was retained in its housing, which was attached to the forward bearing support panel. The aft bearing inner race, outer race, and cage were separated from each other and from the housing. The rolling elements for the aft bearing were not included in the submitted components.

Figure 1. Overall view of the submitted components.

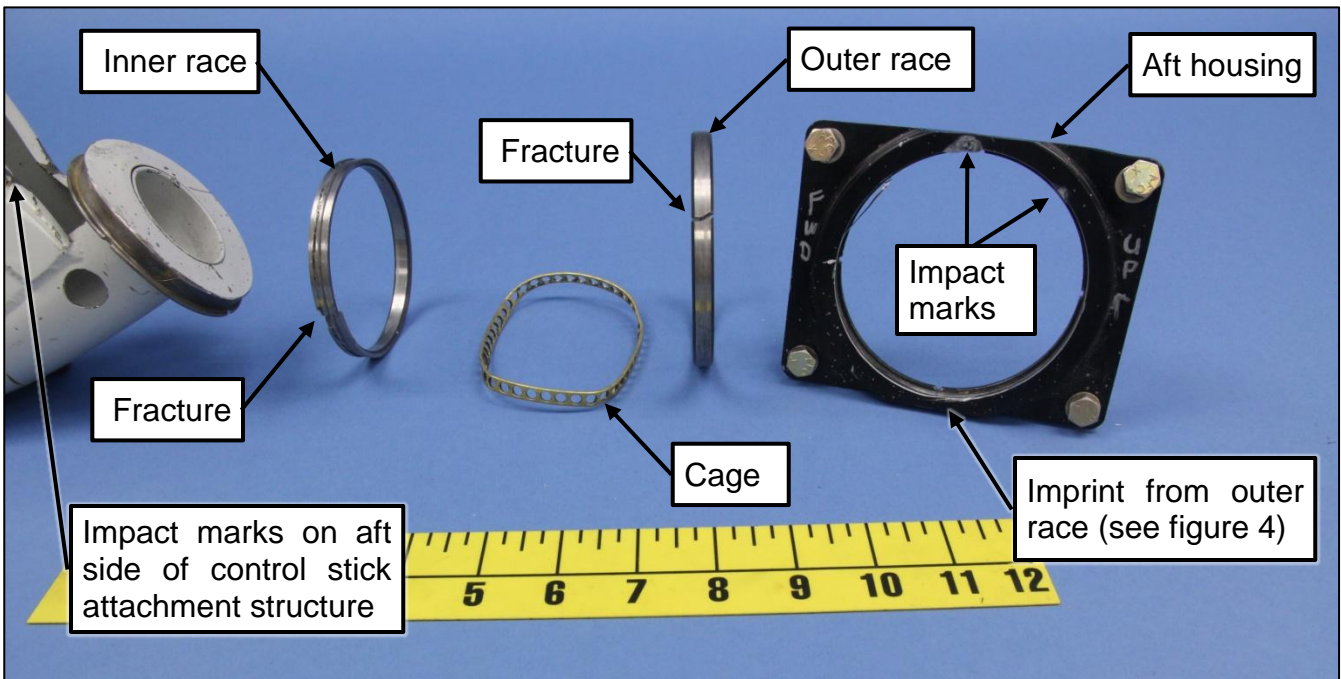
A view of the submitted aft bearing components is shown in figure 2. The inner and outer races of the aft bearing were fractured. Fracture features of both fractures showed uniform matte-gray rough surfaces consistent with overstress fracture. The cage was deformed but intact.

Figure 2. View of the aft control tube bearing components. Fractures in the inner and outer race are indicated.

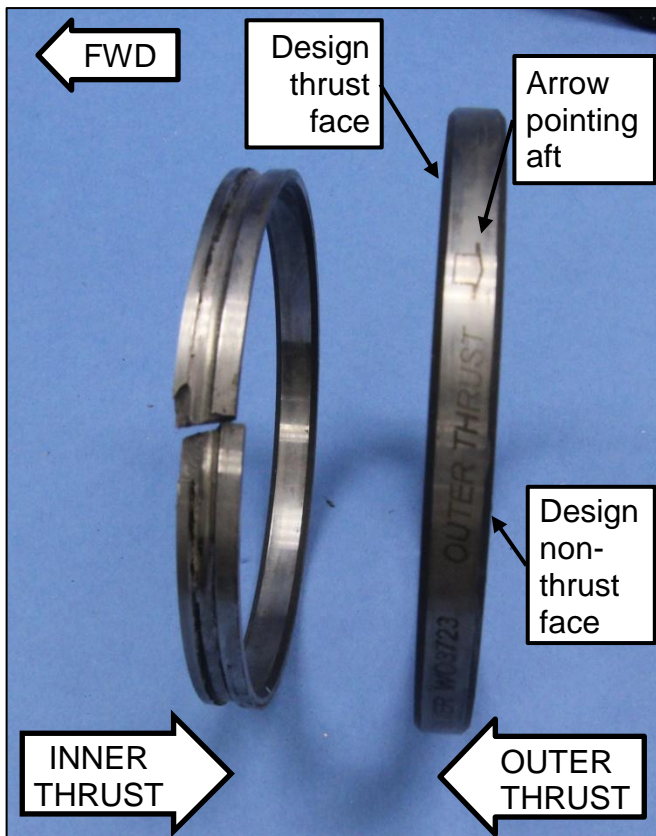
The outer race was marked with the bearing thrust direction as shown in figure 3. An arrow marked on the outer race indicated the direction of thrust applied to the outer bearing race when installed correctly. For a properly installed bearing, the arrow should point toward the torque tube in both the forward and aft bearing positions. Thus the arrow on the aft bearing should point forward, and the arrow on the forward bearing should point to the aft.

Figure 3. Close view of the inner and outer race of the aft bearing. The forward direction indicated is based on witness marks on the aft bearing housing (see figure 4). The arrow pointing aft on the outer face of the outer bearing points in the direction of applied thrust on the outer race when the bearing is correctly installed. The thrust and non-thrust faces of a correctly installed bearing are also indicated. The direction of outer thrust is opposite that of the thrust from the flight control tube (inner thrust). Arrows at the bottom of the figure point to directions of applied thrust as installed on the airplane.

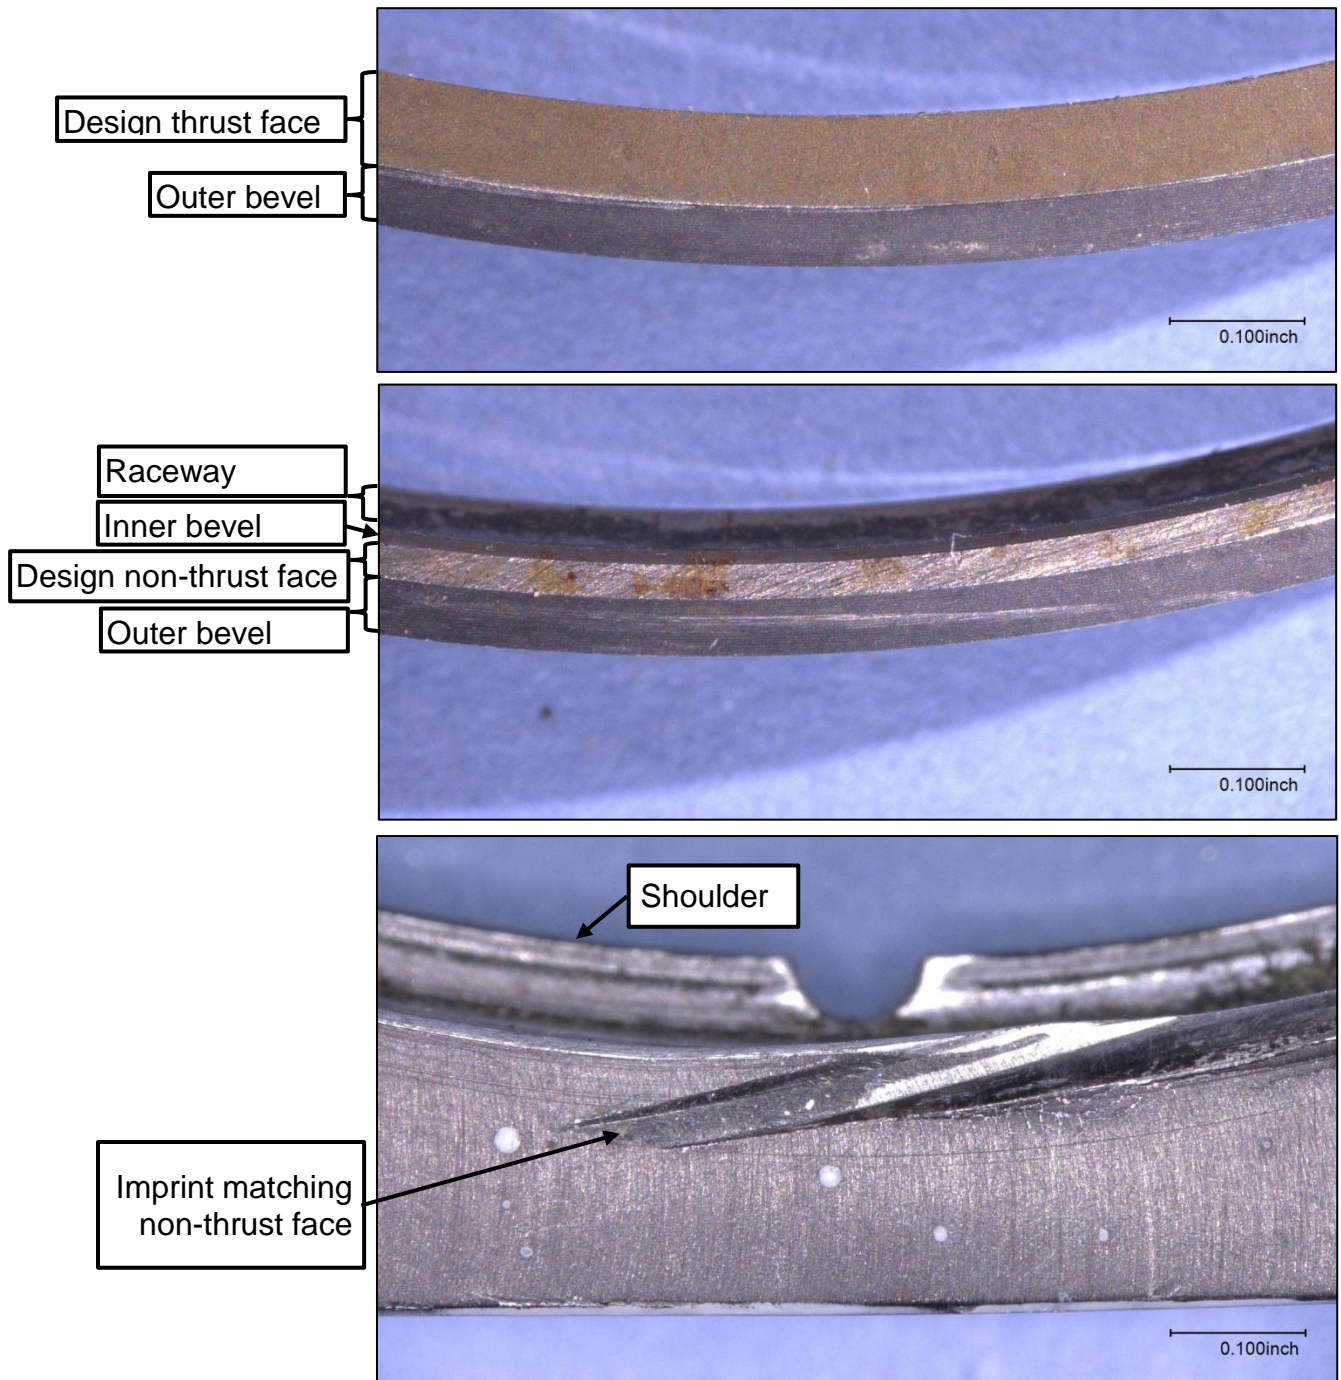
The aft bearing housing showed multiple indications of contact damage on its forward face around the perimeter of the bearing opening as indicated in figure 2. A magnified view of damage on the lower side of the bearing housing is shown in the lower image in figure 4. The indicated damage was an impression that matched the flat face and adjacent bevels of the non-thrust face of the outer race shown in the middle image in figure 4. The impression did not match the shape of the thrust face of the outer race shown in the upper image in figure 4, and similarly the impression did not match either face of the inner race. The impression is consistent with the bearing having been installed incorrectly with the design non-thrust side of the bearing facing the aft direction against the shoulder of the bearing housing. (The shoulder of the bearing housing is indicated in figure 4.) This orientation with the design non-thrust face of the aft bearing facing the aft direction is the orientation shown in figure 3.

Figure 4. Views of the thrust face (upper image) and non-thrust face (middle image) of the aft bearing outer race. The imprint mark on the forward face of the aft housing (lower image) shown at the same magnification as the upper and middle images corresponded to contact with the thinner non-thrust face and not the wider surfaces of the thrust face of the outer race or either face of the inner race.

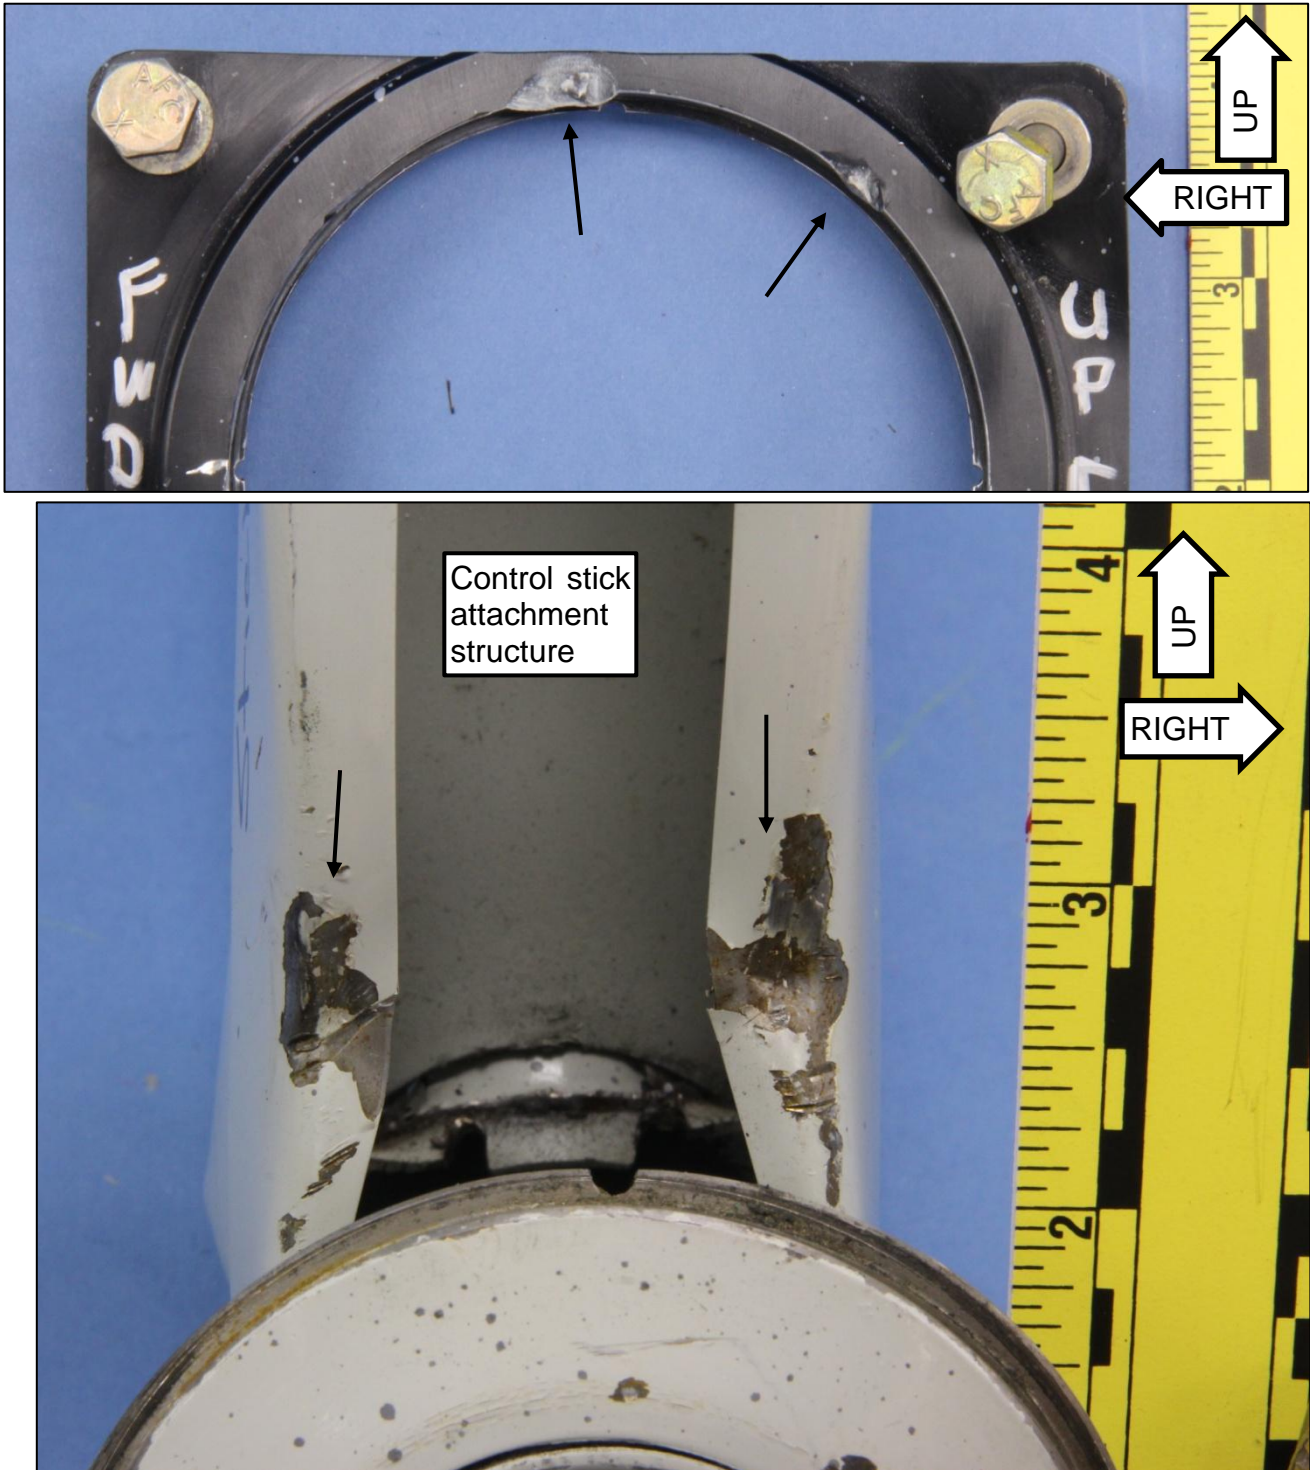
Views of damage at the upper side of the aft bearing housing is shown in the upper image in figure 5. Deformation from the damage extended inward into the opening for the thrust bearing outer race. Corresponding contact damage was present on the aft face of the control stick attachment structure in the areas indicated in figure 5.

Figure 5. Close views of the forward face of the aft bearing housing (upper image) and the aft face of the control stick attachment structure (lower image). Unlabeled arrows in both images indicate corresponding contact damage on the two components.

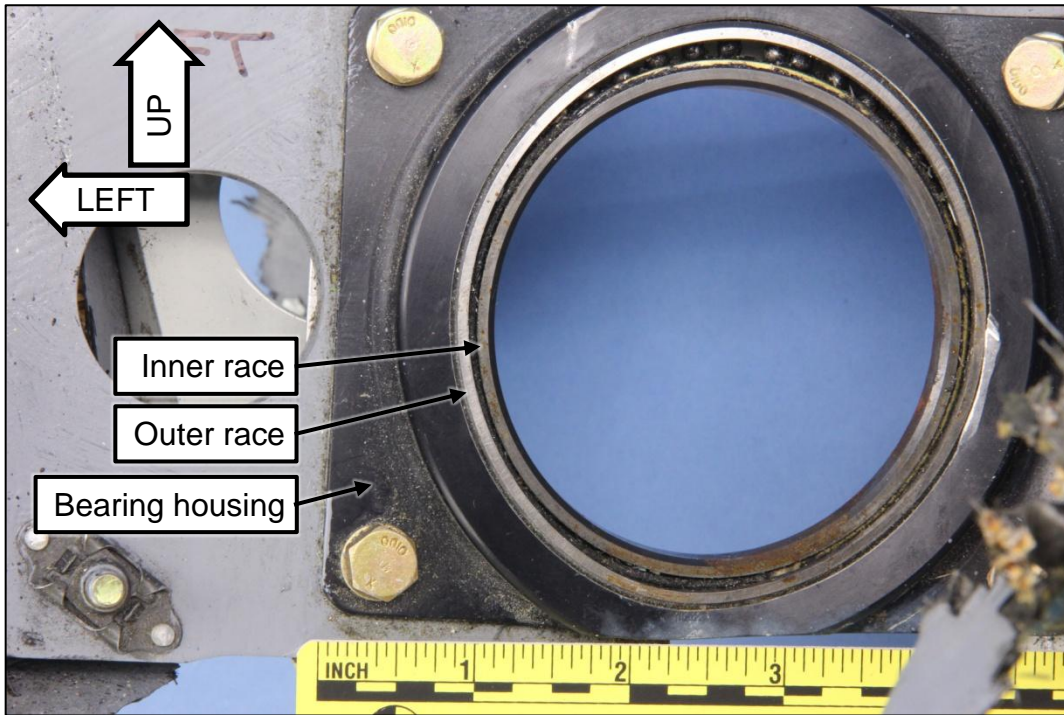
A close view of the forward bearing in the bearing housing is shown in figure 6. The inner race of the bearing was tilted off-axis relative to the outer race with the lower right portion of the inner race displaced forward relative to the outer race. The inner race was lodged within the outer race and could not be rotated by hand.

The forward thrust bearing was installed incorrectly. The thrust face of the outer race (wider face) is visible in figure 6. Thus, the non-thrust face of the outer race (thinner face) was facing forward toward the shoulder of the bearing housing, which is an incorrect installation for the thrust bearing.

Figure 6. View of the aft face of the forward bearing. The design thrust face of the outer race is visible. When correctly installed in the housing, the thrust face of the outer race should face forward on the forward bearing.

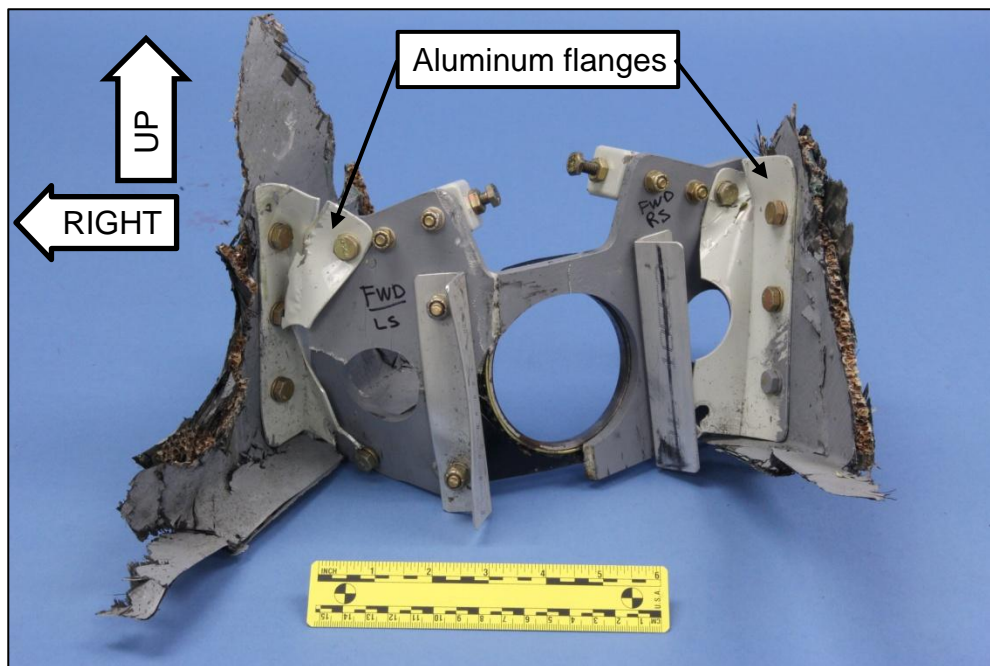
A view of the forward side of the bearing support panel is shown in figure 7. The middle of the panel was bent forward relative to the edges. A piece of the panel around the lower right quadrant of the center hole was fractured and missing (right as viewed looking forward). The area of the fracture corresponded to the area where the inner race of the forward bearing was displaced forward past the shoulder of the bearing housing.

Aluminum alloy flanges were observed at the edges of the bearing support panel attaching the panel to the sidewalls. The flanges were bent and cracked. The flange faces attached to the sidewalls were bent inward such that the corner of the flange was displaced away from the sidewall. Attachment bolts at the lower end of the flanges were pulled out of the flange holes consistent with the attachment bolts displacing inward and downward relative to the flanges. The upper ends of the flanges showed buckling deformation near the upper attach points, also consistent with a downward displacement.

According to representatives of MX Aircraft, the aluminum flanges were inconsistent with the MXS airplane design. Photographs of an exemplar airplane with a reportedly proper installation of the bearing support panel showed flanges located on the aft side of the forward bearing support panel, and the flanges were made of composite material.

Figure 7. View of the forward side of the forward bearing support panel. Aluminum flanges attaching the bearing support panel to the sidewalls are indicated.

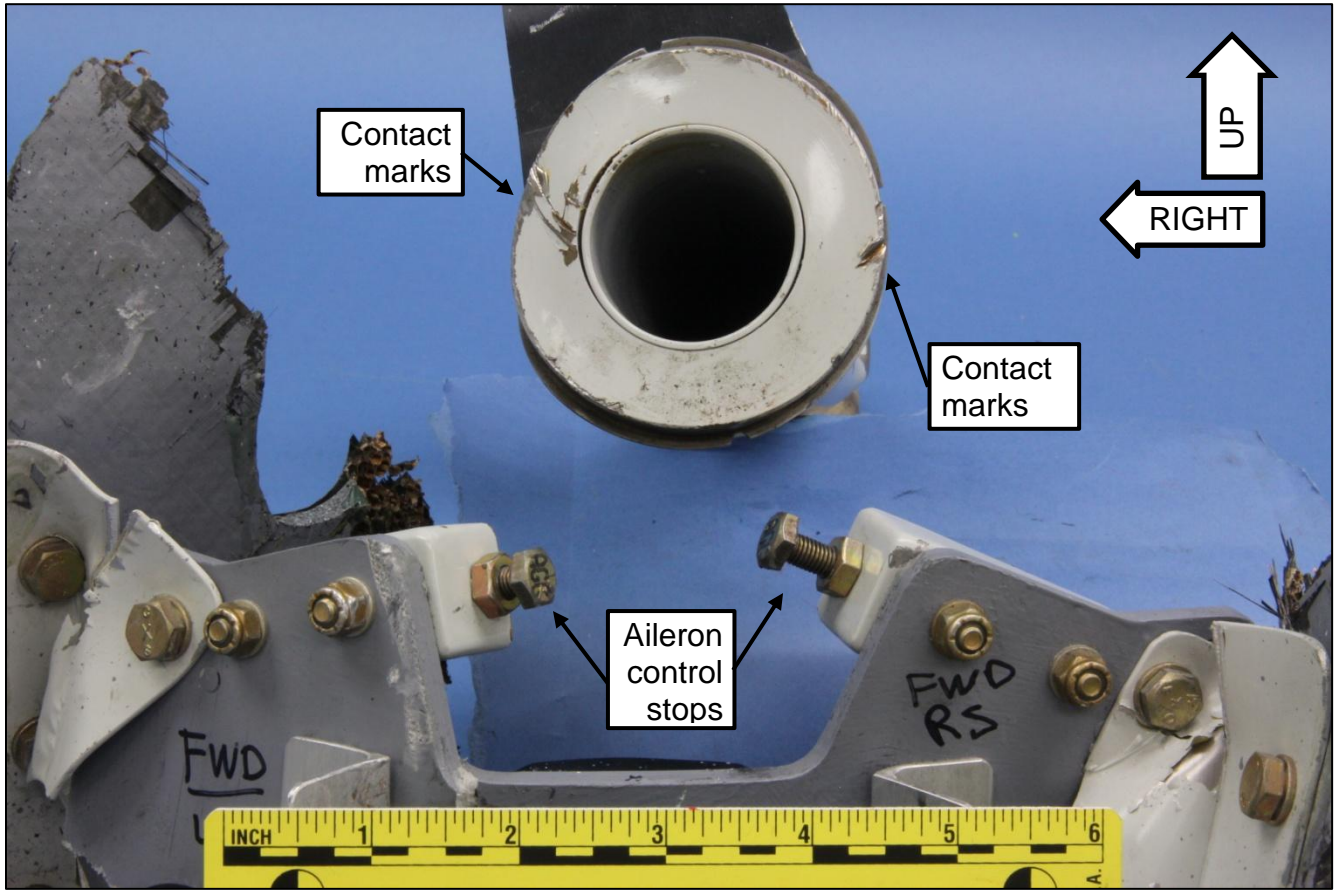
The forward face of the flight control torque tube is shown in figure 8. A number of sliding contact marks were observed on the forward face as indicated in figure 8, and the sides of the face were bent to the aft in the areas of contact. The location and shape of the contact marks were consistent with sliding contact with the aileron control stop assembly on the forward bearing support panel (see figure 8). The aft faces of the aileron control stop assembly also showed missing paint and evidence of contact damage.

Figure 8. View of the forward face of the flight control tube showing sliding contact marks.
