NATIONAL TRANSPORTATION SAFETY BOARD

MATERIALS LABORATORY FACTUAL REPORT

Report No. 12-128

Place : Pukoo, Hawaii.
Date : November 10, 2011.
Vehicle : Eurocopter EC-130B4, N11QV.
NTSB No. : WPR12MA034.
Investigator : Dennis Hogenson.

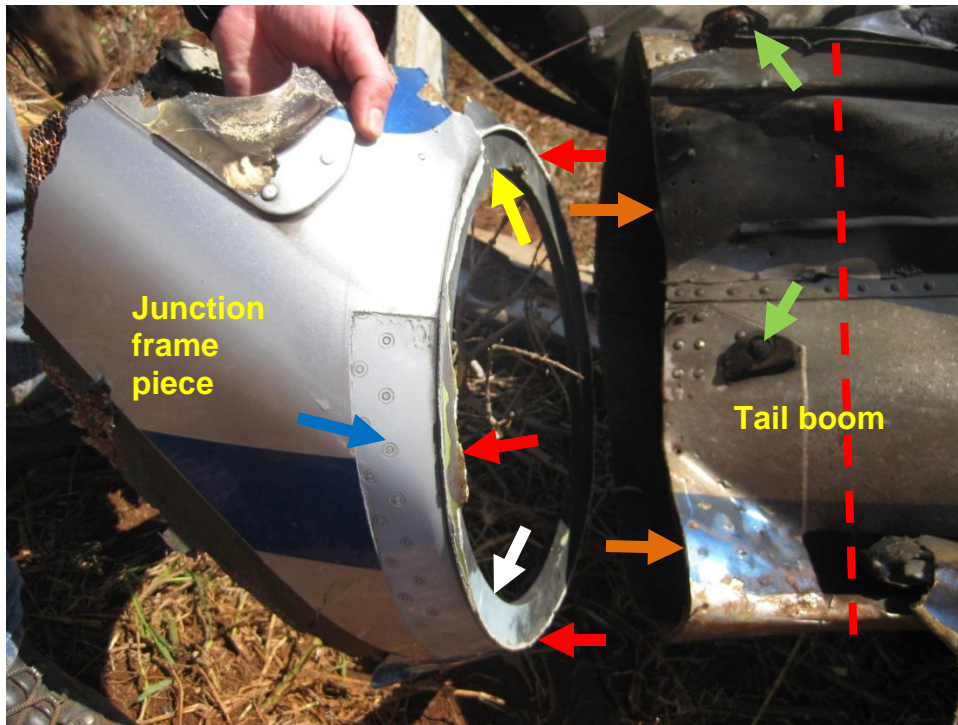
Figure 3. The junction frame piece indicated in Figure 2 positioned adjacent to its original location on the tail boom at the accident site.

A major portion of the junction frame was located in the wreckage path, as indicated in Figure 2. The frame portion consisted of the inner ring, most of the rear flange and a portion of the fenestron skin. The outer edge of the forward face of the inner ring displayed a fracture face where the forward flange was originally located. At the accident site, the junction frame piece was positioned adjacent to the rear end of the fire damaged tail boom to illustrate its relative cleanliness when compared to the fire blackened tail boom and is illustrated in Figure 3 (the tail boom was rotated

from its original inverted impact position for the image). The red arrows indicate the fracture face on the junction frame and brown arrows indicate the mating fracture on the forward flange still in the tail boom. The rear portion of the tail boom containing the forward flange was removed by sawing along the red dashed line and is illustrated later in Figure 55. The blue arrow indicates a rectangular area of exposed rivets and the white arrow indicates a clean portion of the inner ring, both consistent with satisfaction of Alert Service Bulletin 53A019 (document 1 in section C). The green arrows in Figure 3 indicate attachments for the fairing between the tail rotor drive shaft cover and the fenestron.

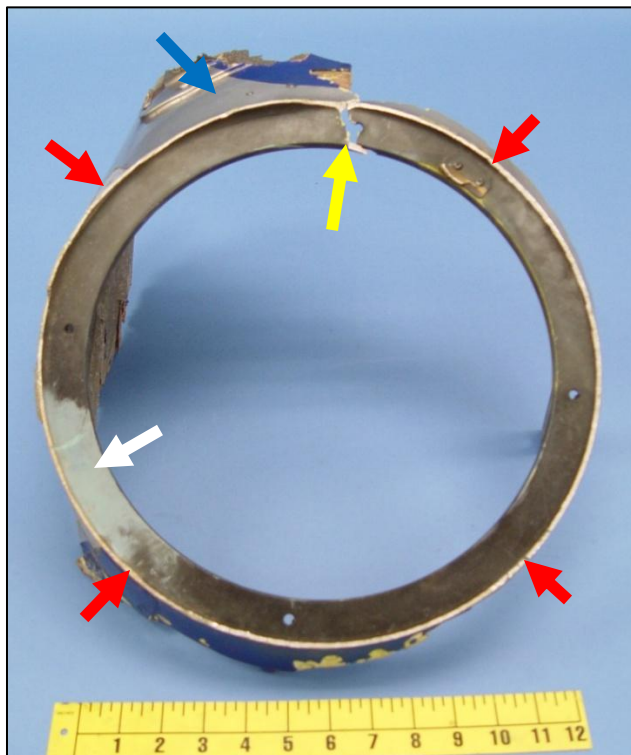
Figure 4. The junction frame piece in Figure 3 as received and looking aft.

A view of the junction frame piece, looking aft, is illustrated in Figure 4 with red arrows indicating the fracture face. The yellow arrow indicates a fracture at the uppermost hole and the blue arrow indicates the attached skin. The white arrow indicates an area on the inner ring, similarly indicated in Figure 3, where the surface deposit had been removed. A view of the junction frame piece, looking forward, is illustrated in Figure 5 with a yellow arrow indicating the fracture at the upper hole. The blue arrow indicates the fenestron skin and the red arrow indicates the honeycomb core. The orange arrows indicate rivets attaching the skin to the rear flange. The inner ring contains four holes and for descriptive purposes looking forward, the upper hole is designated as the 12 o' clock position, the lower hole is designated the 6 o' clock position, the left hole is designated the 9 o' clock position and the right hole is designated the 3 o' clock position. The position of the holes is also illustrated in drawing 350A234007 (document 2 in section C). The purple arrow indicates a fractured portion of the rear flange where the fracture extended from the 7 o' clock position to the 12 o' clock position, following the rivet line from the 9 o' clock position to the 12 o' clock position. The white arrow indicates a portion of a manufactured circle that originally encircled the tail rotor drive shaft and the green circle indicates a portion of a manufactured circle that originally encircled the tail rotor pitch change rod.

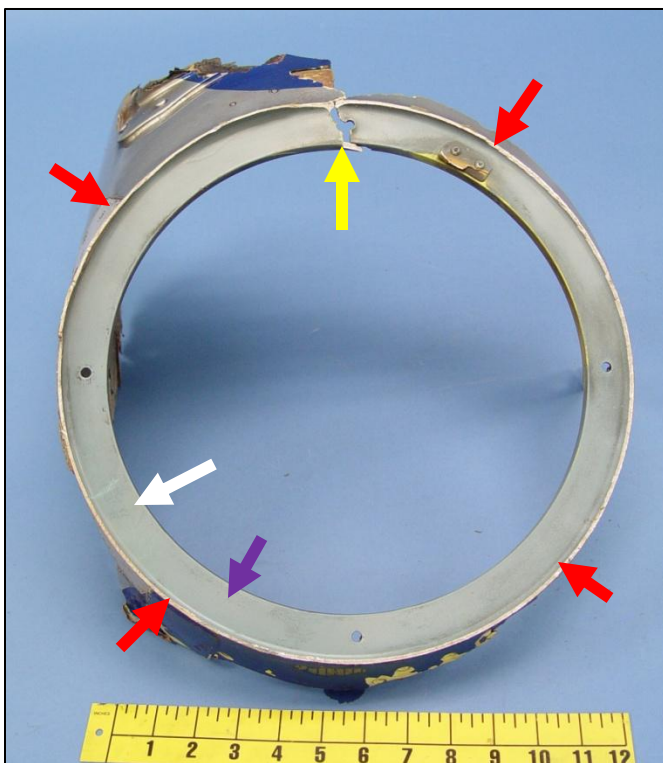
Figure 6. The junction frame in Figure 4 after cleaning.

The forward face of the junction frame was detergent cleaned to reveal a surface similar to the area indicated by the white arrow in Figure 4. The forward face is illustrated in Figure 6 with red arrows indicating the fracture face and a yellow arrow indicating the fracture at the hole at the 12 o' clock position. The white arrow indicates the location of the cleaned area similarly indicated in Figure 4. Examination of the forward face revealed indications of a peened identification at the approximately 5 o' clock location indicated by the purple arrow. As illustrated in Figure 7, paint and primer were removed with a fine abrasive paper to reveal the identifications "350 A23400 720 3" (the part number confirmed by drawing 350A234007, document 2 in section C), "Lot FAB 0055 FR 0630" and Lot HP 51 143101". The red arrows, as in Figure 6, indicate the fracture face.

Low magnification examination of the fracture face revealed a grainy surface with no obvious indications of any pre-existing cracks, consistent with an overload event. A more detailed examination of the fracture face was performed and the results are recorded in Materials Laboratory report 12-089.

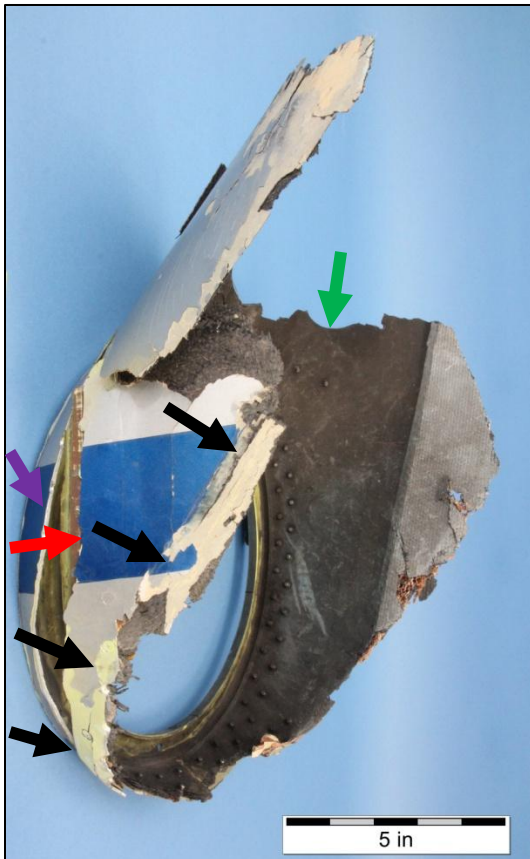
Figure 8. The junction frame in Figure 5 with the recovered mating piece indicated by the yellow arrow in Figure 9.

The fenestron structure piece indicated by the yellow arrow in Figure 9 was found to mate with the left side of junction frame piece and is illustrated in that position in Figure 8. The red arrows indicate a fracture face that had been separated from the junction frame fracture face indicated by the purple arrow (and by the purple arrow in Figure 5). Examination of the fracture faces revealed a grainy

surface consistent with an overload event. The black arrows indicate where the skin had been deflected inwards, along a straight line, removing paint and inducing cracks in that surface. The green arrow indicates the manufactured hole for the pitch change rod similarly indicated in Figure 5.

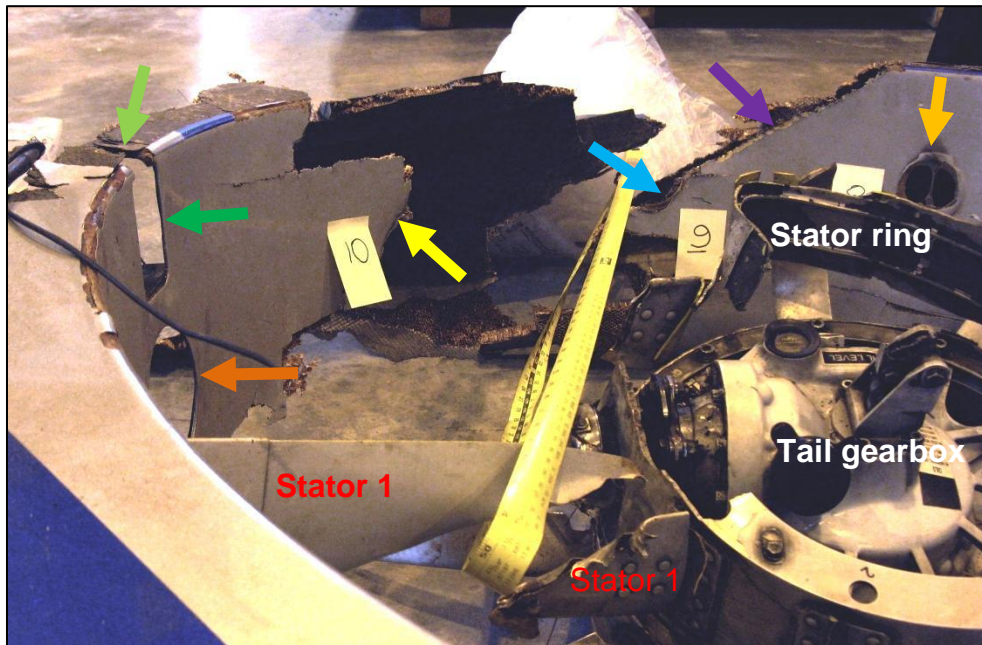
Figure 13. A lower portion of the duct in the recovered Fenestron.

Stator locations 8, 9 and 10 are illustrated in Figure 13 with the tail gearbox, the stator ring and the two portions of stator 1 identified. Stator 8 attachment had been extracted leaving the hole indicated by the orange arrow. There were no indications of contact from stator 8 on the duct surface adjacent to its attachment hole. Stator location 9 was intersected by the diagonal fracture indicated by the purple arrow in Figure 13 and Figure 9 and a portion of the hole is indicated by the blue arrow. The portion of duct between stator locations 9 and 10 was missing and a portion of the hole is indicated by the yellow arrow. As in Figure 11, the brown arrow indicates the hole for the tail rotor drive shaft and the green arrow indicates the hole for the pitch change rod with the pale green arrow indicating the tear in the skin emanating from the pitch change rod hole.

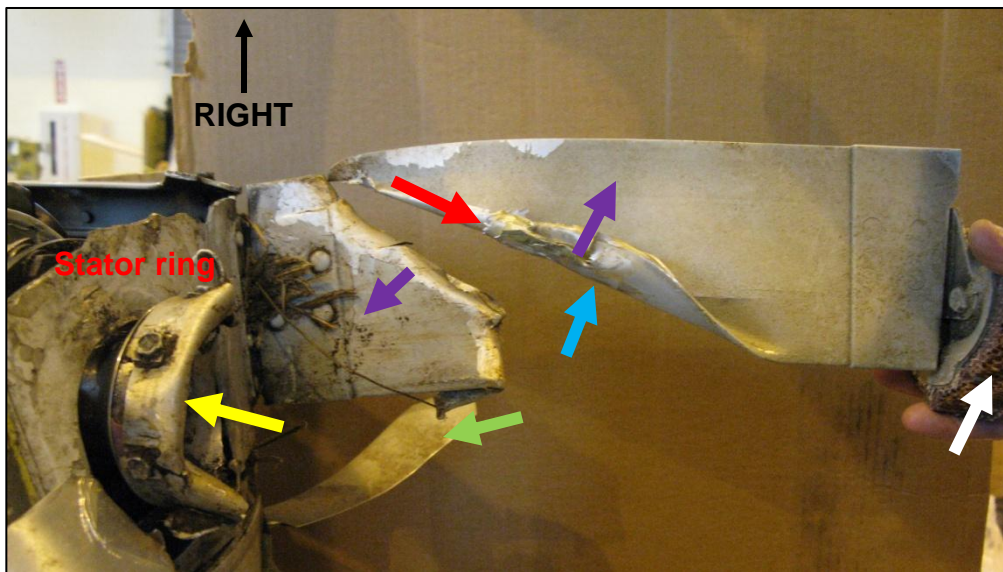
Figure 16. The fractured stator 1 identified in Figures 11 and 15.

The two pieces of the fractured stator 1 identified in Figure 15 are illustrated in Figure 16 with a blue arrow indicating bending of the fractured end of the larger piece similarly indicated in Figure 11. The stator ring is identified and a yellow arrow indicates the tail rotor drive shaft input to the tail gearbox as in Figure 15. Measurements, allowing for the bending, revealed that the stator was complete. Examination of the fracture faces revealed slant fracture faces with grainy surfaces, consistent with an overload event, with several edges displaying a sawtooth pattern, consistent with a high speed separation. The red arrow indicates one of the sawtooth edges. The purple arrows indicate the direction of the bending on both pieces of the stator and the green arrow indicates the bending direction of the adjacent portion of the inner piece. The white arrow indicates the outer end fitting indicated by the white arrow in Figure 11.

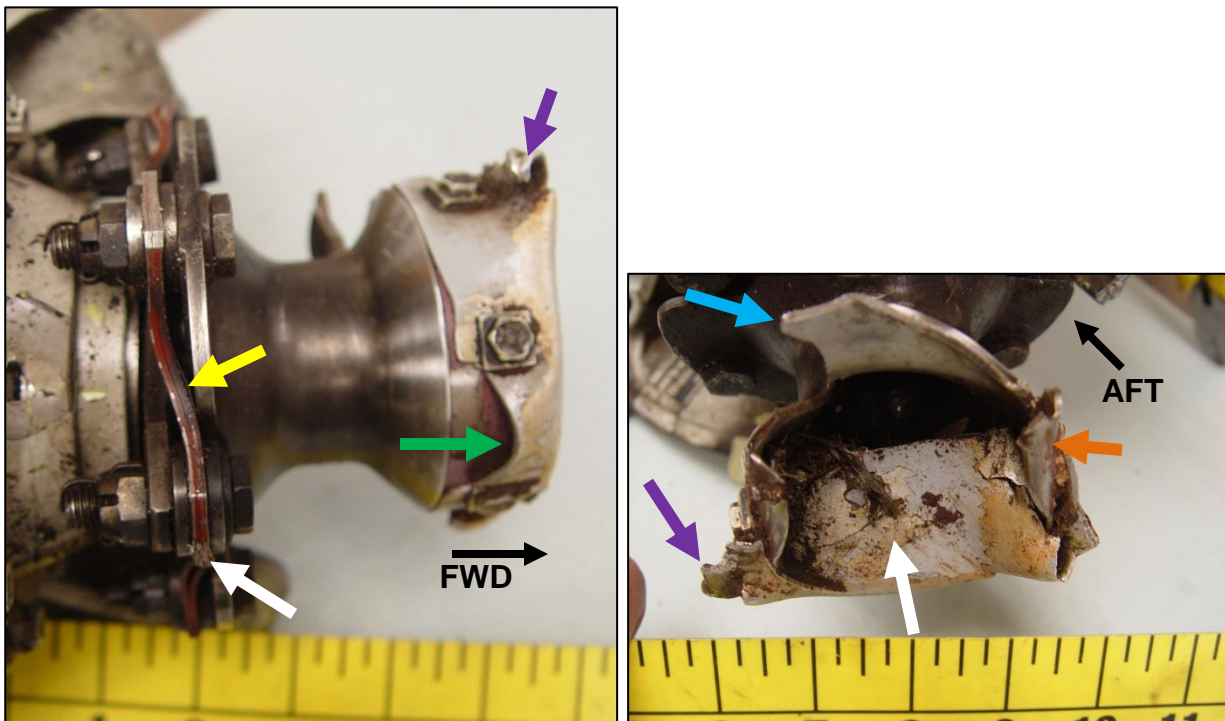
Figure 18. The rear drive shaft connection to the tail gearbox with the shaft rotated 180-degrees (left) and a view of the forward end of the drive shaft (right).

The drive shaft was smoothly rotated 180-degrees looking aft and is illustrated in the left image in Figure 18 with a yellow arrow indicating the coupling and a white arrow indicating mechanical damage at its bolted connection to the splined end fitting. The green arrow indicates a portion of the rear shaft that had been deformed forward by the deformation of the shaft indicated by the white arrow in the right image. In the right image in Figure 18 the blue arrow indicates the bent portion of the flange similarly indicated in the left image in Figure 17, the brown

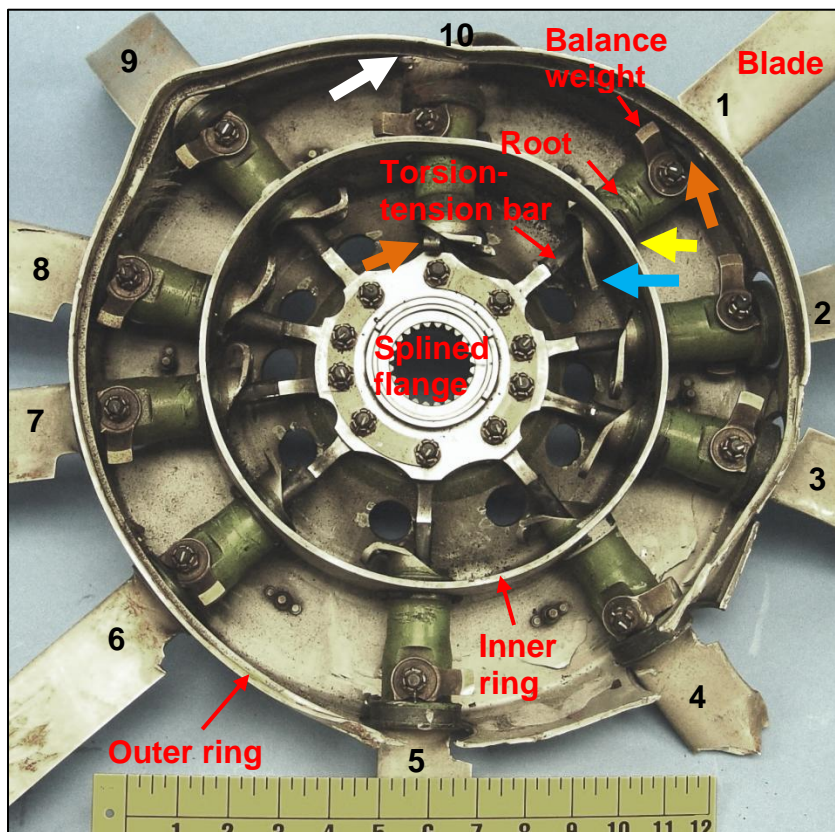
Figure 20. The tail rotor hub removed from the tail gearbox.

The tail rotor hub assembly removed from the tail gearbox was missing the fairing, the outer ring was distorted and fractured, blades were fractured and bent, inner and outer root bearings were missing and arms on the blade roots were bent and fractured. Removal of the center flange revealed that all the torsion/tension bars displayed compression buckling. The tail rotor hub components are illustrated in Figure 20 with the blades arbitrarily numbered 1 through 10 and their component parts identified on blade 1. The inner ring of the hub is identified and a yellow arrow indicates the location for the root inner bearing. The outer ring of the hub is identified and a brown arrow indicates the location for the root outer bearing. The splined flange is identified and provides the inner attachment for the torsion/tension bars and is normally driven by the gearbox. The hub rotates clockwise when viewed from the right. The center flange is normally connected to each of the arms on the blade roots and in operation it changes the blade pitch equally. Examination of the center flange revealed that four of its ten arms had fractured and the tips were missing. The fracture faces displayed rough grainy surfaces consistent with an overload event.

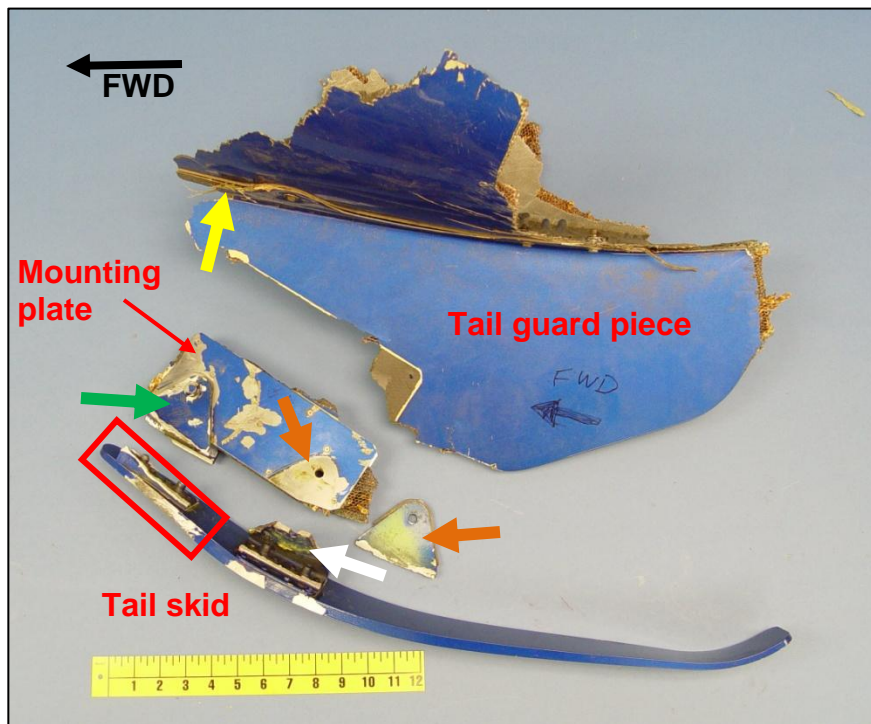
Figure 22. The recovered portion of the tail guard, the mounting plate assembly and the tail skid, left side.

The items in Figure 21 are also illustrated in Figure 22 in a similar orientation but viewed from the left side. The green arrow indicates the left lug of the front tail skid bracket still bolted to the mounting plate assembly. The brown arrow indicates the original location of the rear tail skid bracket lug on the left mounting plate and the white arrow indicates the right lug still bolted to the tail skid with a fracture across the bolt hole. The yellow arrow indicates vegetation trapped between the tail guard piece and the portion of the fenestron it is attached to. Details of the vegetation can be found in the Structures Factual Report.

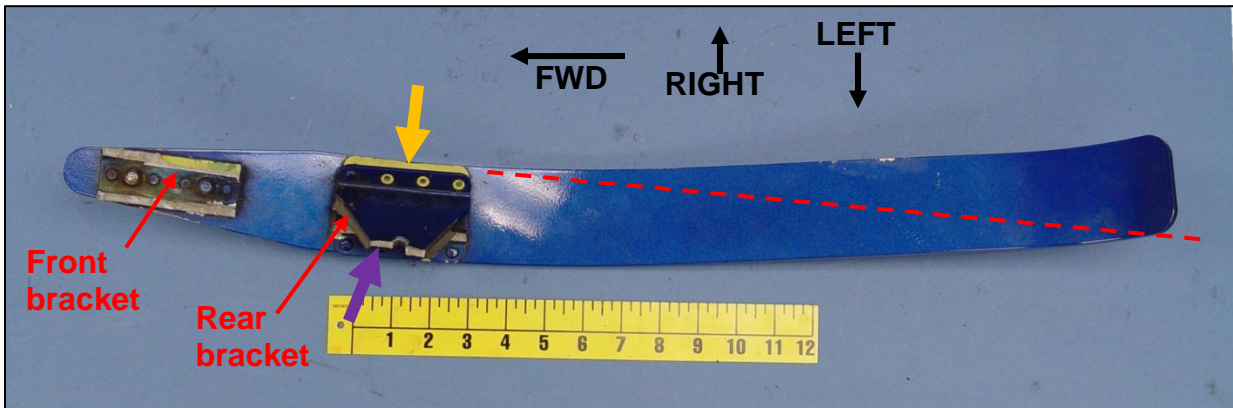
Figure 26. The upper side of the tail skid.

Examination of the tail skid revealed that the skid was bent, mechanically damaged and only portions of the front and rear brackets were still attached. The upper surface of the tail skid bracket is illustrated in Figure 26 with the remnants of the front and rear brackets identified and the forward, left and right directions indicated. The amount of bending is illustrated by the red dashed line which is a continuation of the right side of the skid adjacent to the rear bracket. The lower surface of the skid is illustrated in Figure 27 with the forward, left and right directions indicated. Mechanical damage was observed at the right rear tip of the skid located in the white box in Figure 27 and on the left edge and lower surface of the skid within the yellow box in Figure 27. Paint was missing around the front left rivet of the rear bracket within the green box in Figure 27 and lines on the surface appeared to emanate from the rivet.

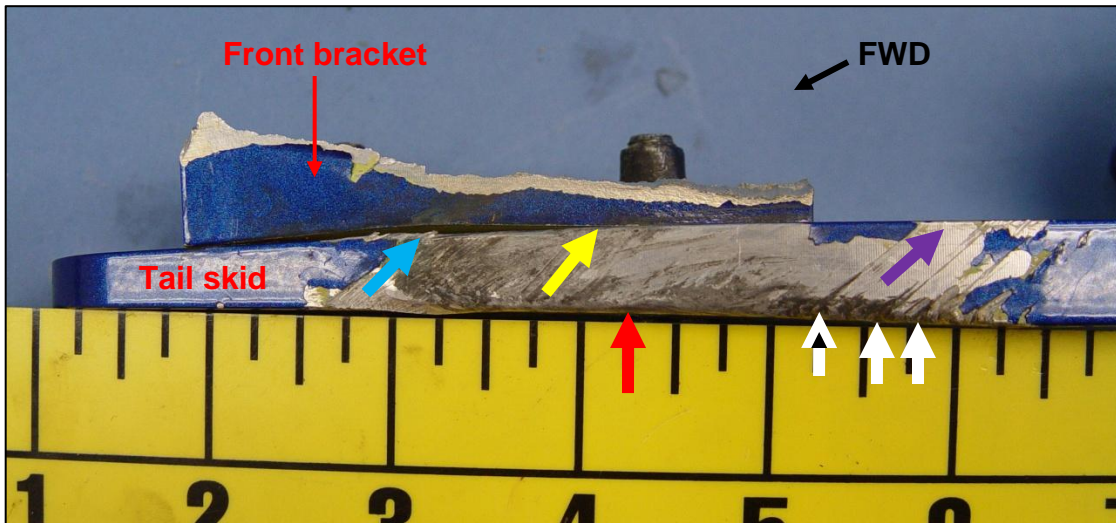
Figure 29. The left forward end of the tail skid within the red box in Figure 22.

The mechanical damage on the left edge of the skid, within the yellow box in Figure 27 is illustrated in Figure 29 with the installed forward direction indicated and the remnant of the front bracket lug identified. The blue, yellow and purple arrows indicate the direction of the adjacent surface scratches originating at the edge and the white arrows indicate some distinct gouges at the corner with the lower surface. The yellow ruler is used as a straight edge to indicate that a significant amount of material is missing from the lower surface of the skis adjacent to the left edge. The lower surface of the skid within the yellow box in Figure 27 is illustrated in Figure 30 with the yellow ruler again being used as a straight edge. The red arrow indicates a relatively small gap between the left edge and the ruler indicating that a small amount of material was missing. The black arrow indicates a straight gouge oriented diagonally and initiating at the left edge. The purple arrow indicates a distinct scratch oriented perpendicular to the edge and initiating at the edge. The blue arrows indicate distinctly radial scratches initiating at the edge. The white arrow indicates where paint had been removed leaving the primer and a dark deposit with a radial orientation.

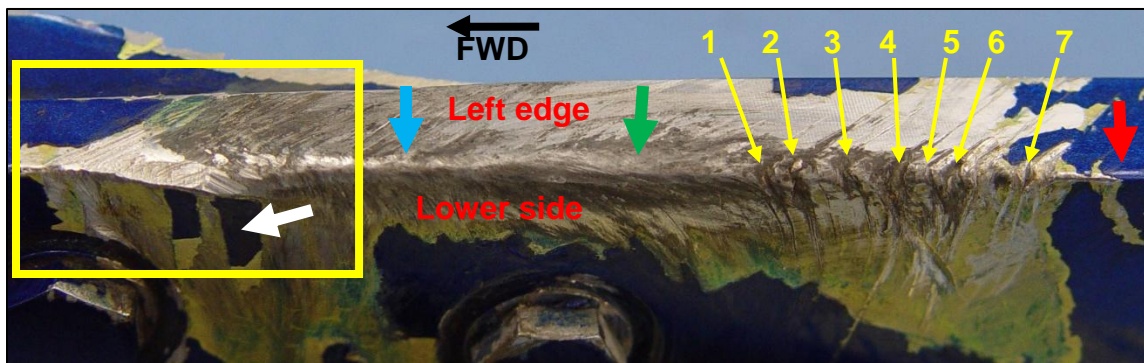
Figure 31. The left forward edge and underside of the tail skid illustrated in Figures 29 and 30.

The corner at the intersection of the left edge and the lower surface is illustrated in Figure 31. The red arrow indicates an undamaged corner and the black and blue arrows indicate the same corner with differing amounts of damage appearing as radii. An area at the forward end was clean, displayed a distinct pattern of scratches and is contained within the yellow box. A group of seven distinct grooves associated with some of the previously noted scratches were observed and are numbered 1 through 7. The white arrow indicates an area of paint that was removed for analysis and is illustrated later in Figure 38.

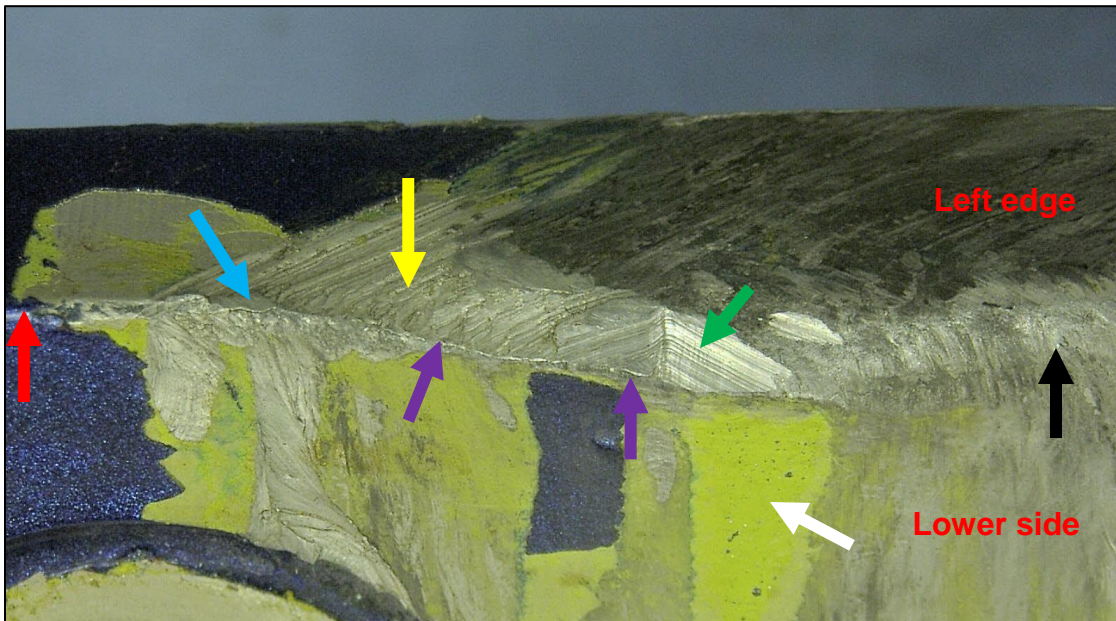
Figure 32. The left forward edge and underside of the tail skid within the yellow box in Figure 31.

The area within the yellow box in Figure 31 is illustrated in Figure 32 with the left edge and the lower side identified. The red arrow indicated an undamaged corner and the green arrow indicates the damaged corner. The white arrow indicates where the paint sample indicated in Figure 31 was located. The yellow arrow indicates an area displaying distinct diagonally oriented scratches and the blue arrow indicates mechanical damage that had smoothed out the scratches. The green arrow indicates a v-shaped area with a distinct center line and parallel scratches on either side. The purple arrows indicate the new corner between the left edge and the lower surface which consisted of a bur where left edge material had been displaced toward the lower surface.

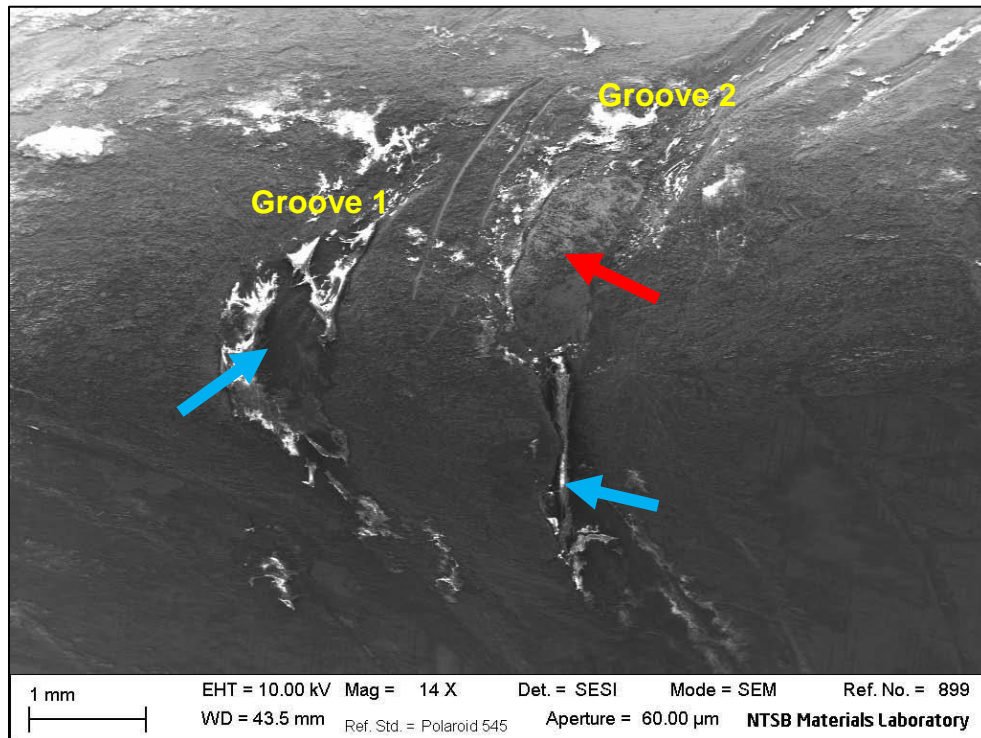
Figure 33. SEM image of the grooves identified as "1" (left) and "2" (right) in Figure 31.

The remnant of the front bracket identified in Figure 26 was removed. The damaged portion of the skid illustrated in Figure 31 was removed by cutting across the skid at the red dashed line and then along the yellow dashed line in Figure 30. The seven distinct grooves identified in Figure 31 were then examined in a scanning electron microscope (SEM). An SEM micrograph of grooves 1 and 2 is illustrated in Figure 33 with the grooves identified. The blue arrows indicate material trapped in each groove and the red arrow in groove 2 indicates an entrapped particle.

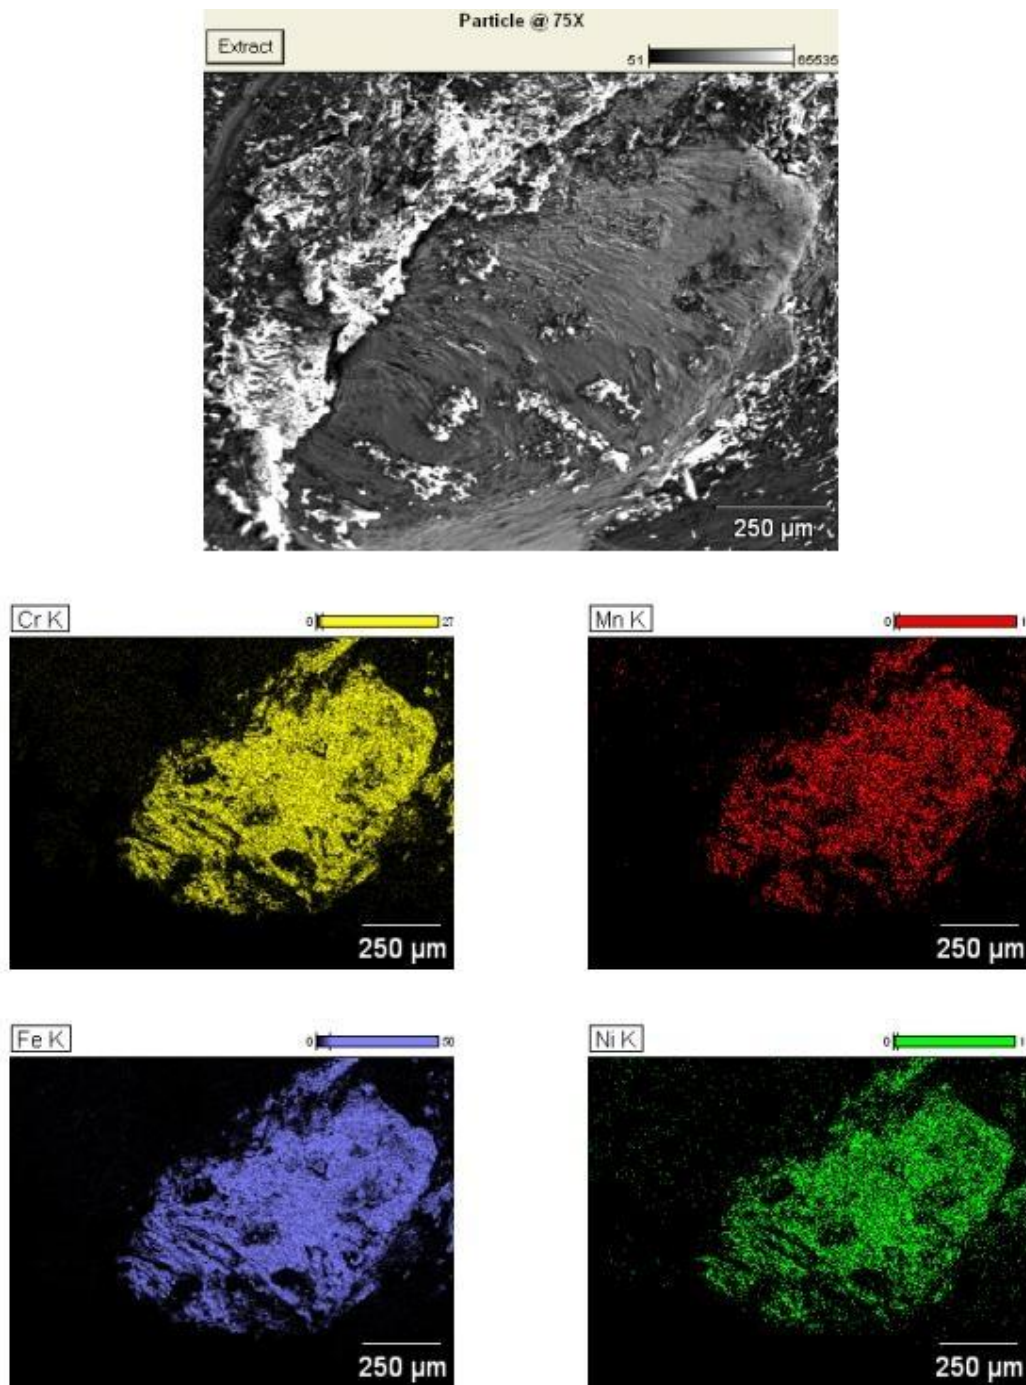
Figure 34. EDS map of major elements in the particle in groove 2 and indicated by the red arrow in Figure 33.

The particle indicated by the red arrow in Figure 33 was analyzed by an energy dispersive spectrometer (EDS) on the SEM and elemental mapping was performed. Figure 34 illustrates the particle and the dispersion of the major elements in the particle. The upper image illustrates the particle, the middle images indicate the presence of chromium (left) and manganese (right), and the lower images indicate the presence of iron (left) and nickel (right), elements consistent with a stainless steel.

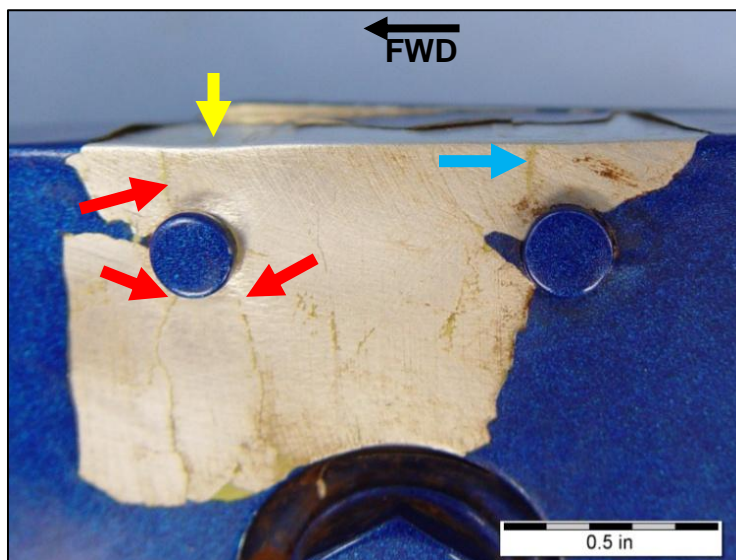
Figure 42. The underside of the tail skid contained in the green box in Figure 27.

The area within the green box in Figure 27 contained rivets with surface lines emanation from them. The area is illustrated in Figure 42 with red arrows indicating the radial lines around the forward rivet and a blue arrow indicating a radial line emanating from the adjacent rivet. The yellow arrow indicates a depression in the left edge. A dye penetrant inspection was performed on the area in Figure 42 and did not display any indications of cracks.

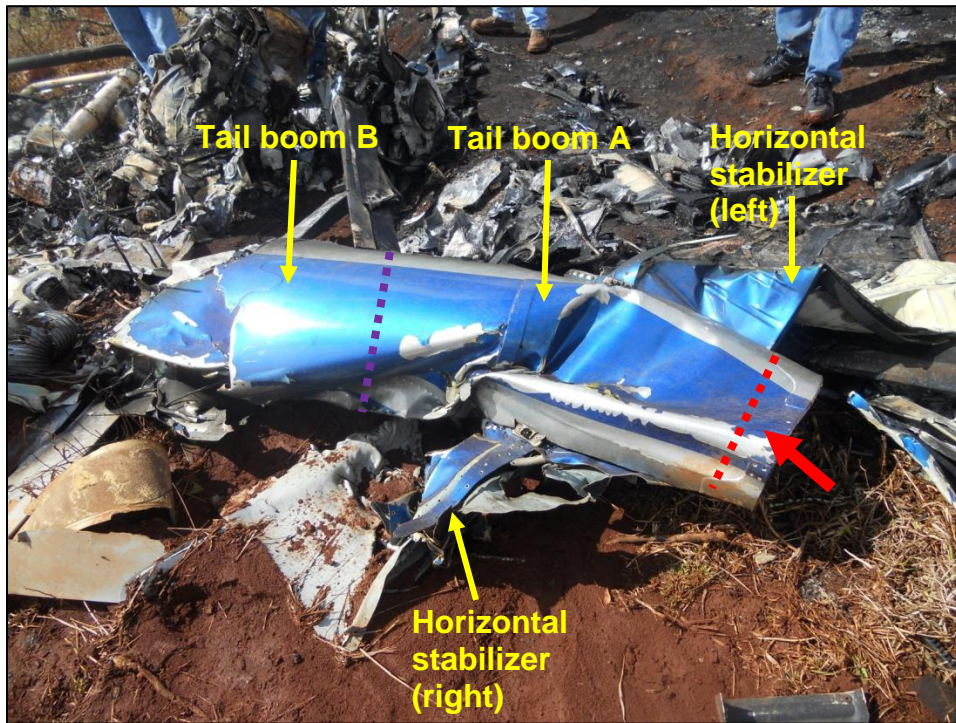
Figure 43. The tail boom and attached horizontal stabilizer at the accident site and identified in Figure 1.

A closer view of the tail boom identified in Figure 1 is illustrated in Figure 43 with the left and right portions of the horizontal stabilizer identified. The lack of longitudinal flanges for attachment of the tail rotor drive shaft cover is consistent with the tail boom being inverted. The tail boom was cut along the red dashed line and the portion indicated by the red arrow was shipped with the fenestron pieces as it contained the mating fracture to the junction frame piece as illustrated in Figure 3. A portion of the tail boom containing the tail rotor drive shaft number 1 bearing was also removed and shipped with the fenestron pieces. The tail boom was subsequently shipped to the NTSB facility in Ashburn, Virginia after being cut along the purple dashed line for shipping. In Figure 43 the rear portion of the tail boom is identified as “A” and the forward portion is identified as “B”. The investigative group was re-convened at the NTSB facility to examine the tail boom but the operator declined the invitation.

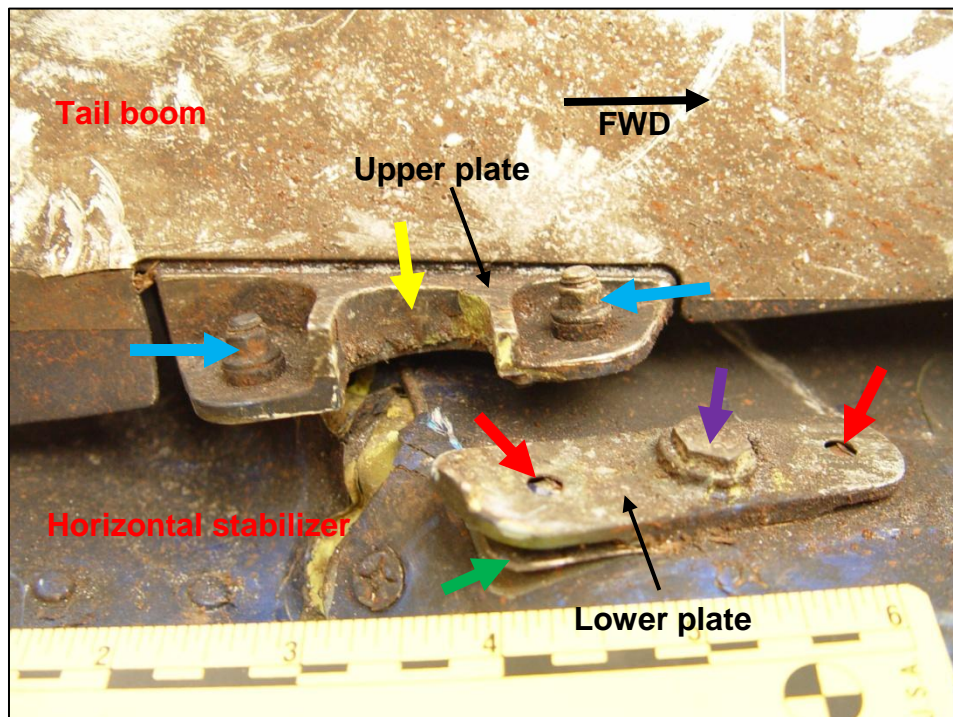
Figure 46. The right upper horizontal stabilizer attachment.

The right upper attachment for the horizontal stabilizer identified in Figure 45 was found displaced forward and outboard and is illustrated in Figure 46 with the horizontal stabilizer and the tail boom identified. The red arrows indicate the fractured ends of screws in the lower plate and the blue arrows indicate the ends of the same screws in the upper plate. The yellow arrow indicated a recess in the upper plate where the main attachment bolt indicated by the purple arrow is normally located. The green arrow indicates a gap between the lower plate and the skin of the horizontal stabilizer. Examination of the horizontal stabilizer attachments can be found in the Structures Factual Report.

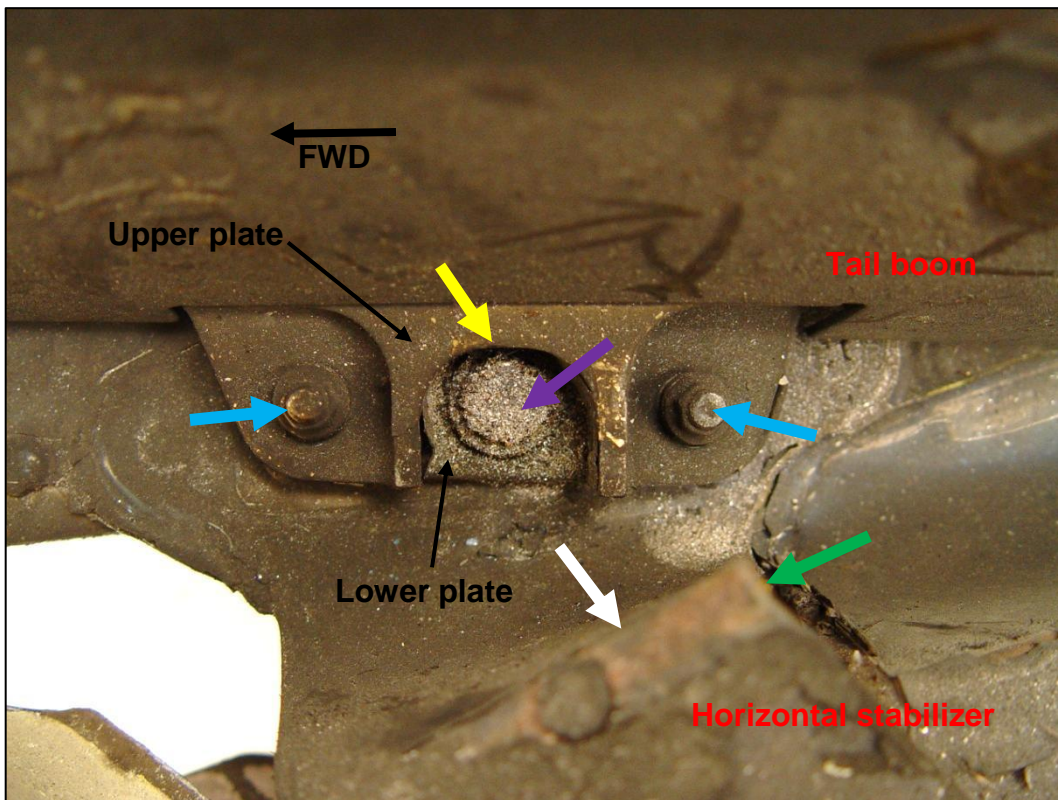
Figure 48. The left upper horizontal stabilizer attachment.

The left upper attachment for the horizontal stabilizer identified in Figure 45 was found displaced slightly inboard and is illustrated in Figure 48 with the horizontal stabilizer and the tail boom identified. The blue arrows indicate the ends of the screws similarly identified in Figure 46. The purple arrow indicates the head of the main attachment bolt which is too close to the recess indicated by the yellow arrow to allow the installation of a socket on the head. The white arrow indicates a buckled

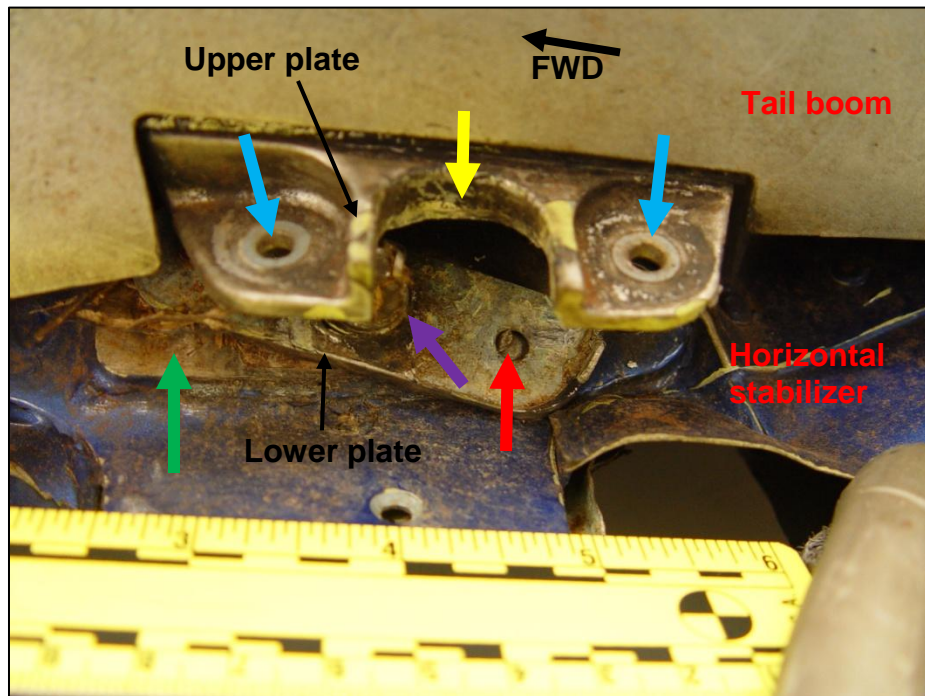
Figure 50. The right lower horizontal stabilizer attachment.

Examination of the horizontal stabilizer right lower attachment revealed that the stabilizer had been displaced forward and the lower plate had rotated. The right lower attachment is illustrated in Figure 50 with the forward direction indicated. The blue arrows indicate the holes in the upper plate normally occupied by screws and nuts similarly indicated in Figures 48 and 48 and the yellow arrow indicates the recess normally occupied by the main attachment nut indicated by the purple arrow. The red arrow indicates the fractured end of a screw and the green arrow indicates the original location of the lower plate.

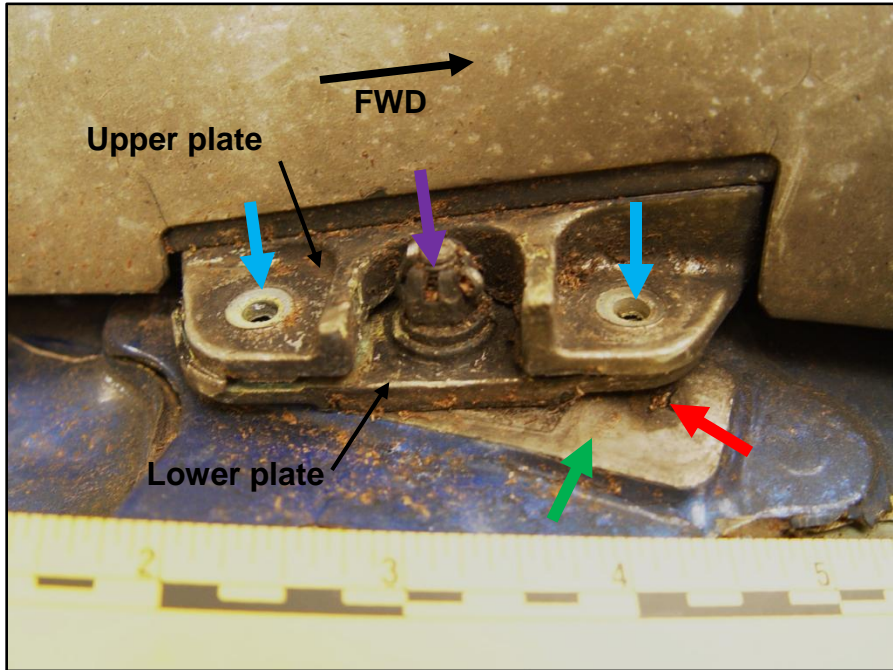
Figure 51. The left lower horizontal stabilizer attachment.

The left lower attachment of the horizontal stabilizer is illustrated in Figure 51 with the forward direction indicated. The blue arrows indicate the holes in the upper plate normally occupied by screws and nuts and the purple arrow indicates the main attachment nut (and cotter pin) still positioned in the recess in the upper plate. The red arrow indicates the fractured end of a screw and the green arrow indicates the original location of the lower plate.

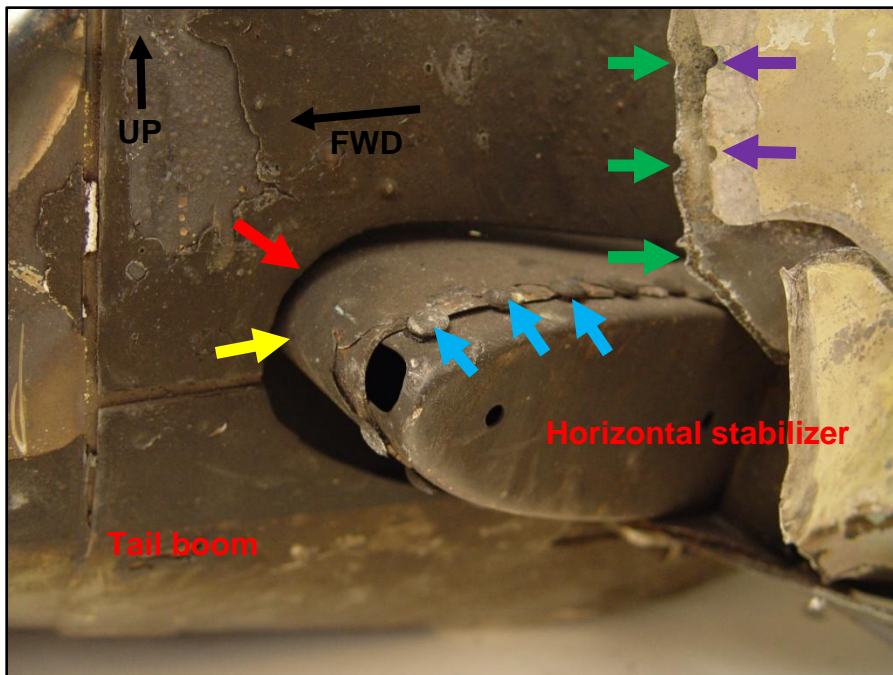
Figure 52. The left leading edge of the horizontal stabilizer.

For comparison with the left image in Figure 47, the leading edge of the horizontal stabilizer indicated by the purple arrow in Figure 45 is illustrated in Figure 52 with the forward and up directions indicated. The yellow arrow indicates the leading edge and the red arrow indicates the forward edge of the slot in the tail boom for the horizontal stabilizer. The blue arrows indicate rivets with fractured skin between them, the green arrows indicate partial rivet holes in the upper skin with fractured skin between them and the purple arrows indicate partial rivet holes in the lower skin with fractured skin between them. Examination of the fracture faces between the blue, green and purple arrows revealed a slant fracture consistent with an overload event although the features between the green and purple arrows were less defined consistent with exposure to fire.

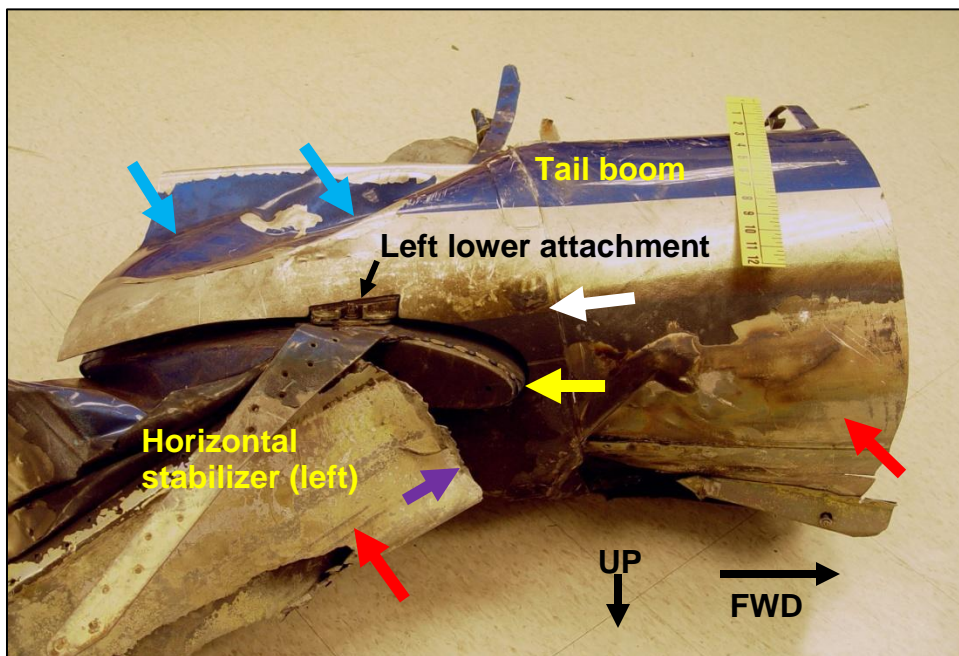
Figure 54. Buckling at the left side of the tail boom.

The left side of the tail boom is illustrated in Figure 54 with the forward and up directions indicated. The left portion of the horizontal stabilizer and the left lower attachment illustrated in Figure 51 are identified. The white arrow indicates the location of the mainframe and the blue arrows indicate the diagonally oriented buckling on the underside aft of the mainframe, similarly indicated in Figure 49. The orange arrow indicates the leading edge of the horizontal stabilizer illustrated in Figure 52 and the purple arrows indicate the fractured edge similarly indicated in Figure 52. The red arrows indicate fire damaged areas on the tail boom and the horizontal stabilizer.
