# NATIONAL TRANSPORTATION SAFETY BOARD

**MATERIALS LABORATORY FACTUAL REPORT**

Report No. 13-012

Place : Parkton, North Carolina  
Date : December 16, 2012  
Vehicle : Piper PA-28-160  
NTSB No. : ERA13FA088  
Investigator : Timothy Monville NTSB-ERA

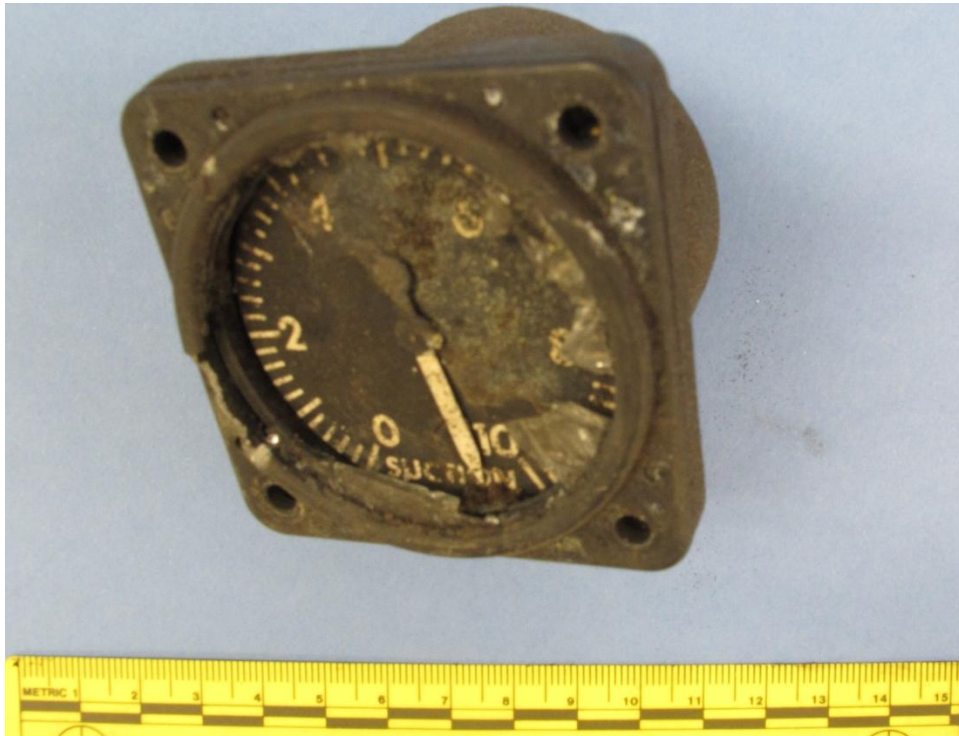
**Figure 1.** Overall photograph of suction gauge.

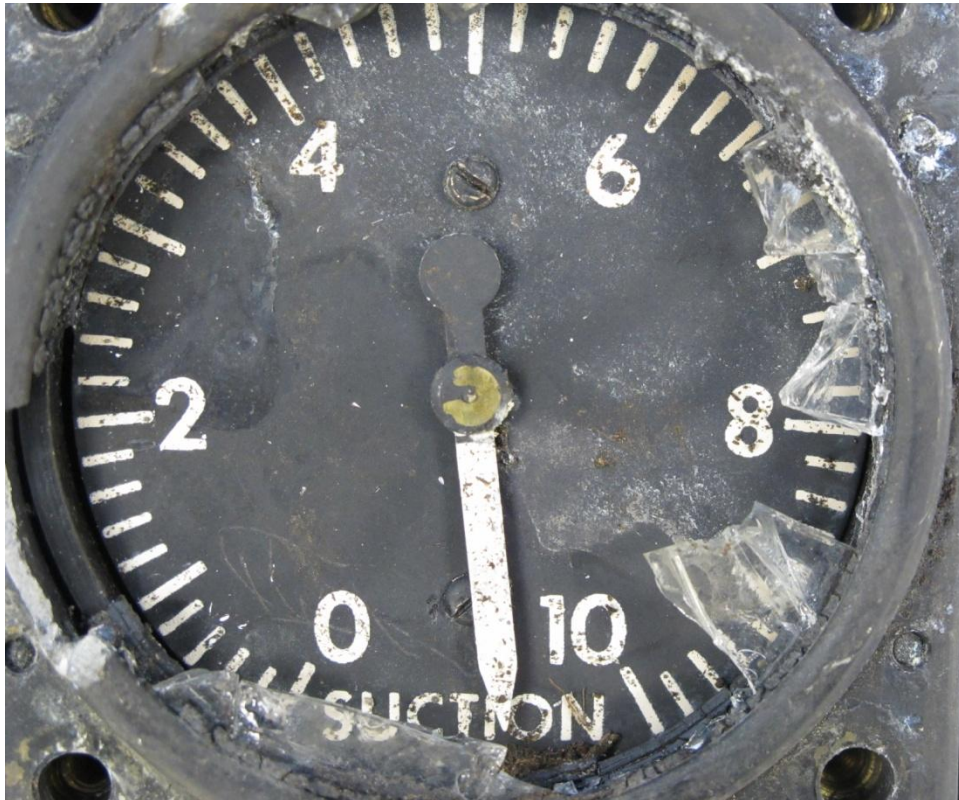
The suction gauge, as shown in Figure 1, from the accident aircraft was submitted to the NTSB Materials Laboratory to examine the indicator face for the presence of witness marks from the indicator arm. The watch glass was broken but the gauge face was intact as shown in Figure 2. The gauge face was cleaned by using dry air to blow away debris on the gauge face. The gauge face was examined with a 5X to 50X zoom stereomicroscope. There was no indication of any witness marks on the gauge face.

**Figure 2.** Photograph of suction gauge face.
