NATIONAL TRANSPORTATION SAFETY BOARD

MATERIALS LABORATORY FACTUAL REPORT

Report No. 13-021

Place : Parkers Prairie, Minnesota
Date : February 20, 2013
Vehicle : Maule MXT7-180
NTSB No. : CEN13FA172
Investigator : Pam Sullivan, AS-CEN

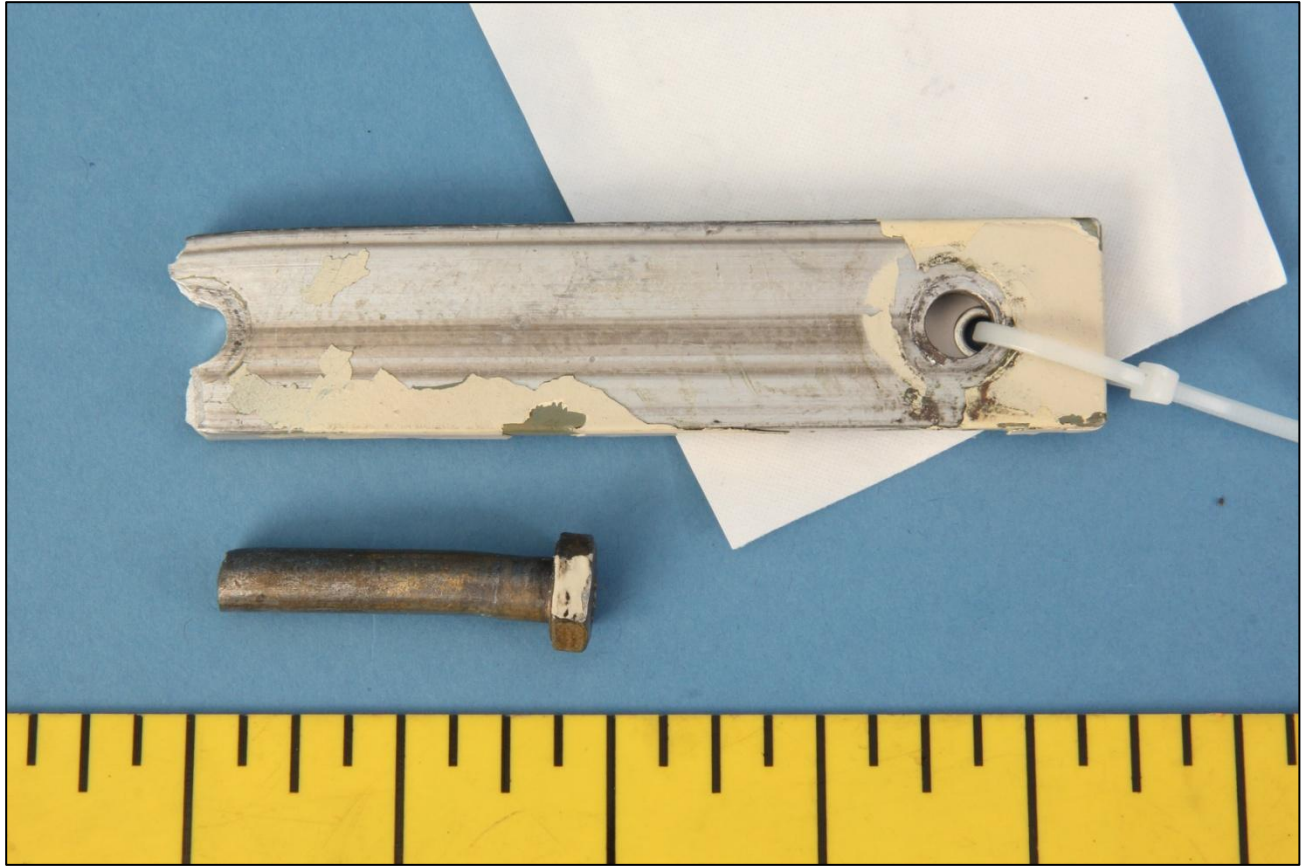
An overall view of the submitted bolt and bracket pieces are shown in figure 1. The bolt was slightly bent and was fractured in the shank. The bracket was fractured through a bolt hole. The bolt fracture surface was flat and showed deformation adjacent to the fracture consistent with overstress fracture under direct shear loading. The bracket had rough matte-gray fracture features with necking deformation and some twist deformation consistent with ductile overstress fracture under mostly tension loading and some torsion loading. No evidence of preexisting cracks was observed on either of the submitted pieces.

Figure 1. Overall view of the submitted bracket and bolt pieces.
