# NATIONAL TRANSPORTATION SAFETY BOARD

## MATERIALS LABORATORY FACTUAL REPORT

Report No. 13-022

Place : Atlanta, Georgia.  
Date : January 13, 2013.  
Vehicle: Cessna 560XL, N662QS.  
NTSB No.: ERA13IA114.  
Investigator: Dennis Diaz.

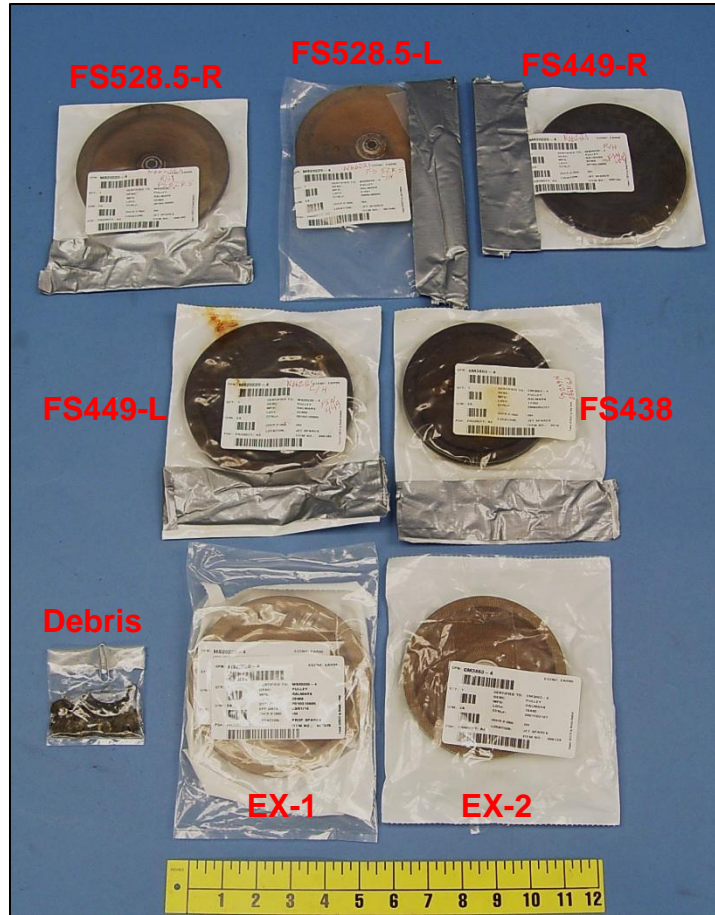
Seven elevator control pulleys and debris removed from the vicinity of the pulleys in the aircraft's tail cone was received for examination and are illustrated and identified in Figure 1. Five pulleys were received in bags, sealed with duct tape, that were reportedly the bags that their replacements were received in and two new pulleys were received in sealed bags. The five duct taped bags were additionally identified with the aircraft registration number, N662QS, and with their location on the aircraft which consisted of their frame station (FS) number followed by their position, left (L) or right (R) where applicable. The five pulleys are identified in Figure 1 as "FS528.5-R", "FS528.5-L", "FS449-R", "FS449-L", "FS 438" and the two new (exemplar) pulleys are identified as "EX-1" and "EX-2". The debris was received in the zip-closure bag illustrated in Figure 1.

Figure 1. The pulleys and debris received for examination.

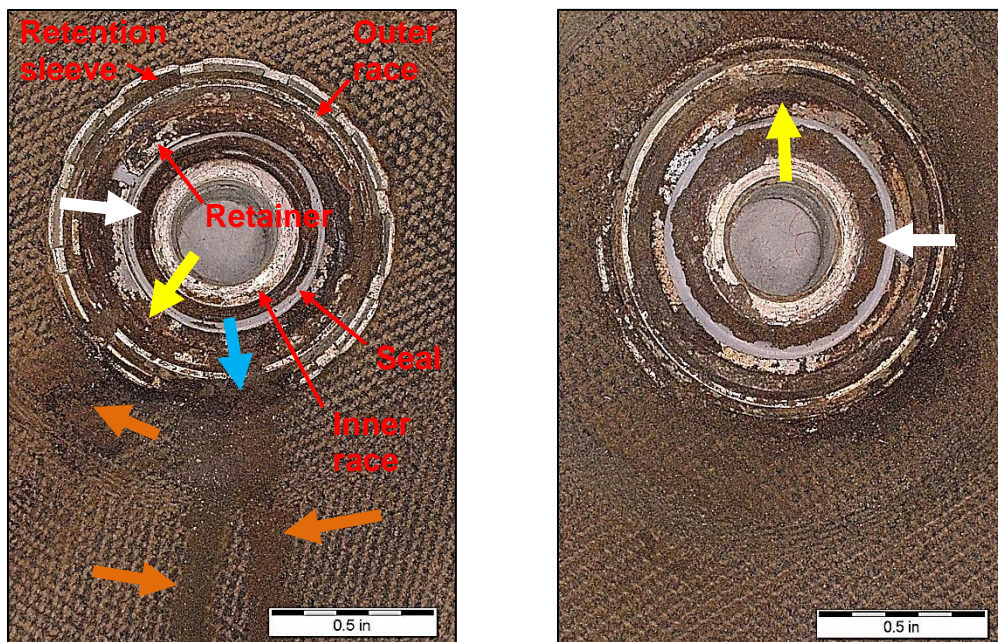
Examination of the pulley revealed the identifications "RALMARK", "MS20220-4" AND "8M" printed on one side. The bearing could not be rotated by hand and radially oriented stains were observed emanating from the bearing on both sides. Both sides of the bearing are illustrated in Figure 2 with the retention sleeve, outer race, inner race, seal and retainer identified in the left image. The white arrow in both images indicates a relatively hard deposit on the seal and around the exposed outer diameter of the inner race that could be removed with a finger nail. The yellow arrow in both images indicates a deposit on the retainer that could be removed by wiping with a finger. The brown arrows in the left image indicate the radially oriented stains that were more prominent on that side of the pulley and the blue arrow indicates a deposit at the origin of the stains.

Figure 2. One side of the bearing in pulley FS528.5-R (left) and the other side (right).

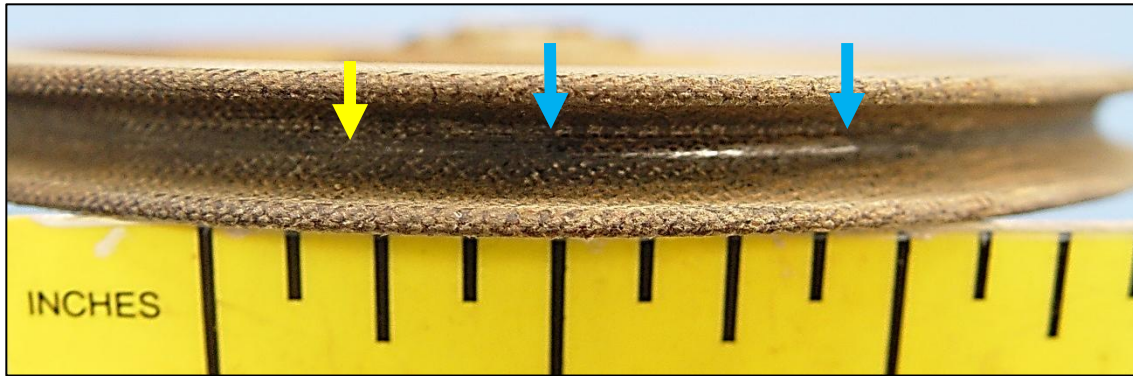
The examination also revealed a shiny surface in the root of the pulley groove. The shiny surface is illustrated in Figure 3 and contained between the two blue arrows. The yellow arrow indicates the root that displayed signs of use that was typical of the remainder of the pulley and can be compared with Figure 14.

Figure 3. A portion of the groove in pulley FS528.5-R.

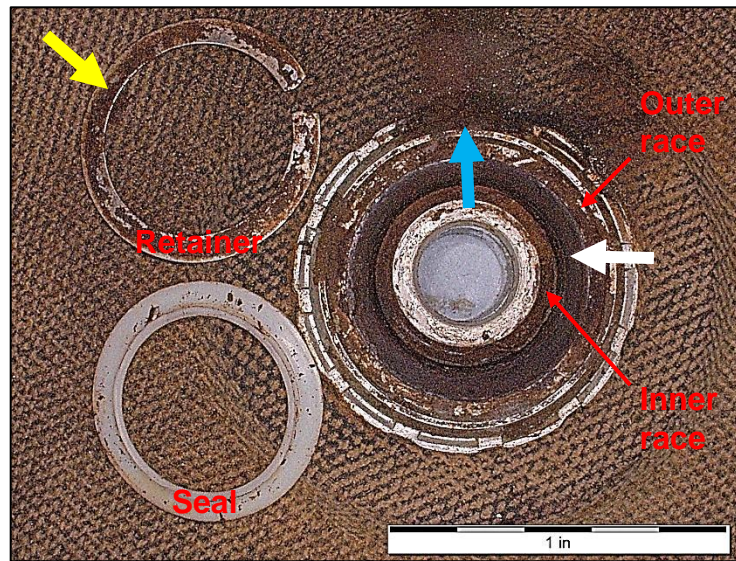
The retaining rings and seals were removed from both sides of the bearing to reveal a smooth hard surface. The side of the bearing illustrated in the left image in Figure 2 is illustrated in Figure 4 with the outer race, the inner race, the retainer and the seal identified. The white arrow indicates the smooth hard surface and the blue arrow indicates the deposit similarly indicated in Figure 2. The yellow arrow indicates the deposit on the retainer, similarly indicated in Figure 2, which was wiped off to reveal the identifications "SCHATZ", USA" and "PD5K".

Figure 4. The bearing in pulley FS528.5-R partially disassembled.

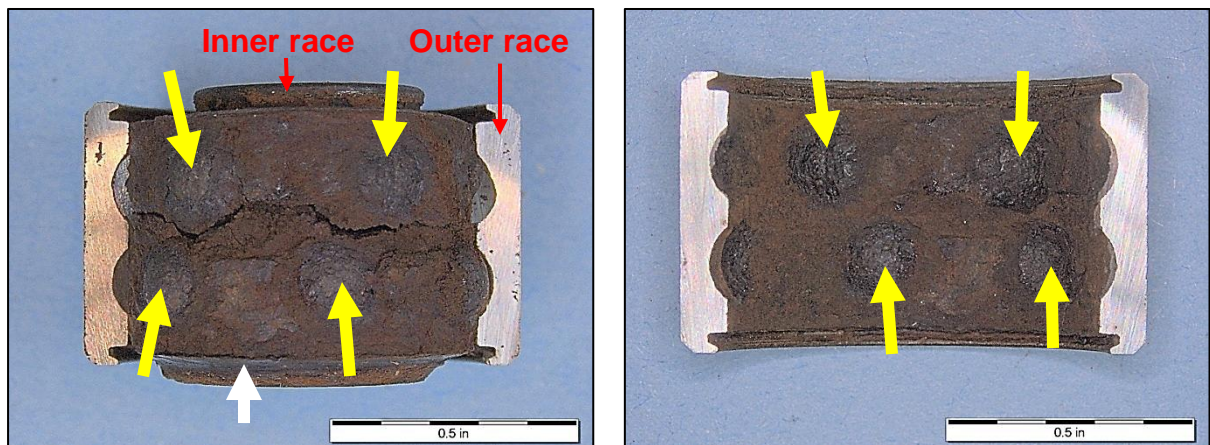
The bearing, with the retention sleeve, was pressed out of the pulley, the retention sleeve removed, the outer race of the bearing cut at opposing sides and one half of the outer race removed to reveal the bearing. The revealed bearing is illustrated in the left image in Figure 5 with the inner and outer races identified and a white arrow indicating one of the smooth hard surfaces previously noted. The yellow arrows indicate corroded balls that were firmly affixed in a cylinder of corrosion product. The removed outer race is illustrated in the right image in Figure 5 with yellow arrows indicating corroded impressions of the balls similarly indicated in the left image.

Figure 5. The exposed balls in pulley FS528.5-R bearing (left) and the inner surface of the outer race (right).

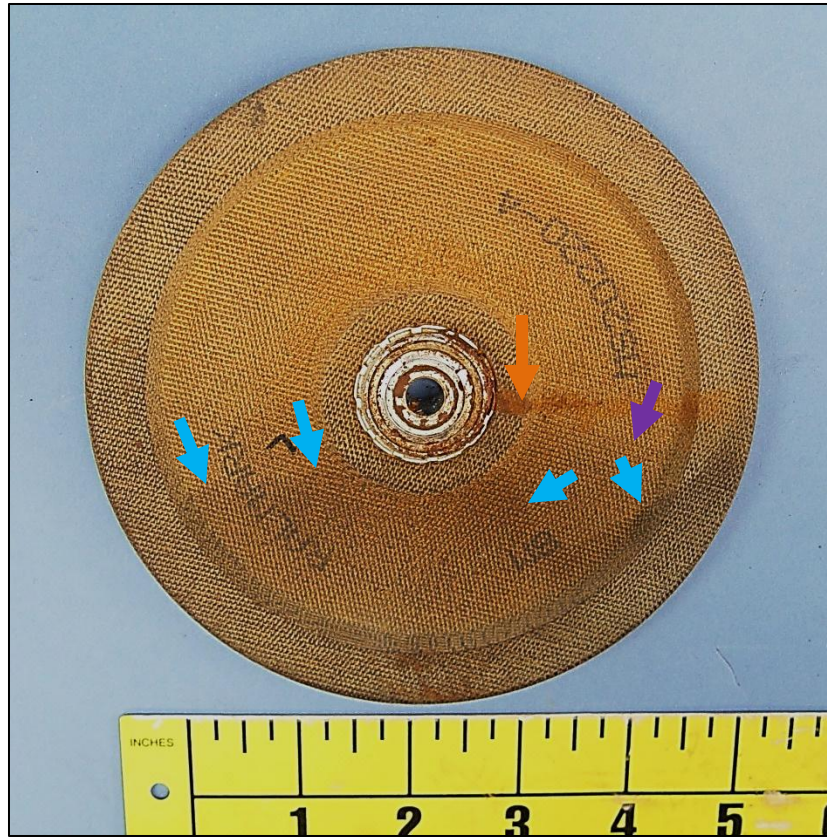
Examination of the pulley revealed the identifications "RALMARK", "MS20220-4" AND "8M" printed on one side. The pulley displayed stains, deposits on the bearing and a shiny area in the root of the groove. The bearing could not be rotated by hand. The identified side of the pulley is illustrated in Figure 6 with blue arrows indicating the relatively straight edges of a stained area. The brown arrow indicates a radially oriented stain emanating from the bearing and the purple arrow indicates an area of lighter staining.

Figure 6. One side of pulley FS528.5-L.

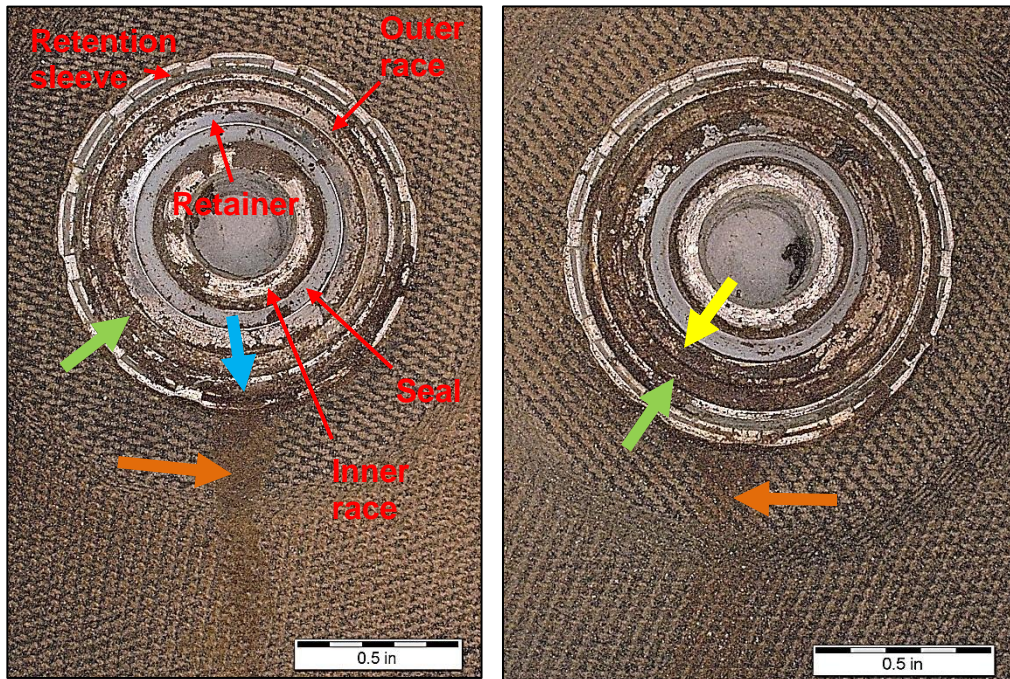
Both sides of the bearing are illustrated in Figure 7 with the retention sleeve, outer race, inner race, seal and retainer identified in the left image. The green arrow in both images indicates a deposit on the edge of the outer race that could be removed by wiping with a finger and the yellow arrow in the right image indicates a deposit on the retainer. The brown arrow in both images indicates radially oriented stains emanating from the bearing and the blue arrow in the left image indicates a deposit at the stain origin.

The retaining rings and seals were removed from both sides of the bearing to reveal a smooth hard surface similar to the bearing in pulley FS528.5-R illustrated in Figure 4. The deposit on the retainer, illustrated in Figure 7, was wiped off to reveal the identifications "SCHATZ", "USA" and "PD5K".

Figure 7. Pulley FS528.5-L bearing illustrated in Figure 6 (left) and the other side (right).

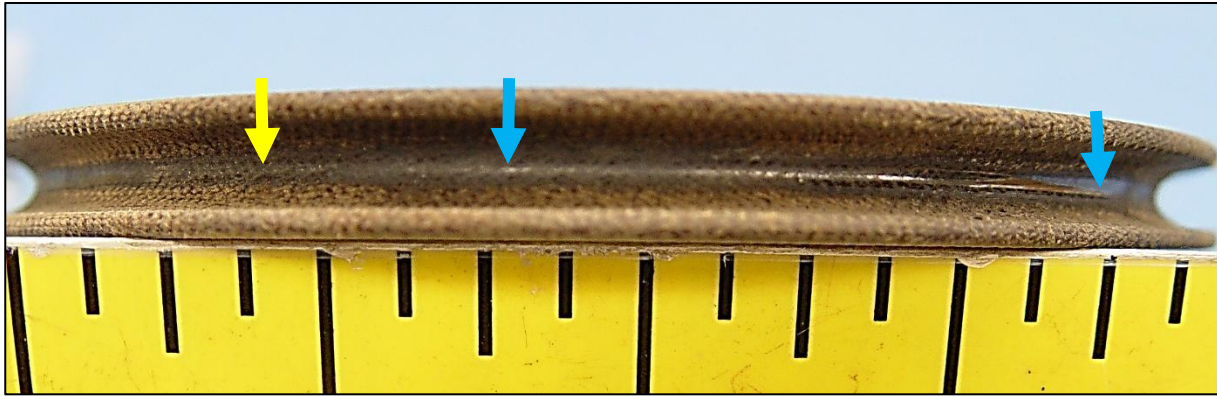
The examination also revealed a shiny surface in the root of the pulley groove. The shiny surface is illustrated in Figure 8 and contained between the two blue arrows. The yellow arrow indicates the root that displayed signs of use that was typical of the remainder of the pulley and can be compared with Figure 14.

Figure 8. A portion of the groove in pulley FS528.5-L.

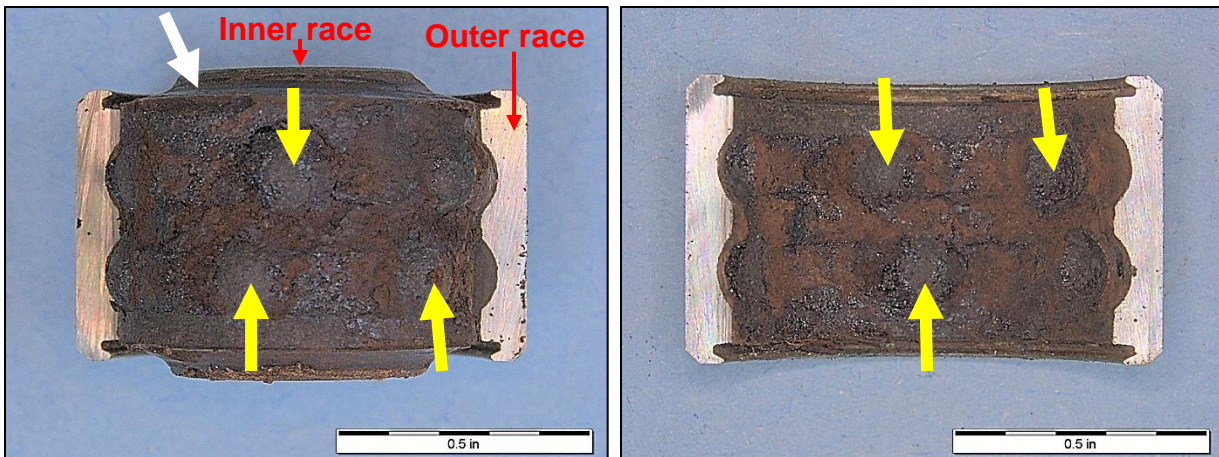
The bearing, with the retention sleeve, was pressed out of the pulley, the retention sleeve removed, the outer race of the bearing cut at opposing sides and one half of the outer race removed to reveal the bearing. The revealed bearing is illustrated in the left image in Figure 9 with the inner and outer races identified and a white arrow indicating one of the smooth hard surfaces previously noted. The yellow arrows indicate corroded balls that were firmly affixed in a cylinder of corrosion product. The removed outer race is illustrated in the right image in Figure 9 with yellow arrows indicating corroded impressions of the balls similarly indicated in the left image.

Figure 9. The exposed balls in pulley FS528.5-L bearing (left) and the inner surface of the outer race (right).

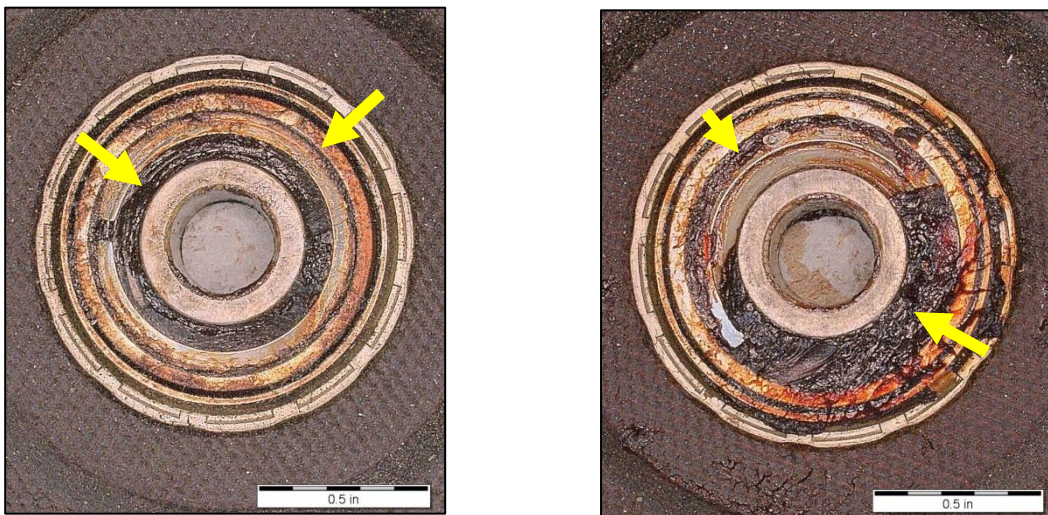
Examination of the pulley revealed that it was uniformly darker in color than the previously examined pulleys from FS528.5 and the exemplar pulleys. The pulley felt damp when handled and had a similar but stronger odor than the pulleys from FS528.5. The discoloration had almost obliterated the identifications but “RALMARK” and “MS20220-4” were still discernible. The bearing was found to rotate smoothly by hand and exhibited grease on both sides. Both sides of the bearing are illustrated in Figure 10 with yellow arrows indicating the grease. The discoloration of the pulley can be compared with a similar image of one of the exemplar pulleys illustrated later in Figure 13. The bearing, with the retention sleeve, was pressed out of the pulley and the retention sleeve removed. The retaining rings and seals were removed to reveal the bearing cage and grease on the cage. Grease was removed from the retainer to reveal the identifications “SCHATZ”, USA” and “PD5K”.

To identify the dampness on the pulley it was swabbed with a clean cotton swab to remove any residue or debris from the surface. The swab was then examined using an FTIR<sup>2</sup> to determine the identity of the residue. The spectra from the swab indicated the presence of water and a silicon-based product.

Figure 10. One side of the bearing in pulley FS449-R (left) and the other side (right).

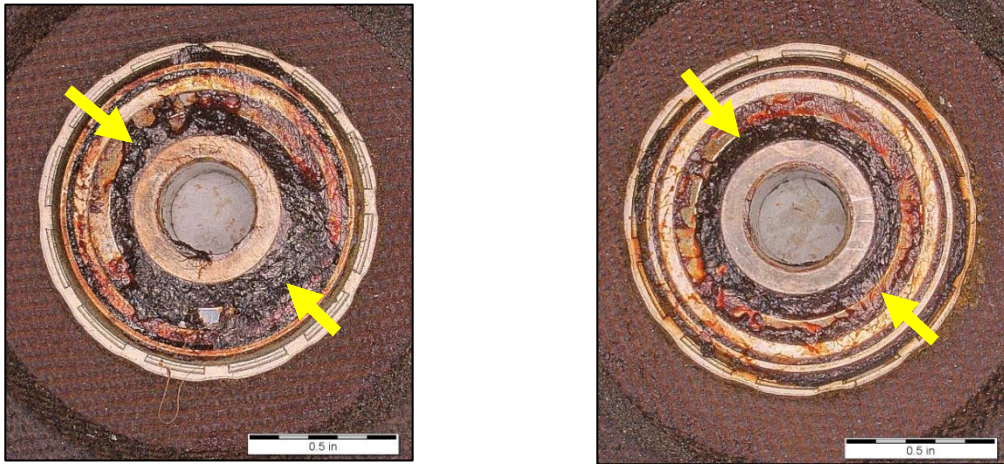
Examination of the pulley revealed that it was uniformly darker in color, similar to pulley FS449-R. The pulley also felt damp when handled and had a similar odor. The discoloration had almost obliterated the identifications but “RALMARK”, and “MS20220-4” were still discernible. The bearing was found to rotate smoothly by hand and exhibited grease on both sides. Both sides of the bearing are illustrated in Figure 11 with yellow arrows indicating the grease. The discoloration of the pulley can be compared with a similar image of one of the exemplar pulleys illustrated later in Figure 13. The bearing, with the retention sleeve, was pressed out of the pulley and the retention sleeve removed. The retaining rings and seals were removed to reveal the bearing cage and grease on the cage. Grease was removed from the retainer to reveal the identifications “SCHATZ”, USA” and “PD5K”.

To identify the dampness on the pulley it was swabbed with a clean cotton swab to remove any residue or debris from the surface. The swab was then examined using an FTIR to determine the identity of the residue. The spectra from the swab indicated the presence of water and a silicon-based product.

Figure 11. One side of the bearing in pulley FS499-L (left) and the other side (right).

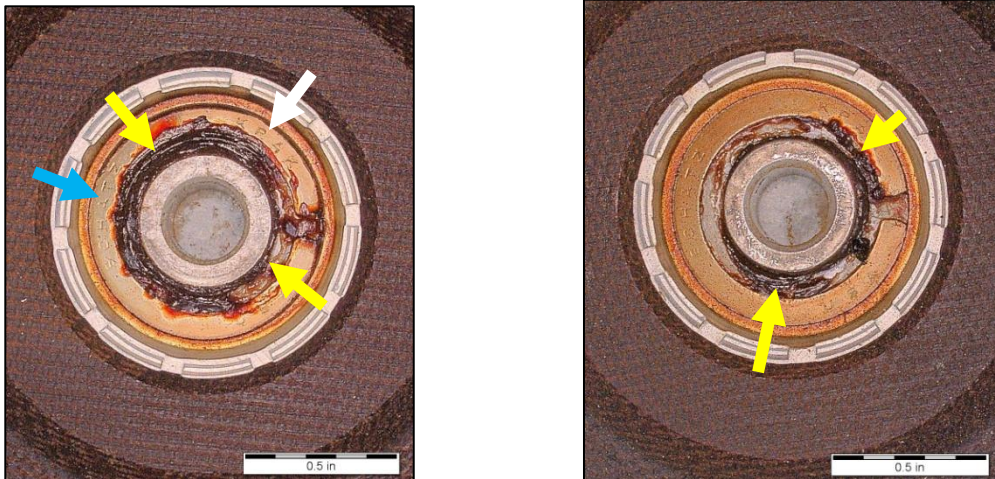
Examination of the pulley revealed that it was uniformly darker in color, similar to pulleys FS449-R and FS449-L and displayed a line of pale green paint on the outer edges of the groove. The pulley also felt damp when handled and had a similar odor. The discoloration had almost obliterated the identifications but “RALMARK”, and “CM3863-4” were still discernible. The bearing was found to rotate smoothly by hand and exhibited grease on both sides. Both sides of the bearing are illustrated in Figure 12 with yellow arrows indicating the grease. The white arrow in the left image indicates the bearing number, “KP4K”, and the blue arrow indicates the manufacturer, “SCHATZ”. The discoloration of the pulley can be compared with a similar image of one of the exemplar pulleys illustrated later in Figure 13. The bearing, with the retention sleeve, was pressed out of the pulley and the retention sleeve removed. The retaining rings and seals were removed to reveal that the bearing cage and the balls were covered in grease.

To identify the dampness on the pulley it was swabbed with a clean cotton swab to remove any residue or debris from the surface. The swab was then examined using an FTIR to determine the identity of the residue. The spectra from the swab indicated the presence of water and a silicon-based product.

Figure 12. One side of the bearing in pulley FS438 (left) and the other side (right).

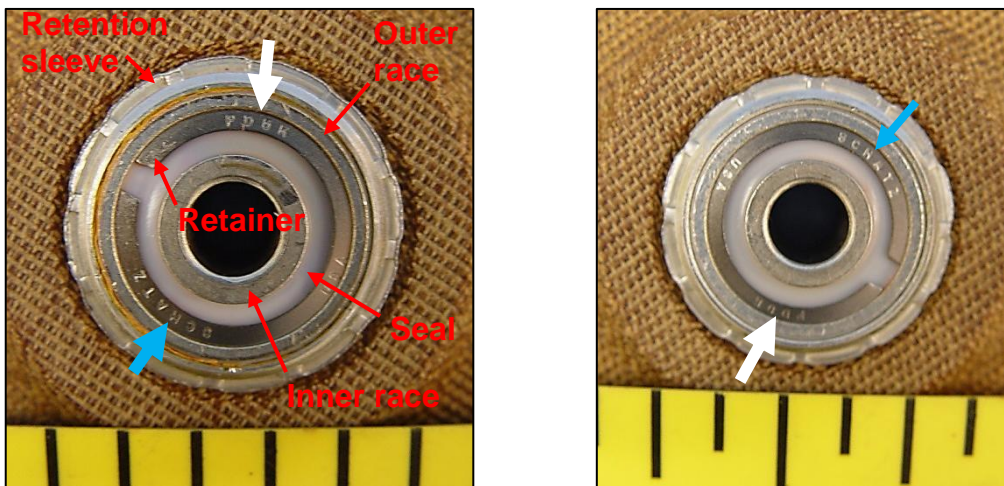
Examination of the exemplar pulleys revealed that both bearings were clean and rotated smoothly by hand. For comparison with the bearings illustrated in Figures 2, 7, 10, 11 and 12, and with the pulley discoloration illustrated in figures 10, 11 and 12 both sides of the bearing in pulley “EX-1” are illustrated in Figure 13 with the retention sleeve, outer race, retainer, seal, and inner race identified in the left image. The blue and white arrows on the retainers indicate the manufacturer’s name, “SCHATZ”, and the bearing part number, “PD5K”. For comparison with the pulley grooves illustrated in Figures 3 and 8 the groove in exemplar pulley “EX-2” is illustrated in Figure 14 with a yellow arrow indicating the root of the groove and red arrows indicating the pale green painted outer edges also observed on pulley FS438.

Figure 13. Both sides of the bearing in exemplar pulley EX-1.

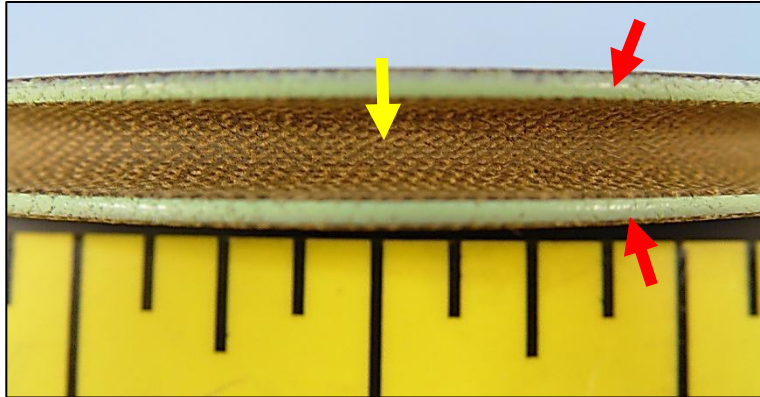
Figure 14. A portion of the groove in an exemplar pulley.

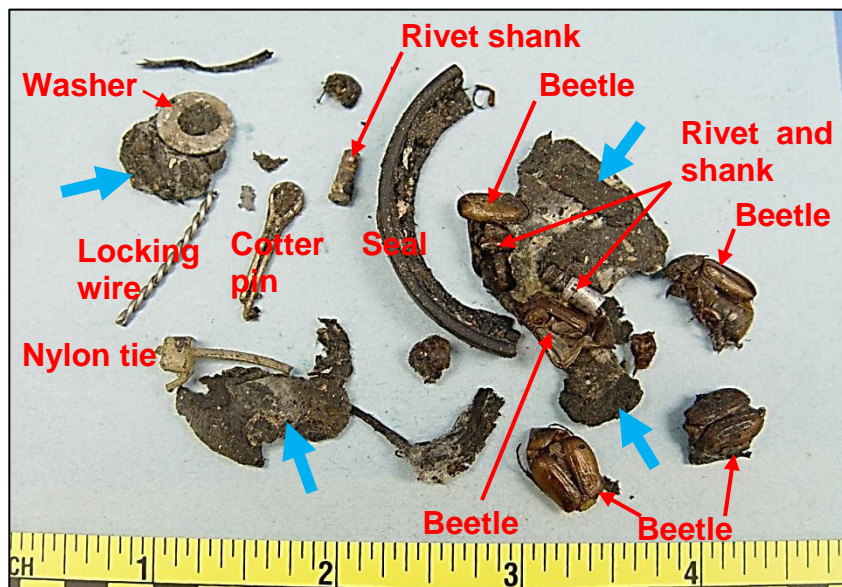
The debris in the zip-closure bag illustrated in Figure 1 consisted of lumps of an unknown material, beetles, a rivet shank, rivet pieces with a shank, a portion of a lip seal, a cotter pin, a portion of a nylon tie, a washer and a piece of twisted locking wire. The debris is illustrated in Figure 15 with the unknown lumps of material indicated by blue arrows and the other items identified. Examination of the lumps of material revealed a distinctly fibrous appearance. The lumps could be easily broken in two to reveal the typical fibrous interior illustrated in Figure 16 which consisted mostly of gray filaments with a uniform diameter. In Figure 16 the black arrow

Figure 15. The debris contained in the bag identified in Figure 1.

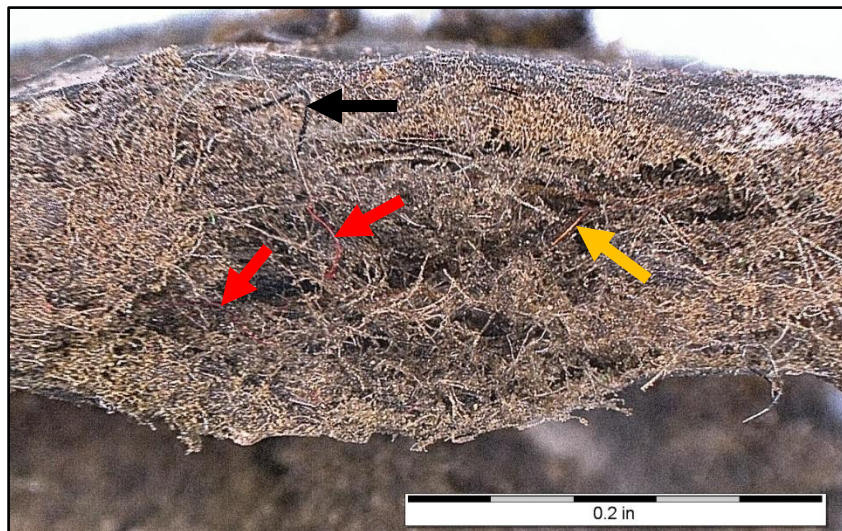
indicates a black filament, the red arrows indicate red filaments and the orange arrow indicates an orange filament.

Figure 16. Typical inside of one of the debris pieces indicated by blue arrows in Figure 15.
