NATIONAL TRANSPORTATION SAFETY BOARD

MATERIALS LABORATORY FACTUAL REPORT

Report No. 13-026

Place : Pukoo, Hawaii
Date : November 10, 2011
Vehicle : Eurocopter EC130B4
NTSB No. : WPR12MA034
Investigator : Dennis Hogenson, AS-WPR

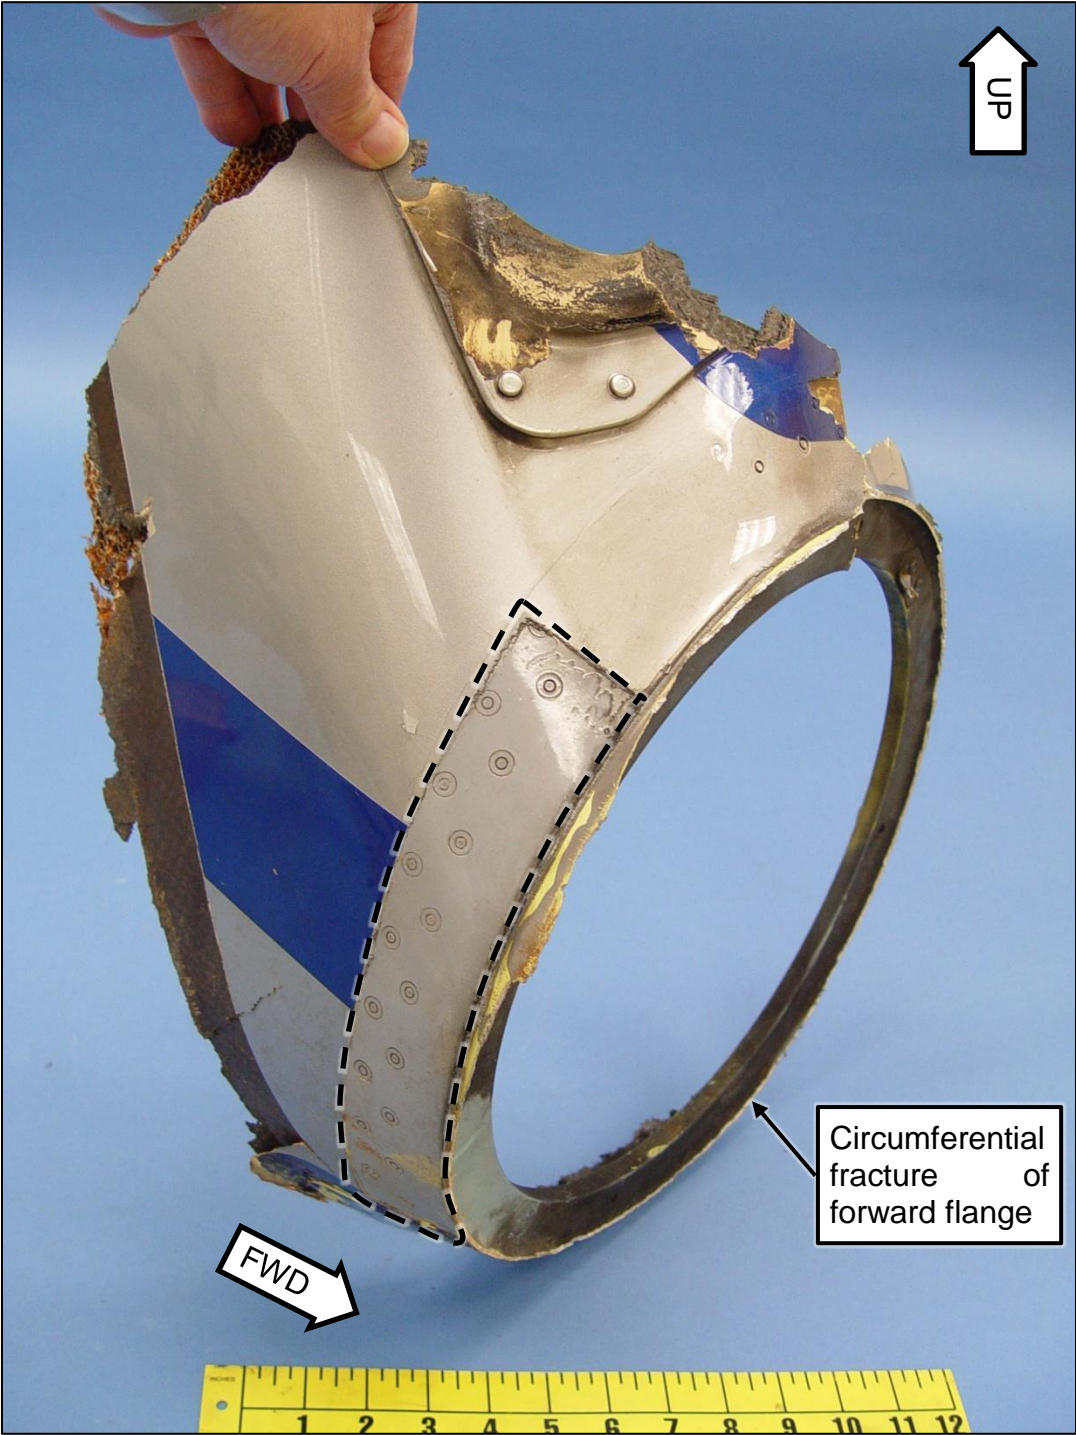
The fenestron attachment ring fractured from the tail boom with a circumferential fracture located in the forward flange of the attachment ring. The location of the circumferential fracture of the forward flange is indicated in figure 1. The forward flange portion of the attachment ring remained attached to the tail boom and was exposed to heat from a post-crash fire. As shown in figure 1, the aft portion of the fenestron attachment ring with attached pieces of the fenestron skin was not exposed to heat or fire, and the aft flange of the fenestron attachment ring was intact at the right side of the fenestron.

A piece of the fenestron attachment ring aft flange was cut from the right side of the attachment ring as indicated with dashed lines in figure 1. Then, rivets attaching the fenestron attachment ring to the fenestron skin piece were removed by drilling. The resulting piece of the fenestron attachment flange used to fabricate the custom tensile specimens is shown in figure 2. Next, nine tensile specimen blanks were cut from the flange. The specimen blanks had a width approximately equal to the width of the grip section of the tensile specimens. The blanks were cut from the middle and upper portion of the flange piece shown in figure 2.

Figure 1. Overall view of the fenestron attachment ring with attached pieces of fenestron. A dashed line indicates the area of the aft flange of the attachment ring where tensile test specimens were fabricated.

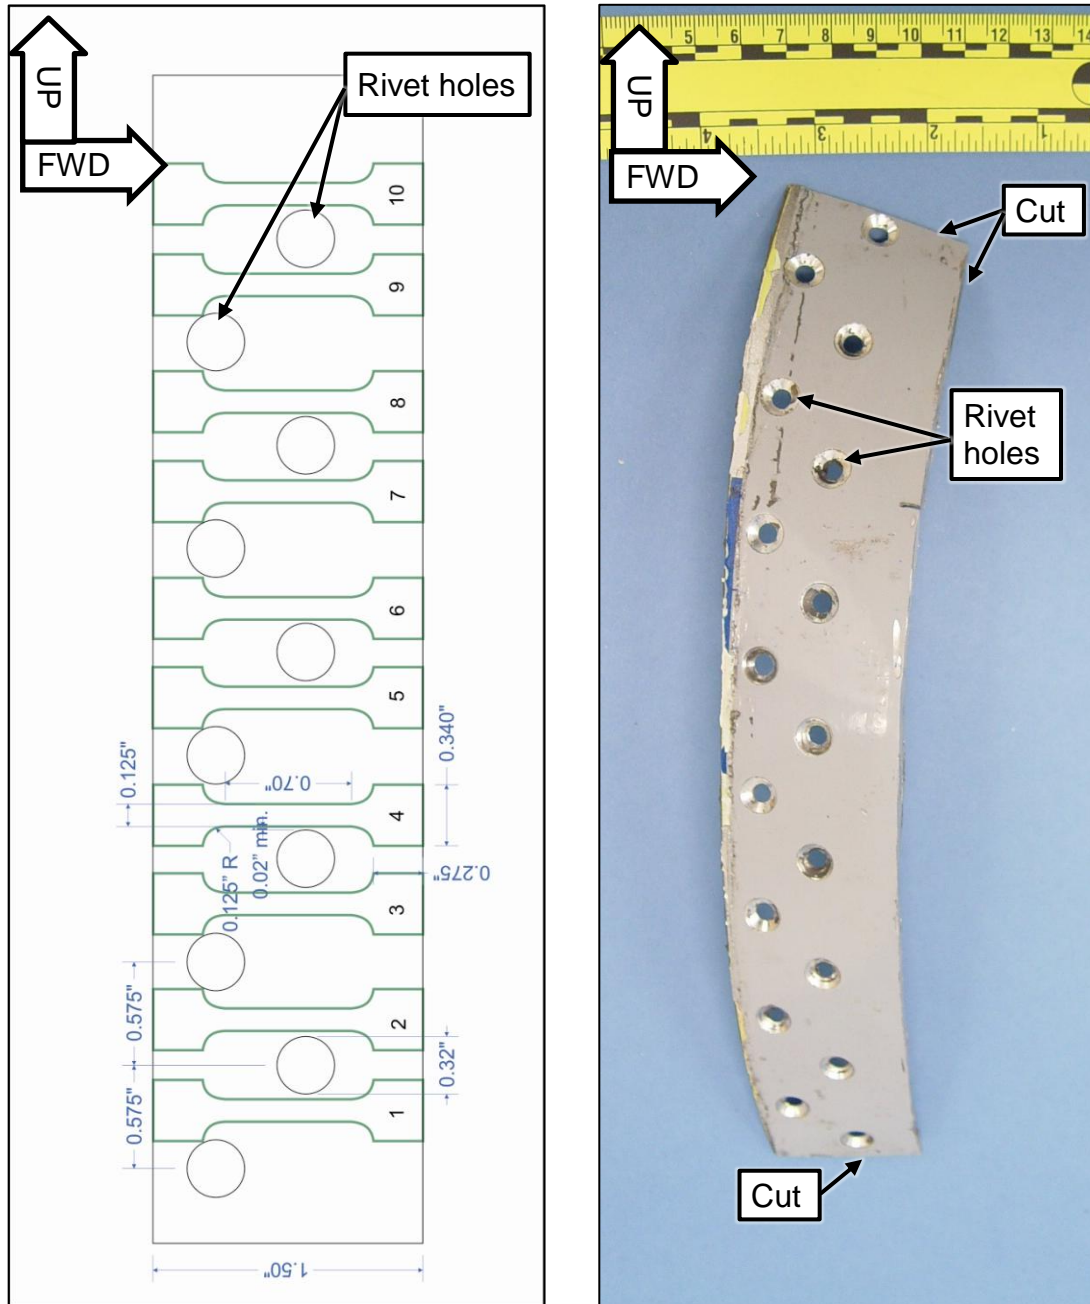
As per the engineering drawing for the fenestron attachment ring, the aft flange of the attachment ring had a tapered thickness where the end closest to the rib at the middle of the ring was thicker than the aft end of the flange. In addition, as evident in figure 2, the flange piece was curved. The taper and curvature were present on the tensile specimen blanks cut from the flange. In order to properly test the specimens, the taper and curvature had to be removed. The specimen blanks were placed in a vice, and the curvature was removed by hand using a crescent wrench. Specimens 1 and 2 were largely free of curvature. Specimens 6 and 9 had the greatest amount of curvature among specimens fabricated for testing.

Figure 2. Drawing of the custom tensile specimens with dimensions showing locations on the aft flange of the attachment ring where 10 specimens could be removed (left) and piece of aft flange with rivets removed and cut as shown to facilitate machining of tensile specimens.

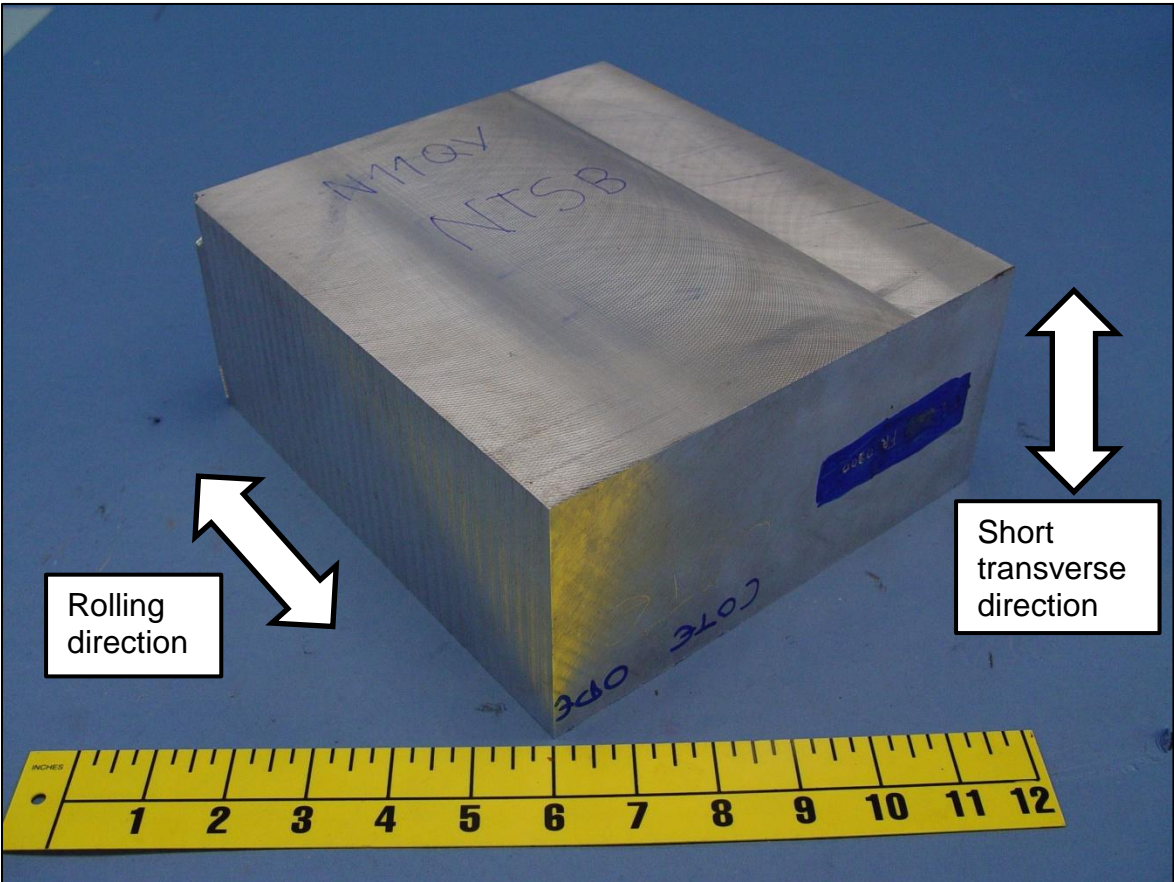
A view of the test block supplied by Eurocopter as cut from a plate of certified material is shown in figure 3. As received, the block was 3.8 inches (98 mm) thick. A piece of the block was cut from the corner, and three faces were polished and etched to determine the rolling direction, which is indicated in figure 3. As shown in figure 3, the rolling direction was approximately parallel to the longest edges of the block, and the short transverse loading direction was parallel to the shortest edges of the block.

Figure 3. Overall view of the block of certified material supplied by Eurocopter for tensile tests.

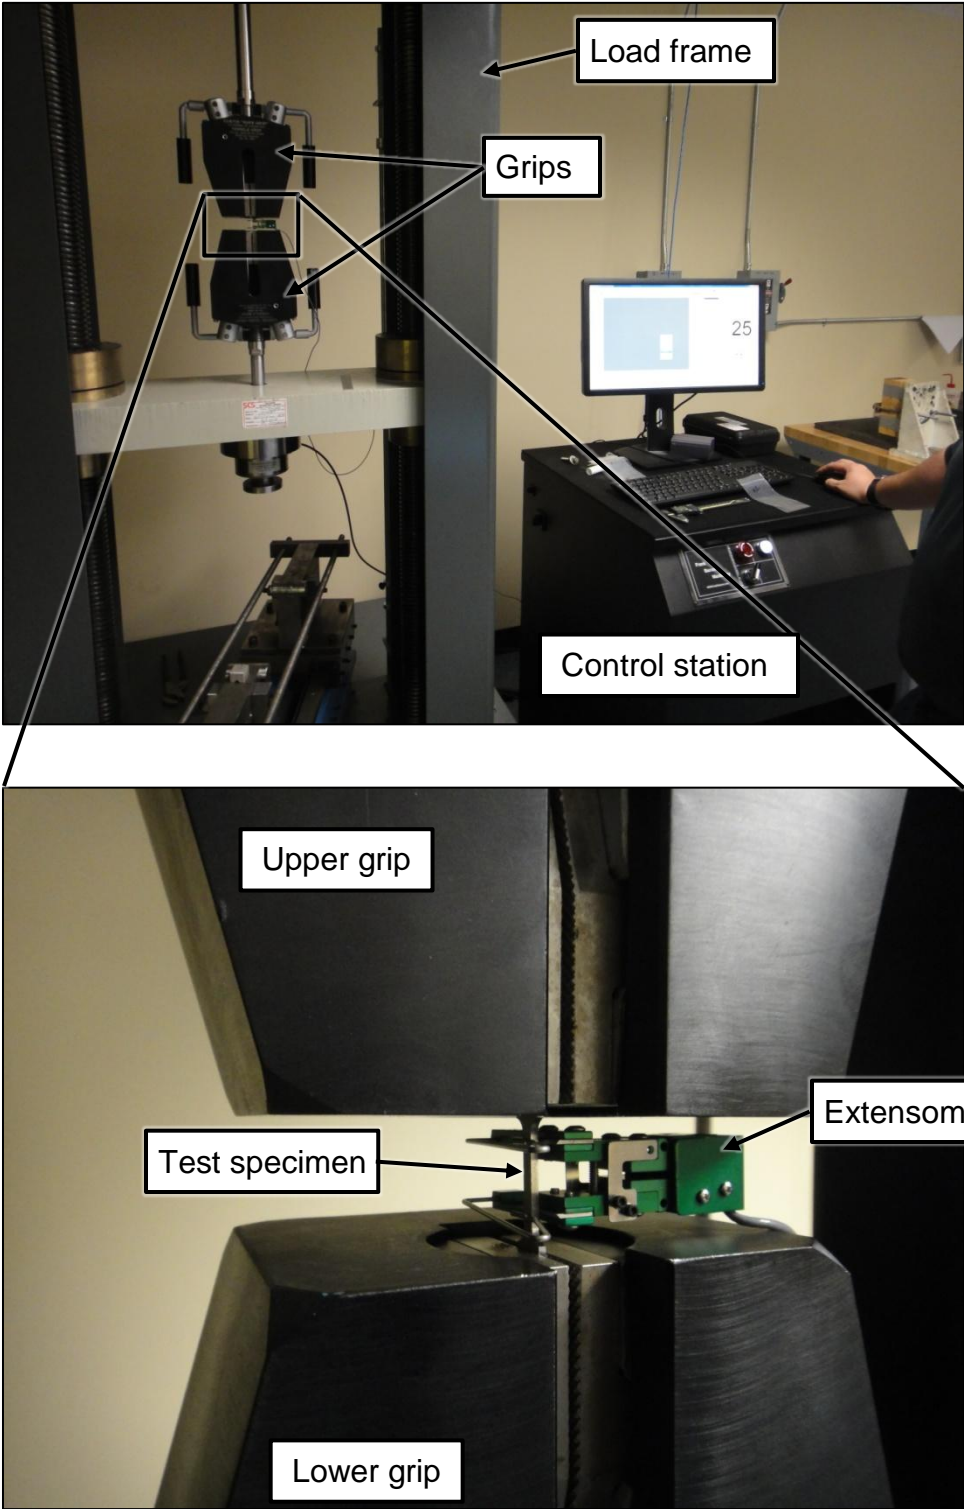
The tensile specimens were placed in grips in a load frame, and an extensometer with a 0.5-inch gauge length was attached to the side of the specimen. Views of one of the test specimens loaded in the test frame are shown in figure 4. The tests were conducted at a constant cross-head speed set to produce an engineering strain rate of 0.5% per minute up to yield, and then the speed was adjusted to produce an engineering strain rate of up to 10% until fracture.

Figure 4. Overall view of the test frame (upper image) and the grip area (lower image) with a tensile specimen from the attachment ring loaded and ready to test.

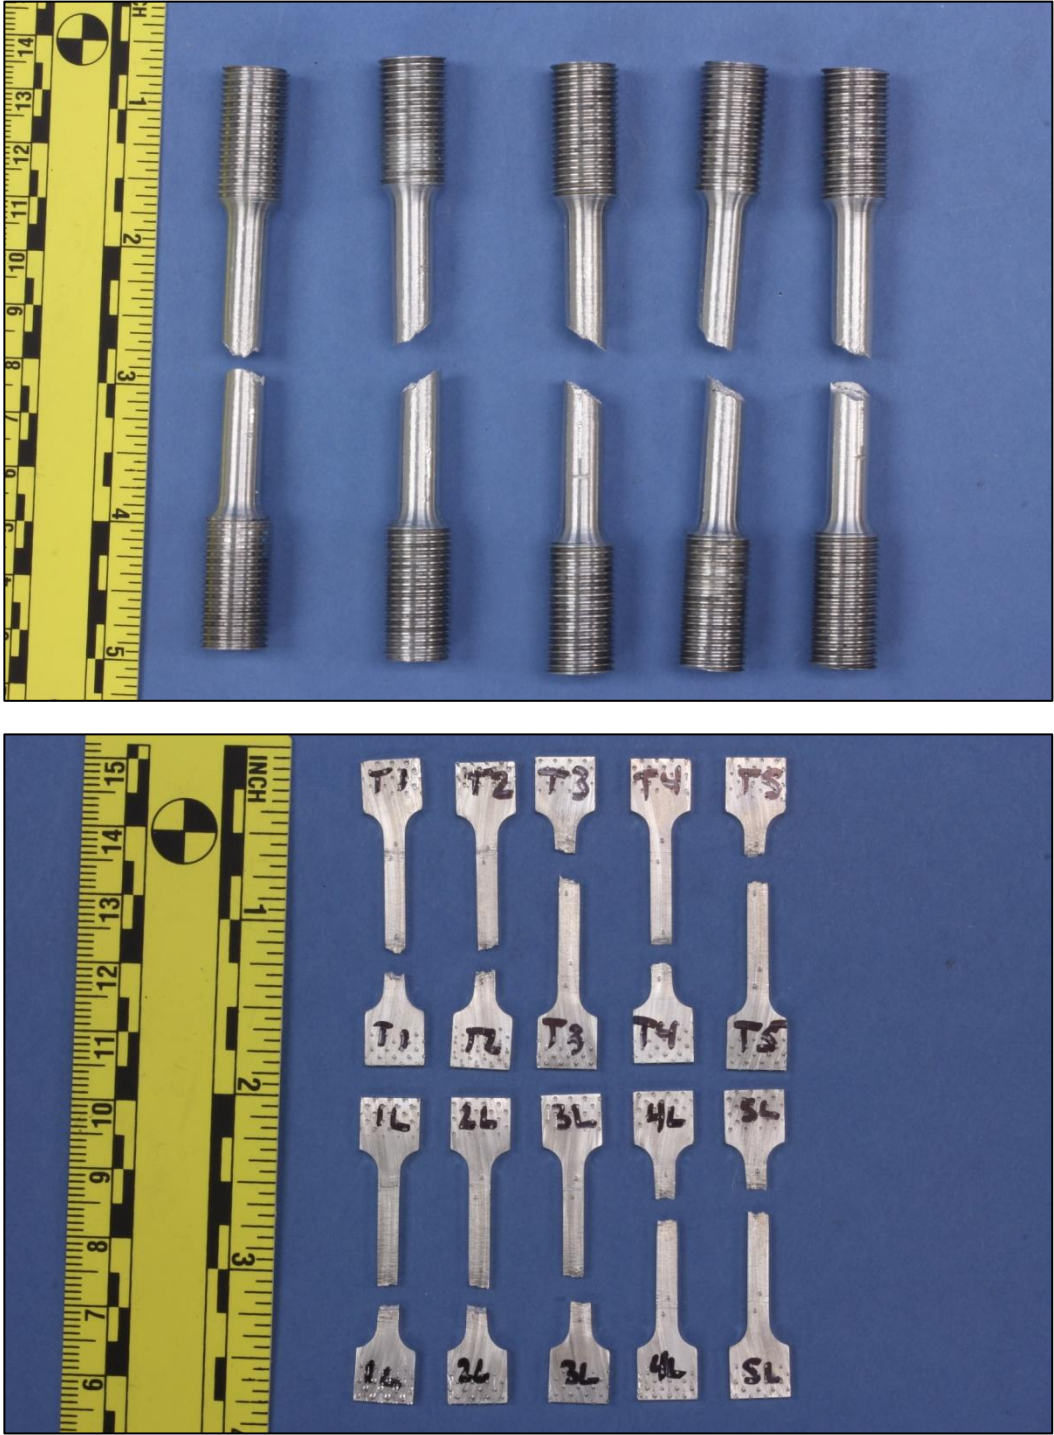
Overall views of the standard round and the custom flat specimens after testing are shown in figure 5. The fracture features of all the specimens generally showed a mix of matte gray and somewhat reflective fracture features on slant planes. Specimens F1L and F1T were arbitrarily chosen for a closer examination of fracture features.

Figure 5. Overall view of the 5 standard round specimens (upper image) and the 10 custom flat specimens (lower image) from the test block after testing.

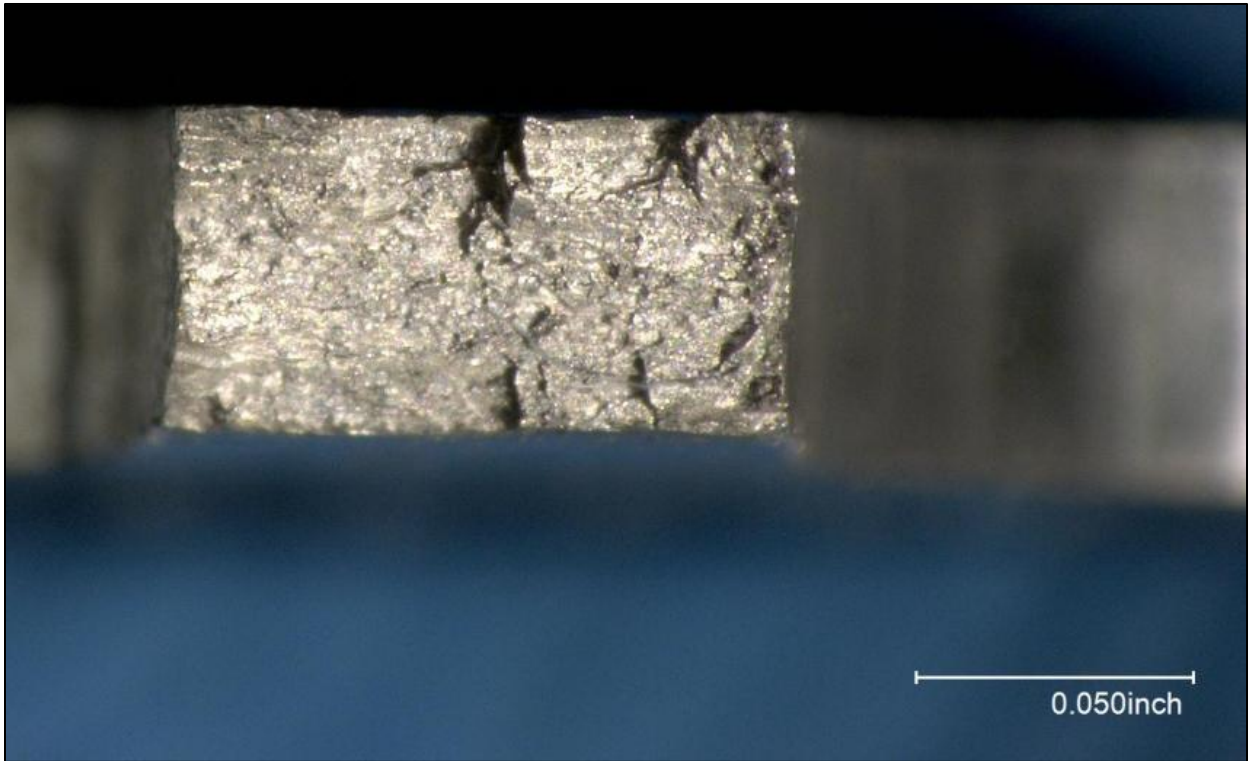
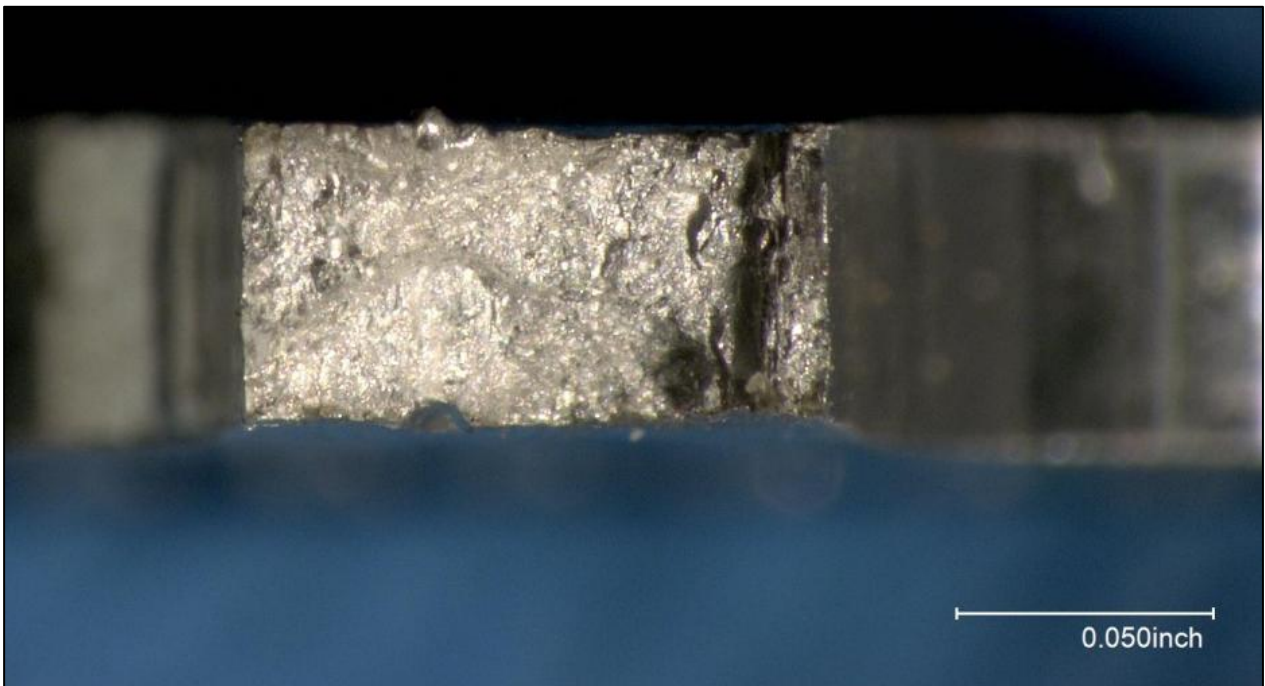
Optical views of the fracture surfaces on the shorter ends of fractured specimens F1L and F1T are shown in figure 6. The difference in orientation with respect to rolling direction was evident in the fracture features. Terrace-like features associated with grain orientation were generally aligned with the width direction in specimen F1L, and the features were more aligned with the through-thickness direction in specimen F1T.

Figure 6. Optical views of fracture features on tensile specimens F1L (upper image) and F1T (lower image) from the test block.

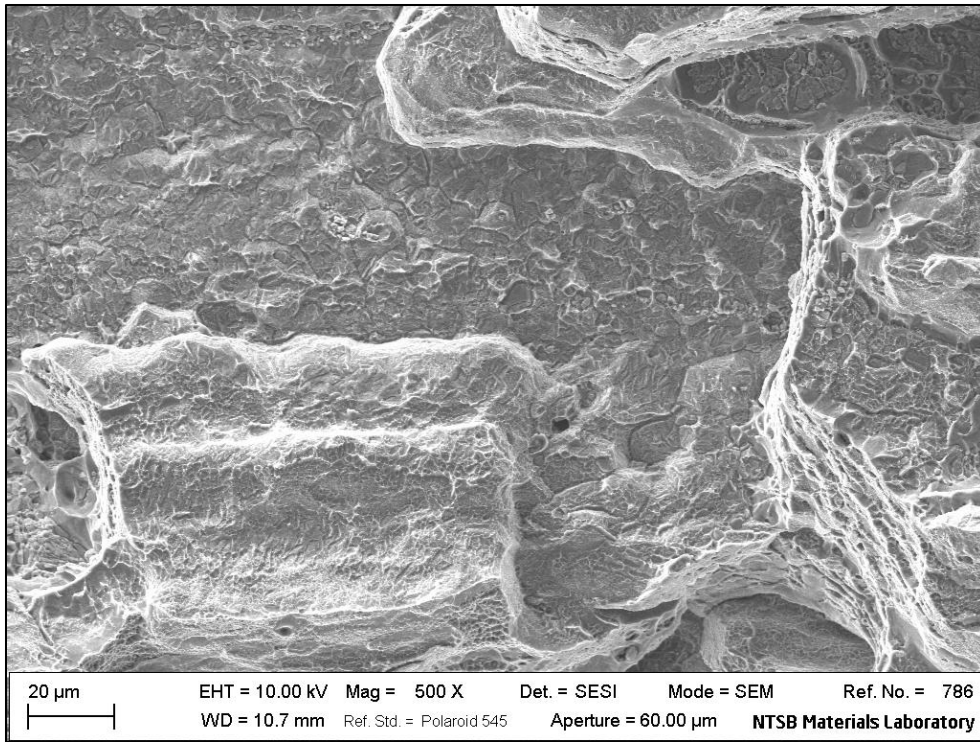
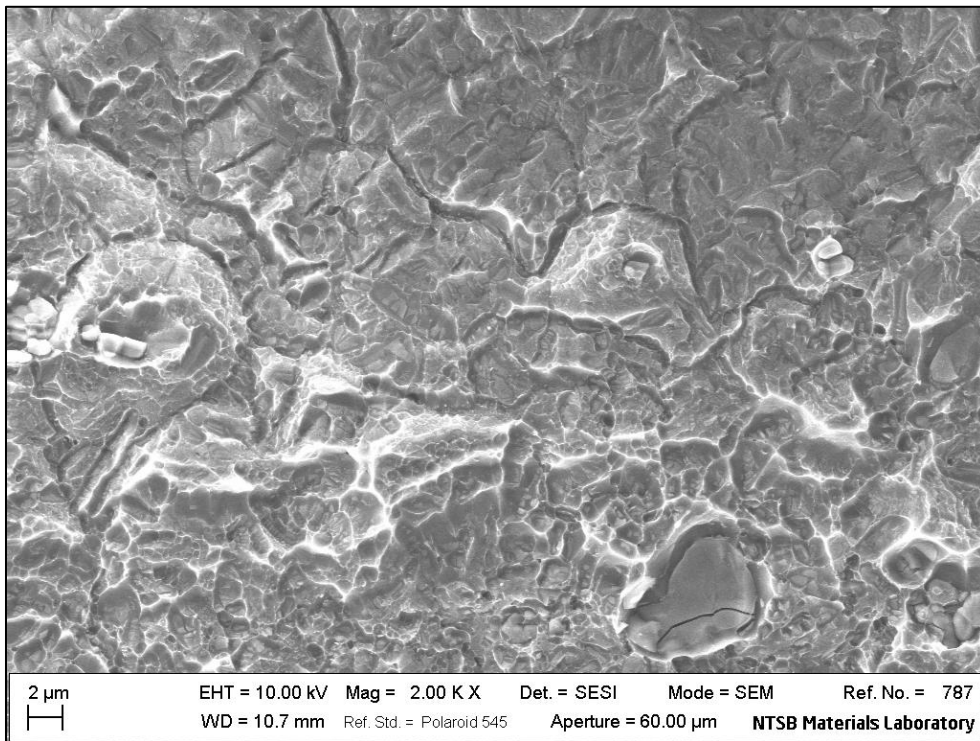
The fracture surfaces were examined using a scanning electron microscope (SEM). Typical fracture features observed on the F1L and F1T specimens are shown in figures 7 and 8, respectively. Fracture features generally appeared like plateaus or terraces with relatively flat areas between step changes in the fracture plane. These features were consistent with fracture along the grain boundaries in the short transverse plane. The flat areas between the steps generally showed fine equiaxed dimples interspersed with areas of larger irregular-shaped dimples. The tear ridges around the dimples were uniform around the perimeter of the dimple. Lighter-gray second-phase particles³ were frequently noted at the middle of the larger dimples, and the shape of the dimple corresponded to the shape of the second-phase particle. In some areas, the larger dimples and second-phase particles were found in clusters such as shown in figure 8.

Figure 7. SEM images of typical features observed on the fracture surface of tensile specimen F1L.

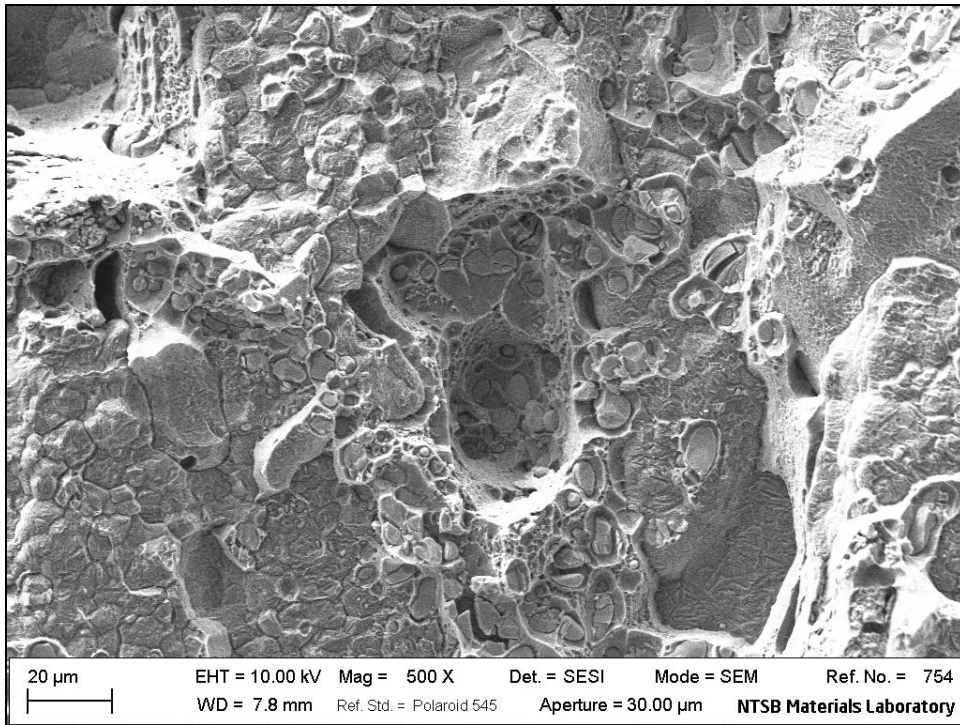
Figure 8. SEM image of typical features observed on the fracture surface of tensile specimen F1T.

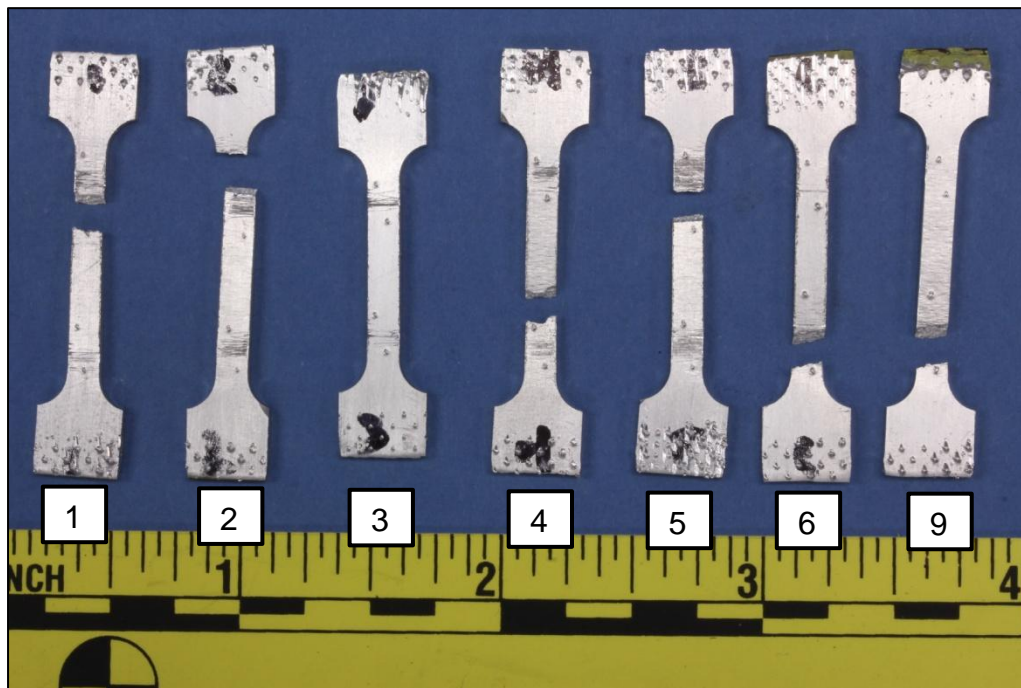
An overall view of specimens from the fenestron attachment fitting after testing is shown in figure 9. A label indicating the specimen number is shown below each specimen. Test specimen 3 is intact as shown in figure 9. Specimens 7 and 8 were not fabricated and tested, and therefore they are not shown in the image. The fracture features of all the specimens generally showed a mix of matte gray and somewhat reflective fracture features on slant planes.

Figure 9. Overall view of the tensile specimens from the fenestron attachment ring after testing was completed.

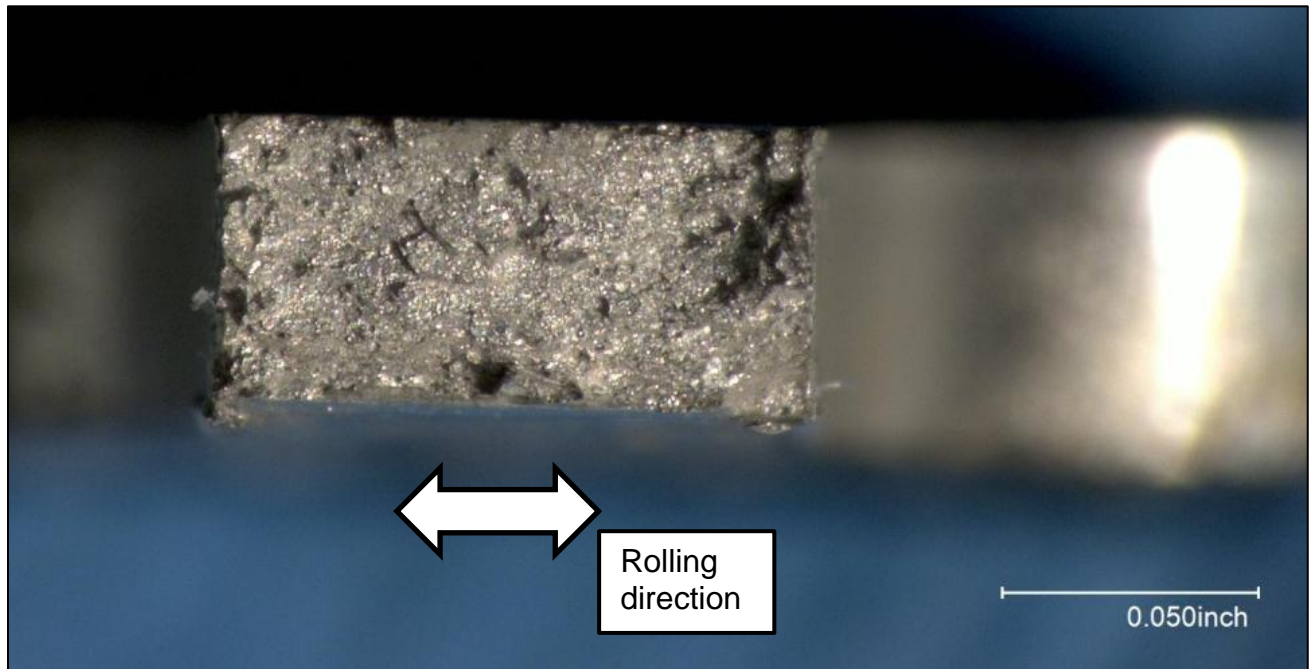
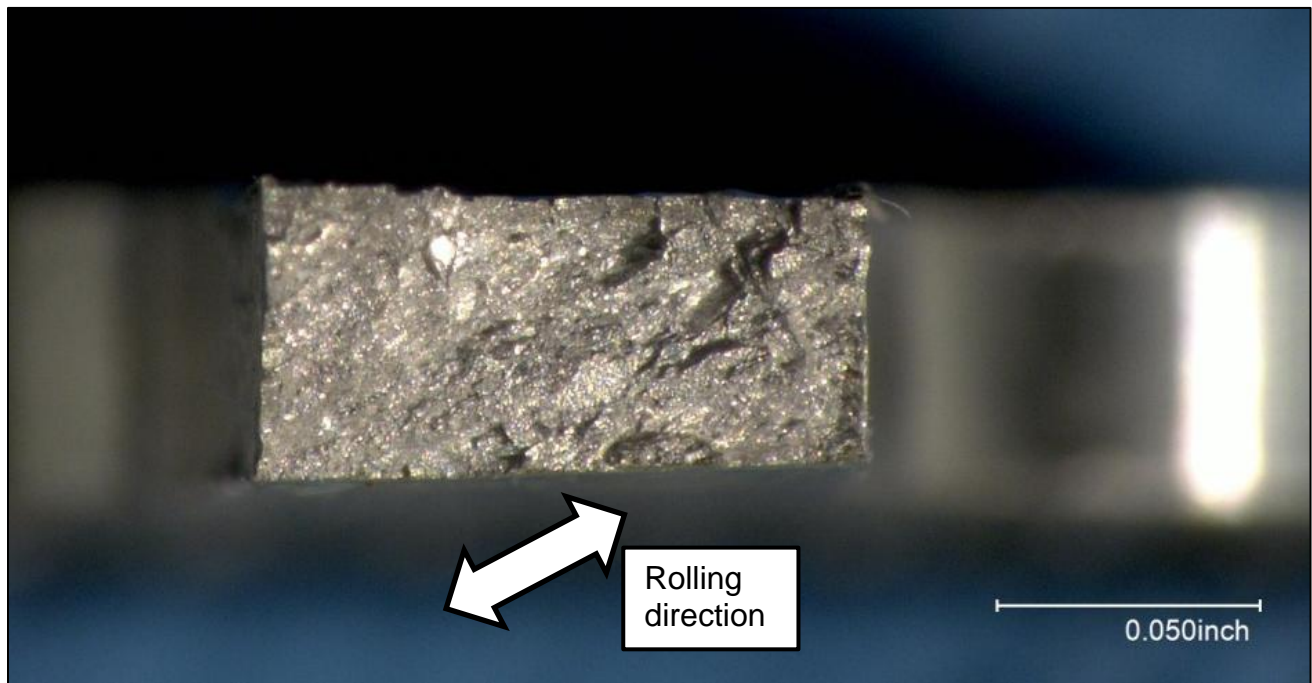
Test specimens 1 and 4 were arbitrarily chosen for a closer examination of fracture features, and optical views of the fracture surface on the shorter end of fractured test specimens 1 and 4 are shown in figure 10. The orientation of the step features on the fracture surface was consistent with the orientation of the specimen relative to the rolling direction. In test specimen 1, the rolling direction is mostly aligned with the width of the fracture face, whereas the rolling direction for specimen 6 was oriented at an angle relative to the specimen face. The approximate rolling direction based on fracture features is indicated in figure 10. The difference in rolling direction is a consequence of the position from which the specimen was removed on the curved surface of the fenestron attachment ring aft flange.

Figure 10. Optical views of fracture features on tensile specimens 1 (upper image) and 4 (lower image) from the fenestron attachment ring.

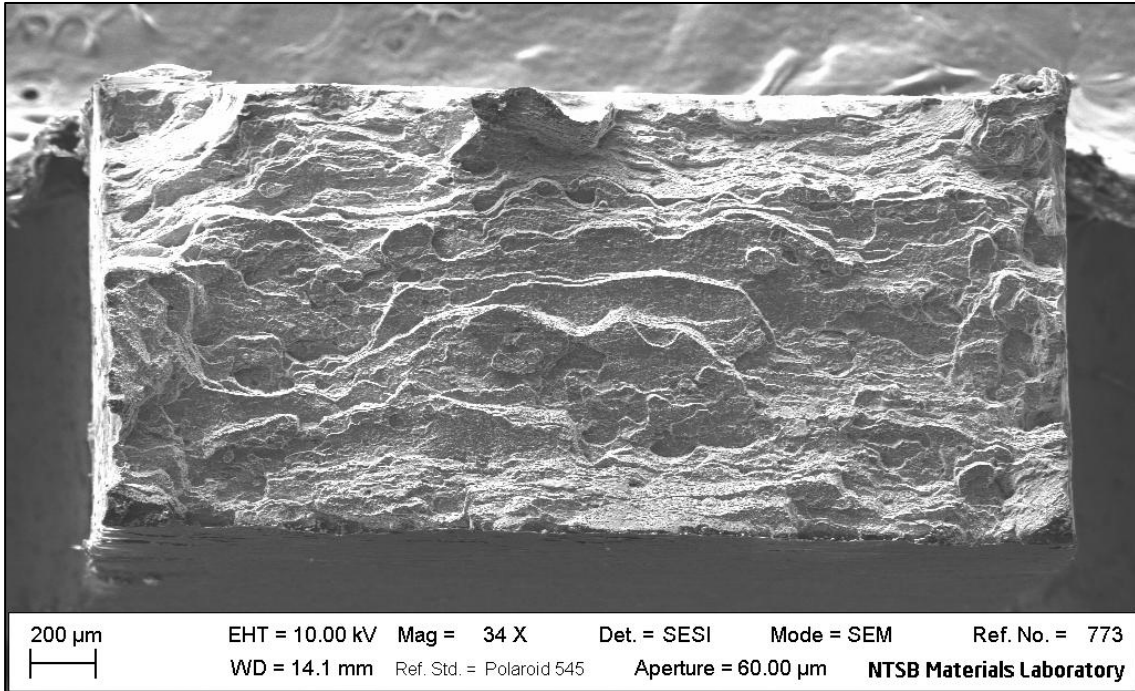
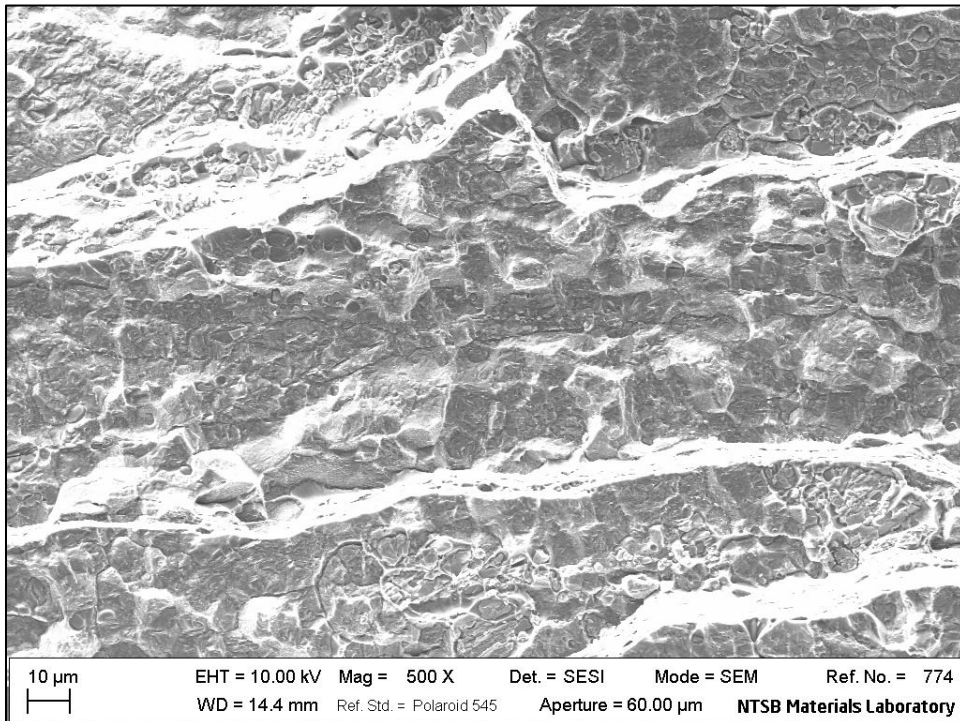
The fracture surfaces were examined using a scanning electron microscope (SEM). Typical fracture features observed on test specimen 1 from the fenestron attachment ring are shown in figures 11 and 12. Fracture features were generally similar to those observed on the test block samples with a terraced appearance at lower magnification and a mix of dimple features observed at higher magnification.

Figure 11. SEM images of Test Specimen 1 from the fenestron attachment ring showing typical fracture features.

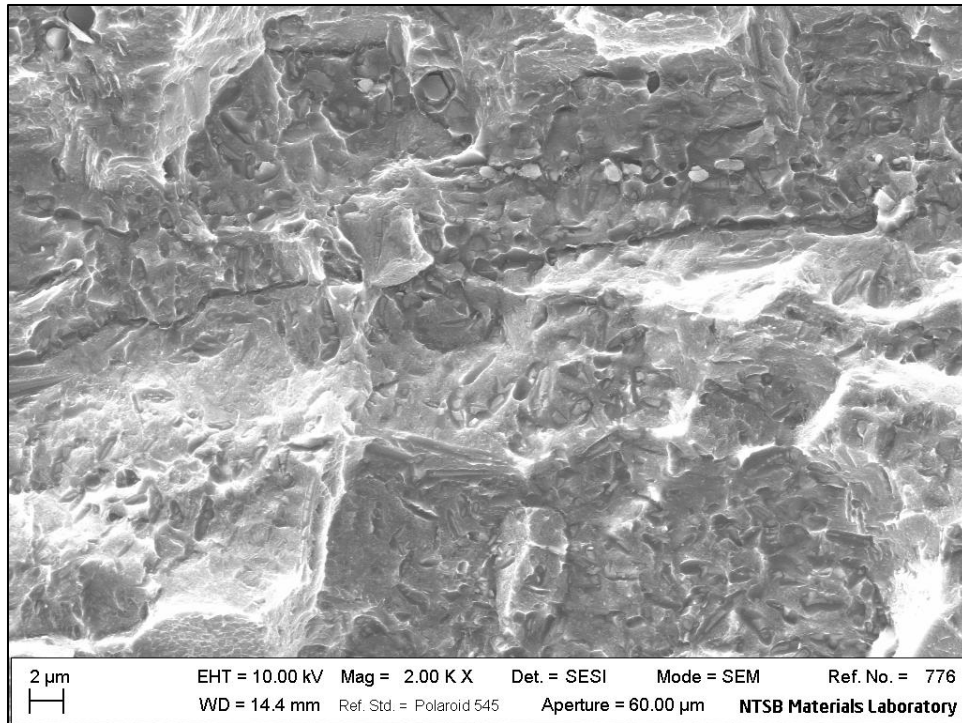
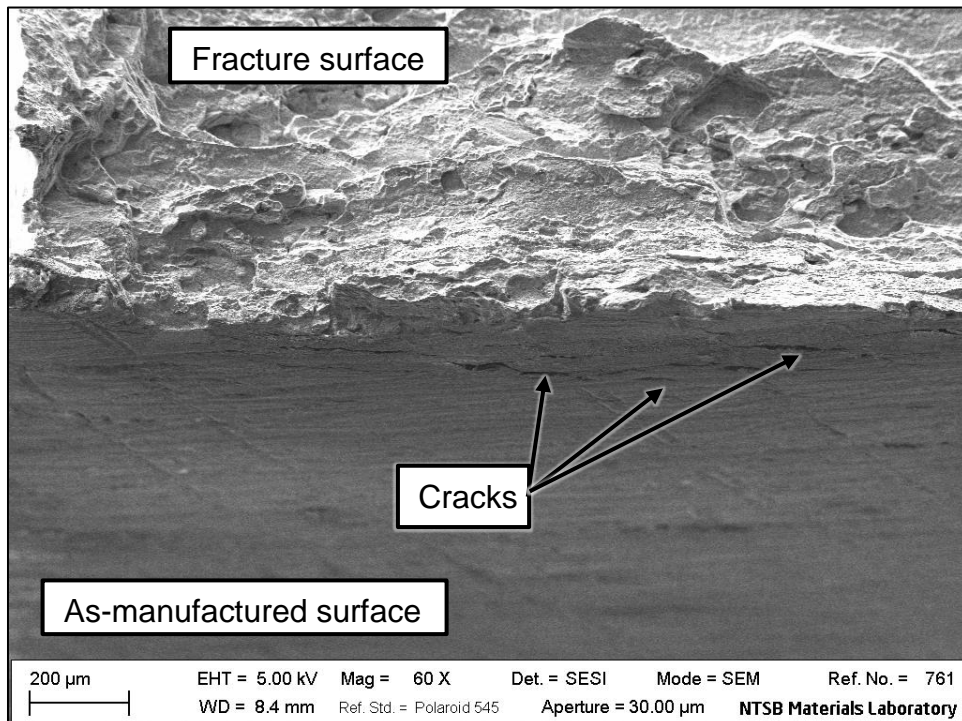
Secondary cracks were observed on the as-manufactured surface adjacent to the fracture as indicated in the lower image in figure 12. On the fracture surface adjacent to the as-manufactured surface, areas appearing relatively dark when imaged using backscattered electrons in composition mode⁴ were observed across portions of the fracture surface edge as shown in figures 13 and 14. The darker areas were consistent with oxides associated with grain boundary etching pits. The crack-like pits and oxidation at the grain boundaries occurred during the manufacturing process where the machined part is chromic acid anodized after an etching step is used to prepare the surface.

Figure 12. SEM images of Test Specimen 1 from the fenestron attachment ring showing typical fracture features (upper image) and an oblique view showing secondary cracks on the as-manufactured surface adjacent to the fracture surface.

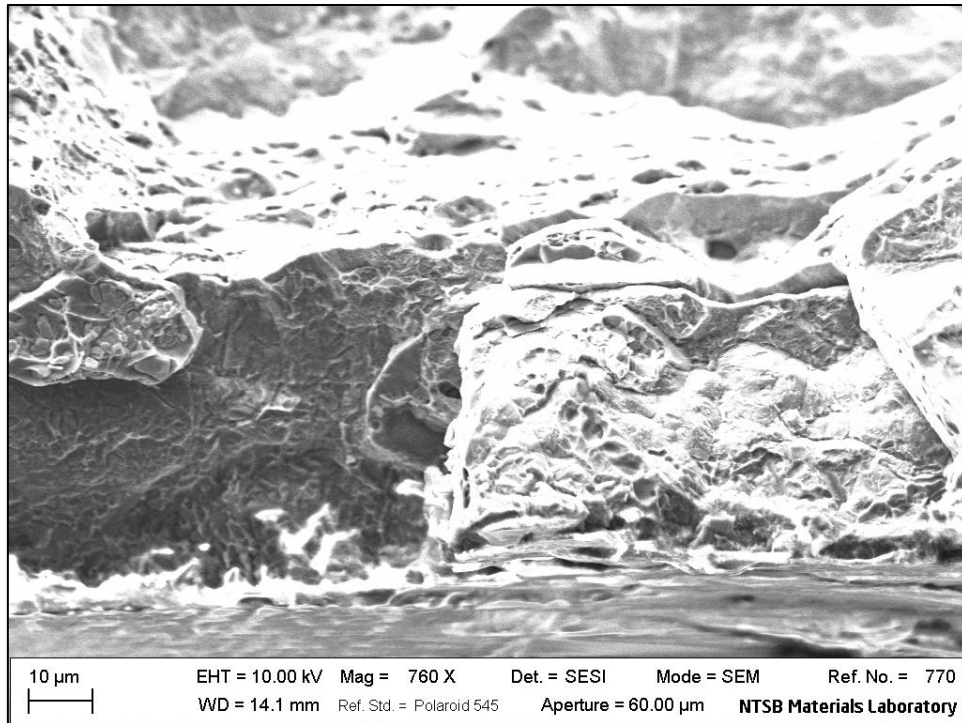
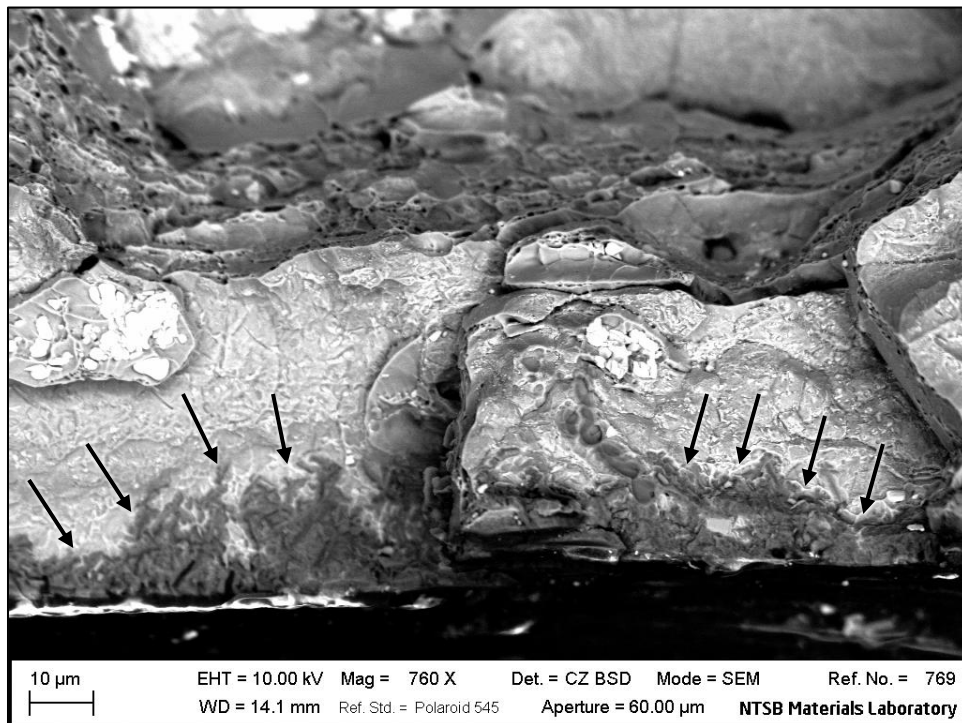
Figure 13. SEM images using secondary electrons (upper image) and backscattered electrons (lower image) to view the same area of the fracture surface on Test Specimen 1 adjacent to the as-manufactured surface. Darker areas indicated with arrows on the lower image are consistent with oxidized grain boundary etch pits.

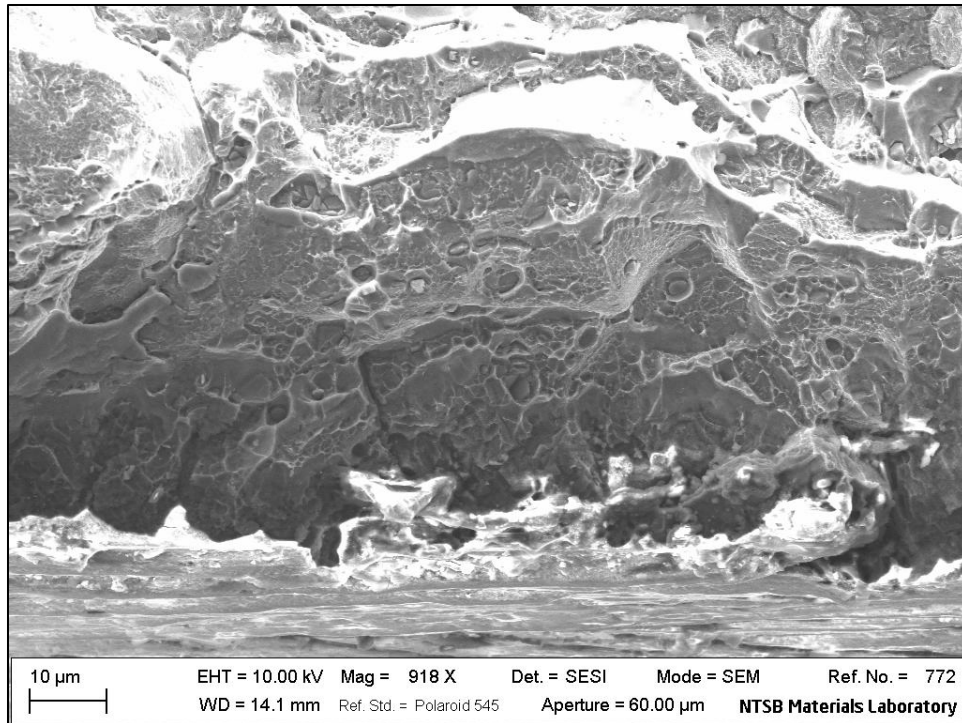
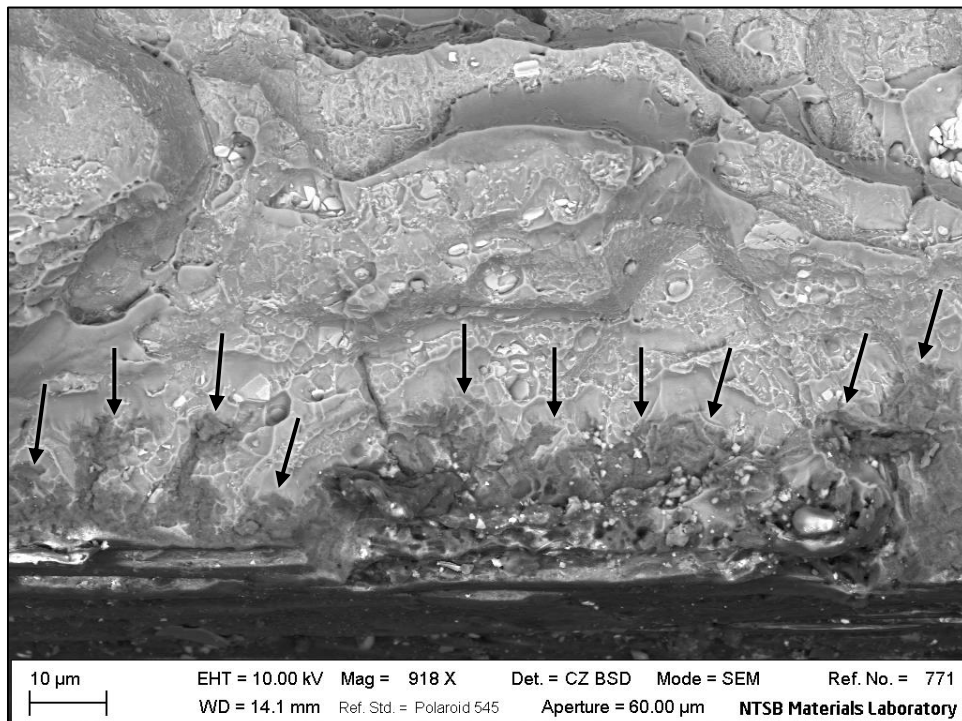
Figure 14. SEM images using secondary electrons (upper image) and backscattered electrons (lower image) to view the same area of the fracture surface on Test Specimen 1 adjacent to the as-manufactured surface. Darker areas indicated with arrows on the lower image are consistent with oxidized grain boundary etch pits.
