NATIONAL TRANSPORTATION SAFETY BOARD

MATERIALS LABORATORY FACTUAL REPORT

Report No. 13-026

Place : Pukoo, Hawaii
Date : November 10, 2011
Vehicle : Eurocopter EC130B4
NTSB No. : WPR12MA034
Investigator : Dennis Hogenson, AS-WPR

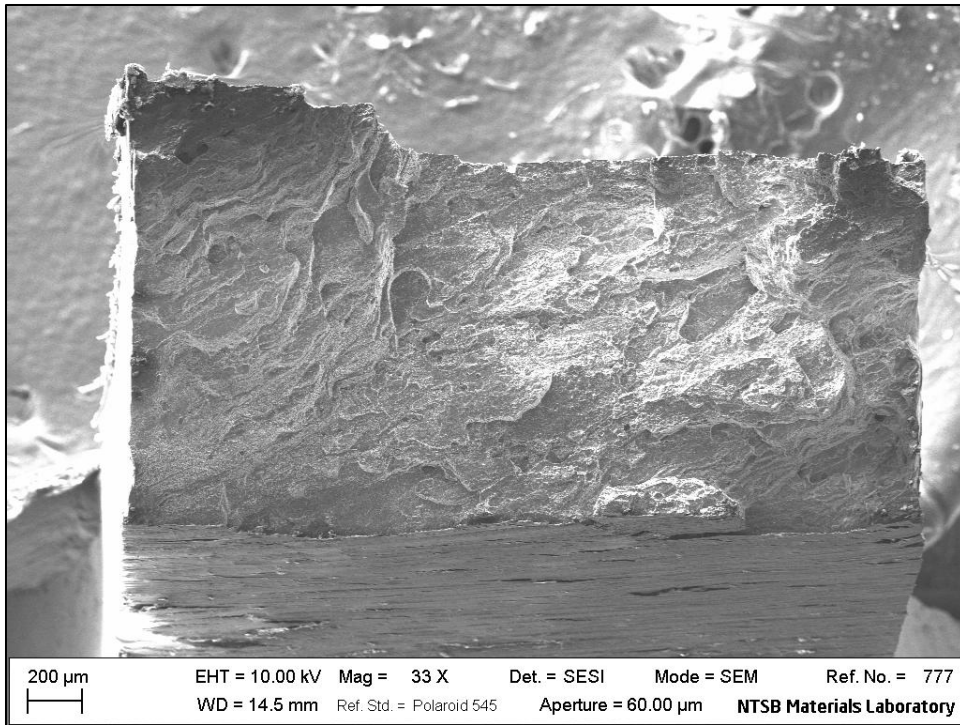
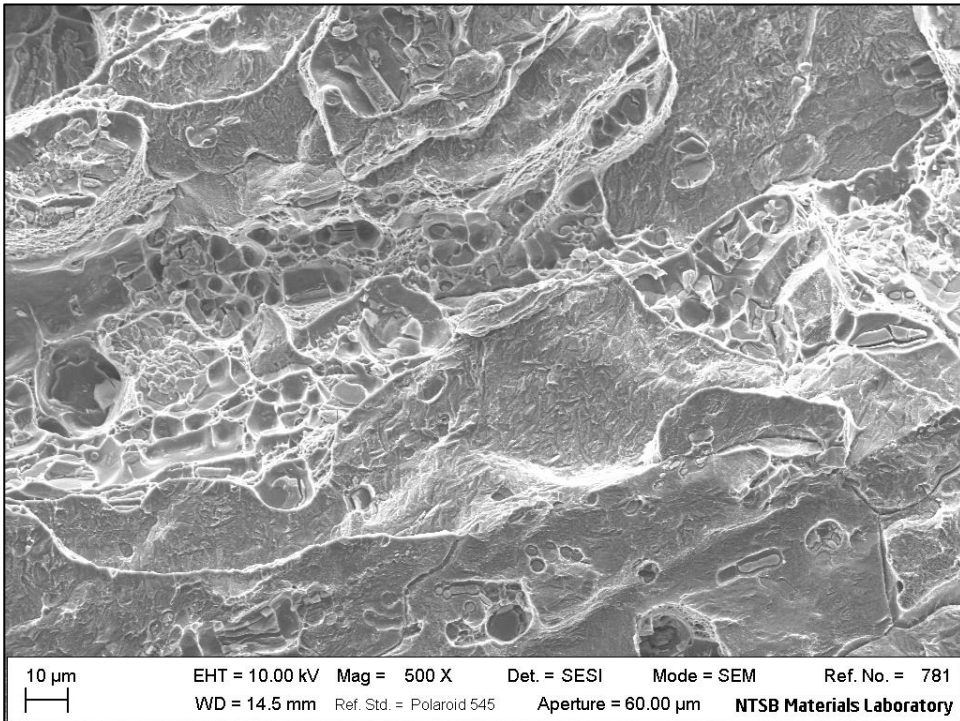
Typical SEM images of fracture features observed on test specimen 4 from the fenestron attachment ring are shown in figures 15 and 16. Fracture features were generally similar to those observed on the test block samples with a terraced appearance at lower magnification and a mix of dimple features observed at higher magnification.

Figure 15. SEM images of Test Specimen 4 from the fenestron attachment ring showing typical fracture features.

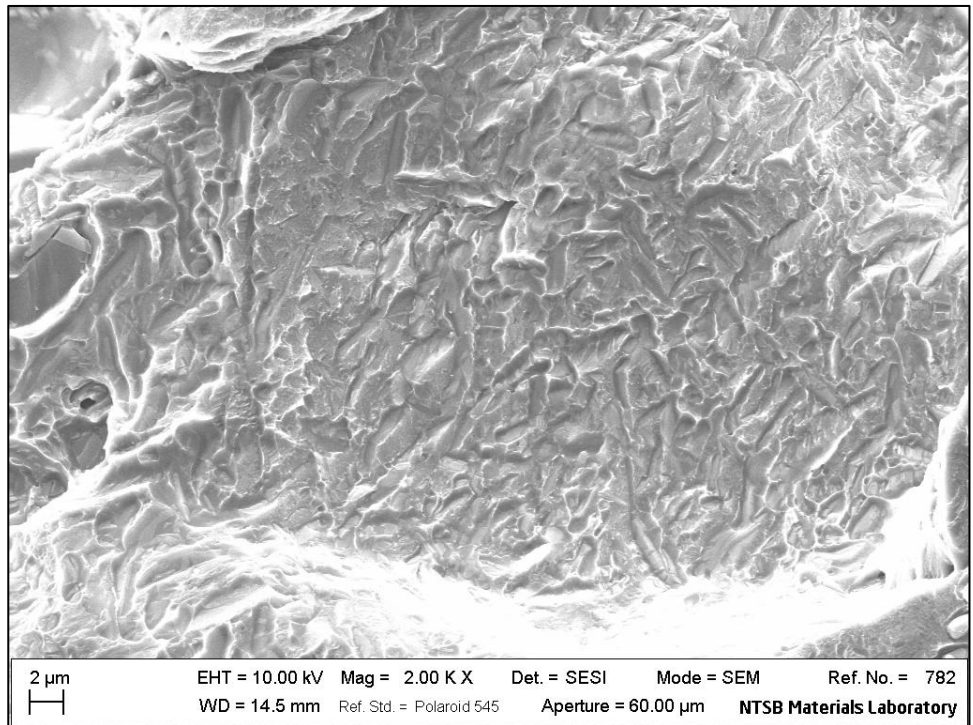
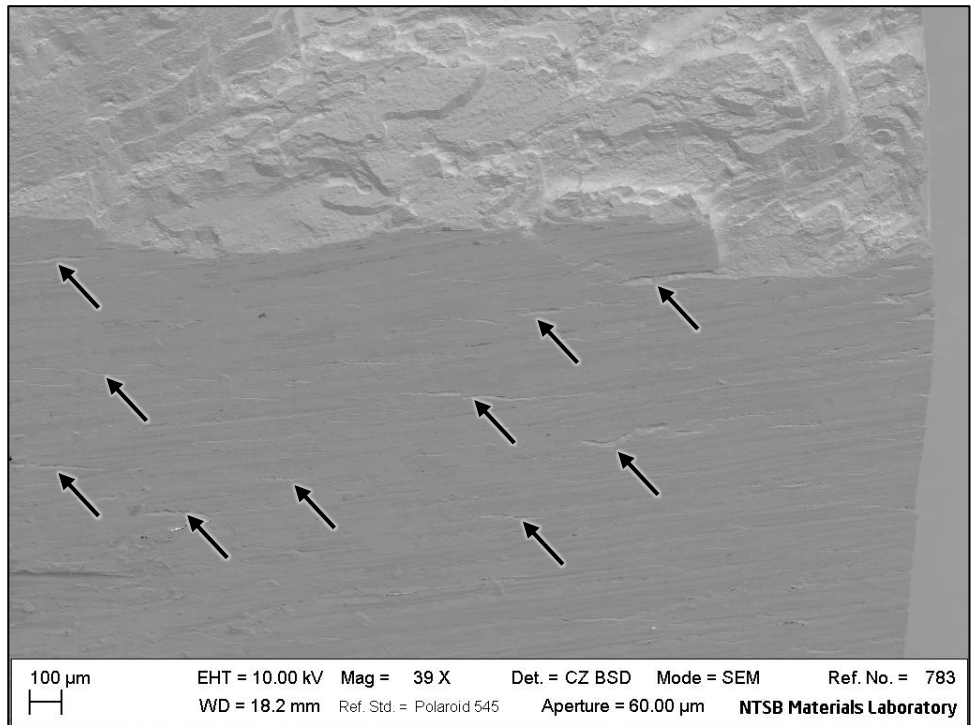
Secondary cracks were observed on the as-manufactured surface adjacent to the fracture as indicated in the lower image in figure 16. On the fracture surface adjacent to the as-manufactured surface, areas appearing relatively dark when imaged using backscattered electrons in composition mode⁵ were observed across portions of the fracture surface edge as shown in figure 17. The darker areas were consistent with oxidized grain boundaries associated with etching pits that formed during the manufacturing process.

Figure 16. SEM images of Test Specimen 4 from the fenestron attachment ring showing typical fracture features (upper image) and an oblique view with arrows indicating some of the secondary cracks observed on the as-manufactured surface adjacent to the fracture surface.

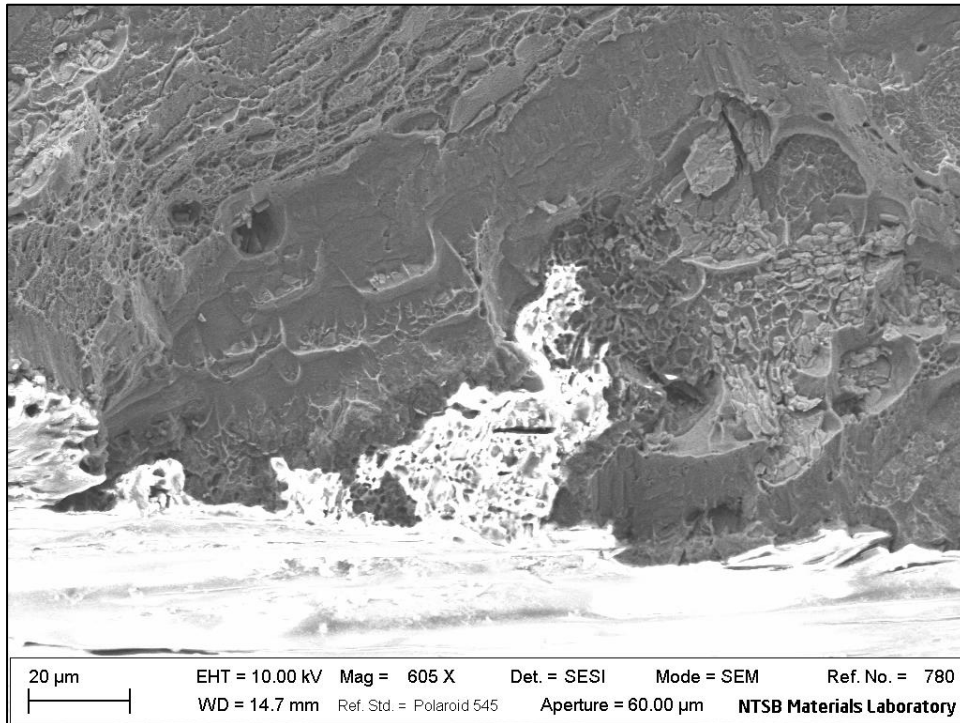
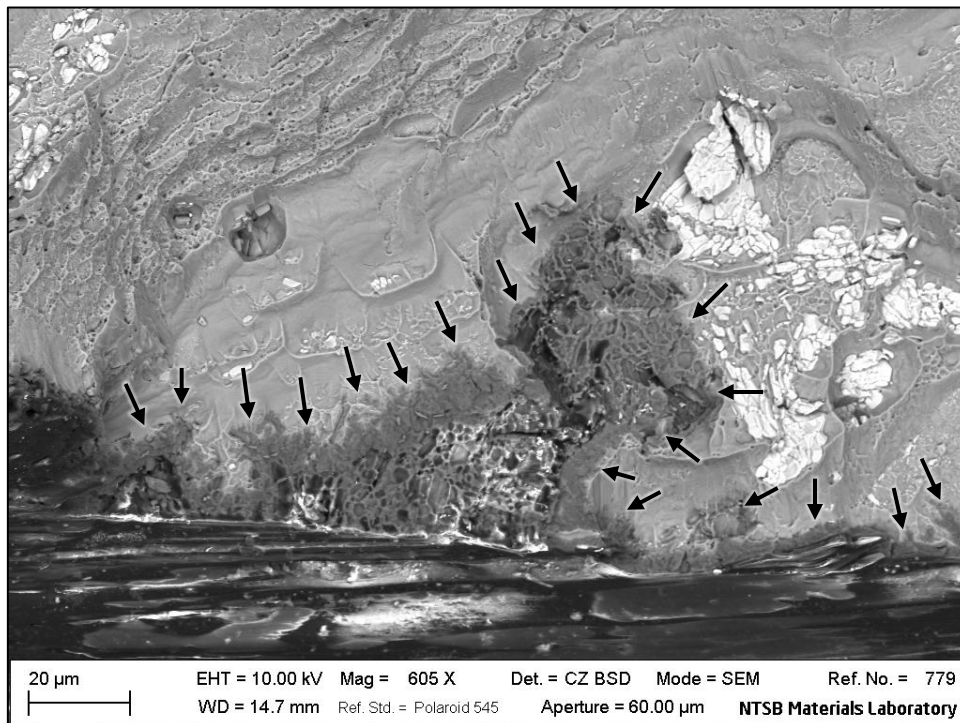
Figure 17. SEM images using secondary electrons (upper image) and backscattered electrons (lower image) to view the same area of the fracture surface on Test Specimen 4 adjacent to the as-manufactured surface. Darker areas indicated with arrows on the lower image are consistent with oxidized grain boundary etch pits.

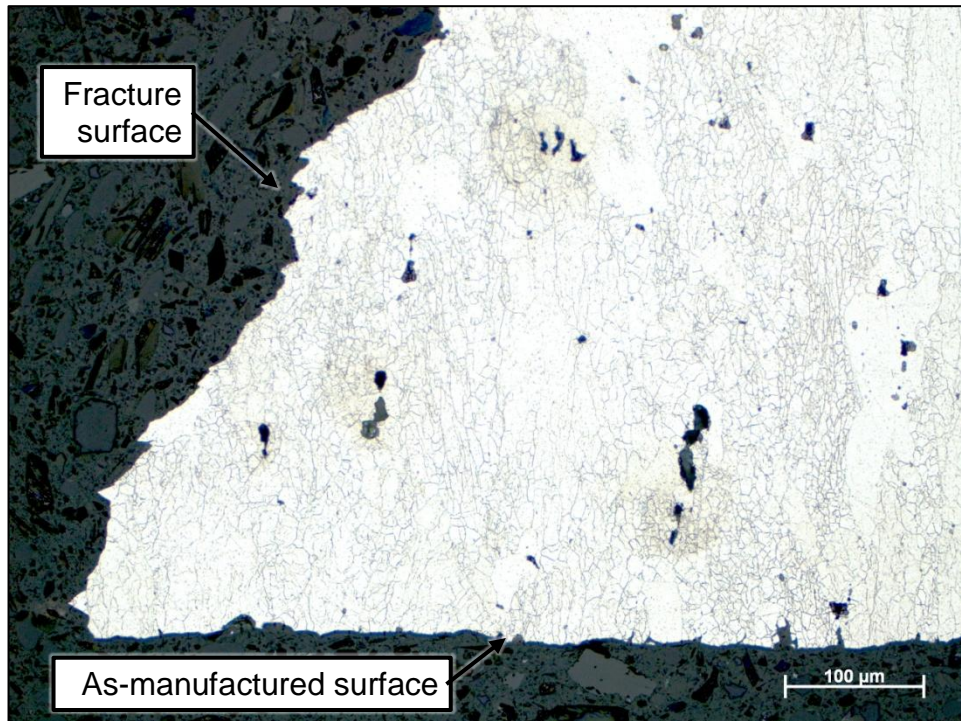
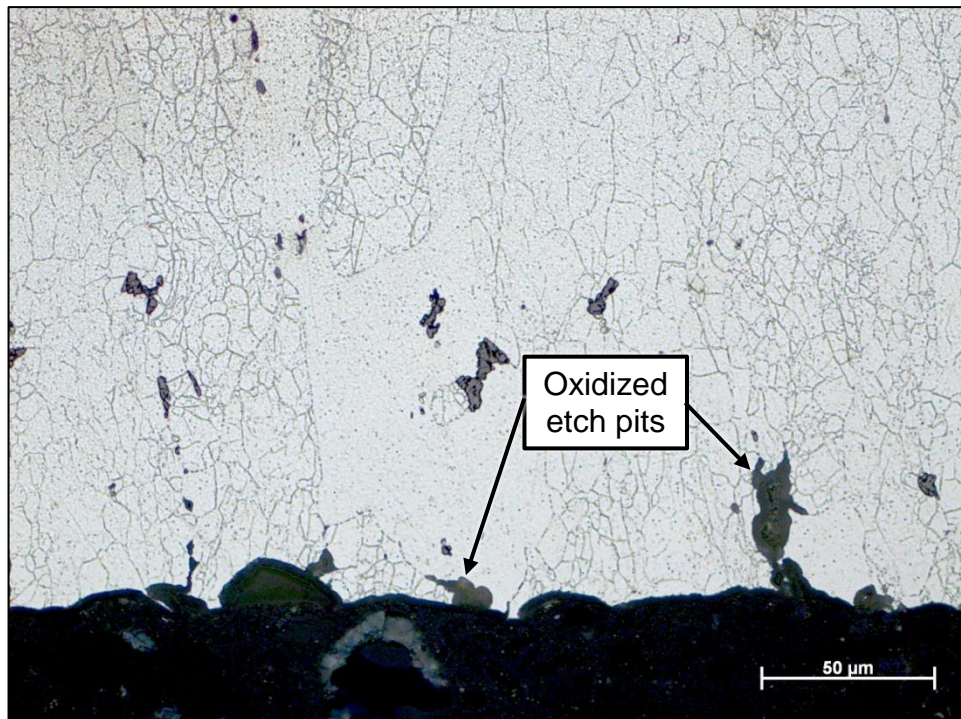
The smaller ends of fractured test specimens 1 and 4 from the fenestron attachment ring were mounted in a metallurgical mount and polished in a plane parallel to the edge face (thin side) of the tensile specimen. The polished cross-sections were then etched with Keller's reagent.⁶ Images of the polished and etched cross-sections are shown in figures 18 and 19. The upper images in figures 18 and 19 show features adjacent to the fracture surface for specimens 1 and 4, respectively. Crack-like grain boundary etch pits were observed at the as-manufactured surface. The etch pits showed oxidation on their surfaces consistent with the chromic anodized surface. The lower images in figures 18 and 19 show some of the deepest oxidized grain boundary etch pits observed in the polished and etched cross-sections. The deepest etch pit in specimen 1 shown in figure 18 was 0.0019 inch deep, and the deepest etch pit in specimen 4 shown in figure 19 was 0.0016 inch deep.

Figure 18. Views of the polished and etched (Keller's reagent) cross-section of test sample 1 showing the microstructure at the as-manufactured surface. The upper image shows the microstructure near the fracture surface, and the lower image shows one of the deepest oxidized grain boundary etch pits.

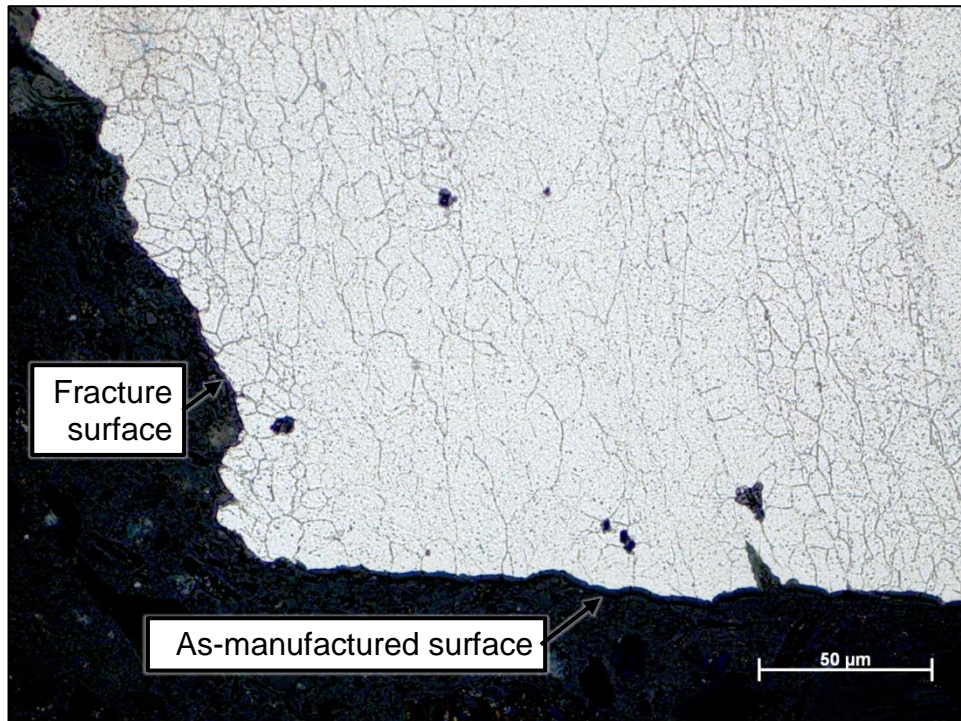
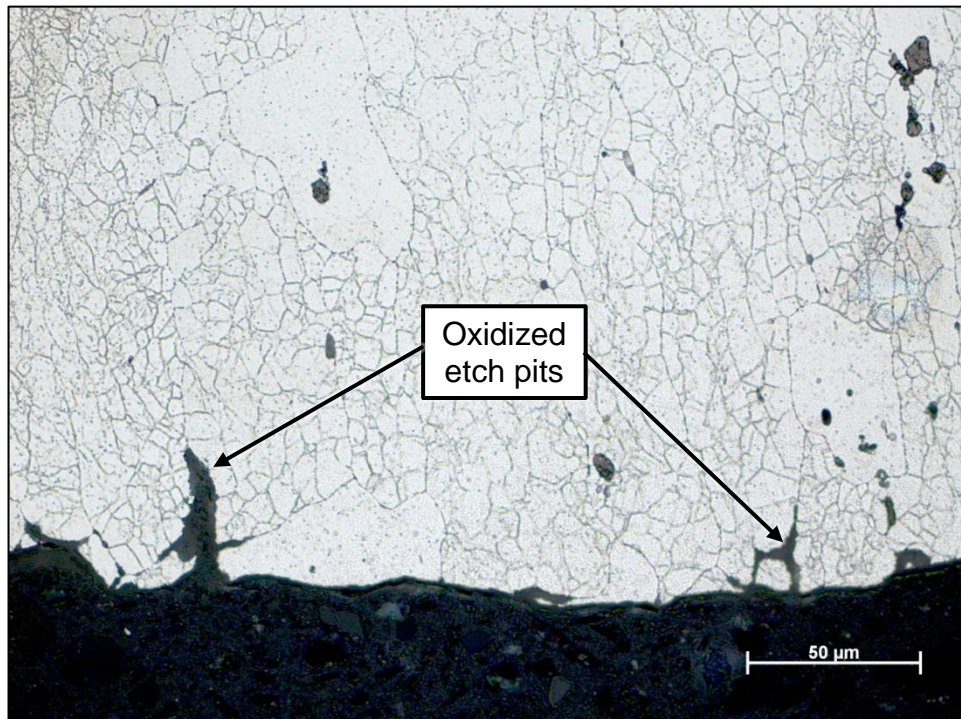
Figure 19. Views of the polished and etched (Keller's reagent) cross-section of test sample 4 showing the microstructure at the as-manufactured surface. The upper image shows the microstructure near the fracture surface, and the lower image shows one of the deepest oxidized grain boundary etch pits.
