NATIONAL TRANSPORTATION SAFETY BOARD

MATERIALS LABORATORY FACTUAL REPORT

Report No. 13-044

Place : Surprise, Arizona
Date : December 10, 2011
Vehicle : Vans RV-7A, N724WD
NTSB No. : WPR12FA059
Investigator : Michael Huhn, AS-WPR

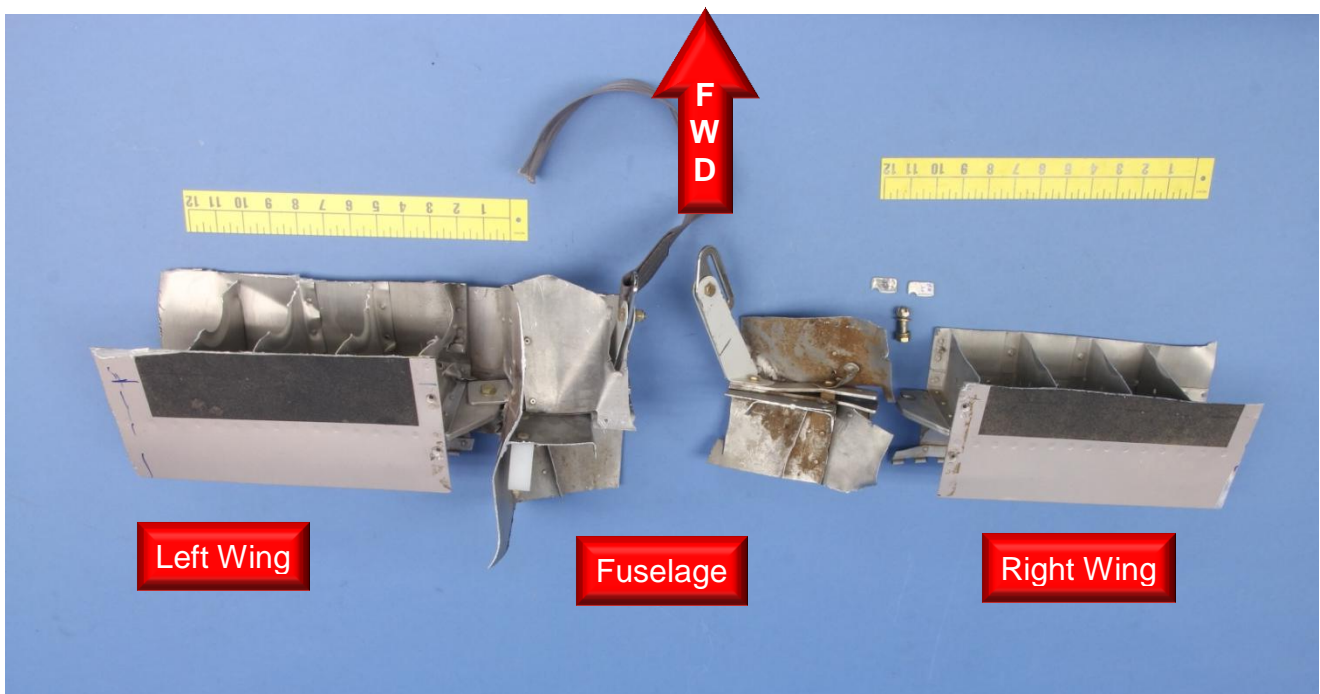
An overall view of the as-received wing components is displayed in figure 1. The components consisted of the inboard ends of the rear spars (W-707 assembly) from both the left and right wings and the respective mating areas of the fuselage structure (F-705 bulkhead). The right wing pieces were separated and the bolt had been removed, as shown in the upper view of figure 2. The left wing components were received still assembled, as shown in the lower view of figure 2. The wing rear spar to fuselage connections were made up of a fork (W-707G) and doubler (W-707D) on the rear spar bolted between a center section bar (F-705B) and a bar doubler (F-605C). A Van's Aircraft representative indicated that the wing pieces were 2024-T3 aluminum sheet and the fuselage pieces were 2024-T4 aluminum.

Figure 1. An overall top view of the as-received wing and fuselage components.

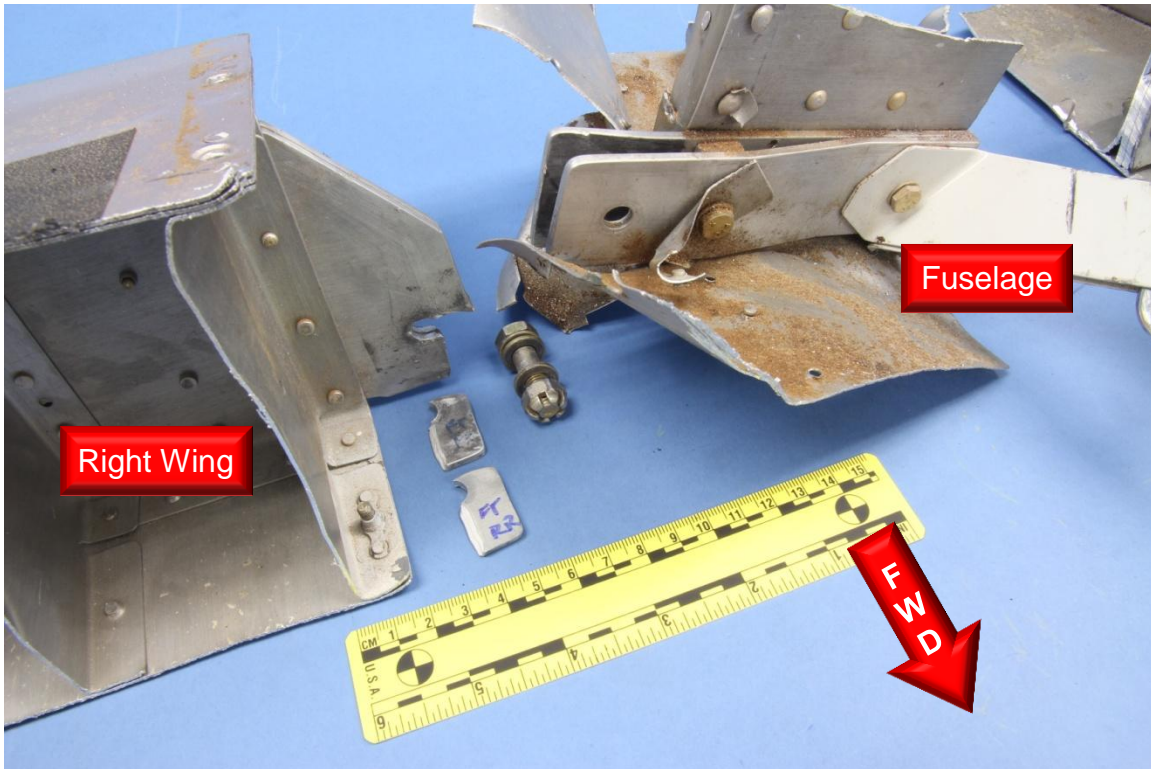
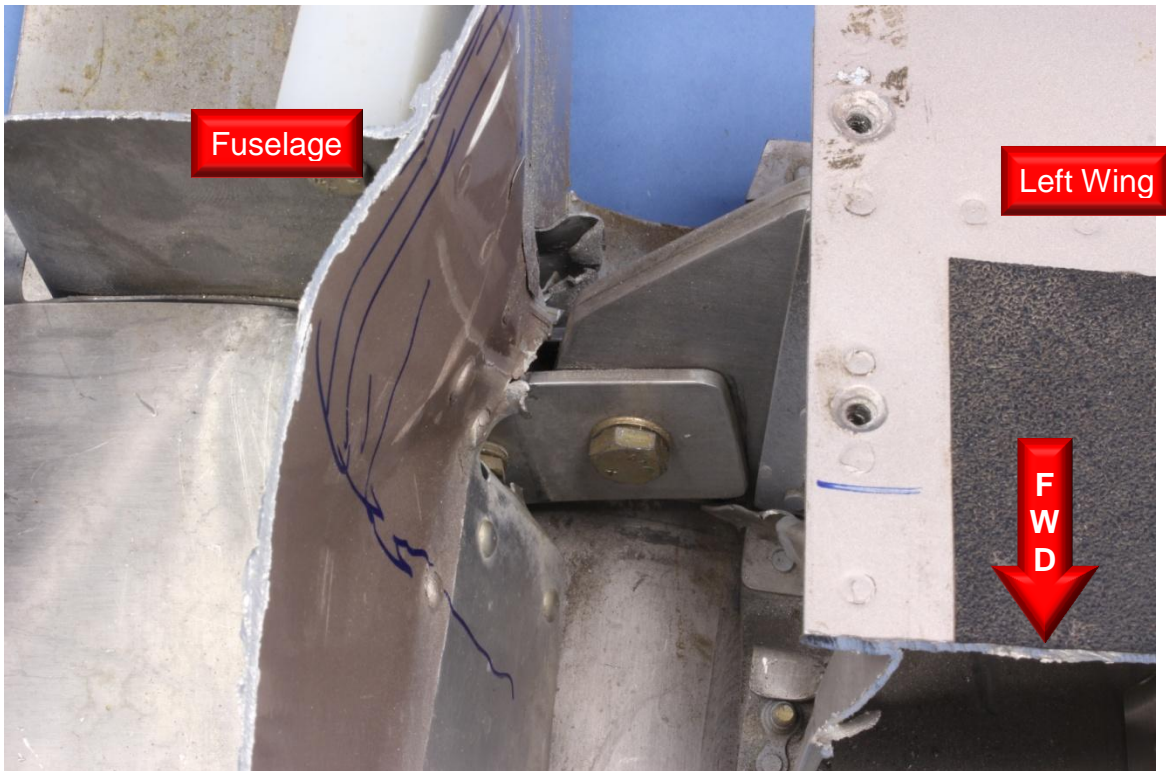
As shown in the upper view of figure 2 and in figure 3, the right wing rear spar components were fractured. Inspections showed horizontal fractures between the bolt hole and the inboard component edges and vertical fractures between the bolt hole and the lower edges of the doubler and fork. Microscopic examinations of the fracture surfaces uncovered features consistent with overstress shearing at the horizontal fractures and tensile overstress at the vertical fractures. With the vertical fractures placed together, as in figure 4, significant deformation and inboard elongation of the bolt hole was apparent prior to separation of the fork and doubler. No indications of preexisting cracking or corrosion were noted at the separation locations.

The left wing rear spar connection to the fuselage was intact as shown in the lower view of figure 2. Removing the bolt and separating the joint revealed some mechanical damage to the faying surfaces of the wing pieces as shown in figure 5. The damage was consistent with relative movement between the faying surfaces of the wing and fuselage while the joint was clamped.

Figure 2. Closer views of the rear spar to fuselage connection as they were received. Right wing at top. Left wing below.

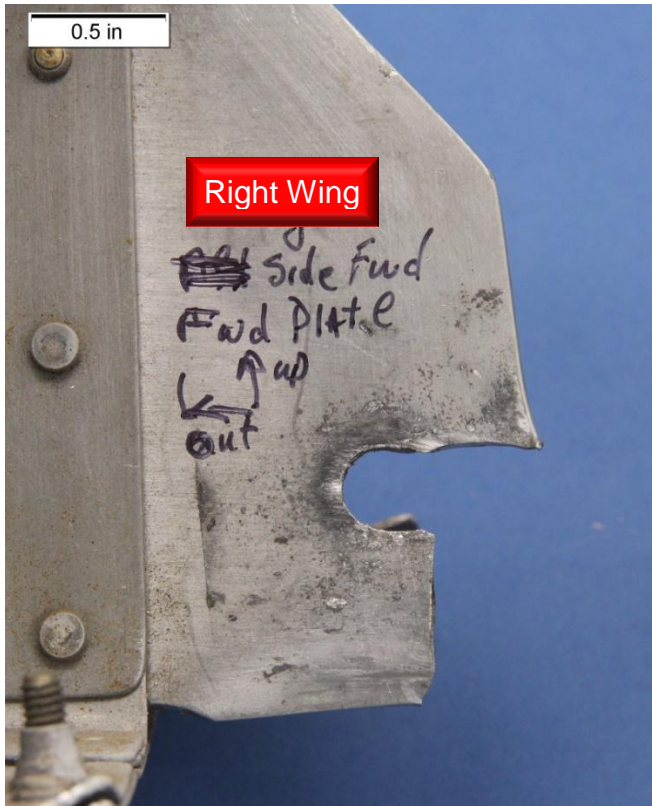
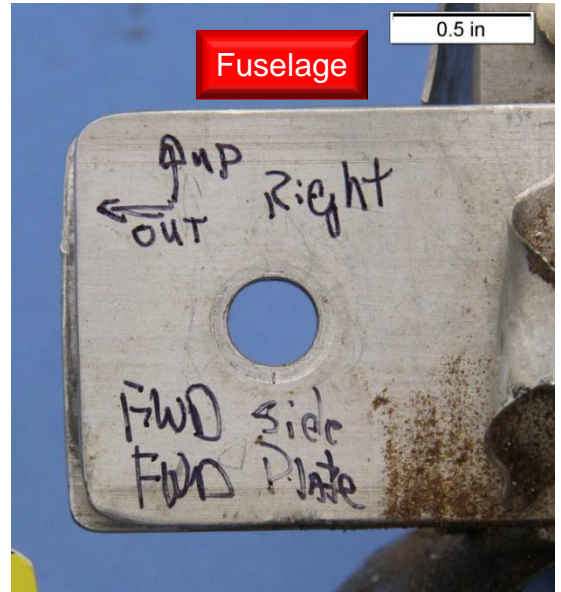
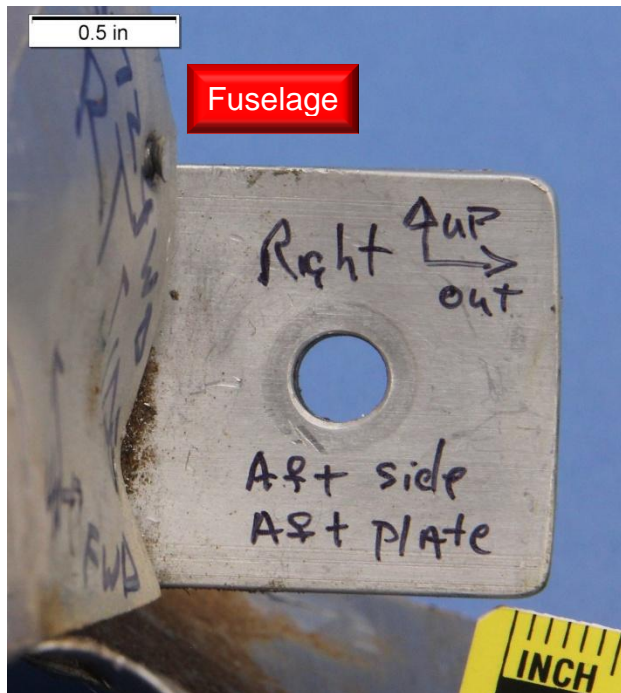
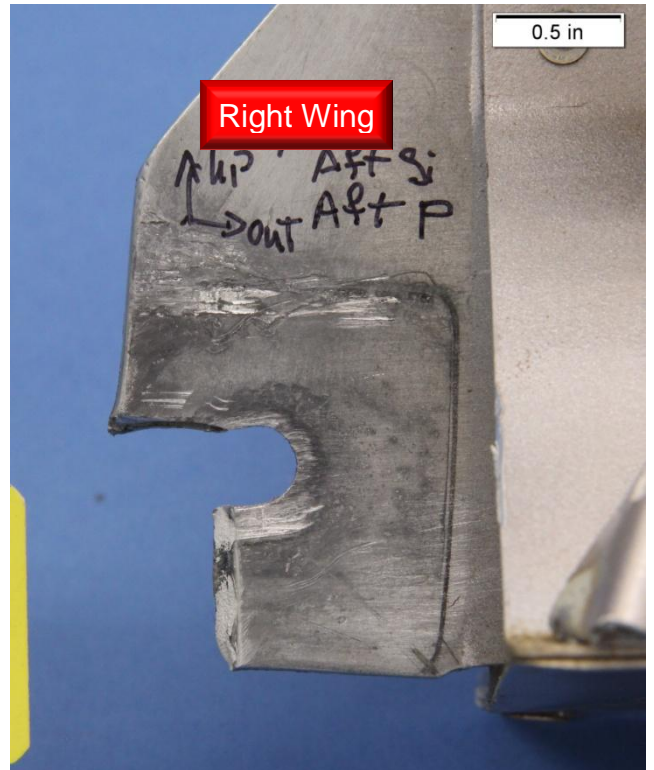
Measurements indicated that the holes were about 0.33 inch in diameter or approximately 5/16 inch (0.3125 inch) as specified in the assembly instructions. Based on measurements of the most outboard portion of the remaining hole, the center of the initial hole was estimated to be located approximately 0.61 inch from the original edge of the spar pieces (edge margin). The assembly instructions specify a minimum of 5/8 inch (0.625

inch) edge margin. The mating holes in the fuselage pieces also measured 5/16 inch but did not display noticeable elongation or deformation. X-ray fluorescence analysis of the fork and doubler found the material to be consistent with 2024 aluminum alloy. Averaged hardness and electrical conductivity measurements, shown in table below, were more consistent with a T4 temper condition than the specified T3.

Figure 3. Views of the forward and aft sides of the right wing and fuselage pieces showing the fracturing and hole deformation of the wing side components.

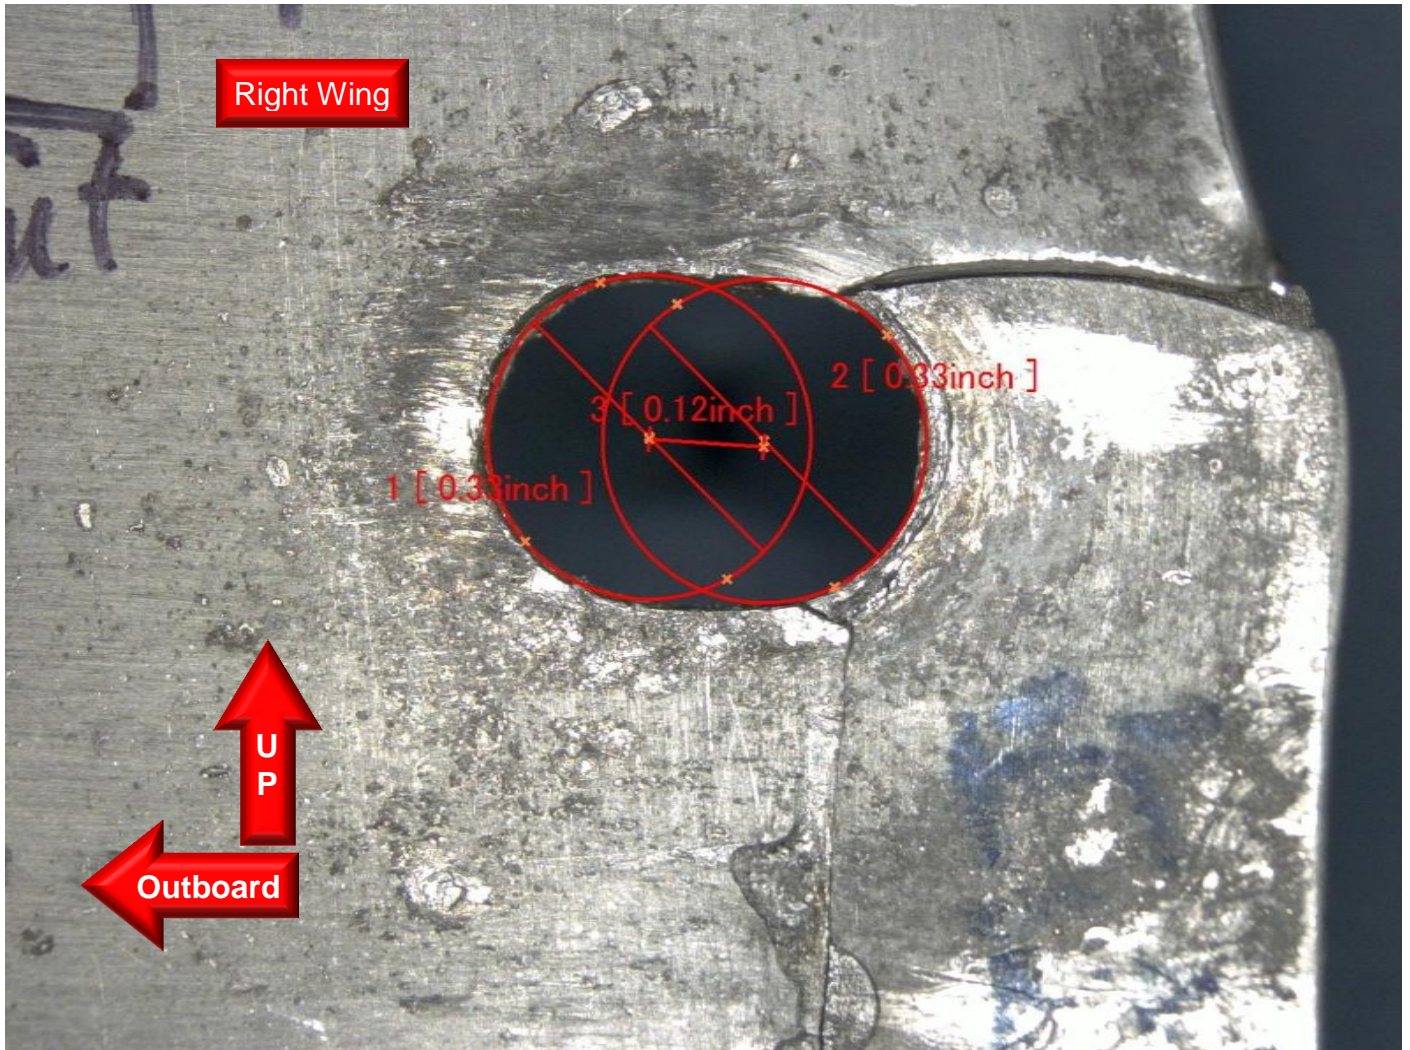
Figure 4. Closer view of the right wing fork attachment hole with the separated piece in its original position showing the inboard elongation of the hole.

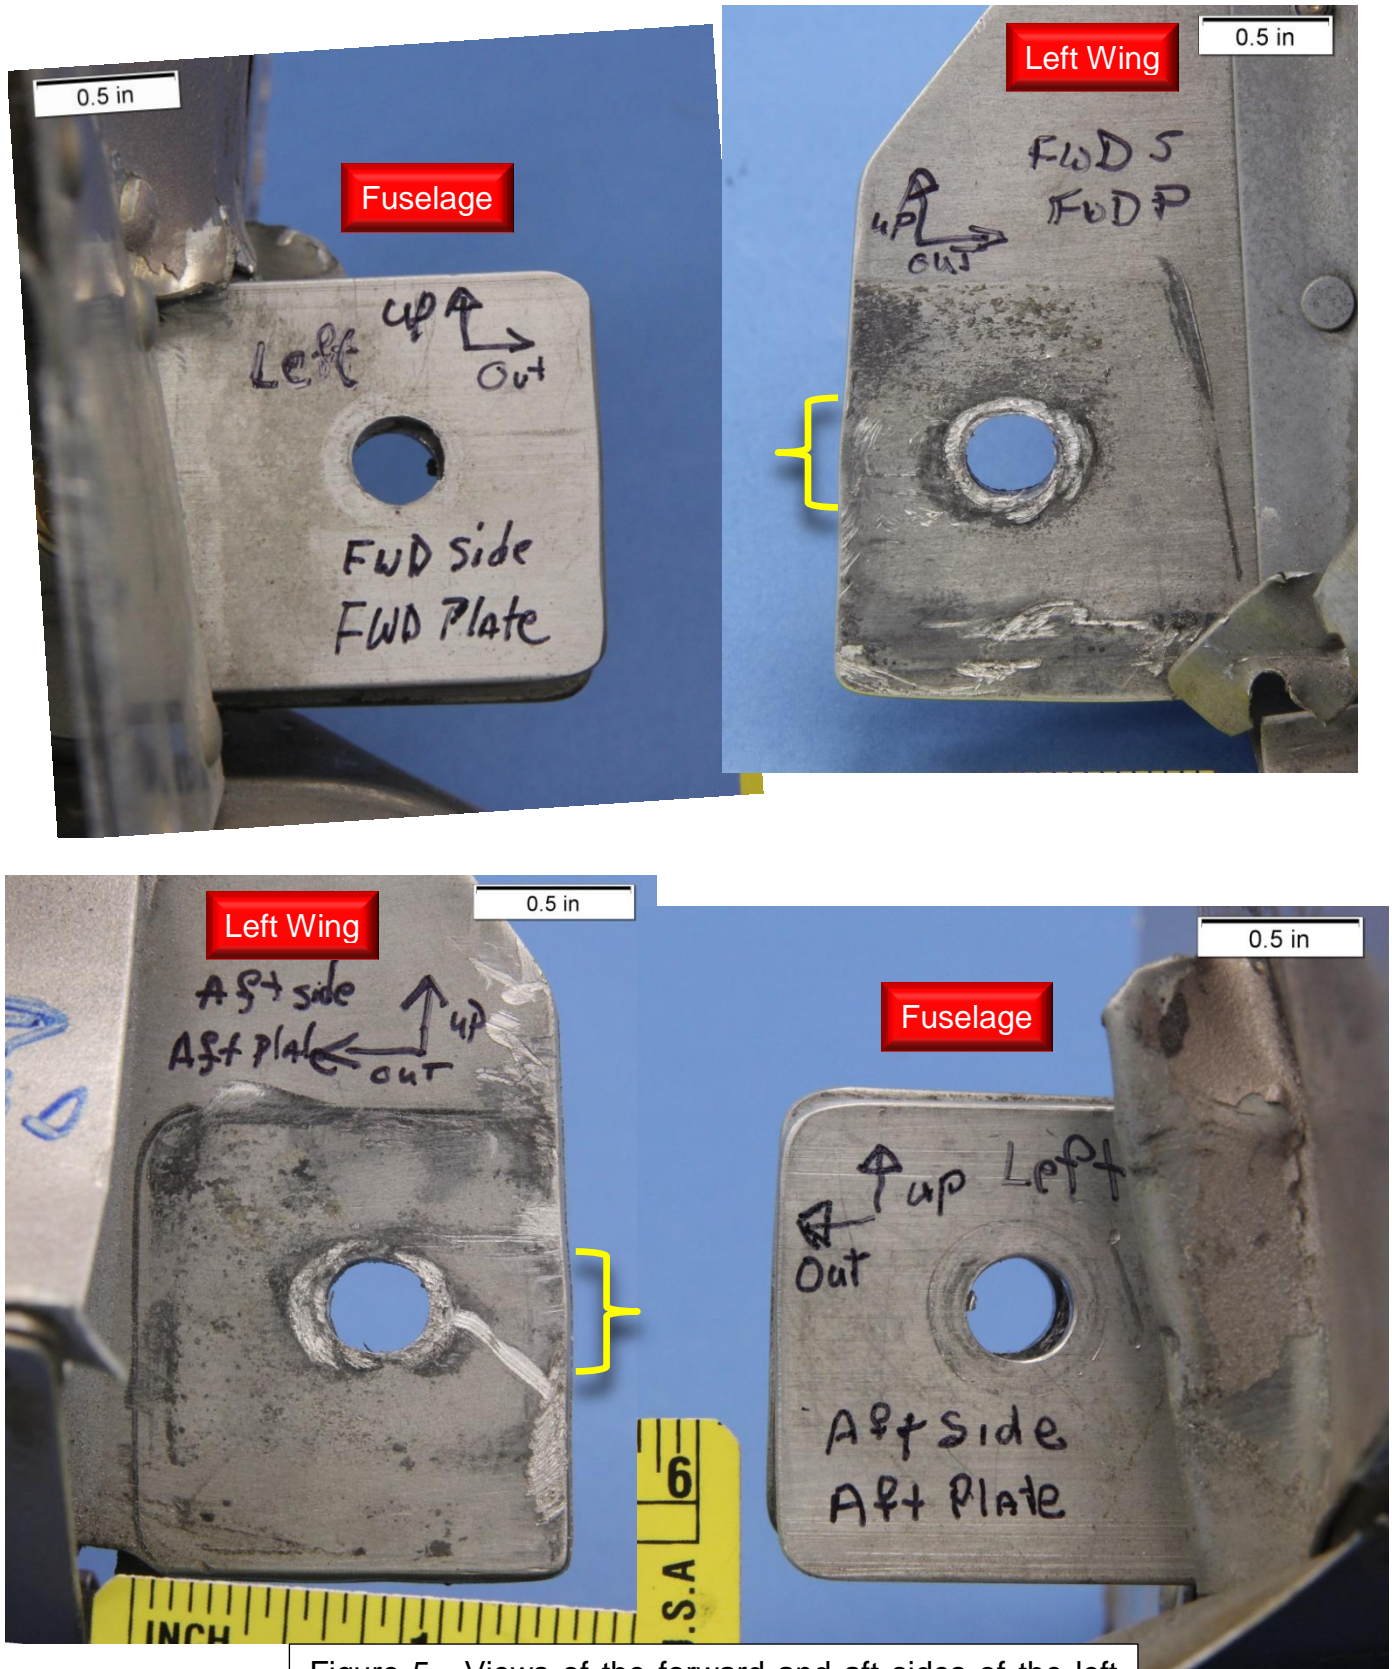
The bolt holes in the wing pieces were also elongated and the inboard edges were bulged and deformed slightly as indicated by yellow brackets in figure 5. As shown in figure 6 the bulging measured about 0.02 inch above the normally straight edge of the wing piece. The bolt hole measured approximately 0.33 inch (~5/15 inch) in diameter and was elongated about 0.03 inch in the inboard direction. The bolt holes in the mating fuselage components were round and undeformed.

Figure 5. Views of the forward and aft sides of the left wing and fuselage pieces showing the hole deformation and damage of the wing side components.

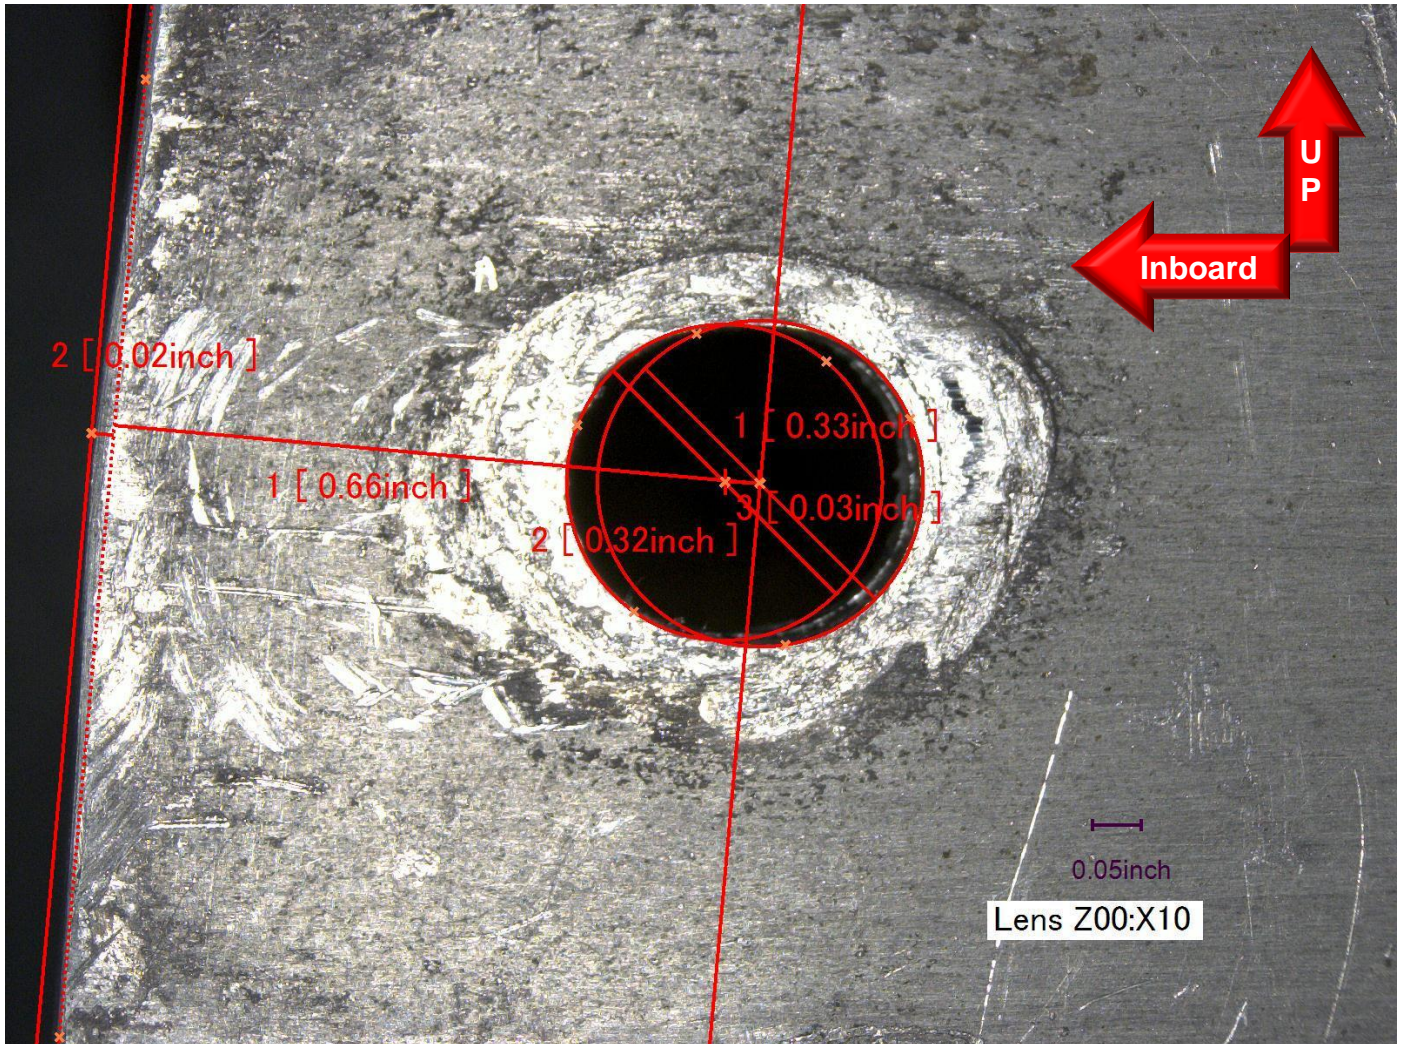
Figure 6. Closer view of the intact left wing fork attachment hole showing the inboard elongation of the hole and surrounding damage. Also the bulge is measured at the left.

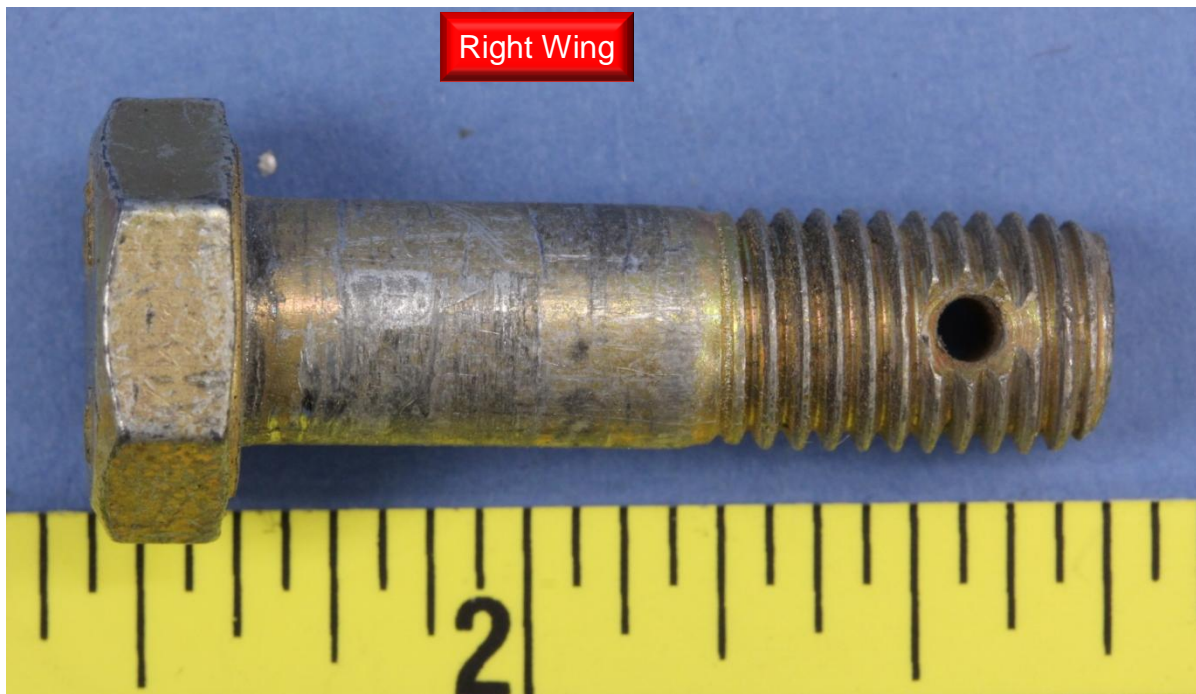
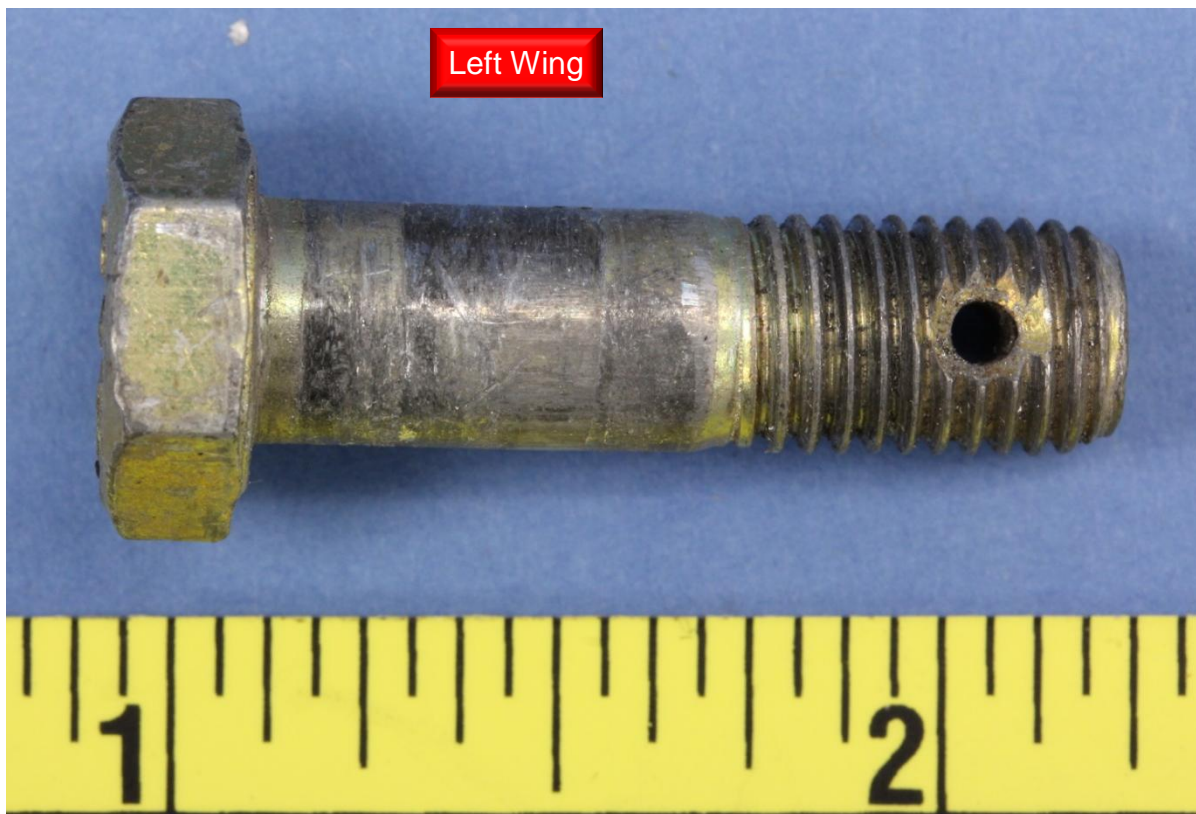
The wing bolts are displayed in figure 7. Neither bolt was significantly damaged but showed marks in the grip regions consistent with contact by the respective wing pieces.

Figure 7. The intact left and right wing rear spar attaching bolts showing grip contact with the respective wing and fuselage components.
