# NATIONAL TRANSPORTATION SAFETY BOARD

MATERIALS LABORATORY FACTUAL REPORT

Report No. 13-054

Place: East Moriches, New York.  
Date: October 20, 2012.  
Vehicle: Swift Museum Foundation, Inc. GC-1A, N80823.  
NTSB No.: ERA13FA032.  
Investigator: Tim Monville.

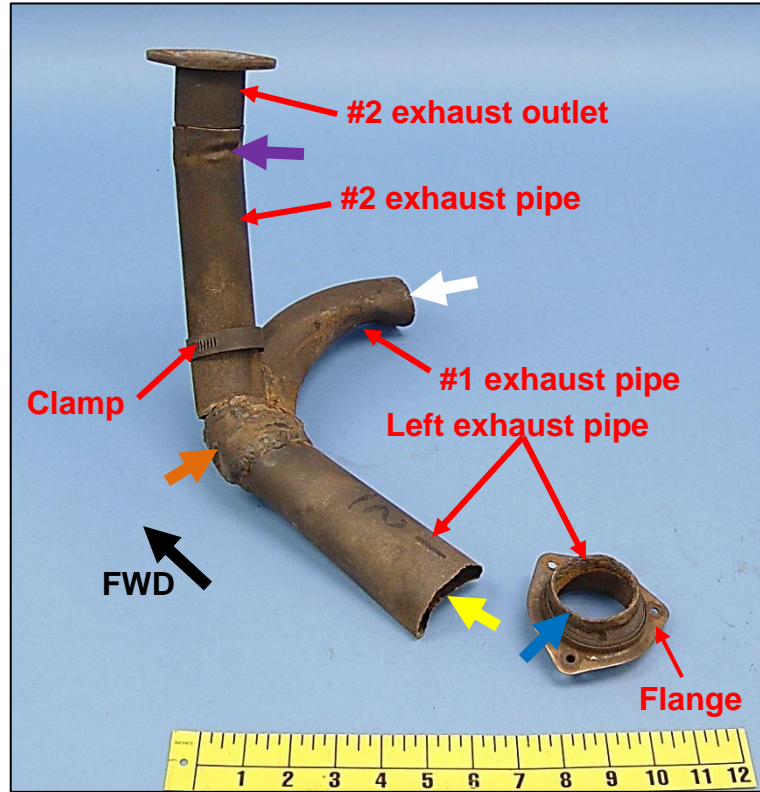
The left exhaust assembly submitted for examination is illustrated in Figure 1 with the #2 exhaust outlet, normally attached to the #2 cylinder exhaust port, the flange, normally bolted to a similar flange on the left muffler, and the clamp, normally retaining the left manifold to the exhaust outlet identified. The left exhaust assembly had been cut at the #1 exhaust pipe that is normally located under the engine and is similarly attached to the #1 cylinder exhaust port. The #1 exhaust pipe had also been deformed inwards at the location indicated by the identifying red arrow. The individual pieces of the left manifold are identified as the #2 exhaust pipe, the left exhaust pipe and the #1 exhaust pipe. The forward (FWD) direction, as installed on the engine, is also indicated. The white arrow indicates the cut end of the #1 exhaust pipe and the yellow arrow indicates the fractured end of the left exhaust pipe. The blue arrow indicates the fractured end of a portion of the left exhaust pipe still attached to the flange. Cylinders #3 and #4 have a separate exhaust arrangement where the #4 exhaust pipe is routed forward and under the engine, attached to and parallel to the #1 exhaust pipe, to join the #3 exhaust pipe and both exhaust through the right muffler.

Examination of the manifold also revealed the compression buckle indicated by the purple arrow in Figure 1, the normal location for the clamp.

Figure 1. The left exhaust assembly received for examination.

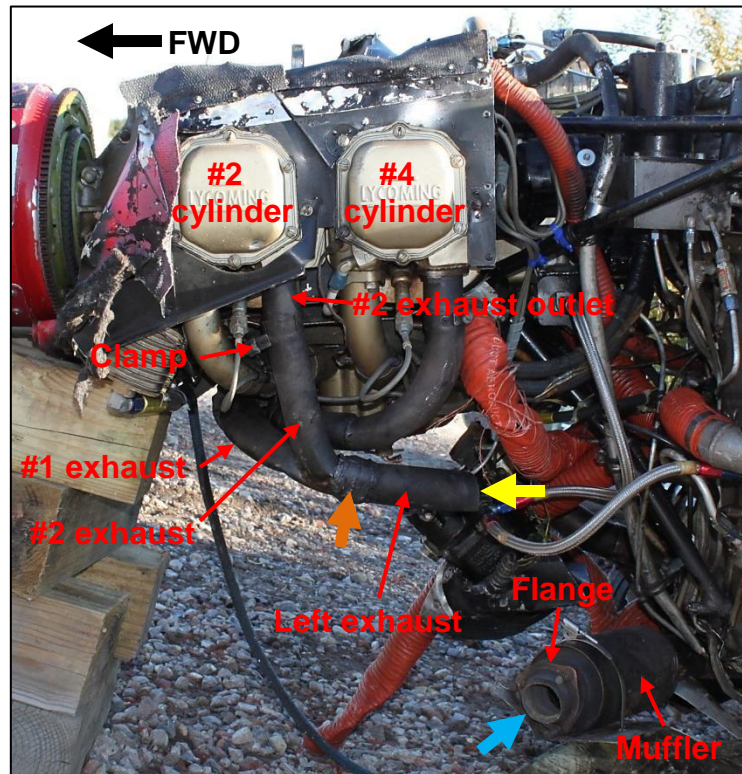
The left side of the engine is illustrated in Figure 2 with the forward direction indicated and the left exhaust components identified as in Figure 1. The yellow and blue arrows indicate the fractures similarly indicated in Figure 1. Figure 2 illustrates the flange with the portion of the left exhaust pipe still bolted to the left muffler. Although the clamp was fractured, it was retained in the vicinity of its original location by other engine components.

Figure 2. The left side of the engine with the left exhaust components in Figure 1 indicated and identified.

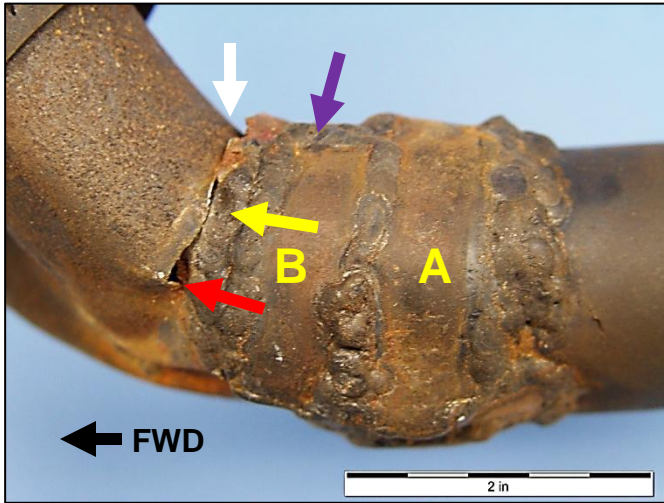
Examination of the left exhaust revealed two welded patch repairs where the #1 exhaust pipe joins the #2 exhaust pipe and a fracture on the upper side immediately forward of the patches. A view of the left side of the repairs indicated by the brown arrows in Figures 1 and 2 is illustrated in Figure 3 with the forward direction indicated. The patch identified as "A" was found to be almost circumferential with a small gap located on the underside. The patch identified as "B" was mostly located on the left side, between the purple arrow in Figure 3 and in the right image in Figure 5. The patch welds had a rough uneven lumpy appearance with areas of undercutting but did not display any indications of escaping exhaust gasses. The red arrow in Figure 3 indicates the left tip of a fracture that extended to the right, over the top of the manifold, to the red arrow in Figure 4 and along the forward edge of the weld indicated by the yellow arrow. The white arrow in Figure 3 indicates where the #2 exhaust pipe was now located under the fractured edge of the weld joining it to the left exhaust pipe.

Figure 3. The left side of the left exhaust repair indicated by the brown arrow in Figure 1.

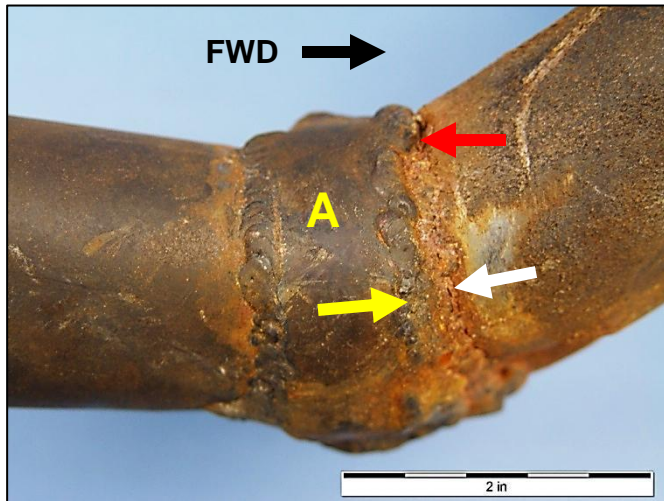
The right side of the patch repairs is illustrated in Figure 4 with the forward direction indicated and patch "A" identified. The patch welds had a rough uneven lumpy appearance with areas of undercutting but did not display any indications of escaping exhaust gasses. The white arrow indicates a previous weld that had been partially obscured by the patch weld indicated by the yellow arrow. The red arrow indicates the right tip of the fracture indicated by the red arrow in Figure 3.

Figure 4. The right side of the left exhaust repair illustrated in Figure 3.

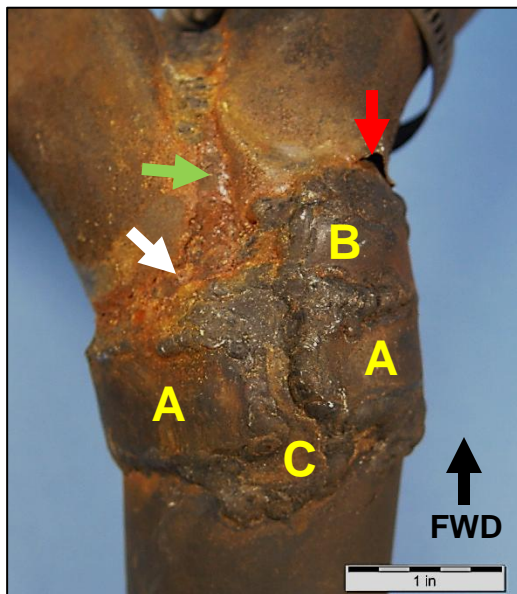
Examination of the patch repairs on the underside of the manifold revealed a third patch. The repair patches are illustrated in the left image in Figure 5 and identified as "A" and "B", as in Figures 3 and 4, and the third patch, located mostly below the ends of patch "A", is identified as "C". The forward direction is indicated. The red arrow indicates the tip of the crack similarly indicated in Figure 3 and the white arrow indicates the weld similarly indicated in Figure 4. The green arrow indicates the original weld that joins the #1 exhaust pipe to the #2 exhaust pipe. The patch repair welds still displayed the rough uneven lumpy appearance illustrated.

Figure 5. The underside (left) and upper side (right) of the left exhaust repair illustrated in Figure 3.

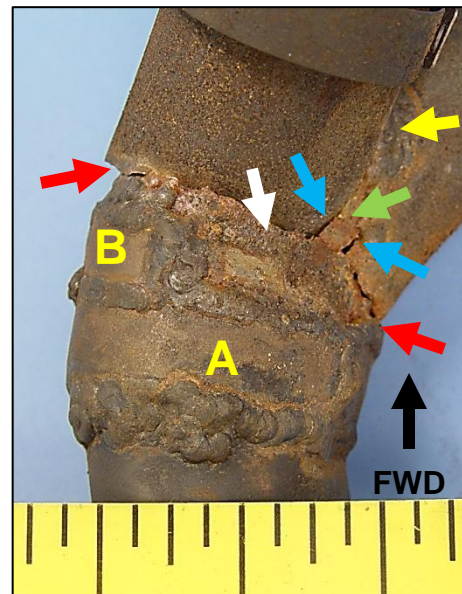
The patch repairs on the upper side of the manifold are illustrated in the right image in Figure 5 and identified as "A" and "B" as in Figures 3 and 4. The forward direction is indicated. The patch repair welds still displayed the rough uneven lumpy appearance illustrated. The white arrow indicates the weld similarly indicated in the left image and in Figure 4, and the red arrows indicate the fracture tips similarly indicated in Figures 3 and 4. The blue arrows indicate cracks that were a continuation of the fractures indicated by the red arrows and had propagated along both sides of the original weld indicated by the green arrow. The yellow arrow indicates a weld on top of the weld indicated by the green arrow. The upper side, looking aft, is illustrated in Figure 6 with patch "A" identified. The green arrow, as in Figure 5, indicates the original weld and blue arrows indicate the cracks on both sides of the weld. The white arrow indicated the weld similarly indicated in the right image in Figure 5 and the yellow arrows indicate the exposed uniform pipe thickness.

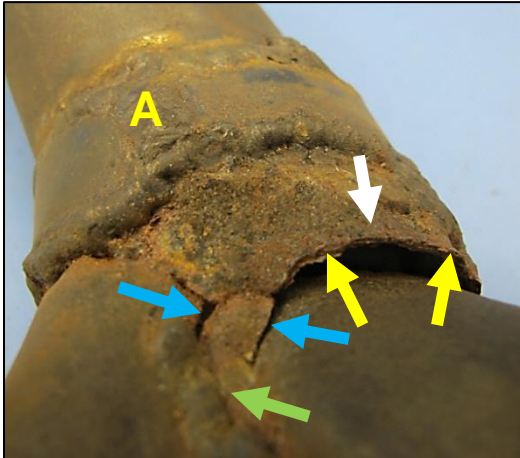
Figure 6. The upper side of the left exhaust repair, looking aft.

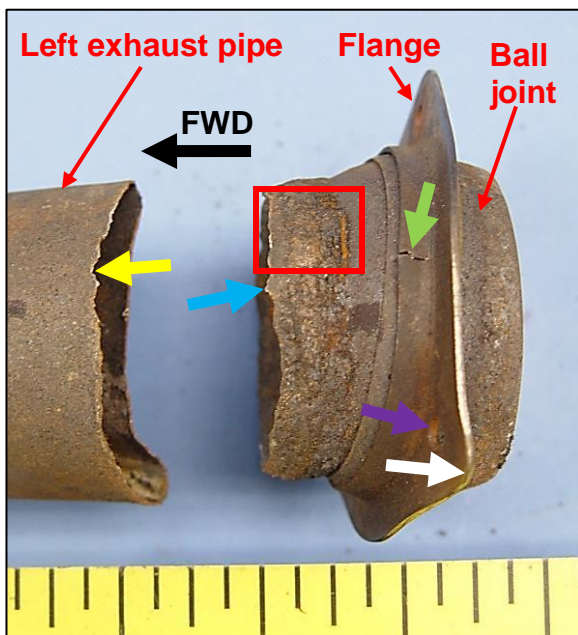
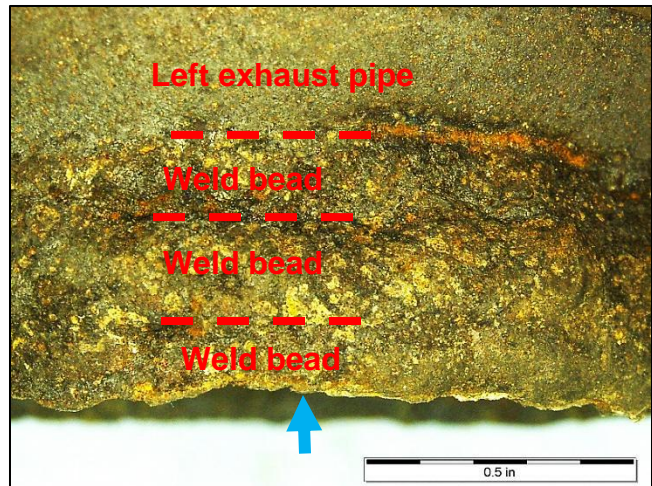
The flange identified in Figure 1 is normally part of the exhaust assembly and bolted to the muffler as illustrated in Figure 2. A side view of the fractures indicated by the yellow and blue arrows in Figure 1 are illustrated in the left image in Figure 7 with mating features indicated by the yellow and blue arrows. The left exhaust pipe, the ball joint and the flange are identified and the forward direction is indicated. The ball joint allows for any misalignment between the exhaust pipe and the muffler. The white arrow indicates the rearward deformation of the flange at the mounting hole indicated by the purple arrow and the green arrow indicates a crack in the lip of the flange that normally conforms to the ball joint. The exhaust pipe is welded to the ball joint and the weld was found on the ball joint portion. The weld was also found to be circular. The weld within the red box is illustrated in the right image in Figure 7 with a blue arrow indicating the fracture as in the left image. The examination revealed that the weld consisted of the three identified beads that are divided by the red dashed lines.

Figure 7. The mating fractures indicated by the yellow and blue arrows in Figures 1 and 2 (left) and the weld in the red box (right).

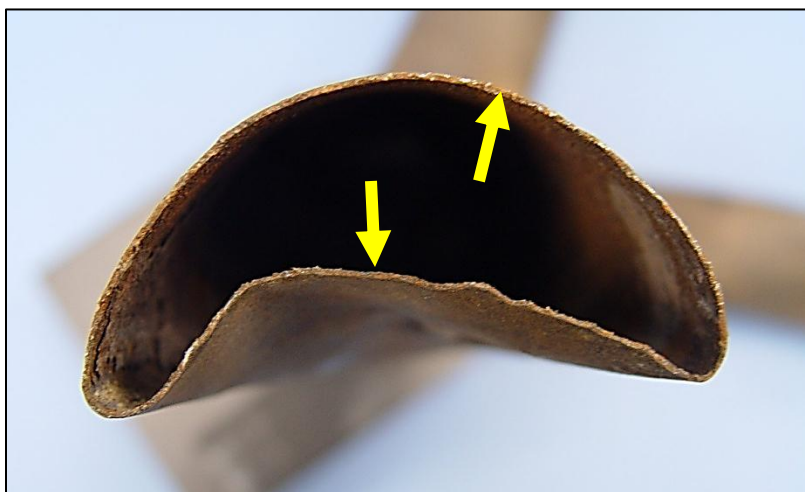
Examination of the rear end of the exhaust pipe revealed the fracture face and deformation of the pipe illustrated in Figure 8. Examination of the fracture face indicated by the yellow arrows revealed a rough grainy surface, consistent with an overload event, on a uniform pipe thickness that was measured at 0.027-0.025-inch thick. The exhaust outlet was extracted from the exhaust pipe and the pipe thickness was found to be uniform and was measured at 0.029-0.028-inch. The thickness of the cut end of the #1 exhaust pipe indicated by the white arrow in Figure 1 was found to be uniform and measured at 0.029-0.025-inch.

Figure 8. The fracture face indicated by the yellow arrow in Figures 1, 2 and 7.
