NATIONAL TRANSPORTATION SAFETY BOARD

MATERIALS LABORATORY FACTUAL REPORT

Report No. 13-062

Place : Flushing, NY
Date : July 22, 2013
Vehicle : Boeing 737-700, N753SW
NTSB No. : DCA13FA131
Investigator : Dennis Jones, AS-10

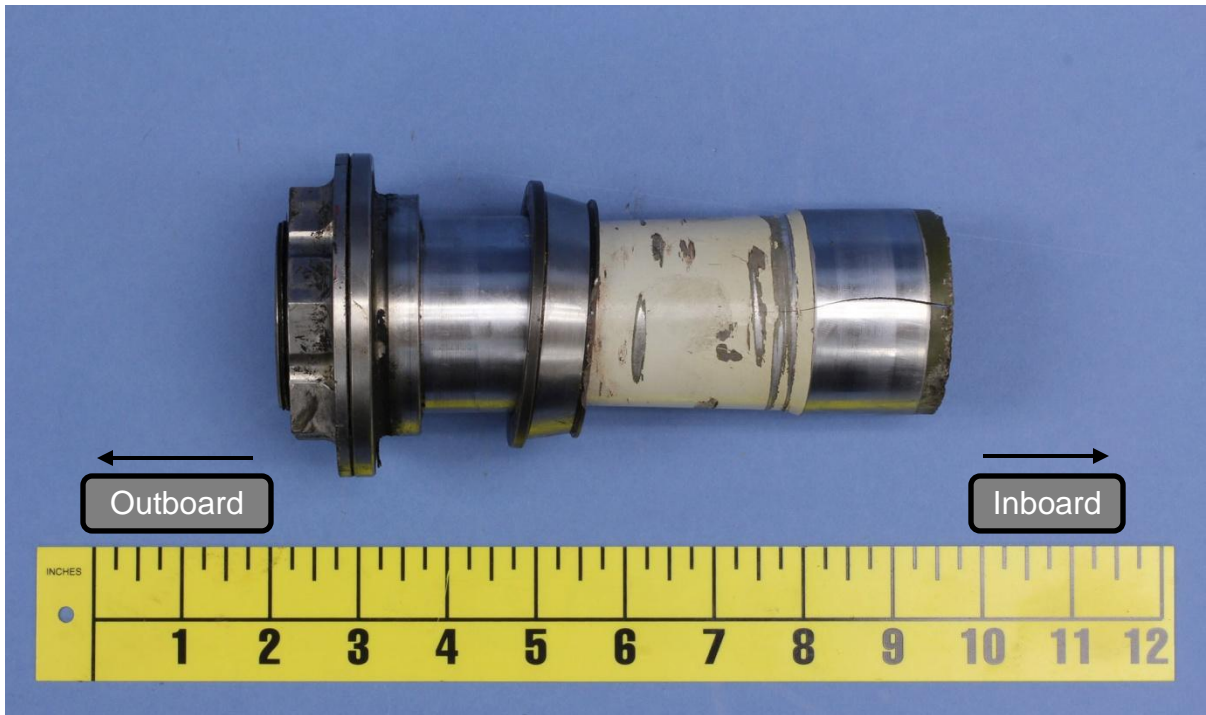
The fractured pieces of the nose landing gear left axle and lower drag brace bolt were received by the lab as shown in figures 1a and 1b, respectively. The left axle was fractured in the transverse plane approximately 0.25 inch inboard of the inboard chrome-plated bearing journal. There was also a longitudinal fracture that started at the transverse fracture and extended approximately 2.2 inch in the outboard direction. The drag brace bolt was fractured in three pieces. The middle piece measured approximately 1.1 inch in the longitudinal direction at its longest and was positioned near the midway point along the length of the bolt. The other two pieces had fracture surfaces that matched those on the opposing ends of the middle piece. The fracture surfaces were cleaned using a soft-bristled brush and an alkaline detergent, sonicated in acetone, and viewed using a stereomicroscope.

Figure 1: a) Fractured piece of nose landing gear left axle, as received; b) the three fractured pieces of the nose landing gear lower drag brace bolt, as received.

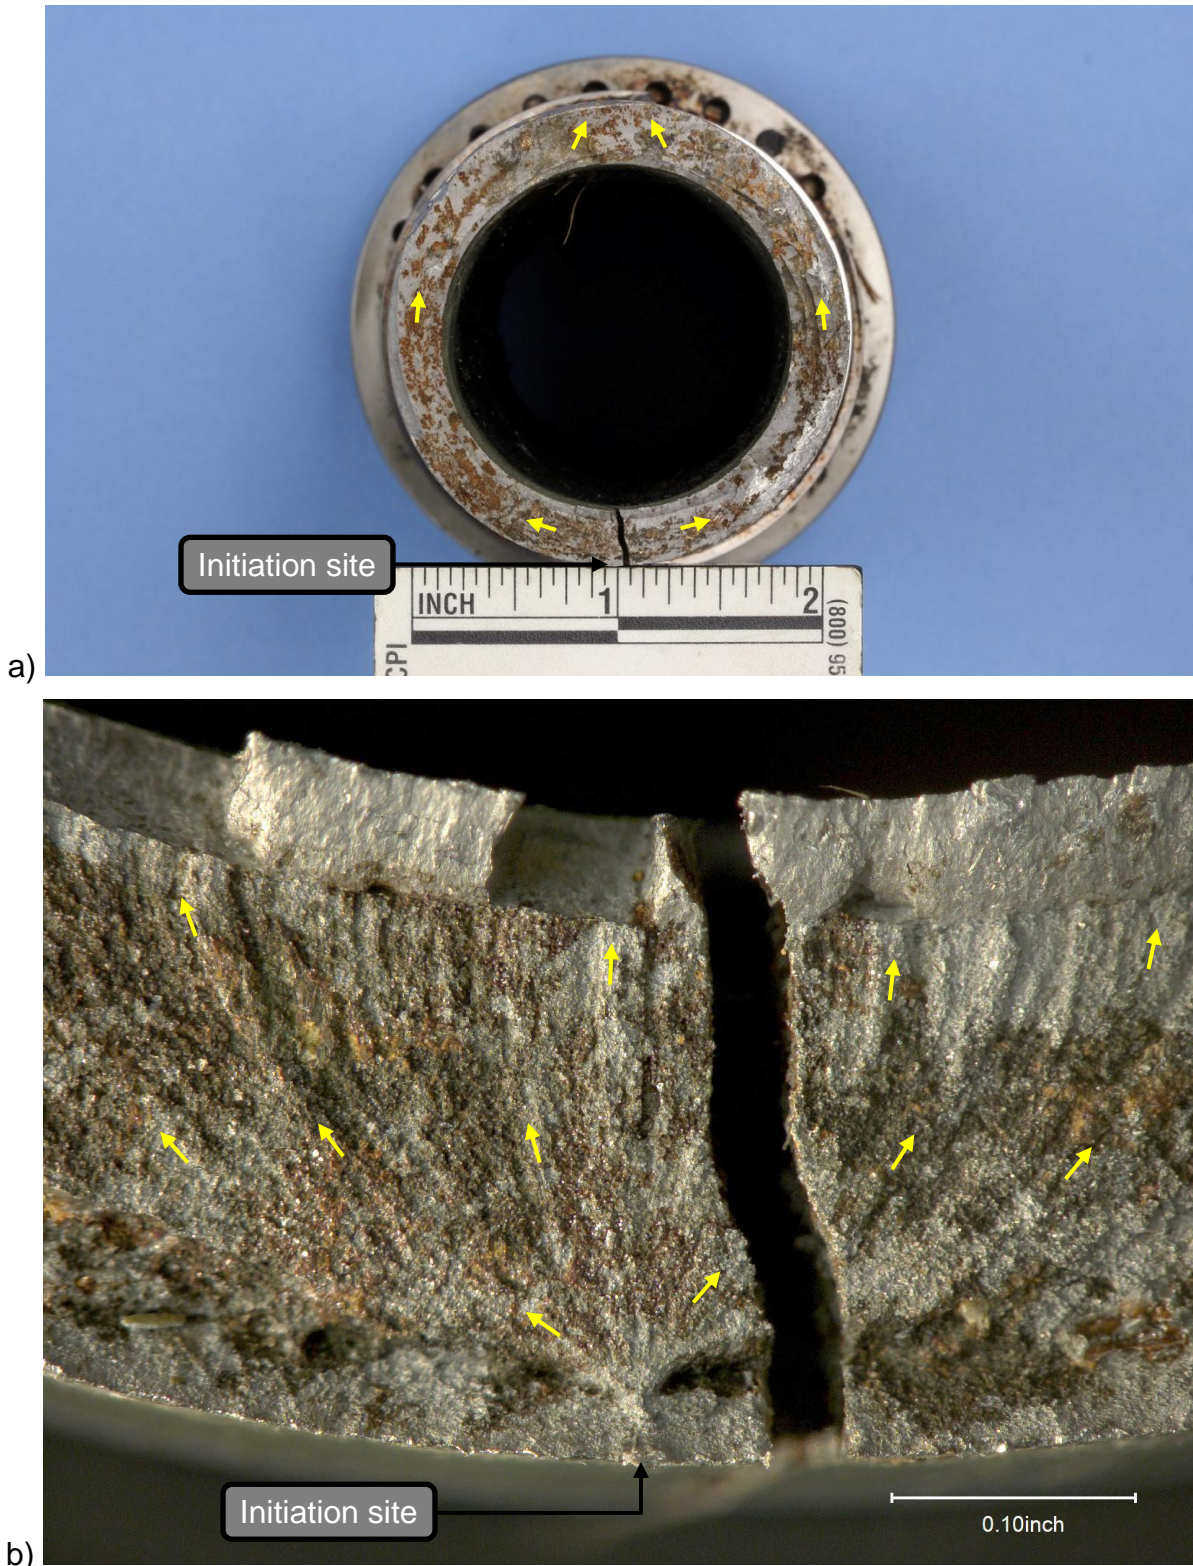
The transverse fracture through the left axle is shown in figure 2a. Viewed under the stereomicroscope, chevron marks and radial lines were observed that pointed back toward the fracture initiation site. A higher magnification image of the initiation site is shown in figure 2b, with the direction of crack propagation indicated by yellow arrows. The radial lines were traced back to a single point near the outer surface of the axle wall. The radial lines were also observed to be continuous across the longitudinal fracture, which was located near the initiation site. Along the outer surface of the wall, the fracture plane was inclined by 45° to the transverse plane. The features were consistent with a bending overstress fracture. No preexisting defects were observed.

Figure 2: a) Image of the left axle fracture surface; b) higher magnification image of the fracture initiation site. The direction of crack propagation is indicated by yellow arrows.

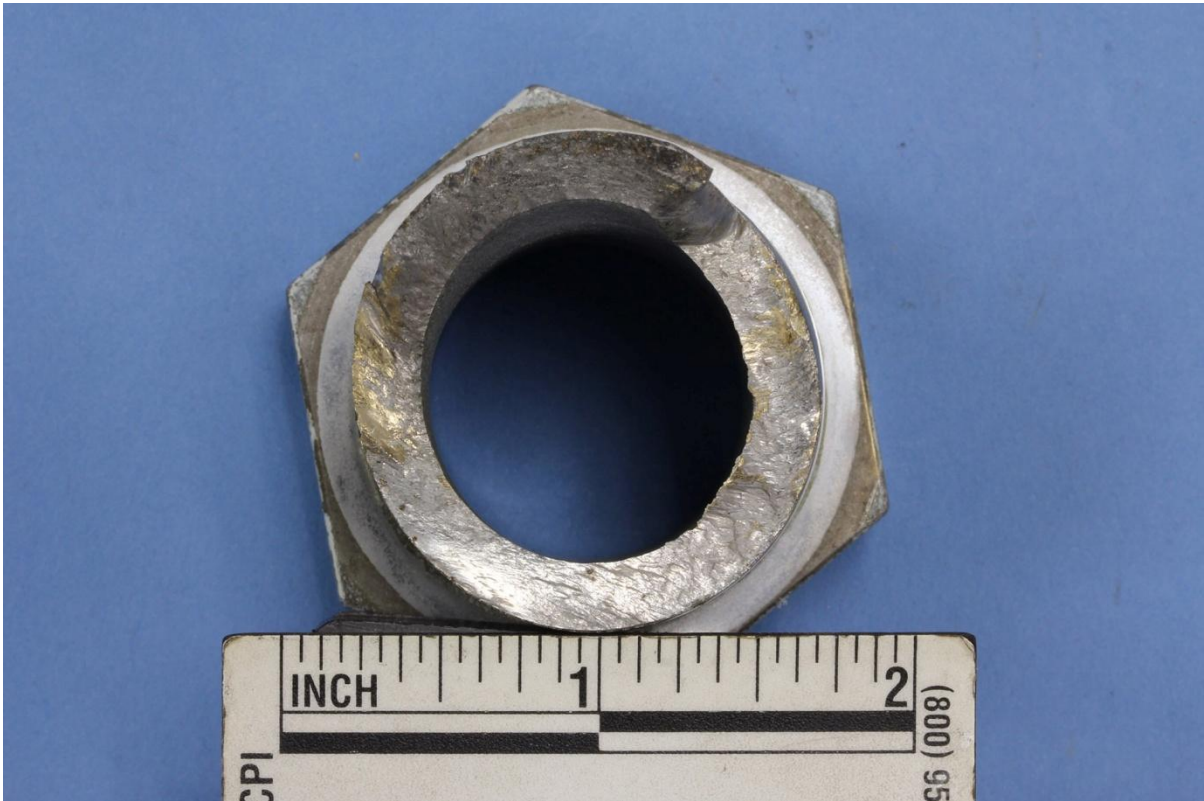
The fractures through the drag brace bolt are shown in figures 3a and 3b. Portions of each fracture surface lied in the transverse plane, were comparatively

reflective (compared to the rough appearance of a typical tensile overstress fracture), and exhibited parallel smear features consistent with shear deformation. Other portions of the fractures followed a 45° spiral plane about the bolt's longitudinal axis. The two bolt end pieces exhibited mirrored deformation bends near the middle fragment as shown in figure 1b. The features were consistent with an overstress fracture under shear and torsion. No preexisting defects were observed.

Figure 3: Images of the lower drag brace bolt fractures; a) fracture on the hex head end of the bolt; b) fracture on the threaded end of the bolt.
