NATIONAL TRANSPORTATION SAFETY BOARD

MATERIALS LABORATORY FACTUAL REPORT

Report No. 13-074

Place : Chesterfield, Missouri.
Date : August 3, 2013.
Vehicle : Cirrus SR22, N225CD.
NTSB No.: CEN13FA456.
Investigator: Jim Silliman.

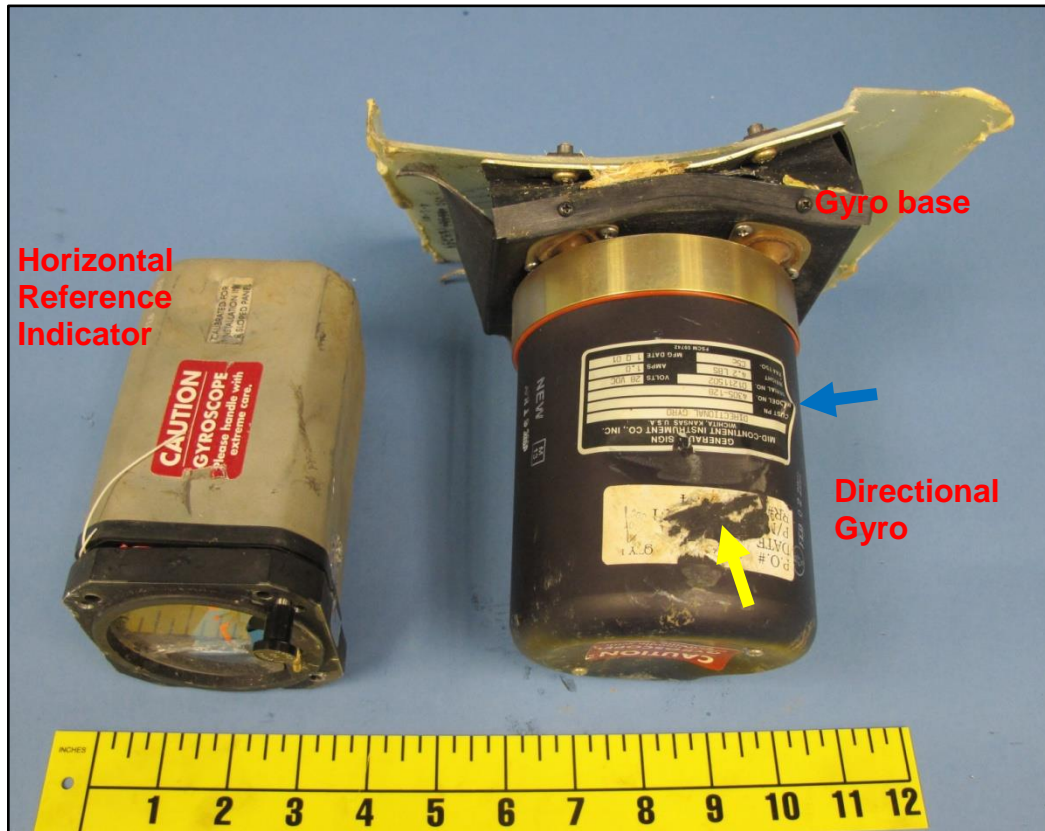
Preliminary examination of the received indicator revealed that the casing displayed numerous indentations. The electrical connection at the rear consisted of four pins protruding through a soil filled hole. The display housing was loose and its attaching screws were missing. The glass window was cracked and a portion was missing. The display immediately behind the missing portion of window had been deformed inwards.

Preliminary examination of the received directional gyro revealed the significant damage and indentation indicated by the yellow arrow in Figure 1 and the outward penetration indicated by the blue arrow.

Figure 1. The Horizon Reference Indicator (left) and the Directional Gyro (right) received for examination.

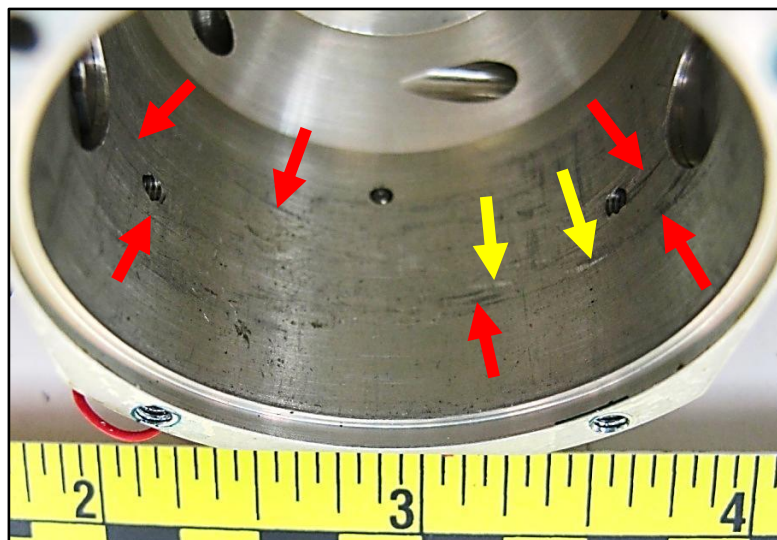
Due to the indentations, the casing of the horizontal reference indicator was cut longitudinally so it could be removed. The gyro assembly was extracted and disassembled for an examination of the housing and rotor for indications of rotation. The interior surface of the housing is illustrated in Figure 2 with red arrows indicating dark, circumferentially oriented marks and yellow arrows indicating circumferentially oriented scratches where the housing material had been exposed. The housing material was found to be non-magnetic. The rotor extracted from the housing is

Figure 2. The inner surface of the gyro assembly extracted from the horizontal reference indicator.

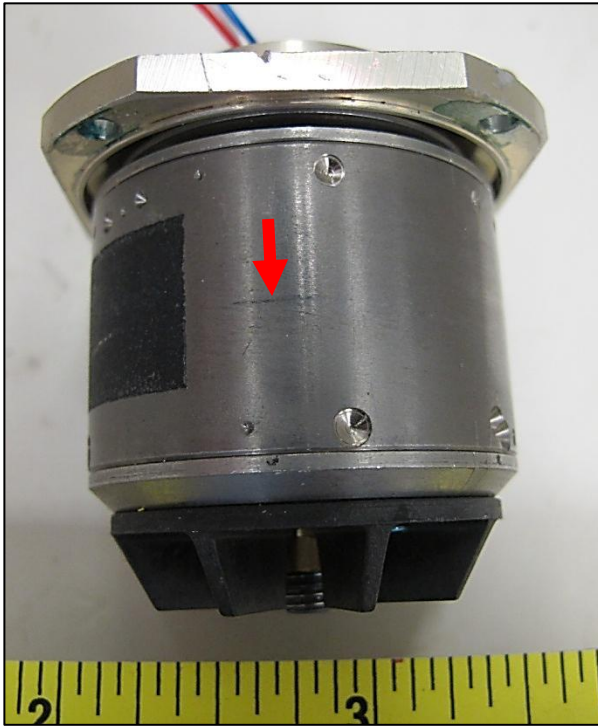
illustrated in Figure 3 with a red arrow indicating a circumferentially oriented mark on the surface. The portion of the rotor containing the mark was found to be magnetic.

Figure 3. The rotor extracted from the gyro assembly housing in Figure 2.

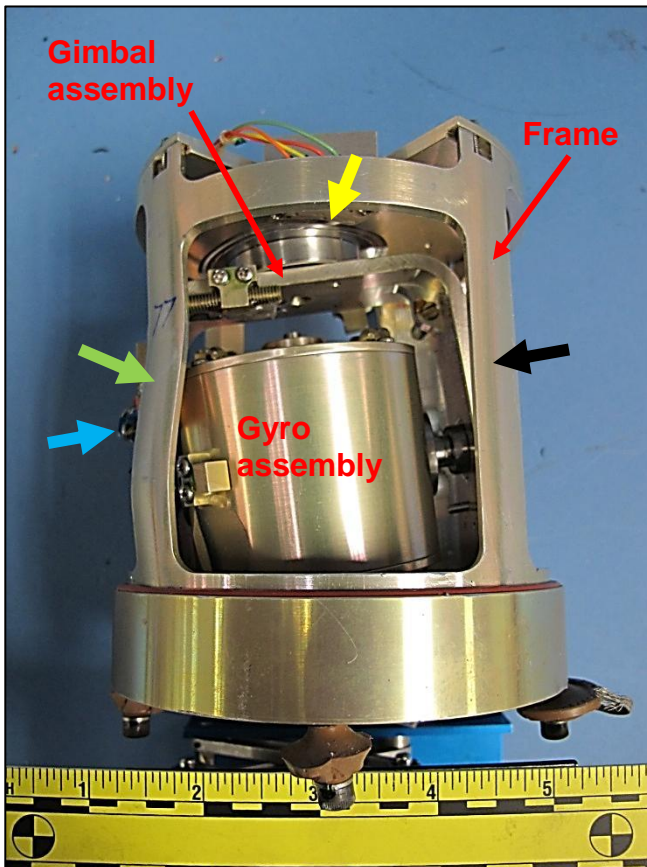
The base was removed from the gyro and, due to the damage, the casing was cut longitudinally so it could be removed. Examination of the inner workings revealed distortion of the frame and misalignment of the gimbal assembly containing the gyro assembly. The inner workings are illustrated in Figure 4 with the gyro assembly, the gimbal assembly and the frame identified. The black arrow indicates an intact portion of the frame for comparison with the distorted portion indicated by the green arrow. The blue arrow indicated a portion of the gimbal assembly protruding outside of the frame.

Figure 4. The inner workings of the directional gyro.

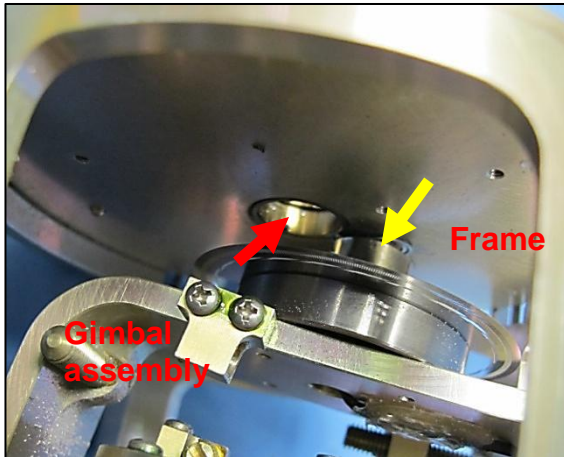
Examination of the misaligned gimbal assembly revealed that a bearing at the location indicated by the yellow arrow in Figure 4 had been dislodged. The dislodged bearing is indicated by the yellow arrow in Figure 5 with a red arrow indicating its original location.

Figure 5. The dislodged bearing in the directional gyro's gimbal assembly.

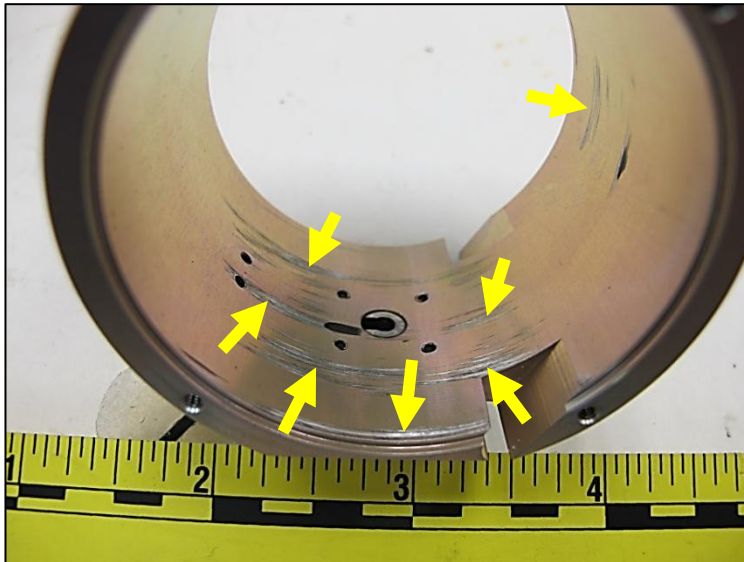
The gyro assembly was removed from the gimbal assembly and disassembled for an examination of the housing and rotor for indications of rotation. The inner surface of the housing is illustrated in Figure 6 with yellow arrows indicating circumferentially oriented scratches where housing material had been exposed. The housing was found to be non –magnetic. The rotor extracted from the housing is illustrated in Figure 7 with yellow arrows indicating circumferentially oriented areas where the surface finish had been disturbed to reveal the underlying metal. The portion of the rotor containing the marks was found to be magnetic.

Figure 6. The inner surface of the gyro assembly housing.

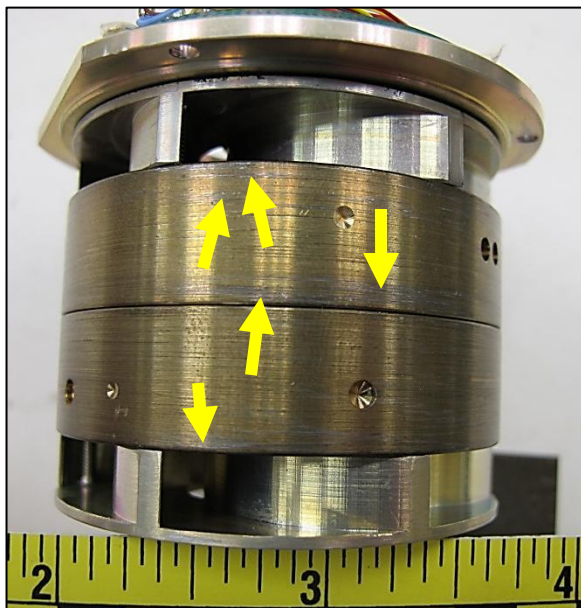
Figure 7. The rotor extracted from the housing in Figure 6.
