NATIONAL TRANSPORTATION SAFETY BOARD

MATERIALS LABORATORY FACTUAL REPORT

Report No. 13-080

Place : Henderson, Nevada
Date : July 28, 2012
Vehicle : Piaggio P180, N146SL
NTSB No. : WPR12FA332
Investigator : Van McKenny, ASI-WPR

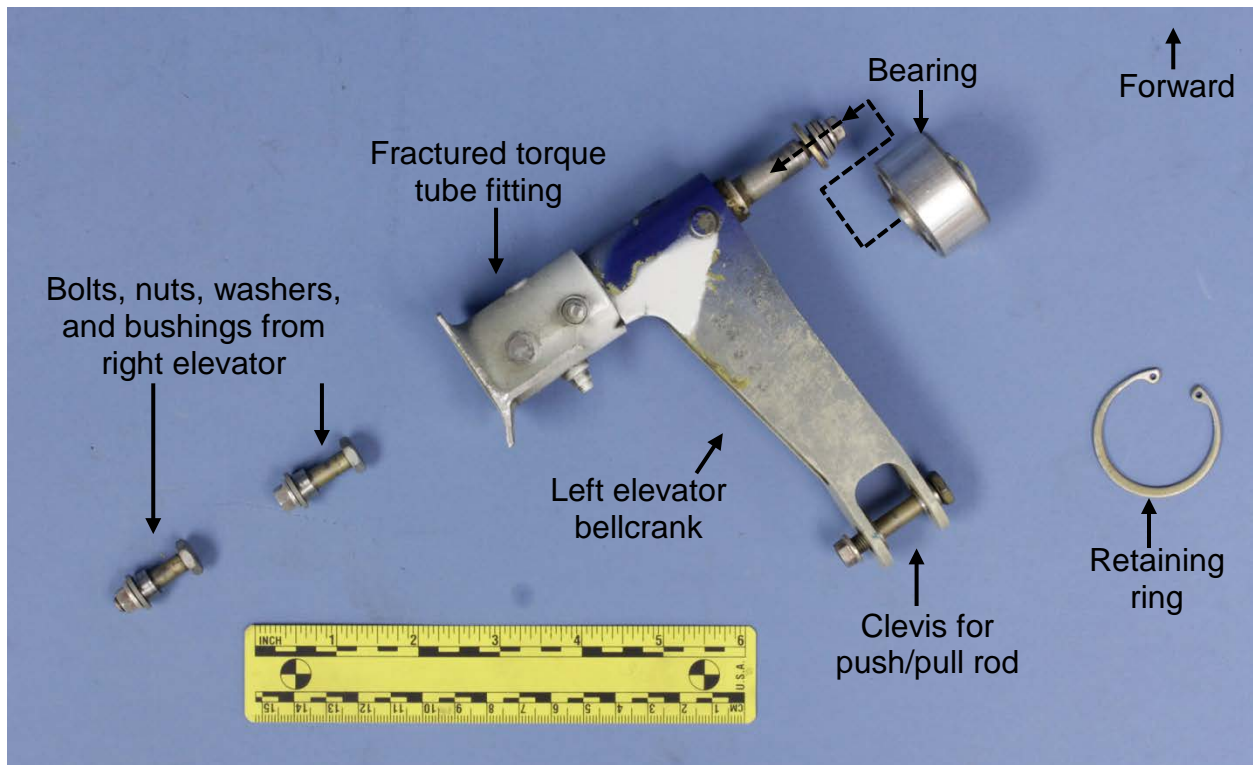
Figure 1: Image of the right and left elevator pieces as-received by the lab. The piece of the bellcrank, bearing, and retaining ring are from the left elevator. The bolts, nuts, washers, and bushings are from the right elevator. For illustration purposes, they have been oriented in a similar manner as their left elevator counterparts. Note: Hardware arrangement not to scale. See the illustration in figure 2.

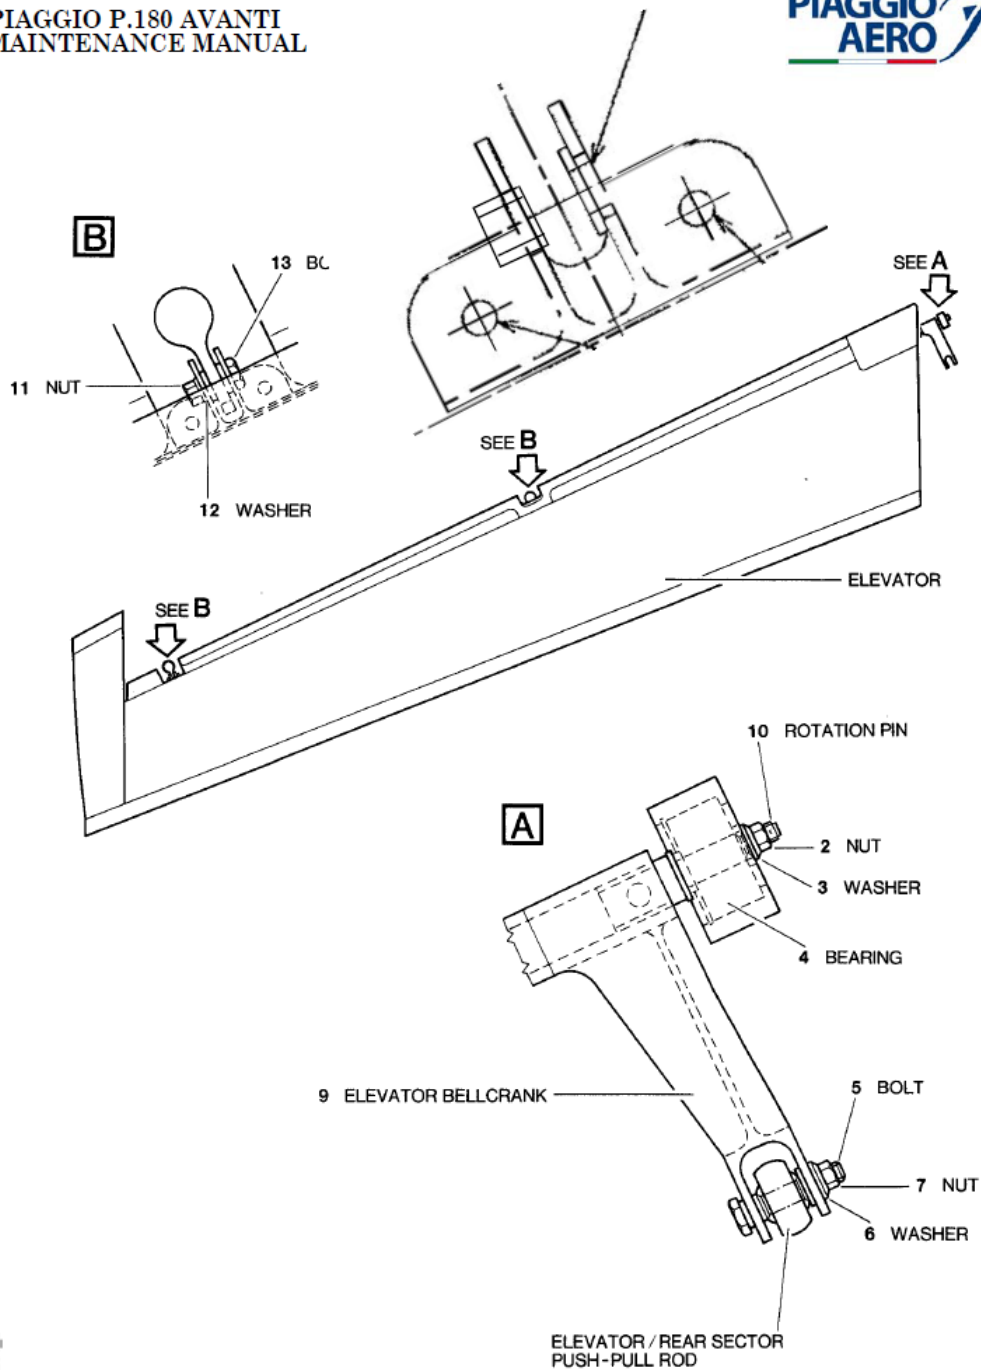
Fig. 201 - Elevator - Removal/Installation (Sheet 2 of 2)

The elevator is controlled by a push/pull rod (not shown) that attaches to the end of the bellcrank. The displacement of the control rod causes rotation of the elevator

about the inboard bearing and about the two outboard attachment fittings. On the outboard attachment fittings, the elevator rotates about bushings that are held in place by ¼-28 bolts, washers, and self-locking nuts.

Figure 2: Illustration from the aircraft maintenance manual showing the arrangement of the elevator bellcrank and the two outboard attachment fittings.

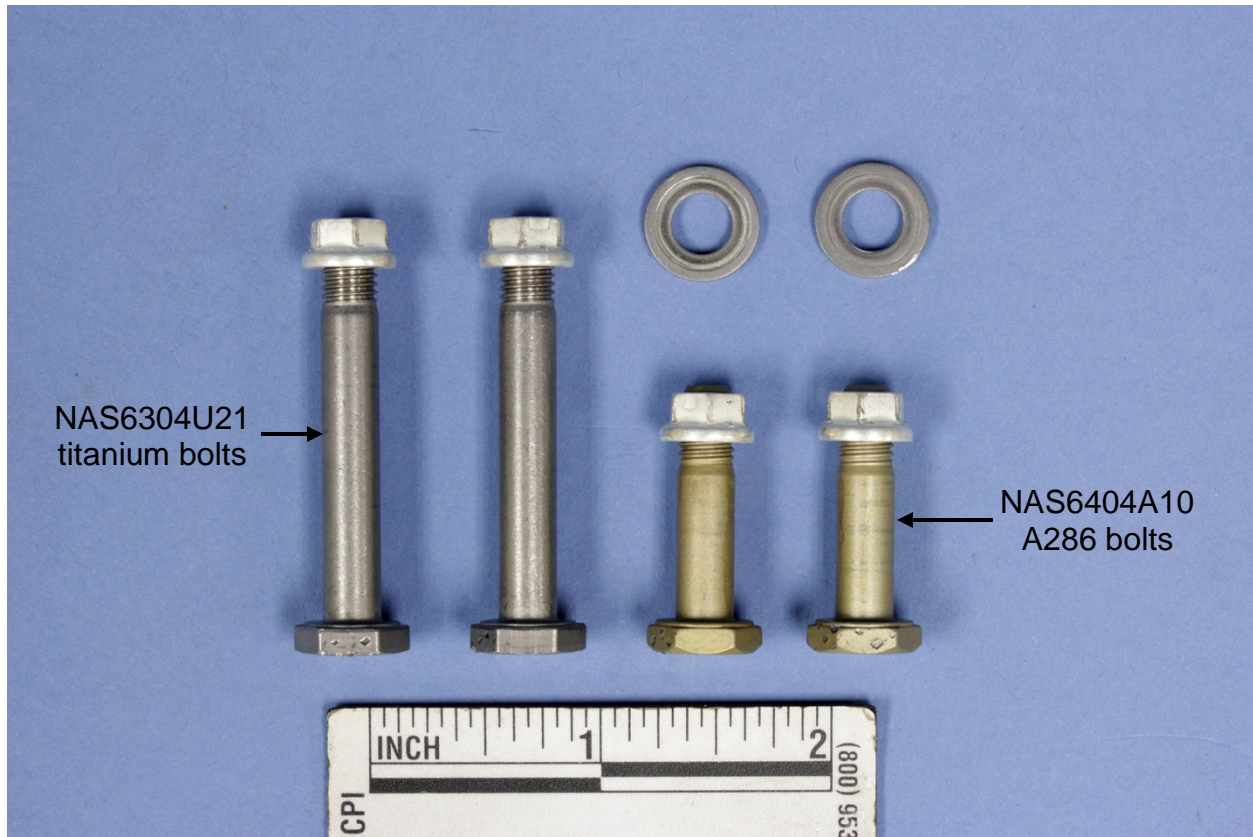
The change in running torque and breakaway torque with sequential torque cycles was measured using exemplar hardware.² Two titanium bolts and two A286 bolts were used in conjunction with silver-plated self-locking nuts and gray-anodized aluminum washers. The A286 bolts, nuts, and washers were the same material types as the accident attachment hardware. The results for the A286 bolts are shown in tables 1 and 2. The results for the titanium bolts are shown in tables 3 and 4.

Figure 3: Exemplar hardware used for torque testing. The hardware included two titanium ¼-28 bolts (NAS6304U21), two A286 ¼-28 bolts (NAS6404A10), two gray-anodized 2024 T3 aluminum washers (NAS1149D0463K), and four silver-plated ¼-28 self-locking nuts (MS21043-4).

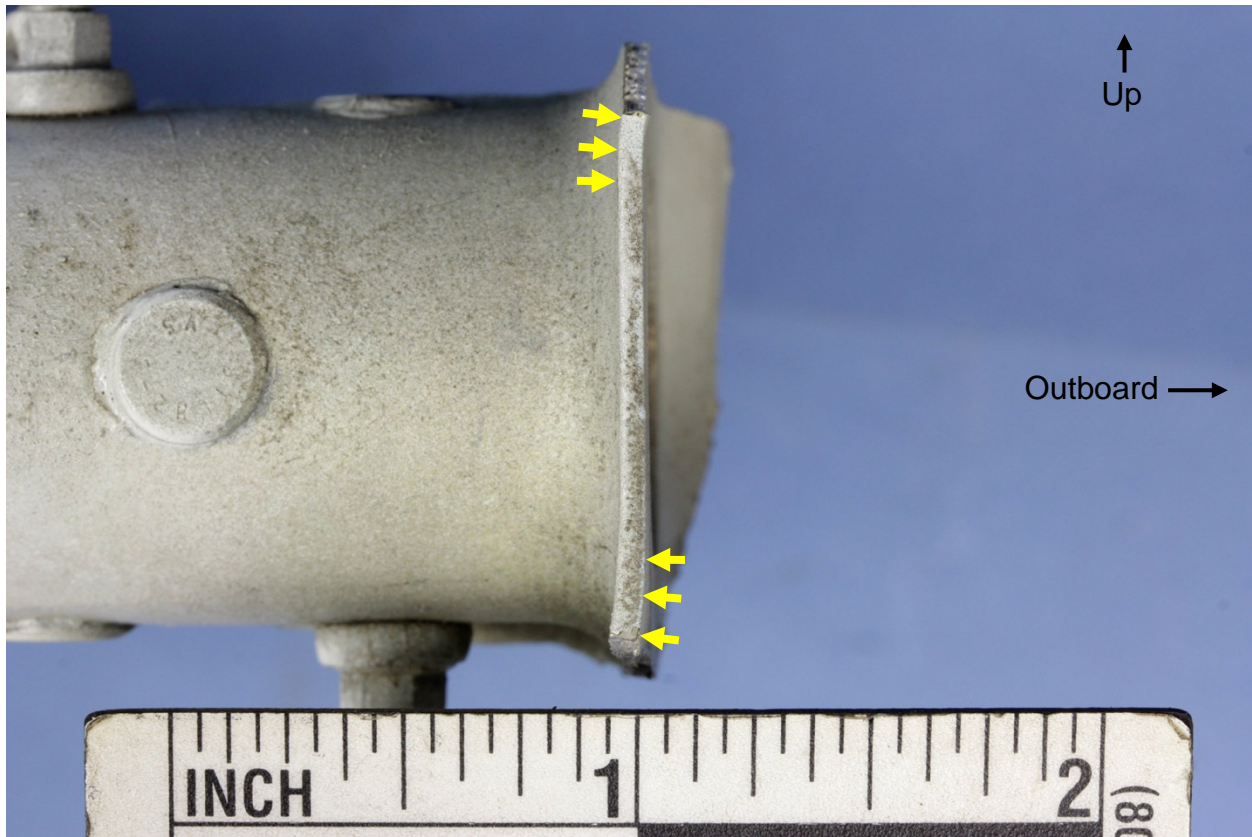
The left elevator torque tube remained bolted to the left elevator attachment fitting just outboard of the bellcrank. The attachment fitting was observed to be fractured through a flange where it transitioned out of a cylindrical section. As shown in figure 4, the top part of the flange was bent in the outboard direction and the lower part of the flange was bent in the inboard direction. Using a stereomicroscope, the fracture surfaces were examined and were found to have a smeared appearance. The deformation and fracture features were consistent with an overstress failure caused by downward bending of the left elevator about the attachment fitting.

Figure 4: Image of the fractured left elevator torque tube fitting looking in the aft direction. Bending deformation of the fitting is indicated by yellow arrows in the image. The deformation of the fitting was consistent with downward bending of the elevator.
