NATIONAL TRANSPORTATION SAFETY BOARD

MATERIALS LABORATORY FACTUAL REPORT

Report No. 14-001

Place : Parkton, North Carolina
Date : December 16, 2012
Vehicle : Piper PA-28-160
NTSB No. : ERA13FA088
Investigator : Timothy W. Monville, AS-ERA

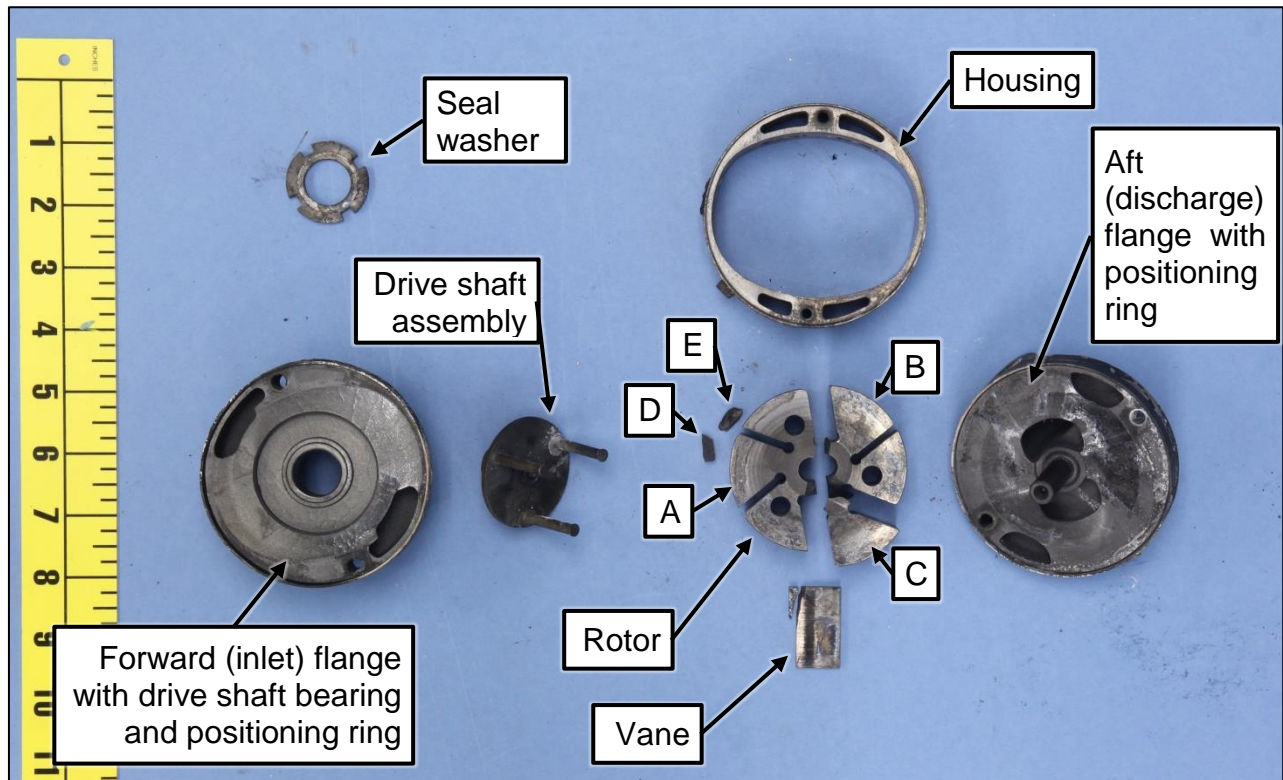
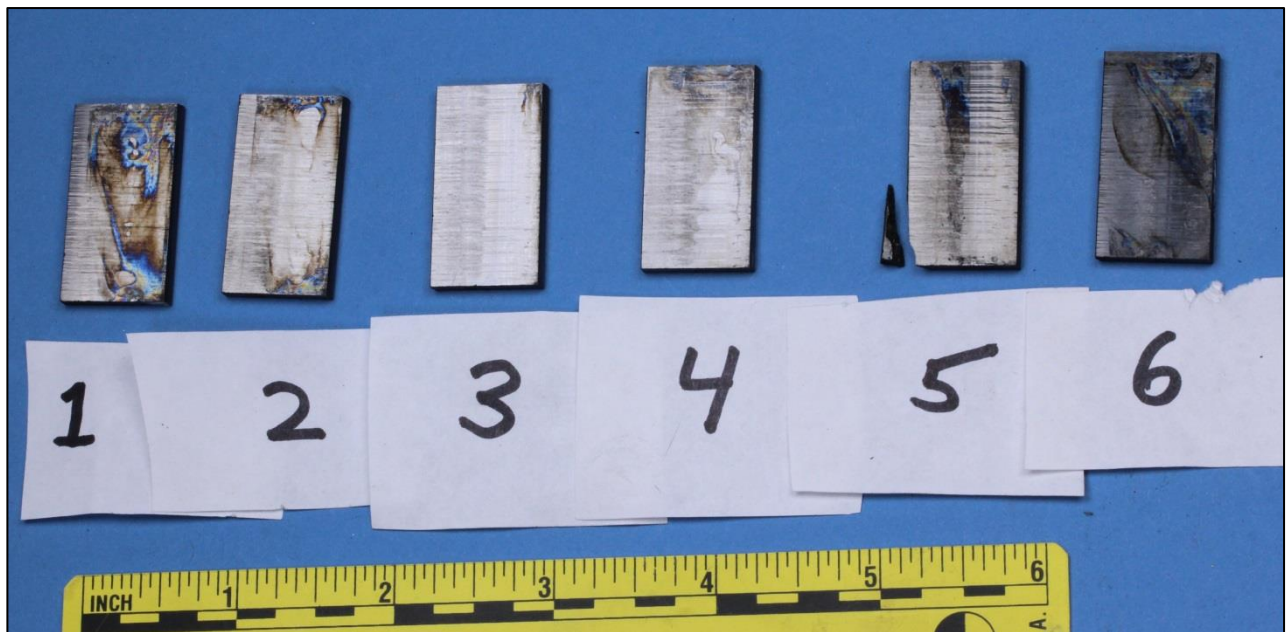
Overall views showing many of the submitted pieces of the engine-driven vacuum pump are presented in figure 1. An inlet tube, forward and aft flange attachment screws, and two bags containing remains of the drive end coupling and drive finger sleeve are not shown. The pump was received in pieces as shown in figure 1. A teardown of the pump had been performed by the pump manufacturer with Federal Aviation Administration personnel present.

The vanes and corresponding slots in the rotor were received numbered as shown in figures 1 and 2. The rotor was fractured, and the 5 submitted pieces of the rotor were labeled A through E for this report. Vane 5 was fractured at the interior forward corner of the vane as shown in figure 1. The other 5 vanes were all intact.

Figure 1. Overall views of submitted components from the vacuum pump assembly. Vanes in the lower image are labeled according to position number as designated during the pump teardown. An inlet tube, flange attachment screws, and two bags containing the remains of drive end coupling and drive finger sleeve material are not shown.

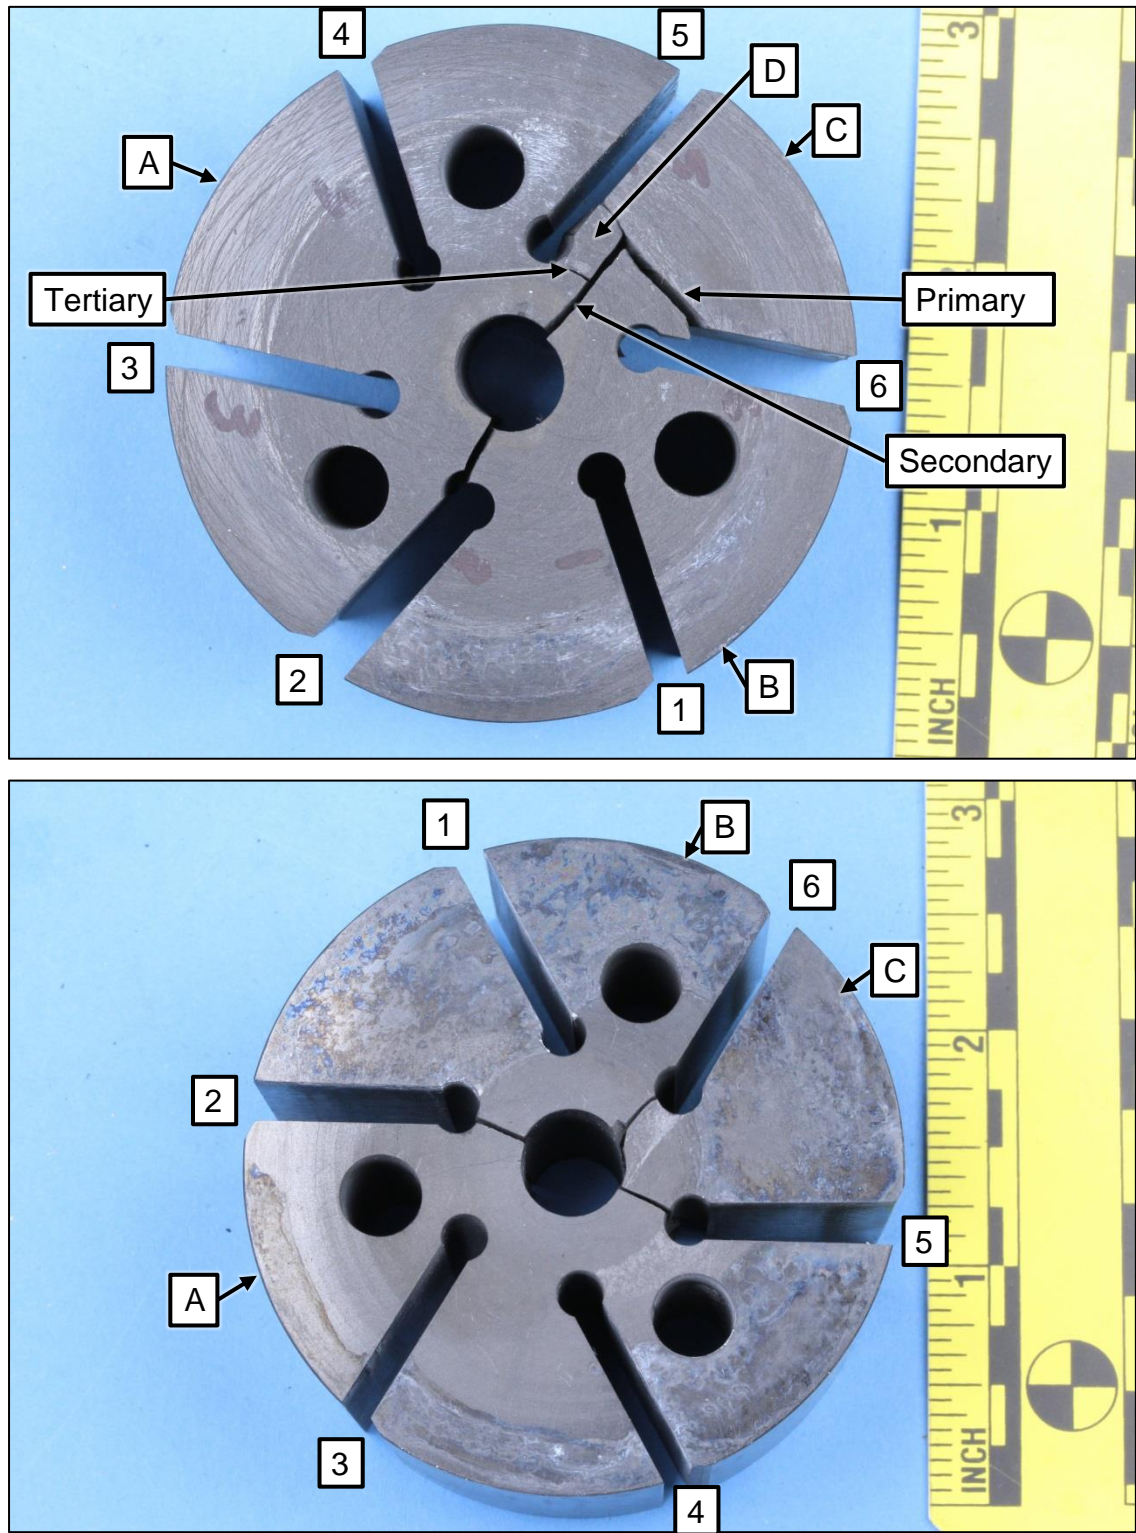
The pieces of the rotor were carefully reassembled as shown in figure 2, where the pieces and the vane slots are labeled with letters and numbers, respectively. The fracture patterns at the forward (inlet flange end) and aft (discharge flange end) surfaces were examined. A sequence of cracking can be determined from the crack intersections at the forward end. Where cracks form nearly perpendicular intersections, the crack that is straight across the intersection is the primary crack, and the crack that terminates at the intersection is the secondary crack. Using this sequencing technique, primary, secondary, and tertiary cracks were identified as shown in the upper image of figure 2.

Figure 2. Overall views of the forward face (upper image) and aft face (lower image) of the rotor. Vane slots are shown as numbered during the teardown. Pieces A through D are labeled as shown in figure 1.

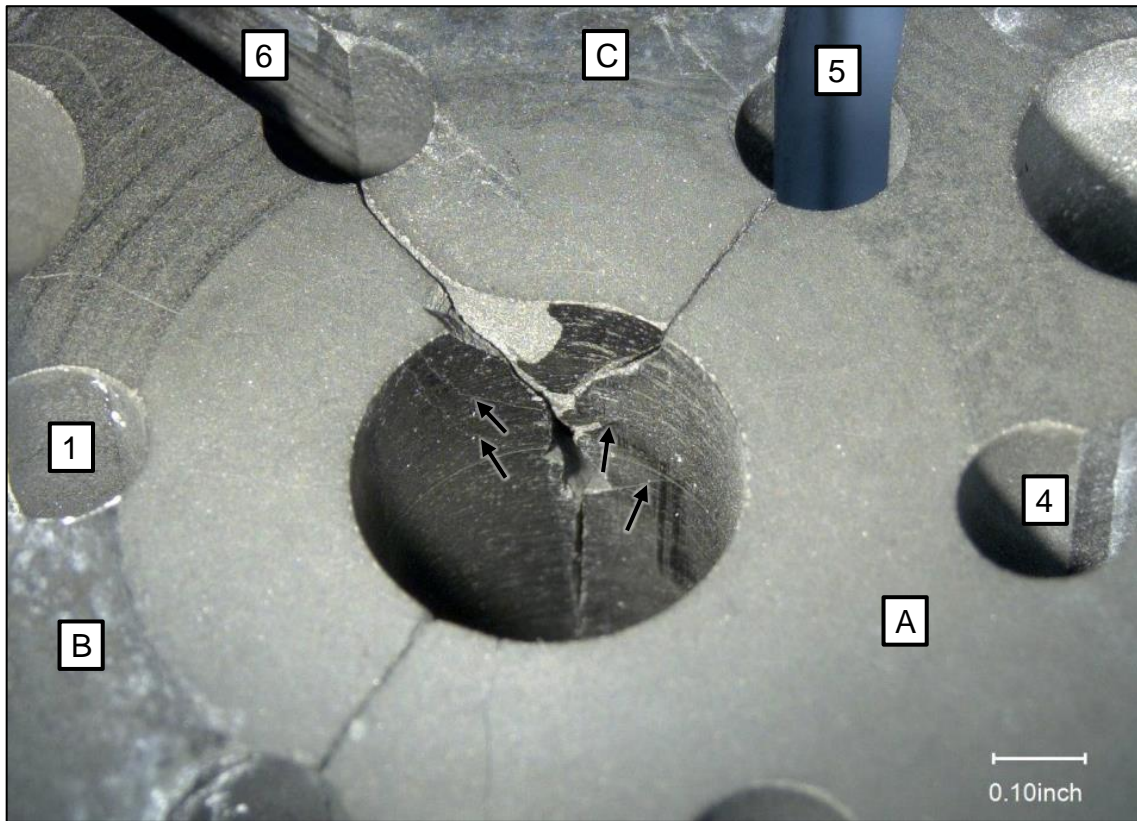
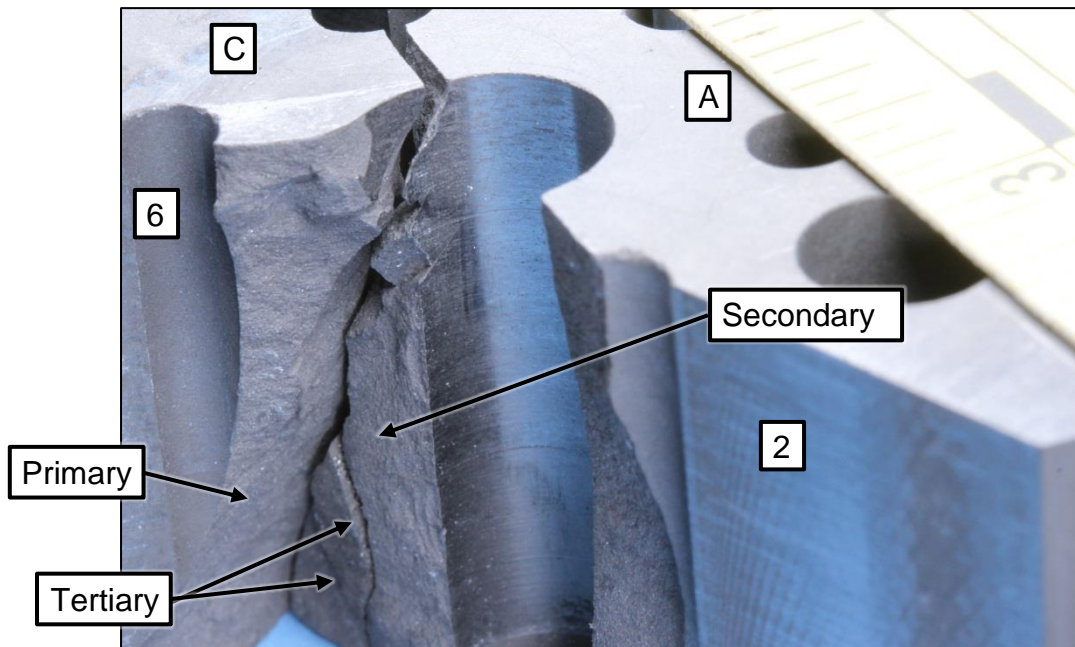
Oblique views of the cracking pattern at the aft end of the rotor and in the center hole both with and without piece B in the image are shown in figure 3. The primary and secondary fractures and fractures extending between the center hole and vane slots 5 and 6 all intersected at an area of the center hole surface approximately 0.25 inch to 0.375 inch from the aft surface. Branching cracks (see unlabeled arrows in the upper image in figure 3) were observed emanating from both sides of the fracture in the area where the fractures intersected. The branching cracks were angled toward the aft face of the rotor. Some of the branching cracks also intersected the aft surface of the rotor and extended radially outward on the aft surface. The primary fracture plane had a plane normal that was oriented between the radial and axial directions.

Figure 3. Close views of the fracture paths at the center of the rotor viewed at an oblique angle looking forward with all fractures placed in close proximity (upper image) and with piece B removed (lower image). Unlabeled arrows in the upper image indicate branching cracks emanating from both sides of the fracture.

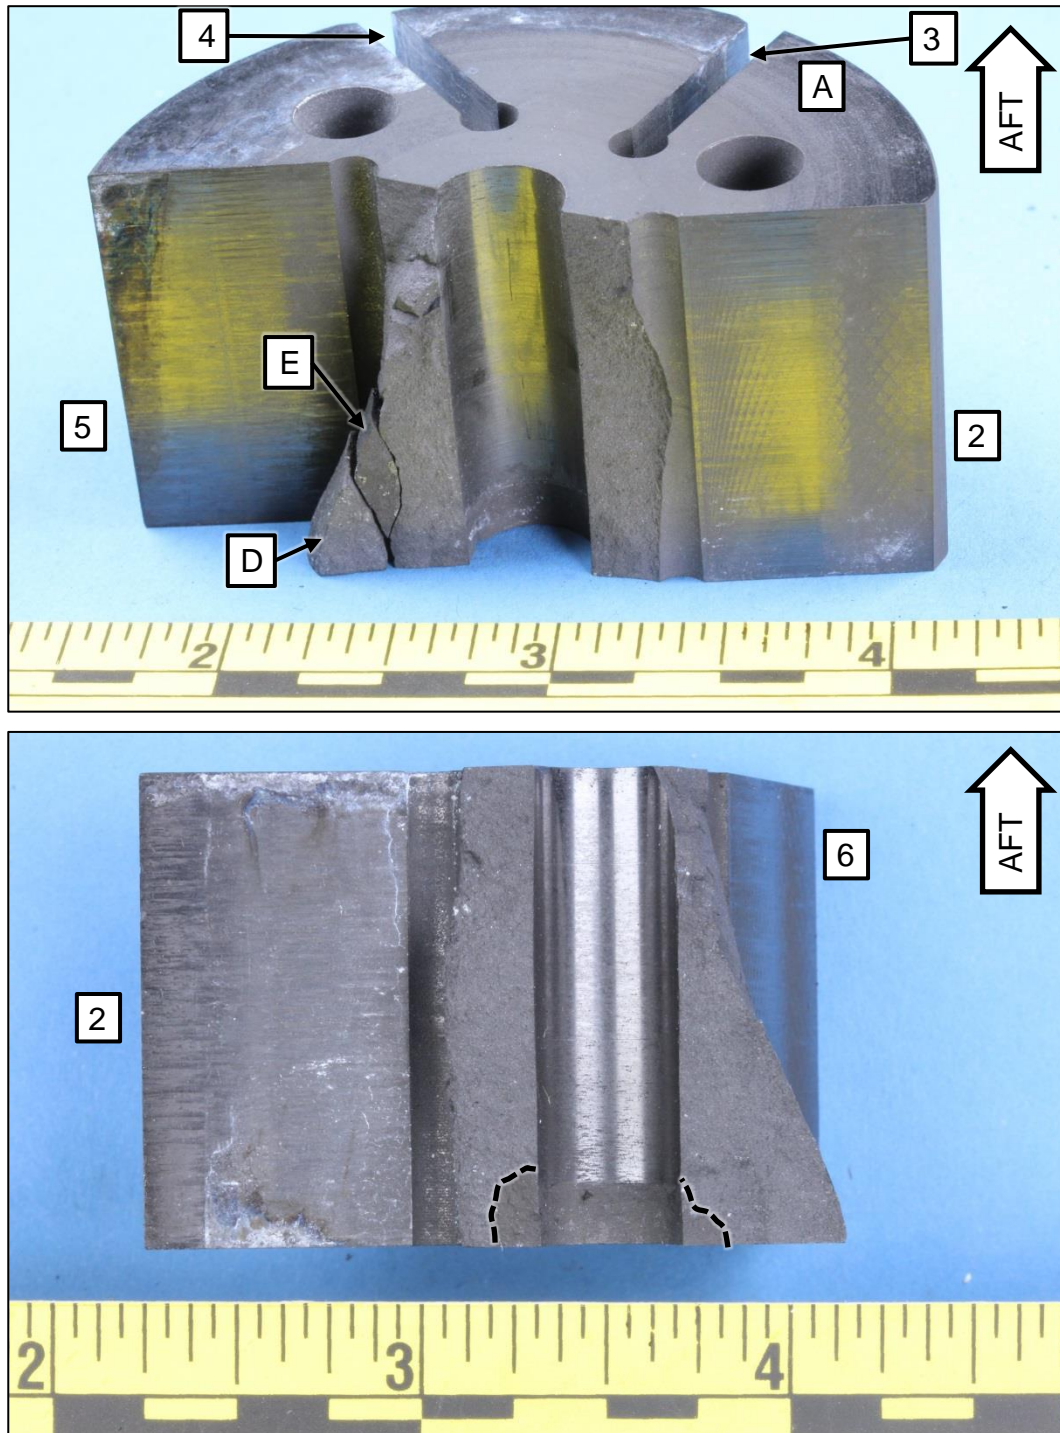
Views of the mating sides of the secondary fracture in the rotor are shown in figure 4. Portions of the fracture surface on the secondary fracture and the radial fracture opposite from the secondary fracture had areas that appeared relatively dark, similar to adjacent surfaces of the center hole. The relatively dark areas were located adjacent to the forward face of the rotor, and dashed lines in the lower image in figure 4 indicate the boundaries of the relatively dark areas. Inspection using a stereo optical microscope did not reveal any cracks at the intersection between the aft face and the center hole of the rotor.

Figure 4. Views of the secondary fracture surfaces on pieces A, D, and E (upper image) and the mating side on piece B (lower image). Dashed lines in the lower image indicate areas that appeared darker relative to the rest of the fracture surface.

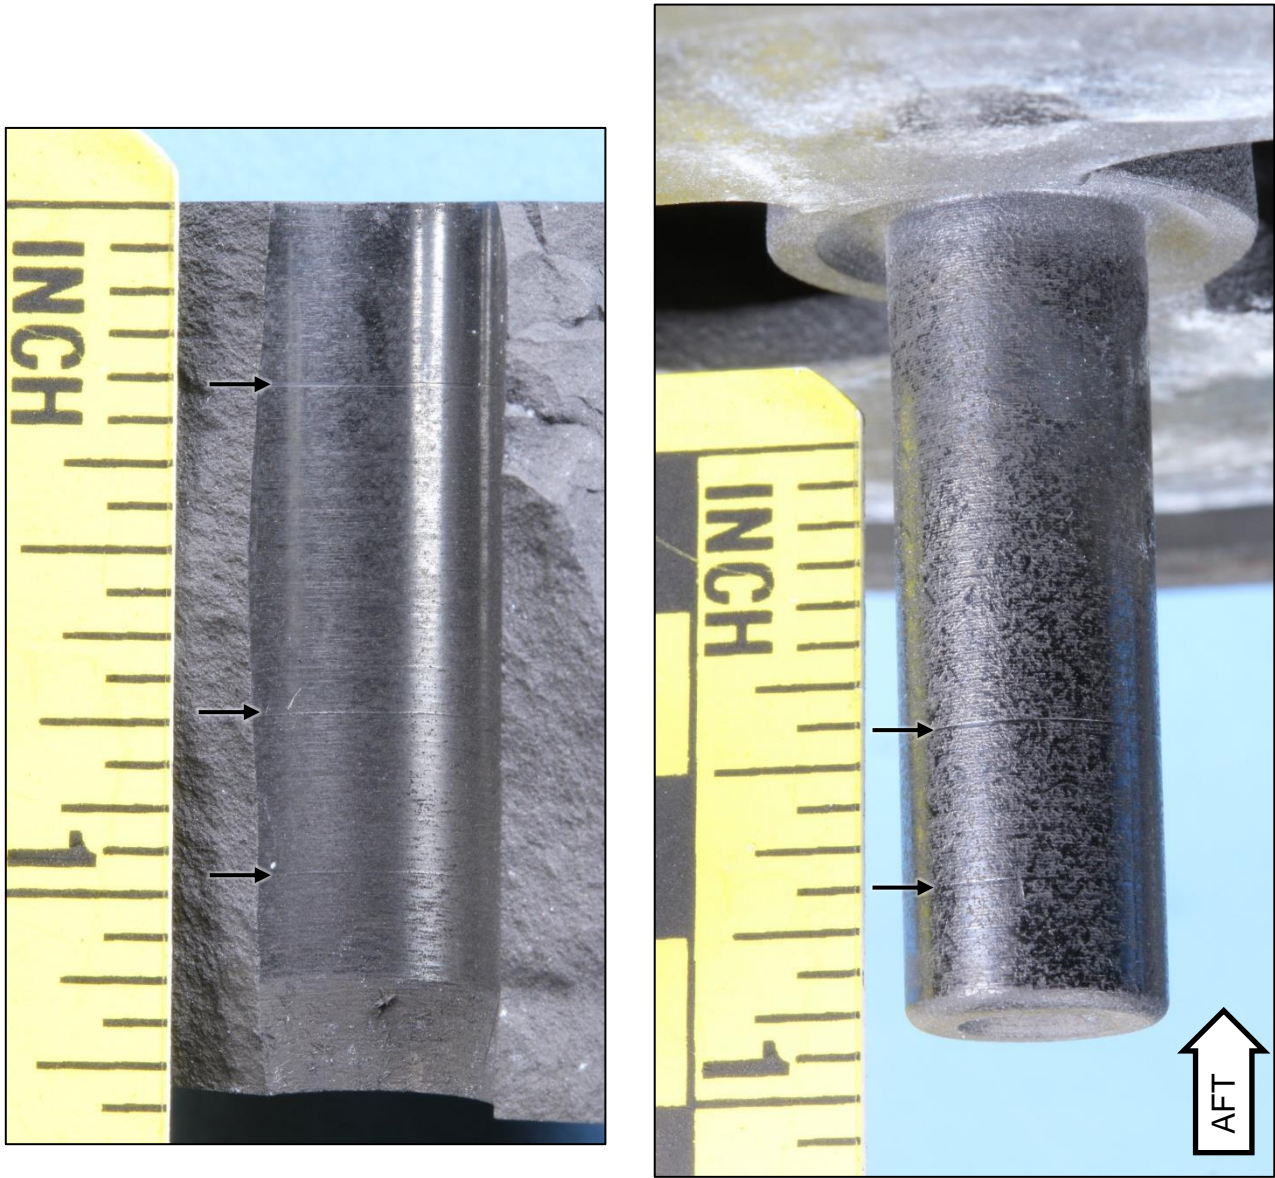
Circumferential score marks were observed on the interior surface of the rotor center hole (left image in figure 5) and on the center shaft on the aft flange (right image in figure 5). Unlabeled arrows in figure 5 indicate locations of the score marks. The marks on the rotor three relatively prominent marks were located 0.274 inch, 0.75 inch, and 0.985 inch away from the aft face, respectively. On the aft flange shaft, two marks were located 0.757 inch and 0.969 inch from the flange face, respectively.

Figure 5. Circumferential score marks on the rotor center hole (left image) and the rotor shaft (right images). Unlabeled arrows indicate score marks.

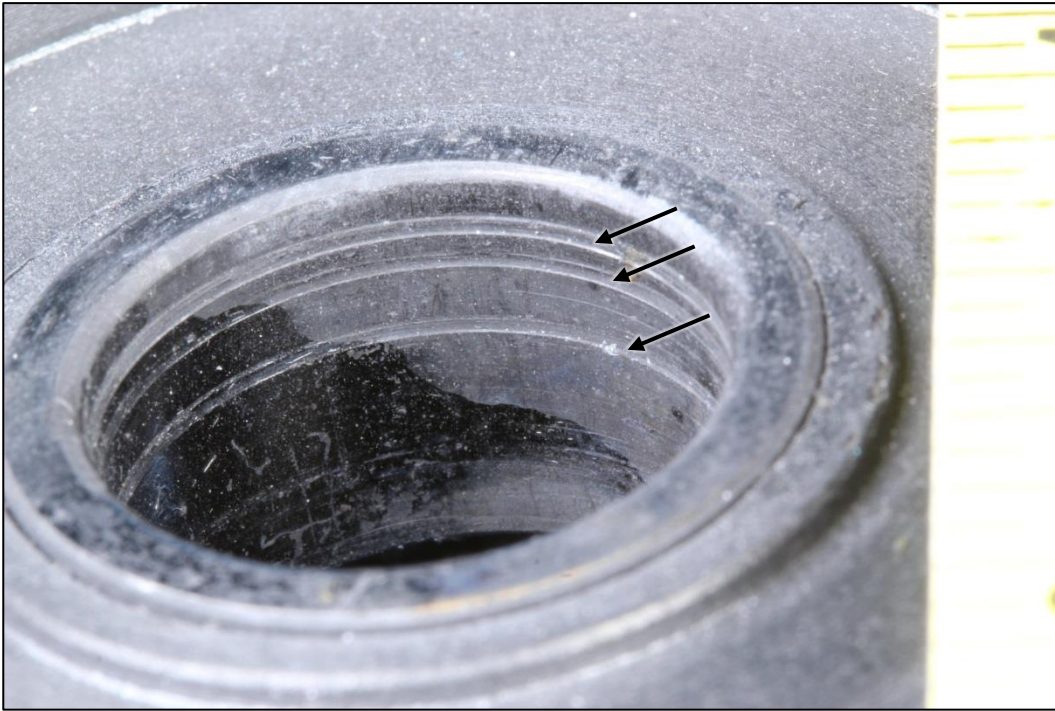
The drive shaft bushing located in the forward housing flange had multiple relatively deep circumferential score marks. A view of the score marks in the drive shaft bushing are shown in figure 6, where unlabeled arrows indicated the three deepest marks.

Figure 6. Circumferential score marks in the drive shaft bearing.. Unlabeled arrows point to the score marks.
