# NATIONAL TRANSPORTATION SAFETY BOARD

MATERIALS LABORATORY FACTUAL REPORT

Report No. 14-011

Place : Amarillo, Texas  
Date : December 14, 2012  
Vehicle : Beechcraft E-90  
NTSB No. : CEN13FA105  
Investigator : Craig Hatch AS-CEN

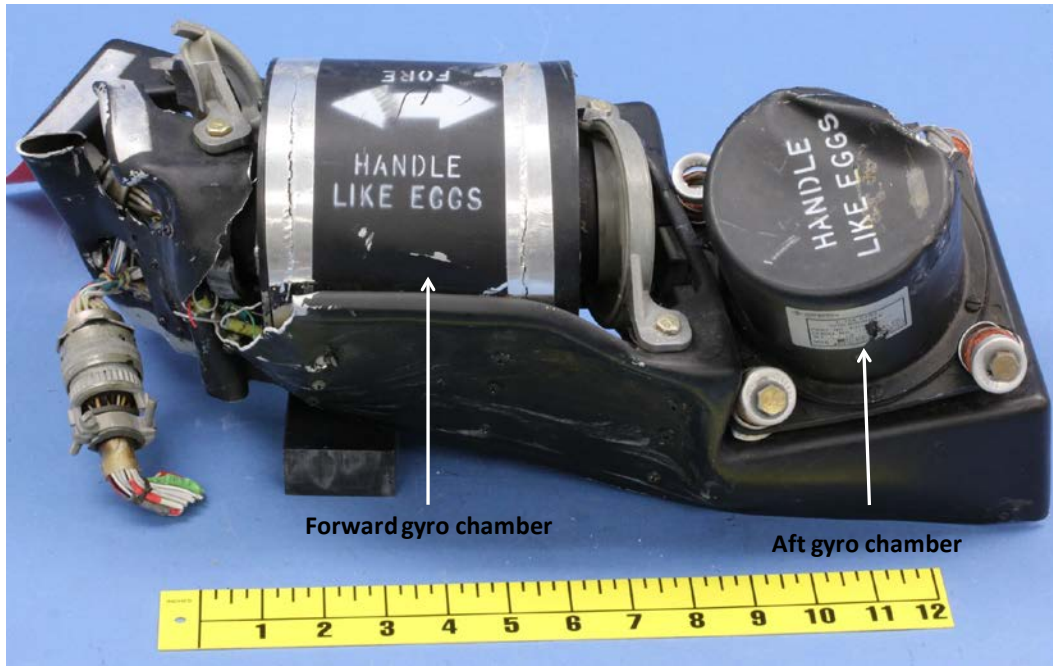
The attitude reference gyro from the accident aircraft was submitted to the Materials Laboratory for examination. The instrument was a Sperry Tarsyn 333, 3-axis gyro. The instrument consisted of two chambers, one forward and one aft as shown in Figure 1. Each chamber contained a gyro bearing.

Figure 1. Overall photograph of attitude reference gyro.

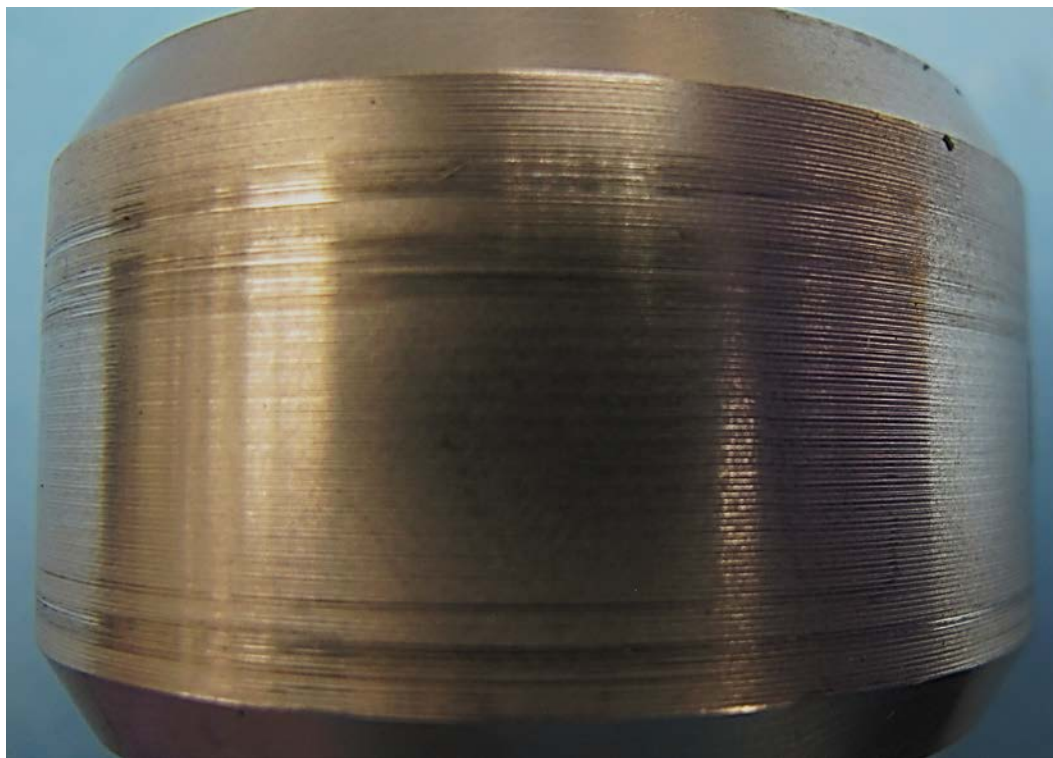
The forward chamber had some minor impact damage to the exterior cover and one leg of the support structure for the gyro. The gyro bearing was found to be free-moving and undamaged by impact. After the bearing was removed from the support structure, several faint, full circumferential rotational marks were found on the surface of the bearing as shown in Figure 2. This was indicative that the bearing was rotational at some point when the surface of the bearing rubbed against another surface, resulting in the rotational marks seen. There was no impact related scoring found on the bearing. However, there was little damage to the interior of the gyro that could have resulted in impact related scoring on the bearing.

Figure 2. Photograph of circumferential rub marks on forward gyro bearing.

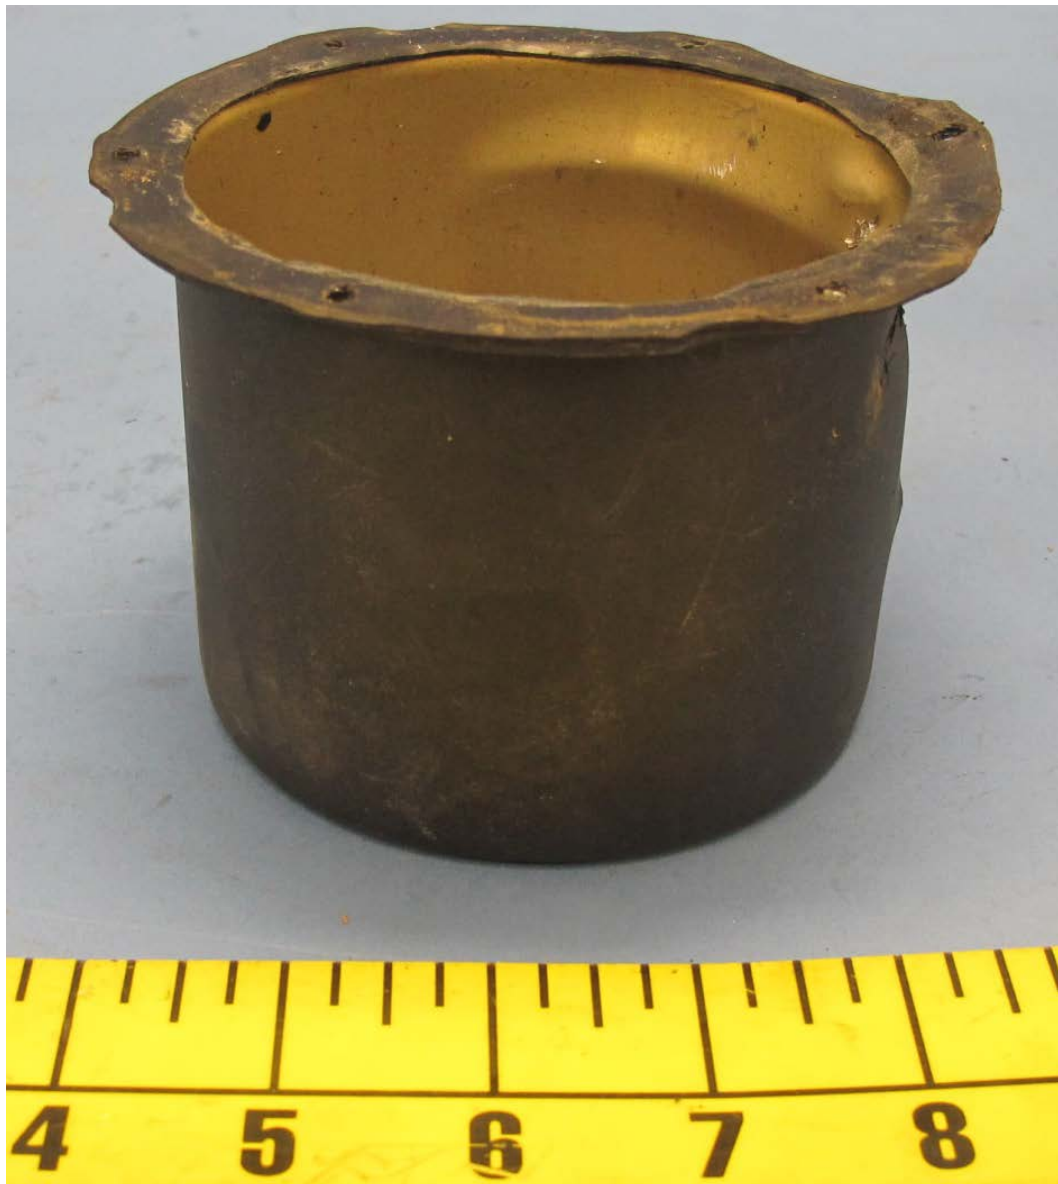
The aft chamber had a significant impact depression in the exterior case as shown in Figure 3. There was evidence of scoring on the interior of the cover as shown in Figure 4. The support structure for the gyro bearing was damaged. One of the support legs for the gyro bearing was fractured. The bearing was intact and partially free-moving. Partial circumferential scoring was found on the surface of the bearing as shown in Figure 5. This observation was indicative that the bearing was rotating, and then subjected to an impact. This condition is consistent with the bearing rotating at the time of the accident.

**Figure 3. Overall Photograph of damage to the aft gyro chamber cover.**

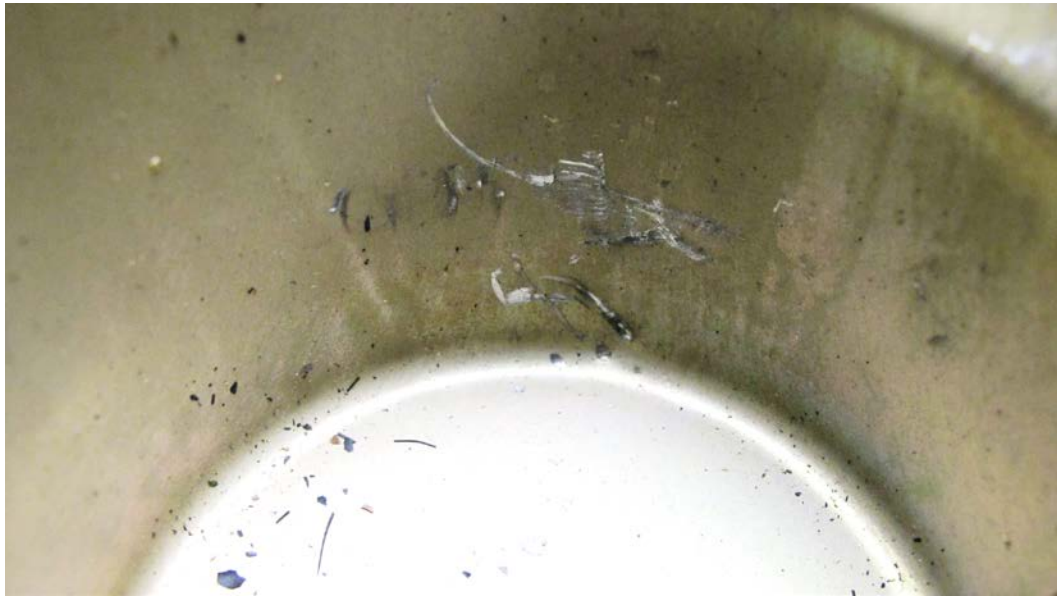
Figure 4. Close up of scoring on interior of aft gyro chamber cover.

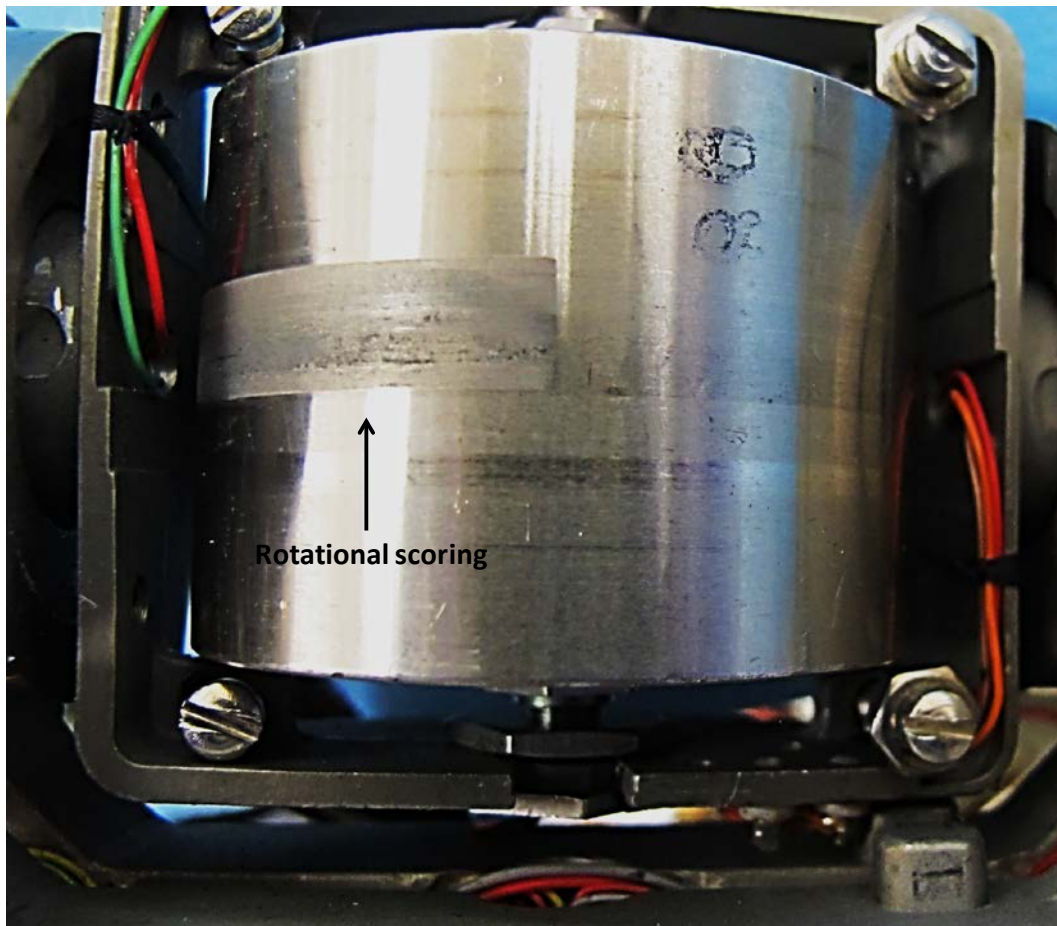
Figure 5. Photograph of partial circumferential scoring on aft bearing.
