NATIONAL TRANSPORTATION SAFETY BOARD

MATERIALS LABORATORY FACTUAL REPORT

Report No. 13-023

Place : Phoenix, Arizona
Date : May 2, 2012
Vehicle : Hughes 269C, N380TL
NTSB No. : WPR12FA191
Investigator : Thomas Little, AS-WPR(SEA)

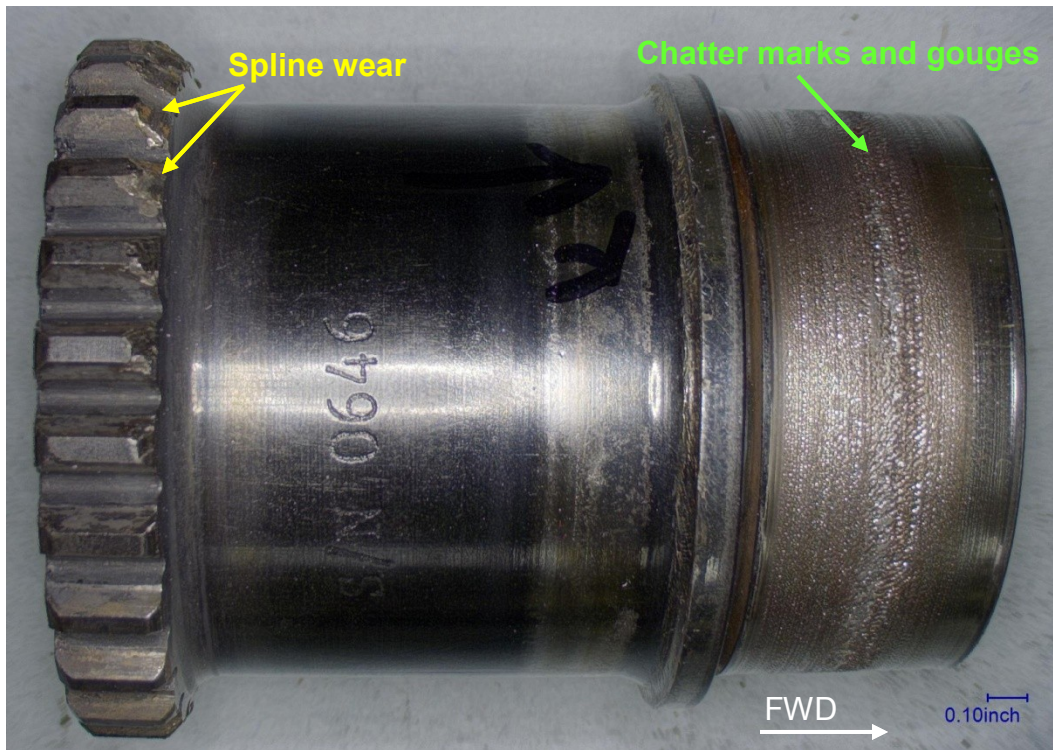
Figure 2 illustrates the driving sleeve (P/N 269A5430-1, S/N 0646) of the aft transmission assembly. Fretting wear scars and material removal were observed on the outer teeth of the driving spline (Figure 3), along with chatter and circumferential gouging on the outer forward surface (Figure 4). The chatter marks in Figure 4 are located where a

Figure 2 – The driving sleeve, after cleaning with acetone. Spline wear and shaft chatter are readily visible.

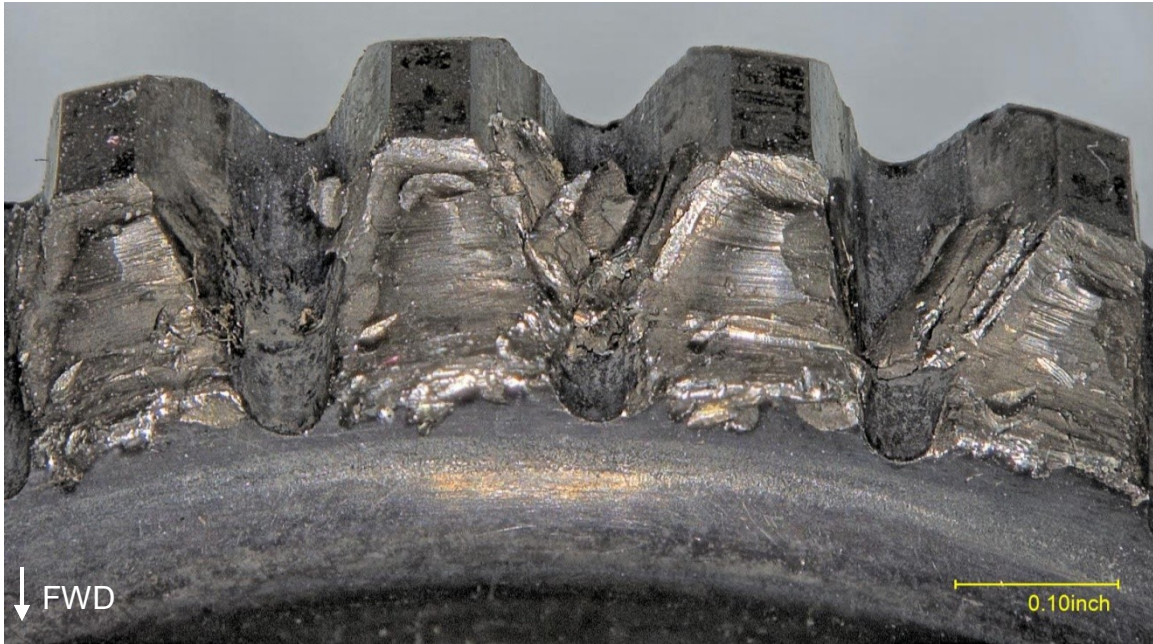
roller bearing is normally in contact with the driving spline. As shown in Figure 3, the damage was located on the forward faces. The smearing pattern is consistent with contact in rotation. While all the splines exhibited some loss of material, the amount varied from negligible to almost 50% of the cross-sectional area, with the largest difference in loss 180° apart. In contrast, the interior splines of the part were relatively undamaged, exhibiting no appreciable loss of material. Some rubbing was observed on the forward interior of the part mirroring the exterior shape of the pinion.

Figure 3 – The most damaged splines from the driving spline showing material removal, viewed forward looking aft (FLA).

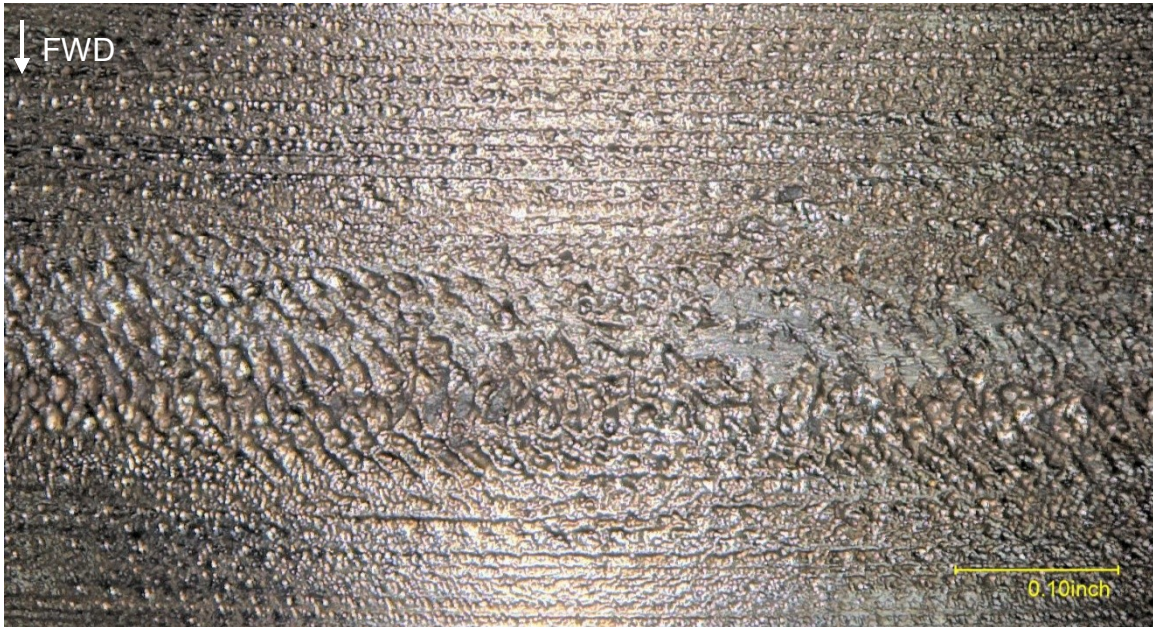
Figure 4 – Closer view of the chatter marks and gouges on the forward outer surface of the driving sleeve illustrated in Figure 2.

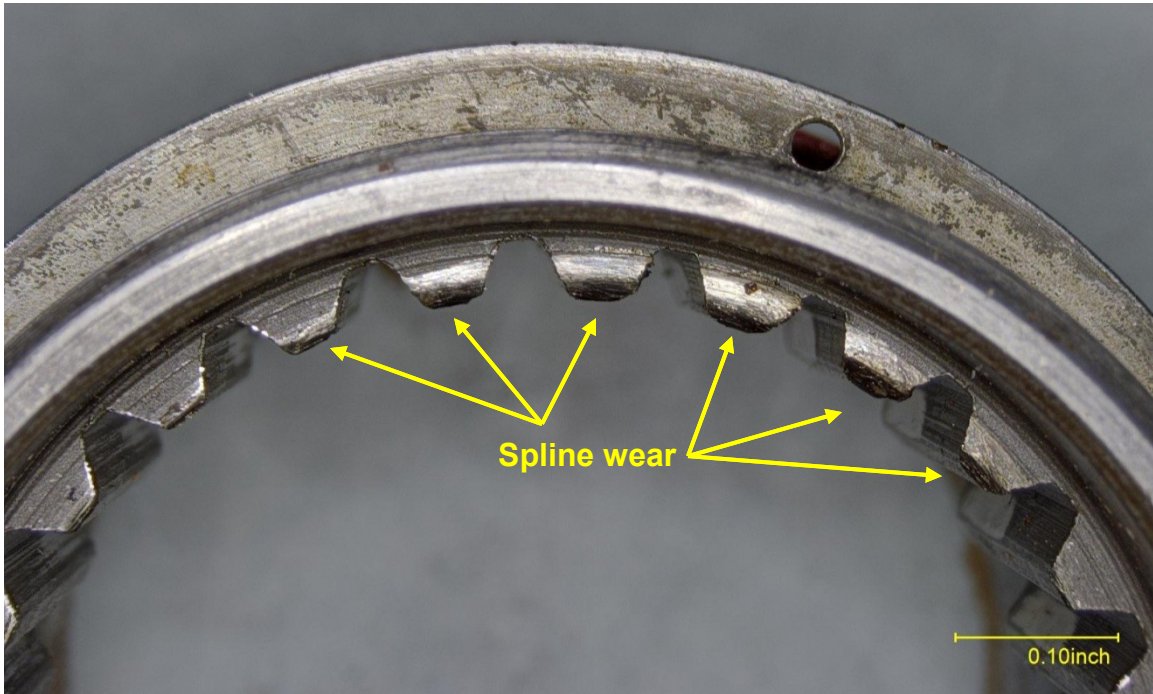
The angle of material removed on the drive spline outer splines mirrored that of the wear and material loss on the mating interior splines of the forward section of the tail rotor drive shaft (P/N 269A6040-7, S/N 3425). Figure 5 displays this damage on the interior splines. The damage is rotational in nature, but is not as severe as on the driving spline—the material loss is confined to an approximately 90° area. The forward faces of the splines also exhibited some smearing and material loss in a counterclockwise direction, forward looking aft (FLA).

Figure 5 – The interior splines of the tail rotor drive shaft, aft looking forward (ALF). Several of the splines exhibited moderate to severe damage missing material.

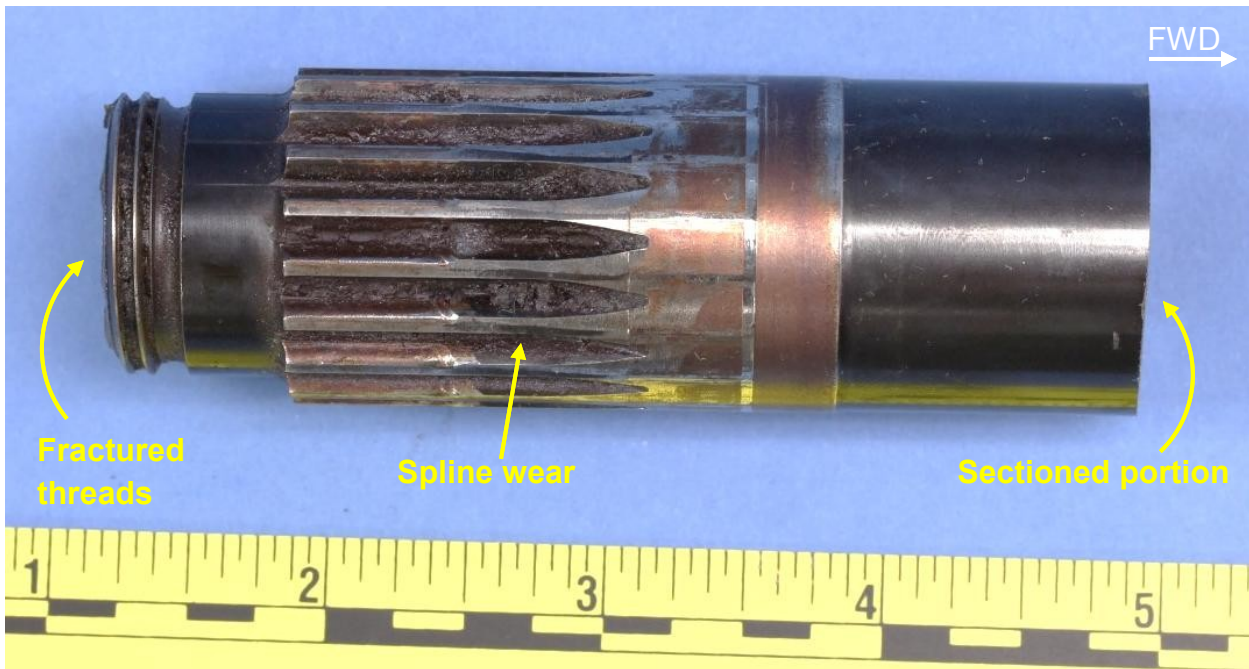
The section of the main transmission pinion (P/N 269A5103-9, S/N 1174915) submitted to the Materials Laboratory is shown in Figure 6. Approximately 0.3 inches of the aftmost portion of the pinion fractured transversely while still fastened inside the aft pinion nut (P/N 269A5449-5) with the cotter pin still in place.

Figure 6 – The forward portion of the main transmission pinion section, as received.

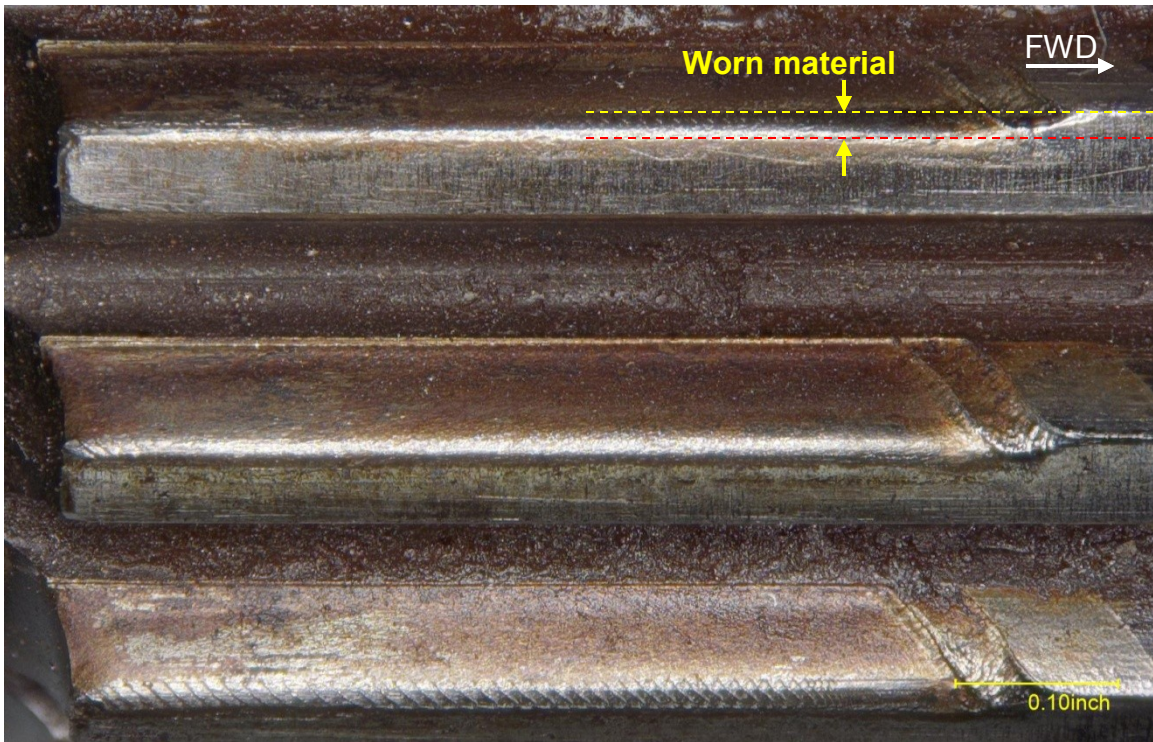
The exterior of the pinion possesses a series of splines that contact the interior splines of the drive spline. The aft 2 inches of the exterior faces of the splines exhibited a shiny luster indicative of the outer surface having been worn off. As shown in Figure 7, the drive faces on the exterior pinion splines showed fretting wear scars and material loss. Upwards of 0.015 inches of material had been removed on the aftmost 0.5 inches of the splines on the contact surfaces. Chatter marks were visible on the pinion exterior just forward of where the splines taper off.

Figure 7 – Contact faces on the splines of the pinion, showing fretting wear scars and loss of material over approximately 0.5 inches.

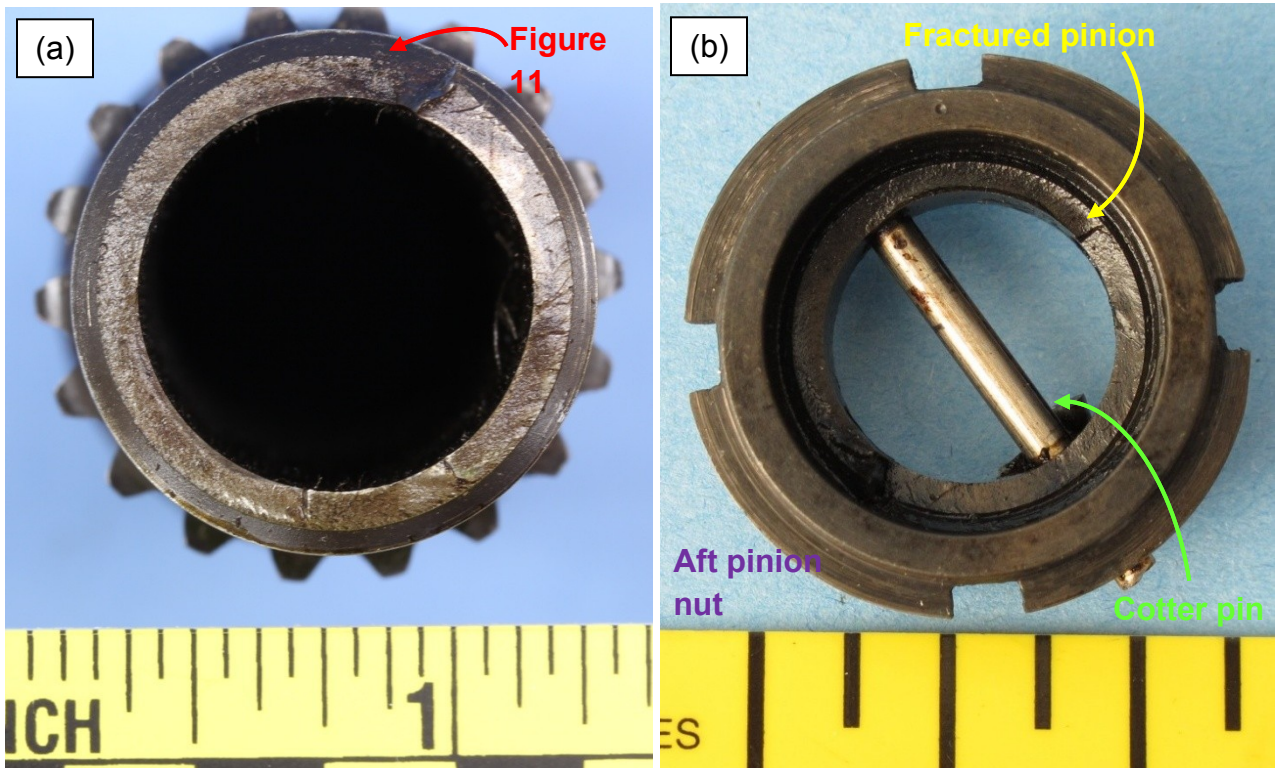
The mating fracture surfaces of the pinion are shown in Figure 8. A small jog was present on the fracture, indicative of torsional failure. The fracture surface was flat, relatively smooth, and perpendicular to the long axis of the part. The surface exhibited fine crack arrest and ratchet marks indicative of progressive cracking. Closer examination using a scanning electron microscope (SEM) revealed an oxidized surface with a pattern consistent with underlying fatigue striations (see Figure 9). Cleaning solutions were able to remove some of the oxide layer, better exposing the striations.

The features on the fracture surface suggest that after initiation, the fatigue crack progressed rotationally, while other cracks initiated ahead of the crack on the outer surface of the pinion in the thread root. Once the crack grew to sufficient size, the remaining cross-section succumbed to overstress. Approximately 0.25 inches of the fracture surface exhibited dimple rupture, indicative of overstress, located on jog (projecting outward in Figure 8a). No indications of other failure mechanisms, such as intergranular cracking, were observed.

Figure 8 – The (a) forward and (b) aft faces of the pinion fracture, as received. The aft side fracture was still threaded in the aft nut with the cotter pin in place. The area labeled in (a) is highlighted in Figure 11.

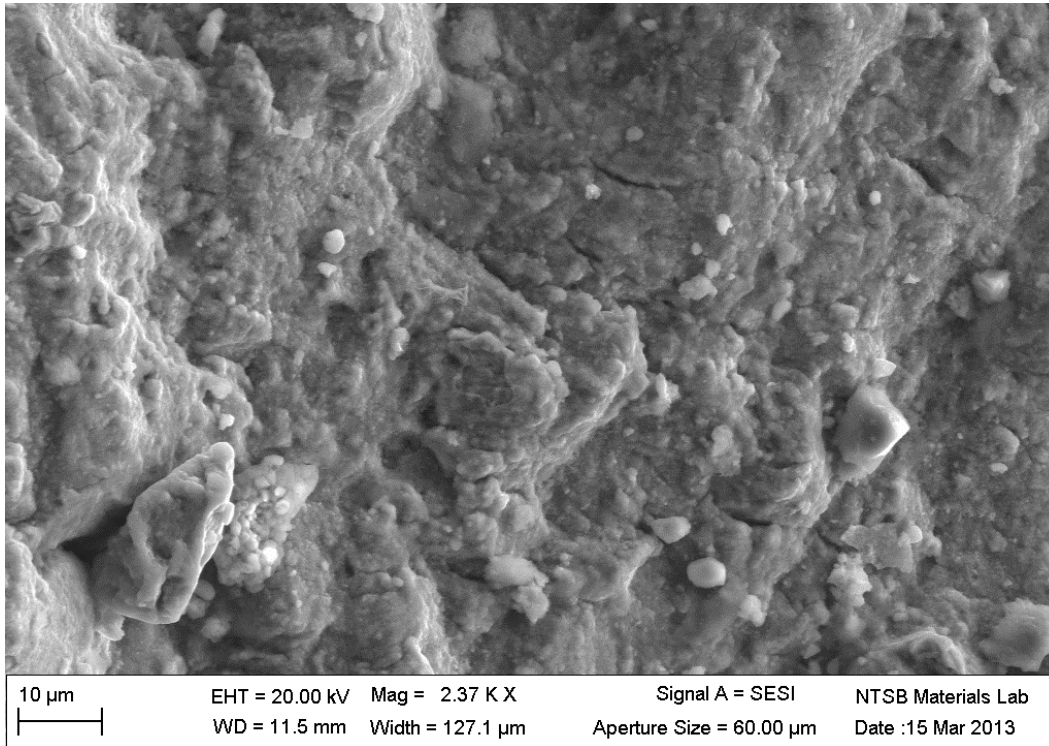
Figure 9 – Secondary electron (SE) micrograph of the pinion fracture surface, showing oxidized fatigue striations.

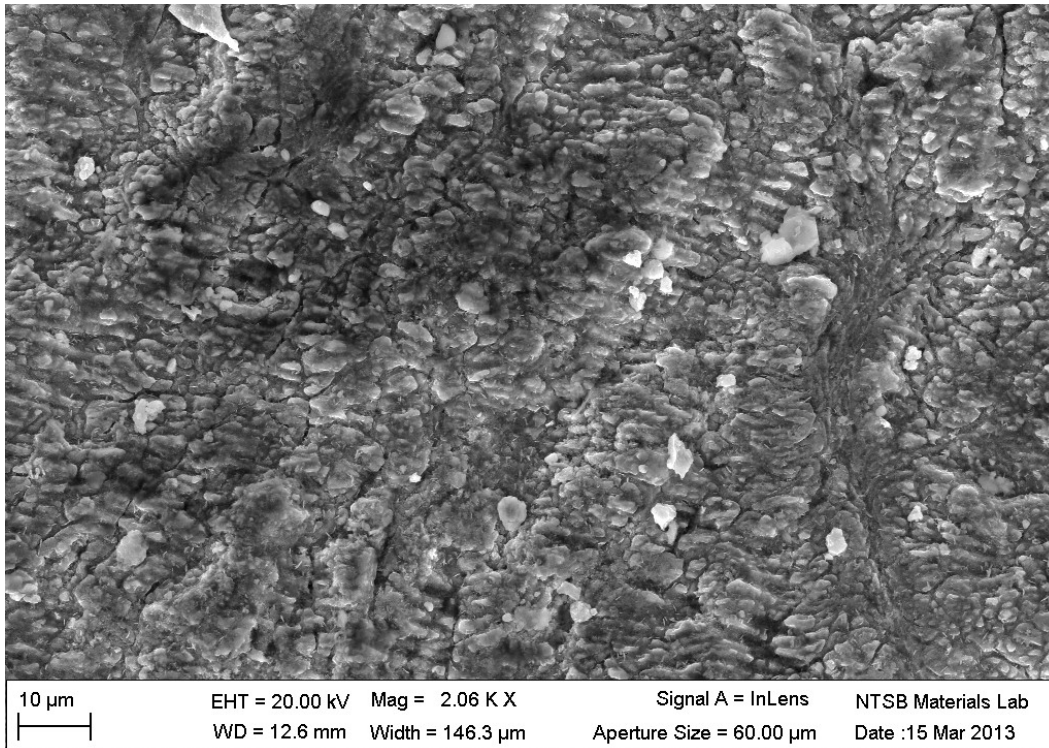
Figure 10 – SE micrograph of the pinion fracture surface, after cleaning, shows oxidized fatigue striations.

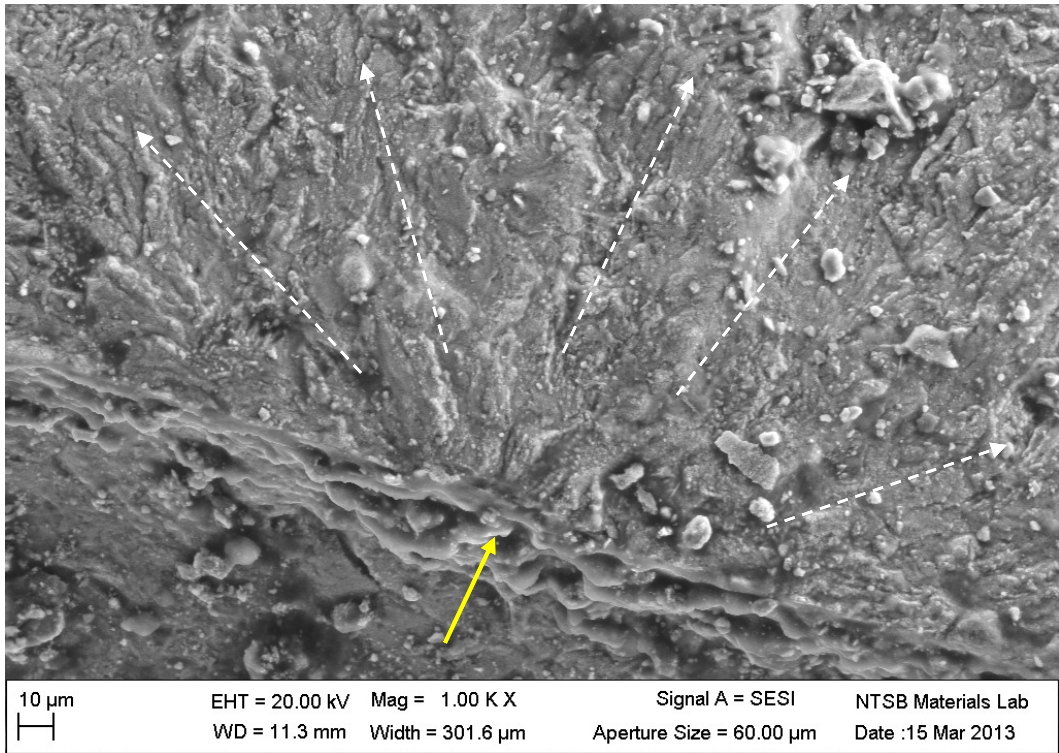
The pinion fracture surface displayed a variety of ratchet marks, indicative of multiple fatigue crack initiation. However, examination of the fatigue striations revealed a primary crack initiation site, shown in Figure 11. This initiation site corresponds to the location shown in Figure 8a, counterclockwise aft looking forward (ALF) from the jog on the fracture surface. The fatigue crack initiated at a thread root, consistent with the area of highest

stress concentration on the part. No material deficiencies such as inclusions, pits, or voids were found at the crack initiation site.

Figure 11 – SE micrograph of the pinion fracture surface, showing the primary fatigue crack initiation site (yellow arrow).

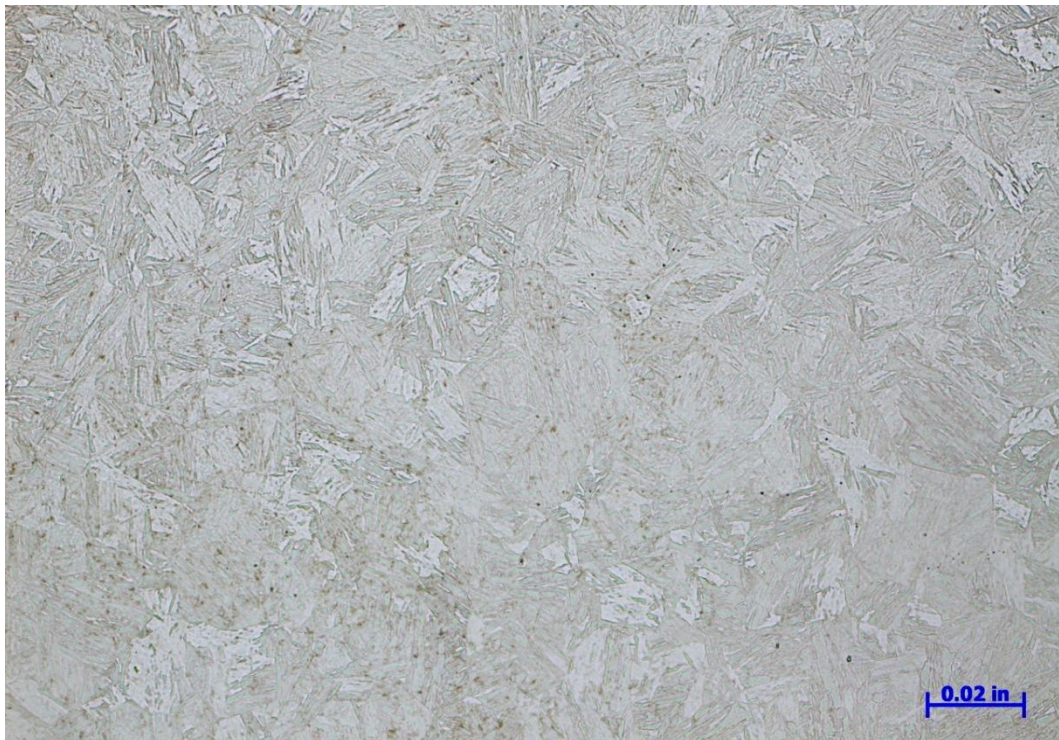
A portion of the pinion was sectioned, mounted, polished, and etched for metallographic examination. A typical area of the pinion microstructure is shown in Figure 12. The microstructure was consistent with that of tempered martensite, expected for the given material composition and heat treatment. The surface areas of the part revealed no indications of decarburization or similar material deficiencies.

Figure 12 – Metallographic cross-section of the pinion core (~500X, etched with 2% Nital).
