NATIONAL TRANSPORTATION SAFETY BOARD

MATERIALS LABORATORY FACTUAL REPORT

Report No. 00-145

Place : Near Port Hueneme, California
Date : January 31, 2000
Vehicle : Boeing MD-83, N963AS
Operator : Alaska Airlines, Flight 261
NTSB No. : DCA00-M-A023

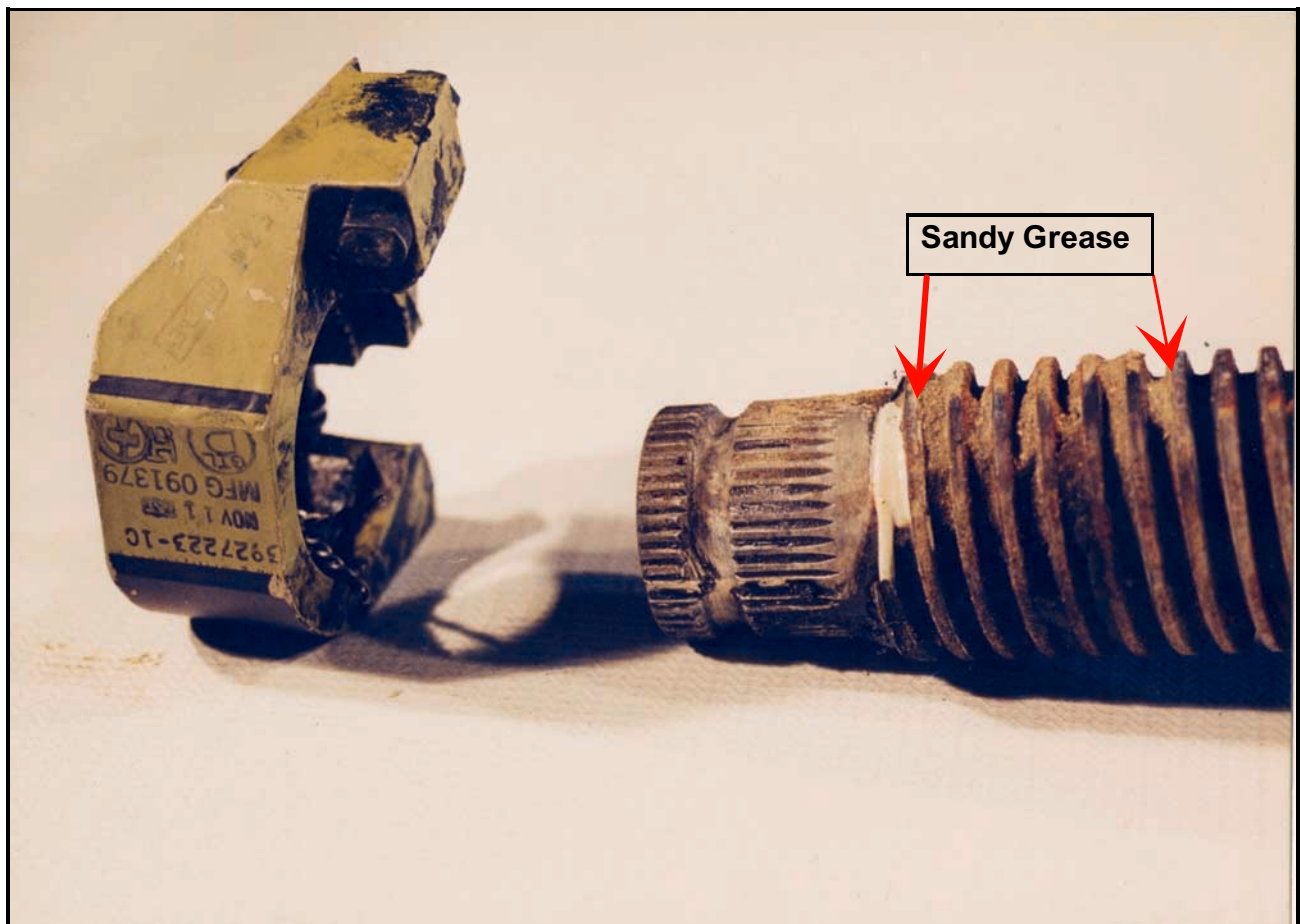
Figure 6--Lower end of Acme screw showing sandy material between the threads in the indicated area. Lower stop also shown.

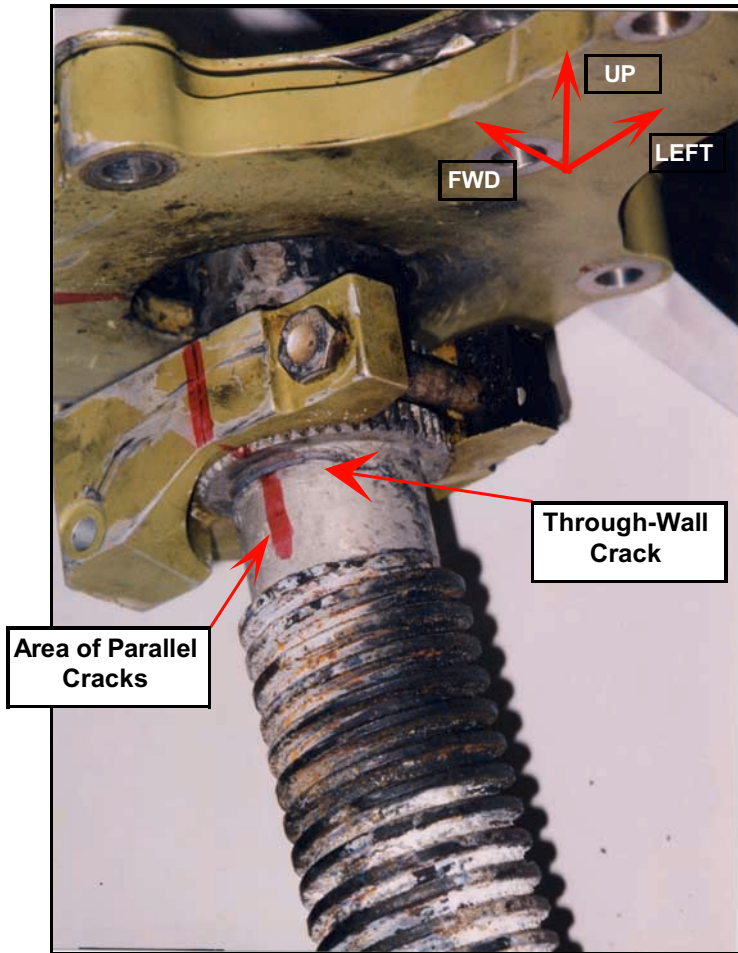
The Acme screw was visibly bent and had a through the wall crack in the area above the Acme threads and below the upper stop splines, as shown in figure 7 and 8. In the as-recovered position of the Acme screw, the lower end of the Acme screw was displaced rearward and to the left. This is best seen in figure 1. The through-wall crack was gapped open and ran around approximately $\frac{3}{4}$ of the Acme screw circumference. At both ends, the crack turned to a longitudinal direction, figure 8. The central region of the crack was open sufficiently to allow viewing of the surfaces. The crack appeared typical of an overstress separation with no indications of preexisting cracking. This was later confirmed by microscopic examinations in the NTSB Materials Laboratory. The through-wall crack was accompanied by a multitude of surface cracks running generally parallel to the through wall crack. These cracks are also visible in figure 7.

Figure 7--The upper end of the Acme screw showing the gaping through-wall crack.

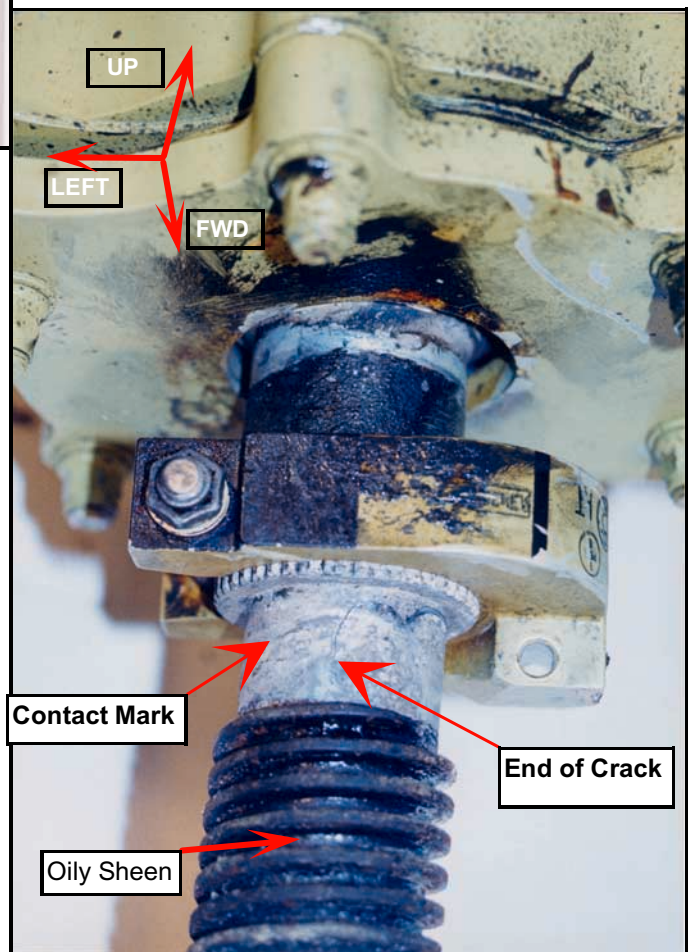
During examination of the Acme screw crack several contact marks were noted on the screw surfaces. On the aft side of the Acme screw, a downward facing "C" shaped mark was noted overlaying one end of the through-wall crack, as shown in figure 8. The mark did not dent the Acme screw but rather was a disturbance in the cadmium plating in this area of the Acme screw. Inspections of the adjacent structure of the stabilizer uncovered a mating dent in the lower flange of the stabilizer forward spar, as shown in figure 9. The spar flange dent was smoothly curved, with a radius that approximately matched that of the Acme screw at the "C" contact mark location. In the as-recovered position, the spar dent was located approximately 2 inches to the left and 2.25 inches behind the Acme screw. The relative locations of the spar dent and the Acme screw are also shown in figure 2.

Figure 8--Side view of the upper end of the Acme screw showing the end of the crack and the "C" shaped contact mark. Also note the oily sheen in the root of the visible threads of the Acme screw.

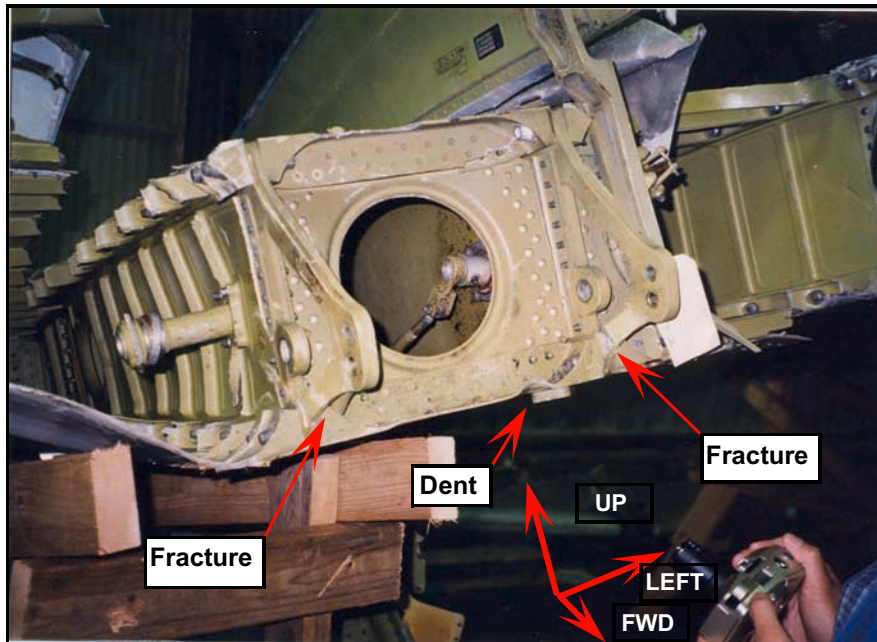
The jackscrew assembly was attached to the front of the horizontal stabilizer forward spar by 6 bolts (3 on either side of the assembly). The bolts passed through aluminum plate brackets projecting forward from the stabilizer spar and into the gearbox support assembly. As examined, the spar brackets were severely bent, offsetting the jackscrew assembly an estimated 1 to 2 inches to the left. This can be seen in figure 9, where the brackets are indicated and the yellow lines denote the original positions of the brackets. The lower legs of both brackets were fractured at bend locations as shown in figure 11. Close visual examination established that the fractures were consistent with overstress separations. The

four most forward attachment bolts (two in either side) were intact and in place but the two rearward attachments (one bolt on either side) were found disconnected from the structure. The bolt at the right rear was pulled through the stabilizer bracket and was still attached to the jackscrew assembly. The jackscrew attachment ear at the left rear attachment point was fractured. Visual examination indicated an overstress fracture. The bolt at this location remained in the stabilizer structure.

Figure 11--Oblique view of the spar attachment brackets after jackscrew removal. Fractures at arrows in lower legs of the brackets. Also note the dent in the forward edge of the spar lower flange.

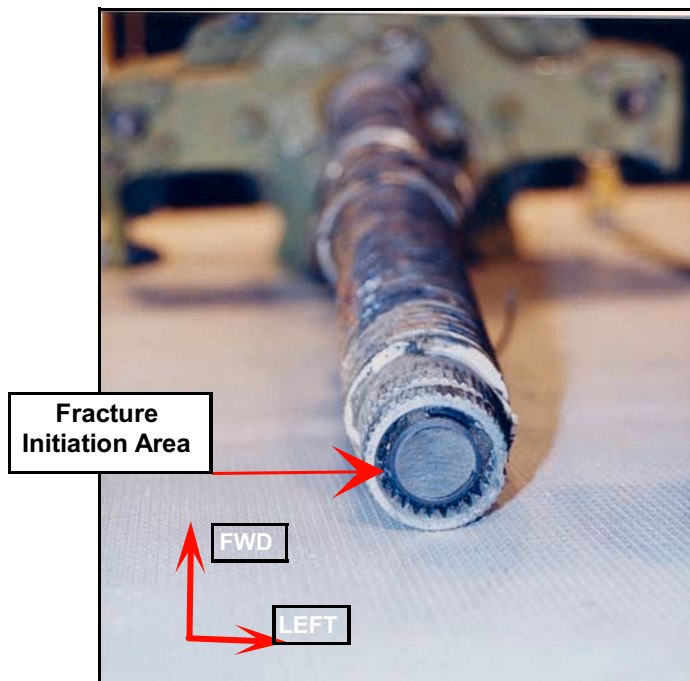
The jackscrew assembly torque tube was fractured at the lower end approximately in line with the bottom of the Acme screw as shown in figure 12. Closer examinations after the jackscrew assembly was removed from the horizontal stabilizer found gross macroscopic features indicating that the fracture initiated in the thread root of one of the torque tube retaining nut threads and propagated across the tube. As recovered, the initiation area was located in the forward right quadrant of the tube. Detailed examinations of the torque tube and the fracture are presented in the Laboratory Examinations section of this report.

Figure 12--Bottom view of the jackscrew showing the fractured internal torque tube. Fracture initiation at left side in this view.

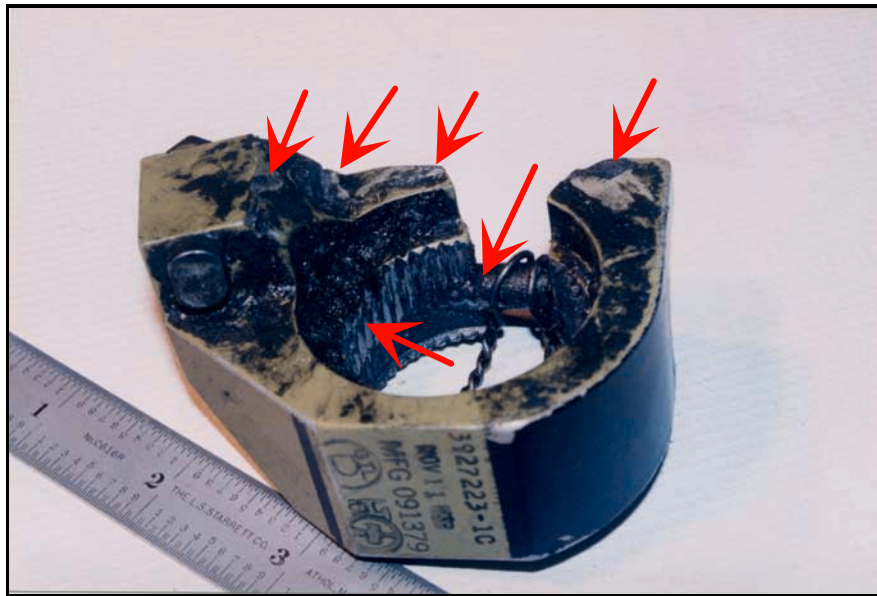
The lower “mechanical” stop of the jackscrew assembly was recovered separate from the Acme screw. The as-recovered stop is displayed in figures 15 and 16. The surfaces of the stop were covered in varying amounts of a black greasy material with the upper surface containing the most, as seen figure 15. Samples of the greasy material were removed for later analysis. The stop was recovered with the pinch bolt and nuts intact and still fastened along with two lengths of heavy gage (0.050-inch diameter) safety wire attached. The safety wire lengths were stretched and fractured at the free end, see figure 16. Later microscopic examination determined the fractures to be consistent with tension overstress breaks. Visual examination of the stop showed many dents and mechanical marks in the upper and lower surfaces and mechanical damage to the internal splines and the pinch bolt. Detail examinations of the stop are reported in Materials Laboratory Factual Report No. 00-045 and are not further discussed in this report.

Figure 15--A view showing the as-recovered lower stop assembly. Note the black grease. Locations of some of the mechanical damage are arrowed.

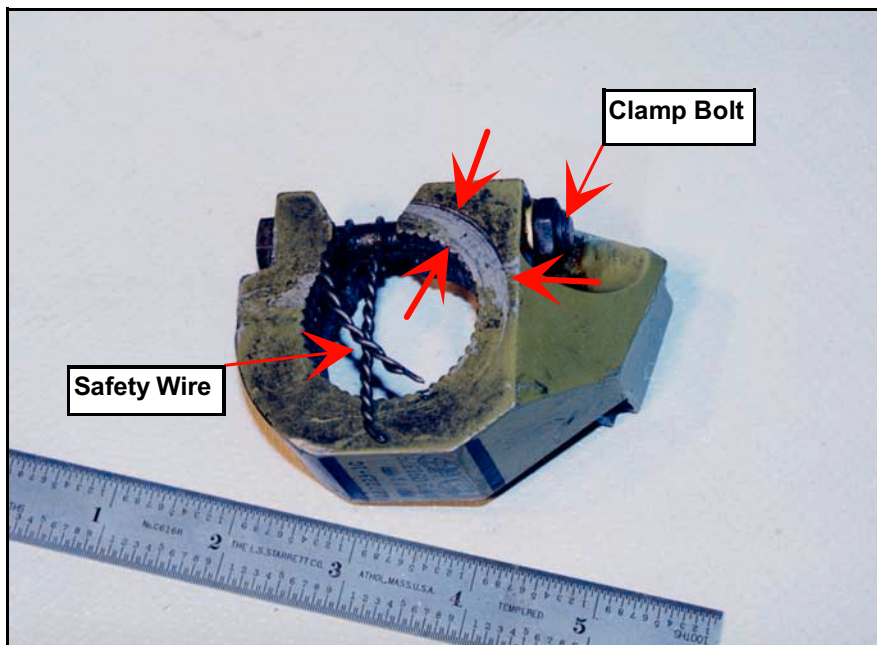
Figure 16--The lower surface of the as-recovered lower stop assembly with arrows at damage locations. Note the fastened and in place clamp bolt and the heavy safety wire.

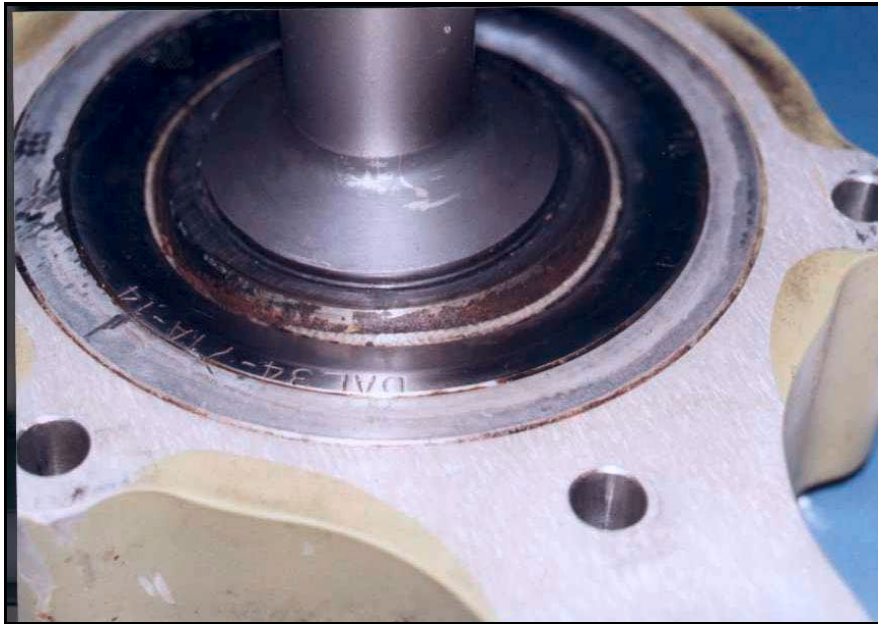
With the upper and lower support plates and the Acme screw removed, surface corrosion and pitting were visible on the exposed lower surface of the torque tube spherical bearing, as shown in figure 24. The torque tube was separated from the spherical bearing by tapping it upward. The bearing was then pressed out of the support plate with a hand press. The bearing separated smoothly and without binding. No corrosion was visible on the exposed upper surfaces of the bearing after it was wiped clean.

Figure 24--Close view showing the corrosion on the lower surface of the pivot bearing. Shown with torque tube installed.

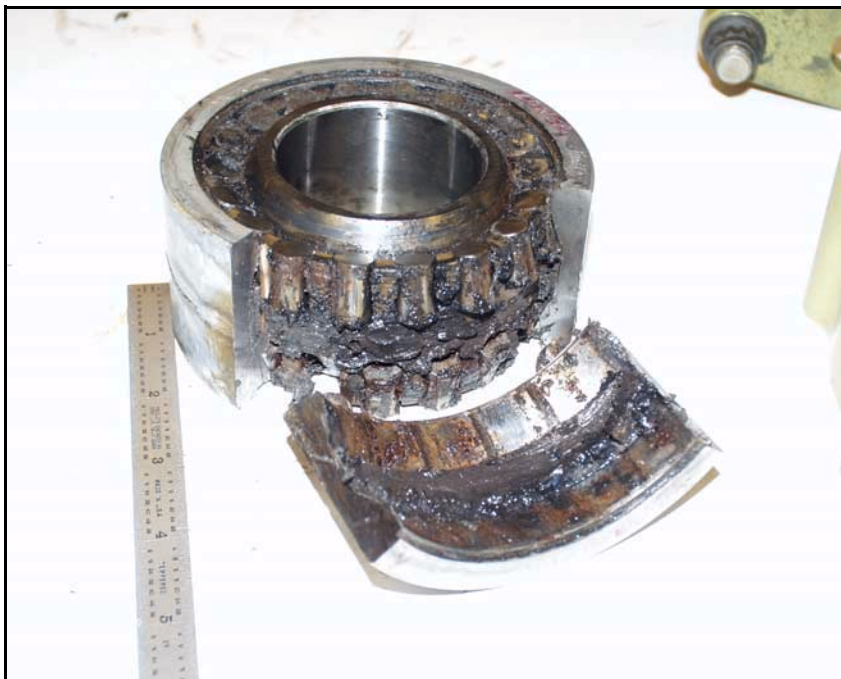
The internal bearing components were inspected after the upper and lower seals were pried out and the bearing outer race was abrasively cut at two locations. The cuts opened a window to the bearing interior as show in figure 25. Darkened grease and rusty red corrosion products obscured the interior bearing components. The grease was soft and black without

Figure 25--The interior of the pivot bearing after removal from the gearbox support assembly and sectioning showing the black grease.

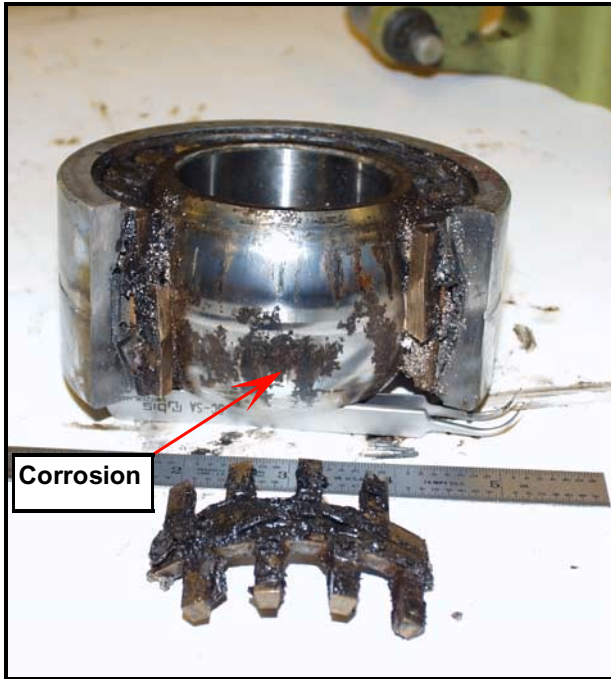
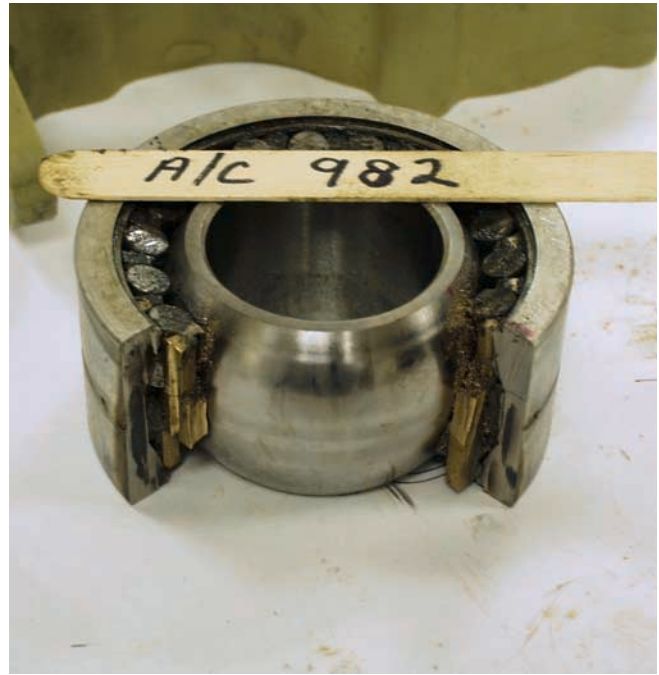
visible metal fragments. A grease sample from between the rolling elements was retained for analysis. Wiping the components cleaned uncovered large areas of surface and pitting corrosion on the inner and outer races and on the rollers, as shown in figure 26 and 27. For comparison, the spherical bearing from another jackscrew assembly⁷ was similarly sectioned and is shown in figure 26 to the right of the accident bearing.

Figure 26--Left corrosion visible on the inner spherical race of the pivot bearing after cleaning. A similarly opened bearing from another jackscrew assembly is shown at right for comparison.

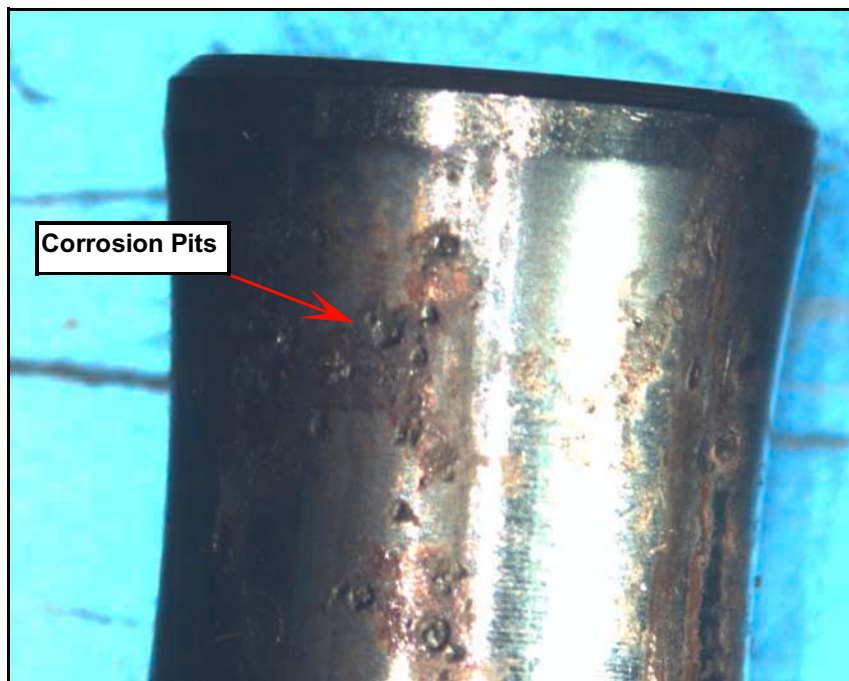
Figure 27--A typical rolling element from the pivot bearing with severe pitting corrosion.

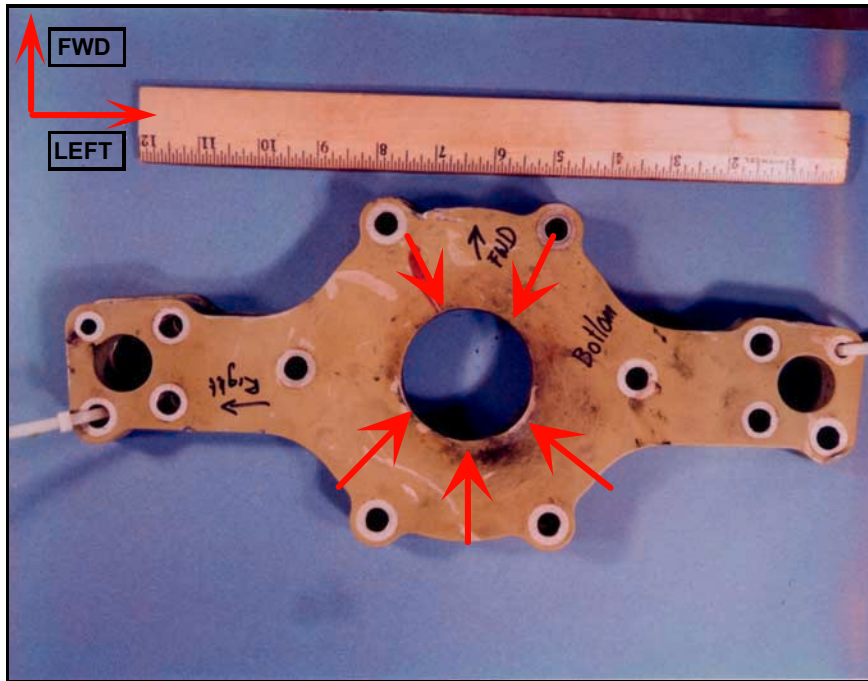
Figure 28--The lower surface of the lower support plate with dents (arrows) in the edges of the pass through hole from contact with the Acme Screw.

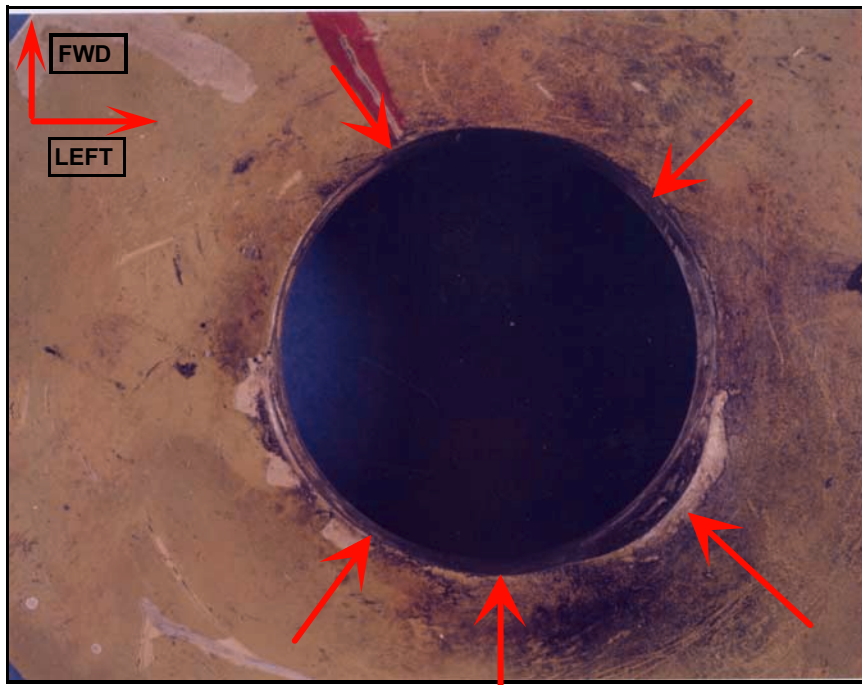
Figure 29--Closer view of the pass through hole showing the damage locations (arrows).

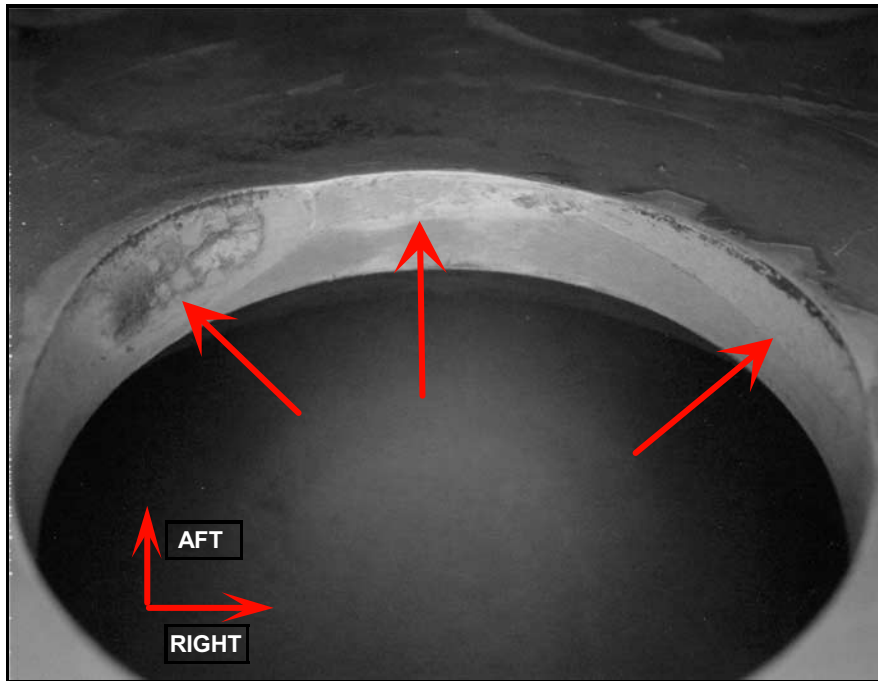
The lower support plate and upper Acme screw “mechanical” stop were disassembled and removed from the Acme screw. Detailed examinations of the upper “mechanical” stop are addressed in Materials Laboratory Report No. 00-045. The bottom surface of the upper support plate is displayed in figures 28 and 29. The lower edge and bore of the pass through hole for the Acme screw was deformed at several locations as previously noted. Close examination uncovered three major areas of deformation consistent with contact by the Acme screw and two smaller minor areas. As shown in figure 30, the major damage areas were all located in the aft half of the hole with the largest dent in the aft left quadrant. The two smaller contact marks were located on the forward half of the hole, as shown in figure 31.

Figure 31--A closer view of the pass through hole showing the two minor dents (arrows) in the forward half.

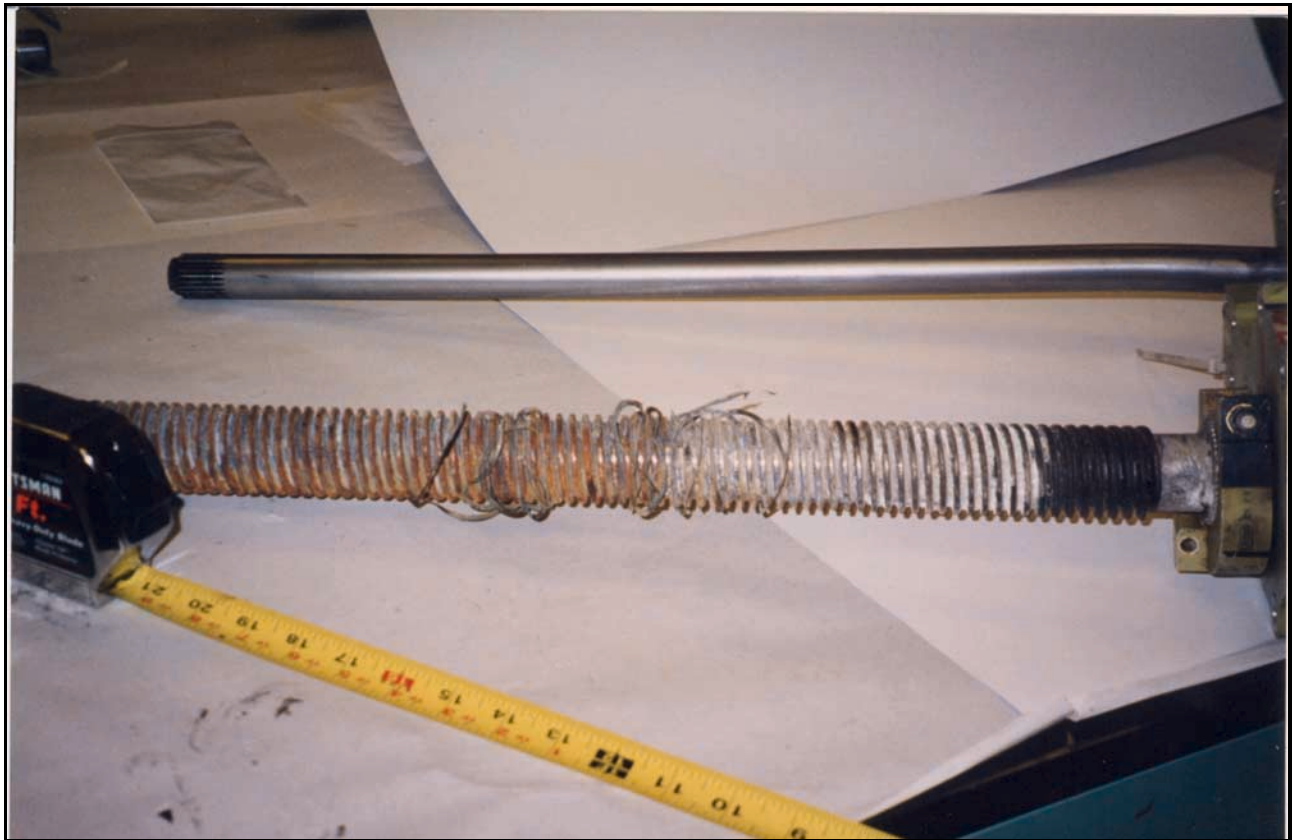
The Acme nut thread remnants remained coiled loosely around the screw during disassembly, as shown in figure 32. Prior to removal of the thread remnants from the Acme screw their overall locations were measured relative to the lower end of the Acme screw. The locations are depicted in the upper drawing in figure 33. The three additional drawings in figure 33 depict the portions of the Acme screw that would be covered by the Acme nut. They show the position of the nut when the trim was positioned at 7 degree aircraft nose up (ANU), at 0.4 aircraft nose down (AND) and with the lower surface of the Acme nut sitting on the upper surface of the lower stop assembly. The depicted positions of the nut were arrived at by scaling the “PK”⁸ dimension onto a scale drawing of the Acme screw.

Figure 32--Side view of the screw showing the thread remnants coiled around the Acme screw. Also note the white deposits and the red rust.

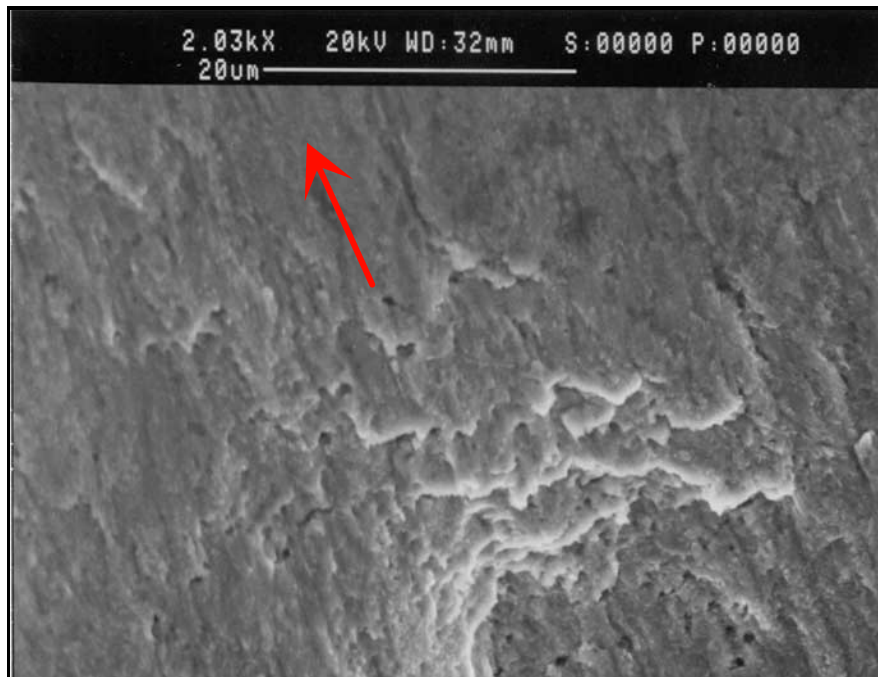
Figure 36--SEM view of typical shear dimple found on the outer edges of the thread remnants. Dimples indicate remnant moving up (arrow).

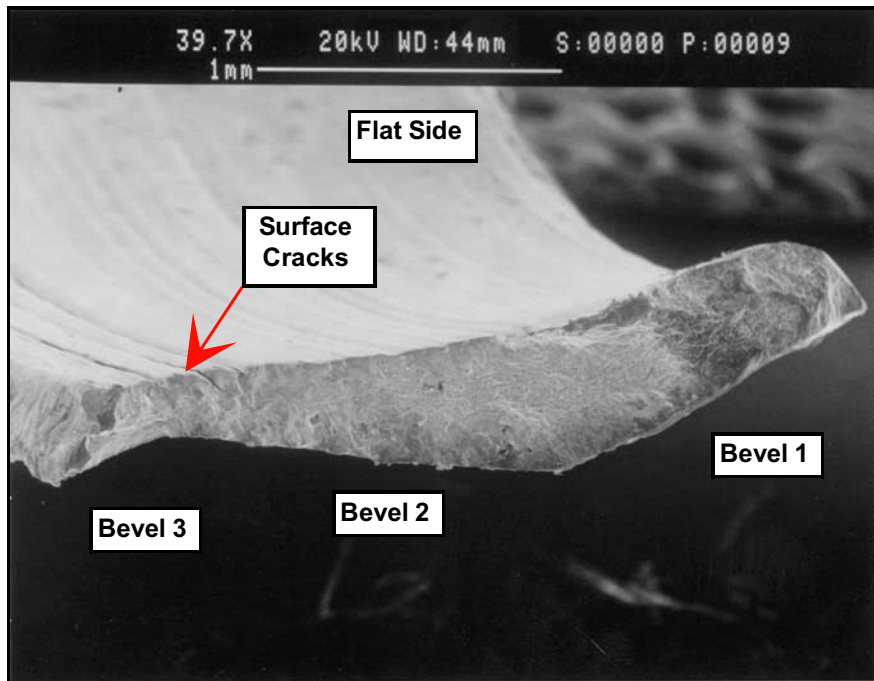
Figure 37--Two SEM views of a radial fracture on remnant #4 showing typical features seen on other remnants. The upper surface is flat while the lower surface is beveled, labeled Bevel 1, 2 and 3. The outer diameter edge fracture is at left in both views. Flat surface cracks near the rim fracture are labeled. Lower view is annotated with local thickness dimensions.

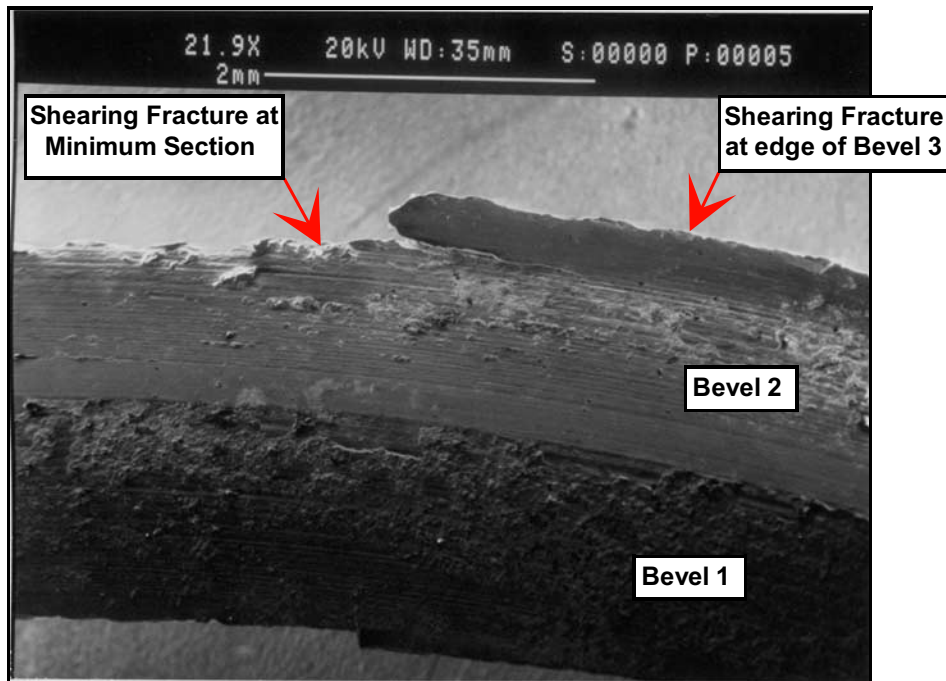
Figure 39--SEM view of fracturing at both the minimum section line and at the free edge of bevel 3.

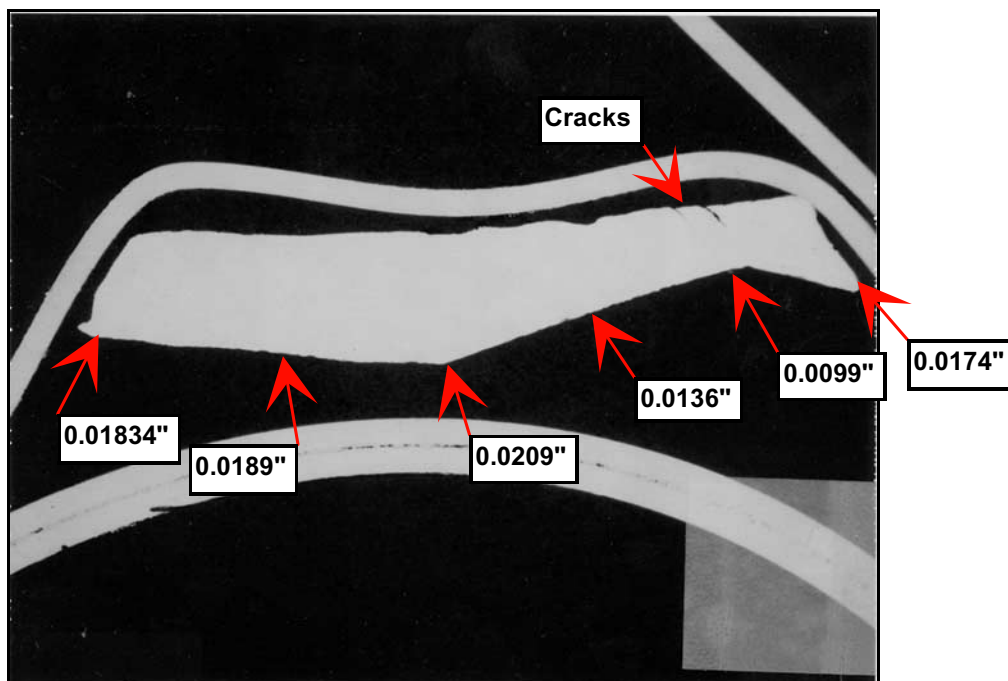
Figure 40--Radial metallographic cross section through remnant #6 showing a similar cross section as that seen during SEM examinations. Note the slight curvature of the flat surface (top). View is reversed with shear fracture at right. Thickness dimensions are noted at selected locations.

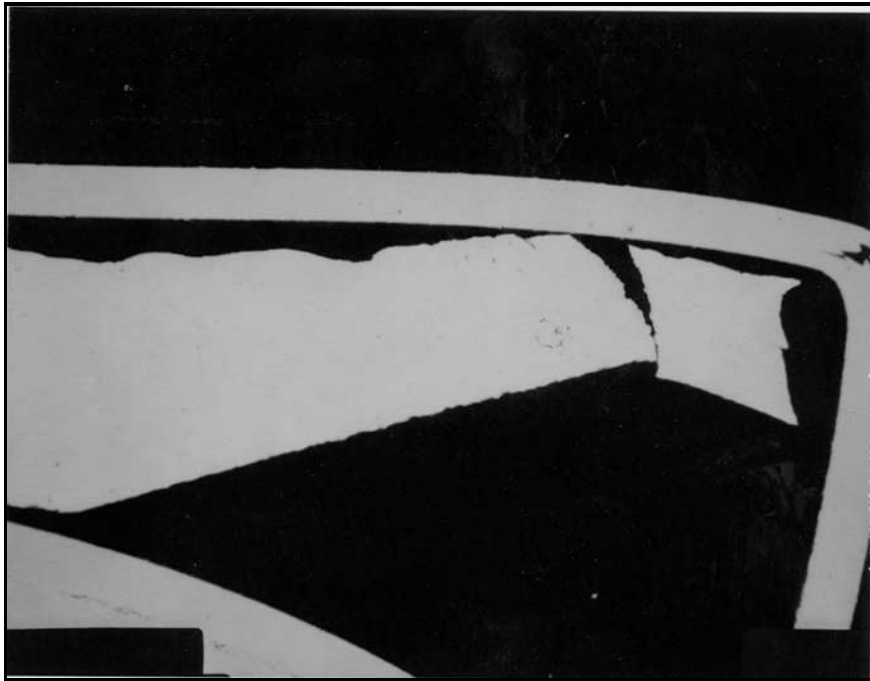
Figure 41--Another mellographic section through #6 showing where the crack broke through the minimum section during mounting.

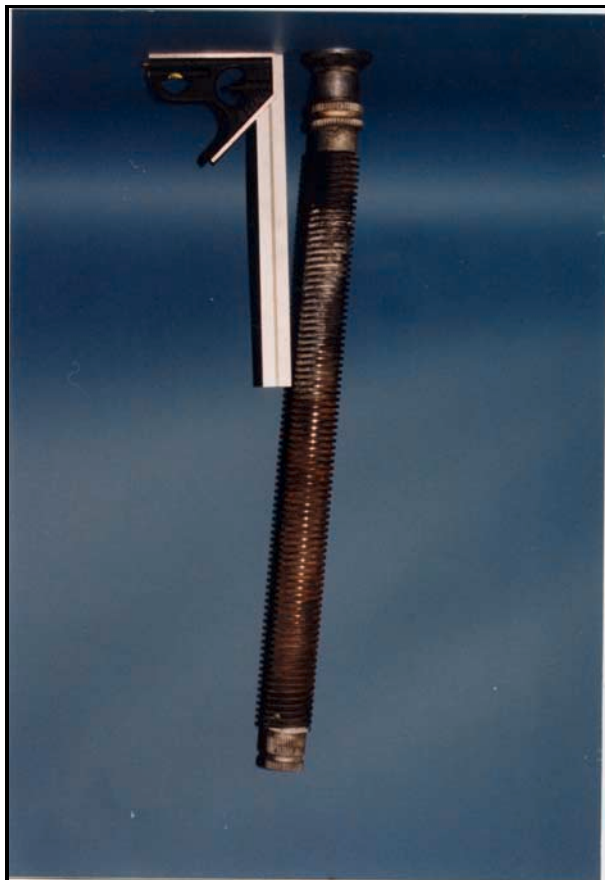
Figure 42--A view of the Acme screw showing the extent of the bending.

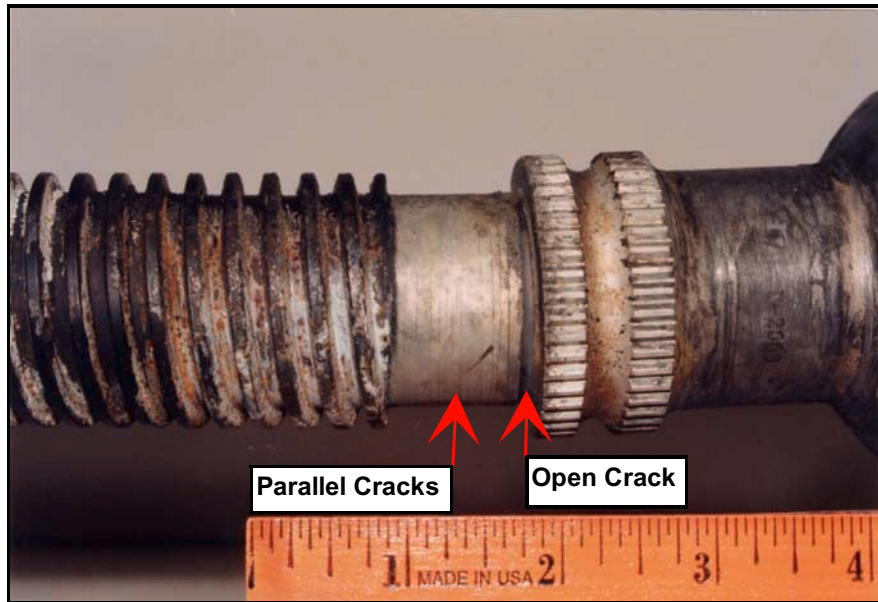
Figure 43--A side view of the Acme screw showing the gaped open crack and the adjacent parallel surface cracks.

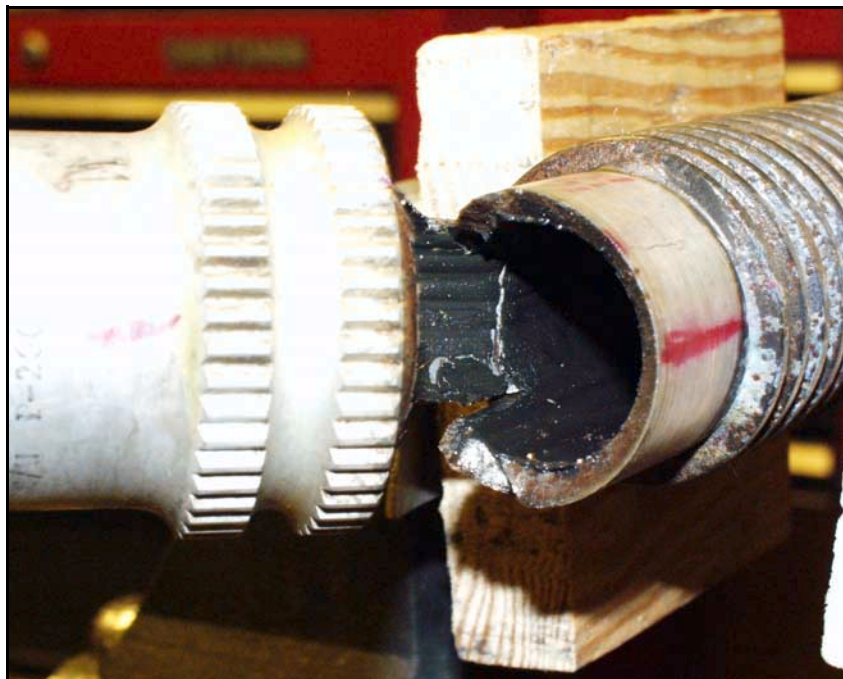
Figure 44--The opened crack at the upper end of the Acme screw. Fracture features typical of an overstress.

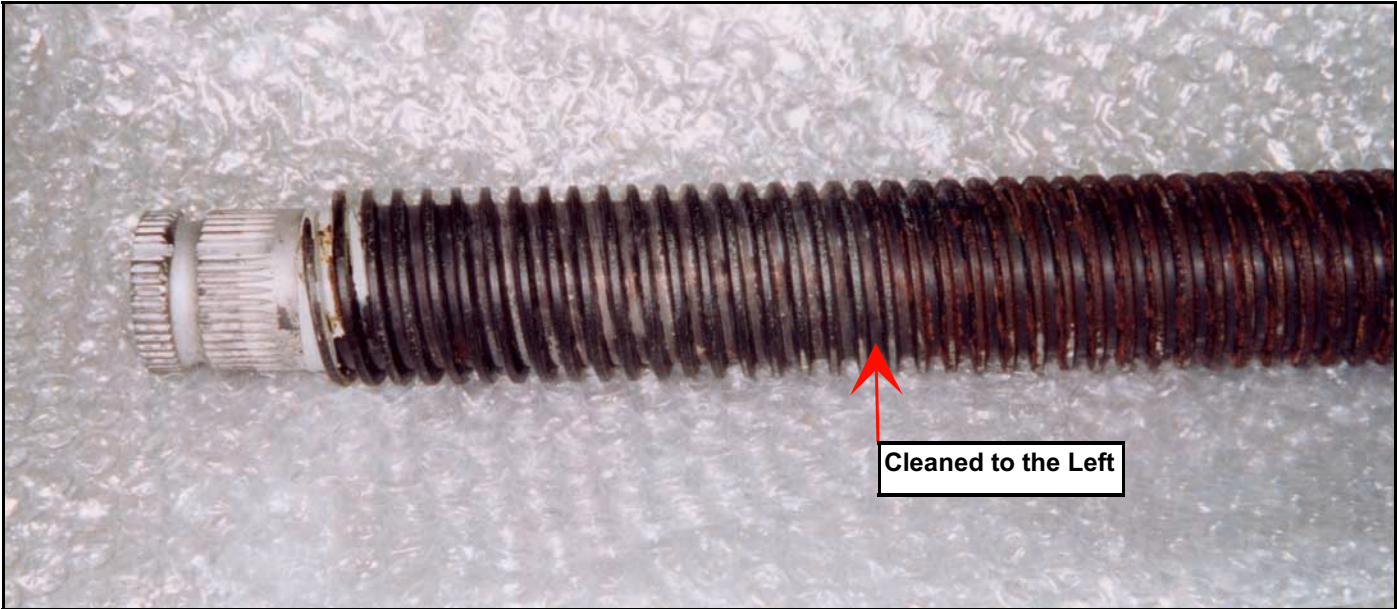
Figure 46--Two views of the Acme screw after electrolytic cleaning the lower end of the screw. Below is a higher magnification view showing the cleaned but pitted surface. Some small areas of corrosion products remained.

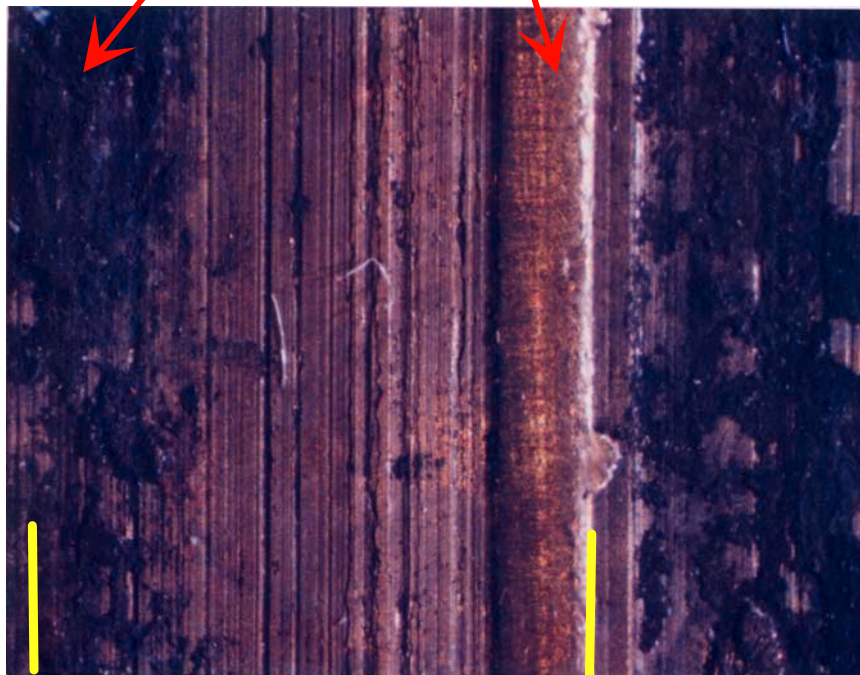
Figure 56--Two views of the interior of the nut showing the pattern of damage. Upper view shows several threads with the raised ridges and the black deposits. Lower view is an enlargement of a single thread area with corresponding feature indicated and the approximate original thread width indicated by vertical lines.

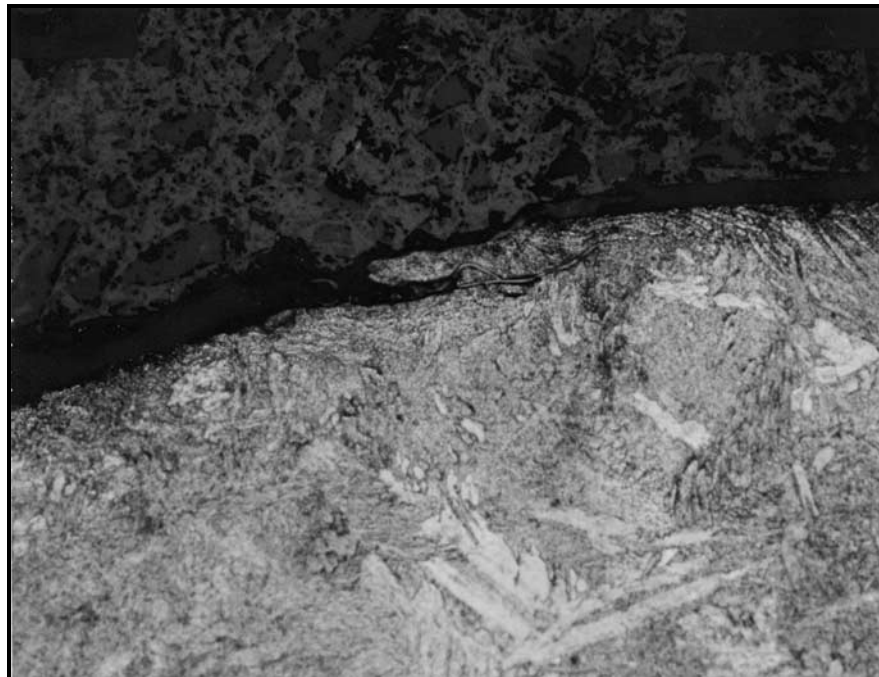
Figure 63-- Two micrographs showing a raised ridge in profile and the surrounding microstructure. The height of the ridge measured 0.006 inches. Etch 50% Nitric in water. Original magnifications 40X and 200X

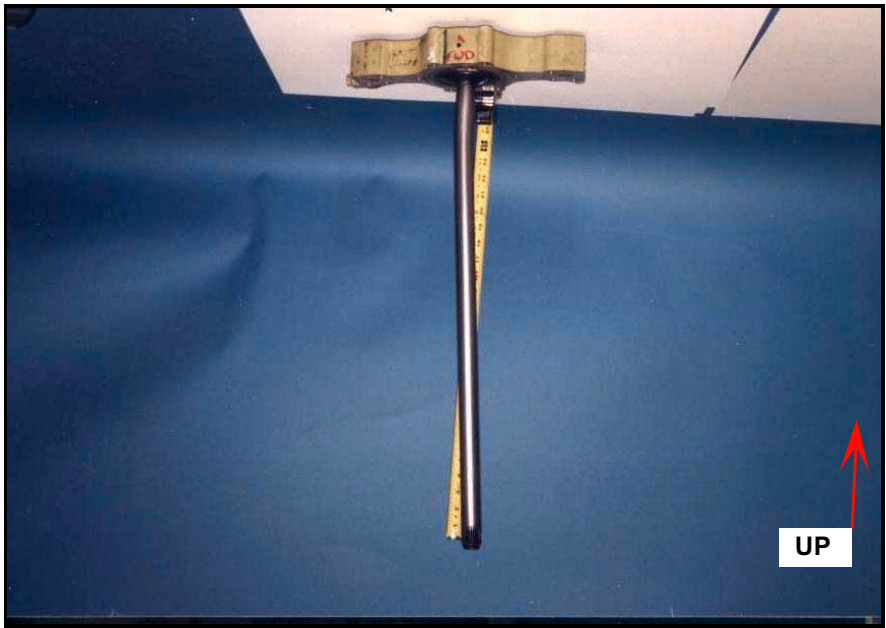
Figure 64--Overall view of the torque tube removed from the Acme screw showing the bend near the upper end.

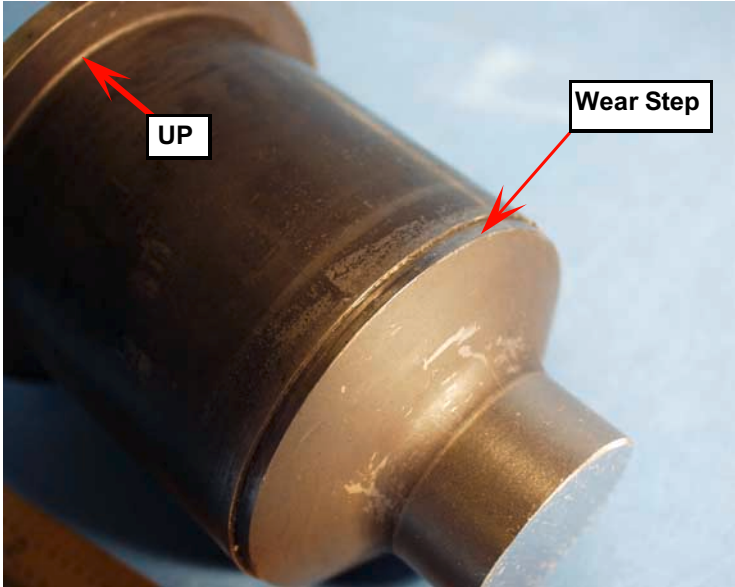
Figure 65--A view of the wear step in the large diameter section of the torque tube.

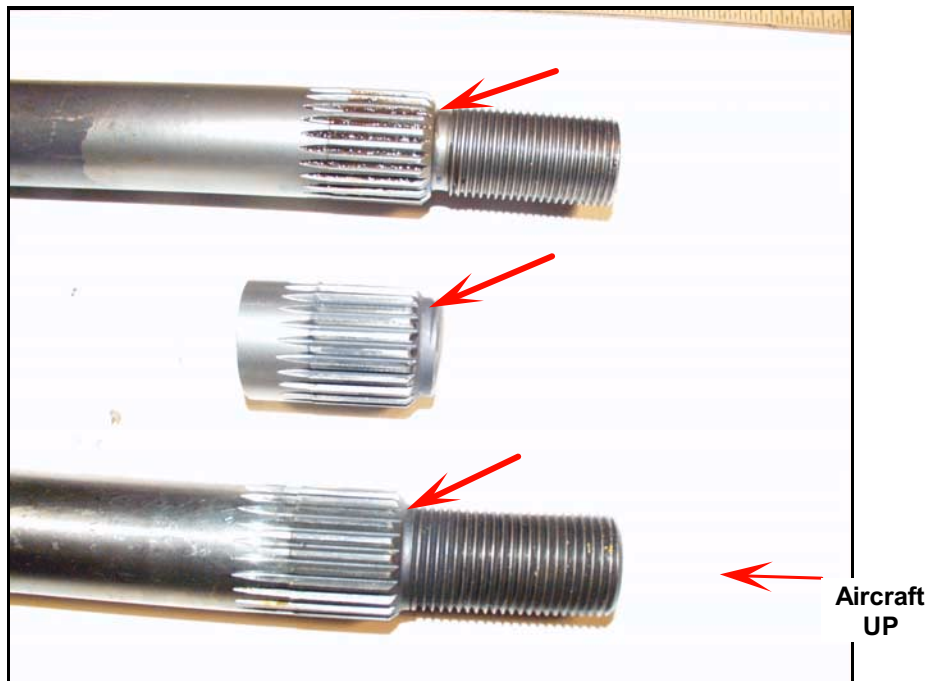
Figure 66--Comparison of the lower end of the accident torque tube (middle) to exemplar torque tubes showing the different thread relief radius details (arrows). The upper tube has the optional relief while the accident tube and lower one do not.

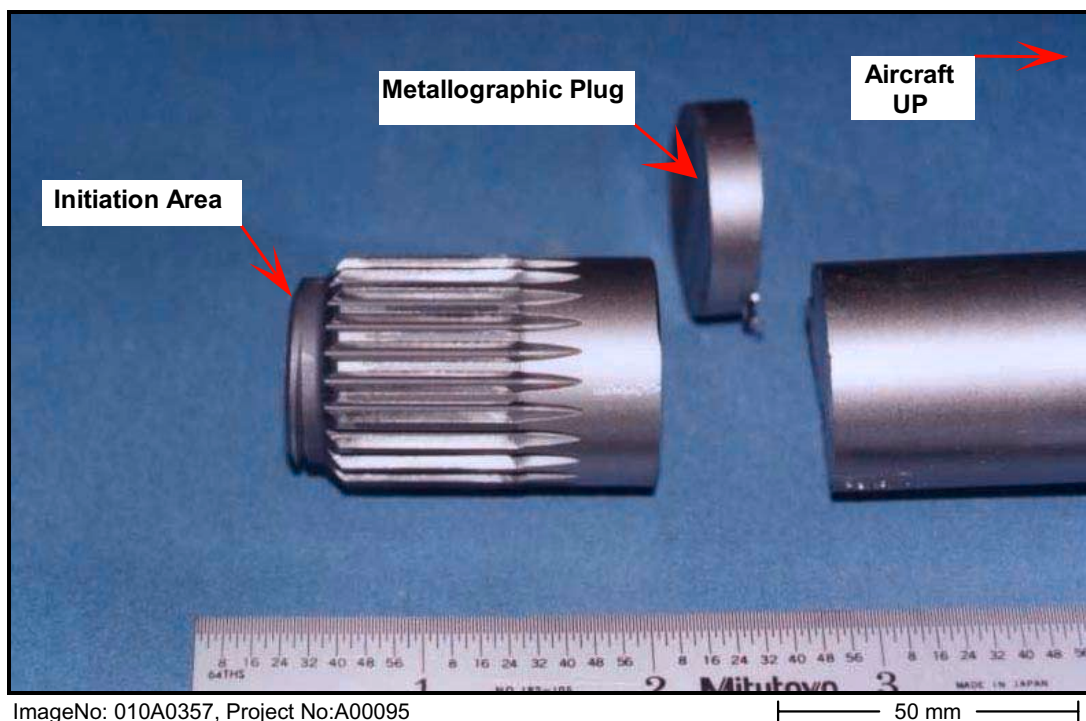
Figure 67--A side view of the torque tube after cutting off the fractured end and the metallograph plug. The initiation area is denoted in the first full thread.
