NATIONAL TRANSPORTATION SAFETY BOARD

MATERIALS LABORATORY FACTUAL REPORT

Report No. 00-145

Place : Near Port Hueneme, California
Date : January 31, 2000
Vehicle : Boeing MD-83, N963AS
Operator : Alaska Airlines, Flight 261
NTSB No. : DCA00-M-A023

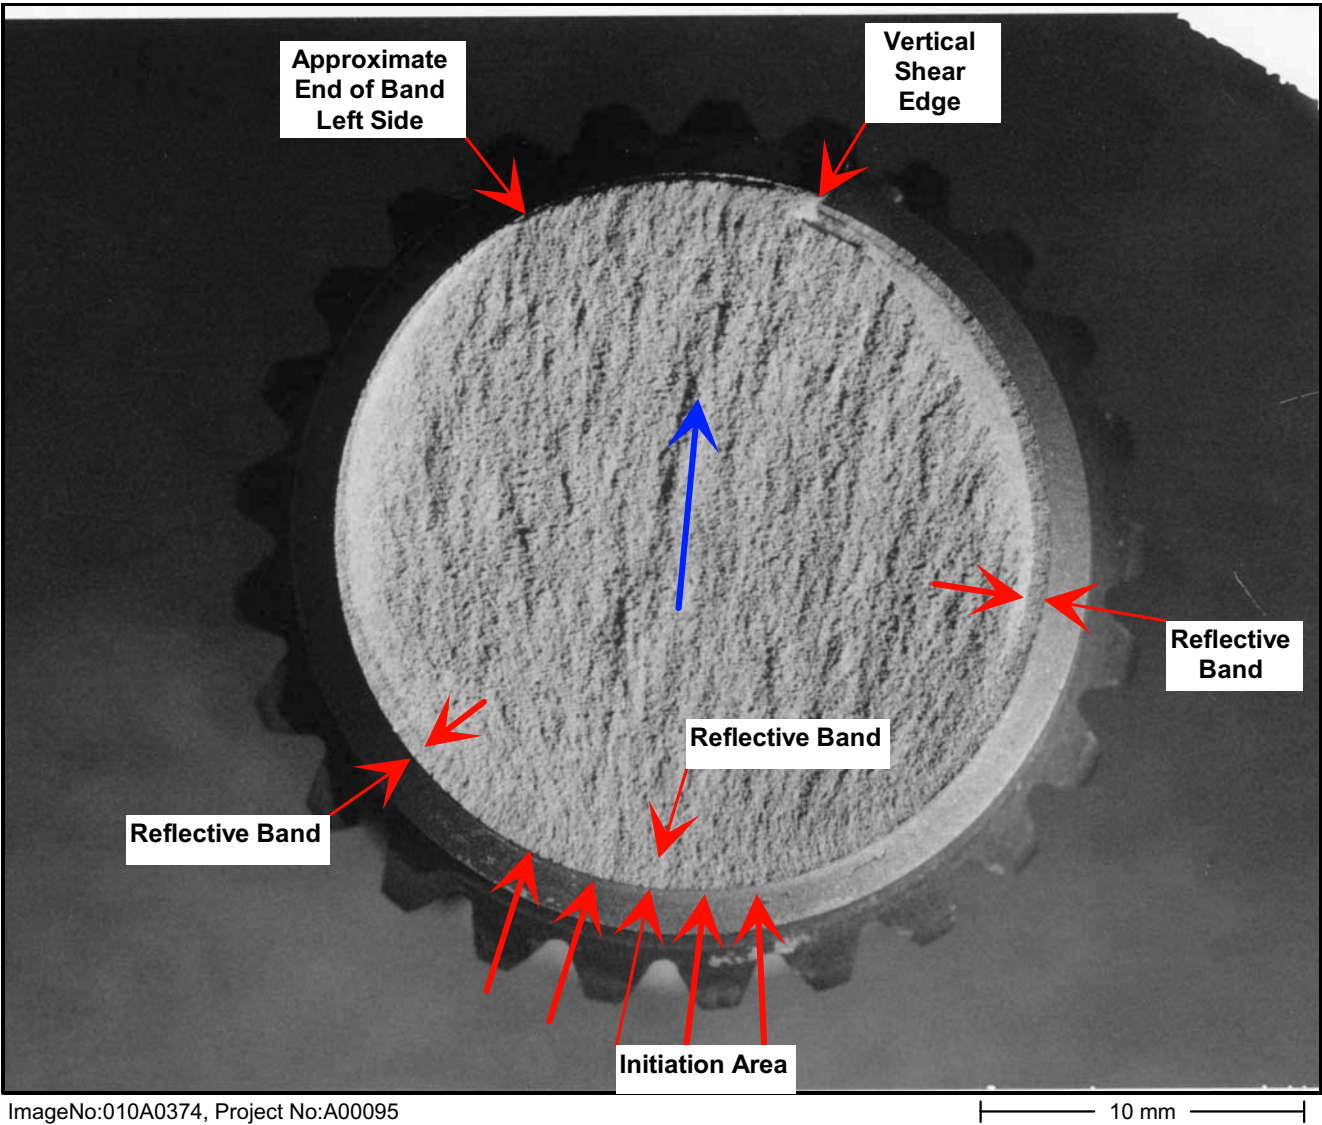
Figure 68--Direct view looking up at the torque tube fracture showing the initiation area, (arrows at lower edge) and the approximate widths of the circumferential band (between arrows) at the thread root. Large blue arrow denotes overall fracturing direction.

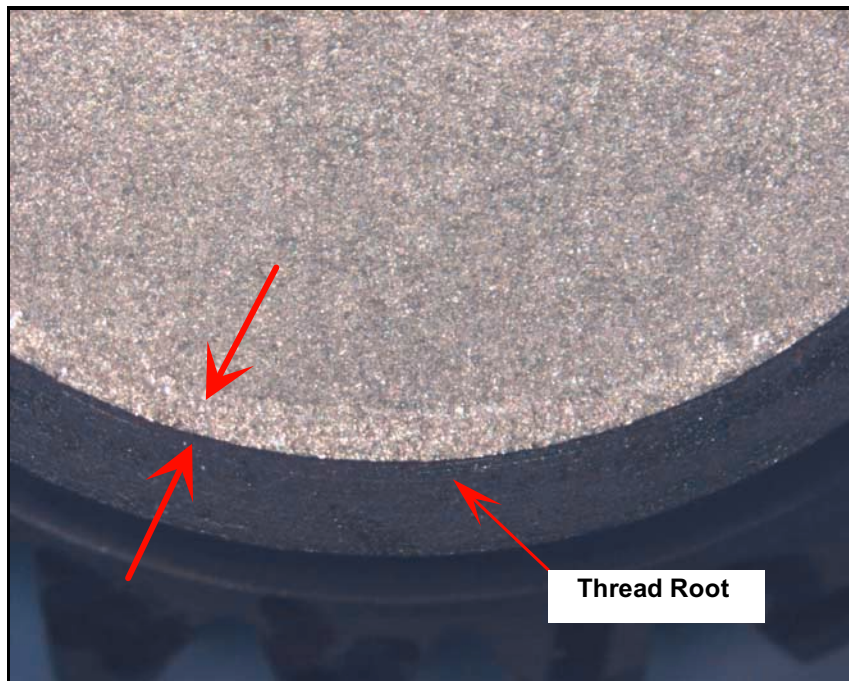
Figure 69--Closer view of the torque tube fracture initiation area showing the reflective band (between arrows) adjacent to the thread root.

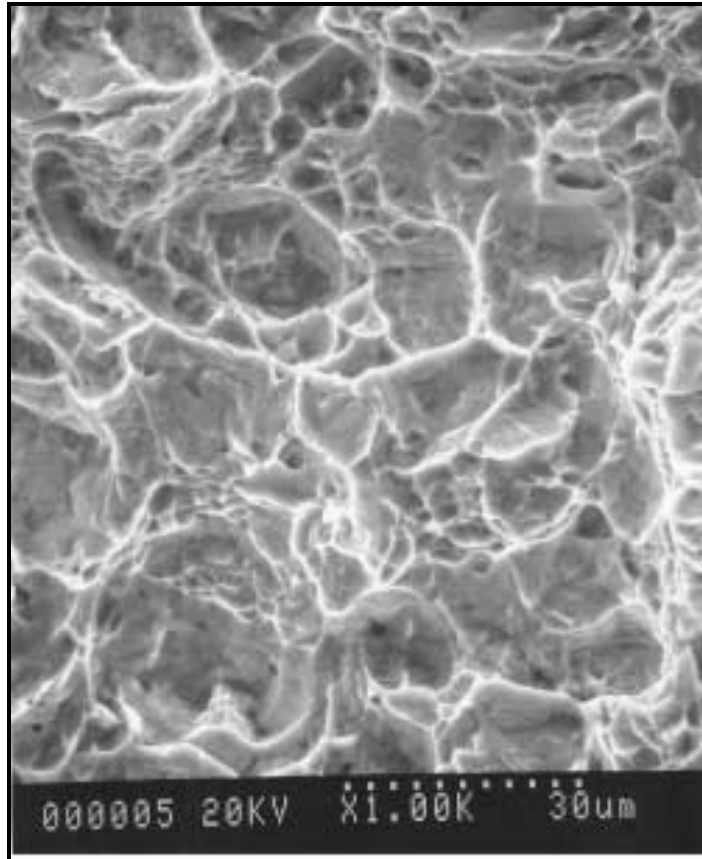
Figure 73--SEM view showing typical overstress ductile dimples present on the majority of the fracture.

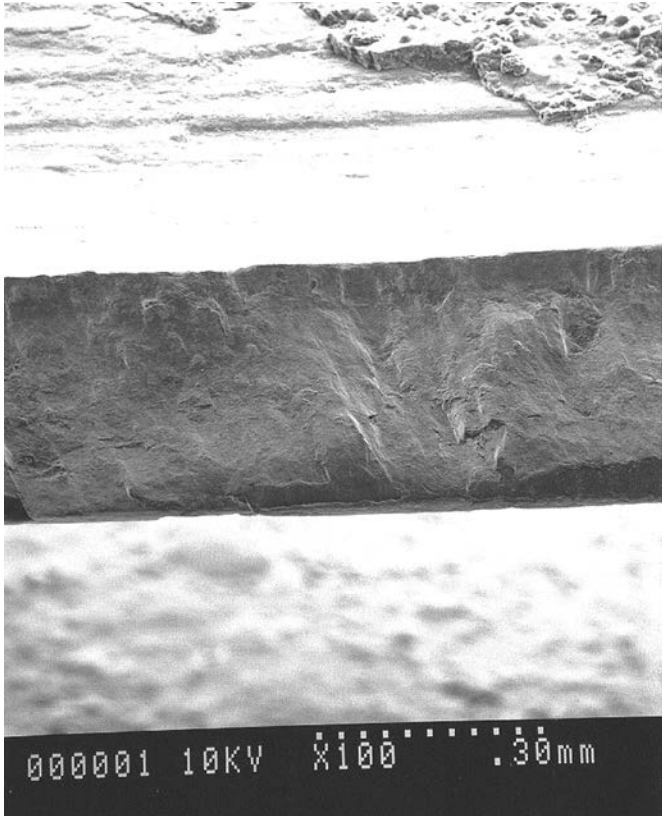
CLOSE-UP OF FRACTURE ALONG OUTER EDGE.
(NEG: 00-S0070)

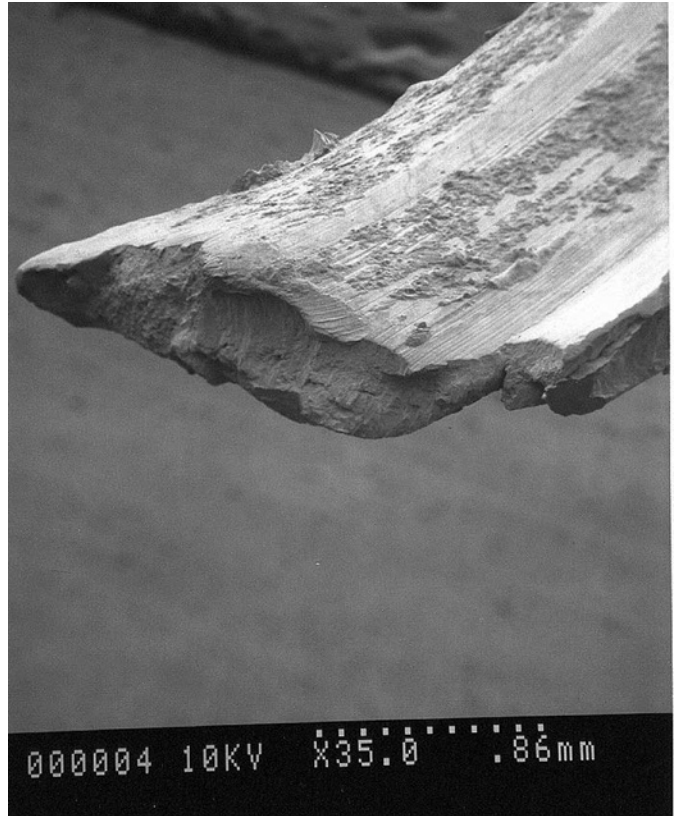
CLOSE-UP OF TRANSVERSE FRACTURE.
(NEG: 00-S0072)

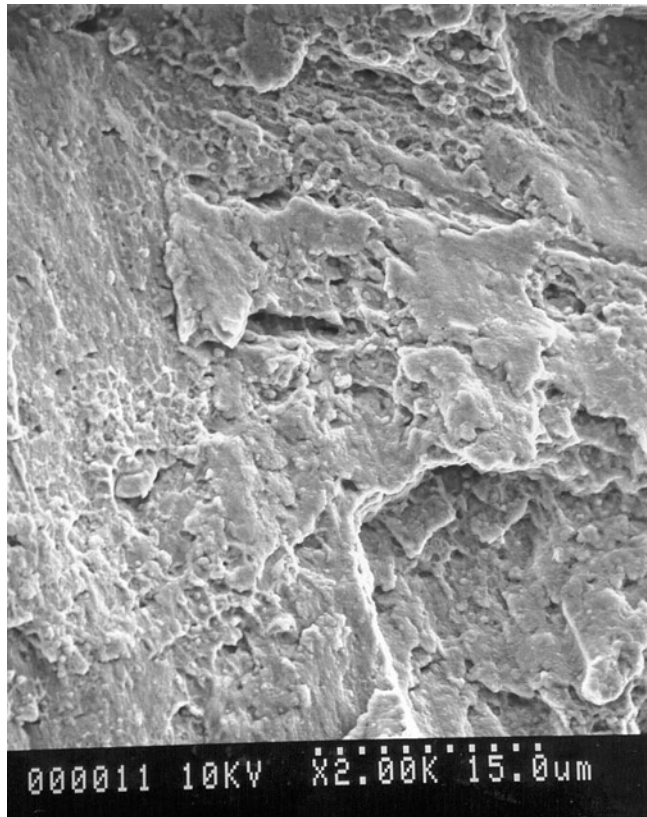
RAPID FRACTURE - DIMPLE RUPTURE.
(NEG: 00-S0071)
