NATIONAL TRANSPORTATION SAFETY BOARD

MATERIALS LABORATORY FACTUAL REPORT

Report No. 98-078 Addendum 1

Place : Monterey, California
Date : October 13, 1997
Vehicle : Experimental Long EZ, N555JD
NTSB No. : LAX98-F-A008
Investigator : George Petterson(LAX)

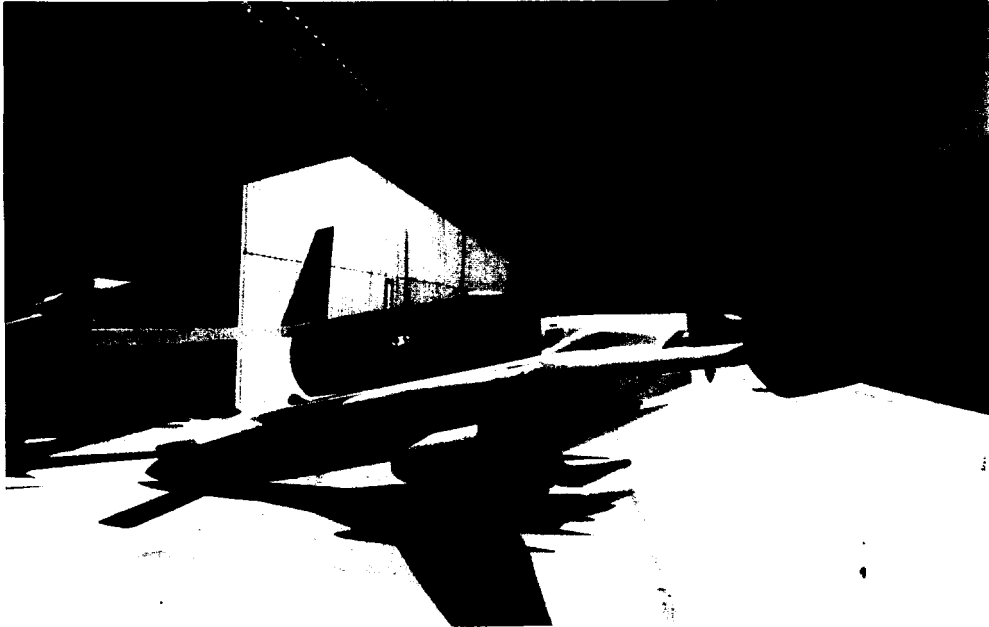
Mr. Melville worked since about 1978 with Bert Rutan who was the designer of the Long EZ airplane. Mr. Melville's airplane, N26MS, was the second Long EZ built (dated 1980), which he had flown to the Santa Paula Airport that day and was available for examination (see figure 1 for side view of airplane). He also was involved with the building of the original prototype Long EZ airplane with Mr. Rutan.

Figure 1. Side view of the reference Long EZ, N26MS.

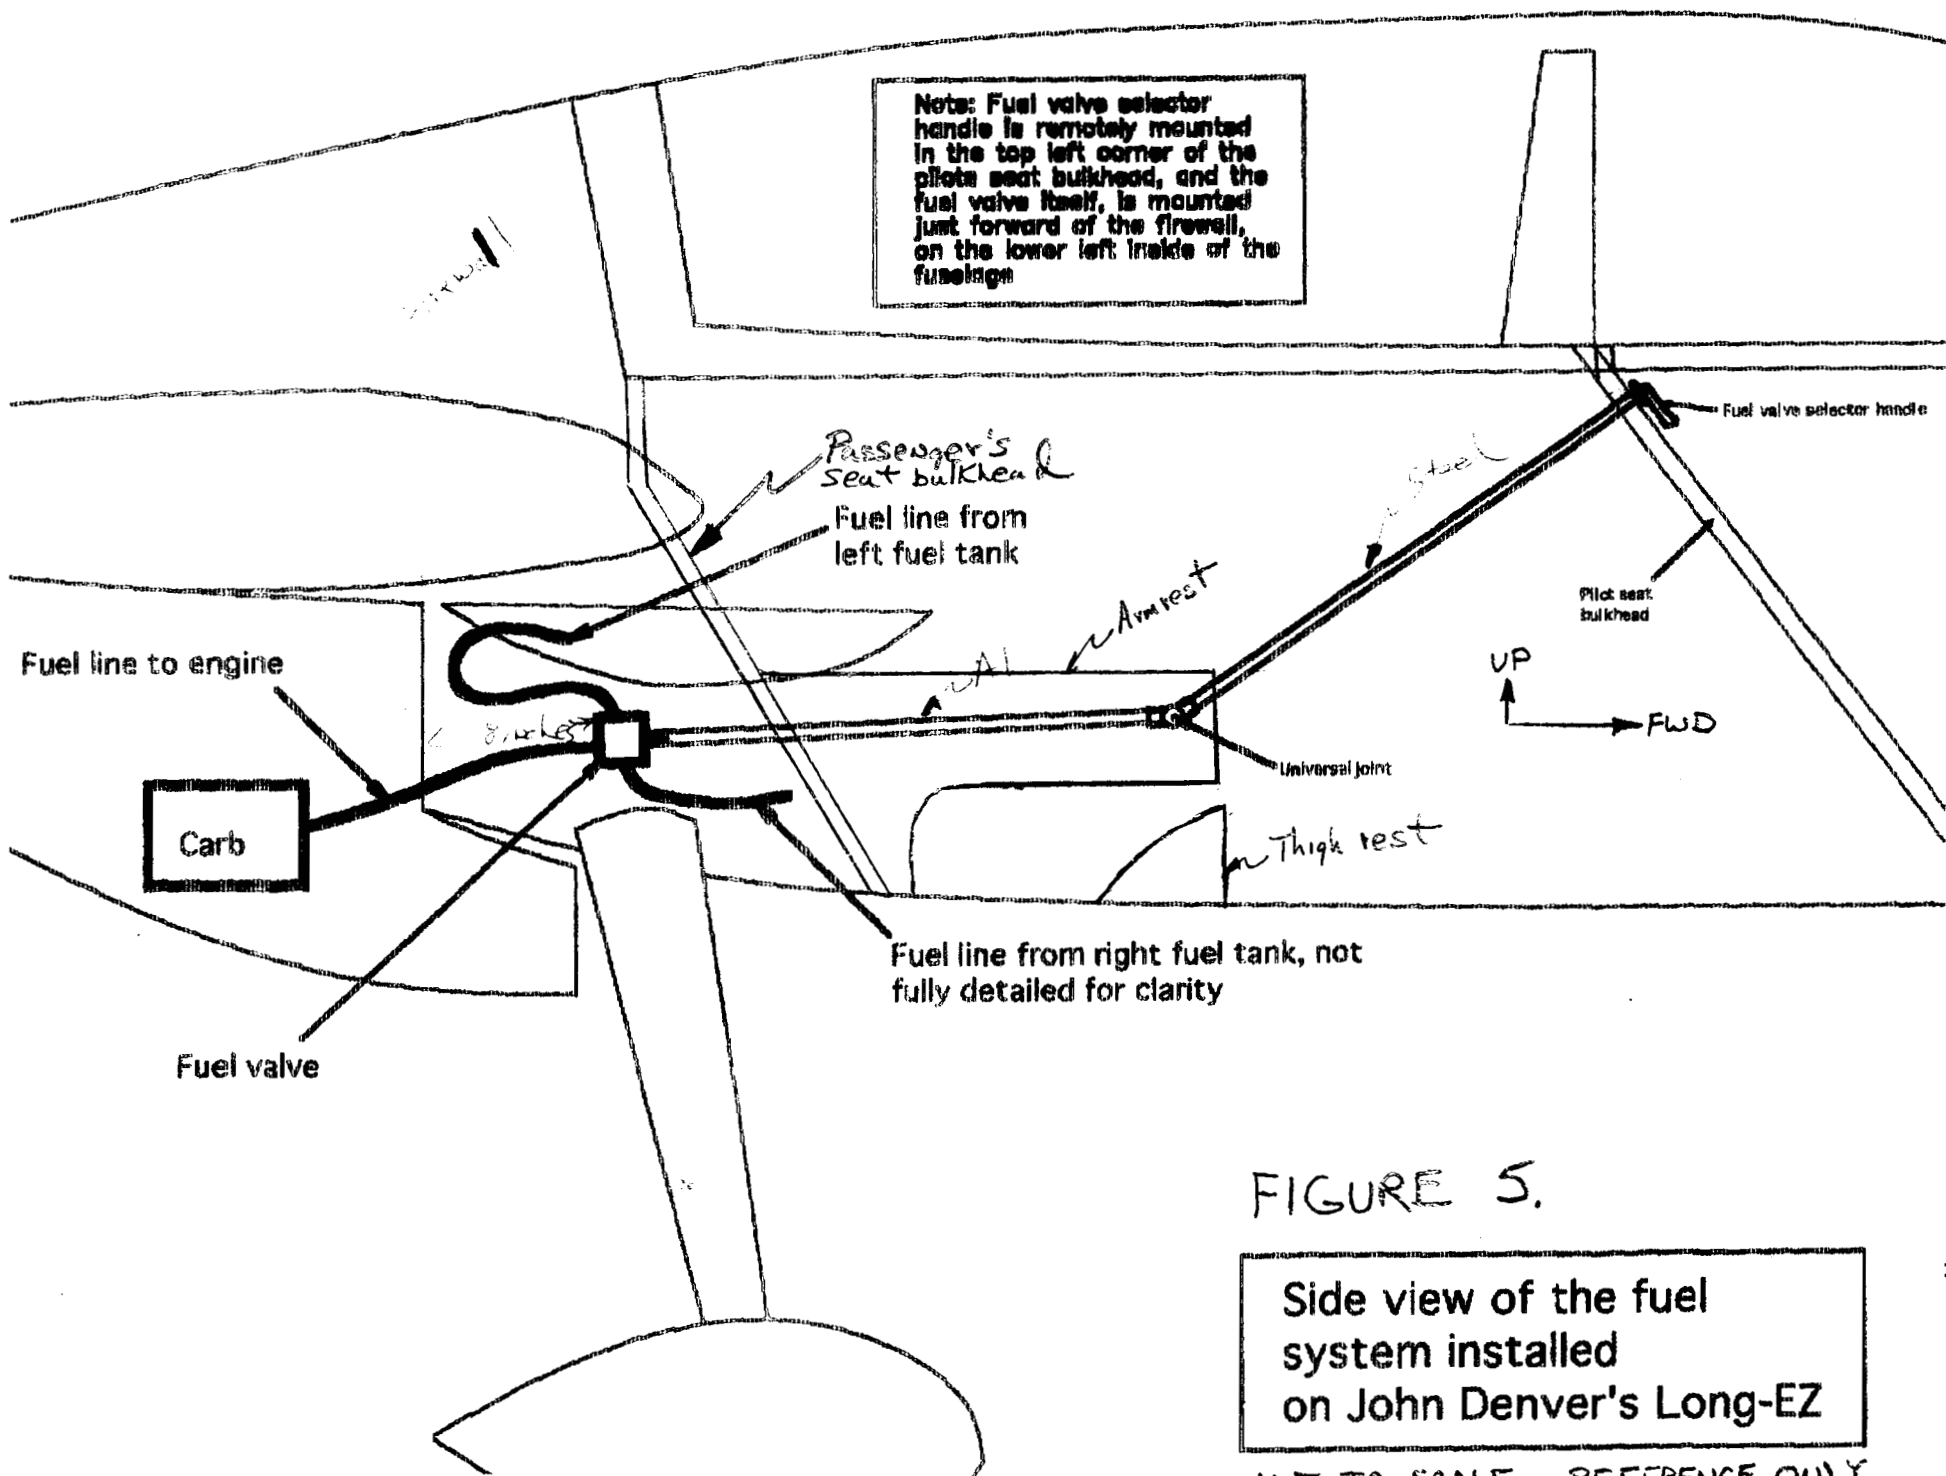
FIGURE 5.

The steel tube between the underside of the selector handle and the center of the universal joint measured 26 ½ inches and the distance along the aluminum tube between the center of the universal joint and the rivets on the valve stem was about 23 inches (taken from actual components). The steel tube was mounted perpendicular to the slanted portion of the pilot's seat back and the geometry showed that the aluminum tube would have to be oriented horizontally or nearly horizontally relative to the interior floor in the rear seat of the airplane. The position of the universal joint using these dimensions and approximate orientations was shown to be below the passenger armrest, arrowed "AR", and to the left of the passenger thigh rest arrowed "TS", in figure 4. Arrow "U" in this figure locates the approximate position of the universal joint as found by measurements. The aluminum rod was believed to be situated under the armrest and through the back slanted wall of the passenger's seat. Therefore, the aluminum rod, universal joint, and the aft few inches of the steel rod would be hidden from view under the passenger armrest. A side view cut away is presented in figure 5 to show the approximate position of the tubes relative to the armrest. This drawing was originally prepared by Mr. Melville and has some additional items added by the undersigned. As drawn, the steel rod is about the same length as the aluminum rod.

Side view of the fuel system installed on John Denver's Long-EZ

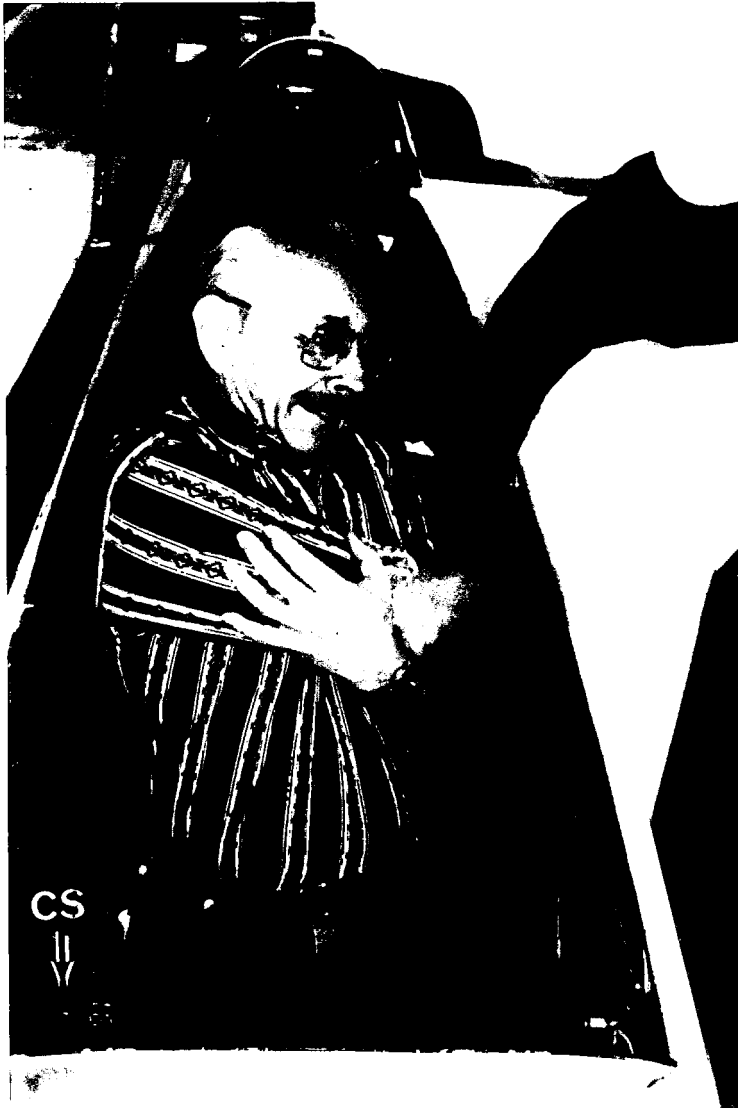
Figure 6 shows the difficulty a pilot would have in reaching the fuel tank selector handle if it were positioned as if in the accident airplane. In order to reach the valve handle the pilot would have to use his right hand as shown in figure 6. In doing so the pilot would have to take his right hand off the control stick (located by arrows "CS" in this figure) and rotate his body around to the approximate position shown.

Figure 6. Two views showing the difficulty in reaching the fuel selector valve handle if positioned as if on the accident airplane. The control stick is indicated by arrow "CS".

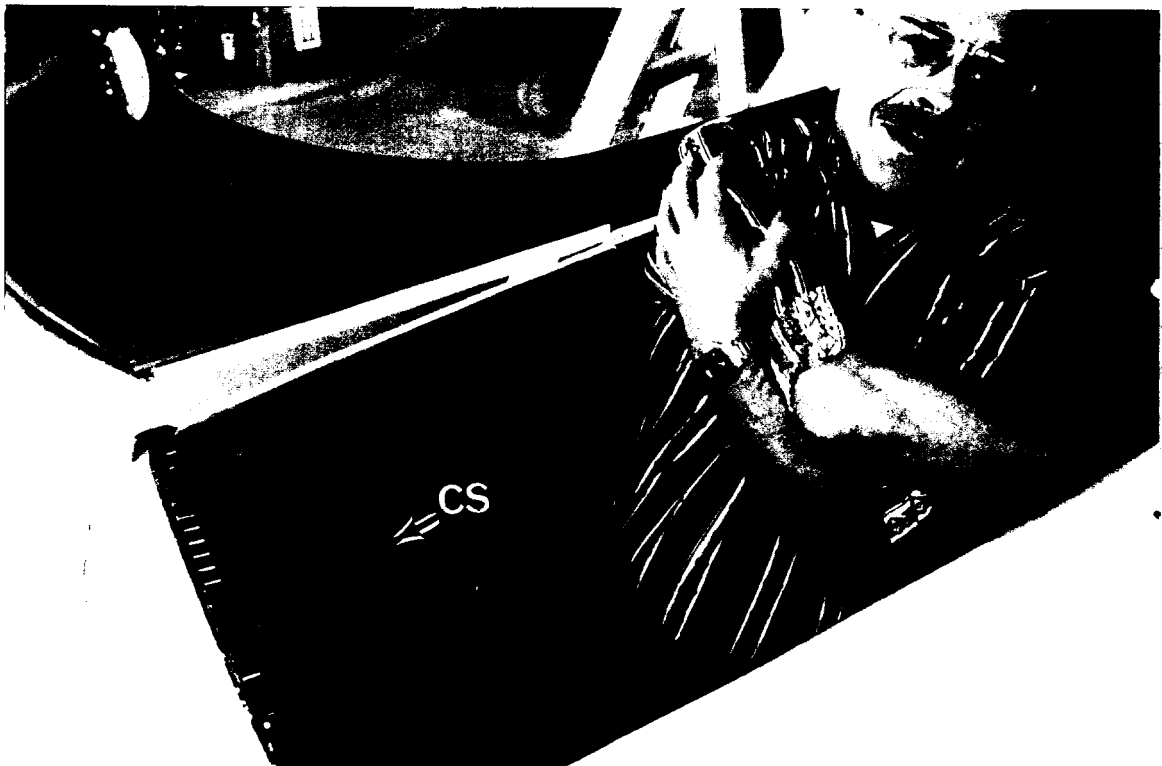
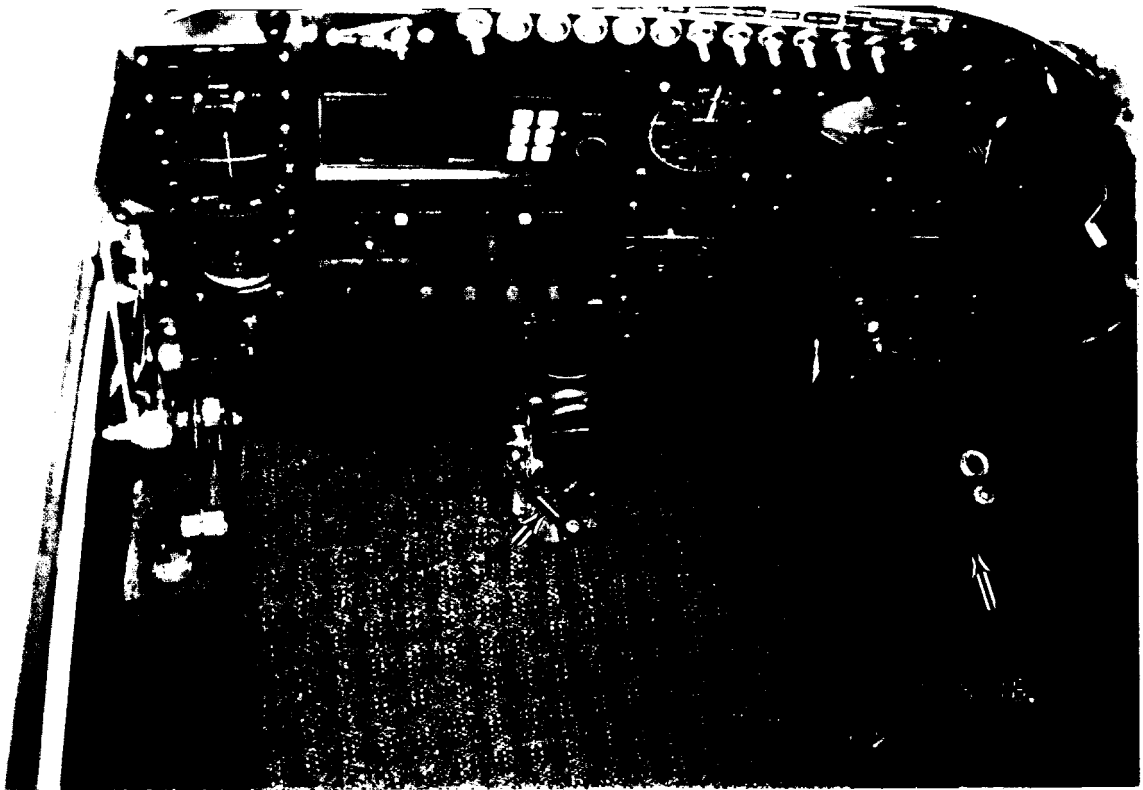
Figure 7 shows views of the normal position of the fuel tank selector handle, which is between the pilot's legs and near the control stick.

Figure 7. Views looking down and forward on the reference airplane showing the normal position of the fuel tank selector handle (arrow "H"). Arrow "CS" locates control stick.

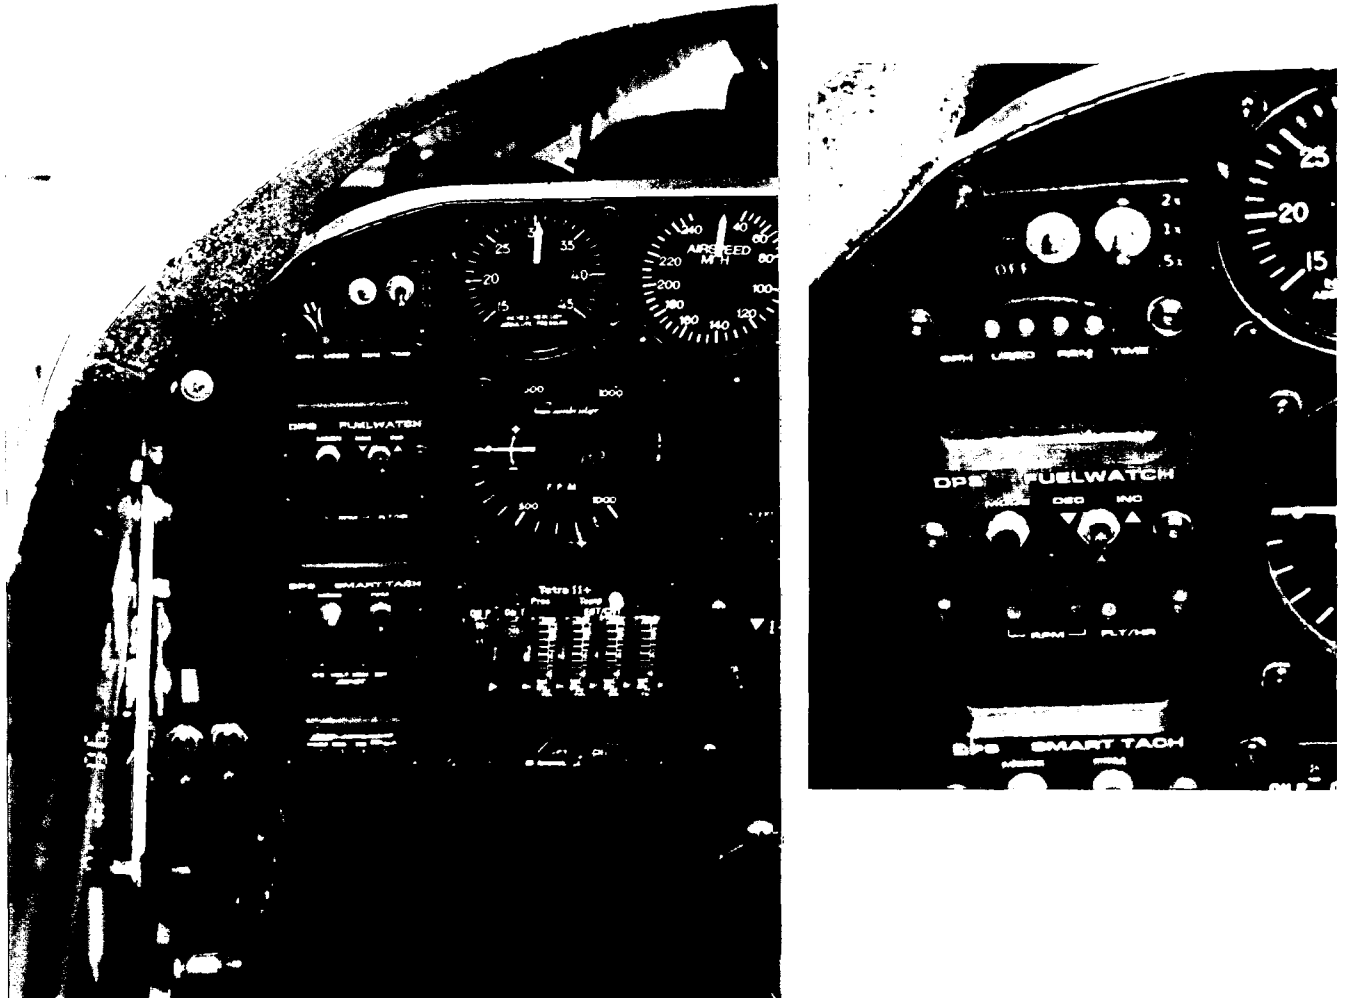
The accident airplane reportedly had a Fuel Watch system indicator as shown in figure 8 (verified by Mr. Cobb and Mr. Savier, who both flew the airplane). If the fuel was low the left indicator light shown arrowed in figure 8 should have been blinking. This light is relatively small and green in color.

Figure 8. Two view of the reference Varieze, N57LG, instrument panel showing the "FUEL WATCH" system that was similarly installed on the accident airplane. Arrow indicates small green light which should have been blinking on the accident flight. In right enlarged view on right, the mode is selected to the REM position indicating the amount of fuel remaining (9.3 gallons).
