# NATIONAL TRANSPORTATION SAFETY BOARD

**MATERIALS LABORATORY FACTUAL REPORT**

Report No. 98-078

Place : Monterey, California  
Date : October 13, 1997  
Vehicle : Experimental Long EZ  
NTSB No. : LAX98-F-A008  
Investigator : George Petterson(LAX)

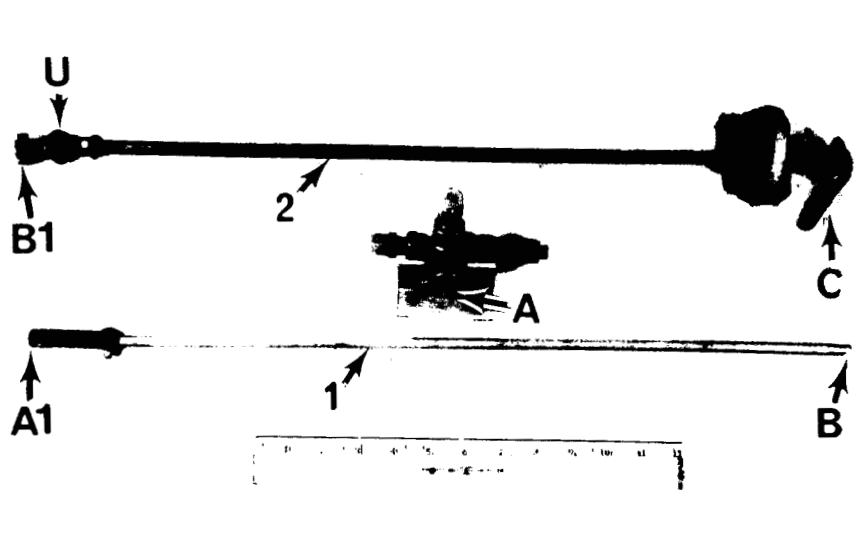
The valve (item "A", figure 1 and shown at higher magnification in figure 2) and selector handle (item "C") were originally connected by two tubes (arrowed "1" and "2") with a universal joint in the middle (arrow "U"). The tubes are fastened to the fittings with sleeves having either rivets, bolts or in the case of the handle a screw aligned transverse to the tube. One of the two separations in the assembly occurred in the valve stem (arrowed "A", figures 1 and 2) where it attaches to the sleeve (at the position arrowed "A1" in figure 1). The other separation was on tube "1" at the position arrowed "B" in figure 1 where it connects to the universal joint at the location depicted by arrow "B1". Tube 1 appeared to be made of an aluminum alloy and tube 2 appeared to be steel.

Figure 1. Overall view of the accident aircraft components as received for examination.

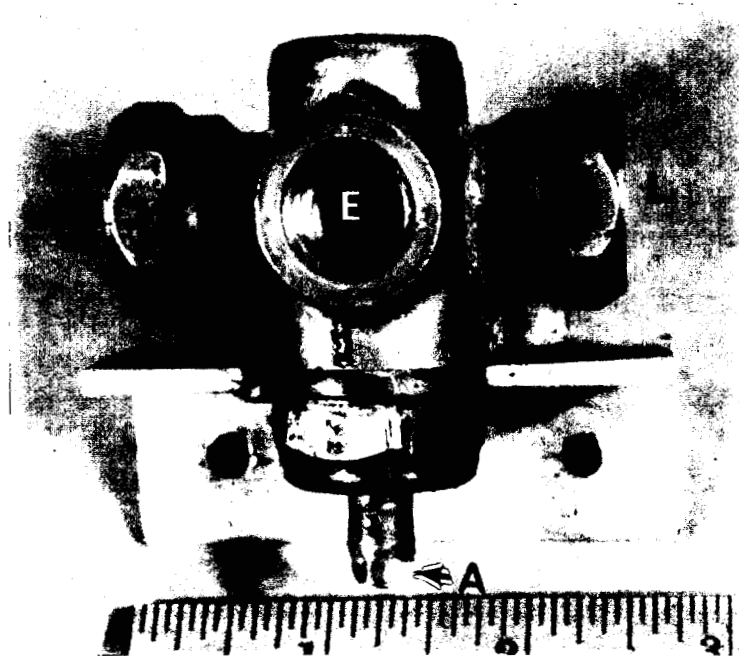
The valve contained markings indicating engine (E), left (L) and right (R) ports. The ports contained fittings when received (as shown in figure 1) but these fittings were subsequently removed (as shown in figure 2) to view the internal portion of the valve.

Figure 2. Valve shown in figure 1 after removing fittings protecting the ports. Arrow "A" denoted fracture on the valve stem. Letters "E", "R", and "L" locate the ports identified as engine, right and left, respectively. Approximately X1.

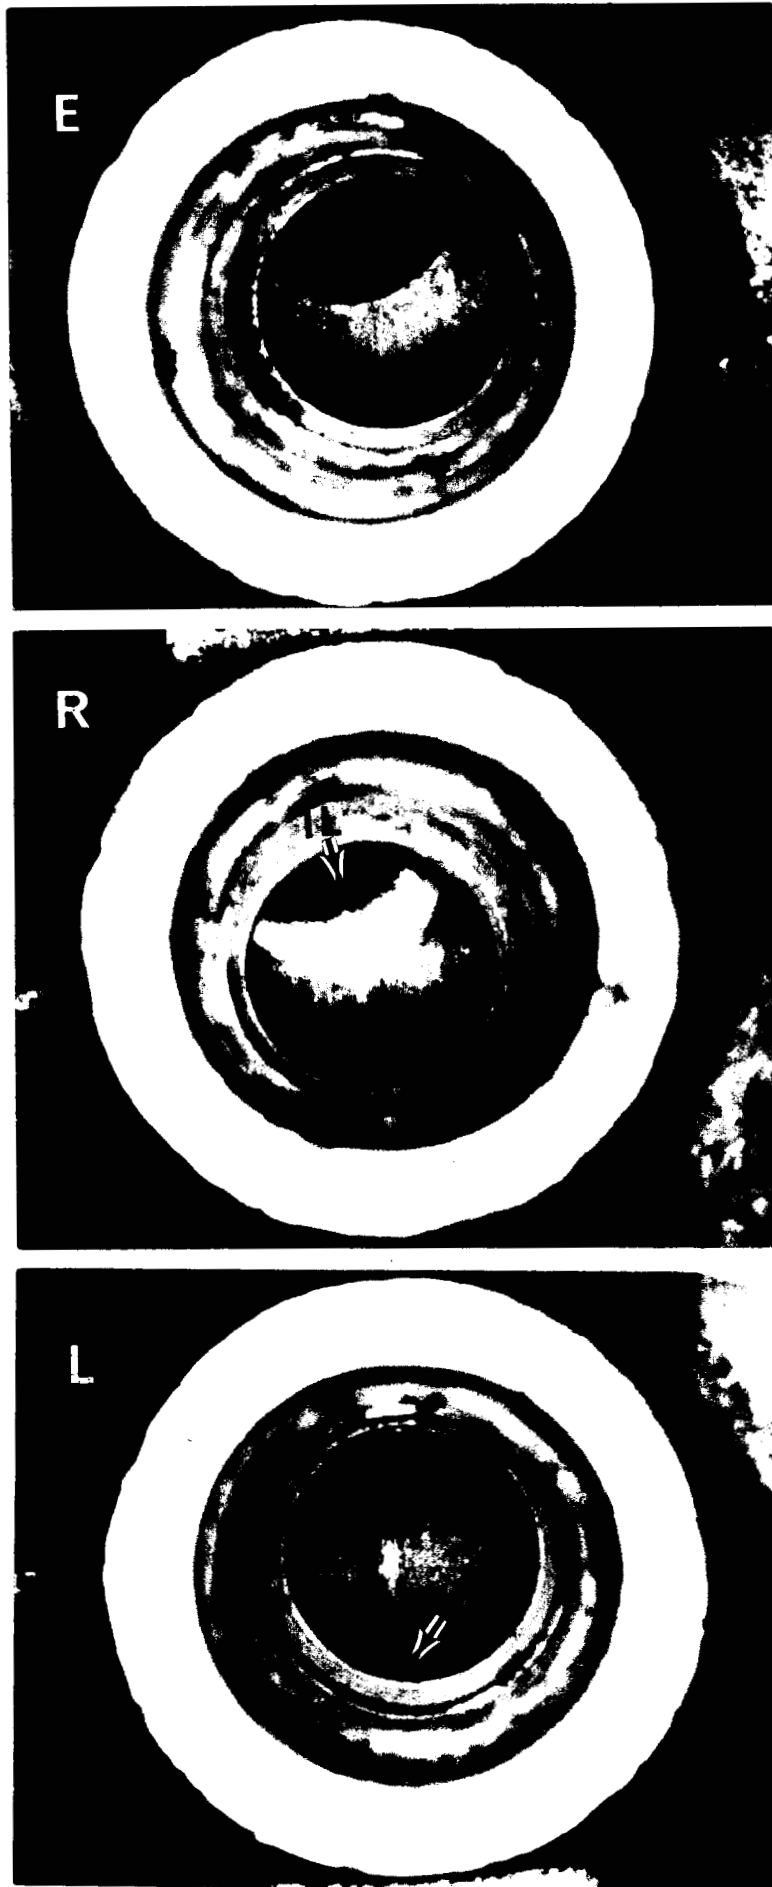
The engine port displayed two portions of circular holes as shown in the top view of figure 3. The larger circular portion (approximately 1/3 exposed) was oriented on the left port side of the valve and the very small portion of the circular opening (estimated to be less than 5% of the circular opening) was oriented on the right port side.

The right port opening (middle photograph figure 3) displayed only a single portion of a circular opening (also about 1/3 exposed) oriented toward the engine port side of the valve.

The left port (bottom photograph, figure 3) showed only a very small portion of the circular opening exposed (estimated to be 2-4%) in the area of arrow "L". This opening is detailed in a higher magnification view in figure 4. In viewing the right port opening from the outside, the inside exposed hole for the left port can be seen (arrowed "IL", figure 3). Both openings "L" and "IL" are the same only viewed from opposite directions.

Figure 3. Views looking from the outside into the valve ports (see figure 2 for orientation). Valve stem location in all views is to the right and all photographs are approximately X 3.75

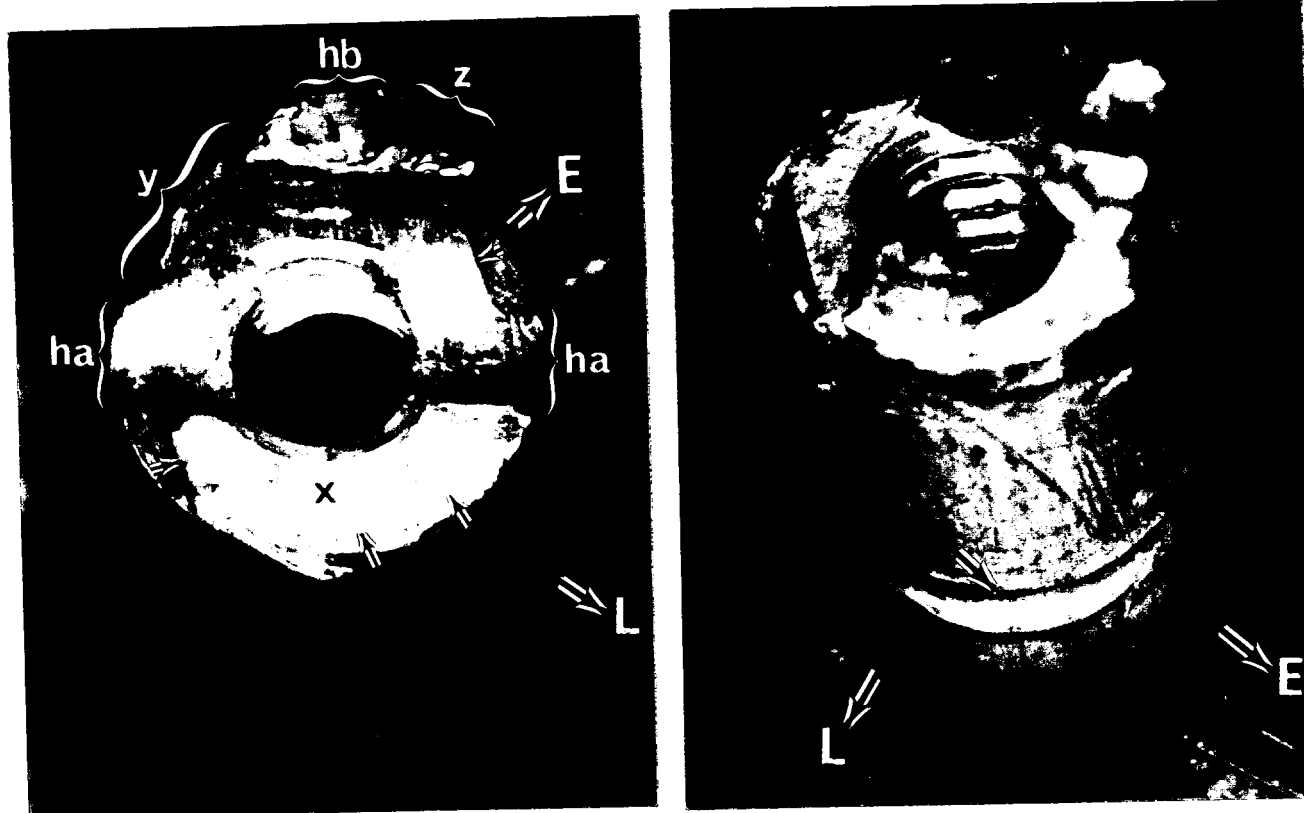
Details of the valve stem separation on the valve side are shown in the two views of figure 6. The mating separation of the stem was located within the sleeve as shown in figure 7. For reference purposes the rivets securing the sleeve to the valve stem were arbitrarily identified as "a" (closest to the valve) and "b" (furthest from the valve). In figure 6 the remnants of the hole for the "a" rivet are indicated by brackets "ha". Unmarked arrows in this figure locate the machined flat areas previously mentioned for the exemplar valve stem. Rivet hole remnant for the "b" rivet is located by bracket "hb" in figure 6. A deformation mark (arrowed "D", figure 6) was found over about 1/2 of the circumference of

the circular valve stem shaft. This deformation was located approximately  $\frac{1}{4}$  inch from the base of rivet hole remnant "ha".

Magnified examination of the valve stem separations showed what appeared to be a relatively undamaged fracture on one side of the stem extending between opposing sides of rivet hole "ha". This fracture corresponded (mated) to a relatively undamaged fracture retained within the sleeve. The mating areas of this fracture are indicated by "x" in figures 6 and 7. On the other side of the stem the separation surface was heavily smeared and oriented in general on an angled plane between rivet holes "ha" and "hb" (indicated by bracket "y" figure 6 and arrow "y" figure 7). A small portion of the separation (bracket and arrow "z") was noted on the other side of the rivet "b" location.

Figure 6. Two views of the valve stem separation on the valve side. Both photographs approximately X7.5

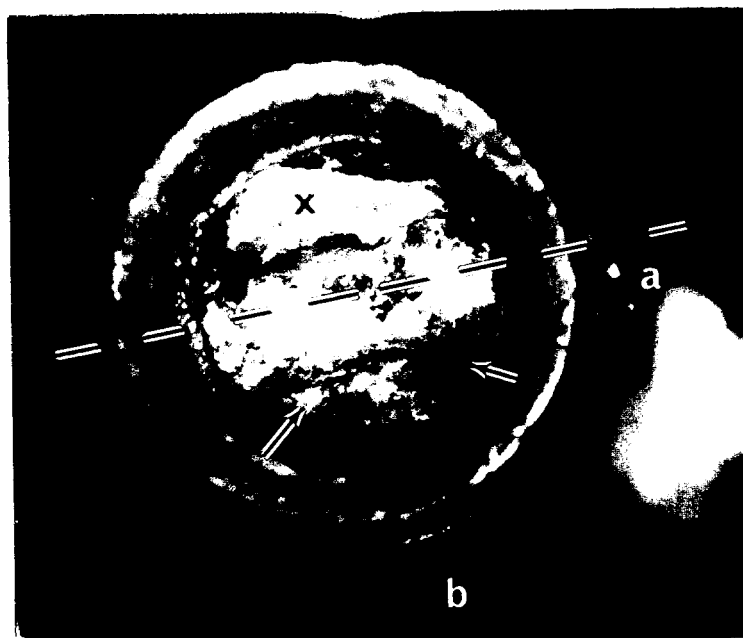
In order to view the valve stem interior separations within the sleeve an attempt was made to remove rivet "b". Both the head and tail of the "b" rivet were removed by drilling and a punch was used to try to excise the rivet. This attempt did not remove the rivet and it was thought that other means would be better to get at the internal portions with minimal damage. The sleeve containing the valve stem remnant was then sectioned longitudinally in half with a slow speed diamond saw along the approximate plane indicated by the dashed line in figure 7. This plane was approximately through the longitudinal center of rivet "a".

Figure 7. View looking into the sleeve (at area arrowed "A1", figure 1) showing the separation of the valve stem still retained in the sleeve. X 3.75

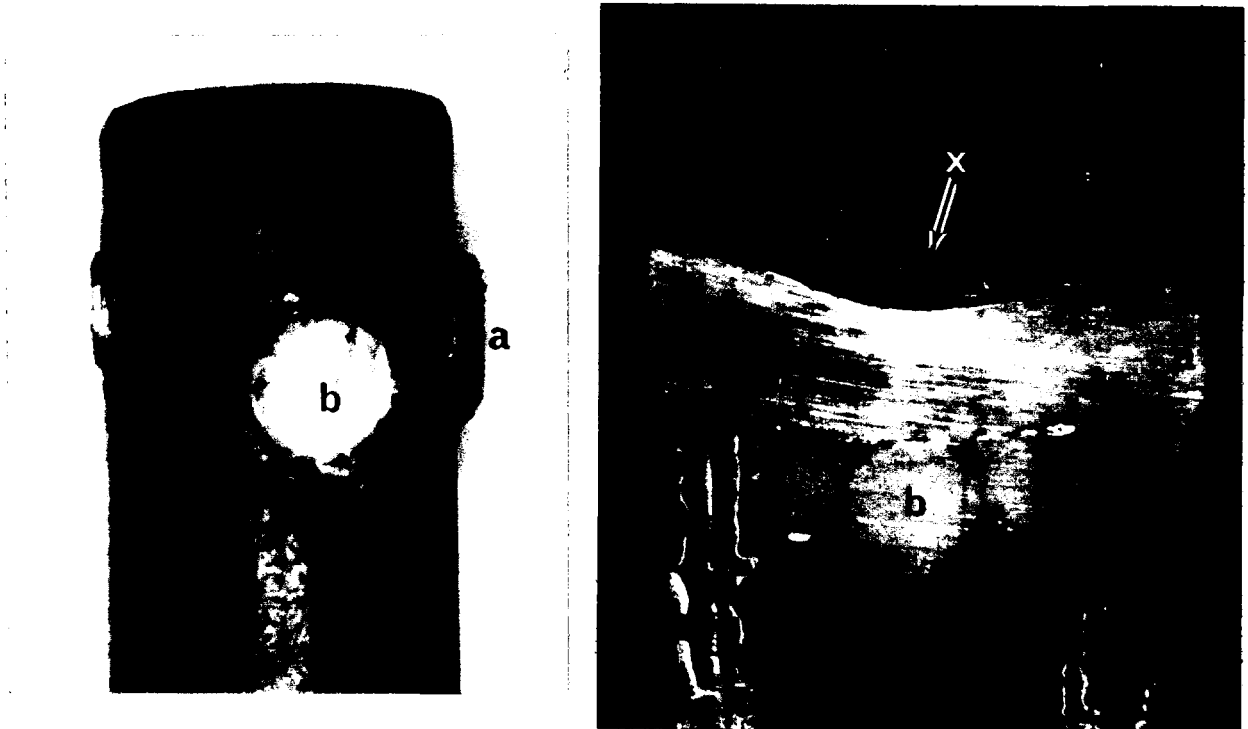
Figures 8 and 9 show both sides of the sectioned sleeve compared to the original side views of the sleeve in the same orientation (before attempting to remove rivet "b"). The section exposed showed that rivets "a" and "b" were notably bent along their longitudinal axis and were actually in contact with each other where they crossed. Figure 10 displays the section after rivet "a" was removed allowing for better viewing of the fracture and rivet hole. Remnants indicated by arrows "x", "y" and "z" in figures 9 and 10 contained the fractures similarly indicated in figure 7. The small piece arrowed "z" in figure 10 is shown at higher magnification on the right. Brackets "f" and "h" denote the fracture and hole wall surfaces, respectively. It was clear that the saw cut did not go through any fracture or separation in the valve stem.

Figure 8. Section above dashed line in figure 7 compared to a side view of the sleeve as received in the same orientation. Left photo X 3.75 right photo approximately X5

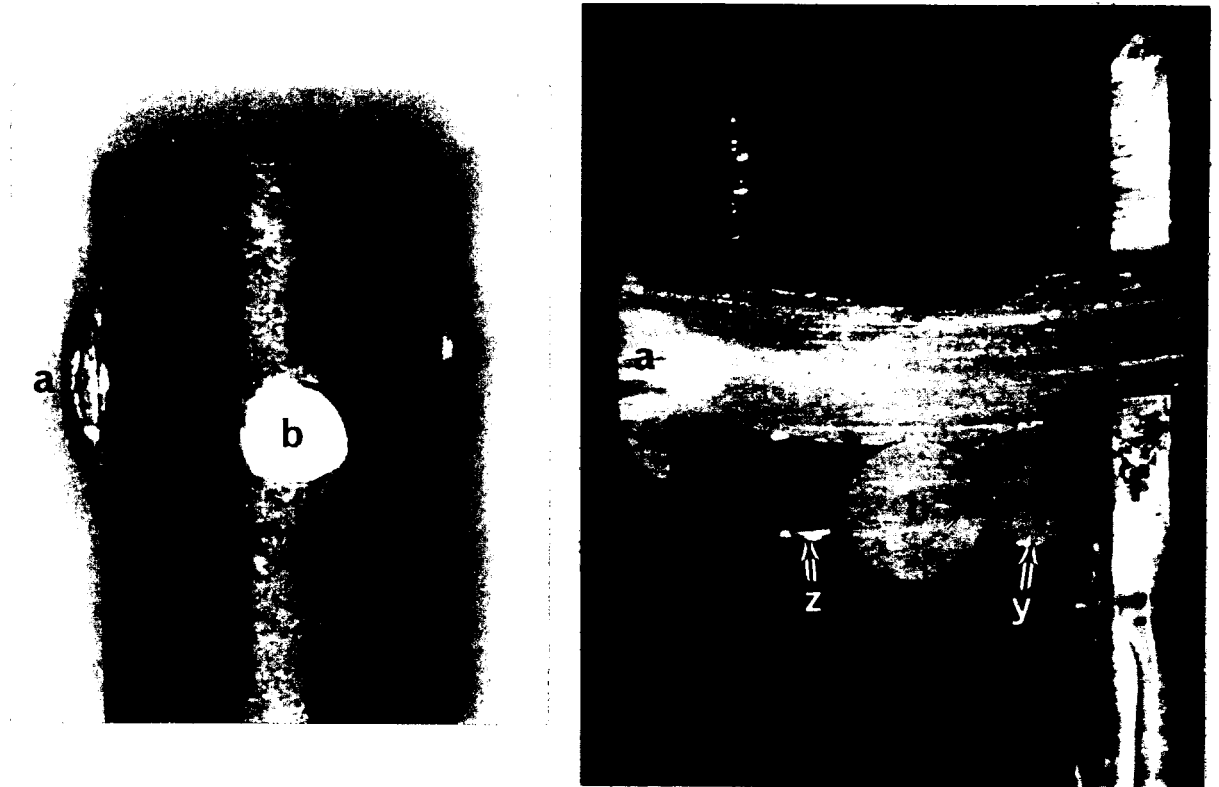
Figure 9. Section below dashed line in figure 7 compared to a side view of the sleeve as received in the same orientation. Left photo X 3.75 right photo approximately X5

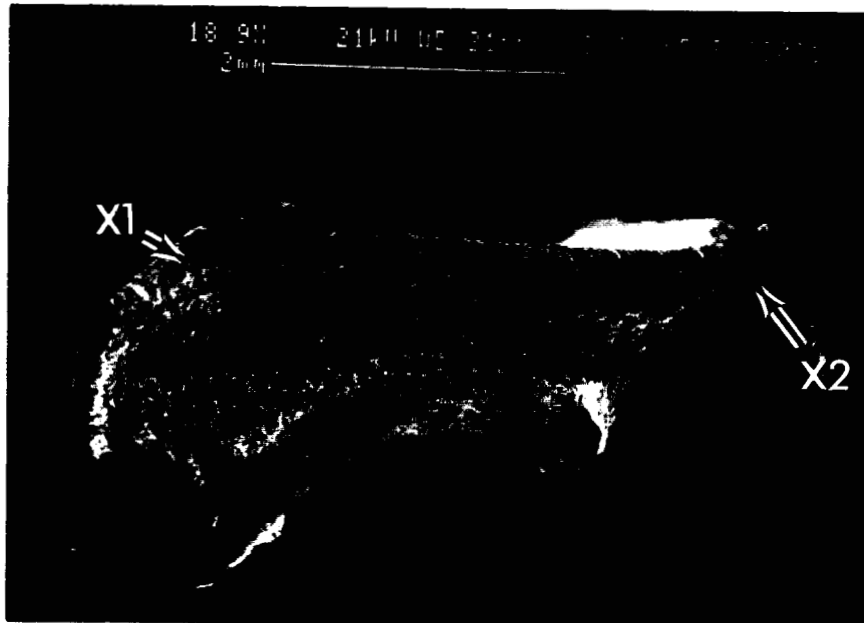
The valve stem remnants arrowed "x", "y" and "z" in figure 10 were carefully removed with tweezers from the sectioned pieces, ultrasonic cleaned in acetone and examined with the aid of a scanning electron microscope (SEM). Figure 11 shows a low magnification SEM view of fracture "x". Most of the fracture contained ductile dimples typical of a ductile overstress separation. Energy dispersive x-ray analysis (EDXA) of this fractured area indicated the material was a copper (54%) zinc (36%) alloy containing small amounts of lead (5%), iron (2%) and oxygen (3%). The % indicated is by weight and suggests this alloy is a leaded brass.

Figure 11. SEM view of the fracture identified by arrow "x" in figure 10 after removal from the section. (X18.9)

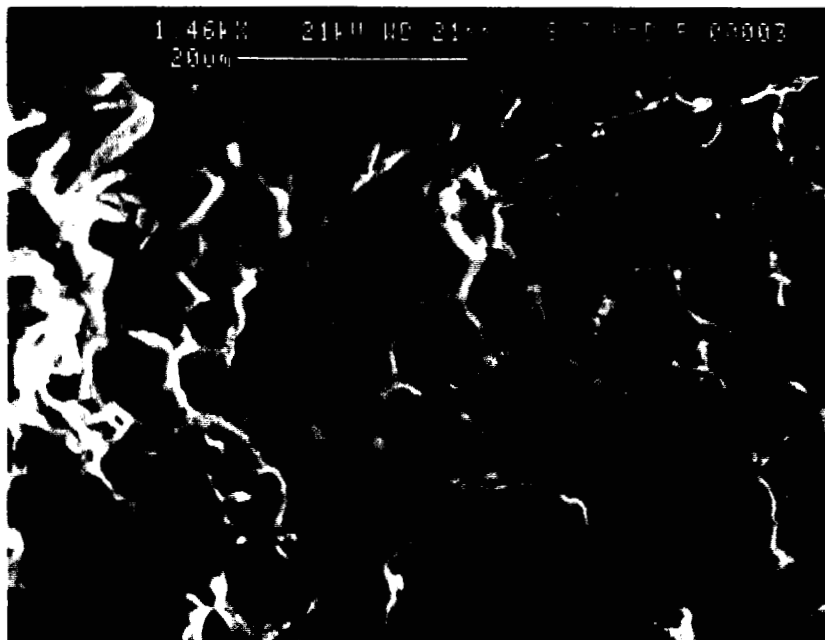
Figure 12. High magnification view of the fracture shown above in the central area just off the thread root. (X 1,460)
