# NATIONAL TRANSPORTATION SAFETY BOARD

MATERIALS LABORATORY FACTUAL REPORT

Report No. 13-008

Place : Gulf of Mexico  
Date : April 17, 2012  
Vehicle : Sikorsky S-76B, N56RD  
NTSB No. : CEN12FA250  
Investigator : James Silliman, AS-CEN(CHI)

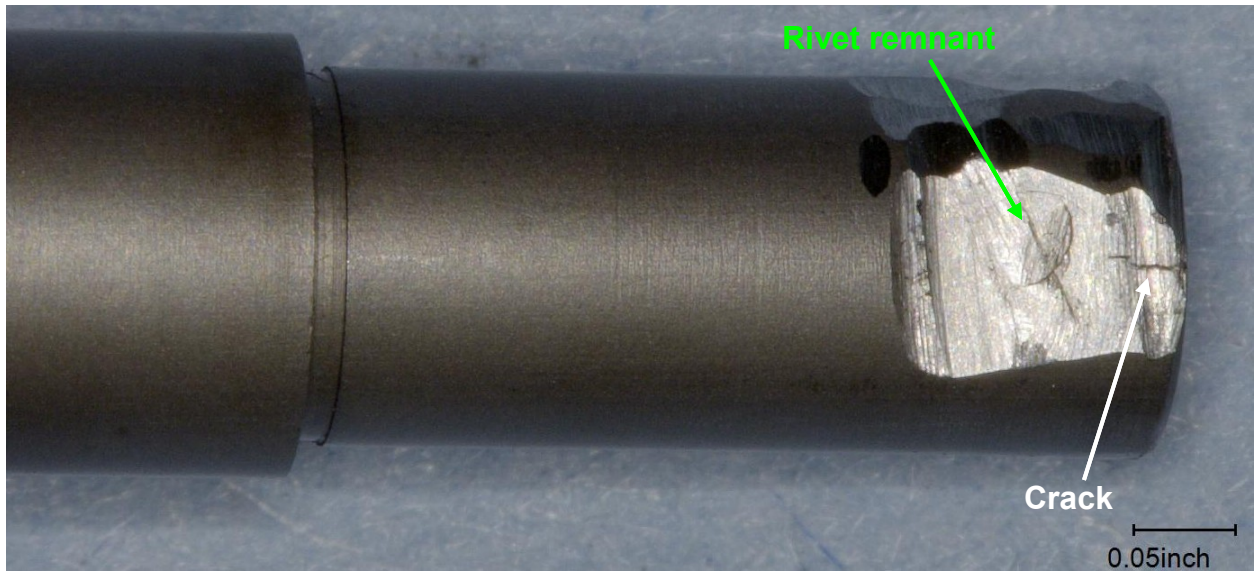
Figures 4, 5, and 6 highlight the end of the gearshaft. Portions of material from the end had been damaged when removing the lever during disassembly of the stepper motor at Kearfott. The remnant of the rivet is shown in Figure 5. The output gearshaft exhibited a slight bend (runout) 90° from the rivet that was measured as a 0.0048" deflection at Kearfott (see Figure 4). Of note was the cracking apparent on the gearshaft end, shown in Figure 6. The main portions of the crack penetrated along the gearshaft long direction into the cylindrical cavity occupied by the rivet remnant.

Figure 5 – The output gearshaft, rotated 90° from Figure 4, showing one of the cracks and the rivet remnant in the gearshaft cavity.

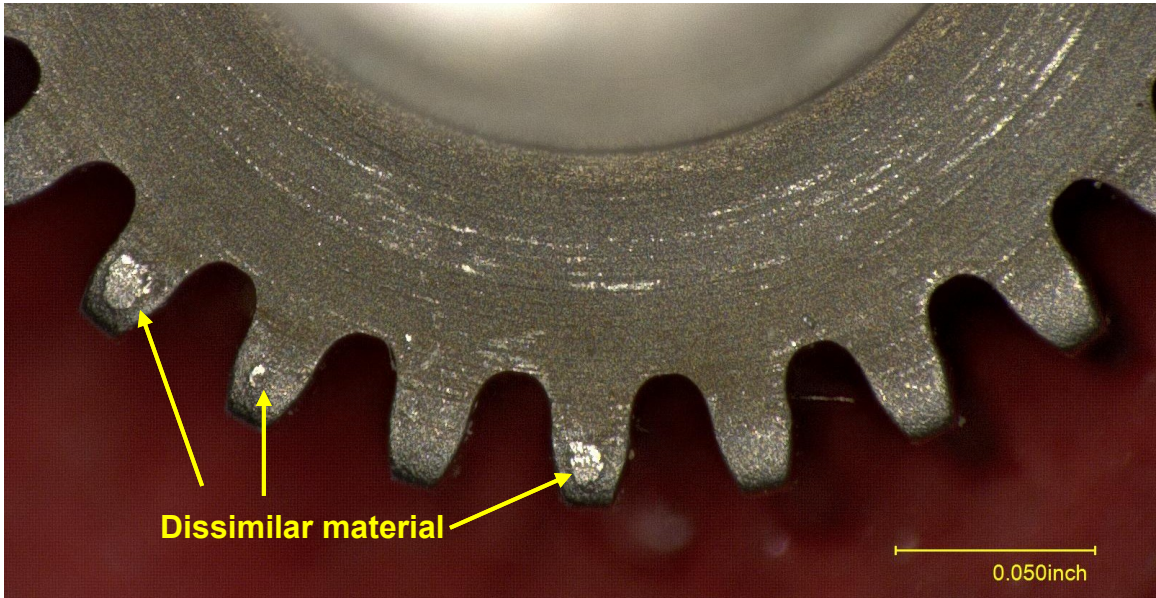
The gear teeth of the output gearshaft were examined to determine if there was any mechanical damage. Several of the faces of the gear teeth exhibited raised masses consistent with foreign material (see Figure 7). The crests and valleys of the gear teeth did not exhibit any indications of mechanical damage, and the case hardened surface layer did not appear compromised (see Figure 8). No extraneous material was found between the gear teeth.

Figure 7 – The gear teeth of the output gearshaft, as viewed from above. Some areas of foreign material were found on the teeth faces.

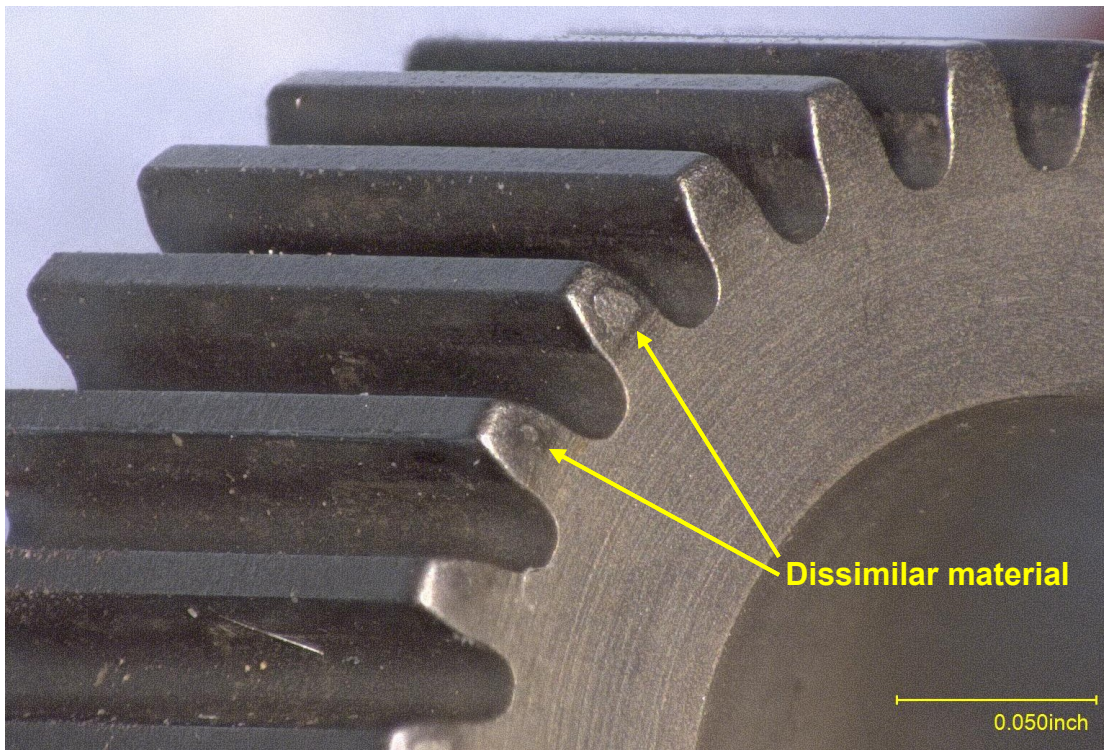
Figure 8 – The output gearshaft gear teeth, from a 45° angle.

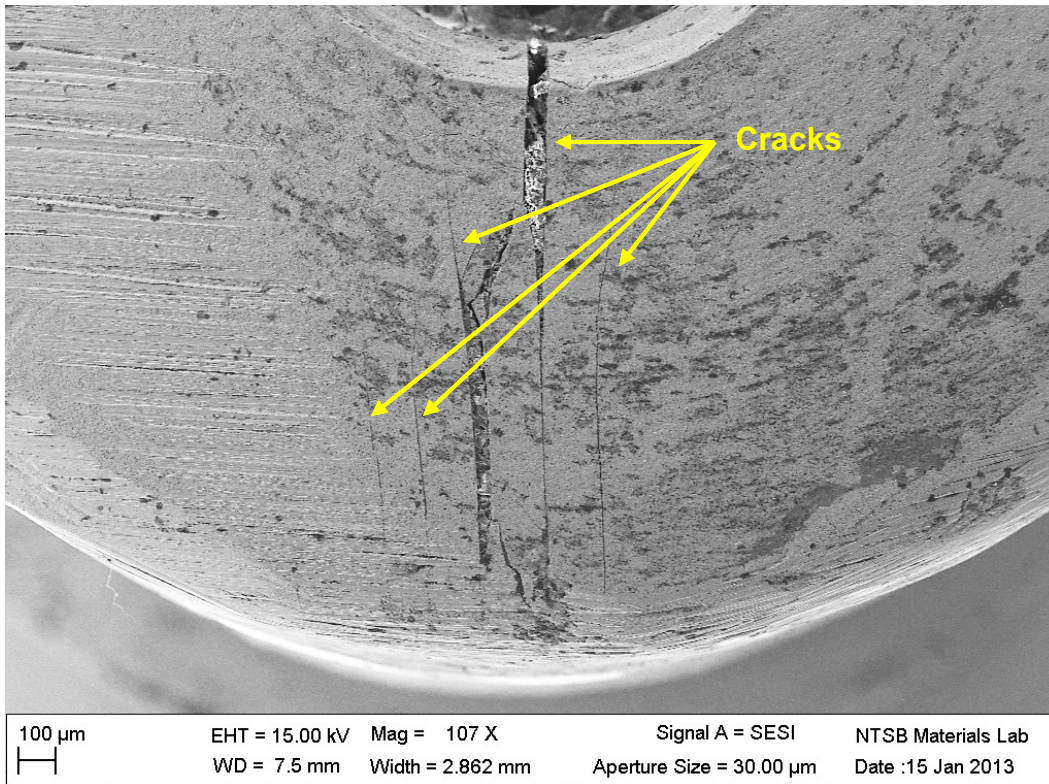
The output gearshaft was examined in a scanning electron microscope. Figure 9 illustrates the face of the gearshaft, showing at least five cracks nearly parallel to each other. The character of these cracks was not consistent with progressive cracking, which typically exhibits branched rather than parallel cracks. In addition, organic material was embedded inside the cracks on the gearshaft face.

Figure 9 – Secondary electron (SE) micrograph of cracks on the face of the output gearshaft.

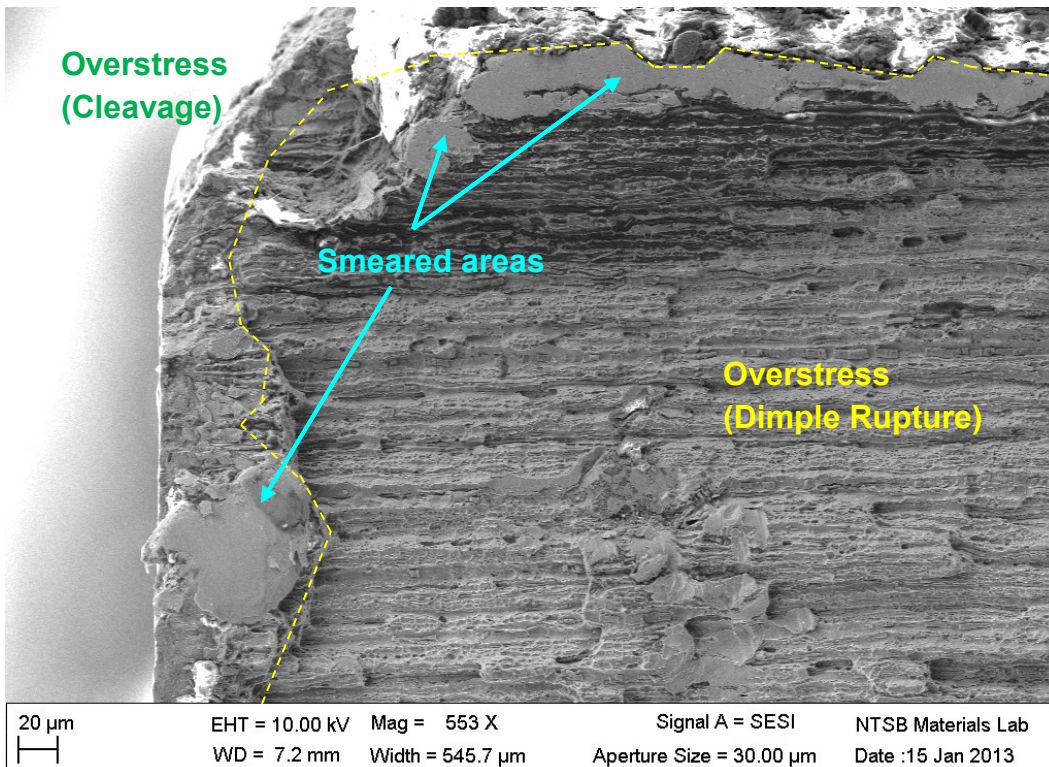
A portion of the output gearshaft above the rivet was backcut in order to reveal the crack faces. Part of the fracture surface is illustrated in Figure 10. Approximately 90% of the fracture surface exhibited dimple rupture fracture features, indicative of tensile overstress in ductile materials (see Figure 11). The pattern of the fracture features was elongated towards the long direction of the output gearshaft, consistent with the grain direction of the part. The fracture surface area closest to the gearshaft exterior exhibited a faceted morphology indicative of cleavage fracture (see Figure 12). This morphology is consistent with fracture in case hardened steel, where the hardness is enhanced but ductility is reduced.

Figure 10 – SE micrograph of the output gearshaft fracture surface after opening. The case hardened layer could be distinguished from the rest of the gearshaft fracture.

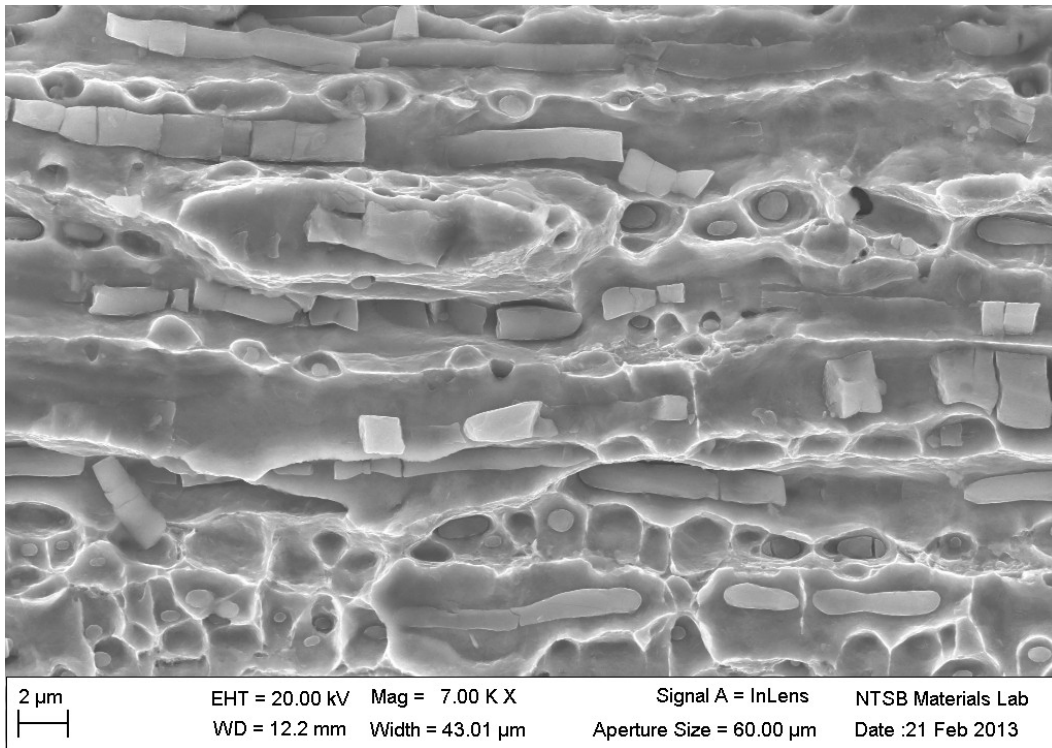
Figure 11 – SE micrograph showing dimple rupture, indicative of overstress, on the output gearshaft fracture surface.

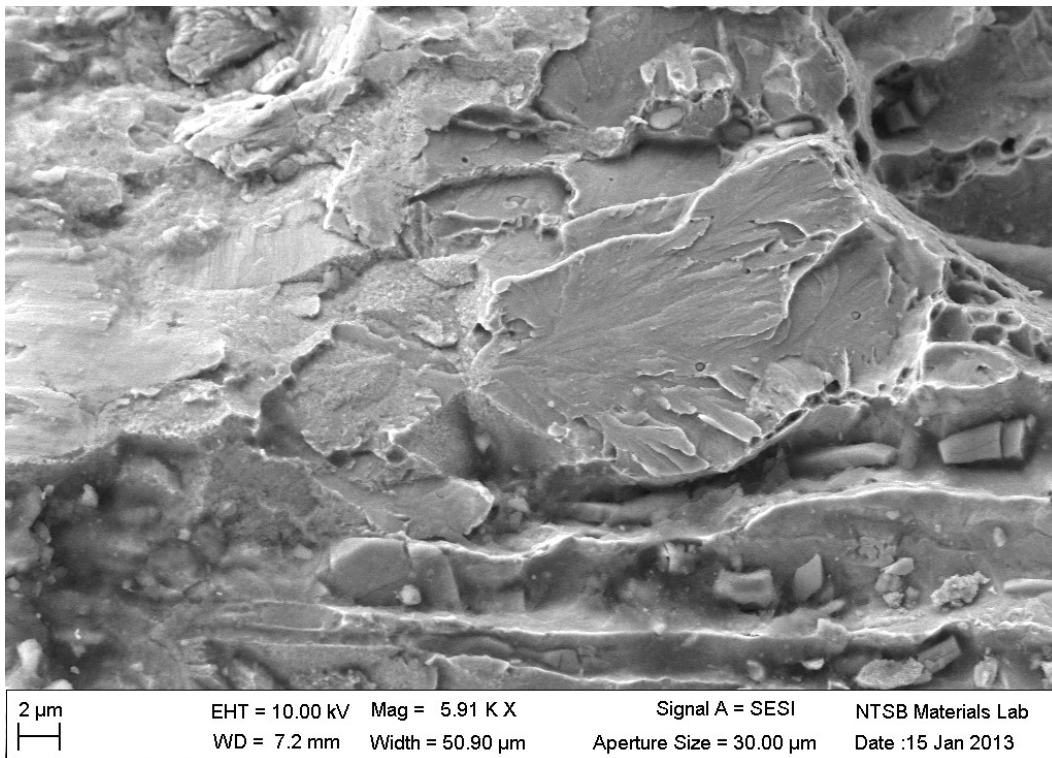
The core hardness and nitride case depth were inspected per ASTM E384. The average core hardness is 32 HRC (322 HK<sub>500</sub>), which is within the prescribed drawing requirement. The average nitride case depth is 0.016 in, which is within with the drawing requirements and consistent with the depth of the cleavage portion of the examined fracture surface.

Figure 12 – SE micrograph of cleavage facets on the nitrided area of the output gearshaft fracture surface.

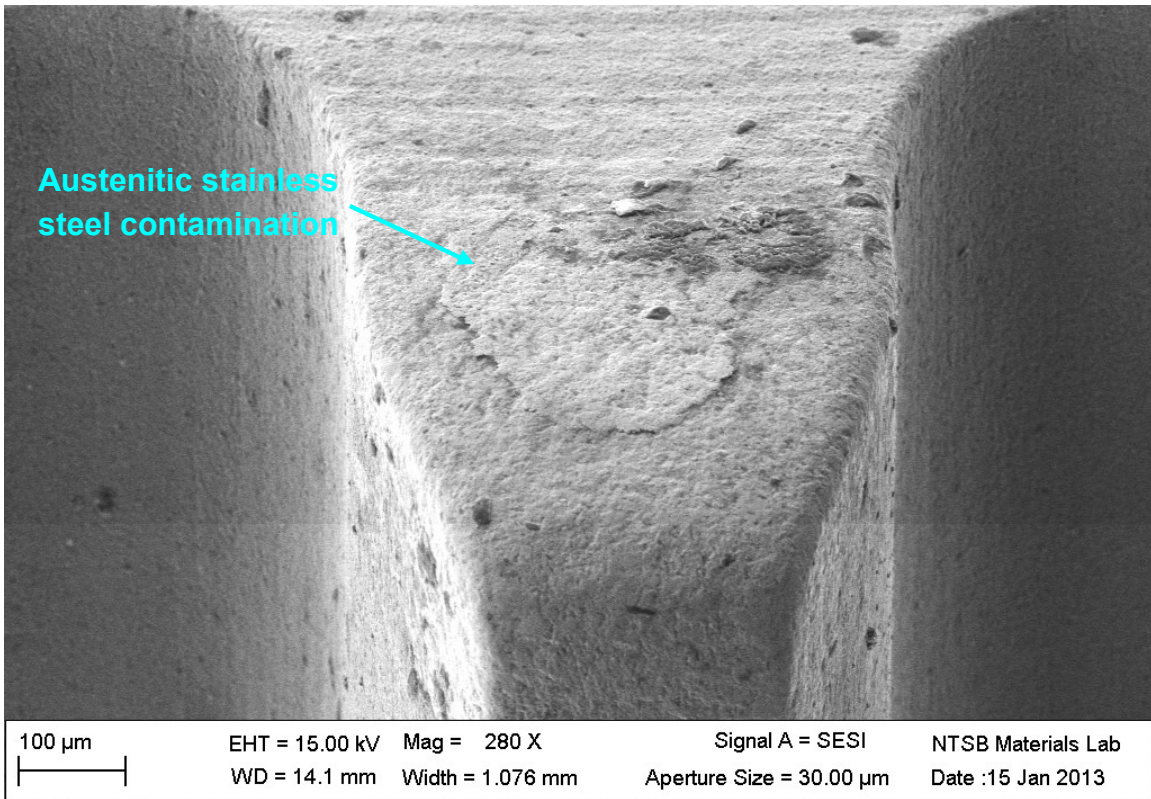
Some non-conductive material was observed on the fracture surface of the gearshaft by EDS analysis. This material was predominately carbon and oxygen, with significant quantities of nitrogen, silicon, sulfur, and calcium. These elements are commonly found in epoxy-based materials. The bond material used in the riveting process is Hysol® EA-901 (Henkel Corporation, Westlake, OH), an epoxy bonding compound.

Figure 13 – SE micrograph of the dissimilar material on a gear tooth face.

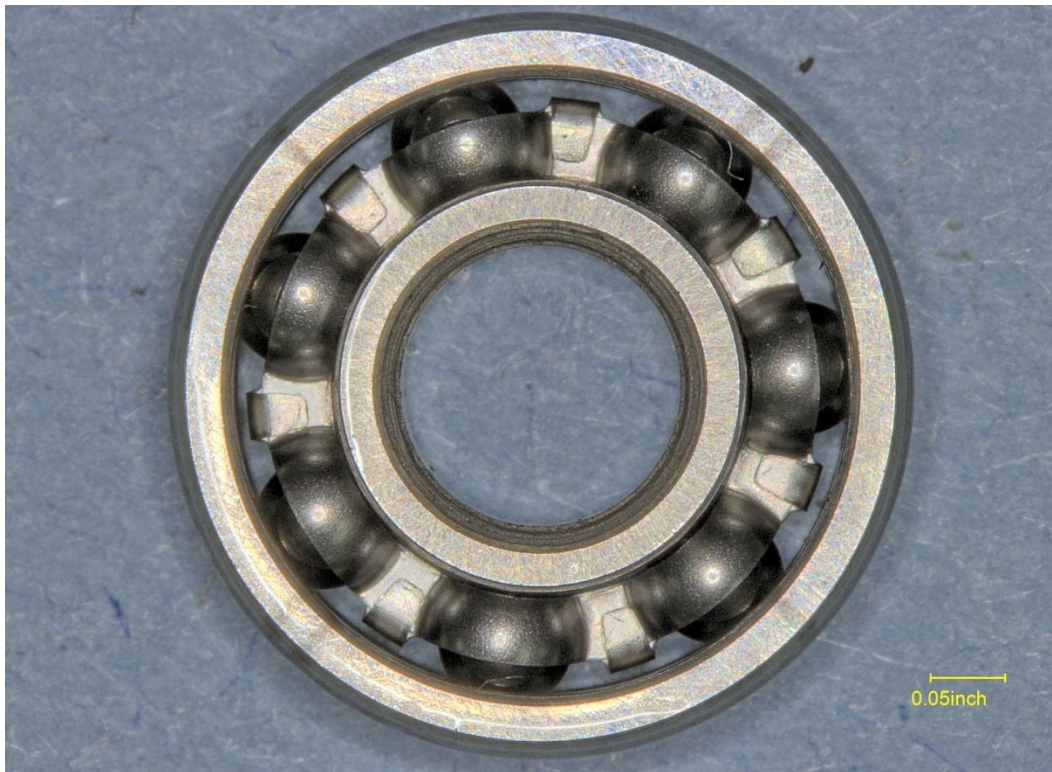
The output front bearing the surrounds the output gearshaft is shown in Figure 14 as received. The bearing was able to freely spin about the inner race when force was placed on the outer race. No indications of external corrosion or mechanical damage were observed.

Figure 14 – The output gearshaft bearing, as received.

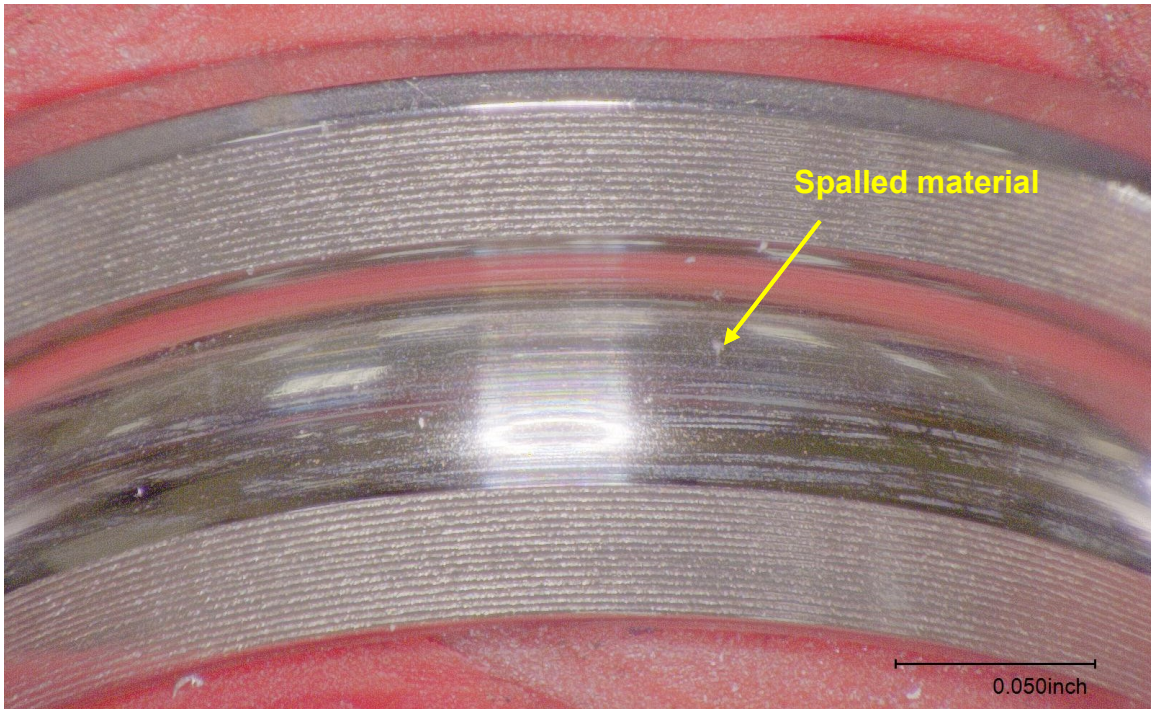
The outer race exhibited some isolated areas of material spalling, as shown in Figure 15. These areas were less than 0.01 in and did not appear to have a depth that would interfere with immediate bearing operation. There were several shallow circular impressions on one side of the contact surface of the outer race consistent with brinelling of the bearing balls. This pattern in the outer race typically occurs with axial loading on the bearing.

Figure 15 – The race of the outer bearing ring from the output gearshaft gearing, after disassembly. Isolated areas of material spalling were identified.

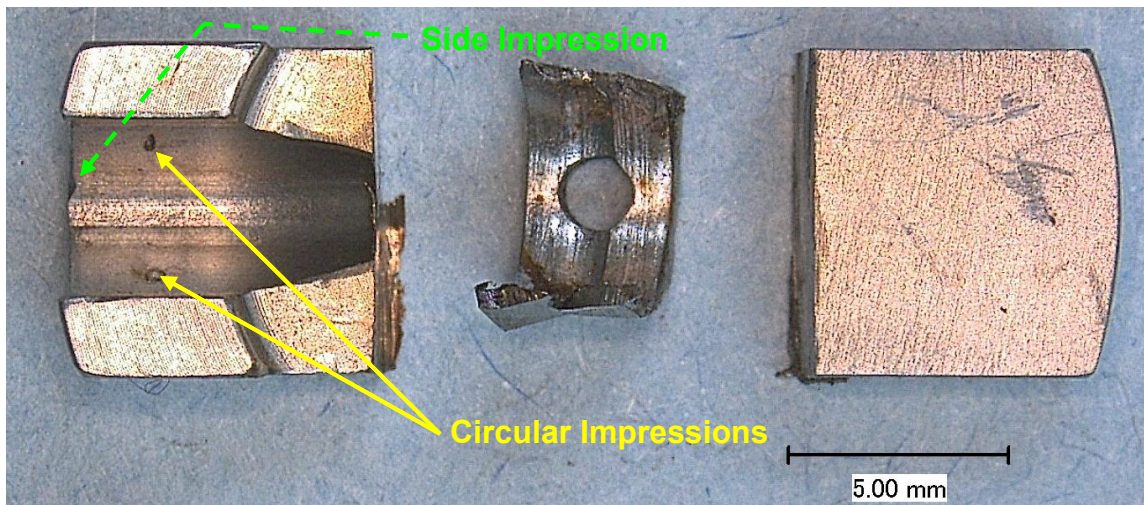
The remnants of the output lever are illustrated in Figures 16 and 17. The lever had been sectioned at Kearfott in order to remove it from the output gearshaft. Of most concern were the circular impressions on the inner bore surface of the lever, labeled in Figure 16. These were consistent with the adjacent component in contact with the lever. Another small deformation mark was found on the edge of the lever toward the bore surface.

Figure 16 – Remnants of the lever arm, as positioned facing outside the stepper motor.

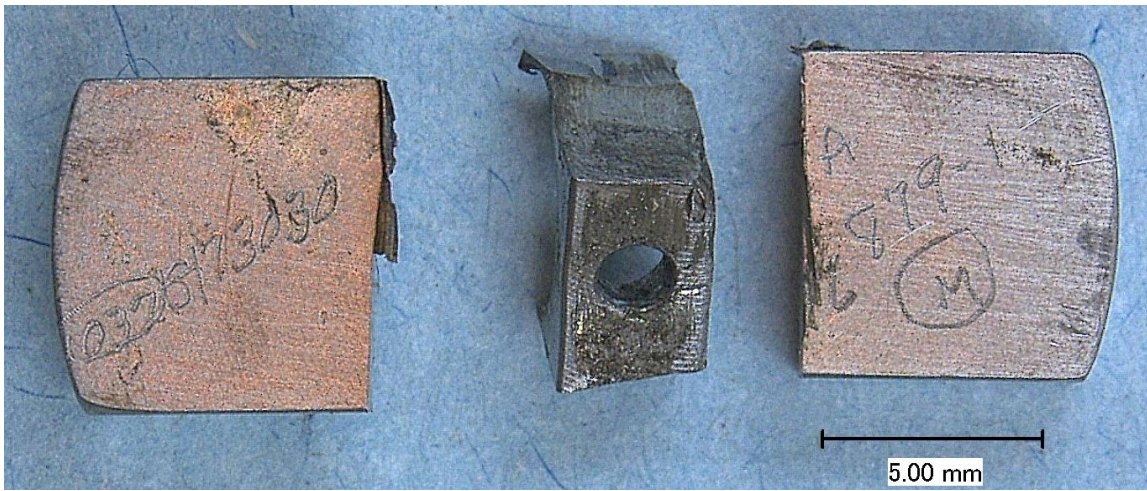
Figure 17 – The lever arm, reverse side of Figure 16 (faces towards motor housing).
