NATIONAL TRANSPORTATION SAFETY BOARD

MATERIALS LABORATORY FACTUAL REPORT

Report No. 13-024

Place : Effingham, SC
Date : September 25, 2012
Vehicle : Beech V35B, N11JK
NTSB No. : ERA12LA500
Investigator : Dennis Diaz, AS-ERA(ASH)

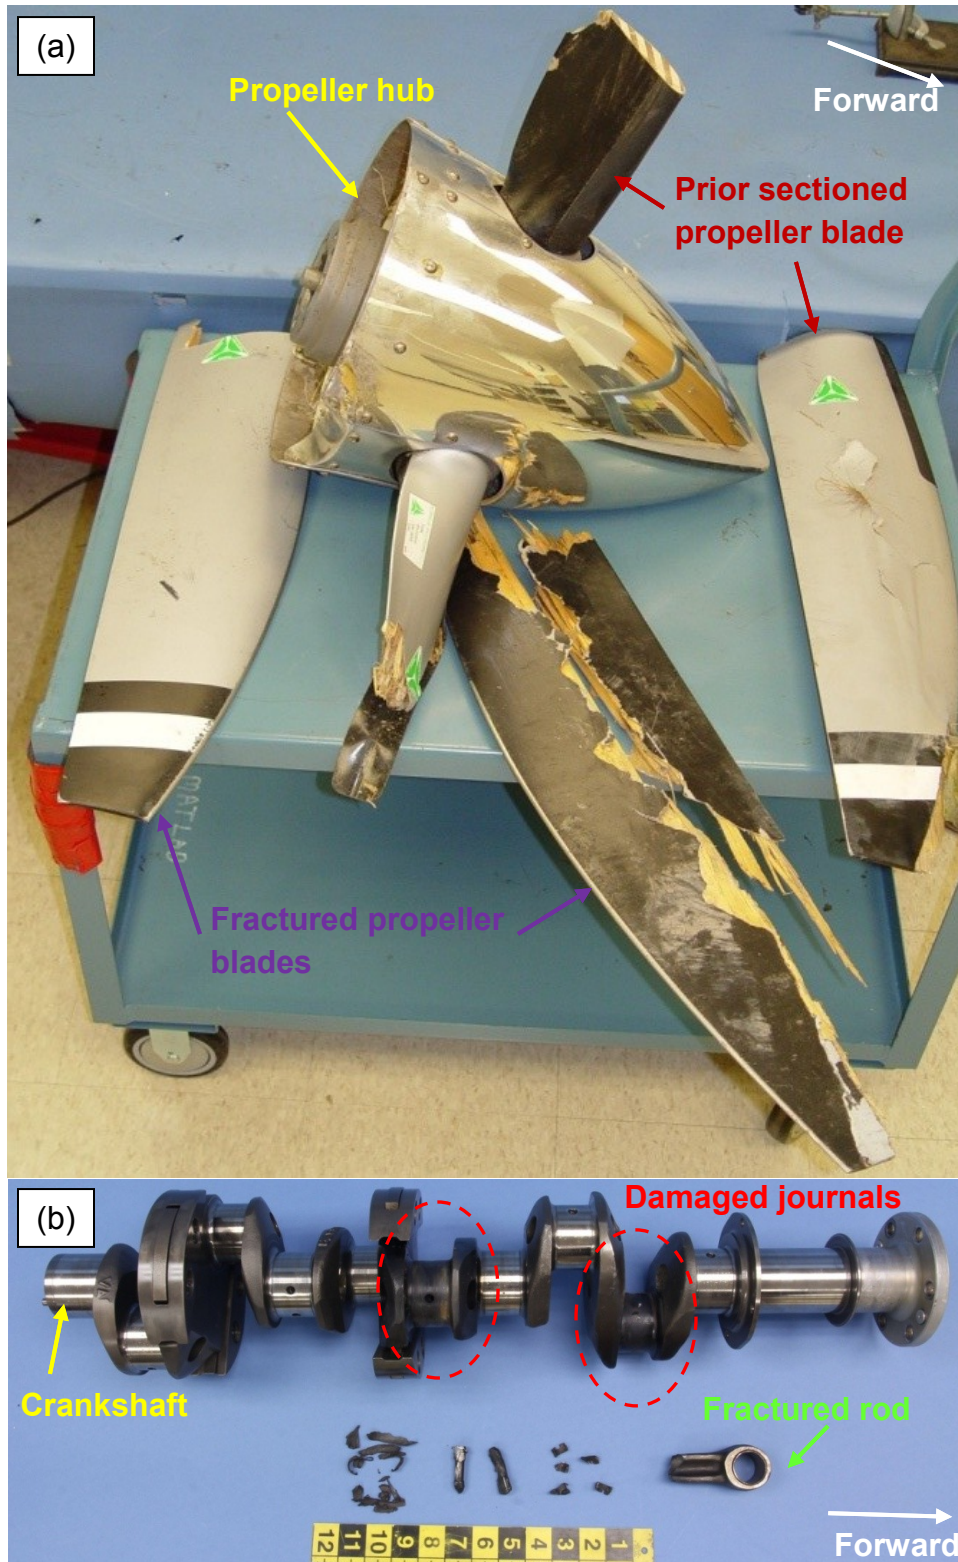
Figure 1 shows the propeller hub assembly, crankshaft, and other parts, as received. As can be seen in Figure 1a, two of the blades had broken off of the propeller hub assembly. The third blade had been sectioned off prior to shipment to the NTSB. The hub spinner shell exhibited a small dent in an area adjacent to the aircraft engine, showing cracking in the surface plating on the shell (but not the shell itself). Except for the aft hub section that mates to the crankshaft flange, no other indications of damage were observed externally on the hub assembly. The crankshaft exhibited material deformation and heat tinting on two of the connecting rod journals. A connecting rod had fractured approximately

Figure 1 – The propeller parts as received, showing (a) the propeller hub and fractured blades and (b) the crankshaft, fractured rod and miscellaneous damaged parts.

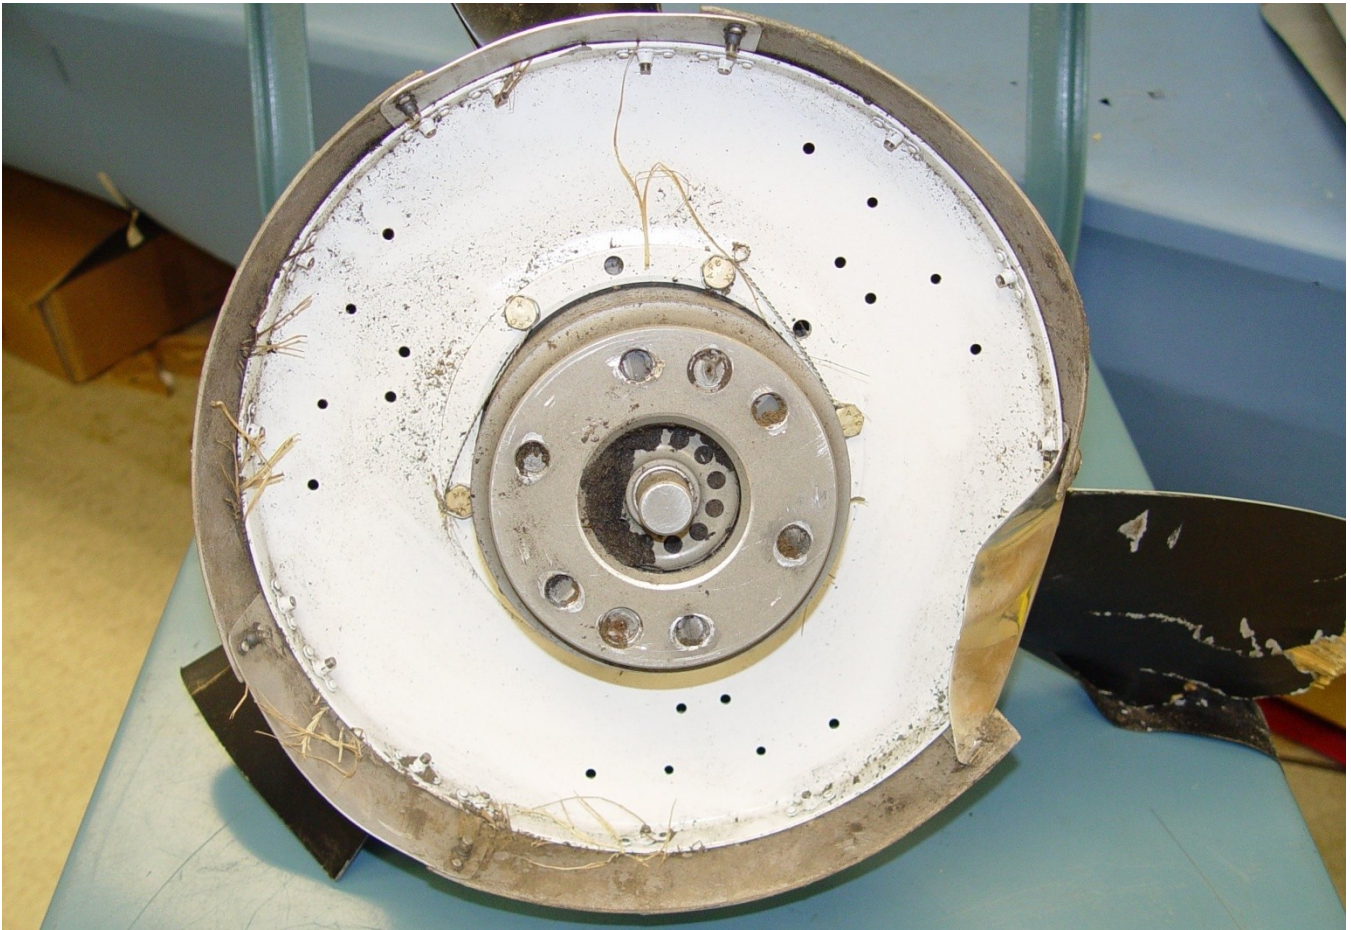
The aft side of the propeller hub separated from the forward side of the crankshaft due to the failure of eight hub-mounting bolts. Figure 2 shows the aft side of the propeller hub assembly, as received. The spinner shell and bulkhead were removed from the hub assembly to examine the fractured bolt fragments. Figure 3a illustrates the fractured mounting bolts, which were labeled 1 through 8 for the purposes of this report. Figure 3b shows the corresponding bolt holes on the adjacent forward mounting flange of the crankshaft. Both the mating faces of aft of the hub and forward flange of the crankshaft show pairs of hemispherical-shaped wear marks at each bolt hole. The hemispherical marks are 180° degrees from each other at each respective hole, located along a circular path relative to each other.

Figure 2 – The fractured bolts of the propeller hub as received, viewed aft-looking forward.

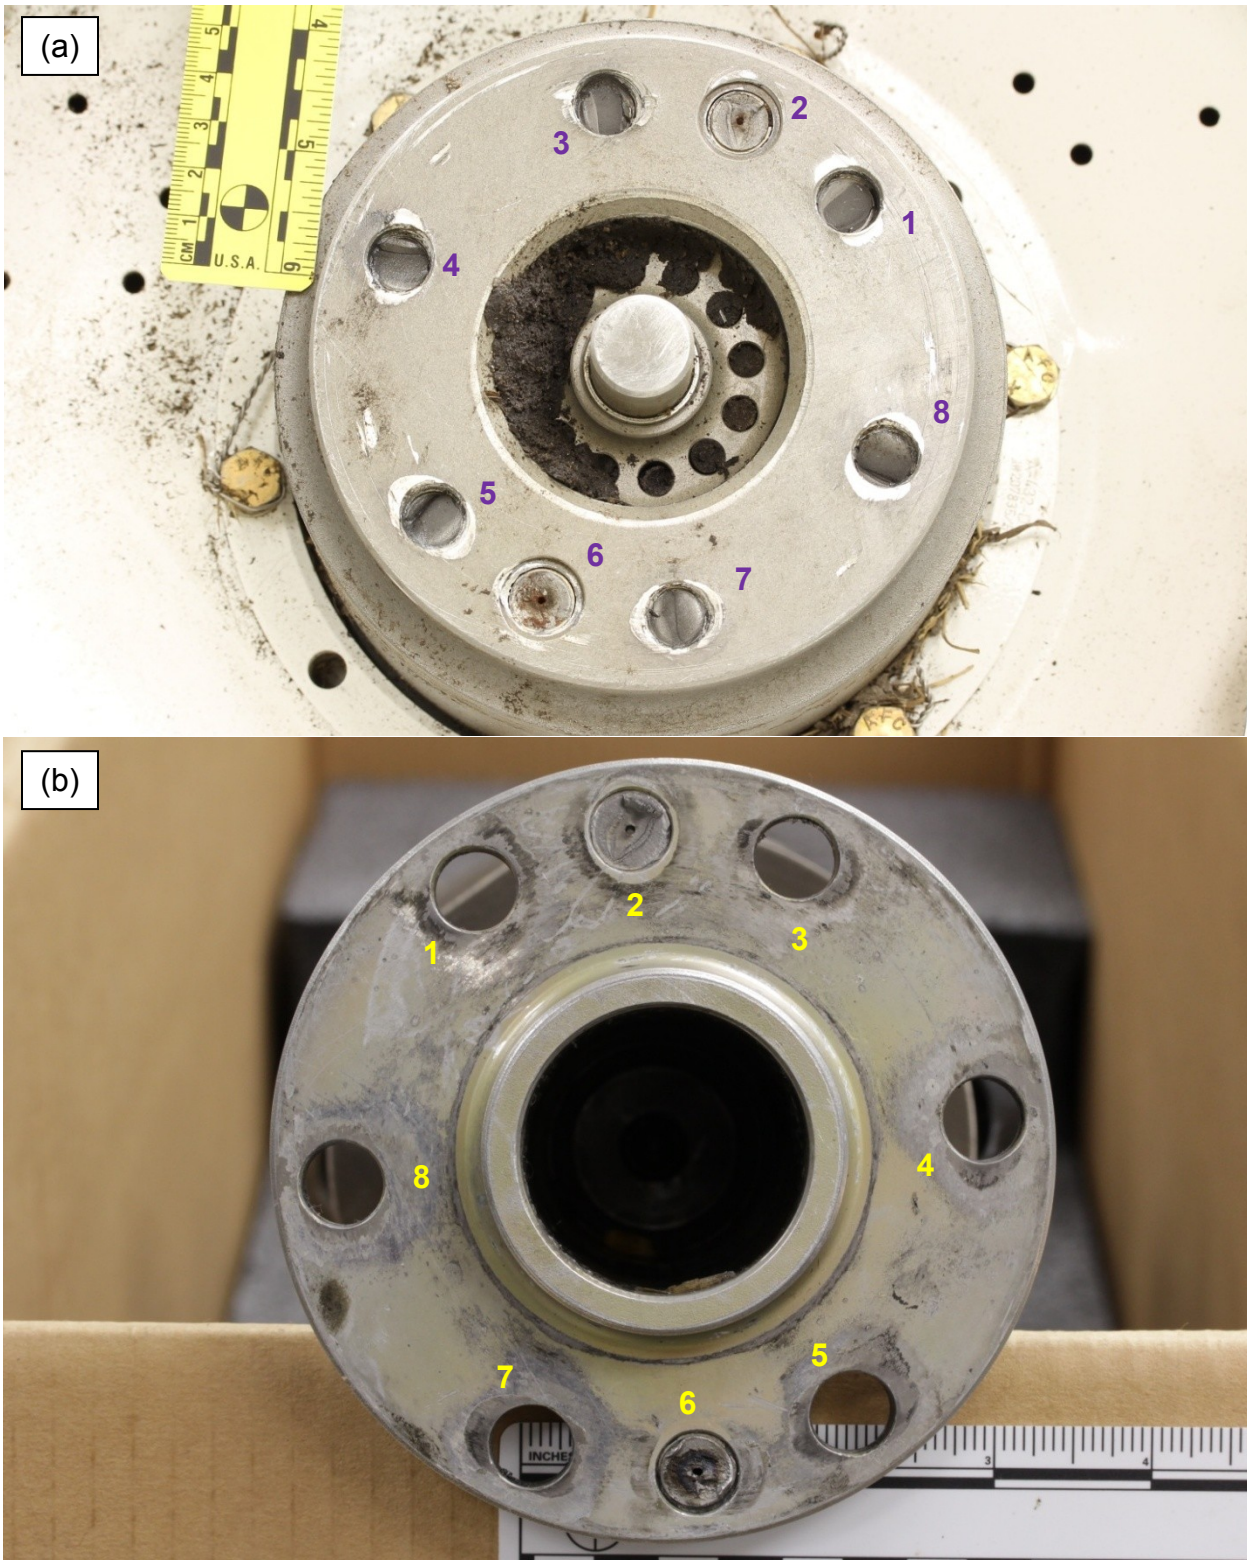
Figure 3 – The bolts fragments and bolt holes of the propeller assembly from (a) the hub side with the aft bulkhead removed and (b) the crankshaft side. The numbering system is used to identify the bolts in the investigation.

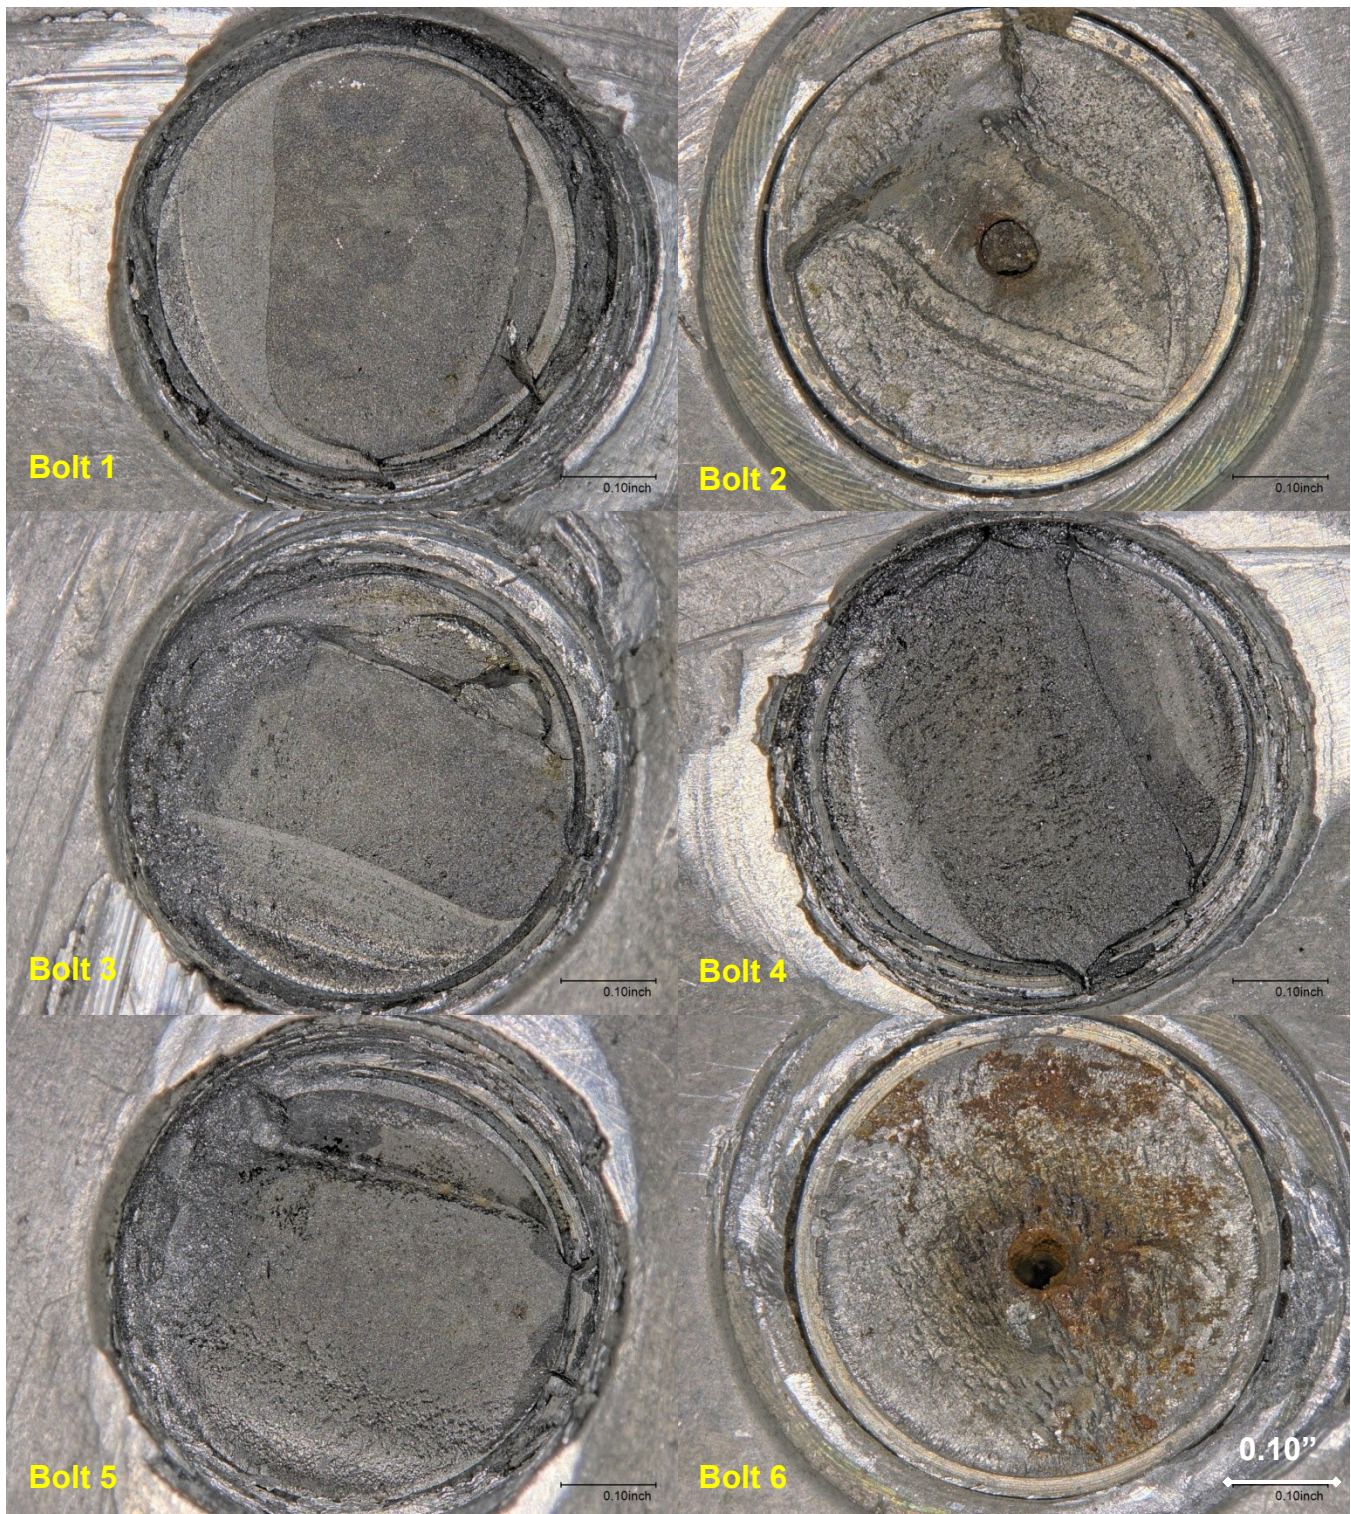
Figure 4 and Figure 5 show the fracture surfaces of all eight bolts as viewed from the propeller hub side. All eight bolts exhibited two thumbnail crack features located 180° from each other, corresponding with the hemispherical wear marks on the hub case aft surface. The thumbnail cracks exhibited crack arrest marks emanating from the surface of the bolts. The regions of the fracture surfaces between the thumbnail cracks were generally rougher and of lower luster than the thumbnail regions. These fracture characteristics are consistent with failure from reverse bending fatigue. In this failure mode, fatigue cracks developed on opposite sides of the part until the cracks penetrated deep enough for the remaining cross-section in between to succumb to overstress. In general, the thumbnail portions of the bolt fracture surfaces were approximately half the bolt cross-sections. Bolt 7 exhibited the deepest fatigue crack penetration in the bolt cross-section.

Figure 4 – Fracture surfaces of bolt fragments 1 through 6. Each fracture surface exhibited patterns indicative of reverse bending fatigue.

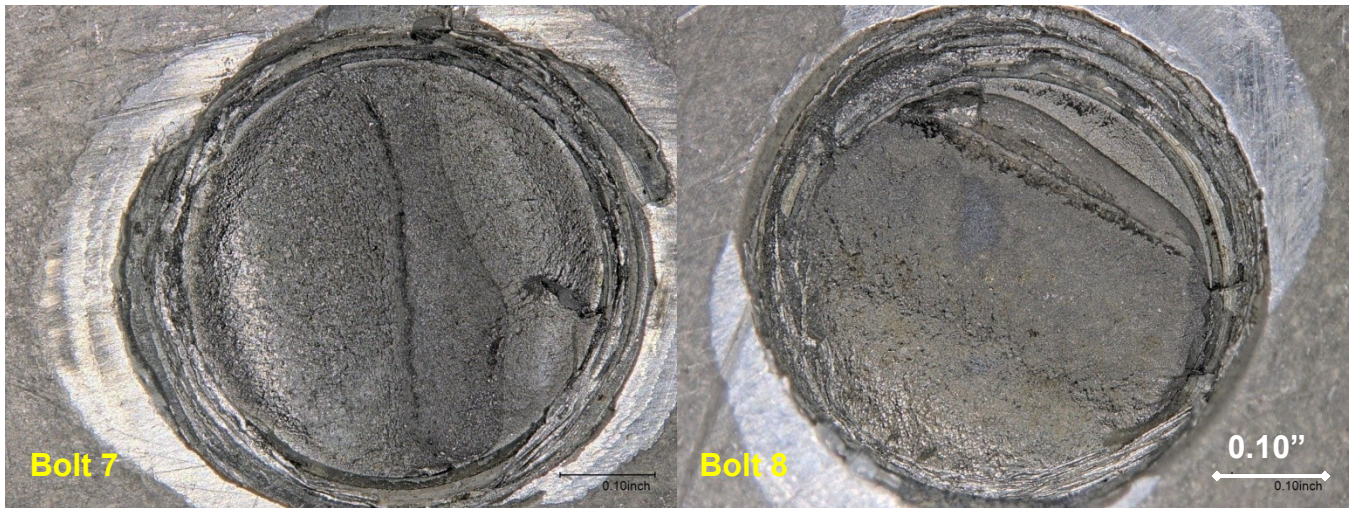
Figure 5 – Fracture surfaces of bolt fragments 7 and 8. Each fracture surface exhibited patterns indicative of reverse bending fatigue.

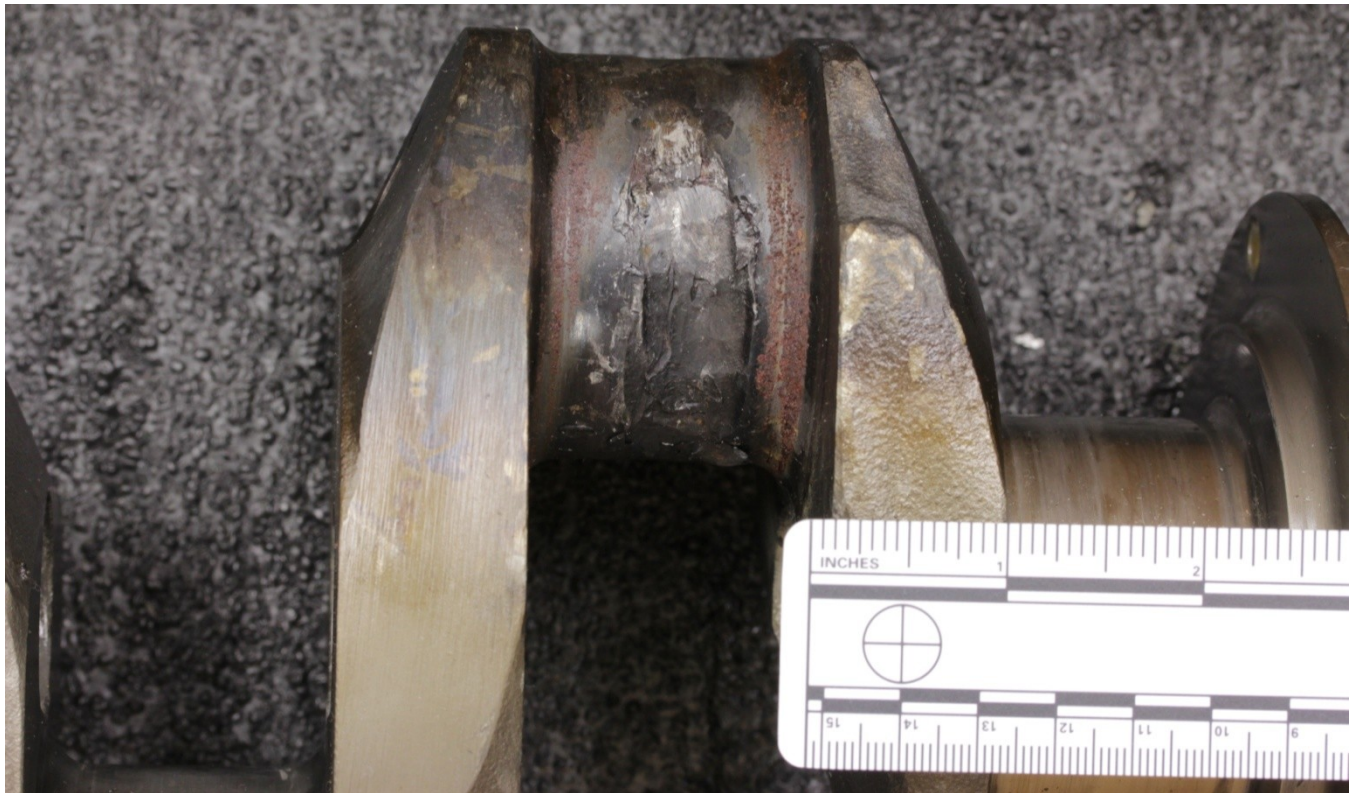
Figure 6 and Figure 7 illustrate damage to the crankshaft connecting rod journals for rods 6 and 4³, respectively. The journal surface in Figure 6 showed plastic deformation in the form of smearing, batter, and cutting into the surface. Circumferential wear marks were present on the journal. The areas on the journal outside the plastically deformed center displayed indications of rust-colored oxidation. These features were consistent with high temperature exposure and wear due to interaction with an adjacent component, the

Figure 6 – Damage on the crankshaft at the #6 connecting rod bearing journal, showing indications of heat tinting and material deformation.

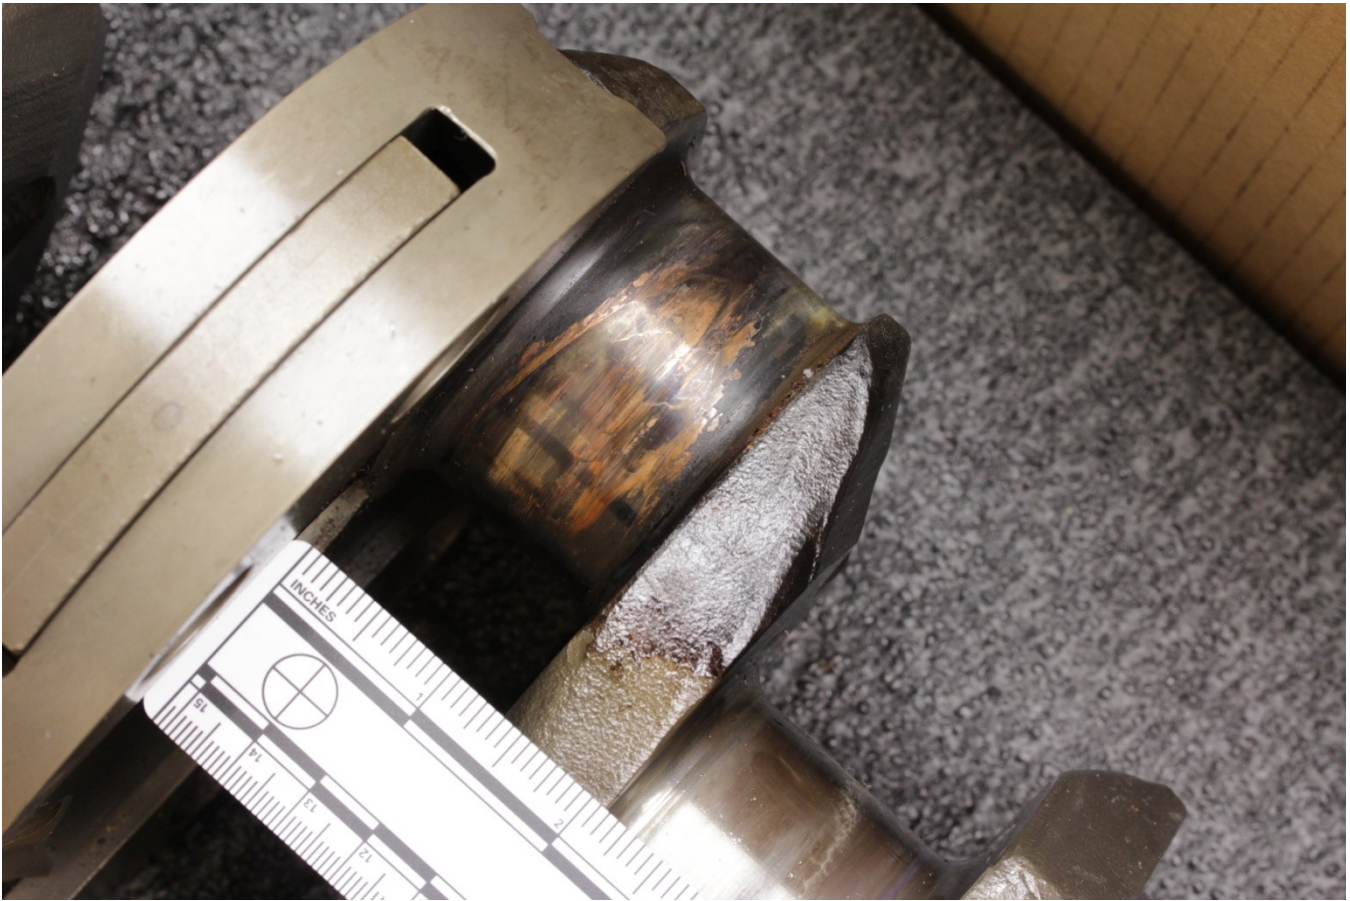
connecting rod. The #4 piston connecting rod journal surface shown in Figure 7 showed circumferential wear, heat tinting, and oxidation consistent with high temperature exposure. In examination of the engine teardown photographs, the #4 piston connecting rod exhibited rust-colored oxidation on the rod cap, I-beam, and rod bolts adjacent to the crankshaft. These features are consistent with high temperature exposure.

Figure 7 - Damage at the #4 connecting rod crankshaft bearing journal location, showing indications of heat tinting and material deformation.

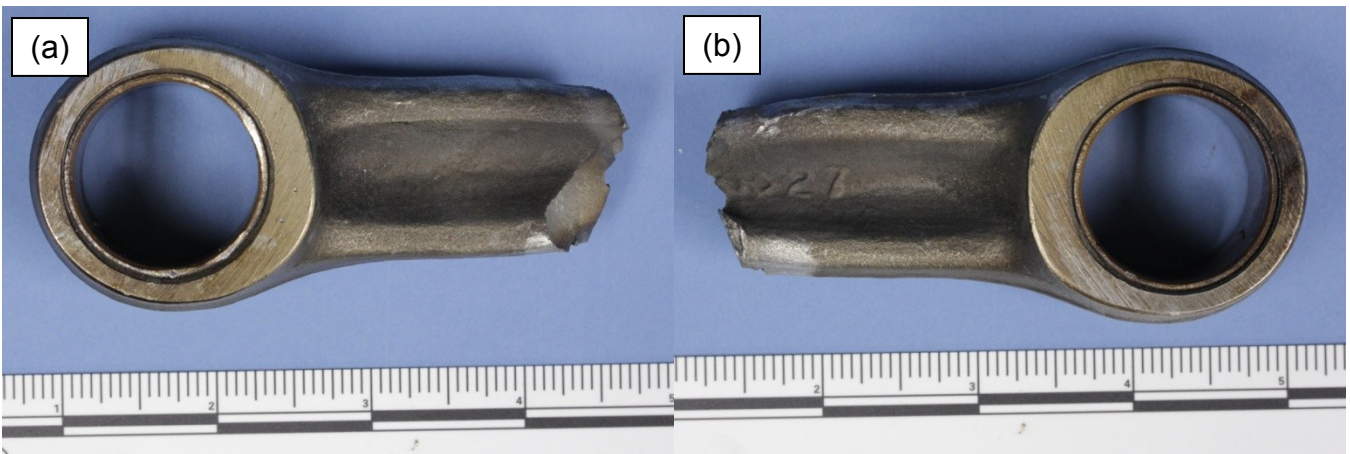
Figure 8 shows the #6 piston connecting rod from both sides. The rod had fractured along the I-beam approximately 2.5 inches from the small end of the rod. Figure 9 shows the rod fracture surface after being sectioned from the I-beam. Most of the fracture surface exhibited a dark color, with tortuous fracture surface. As illustrated in Figure 10, the fracture surface exhibited indications of heat tinting near one edge. This tinted area showed crack arrest features consistent with a small thumbnail crack.

Figure 8 – The fractured connecting rod end as seen from both sides (a) and (b).

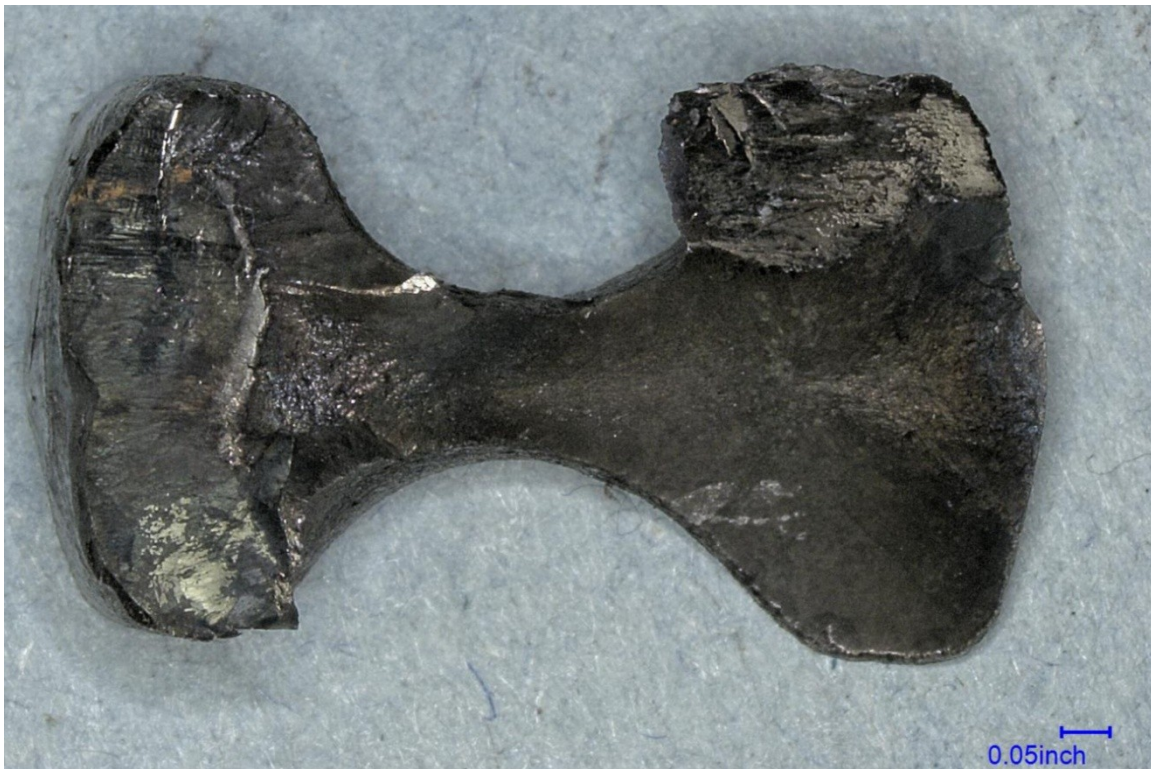
Figure 9 – Fracture surface of the fractured rod, after sectioning from the main part fragment.

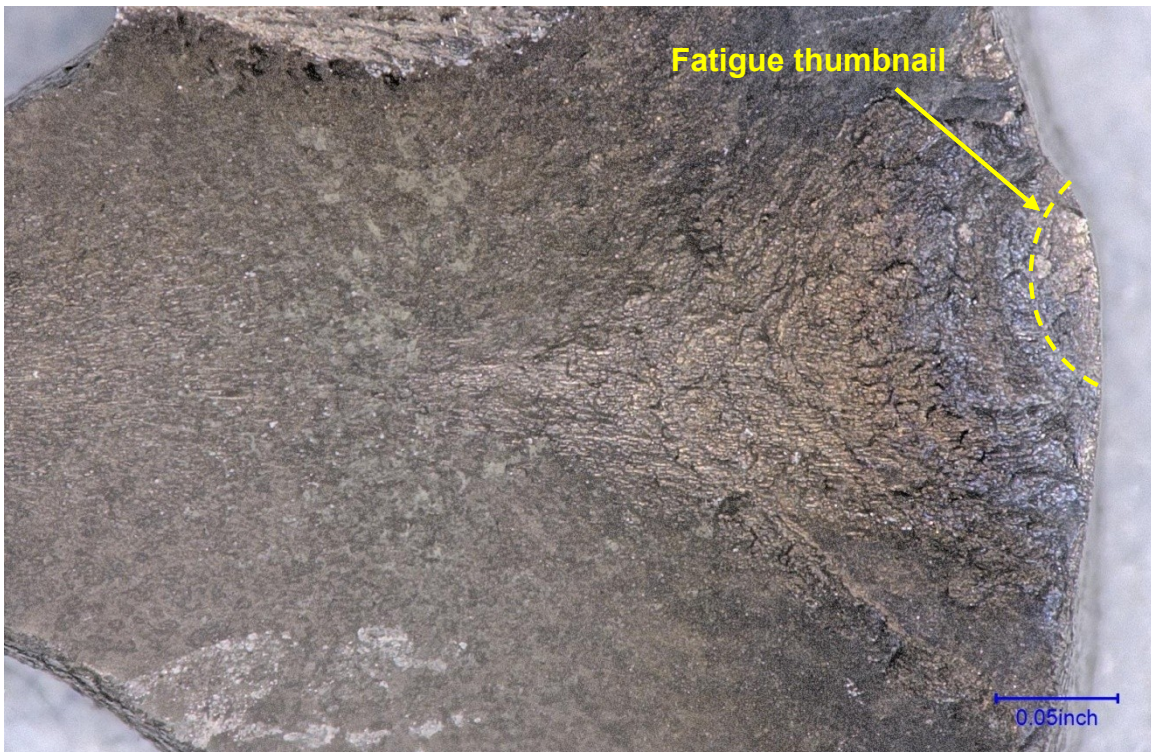
Figure 10 – Closer view of the fracture surface from Figure 9, showing a small thumbnail on the edge of the part.

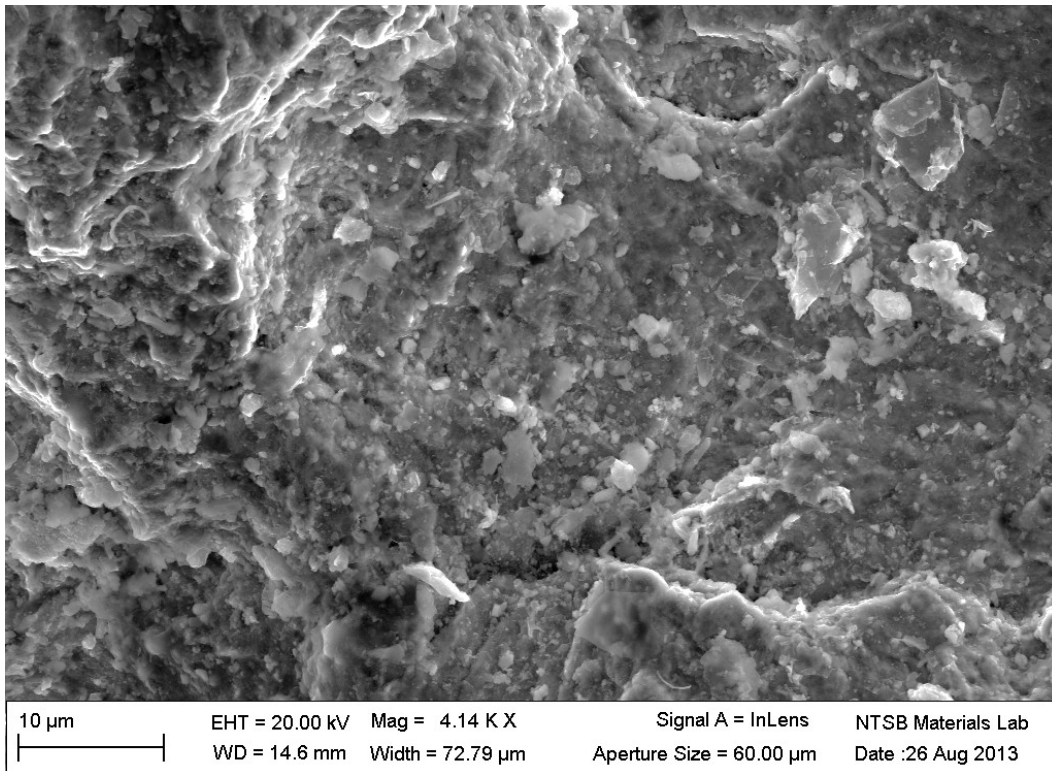
The fracture surface was examined in a scanning electron microscope. While most of the fracture surface had been damaged, isolated areas within the thumbnail region exhibited features consistent with fatigue striations (Figure 11). No indications of other failure modes were found in this area. The fatigue thumbnail region had been oxidized enough to obscure much of the fracture features. All the areas outside of the thumbnail region exhibited dimple rupture features consistent with failure by overstress (see Figure 12). Across the entire fracture surface, small lead-based particles were found. These particles are consistent with additives in leaded aviation fuel.

Figure 11 – Secondary electron (SE) micrograph of the thumbnail area identified in Figure 10, showing faint fatigue striations.

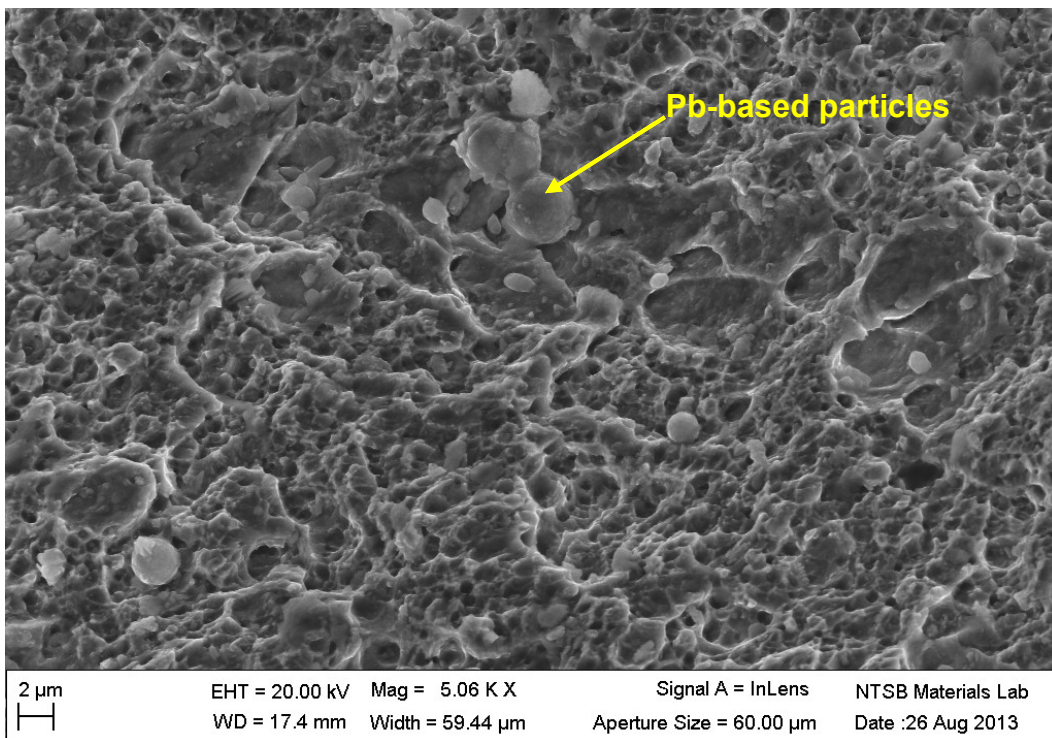
Figure 12 – SE micrograph of dimple rupture, indicative of overstress, typical of what was found on the rod fracture surface outside of the thumbnail area.
