NATIONAL TRANSPORTATION SAFETY BOARD

MATERIALS LABORATORY FACTUAL REPORT

Report No. 13-085

Place : Hallandale, FL
Date : May 23, 2012
Vehicle : Bombardier Challenger 601-3R, N207JB
NTSB No. : ERA12LA356
Investigator : Ralph Hicks, AS-ERA

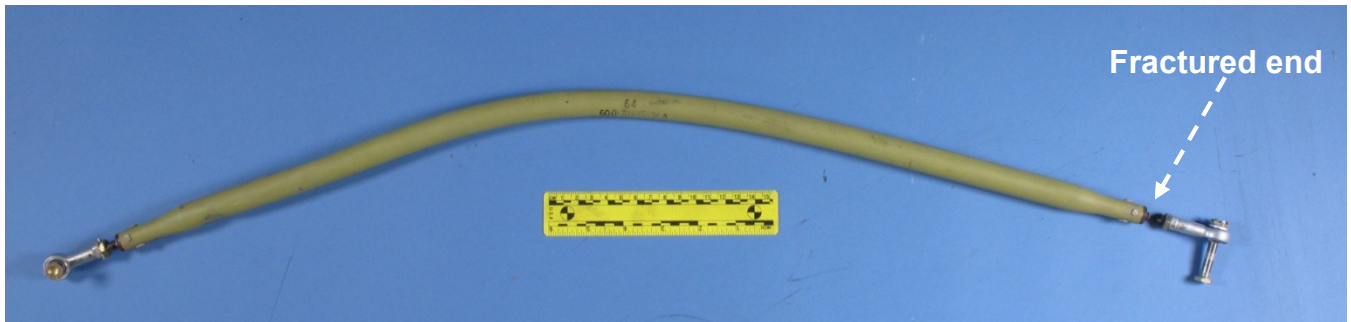
A passenger door from a Challenger 601 departed the aircraft at approximately 3000 feet on May 23, 2012. The materials laboratory received the pushrod, as illustrated in Figure 1. The rod was bent approximately 45° at the center and had fractured at one of the threaded ends. The pushrod also showed two dents approximately 3 inches from the opposite and intact end of the rod assembly.

Figure 1 – The fractured pushrod, as received.

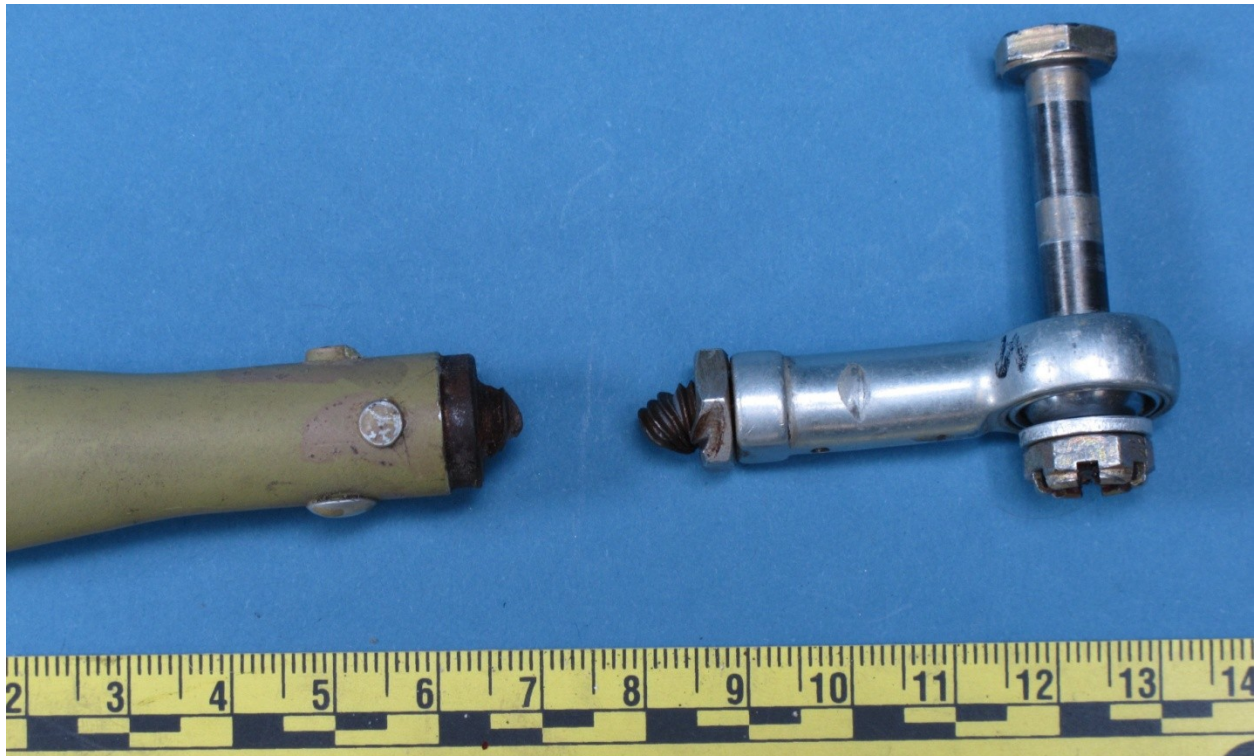
The threaded end that had fractured is depicted in Figure 2. The threaded bolt showed compressed thread crests on one side and outstretched thread valleys on the other side (see Figure 3). The majority of the original threaded surfaces bore a layer of rust-colored oxidation. This surface oxidation was not present on any of the fracture surfaces. Examination of the fracture surface revealed dimple rupture, which is indicative of overstress (see Figure 4). The cracked areas in the stretched thread valleys also displayed dimple rupture. No other indications of other failure modes, including corrosion leading to fracture, were found. The observed features are consistent with bending overstress of the pushrod.

Figure 2 – The fractured end of the pushrod, as received. The threaded end shows indications of bending in the threads.

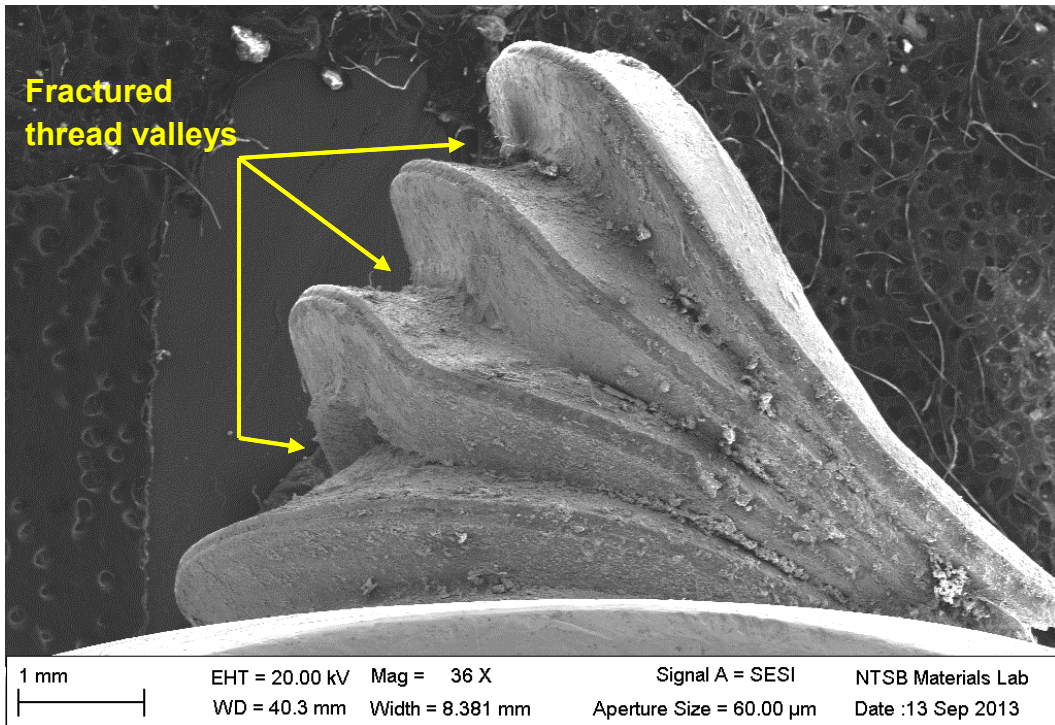
Figure 3 – Secondary electron (SE) micrograph of the fractured threaded end, showing cracking in the thread valleys on one side and compression of the thread crests on the other.

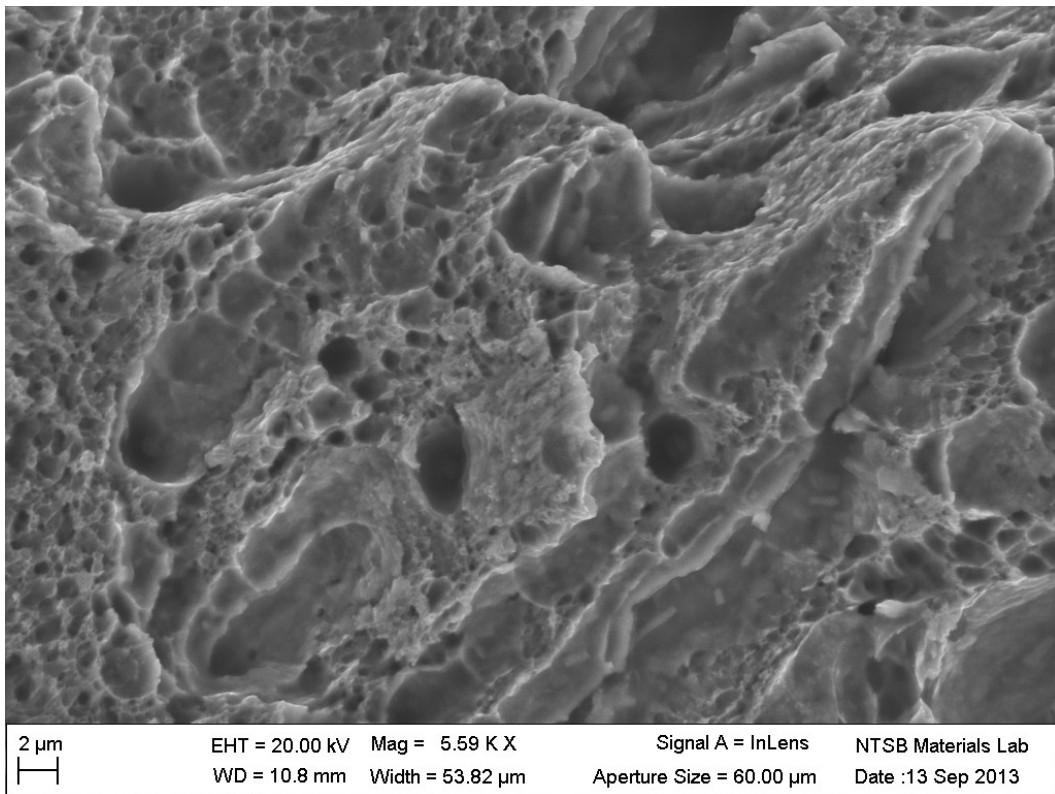
Figure 4 – SE micrograph of dimple rupture on the main fracture surface.
