NATIONAL TRANSPORTATION SAFETY BOARD

Office of Research and Engineering
Materials Laboratory Division
Washington, D.C. 20594

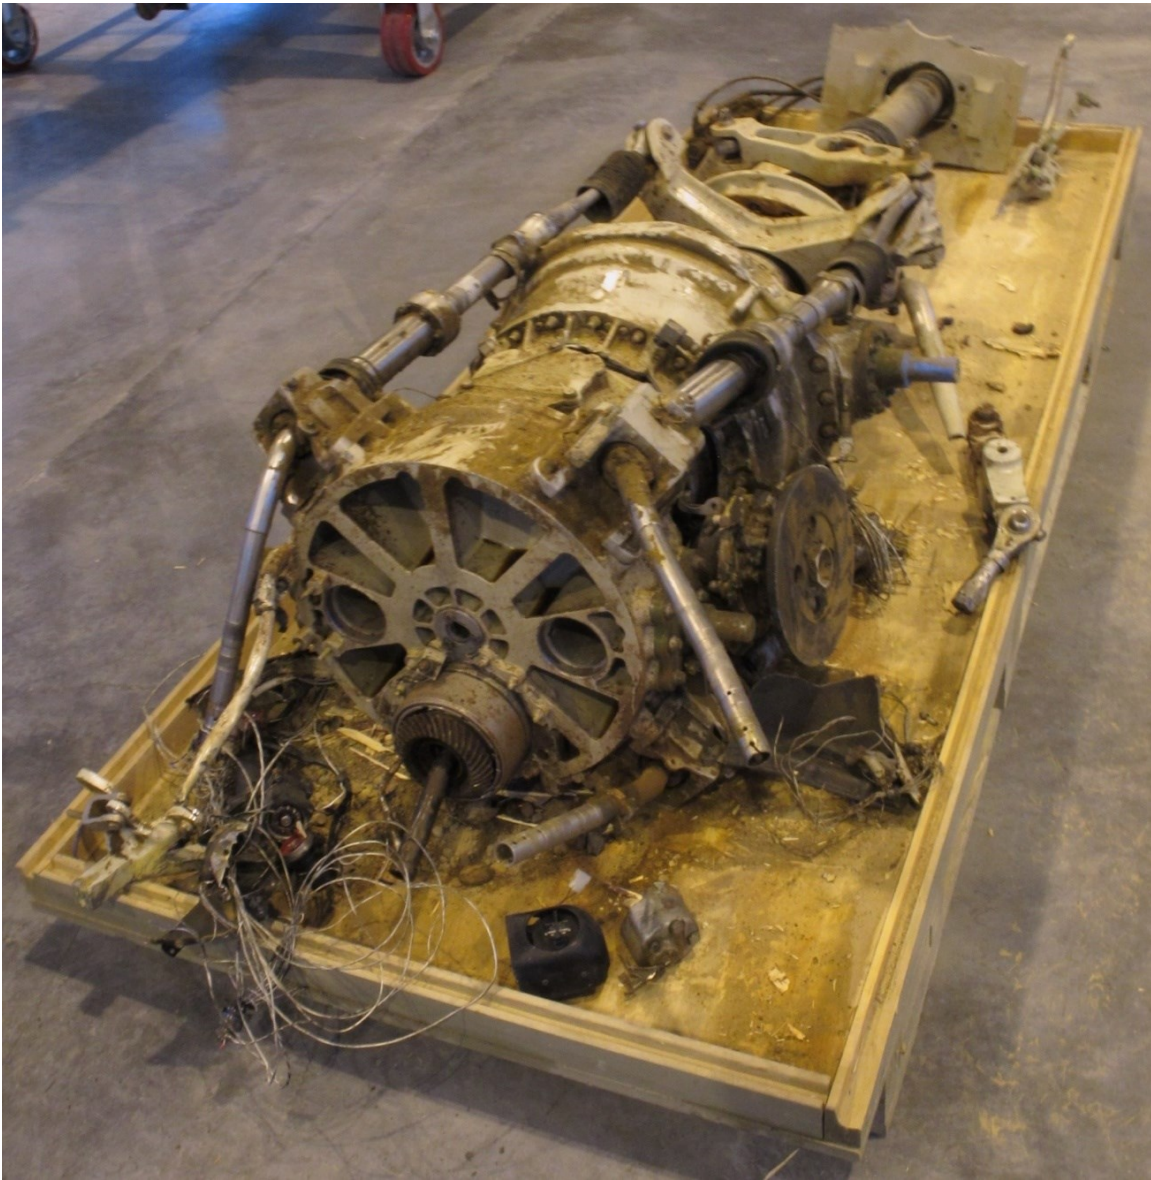
Figure 1 – The main rotor control assembly as received in the NTSB Ashburn training facility.

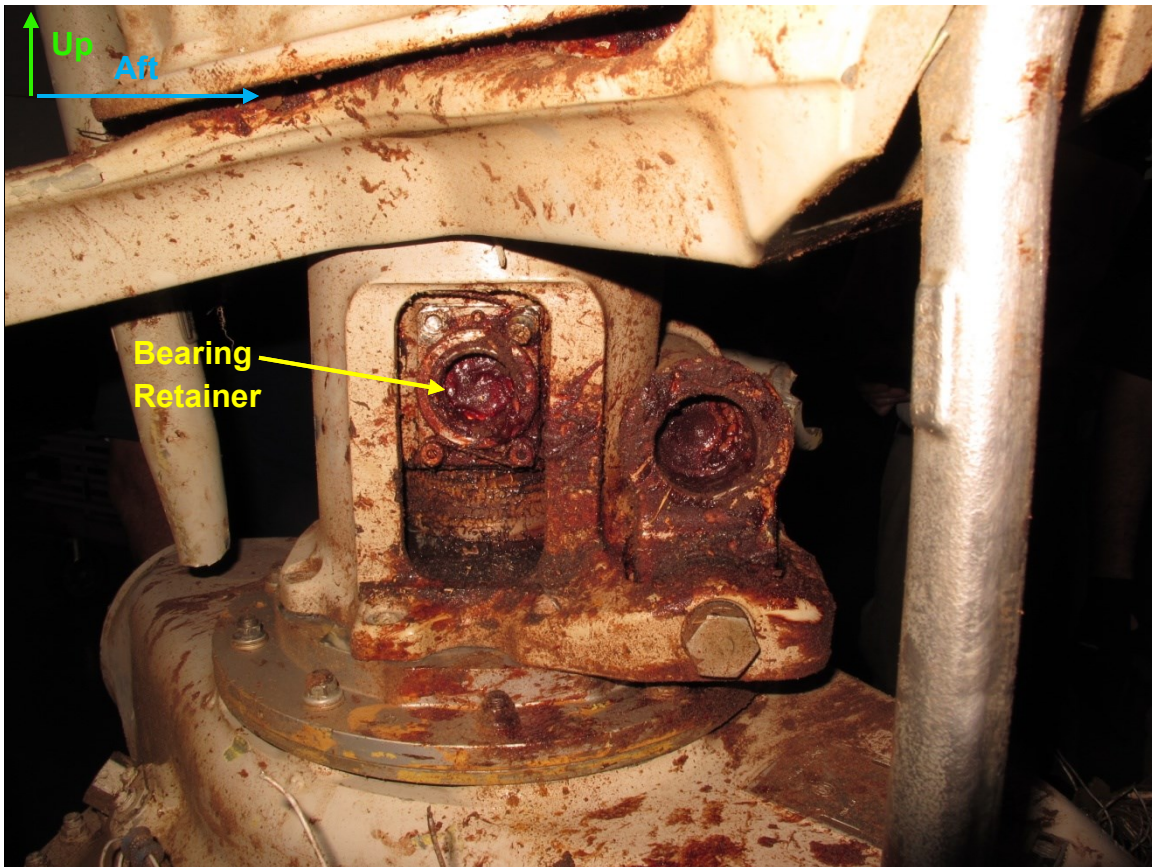
Figure 2 – Closer view of the area of interest on the swashplate assembly, showing the location of the missing collective lever assembly under the control arms from the helicopter left side.

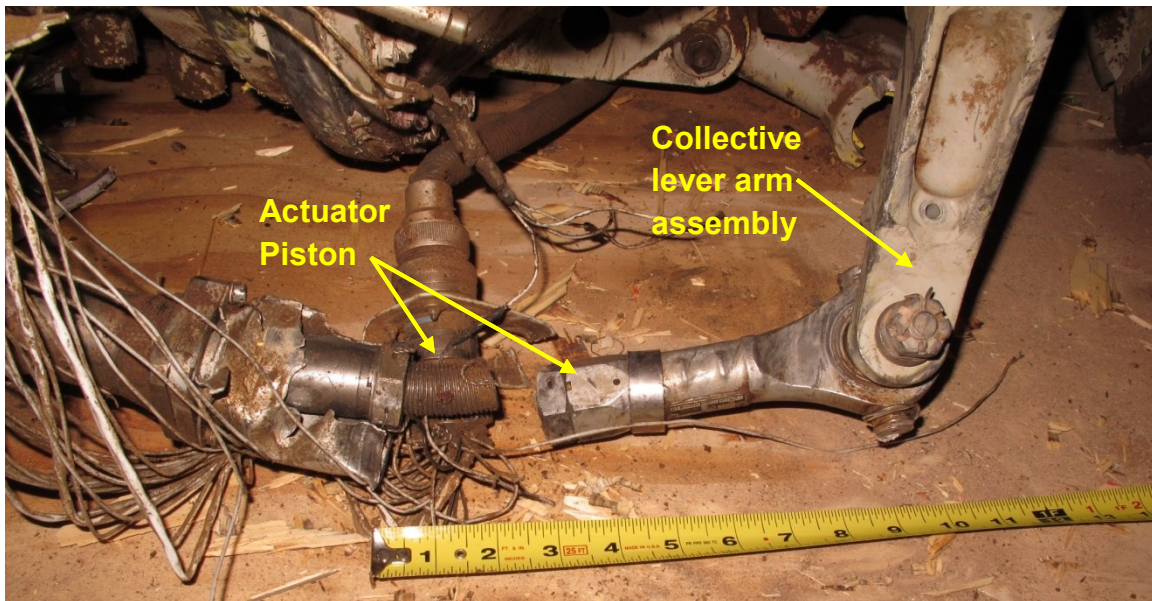
Figure 3 – The fractured actuator piston attached to the lever arm assembly.

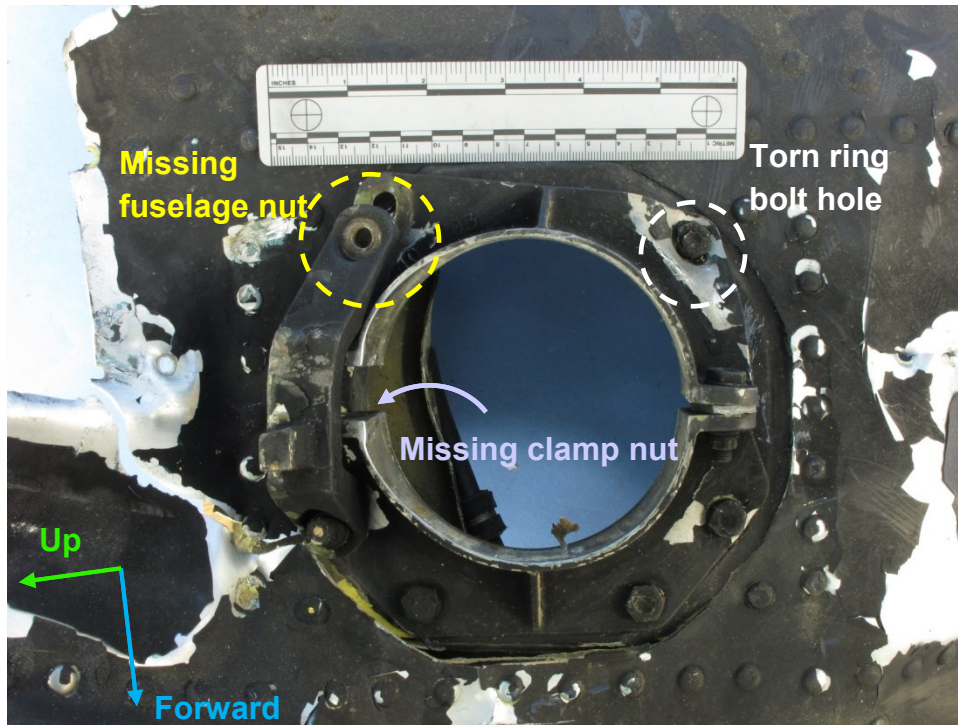
Figure 4 – The right side of the helicopter fuselage where the tail horizontal stabilizer inserts, showing the stop arm in its expected position.

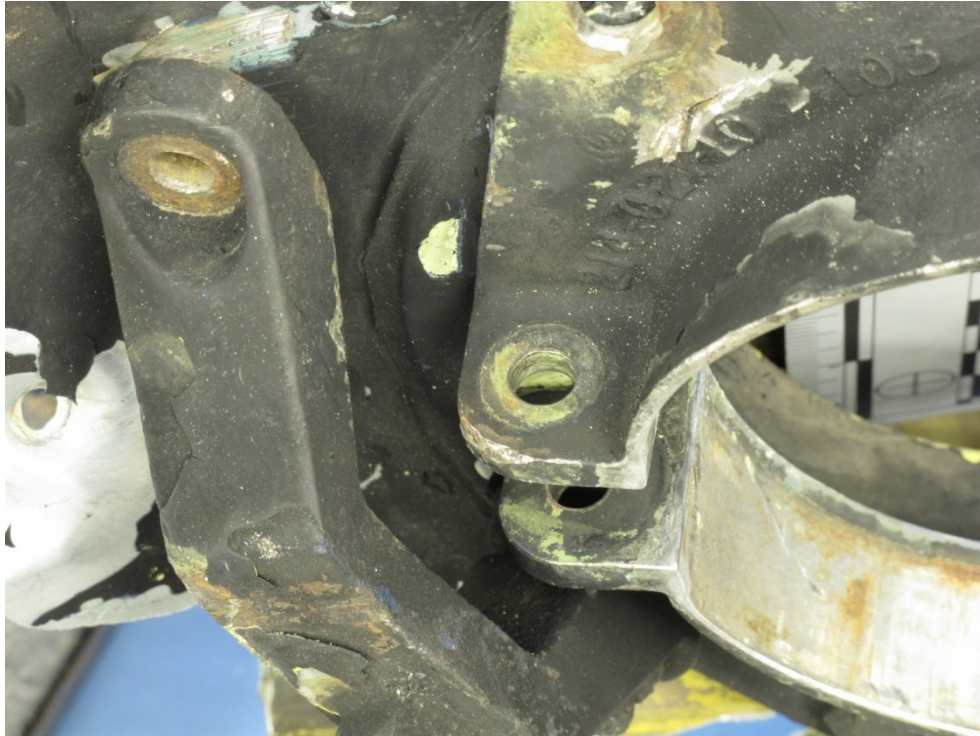
Figure 6 – Position of the stop arm in relation to the fuselage witness mark. The clamping bolt on the stabilizer support cylinder was missing.

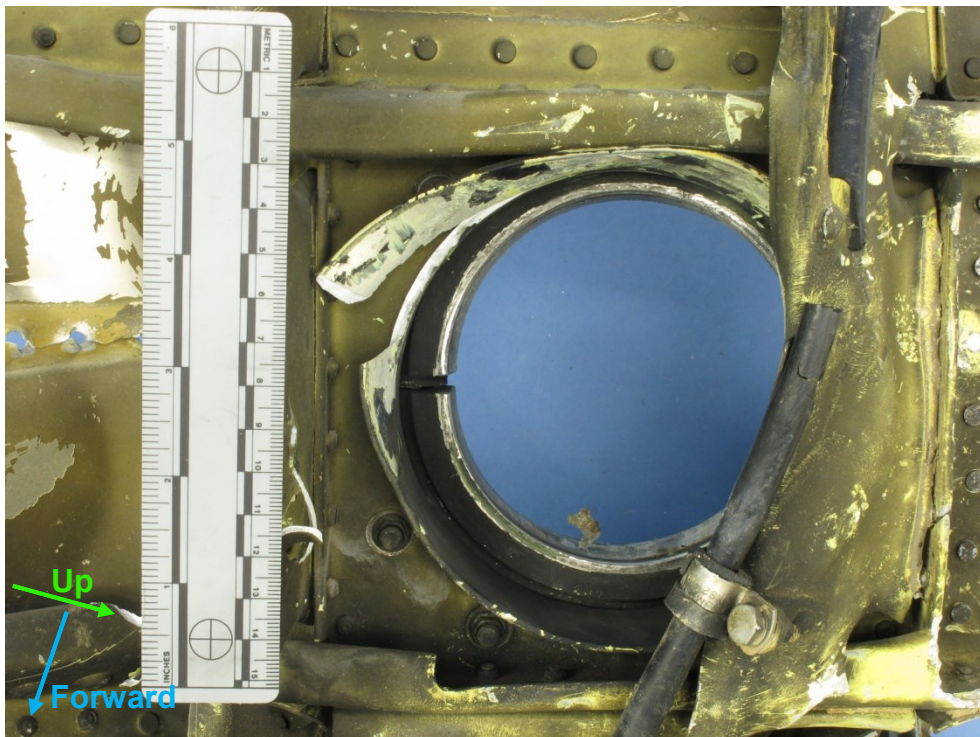
Figure 7 – Reverse side of the fuselage from Figure 4 and Figure 5 (inside), showing the deformation in the sheath indicative of a likely horizontal stabilizer position.

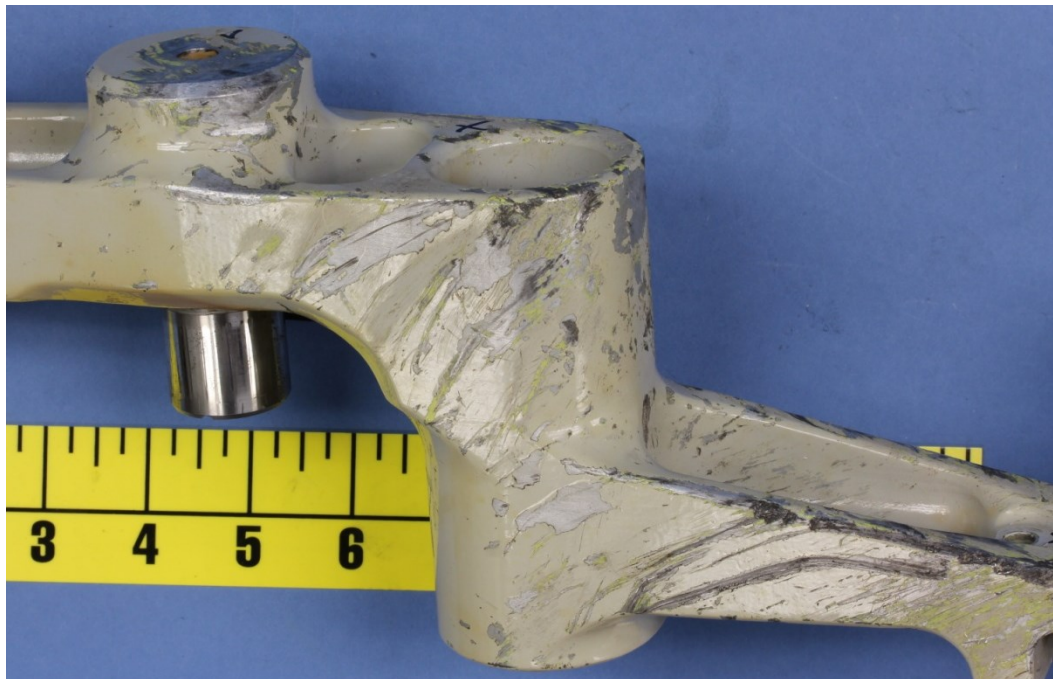
Figure 15 – Damage to the lower side of the lever arm.

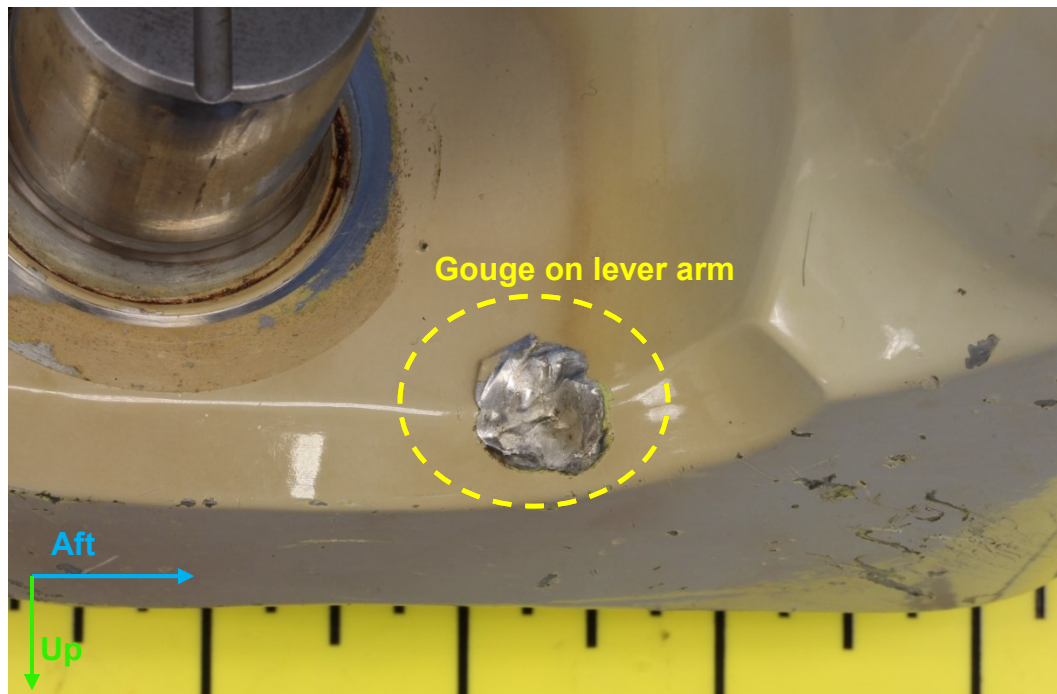
Figure 16 - Large depression on the upper side of the lever arm.

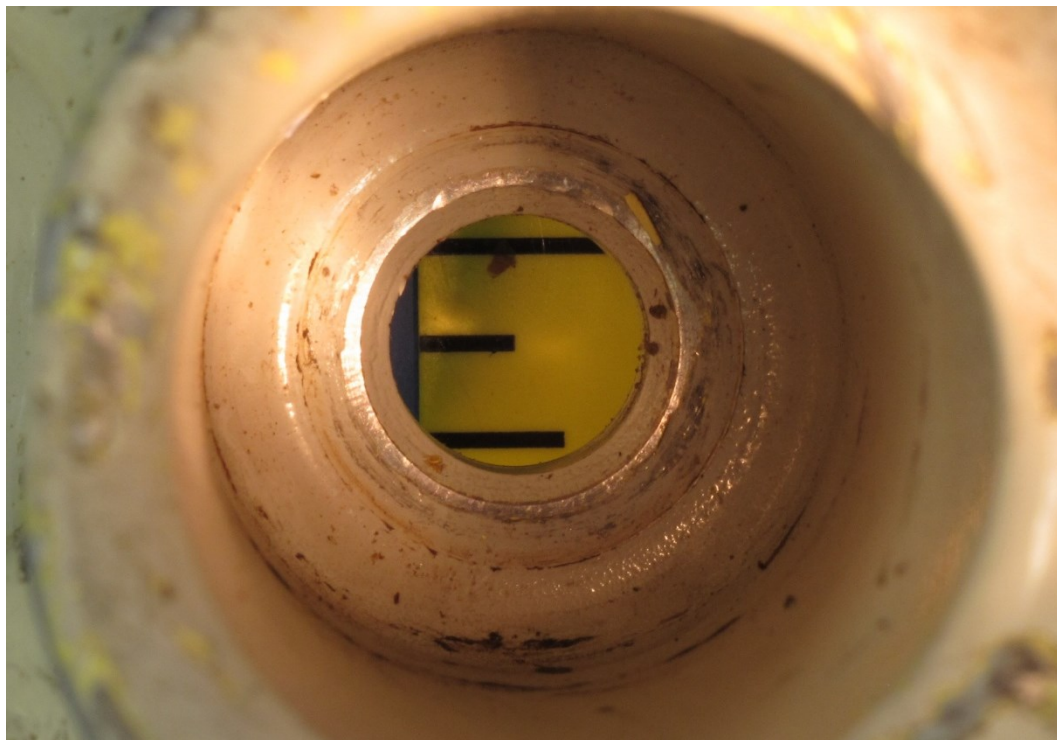
Figure 17 – The recessed bolt hole for bolt P/N MS2150-10014 (missing), showing circumferential wear on the outboard side.

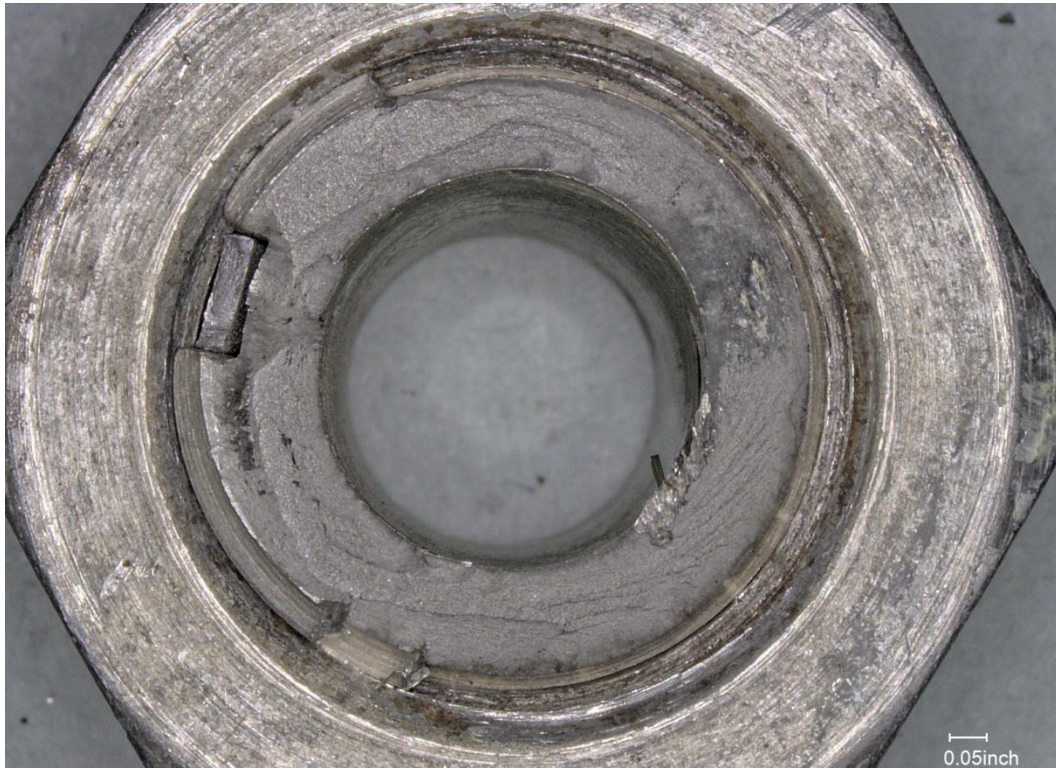
Figure 18 – Fracture surface of the upper rod end that attaches to the collective actuator output piston at the nut, showing indications of overstress.

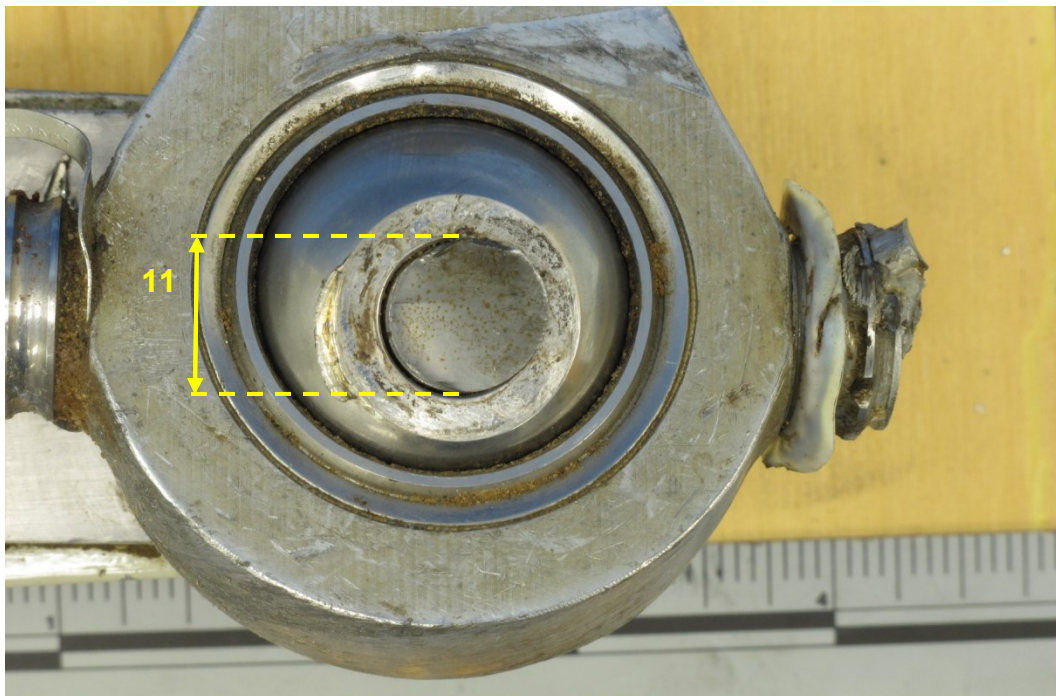
Figure 19 – The fractured bolt attaching the rod end bearing of the actuator piston to the collective lever arm assembly. The measured dimension is listed in Table 1.

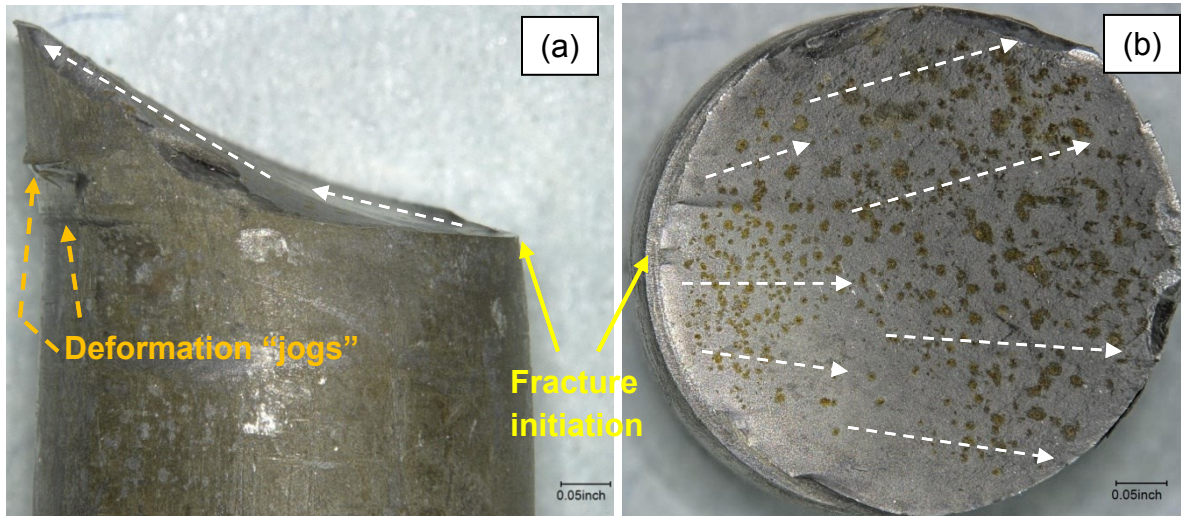
Figure 20 – The fractured bolt from Figure 14 after removal and cleaning, showing the fracture surface from (a) the side and (b) the face. The white arrows indicate the fracture direction.

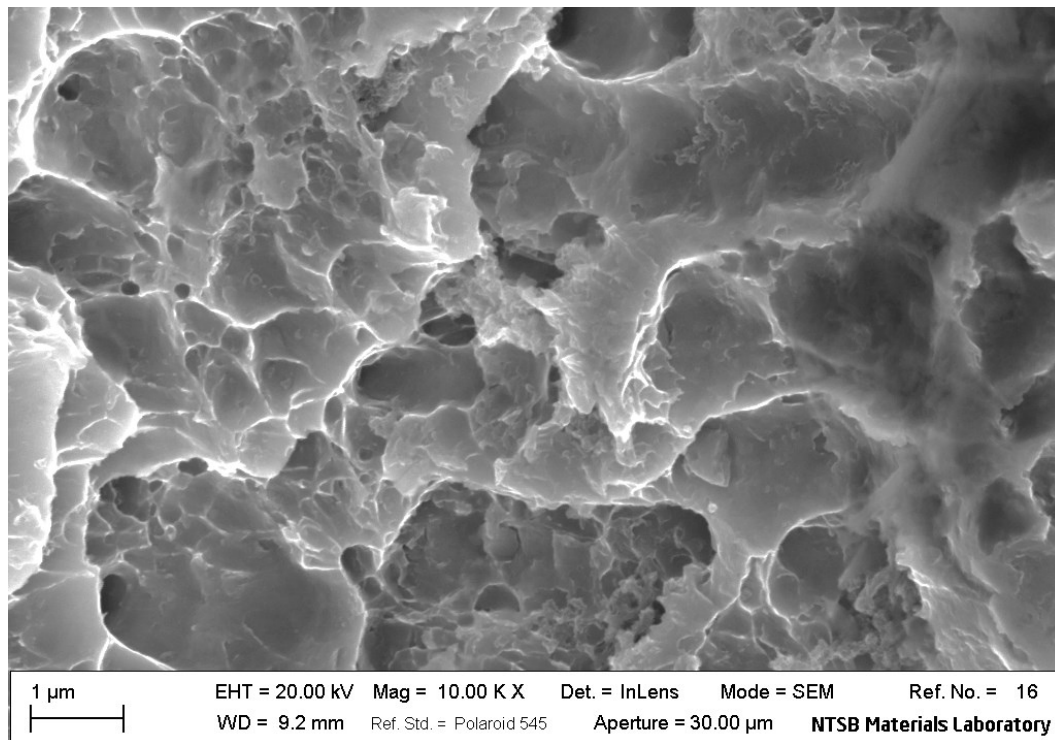
Figure 21 – Secondary electron (SE) micrograph of the fracture surface of the bolt from the actuator piston, showing dimple rupture indicative of overstress.

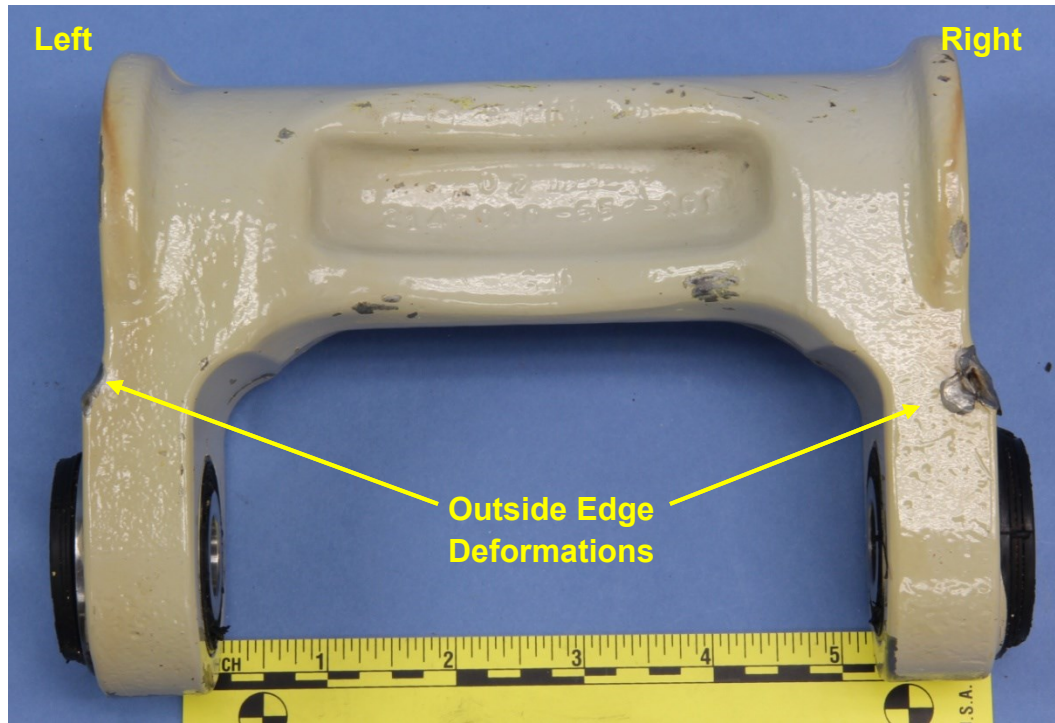
Figure 22 – The idler link assembly, after removal from the collective assembly and cleaning, aft-looking forward. Two witness marks were noted where the link can contact the collective arms.

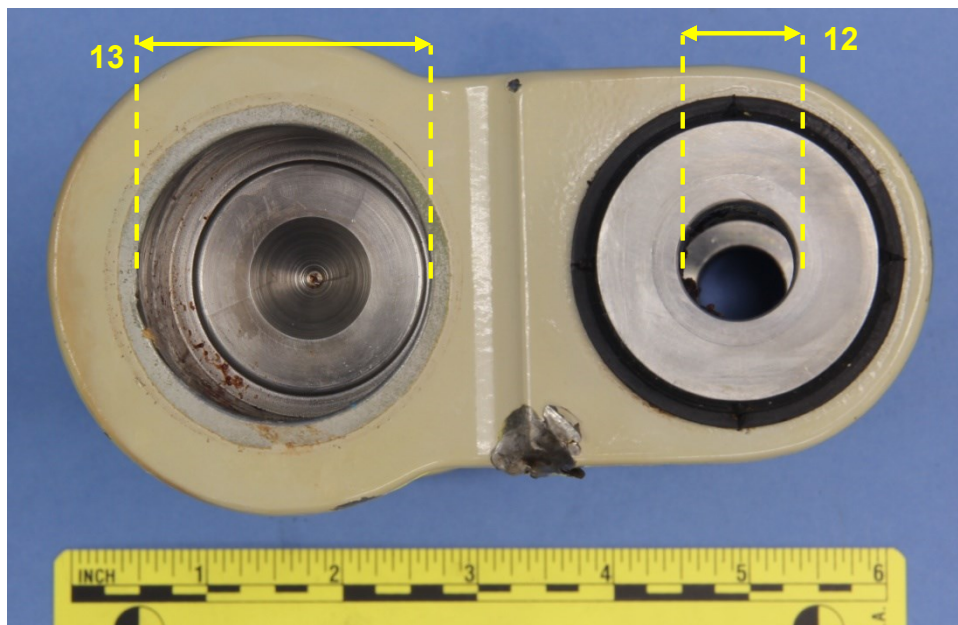
Figure 23 – The idler link assembly from the right side. The dimensions marked were measured and tabulated in Table 1.

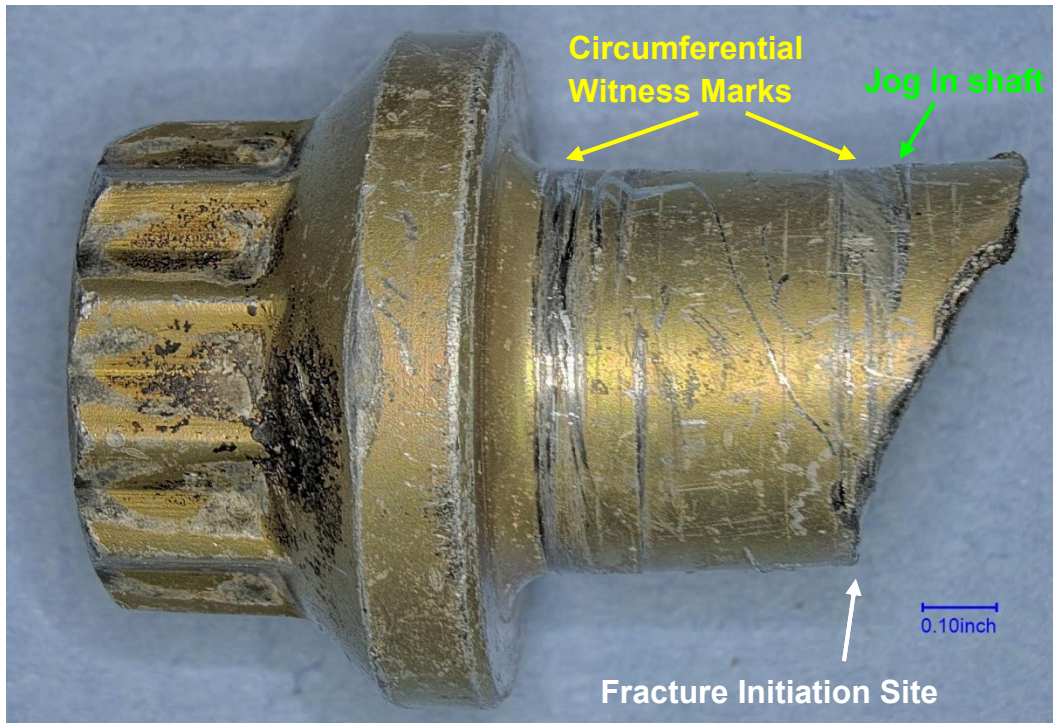
Figure 27 – The recovered external wrenching bolt from the side, showing circumferential witness marks, and a jog in the bolt shaft corresponding with the wear mark along the fracture initiation site.

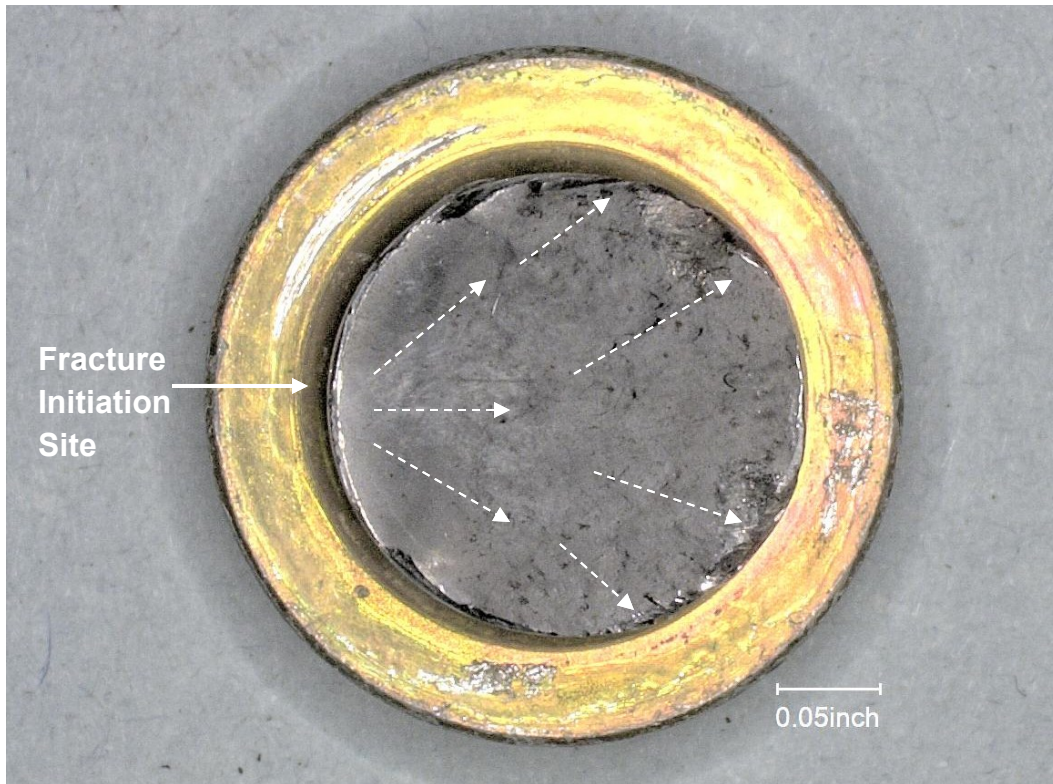
Figure 28 – Fracture surface of the recovered bolt. The fracture initiation and direction are noted (arrows).

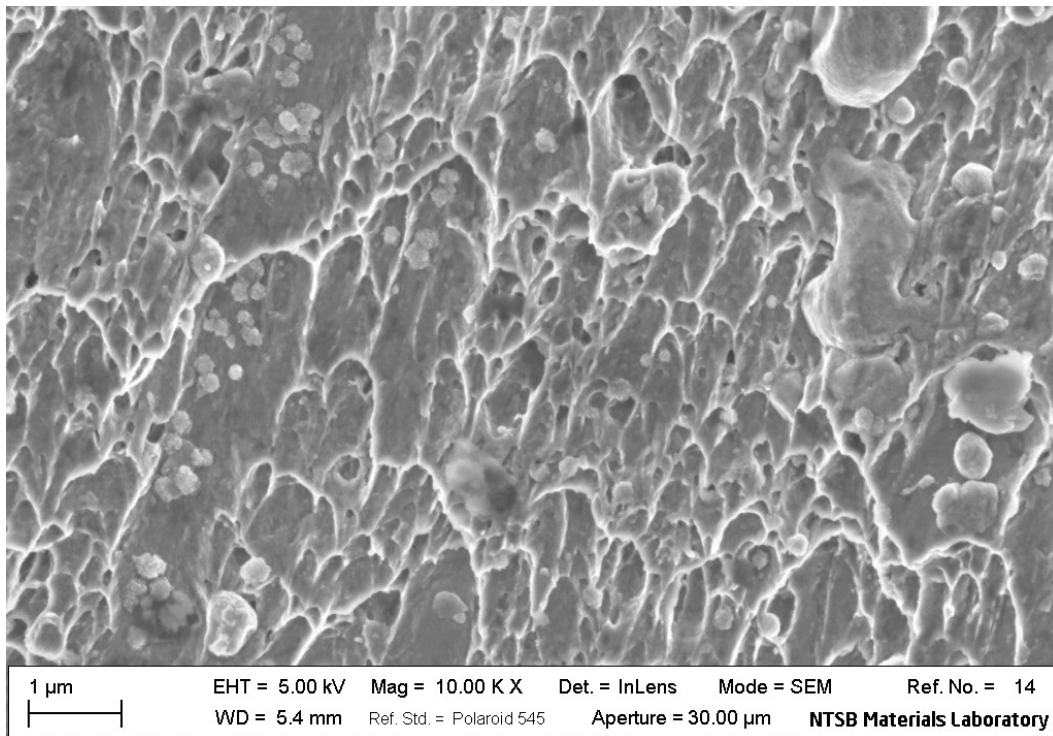
Figure 29 – SE micrograph of the fractured bolt from the actuator piston, showing dimple rupture indicative of overstress.

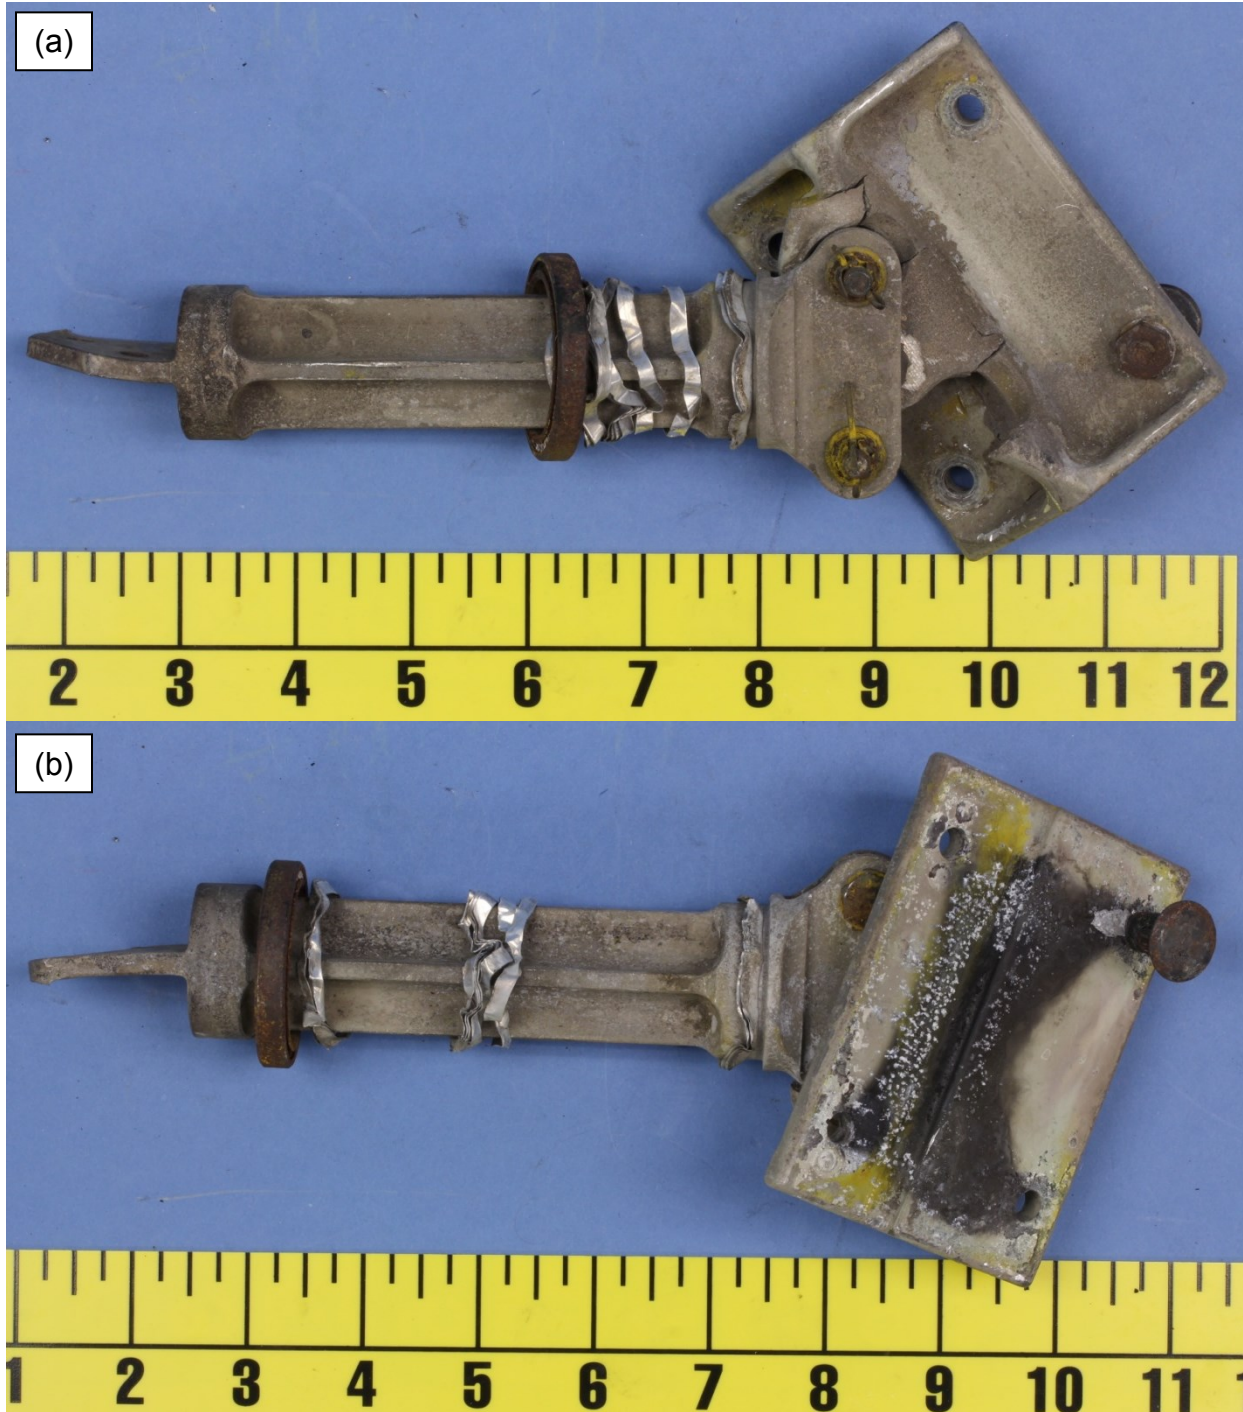
Figure 30 – Torque shaft and support bracket from opposite sides (a) and (b).
