NATIONAL TRANSPORTATION SAFETY BOARD

MATERIALS LABORATORY FACTUAL REPORT

Report No. 01-030

Place : Montello, Nevada
Date : August 3, 2000
Vehicle : Bell 206L, N10864
NTSB No. : LAX00-G-A286
Investigator : Richard Parker

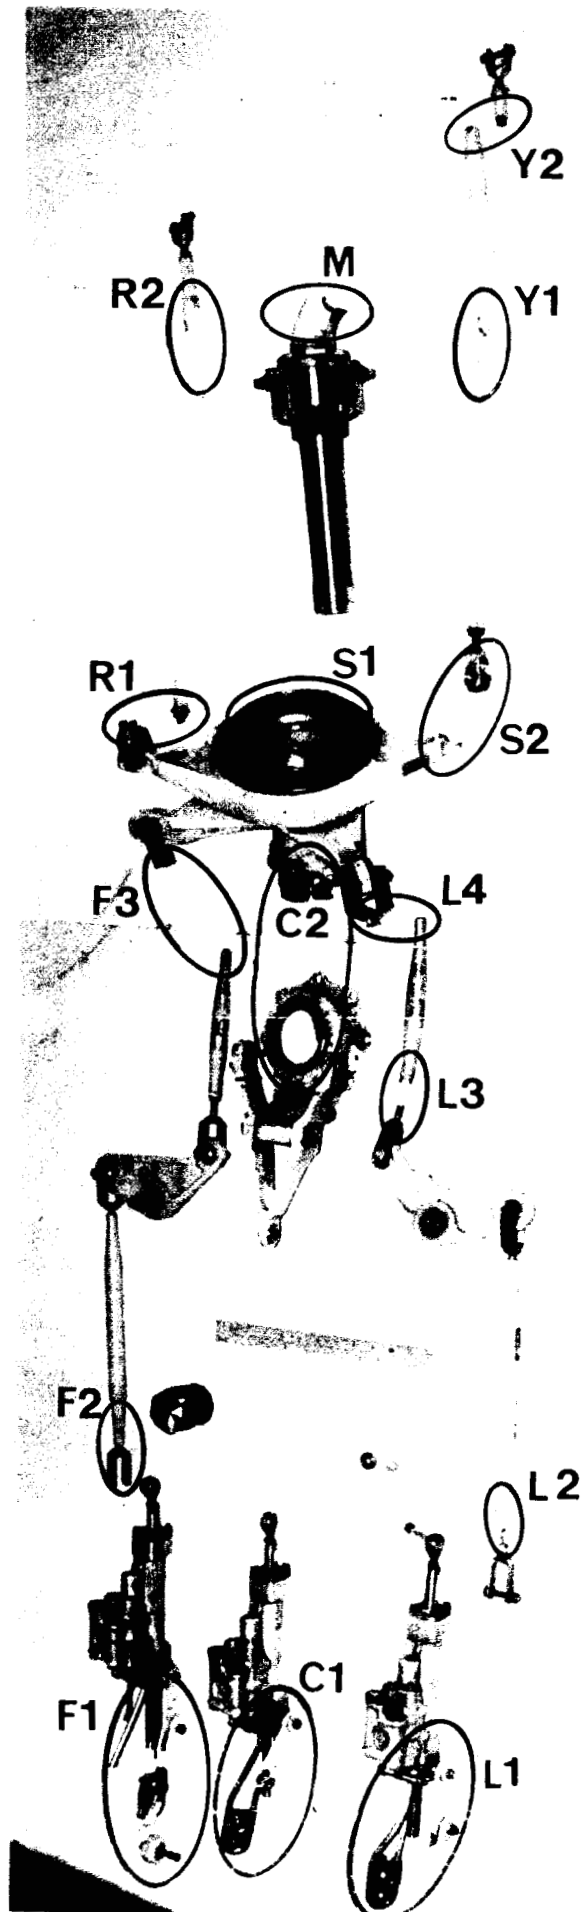
The components received for examination are illustrated in figure 1. Identifications written on the servo's and matching of fracture faces located the supplied components as illustrated.

Fractures in the lateral cyclic system are encircled and identified as "L1" to "L4". Fractures and bending in the fore and aft cyclic system are encircled and identified as "F1" to "F3". Fractures and bends in the collective system are encircled and identified as "C1" and "C2". Damage and a fracture to the swashplate are encircled and identified as "S1" and "S2" respectively. Fracturing of the mast is encircled and identified as "M". Fractures and bends in the pitch link to the main rotor blade, color-coded yellow, are encircled and identified as "Y1" and "Y2". A fracture and a bend in the pitch link to the main rotor blade, color-coded red, are encircled and identified as "R1" and "R2".

Examination of the fractures identified as "L2" and "L3" in figure 1 revealed a mixture of bending and 45 degree shear lips consistent with an overstress separation. At fracture "L4" a cup and cone feature was found, consistent with an overstress separation, and a barely visible deformation was noted on the few threads that were exposed.

Bending of the rod adjacent to the clevis was observed at location "F2" in figure 1. Features observed at "F3" in figure 1 were similar to those at "L4".

Severe bending of the mast portion supplied can be seen identified as "M" in figure 1. The fracture face displayed a 45-degree lip, with a little twisting, consistent with a rotating bending overstress event.

As can be seen in figure 1, the yellow pitch link was subjected to severe bending at the fracture indicated as "Y1". Examination of the fractured tube revealed a 45-degree lip consistent with an overstress separation.

Examination of the pitch link rod fracture identified as "Y2" in figure 1 revealed faces with a shear lip around the complete circumference and with little or no bending deformation consistent with an overstress tensile separation.

The fracture on the red pitch link rod end, identified as "R1" in figure 1, revealed cup and cone features and approximately 20 degrees of bending deformation consistent with an overstress bending separation.

At the location identified as "R2" in figure 1 the red pitch link had been bent approximately 10 degrees starting approximately 9 inches from the center of the clevis attachment hole.

Figure 1. The components received for examination.

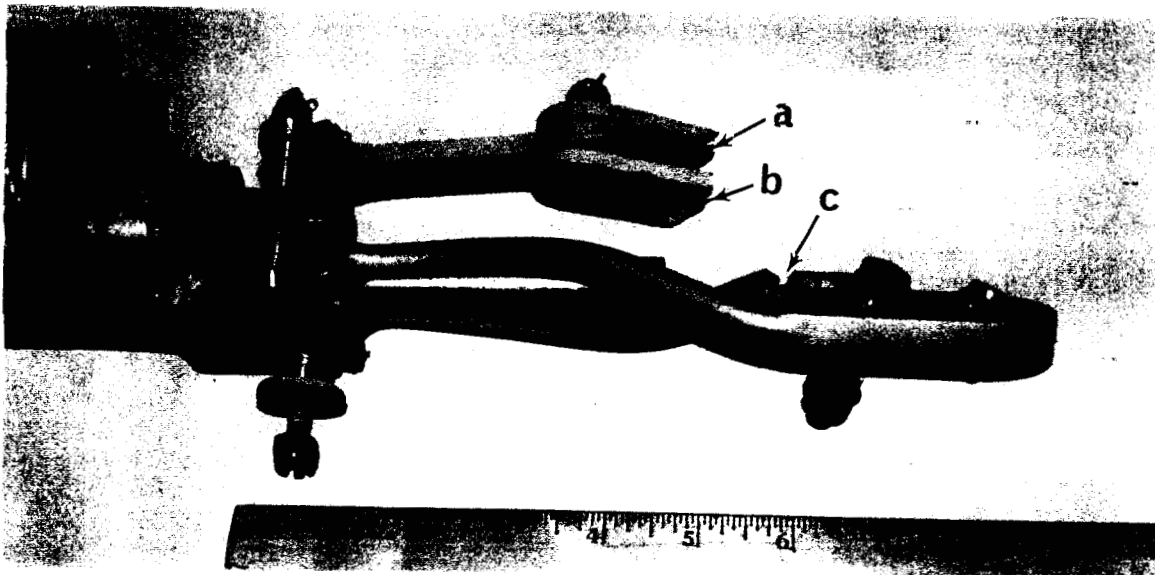
Figure 2 illustrates a portion of the lateral cyclic servo indicated by "L1" in figure 1. The fracture faces arrowed "a" and "b" displayed a bright sparkling appearance with minimal deformation of the adjacent material, typical of an overstress brittle failure. The fracture indicated by arrow "c" displayed a dull fibrous surface and a shear lip, consistent with a ductile overstress separation. Significant bending and twisting was observed in the vicinity of fracture "c".

Figure 2. The portion of the lateral cyclic servo indicated as "L1" in figure 1.

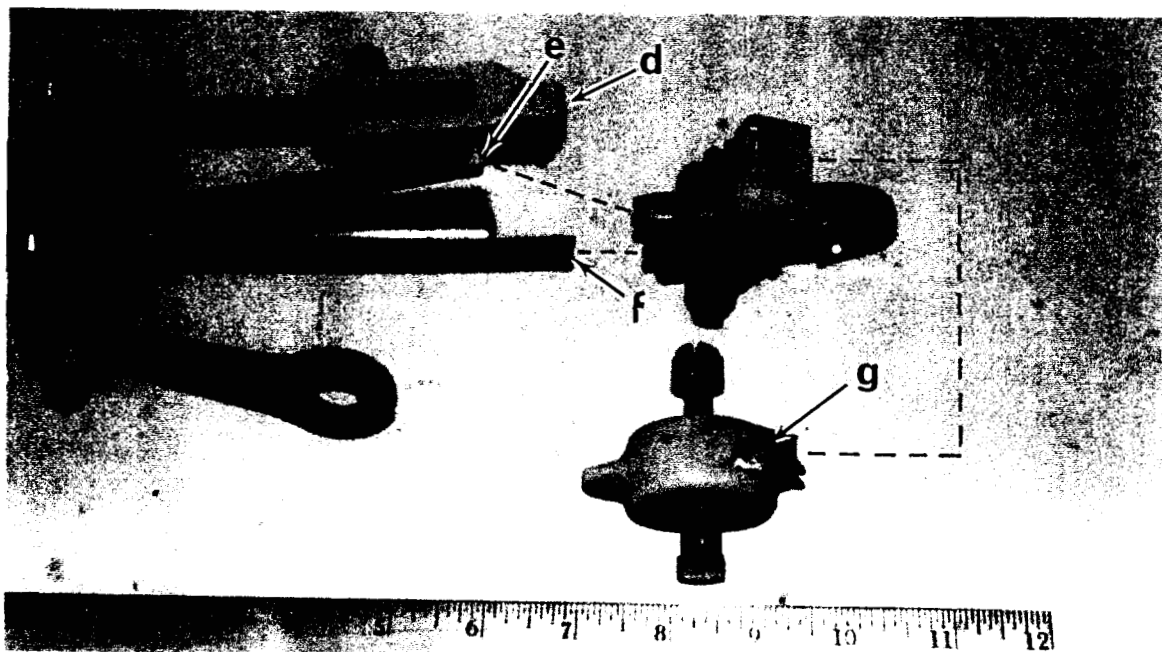
Figure 3 illustrates a portion of the fore and aft cyclic servo indicated by "F1" in figure 1. The dashed lines indicate adjoining fracture faces. The fracture face arrowed "d" displayed the same features as those indicated by arrows "a" and "b" in figure 2, indicative of a brittle overstress fracture. Fracture faces "e" and "f" displayed the same features as the one indicated by arrow "c" in figure 2, indicative of ductile overstress separations.

Figure 3. The portion of the fore and aft cyclic servo indicated as "F1" in figure 1.

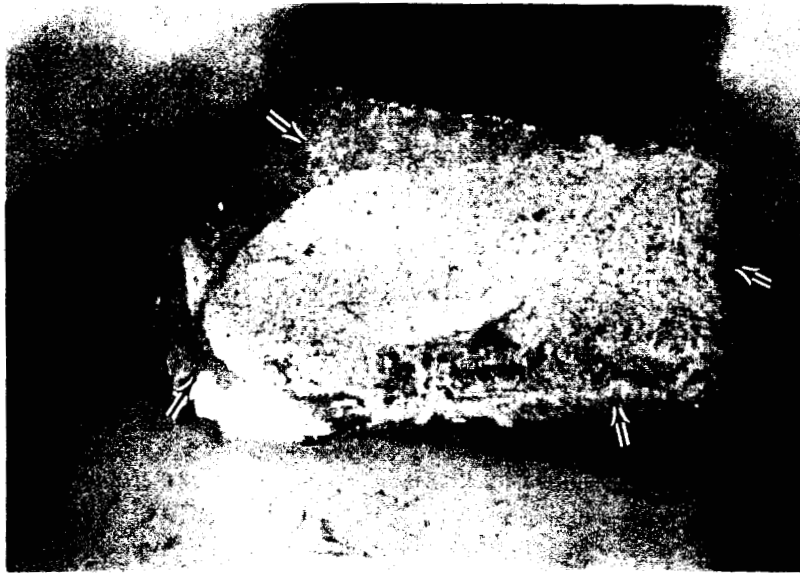
The fracture face indicated by arrow "g" in figure 3 is illustrated in figure 4. The small white arrows on the fracture face indicate radial lines emanating from the fracture origin. The black on white arrows indicates shear lips. This fracture was typical of a ductile overstress fracture emanating from one side of the component.

Figure 4. The fracture face indicated by arrow "g" in figure 3. (3.7X)

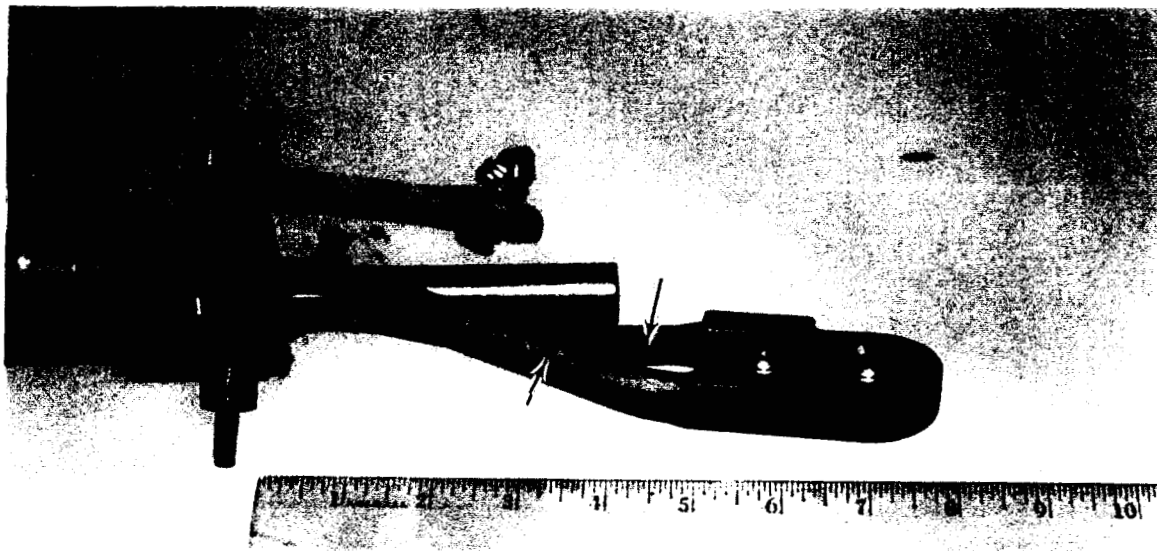
Figure 5 illustrates a portion of the collective servo indicated by "C1" in figure 1. The sections indicated by the unmarked arrows had been bent and twisted, similar to those of servo "L1" illustrated in figure 2, but had not fractured.

Figure 5. The portion of the collective servo indicated as "C1" in figure 1.

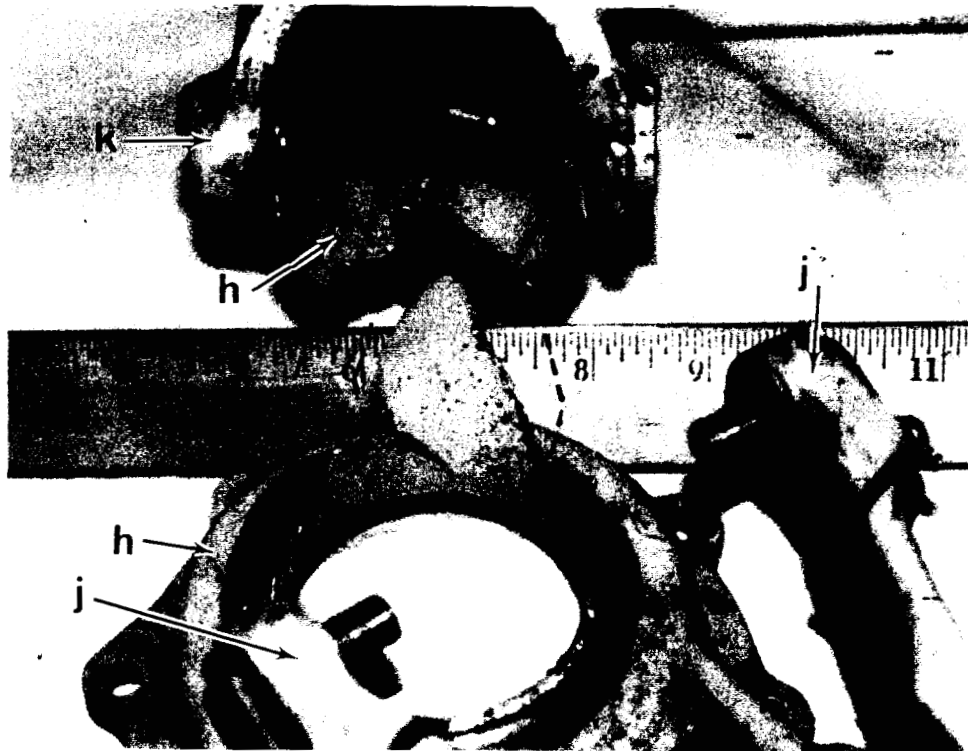
The fracture at the collective lever and support assembly, encircled and identified as "C2" in figure 1, is illustrated in figure 6. The dashed lines indicate matching fracture locations on the support assembly, arrowed "h". The collective lever is arrowed "j" and the lower end of the swashplate pivot sleeve is arrowed "k". All of the fracture faces on the support assembly displayed 45-degree shear lips and mechanical deformation consistent with bending overstress fractures.

Figure 6. The fracture at the collective lever and support assembly identified as "C2" in figure 1.

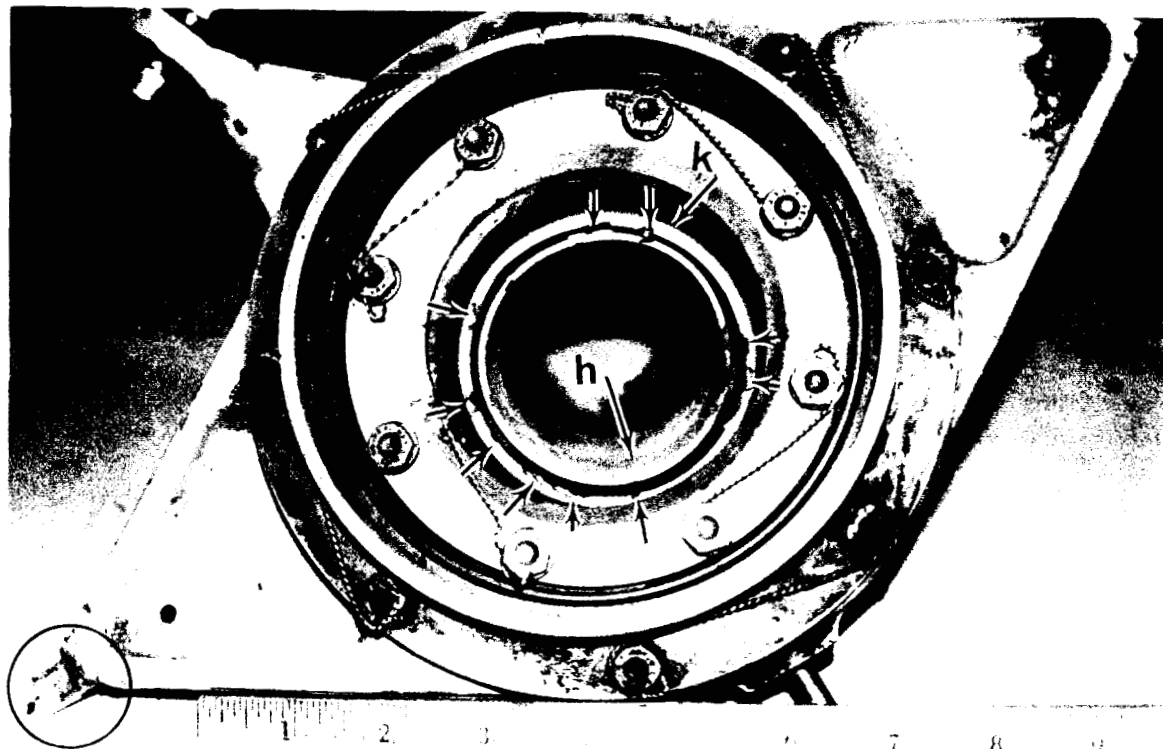
Figure 7 illustrates the upper surface of the swashplate. Arrow "h" indicates the upper end of the support assembly and arrow "k" indicates the upper end of the pivot sleeve. The unmarked arrows indicate mechanical damage to the upper ends of the support assembly and the pivot sleeve. The unmarked circle in the lower left corner of figure 7 indicates the swashplate portion of the fracture identified as "S2" in figure 1.

Figure 7. The upper surface of the swashplate identified as "S1" in figure 1.

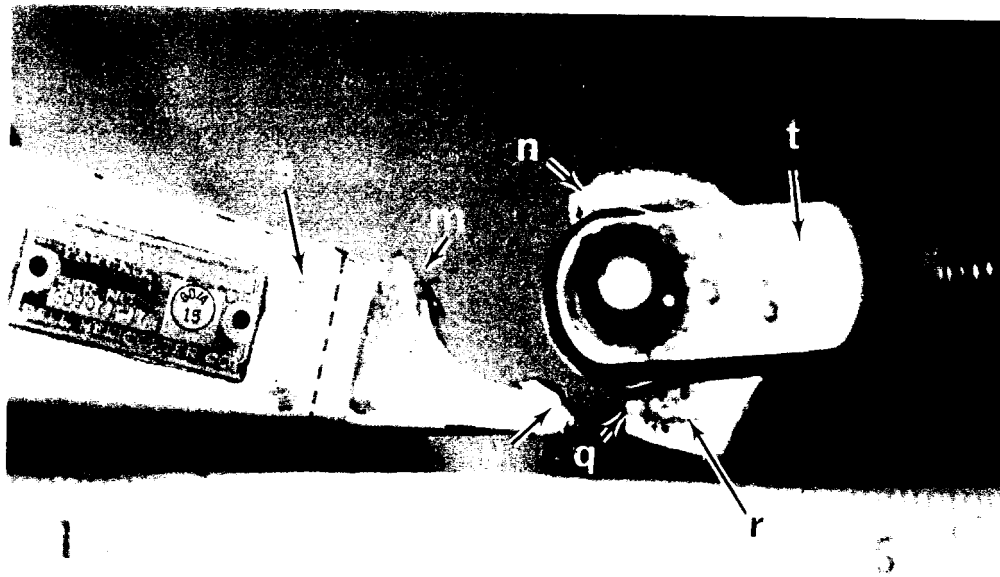
The fracture identified as "S2" in figure 1 is illustrated in figure 8. Individual fracture faces are arrowed "m", "n", "p" and "q" and the black dashed lines indicate matching fracture faces. Arrow "r" indicates a crack appearing to emanate from fracture face "q". The swashplate arm is indicated by arrow "s" and the clevis end of the yellow pitch link is indicated by arrow "t". The red dashed line on the swashplate arm indicates where the fractured portion was removed for ultrasonic cleaning in acetone for further examination.

Figure 8. The fracture at the connection of the yellow pitch link to the swashplate identified as "S2" in figure 1.

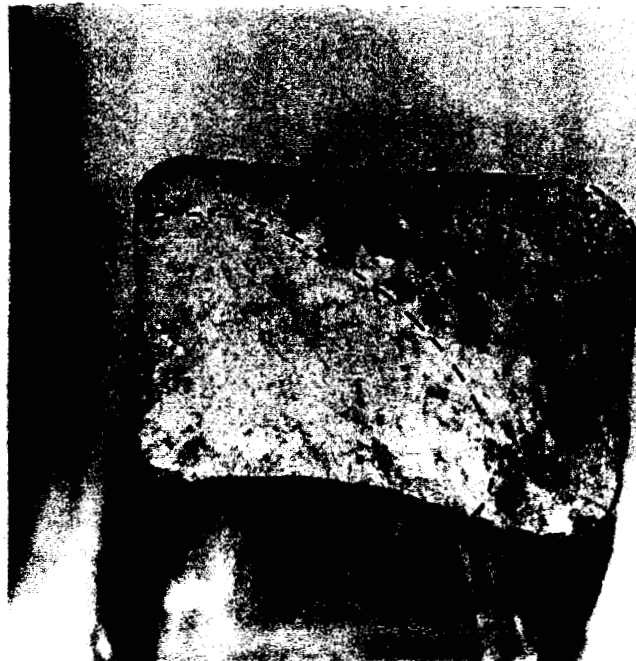
The fracture face arrowed "n" in figures 8 and 9 is illustrated in figure 11. SEM examination revealed ductile dimples over all portions of the fracture, including isolated pockets within the damaged area enclosed by the dashed line.

Figure 11. The fracture face arrowed "n" in figures 8 and 9. (5X)
