NATIONAL TRANSPORTATION SAFETY BOARD

FIRE TESTING FACTUAL REPORT

Report No.08-136

Place : San Francisco, California
Date : 6/28/2008
Vehicle : Boeing 767-200 Freighter
NTSB No. : DCA08MA076
Investigator : Lorenda Ward

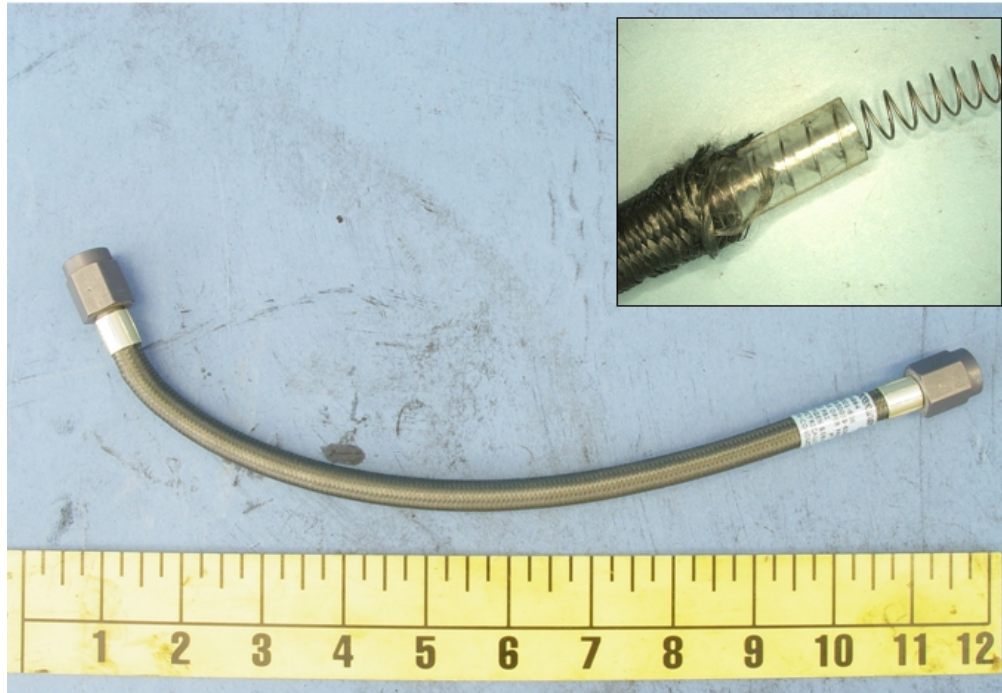
Figure 1: Exemplar flexible hose assembly. Inset shows flexible hose assembly construction.

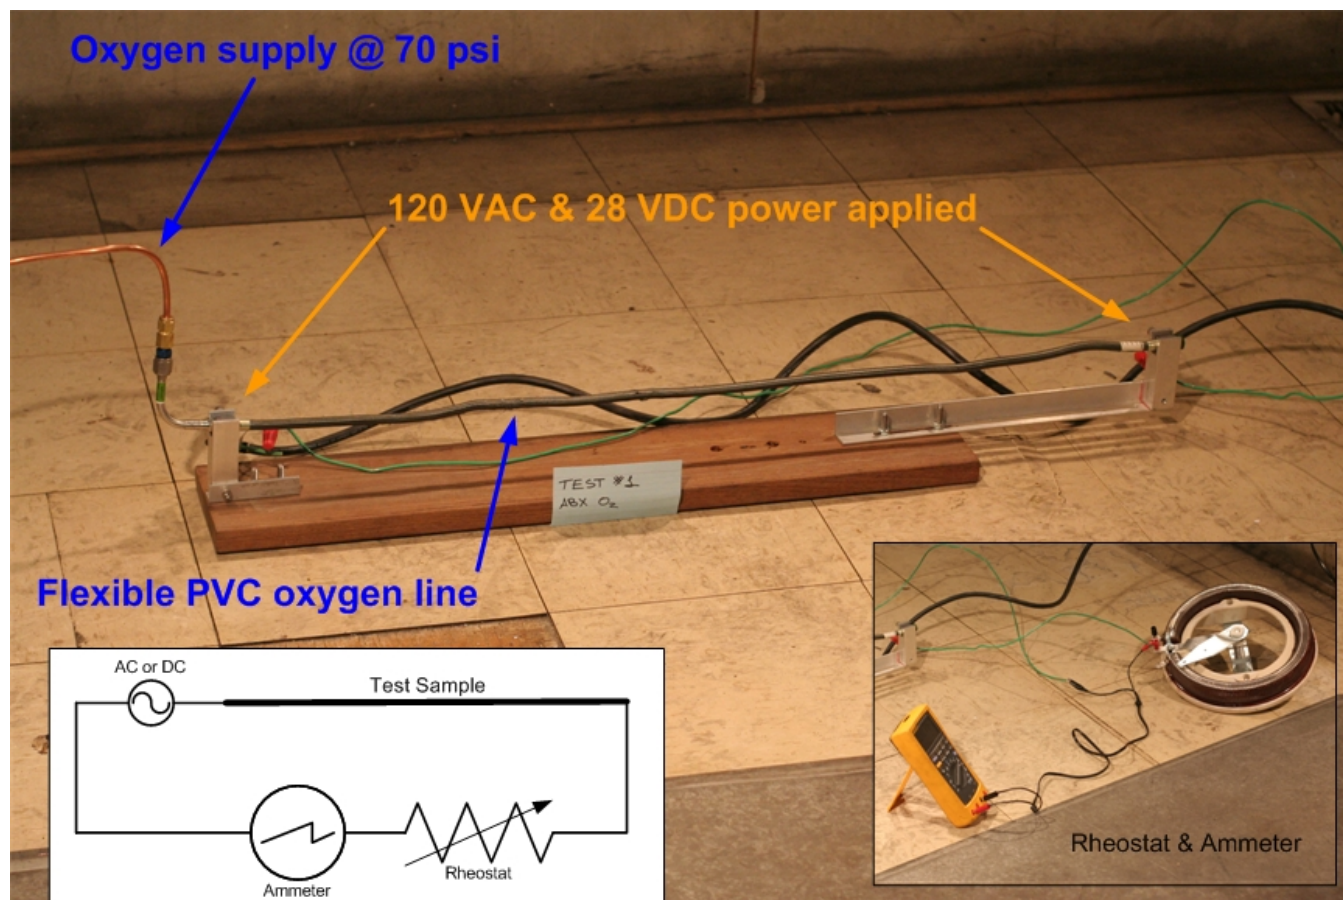
Figure 2: Fixture and setup used in the tests. Inset shows rheostat and ammeter used to control and monitor the applied current.

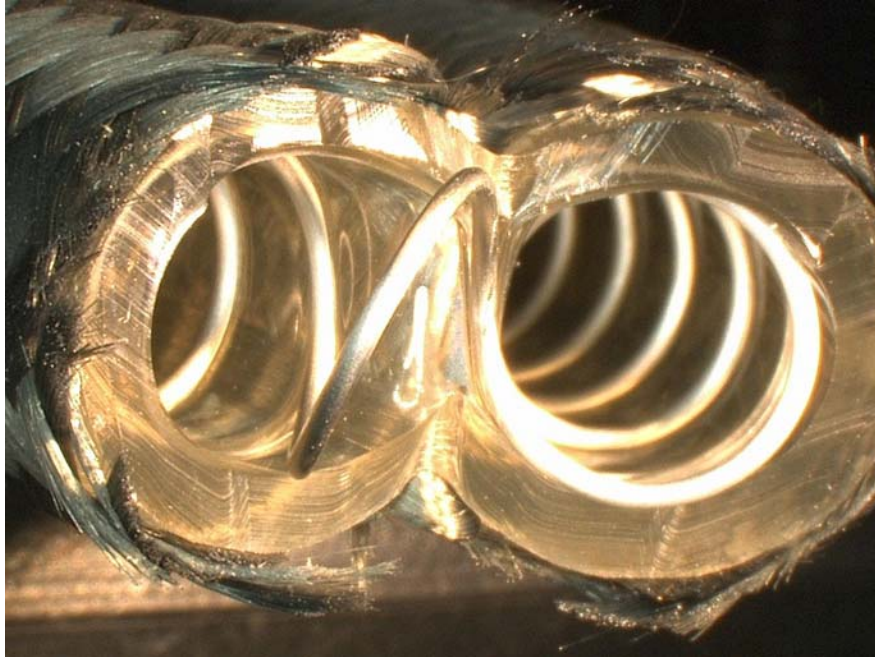
In Test #1, the conductive flexible hose assembly was exposed to 120 Volts AC and a current of 2.3 Amperes. From the time of current application, it took 120 s for the hose to fail with a mid span rupture of the PVC tube in the hose assembly causing a loud hissing sound. The electrical current continued flowing after the hose failed until the test was terminated. No fire resulted. Immediately after the test was concluded, the hose was found to be warm and very pliable. After testing, a transverse cross sectional cut of the hose revealed that the inner hose surfaces were not damaged or noticeably discolored (figure 3).

Figure 3: Interior of flexible hose after Test #1

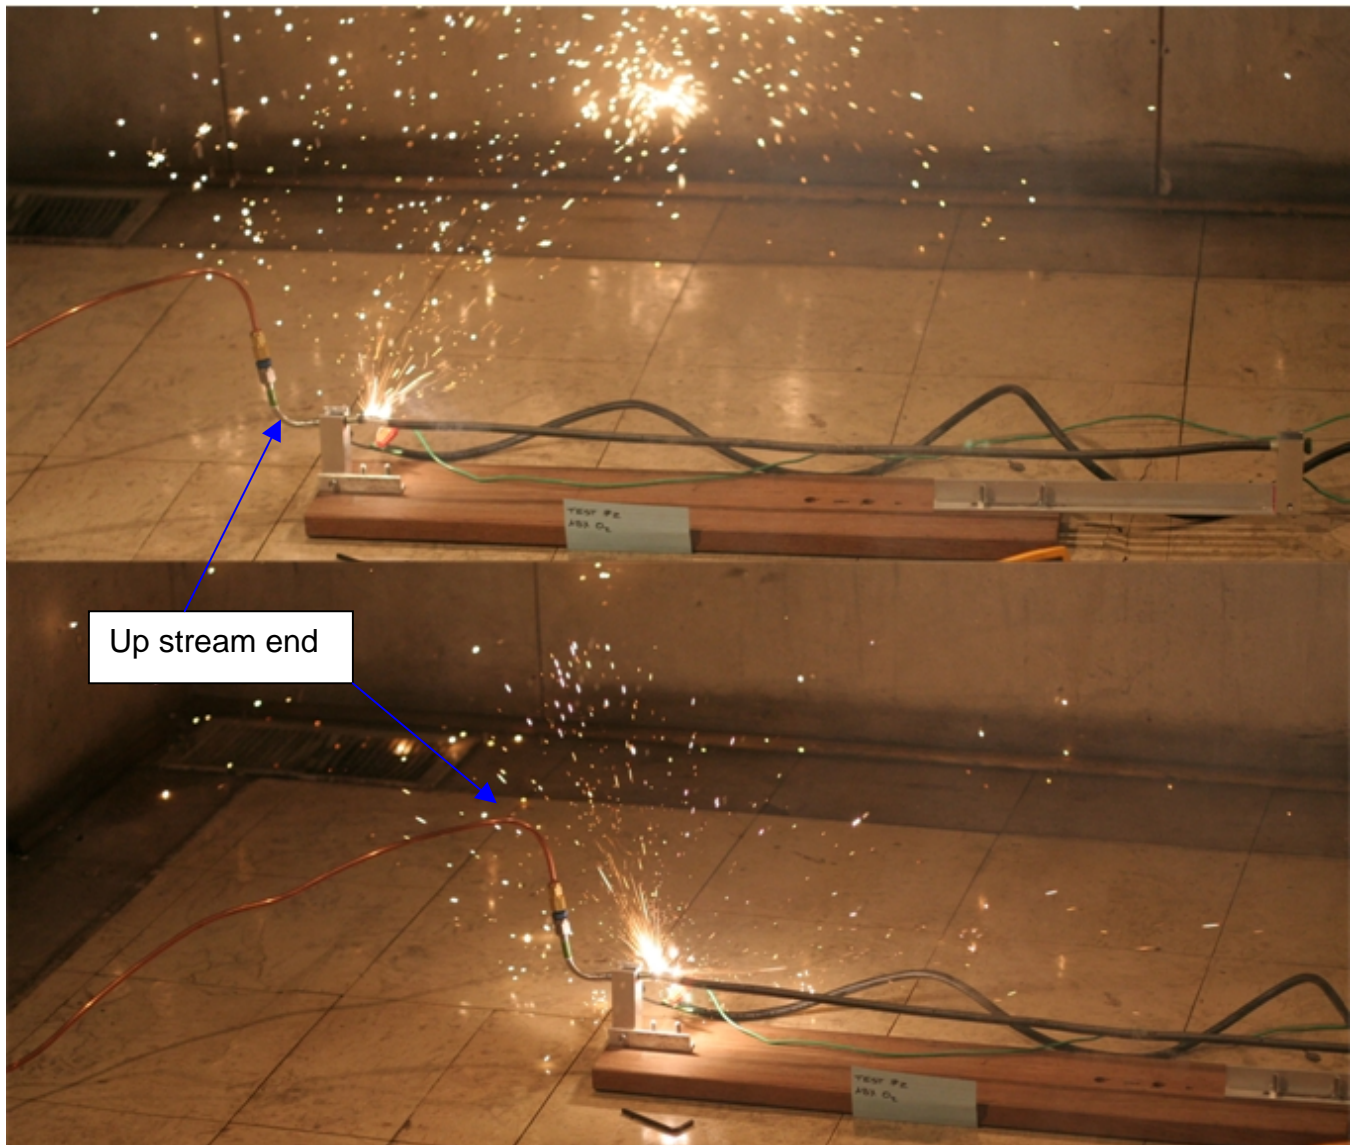
In Test #2, the conductive flexible hose assembly was exposed to 120 Volts AC and a current of 3 Amperes. From the time of current application, a slight hissing sound occurred after 60 s. At approximately 80 s, a light white smoke was observed rising from the entire length of the hose. At approximately 90 s, the hose failed at the upstream end with a loud bang/pop, ejection of incandescent particles, a short duration fire, and a loud hissing sound (figure 4). The fire self-extinguished once the hose was severed at the upstream aluminum fitting. After the test, examination of the hose remains revealed the presence of small beads of resolidified plastic material which adhered to the over-braid component of the hose assembly. The source of the material for the plastic beads appears to have been the PVC tube inside the over braid. A transverse cross-sectional cut was made in the hose, revealing that the inside surfaces of the hose had charred and intumesced creating a sponge-like material (figure 5).

Figure 4: Two photos at the time of ignition in Test #2.

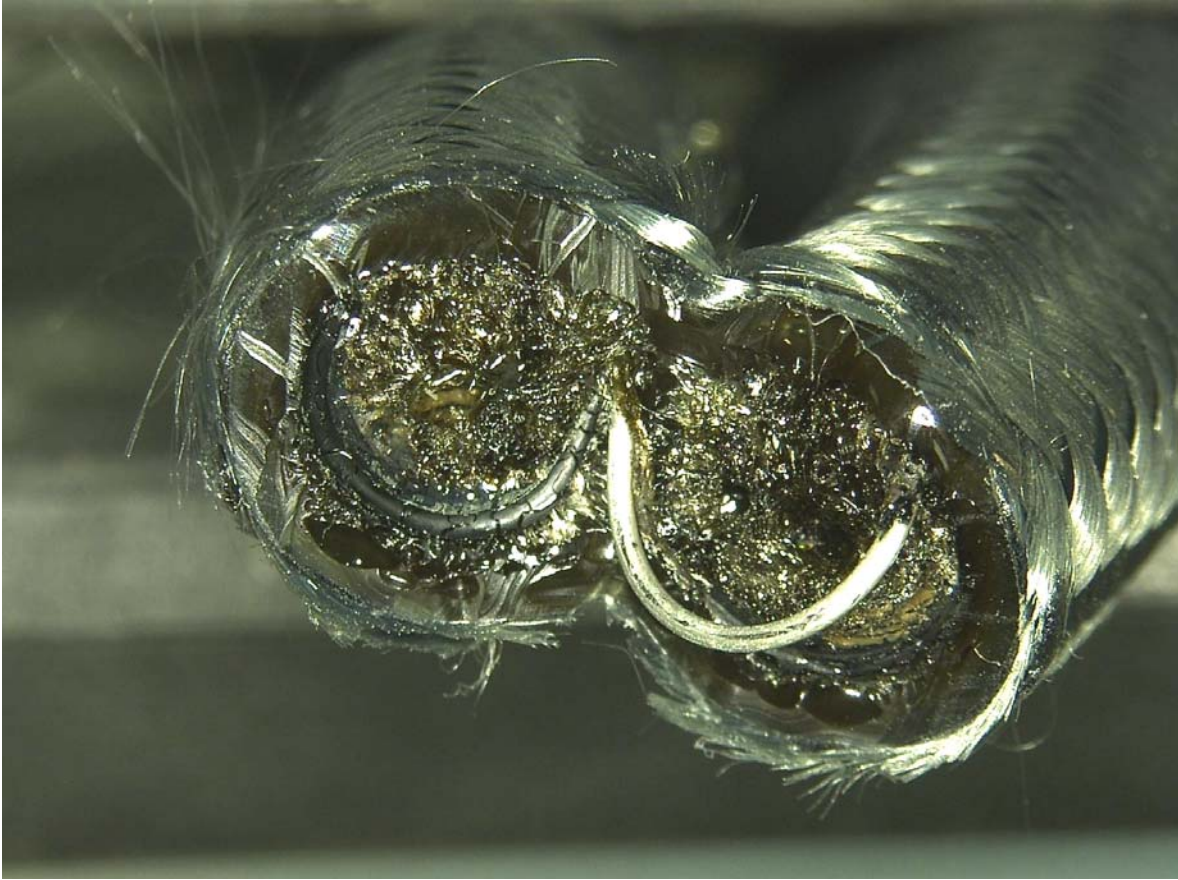
Figure 5: Sponge like material on inside of flexible hose after Test #2

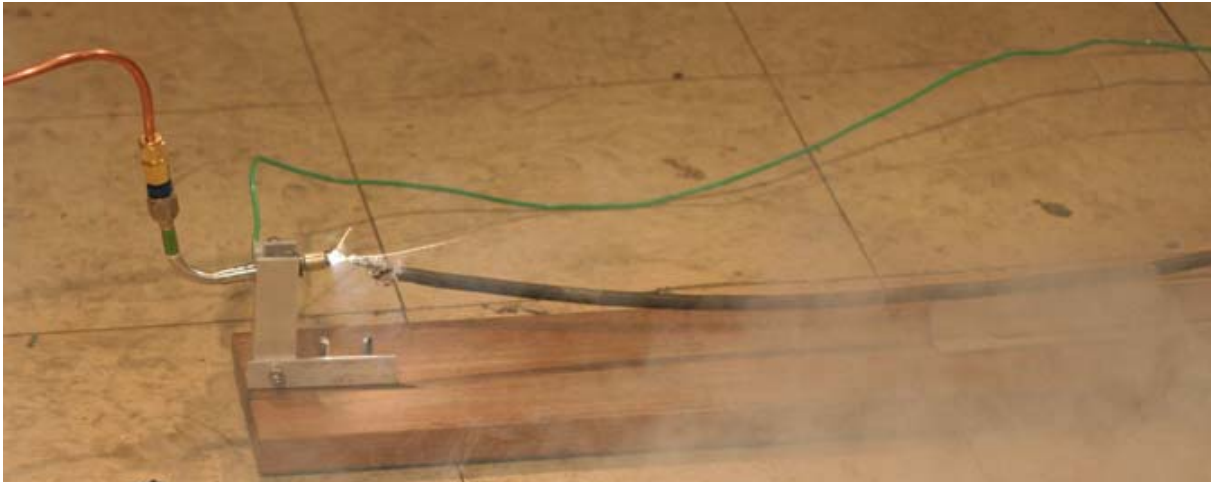
In Test #3, the conductive flexible hose assembly was exposed to 120 Volts AC and a current of 4.7 Amperes. From the time of current application, it took 11 s before a white flash was observed and an explosion with a sharp crack was heard that seemed to originate from the inside of the hose assembly. After 19 s, a hissing sound was heard followed immediately by an explosive bursting of the hose with a loud bang and the ejection of incandescent particles. A fire at the upstream end of the hose assembly followed (figure 6). The fire self-extinguished once the hose was severed at the upstream aluminum fitting. After the test, a transverse cross-sectional cut was made in the hose revealing a thick coating of soot adhering to the inner surfaces of the hose (figure 7).

Figure 6: Hose failure during Test #3.

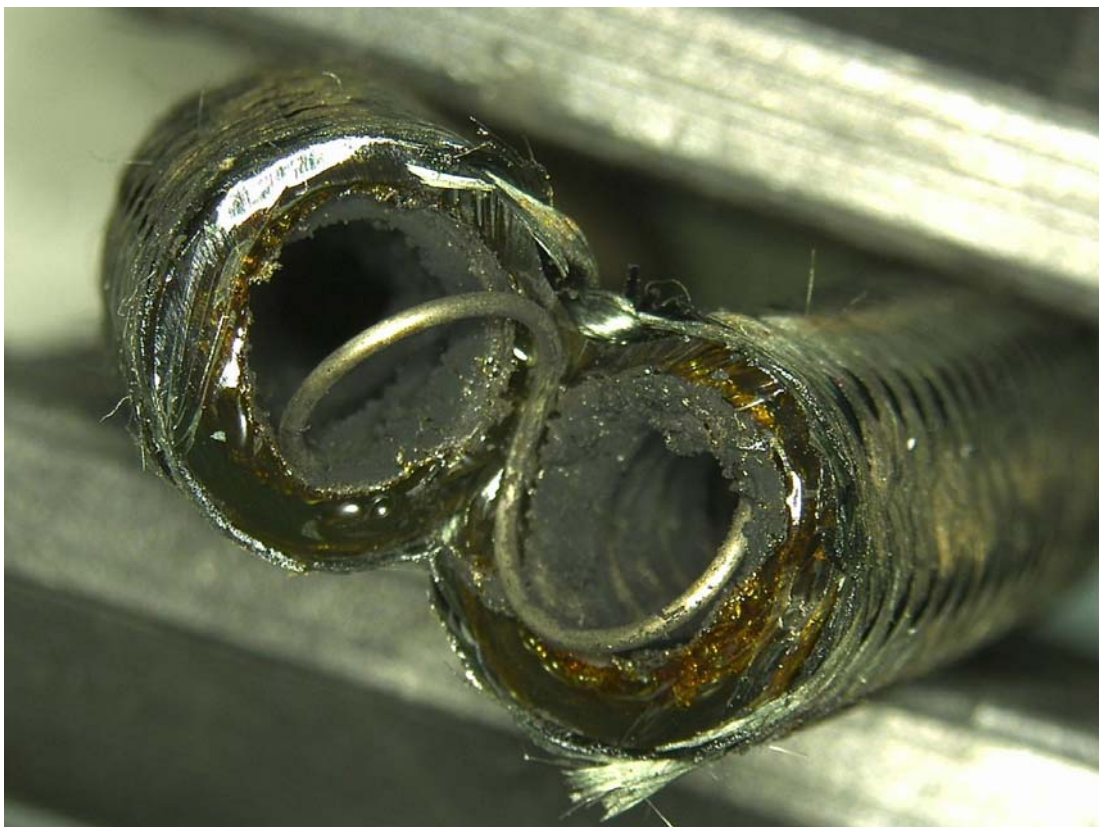
Figure 7: Soot coating the inner surface of the hose from Test #3

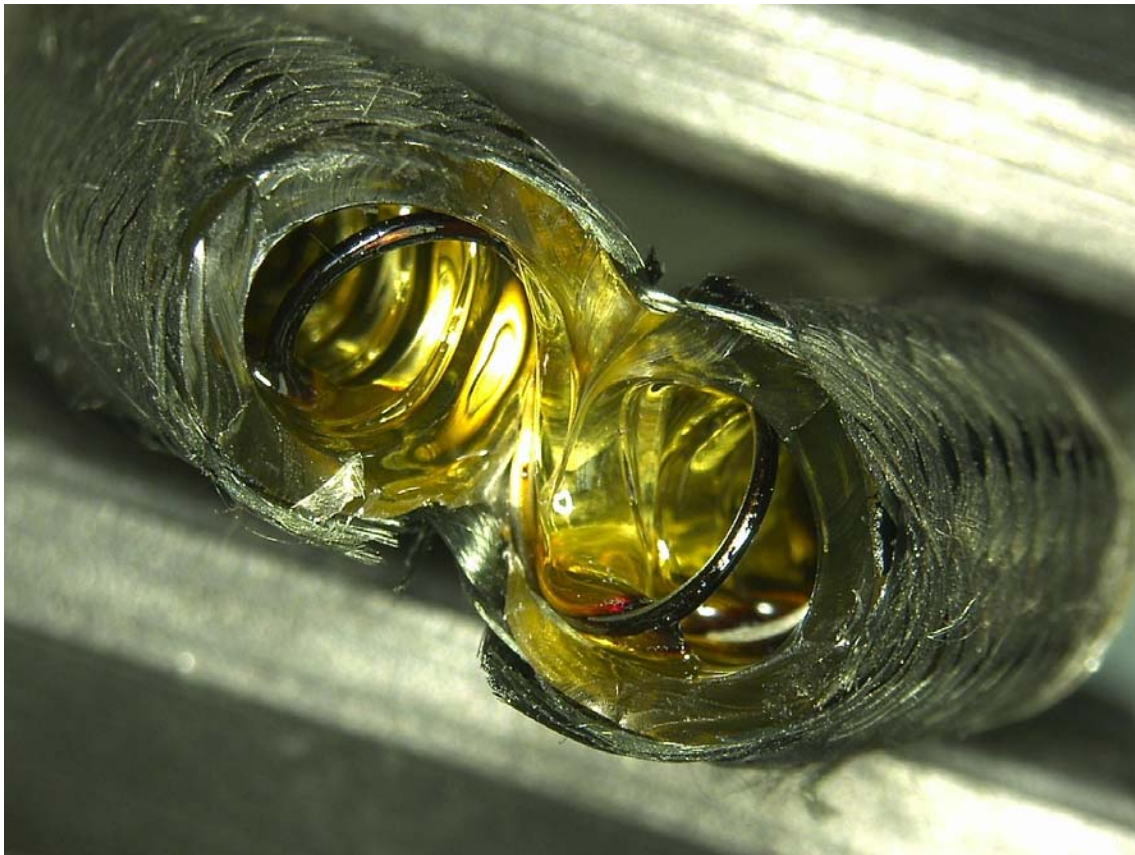
In Test #4, the conductive flexible hose assembly was exposed to 28 Volts DC and a current of 3 Amperes. From the time of current application, it took 80 s for the hose to fail causing a light hissing sound. This hissing sound gradually grew in volume over a 60 s duration. No fire resulted. Immediately after the test, the hose was found to be hot and pliable. After the test, a transverse cross-sectional cut was made in the hose revealing that the inside of the hose had become yellow/amber in color but no char or soot-like material had developed (figure 8).

Figure 8: Inside surface of hose after Test #4

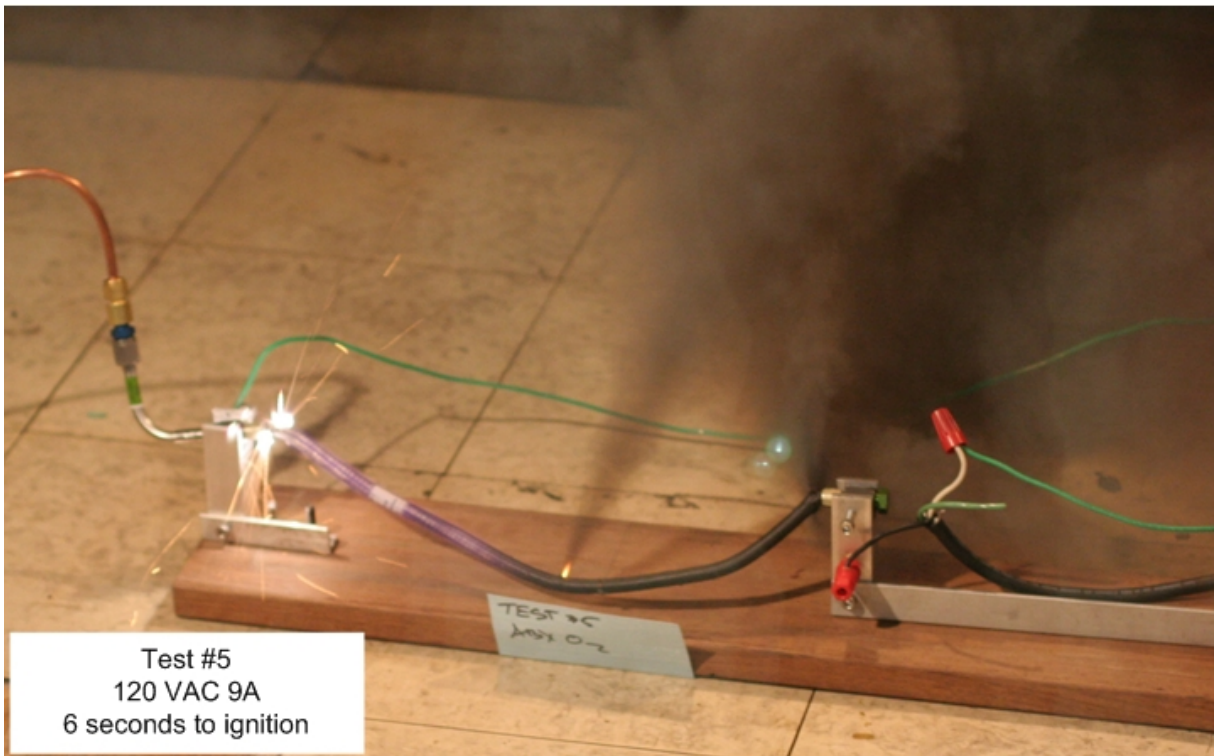
In Test #5, the conductive flexible hose assembly was exposed to 120 Volts AC and a current of 9 Amperes. After 4 s, a flash resembling an electrical arc was observed from the upstream end of the hose extending to approximately mid span of the hose. The hose also began to contort. After 6 s, the hose ignited (figure 8) with a loud pop and hissing sound. The hose failed nearly simultaneously at the downstream end, the upstream end, and at approximately mid-span. At the downstream end, the hose burst with a white flash and ejected

a jet of thick black smoke followed by bursting and flaming ignition. A small jet of fire and black smoke emanated from a failure point at the mid-span location, and flaming ignition with the ejection of incandescent particles took place at the up stream end. From the upstream end, a bright white glow extended to about mid-span for about a second after the failure. This portion of the hose that was glowing white is seen in figure 9 as a purple region. This region eventually changed to white as the reaction ensued.

Figure 9: Hose failure during Test #5.

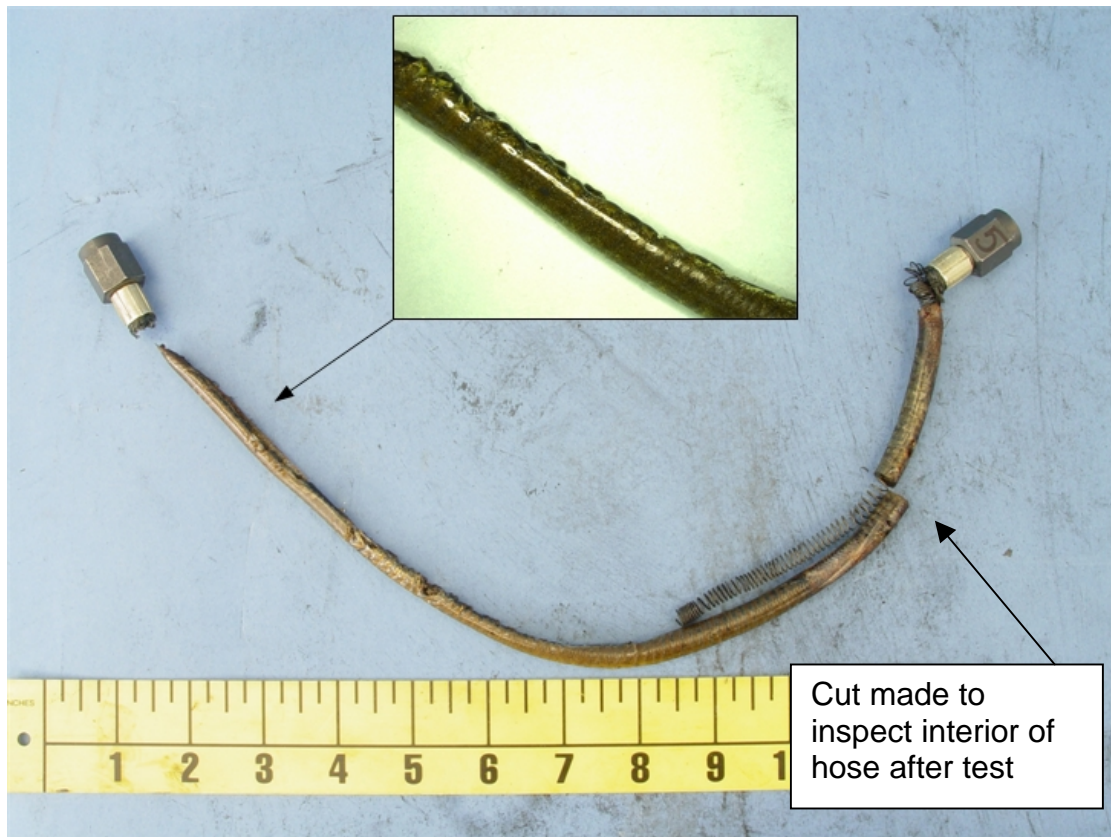
Examination of the hose remains after the test revealed that the hose had been heavily consumed from the upstream end to the mid span location (figure 10). What remained along this section of the hose was a c-shaped channel as seen in the inset of figure 10. From the upstream fitting to approximately the mid-span location, the helical coil that would have been on the inside of the hose was missing. A longitudinal cross sectional cut was made on the remaining down stream portion of the hose and the interior of the hose was found to have a heavy coating of soot adhering to the surface (figure 11).

Figure 10: Hose assembly after Test #5 (over braid removed for clarity)

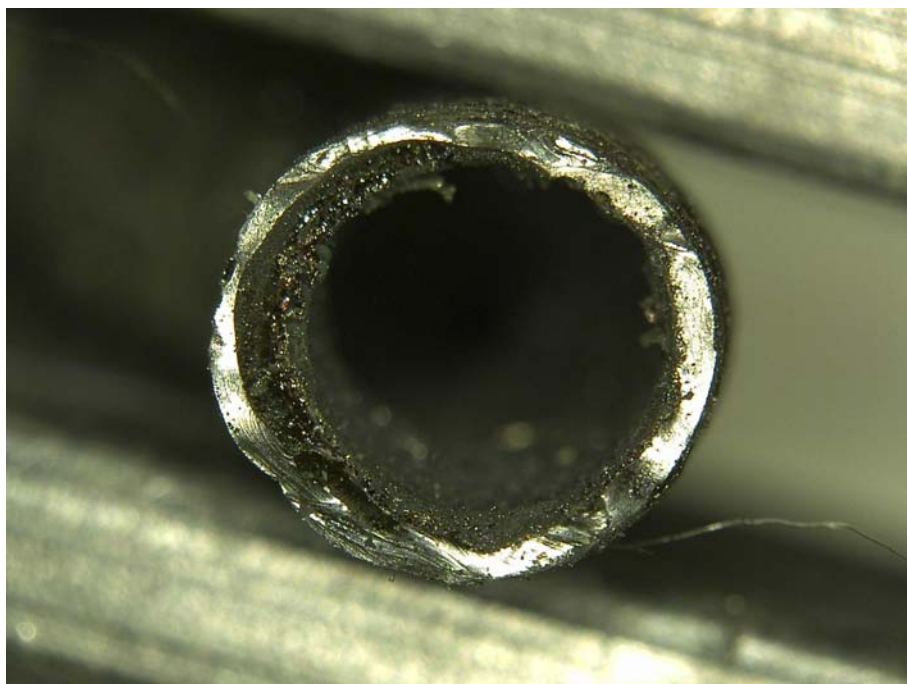
Figure 11: Inside of hose after Test #5 (cut made near down stream end)

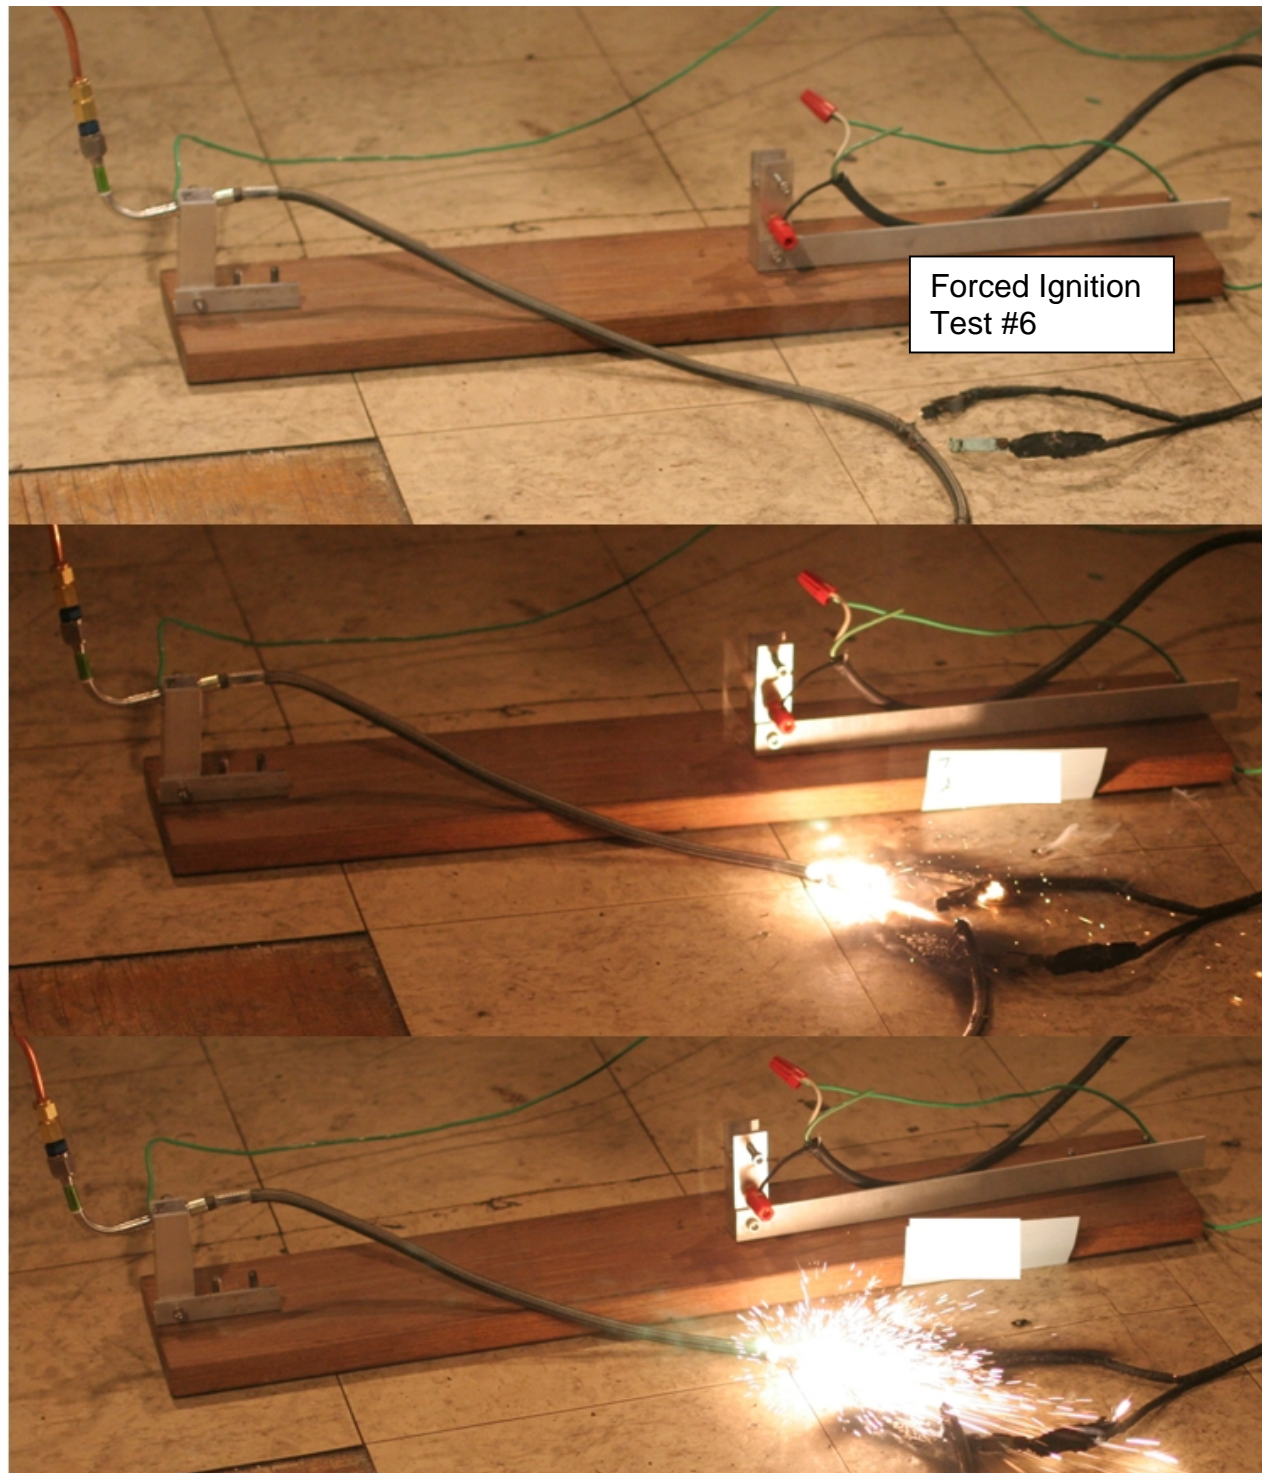
Figure 13: Burning oxygen hose resulting from forced ignition

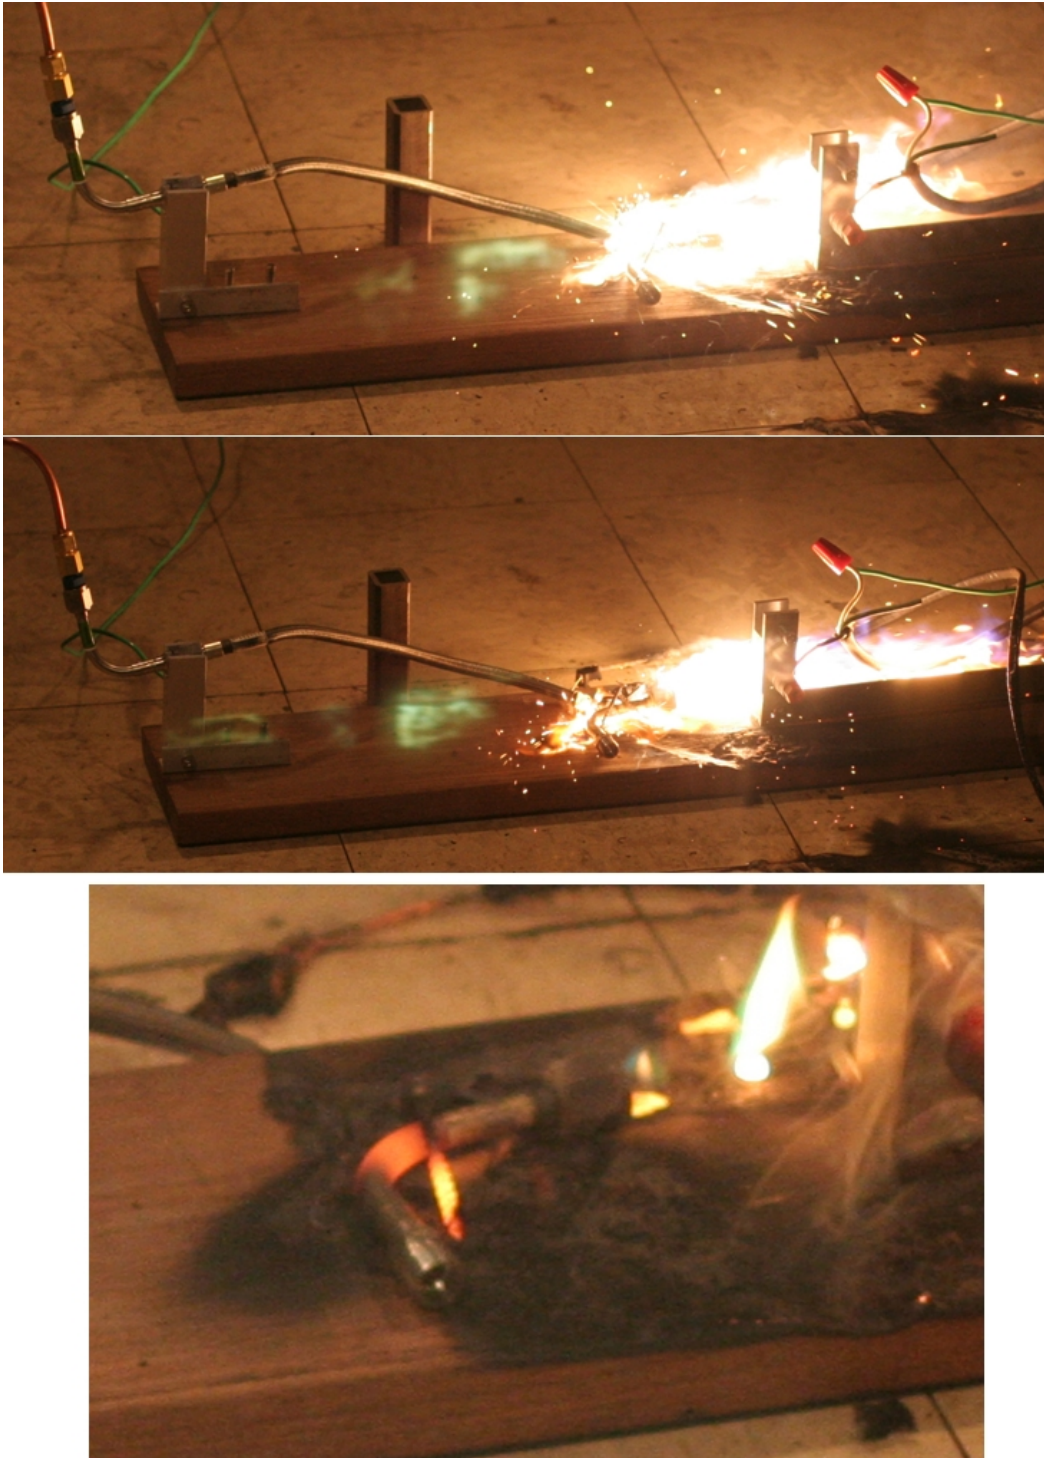
A forced ignition test was conducted where the burning end of the flexible oxygen hose was aligned so that the resulting fire impinged on a 90-degree elbow made from stainless steel tube (figure 14) (same type of tube used on the aircraft oxygen system). The test was stopped once the flexible hose deflected far away from the elbow. Upon termination of the test, the elbow was glowing but had not melted. The heat-affected zone on the elbow was quite narrow as seen in figure 14, indicating that the burning hose produces a concentrated and directional heat output.

Figure 14: Forced flexible oxygen hose fire impinging on stainless steel tube
